# Wood Destroying Pests and Organisms Inspection Report

| Building No.<br><b>2963 23rd St</b> | Street | City<br><b>San Francisco</b> | Zip<br><b>94110</b> | Date of Inspection<br><b>7/28/2026</b> | Number of Pages<br><b>6</b> |

| General Description:<br><b>3 story single family residence with attached garage.</b> | Inspection Tag Posted:<br><b>Garage</b> |

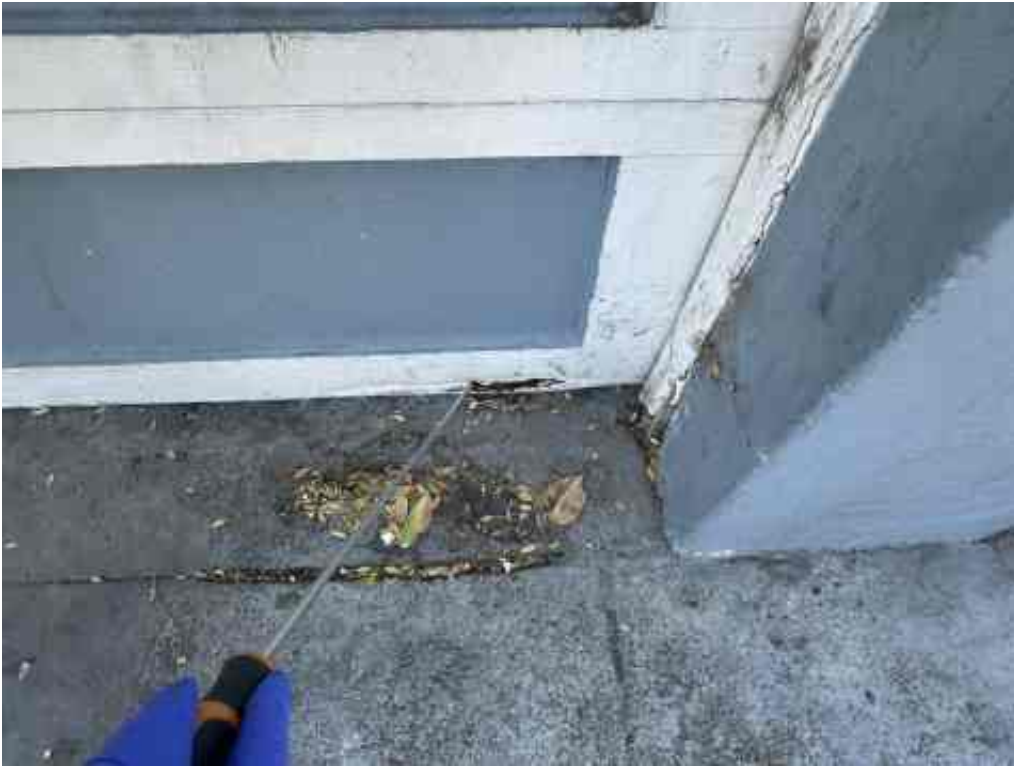
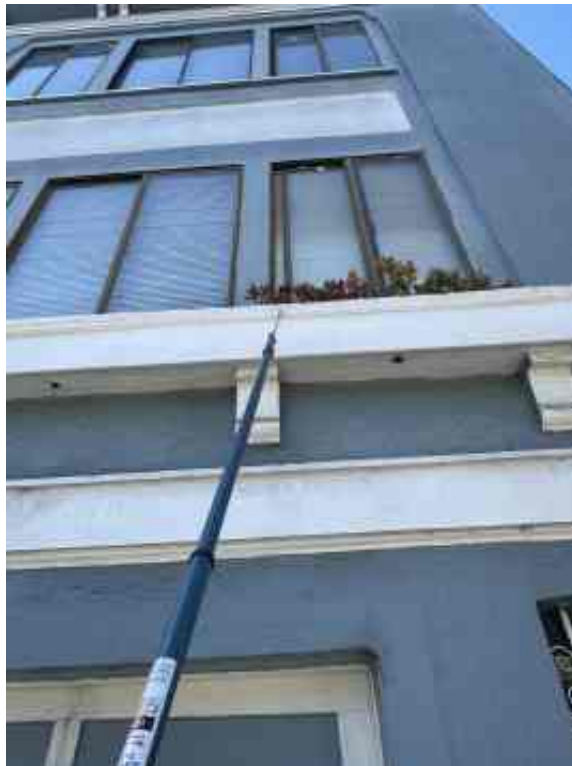
3A FINDING: Evidence of fungus infestation and wood rot noted at garage door and planter at front of property. (Section 1)  
RECOMMENDATION: Owner to contact related trade for necessary repair and/or replacement. (Owner Responsibility)

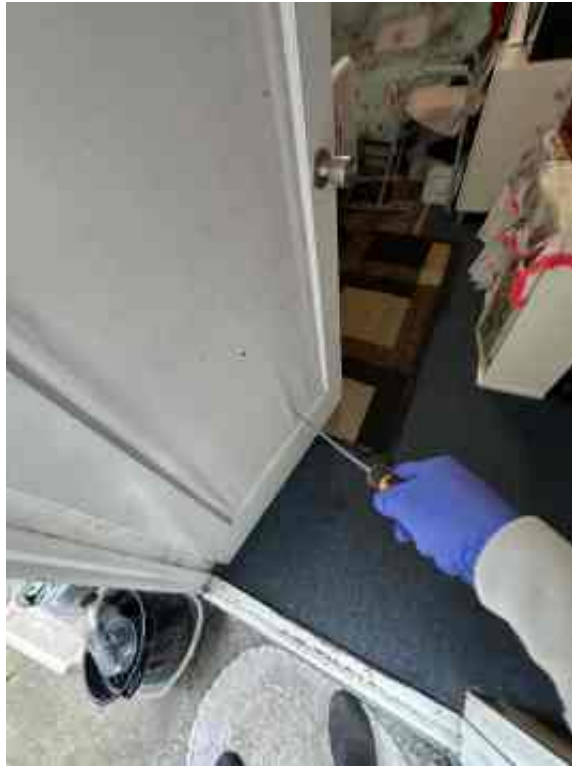
3B FINDING: Evidence of fungus infestation and wood rot noted at the door for bonus room at left side of the property as indicated in the diagram. (Section 1)  
RECOMMENDATION: Remove and replace damaged door with similar grade, paint to match as closely as practicable. - \$1,254.00

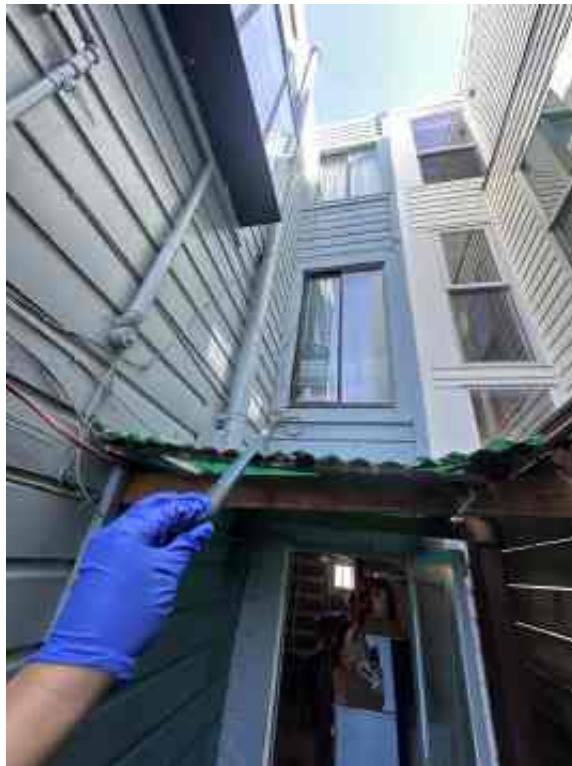
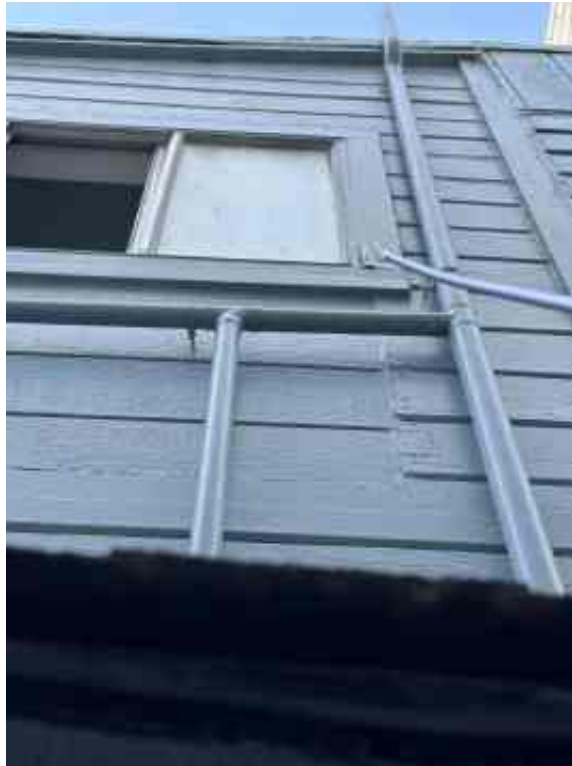
3C FINDING: Evidence of fungus infestation and wood rot noted at trims at left of property as indicated in the diagram. (Section 1)  
RECOMMENDATION: Remove and replace damaged trims with exterior material and paint to match as closely as practicable. In the event that additional damage is uncovered after removal of the damage wood member(s) or extended into wood structure, a supplemental report will be issued for further correction. - \$1,968.00

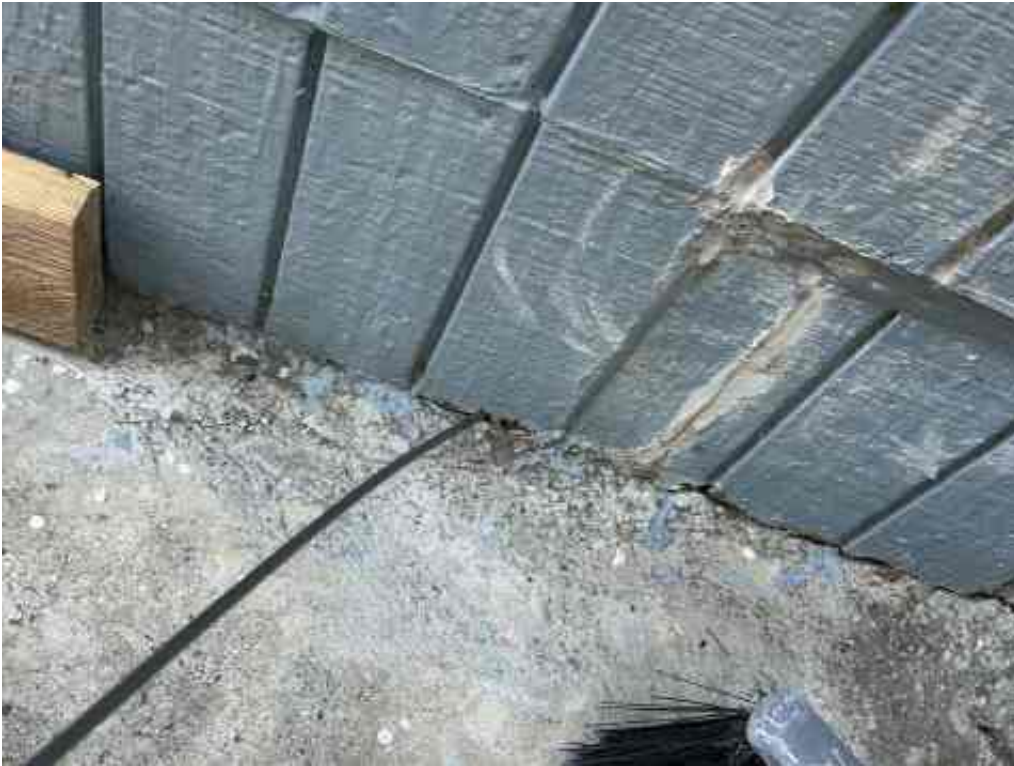
3D FINDING: Evidence of fungus infestation and wood rot noted at siding at left of property as indicated in the diagram.

(Section 1)

RECOMMENDATION: Trim off damaged siding and fill void with mortar. In the event that additional damage is uncovered after trim off the damage wood member(s) or extended into wood structure, a supplemental report will be issued for further correction. - \$579.00

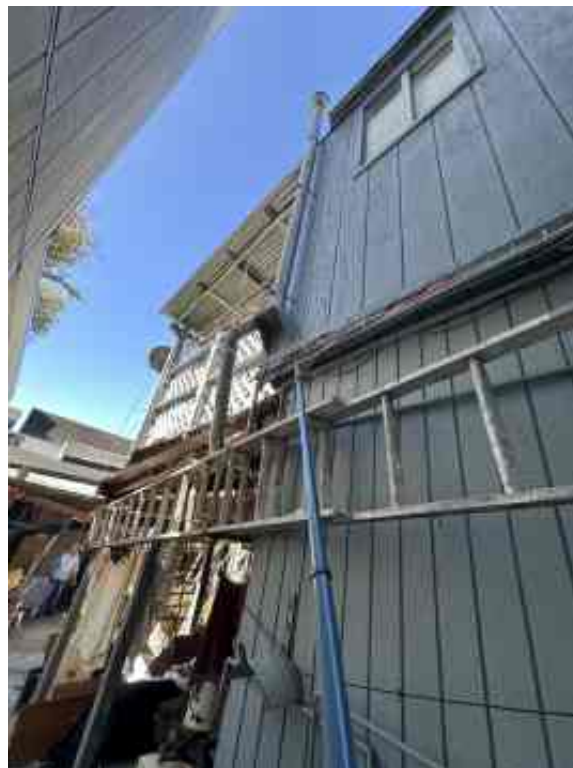
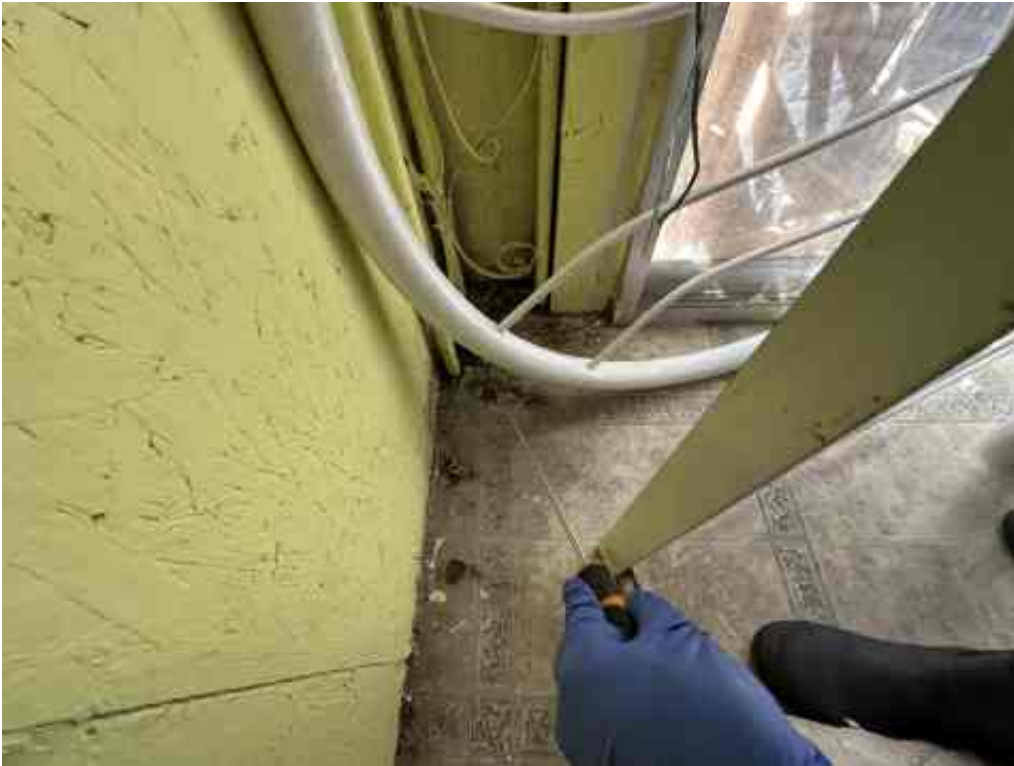
3E FINDING: Evidence of fungus infestation and wood rot noted at subfloor/soffit at left side of the property and in the sunroom as indicated in the diagram. (Section 1)

RECOMMENDATION: The full extent of the concealed damage could not be determined at the time of inspection. Due to the extents of damages, owner is recommended to contact related trade for repairs/corrections. (Owner Responsibility)

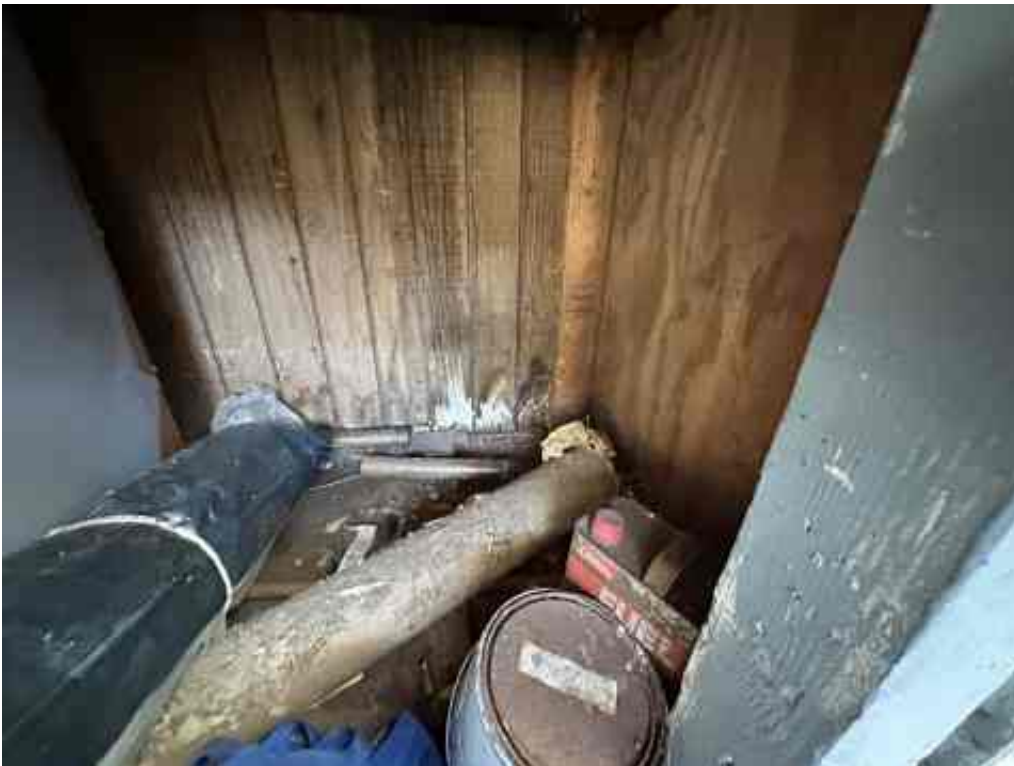
3F FINDING: Evidence of water intrusion and surface fungus noted at siding under sunroom/rear deck as indicated in the diagram. (Section 1)

RECOMMENDATION: Wire brush infected areas and local treatment with TIM-BOR. In the event that additional damage is uncovered after wire brushing infected areas, a supplemental report will be issued for further correction. - \$518.00

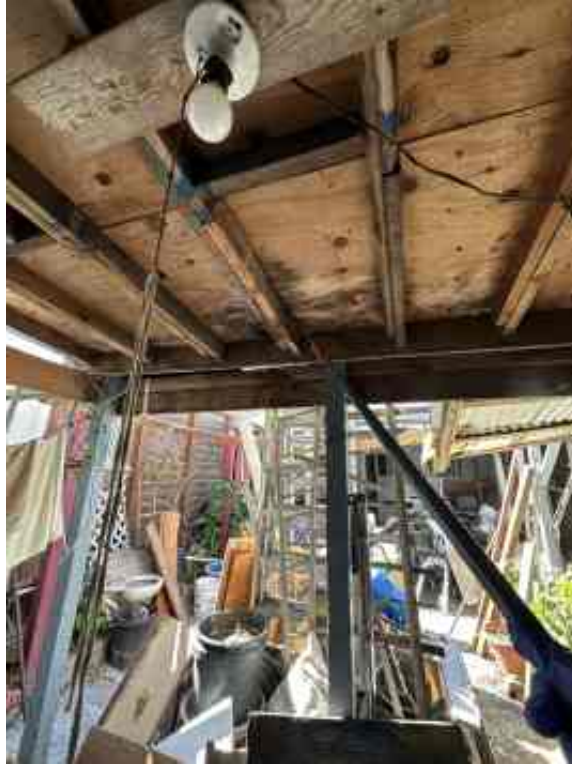
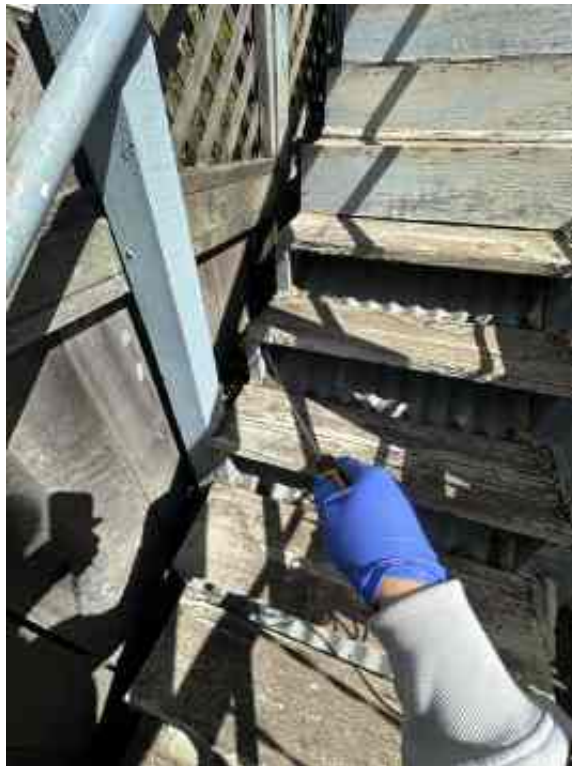
3G FINDING: Evidence of fungus infestation and wood rot noted at wood members across the rear deck/staircase structure. (Section 1)

RECOMMENDATION: Due to the extents of damages, owner is recommended to contact related trade for necessary repair. (Owner Responsibility)

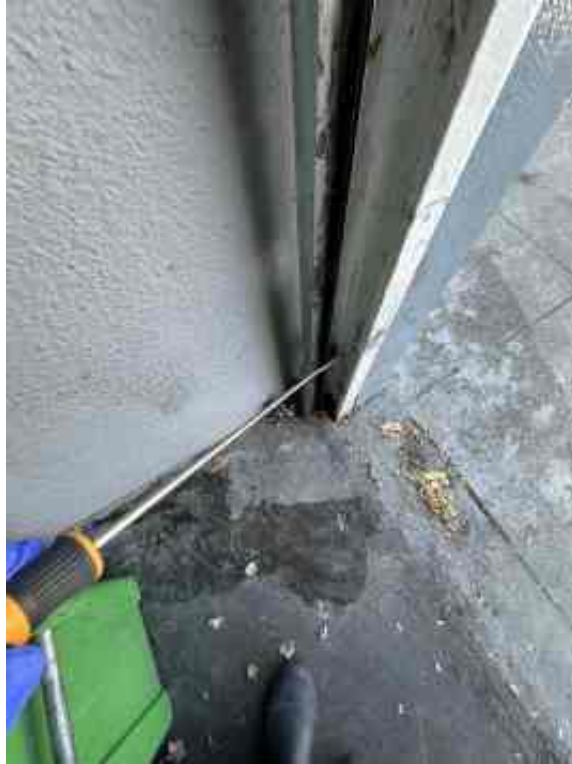
3H FINDING: Evidence of fungus infestation and wood rot noted at stud in garage as indicated in the diagram. (Section 1)

RECOMMENDATION: Remove and replace damaged studs. In the event that additional damage is uncovered after trim off the damage wood member(s) or extended into wood structure, a supplemental report will be issued for further correction. - \$854.00

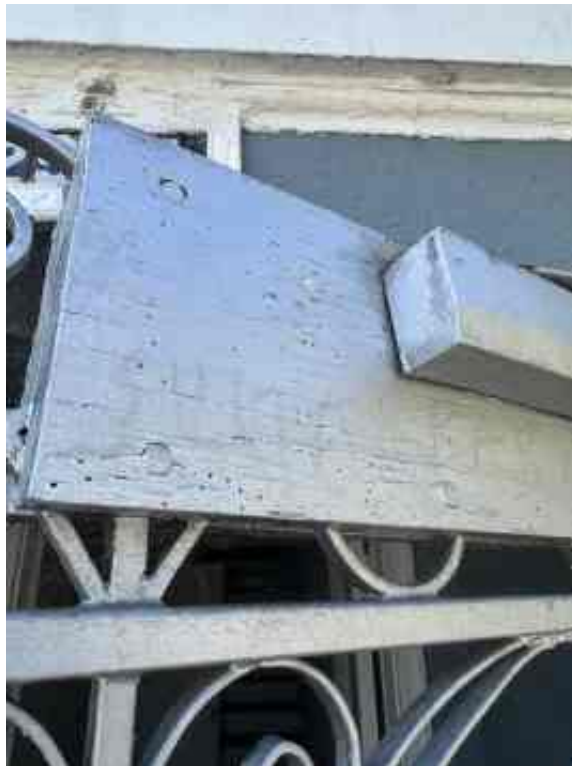
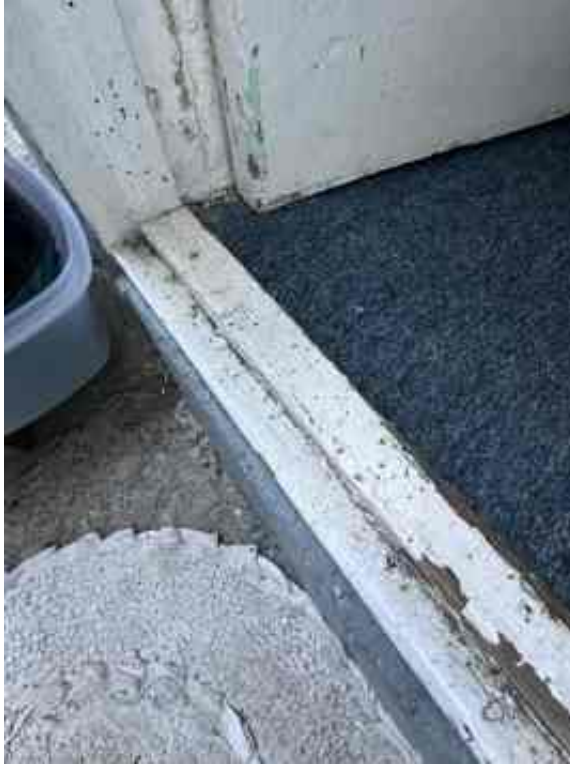
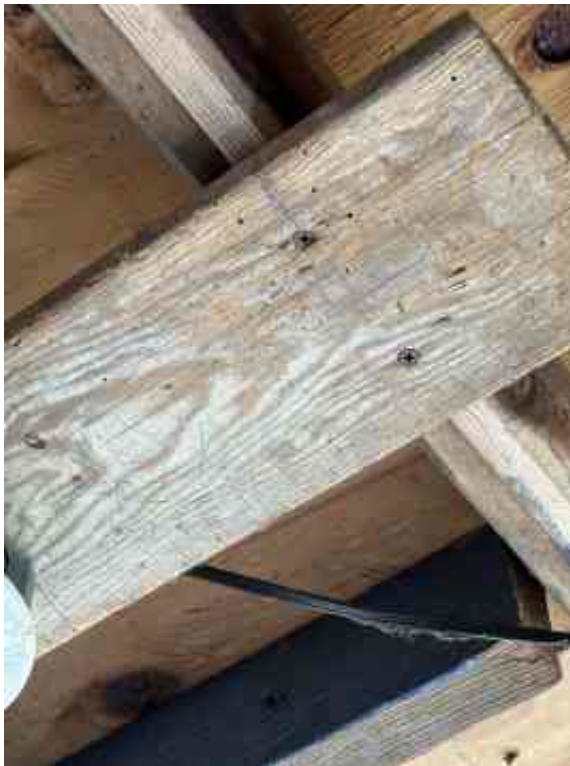
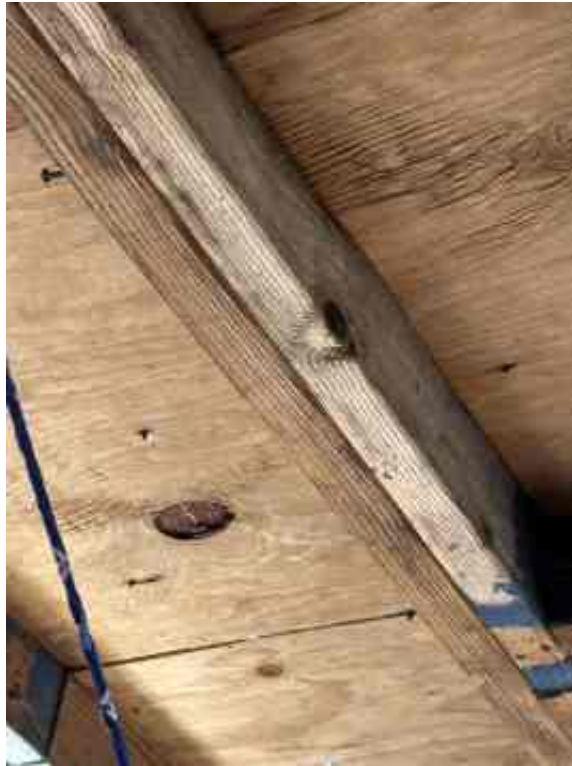
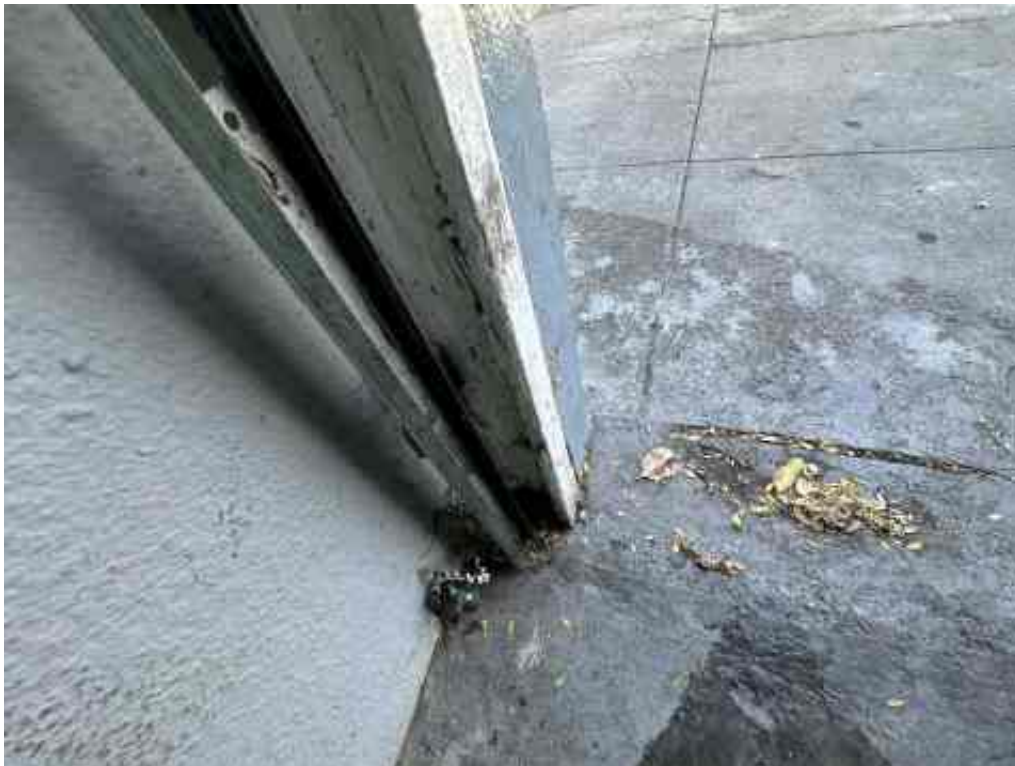
4A FINDING: Evidence of wood boring beetle infestation noted at the following areas as indicated in the diagram: (Section 1)

- Wood member at front gate.
- Door jambs/threshold at left side of property.
- Across wood members under rear deck.
- Stud in garage (w/damage) - Refer to item 3H for repair recommendation.

PRIMARY RECOMMENDATION: Fumigate the structure with Vikane Gas for the control of wood destroying beetles. It will be necessary to vacate the property 4 1/2 days. After the fumigation is completed, The property will be posted with safe for re-entry. It is property owner's responsibility to contact gas company to relight the pilot. (Fumigation cannot be performed since subject is an attached row house)

SECONDARY RECOMMENDATION: Local treatment with TIMBOR. Local treatment is not intended to be an entire structure treatment method. If infestations of wood-destroying pests extend or exist beyond the area(s) of local treatment, they may not be exterminated. - \$1,321.00

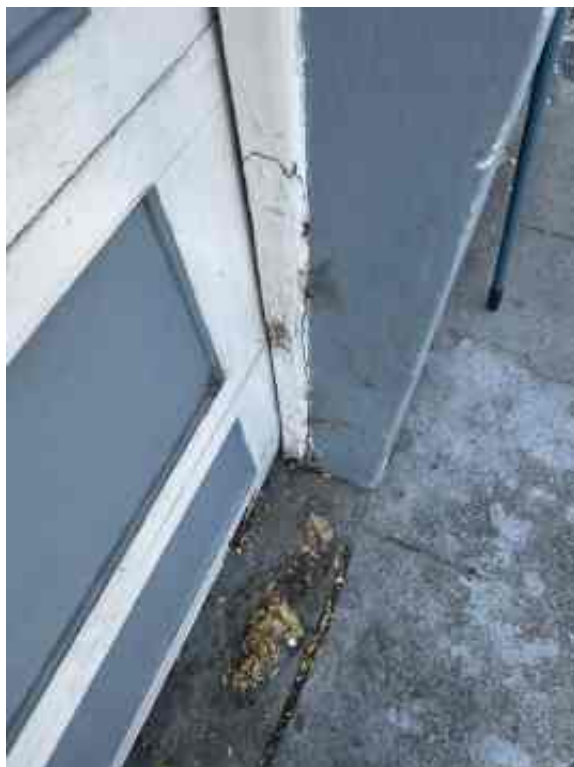
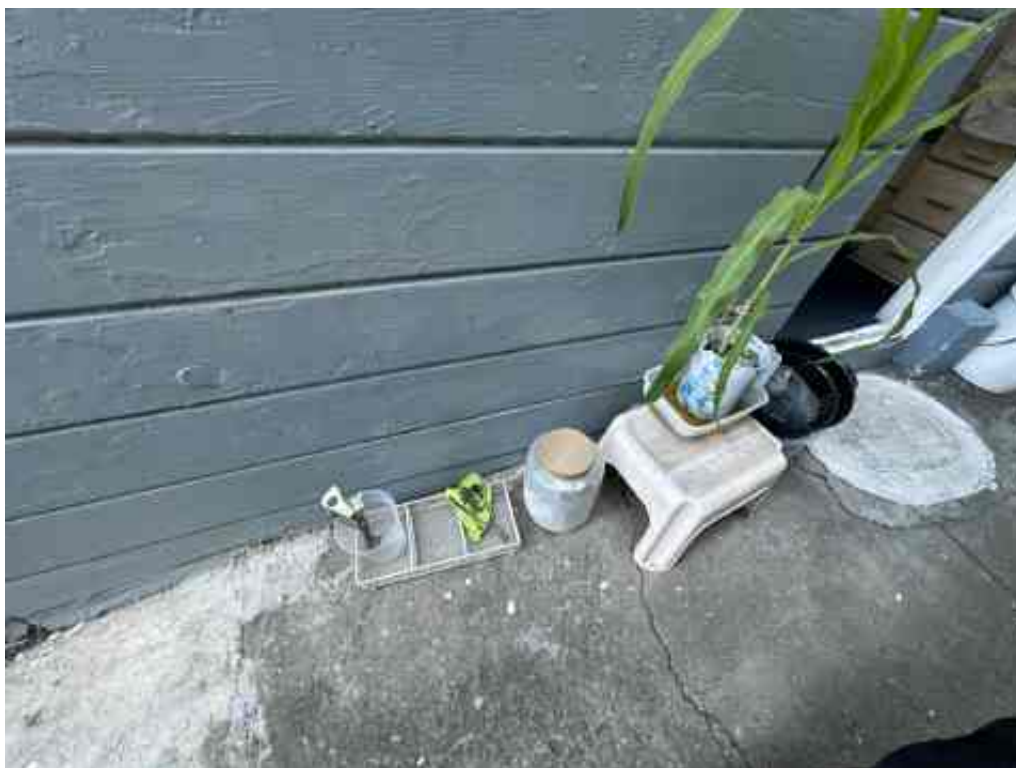
4B FINDING: Wood/Concrete contact noted at garage door jambs and sidings at left of property and under sunroom/rear deck as indicated in diagram. (Section 2)

RECOMMENDATION: Trim door jambs approximately 2" from concrete floor and fill void with mortar. - \$1,277.00

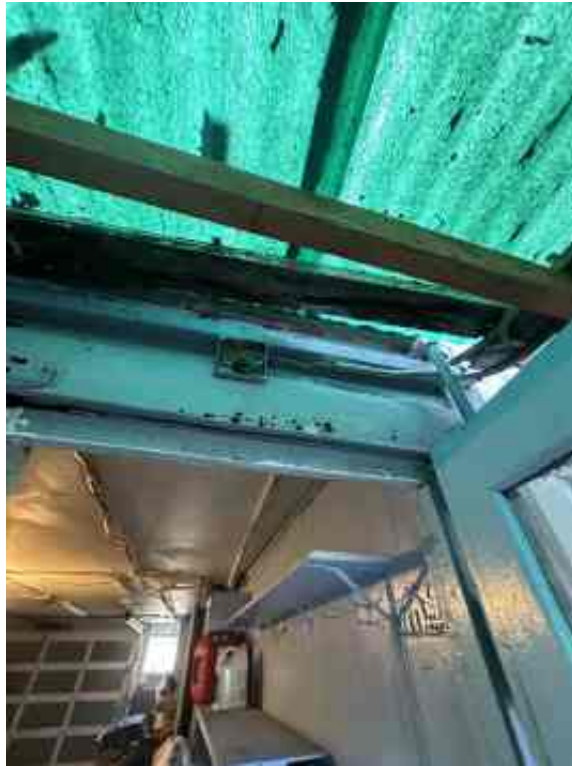
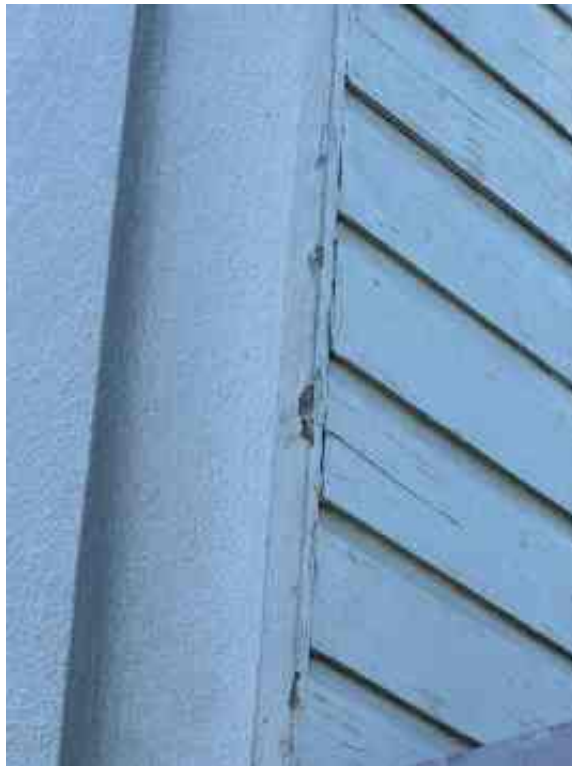
4C FINDING: FINDING: Peeling paint, exposed nails/holes/seams were observed across the exterior walls and wood members. (Section 2)

RECOMMENDATION: Owner is advised to keep the exterior walls and wood members well sealed, painted at all times, to prevent water intrusion/penetration, and potential future damage. (Owner Responsibility)

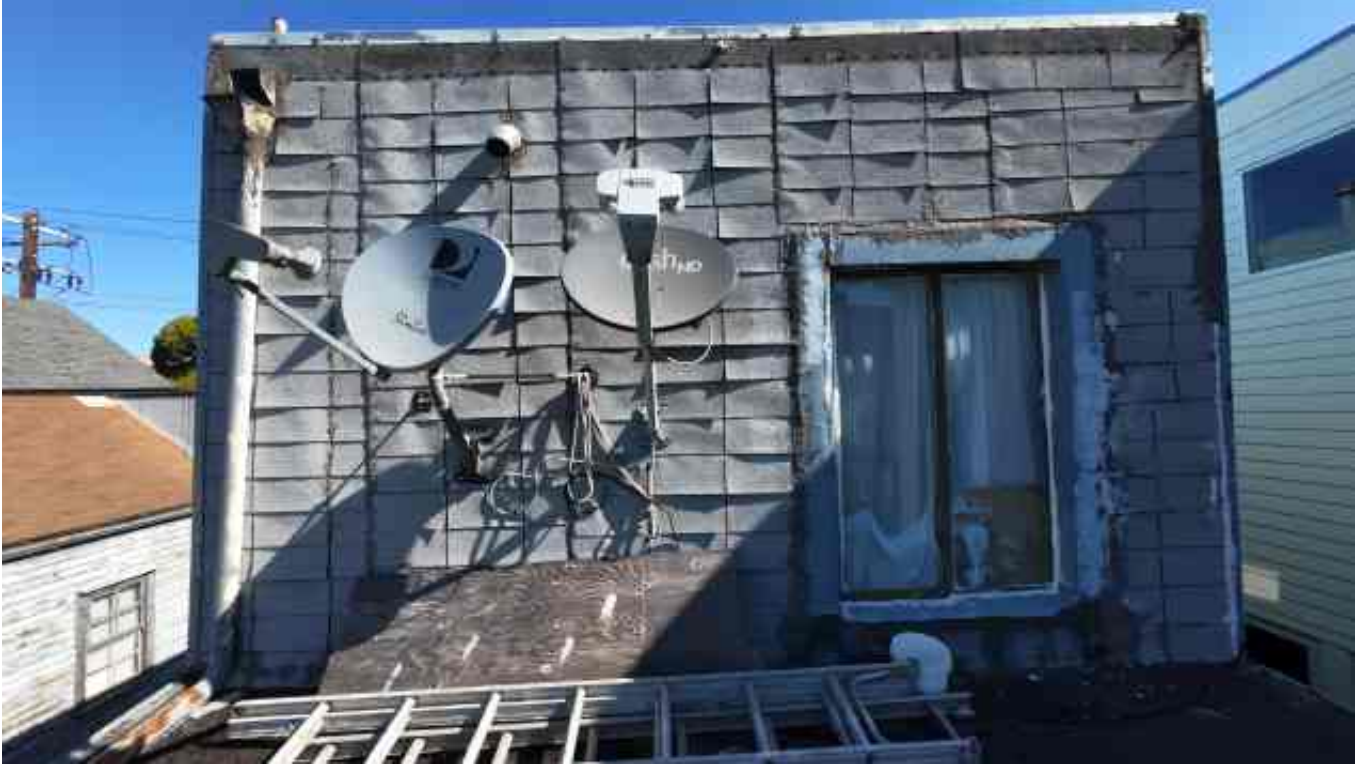
4D FINDING: The rear exterior wall was covered with asphalt shingles with exposed fasteners and extensive patchwork observed. The installation appeared not to have been performed in a workmanlike manner. (Section 2)

RECOMMENDATION: The condition of the underlying wall/siding could not be determined during visual inspection. Recommend to contact related trade for further investigation and necessary corrections. (Owner Responsibility)

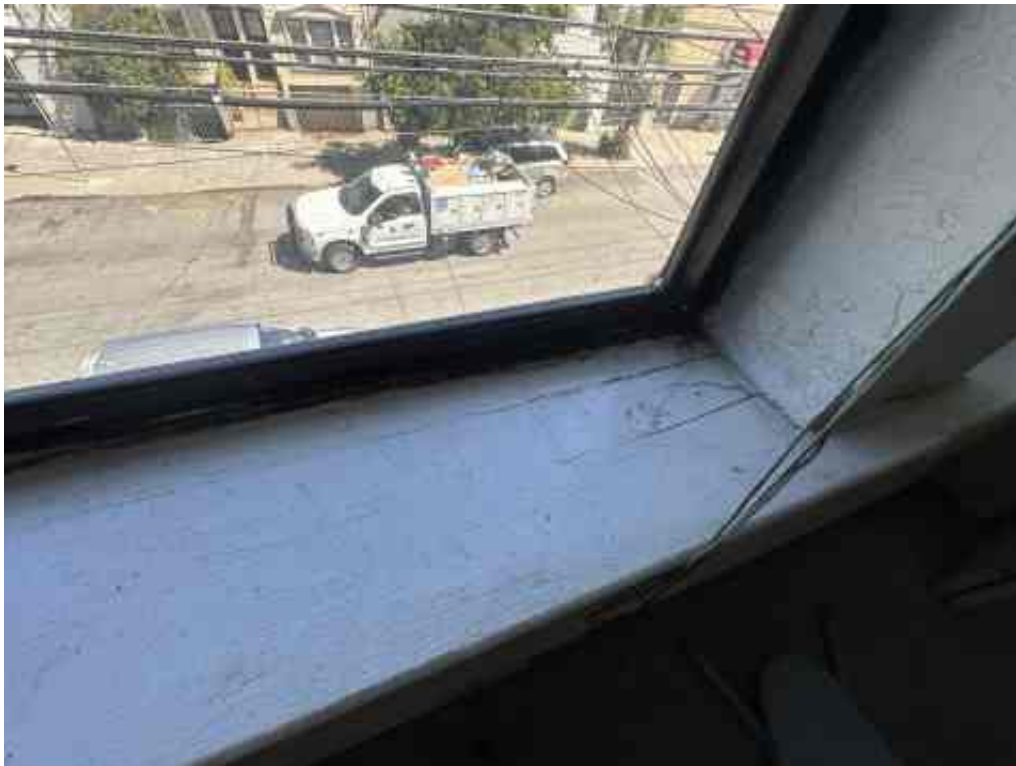
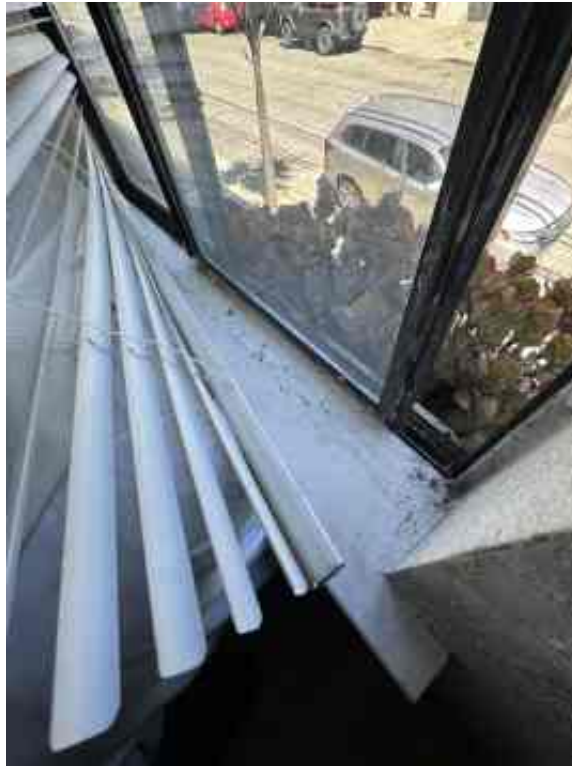
4E FINDING: Water damage noted at window aprons in Bedroom #3 & living room. (Section 2)

RECOMMENDATION: Owner is recommended to contact related trade to identify and correct the source of the water intrusion. (Owner Responsibility)

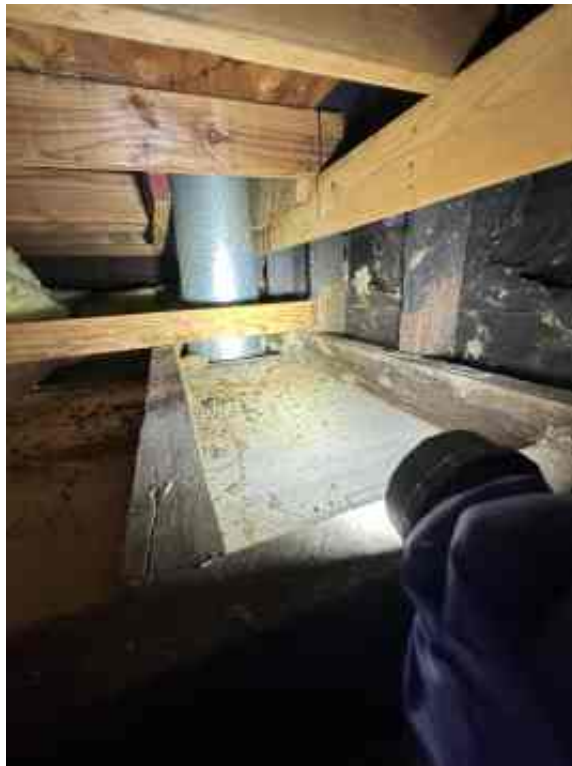
4F FINDING: Evidence of possible rodent infestation noted in attic area. (Section 2)

RECOMMENDATION: Owner is recommended to contact rodent exterminator for clarification or necessary correction. (Owner Responsibility)
