ANARUMO INSPECTIONS

## RESIDENTIAL INSPECTION

20431 7 Seas Ln  
Huntington Beach, CA 92646

04/07/2026

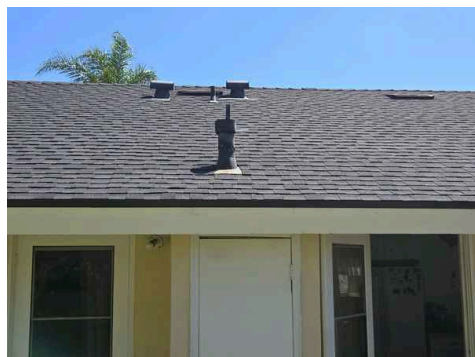
An asbestos like material was present and this material was in one or more areas of the home. Evaluation and testing of the material is recommended by an environmental company, with abatement and removal conducted as needed, if needed.

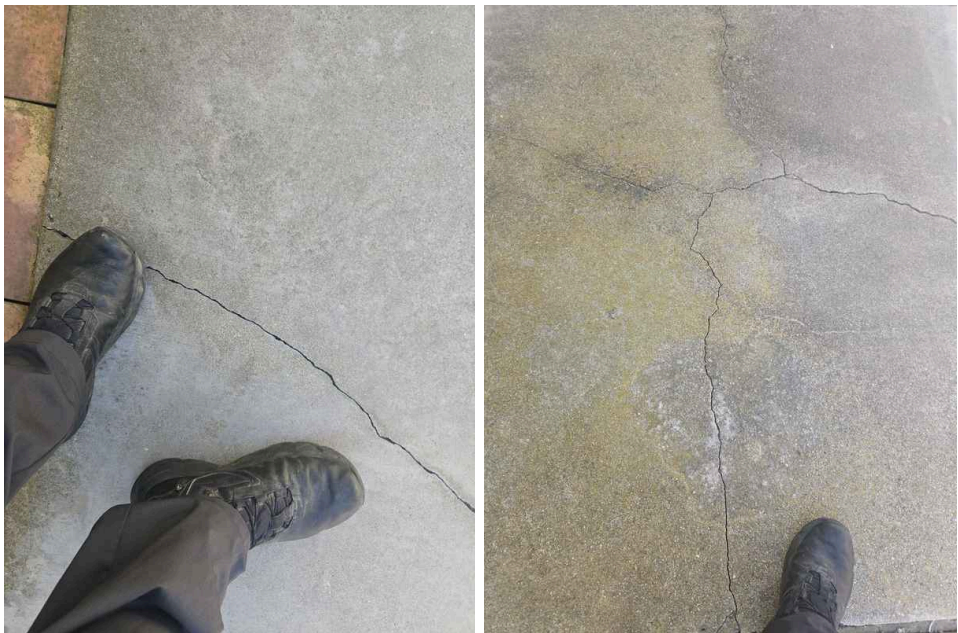
5.2.3 Walkways

**WALKWAY MATERIAL - MINOR CRACKS**

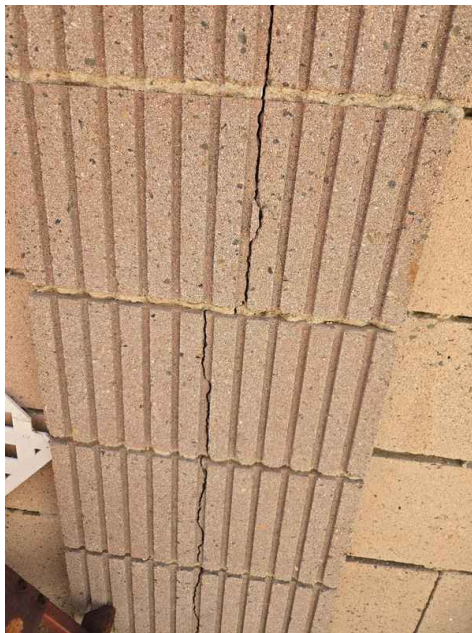
Cracks in material is a signs of failing. Recommend qualified contractor evaluate and repair.

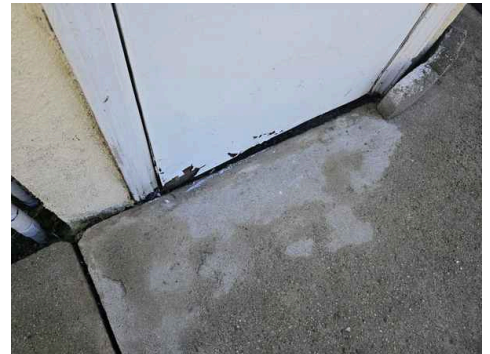
**DETERIORATED WOOD**

One or more doors are deteriorated. Recommend a Termite Company evaluate the whole home.

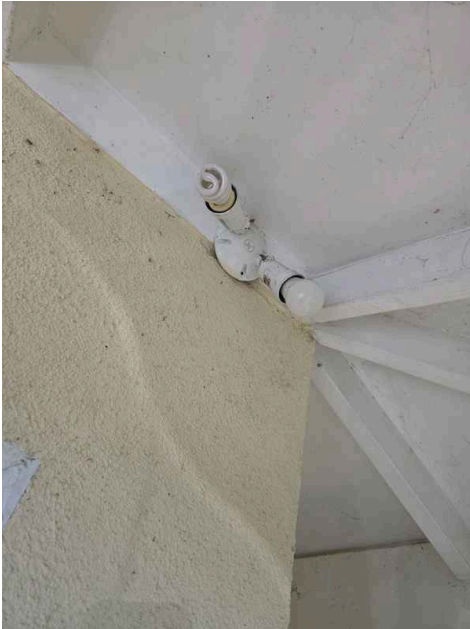
One or more light fixtures are not properly installed. Recommend correcting.

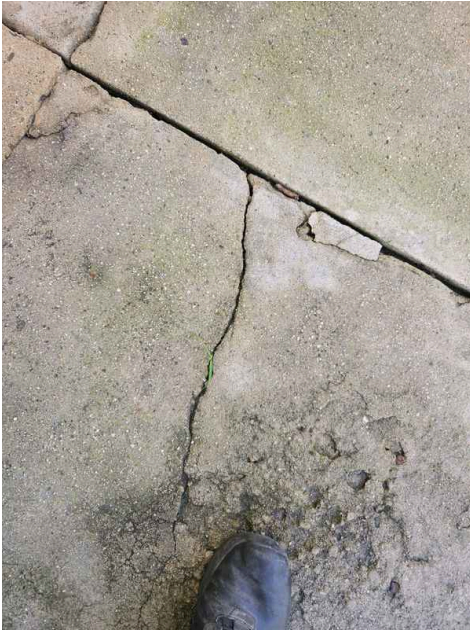
6.1.2 Outdoor Living Spaces and Stairs  
**DECK - EXPANSIVE CRACKS**

Expansive Cracks noted in decking. Recommend sealing cracks to prevent damage.

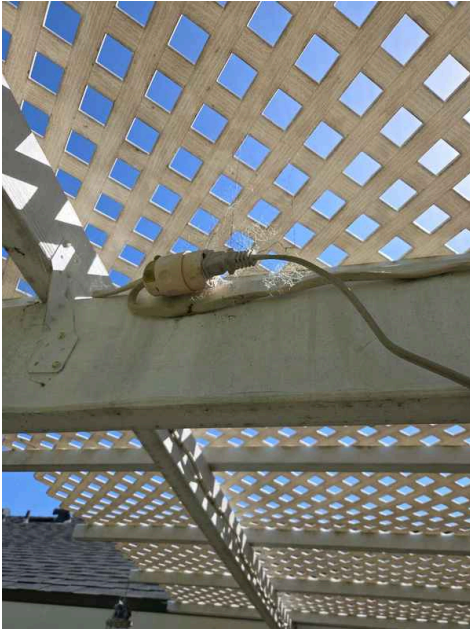
#### **ELECTRICAL - EXTENSION CORD**

Extension cord-type wire(s) are being used for electrical supply. This is not an accepted method of installation by most municipalities. We suggest removing.

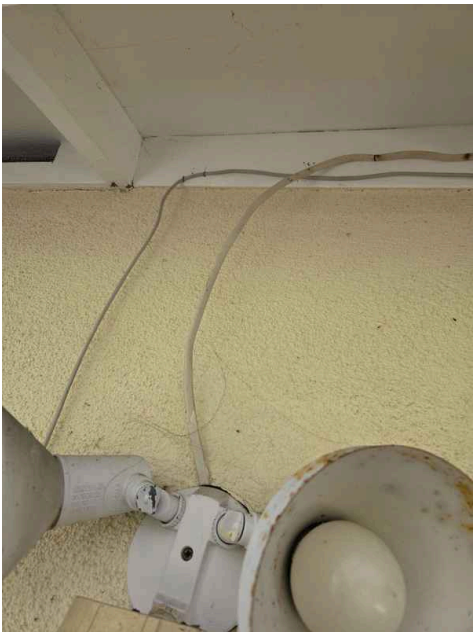
6.1.7 Outdoor Living Spaces and Stairs

Exposed romex wiring noted. This may be a safety concern if used where it could be subject to physical damage. Client may wish to encase as a safety upgrade.

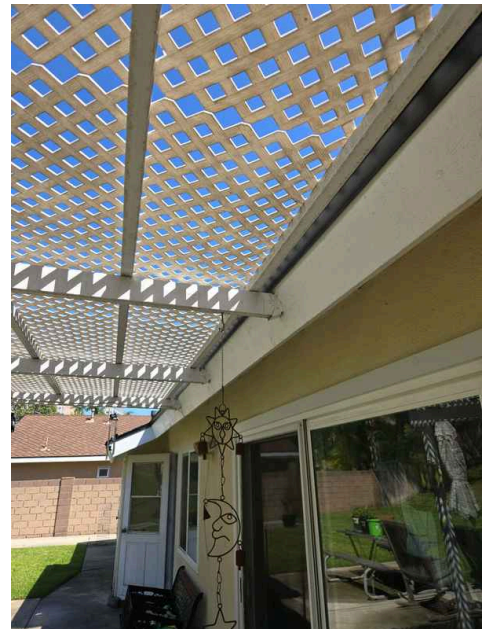
#### 6.1.9 Outdoor Living Spaces and Stairs

Deck was observed to have general poor construction. Recommend qualified deck contractor evaluate.

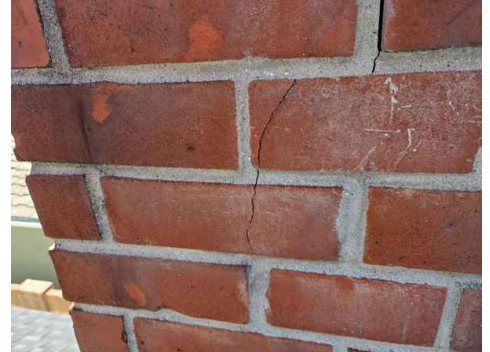
Chimney has cracks, which can deteriorate the chimney structure and allow water intrusion into the home. Recommend a qualified masonry or chimney contractor evaluate and remedy.

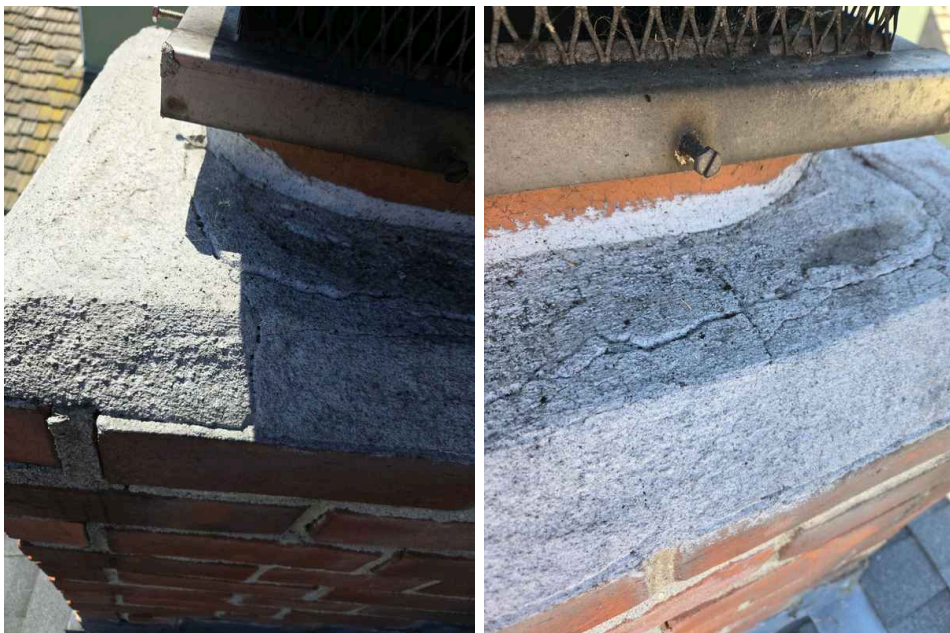
7.4.2 Roof - Chimneys / Skylights: Chimney Crown - Damage

Damage noted in chimney crown. Recommend repairing as needed.

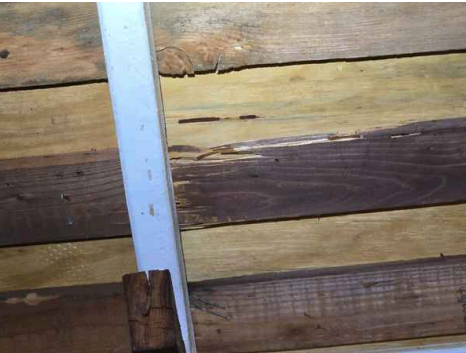
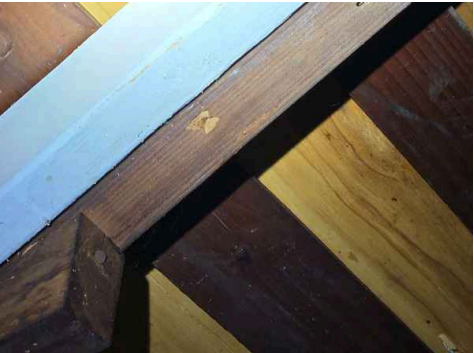
DETERIORATED WOOD

One or more sections of the ceiling are deteriorated. Recommend a Termite Company evaluate the whole home.

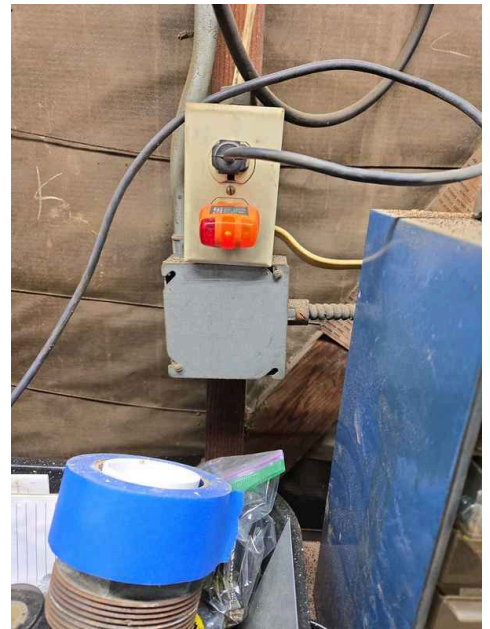
## 8.13.6 Electrical

One or more outlets were found to be ungrounded or open ground in this home and may not be limited to just one area. We will attempt to name all the areas that have them, however sometimes outlets may be hidden, used, or not tested as we are only required to check a representative number of receptacles or outlets around the property. All receptacles or outlets ideally should be grounded and due to the age or configuration of this system, we are unable to determine if proper grounding is in place or can occur. Suggest consulting a licensed electrician for further review of the entire electrical system prior to release of contingencies.

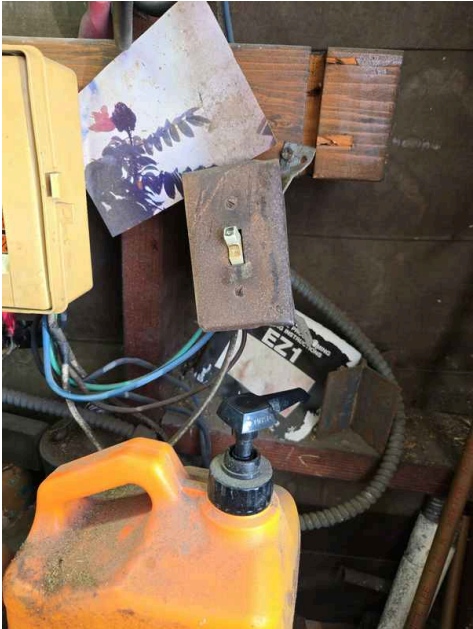
**IMPROPERLY INSTALLED SWITCH**

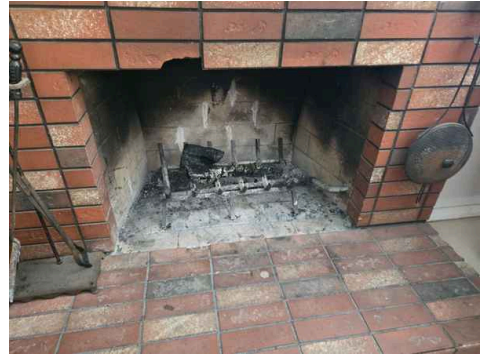
**MISSING SCREEN OR GLASS DOORS**

Recommend adding permanent doors or permanent screens for safety

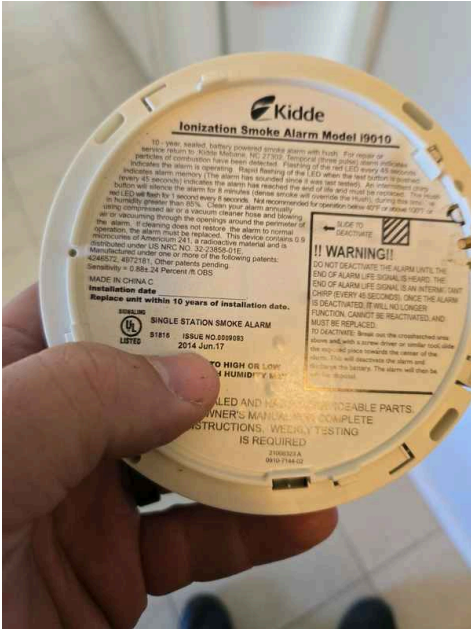
NFPA 72, National Fire Alarm Code, requires smoke alarms be replaced at least every 8 - 10 years, but because the public is generally unaware of this requirement, many homes have smoke alarms past their expiration date, putting people at increased risk.

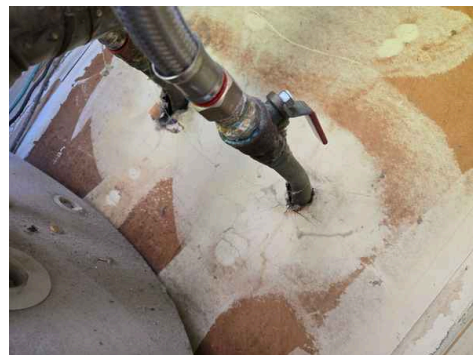
#### **CORROSION ON SUPPLY LINES**

Corrosion was noted at supply lines. One or more lines may need replacement. No leak at time of inspection.

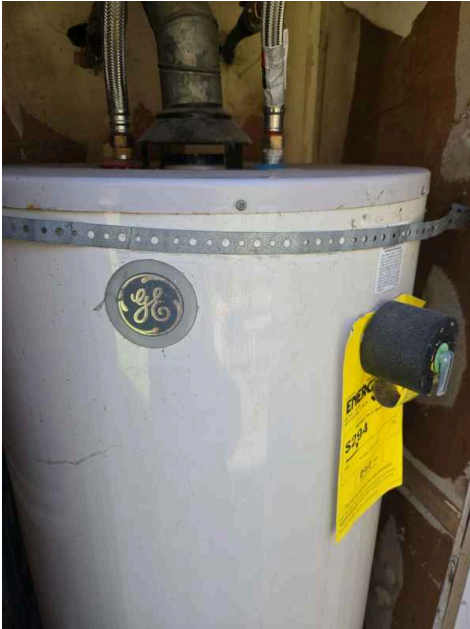
#### **EARTHQUAKE STRAPS - IMPROPER**

Improper Earthquake straps Present at time of inspection. Recommend installing as a safety upgrade.

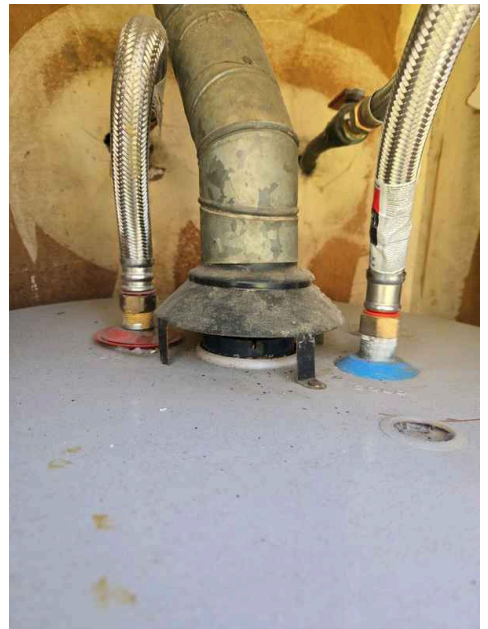
10.3.4 Plumbing - Water Heater, Controls, Flues & Vents: Flue - Missing Set Screws

It's required to use (3) three set screws to fasten the flue and down draft together. One or more of these screws are missing. Recommend installing.

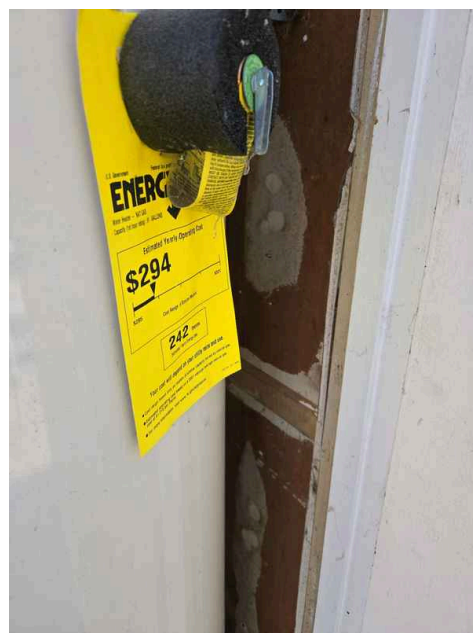
#### 10.3.5 Water Heater, Controls, Flues & Vents

No extension pipe found on the temperature and pressure relief valve. Suggest installing extension pipe as a safety upgrade.

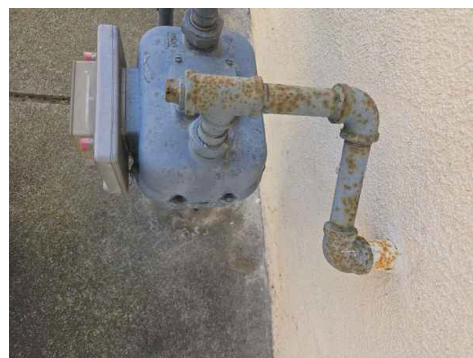
Some degree of surface rust was present on the gas piping in the area of the gas meter. Sanding and painting the pipes with rust-inhibiting paint is recommended to extend the life of the pipes.

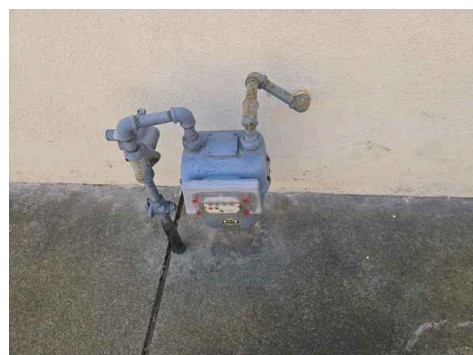
**NO EARTHQUAKE SHUT OFF VALVE**

The gas main does not have an automatic seismic shut-off valve. This device is required in some jurisdictions, and is a recommended upgrade for safety. Also some insurance companies are requiring this to be installed, recommend consulting with your insurance company to see if they want or require this to be installed.

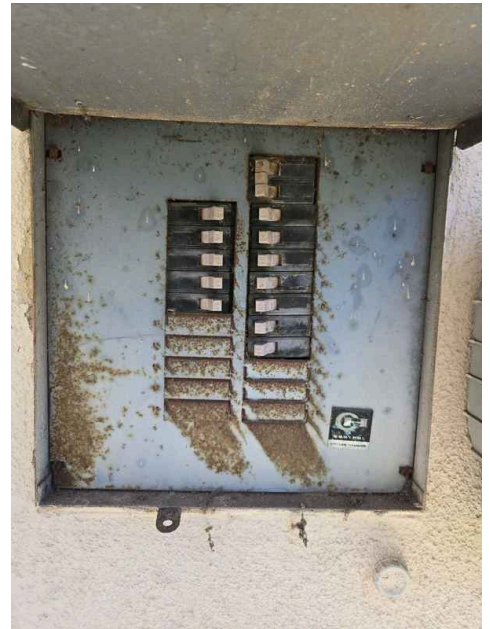
At the time of inspection, panel was missing permanent labeling. Recommend a qualified electrician or person identify and map out locations.

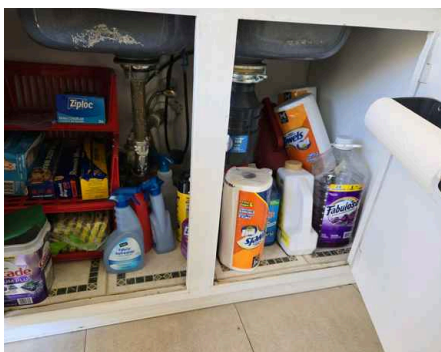
### Sink, Faucets, & Drains: Under Sink Photo - LIMITED

Limited visual access under sink.  
Hidden defects may arise.

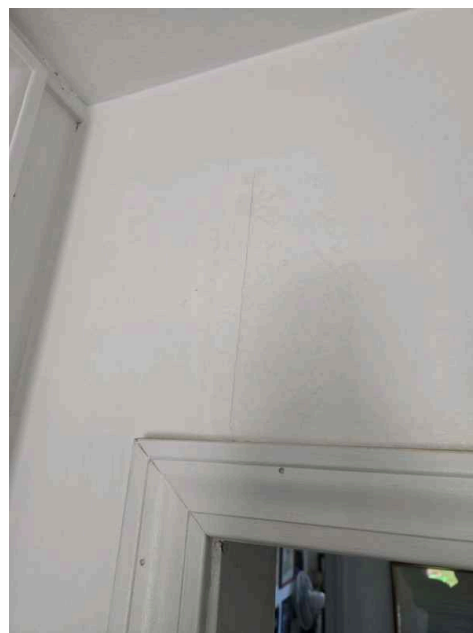
Minor cracks in walls. Some settling is not unusual in a home of this age and these cracks are not a structural concern.

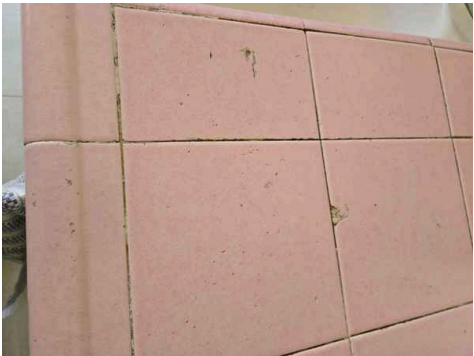
During the inspection, it was observed that the kitchen countertop displayed multiple indications of damage, potentially including but not limited to cracks, chips, dings, burn marks, and general wear. These findings imply significant use and impact on both the appearance and functionality of the countertop.

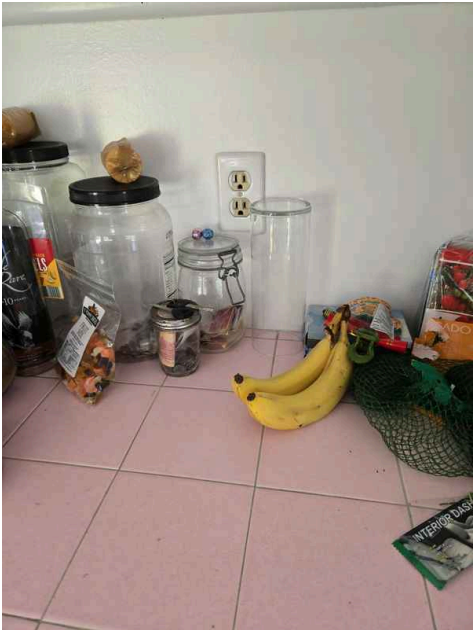
Recommend securing loose outlets

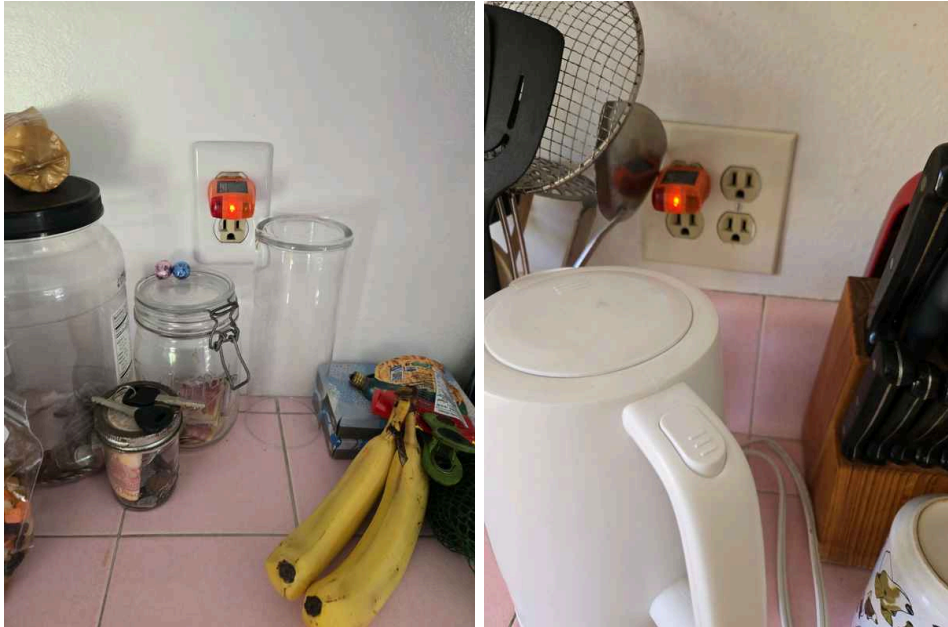
### 12.8.3 Electrical

## UNGROUND RECEPTACLES

One or more outlets were found to be ungrounded or open ground in this home and may not be limited to just one area. We will attempt to name all the areas that have them, however sometimes outlets maybe hidden, used, or not tested as we are only required to check a representative number of receptacles or outlets around the property. All receptacles or outlets ideally should be grounded and due to the age or configuration of this system, we are unable to determine if proper grounding is in place or can occur. Suggest consulting a licensed electrician for further review of the entire electrical system prior to release of contingencies.

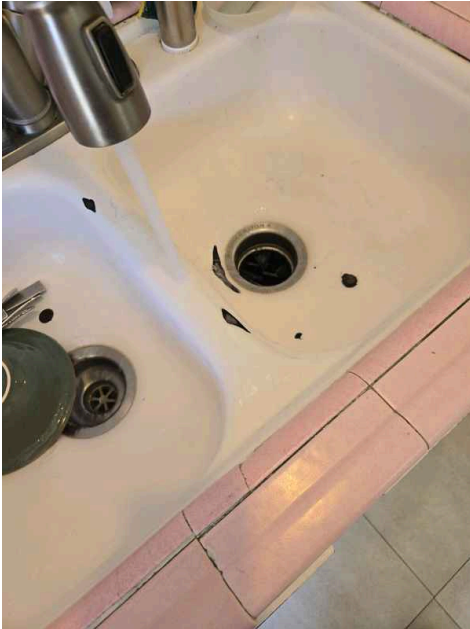
One or more chips noted in sink. No signs of leaking at time of inspection.

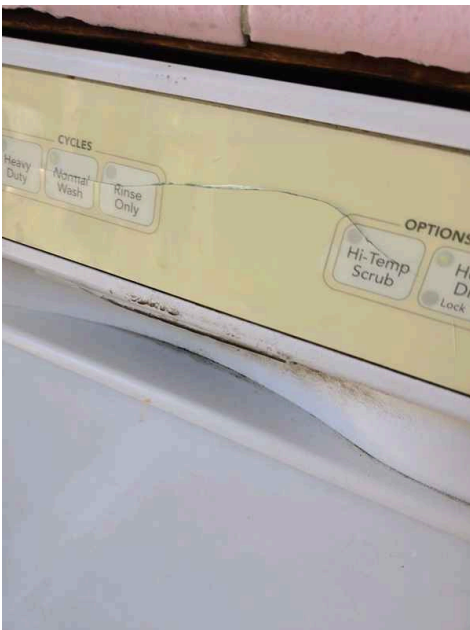
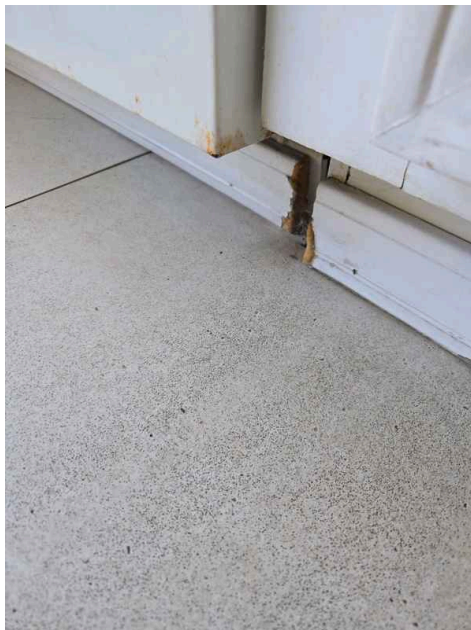
## 12.11.1 Dishwasher

**DAMAGE - GENERAL**

General damage noted. Recommend repairs as needed

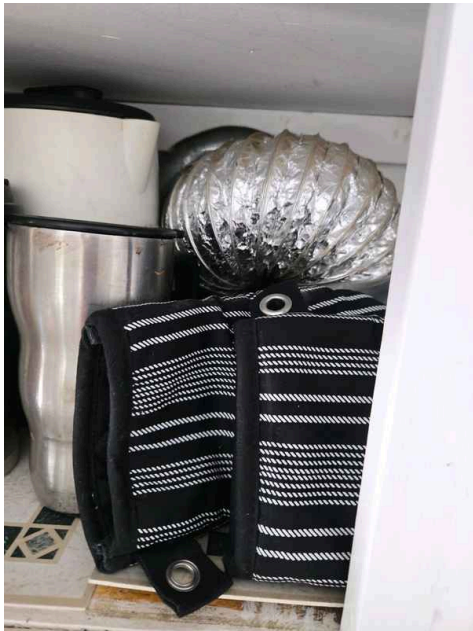
## 12.12.1 Vent

**EXHAUST FLUE RIBBED**

Exhaust fan flue pipe is ribbed; suggest changing to a straight metal pipe as a safety upgrade.

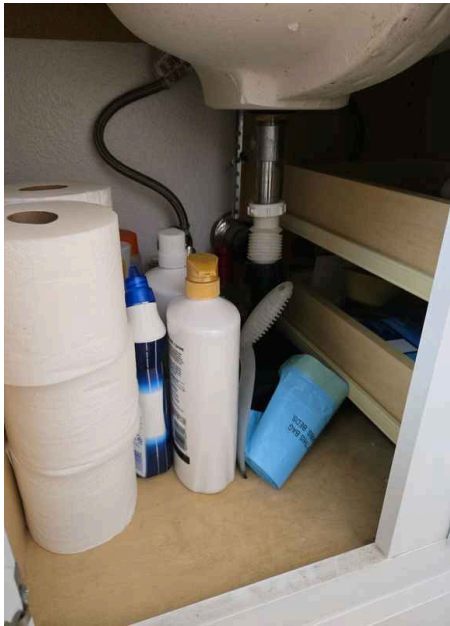
Sink/Faucet/Drains/Supply: Photo Under Sink - LIMITED

Limited visual access under the sink was noted due to personal belongings obstructing the view. Hidden defects may exist in this area.

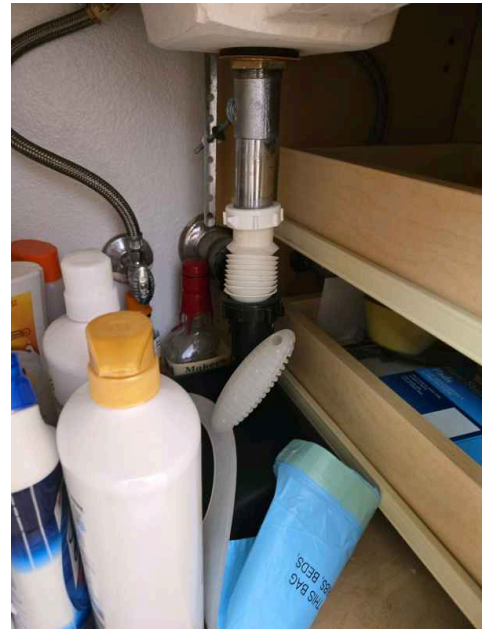
These types of installations are not typically preformed by a licensed plumber. As most would not use one. Mainly because these pipes have ribs. The ribs are prone to cracking, leaking, and they accumulate debris and could become slow or clog. We recommend changing them out to a proper solid pipe or having it review by a licensed plumber.

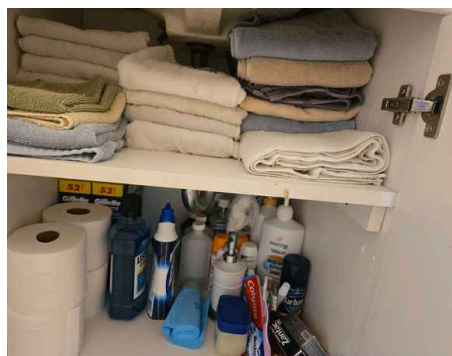
## Sink/Faucet/Drains/Supply: Photo Under Sink - LIMITED

Limited visual access under the sink was noted due to personal belongings obstructing the view. Hidden defects may exist in this area.

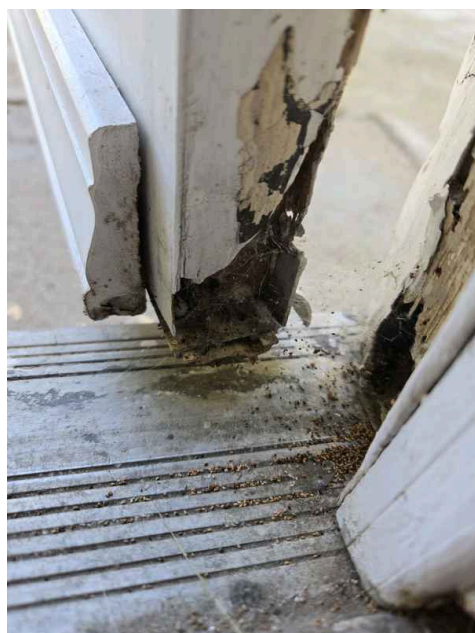
One or more sections of the door are deteriorated. Recommend a Termite Company evaluate the whole home.

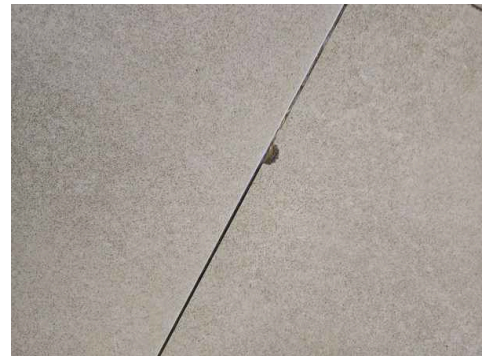
#### FLOORING - DAMAGED

During the inspection, damaged flooring was noted in one or more areas. This can include cracks, chips, torn, dings, and a broken material. These conditions, while not alarming, can be addressed to maintain minor safety concerns and aesthetics. We recommend consulting a flooring professional for necessary repairs or replacement.

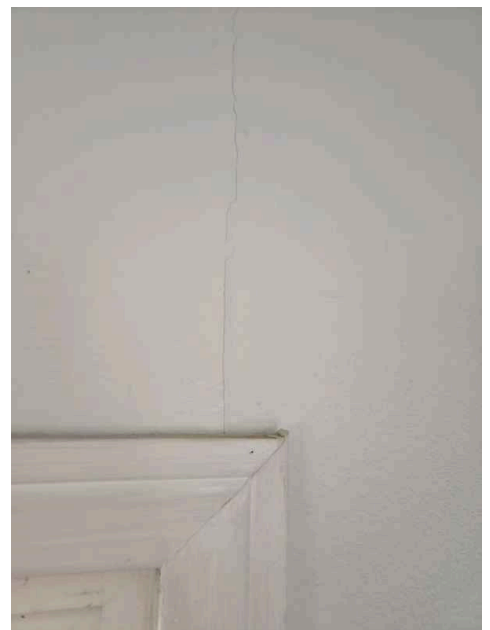
Minor cracks in walls. Some settling is not unusual in a home of this age and these cracks are not a structural concern.

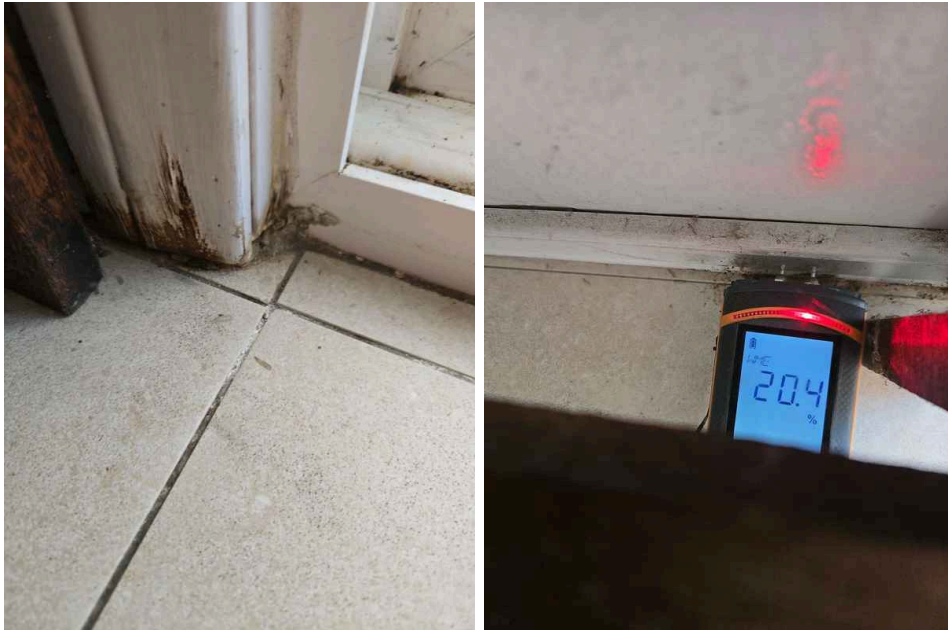
#### 15.2.2 Walls

Stains on the walls visible at the time of the inspection appeared to be the result of moisture intrusion. The source of moisture may have been corrected. Recommend further examination by a qualified contractor to provide confirmation.

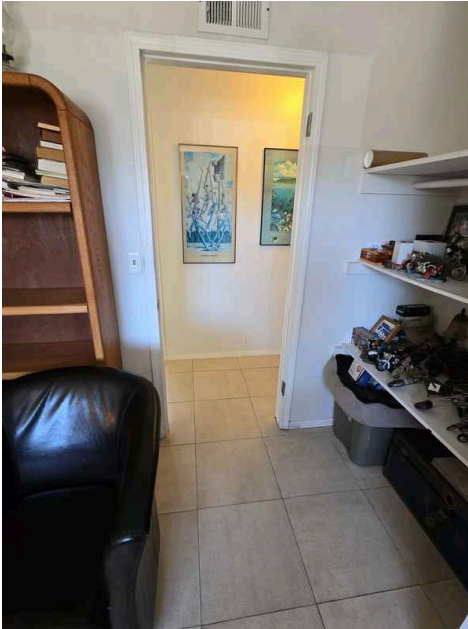
#### DOOR - MISSING

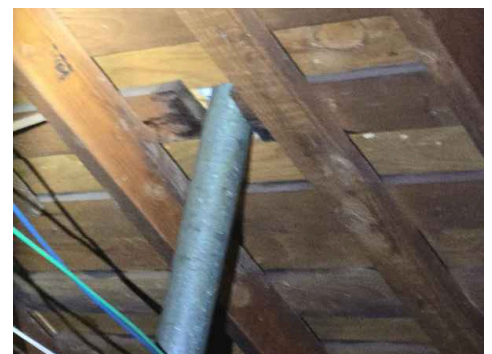
20.3.1 Evidence of leakage

**STAINS DO NOT APPEAR TO BE ACTIVE**

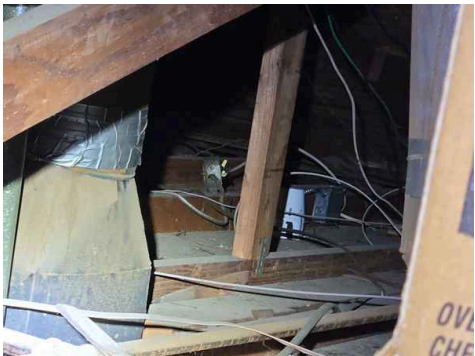
20.6.2 Attic Comments

**OPEN JUNCTION BOX**

On a more open junction boxes noted in the attic. Recommend covering.
