# KEYS PROPERTY INSPECTIONS

## KEYS RESIDENTIAL REPORT

2002 E Woodlyn Rd  
Pasadena, CA 91104

07/27/2026

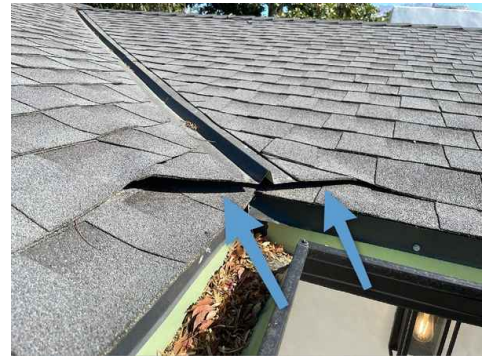
Lifting flashings observed. Suggest correcting by a qualified roofer.

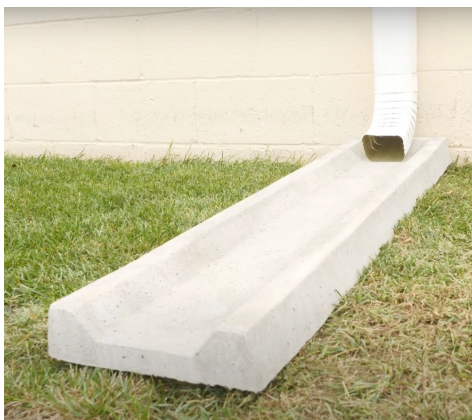
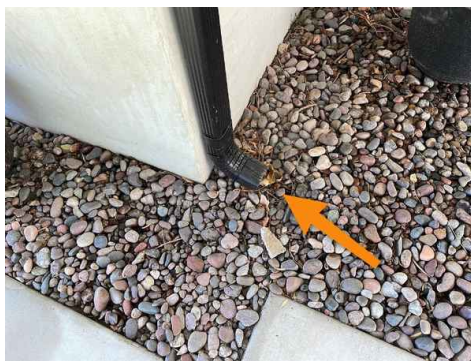
## 2.5.1 Gutters and Downspouts

**KICKOUTS NOT INSTALLED**

Kickouts are not installed to divert water away from the structure. Recommend installing.

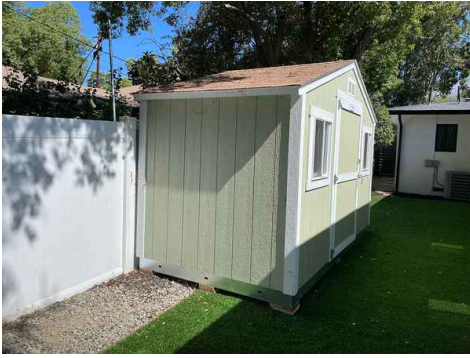
**STORAGE SHEDS/OUTBUILDINGS**

Inspection of outbuildings and storage sheds are beyond the scope of this inspection. Suggest verifying condition.

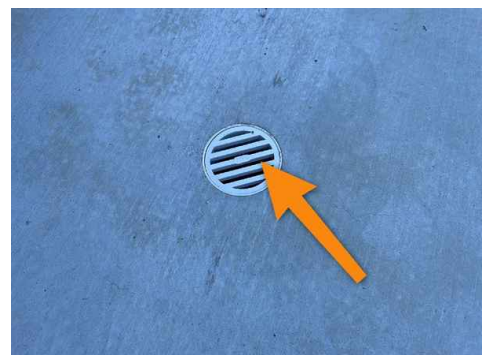
### **SUB SURFACE DRAINS**

Sub-surface lot drainage system is present. The client is advised to have a qualified drainage contractor verify its overall condition.

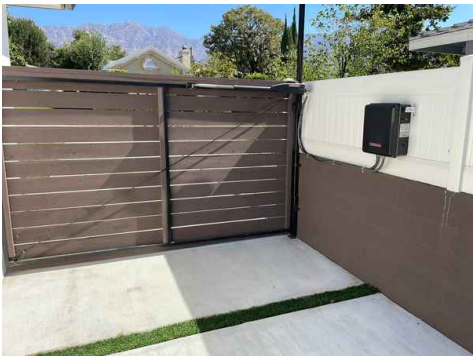
AUTOMATIC GATE OPENER

Automatic gate openers and testing motors is beyond the scope of this inspection. Suggest verifying operation and condition.

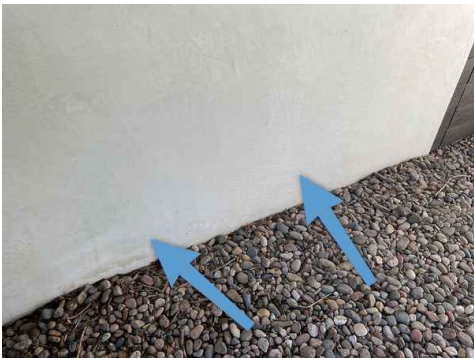
3.2.1 Wall Cladding

MISSING WEEP SCREED

Weep screed is not installed at the exterior wall cladding in all areas or is missing altogether. Suggest installing for moisture wicking and draining purposes.

Contact a qualified siding specialist.

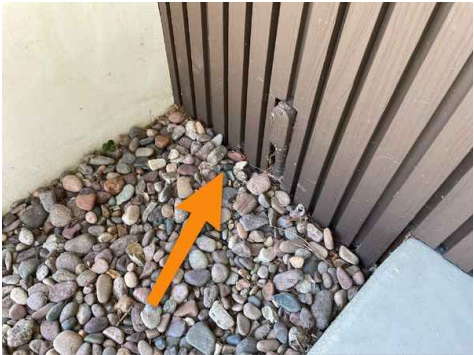
3.2.2 Wall Cladding

SIDING TO GROUND CONTACT

Siding is in direct contact with ground in areas. Because the siding is in contact with ground it is possible for framing to be deteriorated. We did not inspect behind this siding. Recommend a ground clearance of six to eight inches where possible.

Contact a qualified general contractor.

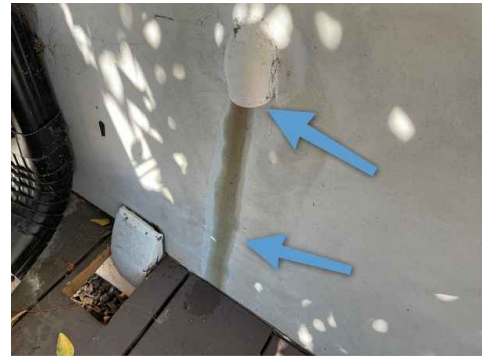
3.2.3 Wall Cladding

STAINING

Staining/evidence of moisture seepage observed at exterior wall cladding. Suggest repairs.

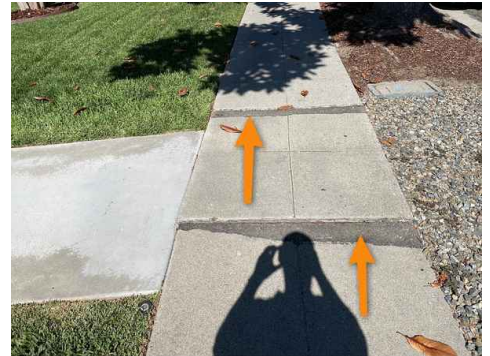
### 3.3.1 Walkways and Driveway

#### **DISPLACEMENT AT THE CITY SIDEWALK**

Trip hazard. Recommend repairs.

Contact a qualified concrete contractor.

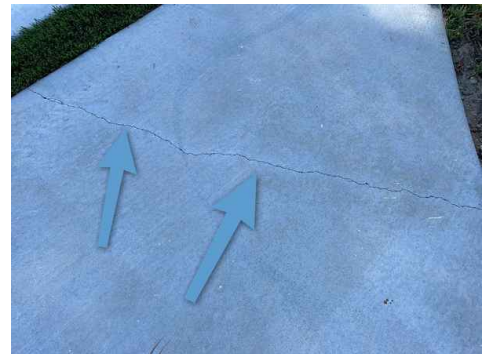
### 3.3.2 Walkways and Driveway

#### **CRACKS WALKWAY AND DRIVEWAY**

Cracks observed at the walkways/ driveway. Suggest sealing/repairs as necessary.

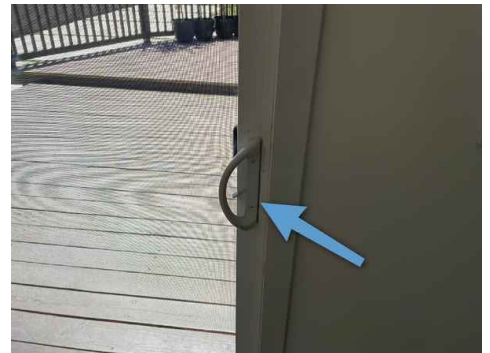
### 3.4.1 Doors (Exterior)

#### **STIFF HARDWARE**

MAIN HOUSE REAR SLIDER LOCK

Stiff hardware observed at exterior door(s). Suggest maintenance.

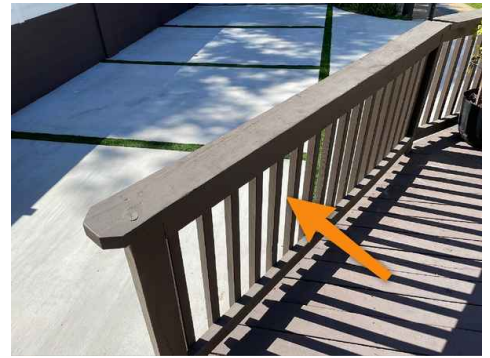
### 3.6.1 Decks, Balconies, Stoops, Steps, Areaways, Porches, Patio/Cover and Applicable Railings

#### **LOOSE RAILINGS**

Loose railing(s) were observed in areas. Recommend correcting.

Contact a qualified general contractor.

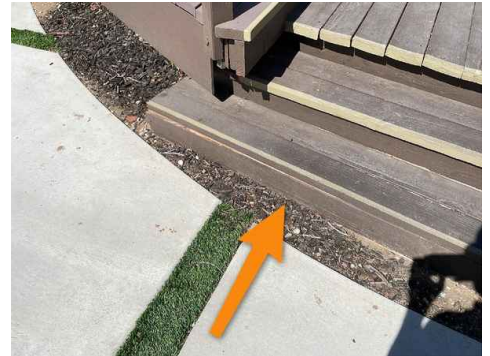
3.6.2 Decks, Balconies, Stoops, Steps, Areaways, Porches, Patio/Cover and Applicable Railings

Earth to wood contact(s) observed at deck, balcony or steps. Recommend correcting to prevent deterioration.

Contact a qualified general contractor.

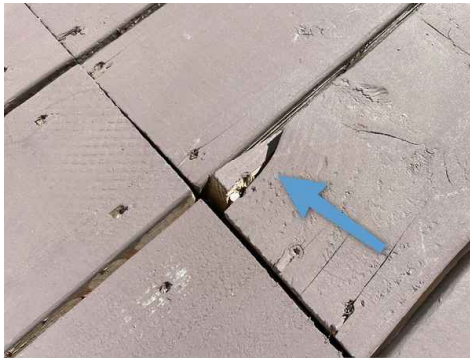
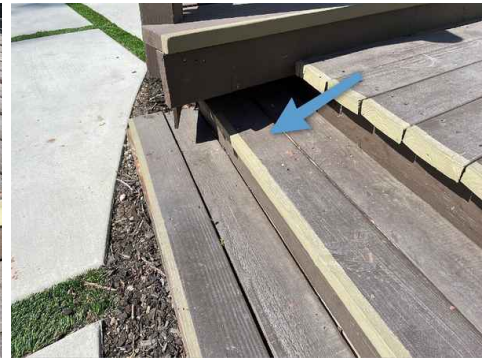
3.6.3 Decks, Balconies, Stoops, Steps, Areaways, Porches, Patio/Cover and Applicable Railings

### **DAMAGED OR WARPED DECKING**

Suggest repair to minor damaged and or warped decking material materials.

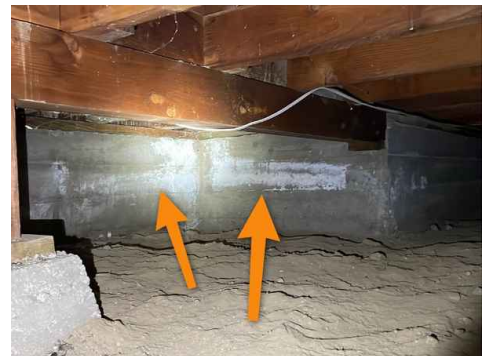
## 6.2.2 Foundations, Basement and Crawlspace

Efflorescence observed at foundation stem walls. See exterior drainage category.

Contact a qualified grading contractor.

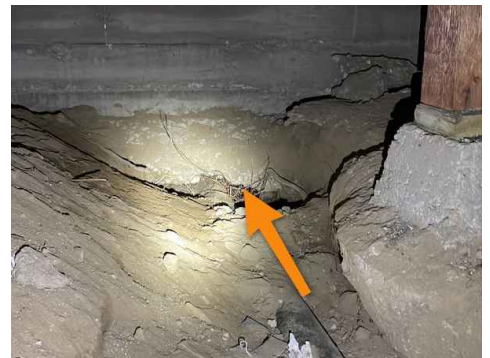
## 6.2.3 Foundations, Basement and Crawlspace

**UNDERMINING**

Undermining observed at the foundation stem wall(s). Recommend correcting/backfilling.

Contact a foundation contractor.

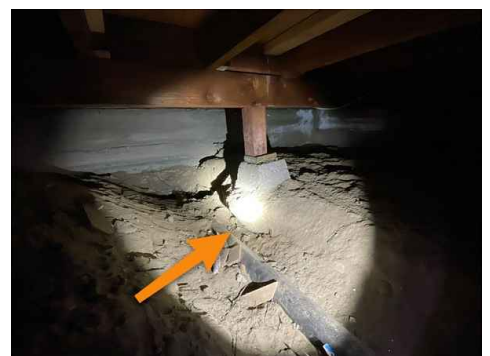
## 6.3.1 Columns or Piers

**UNDERMINED**

Undermined piers observed. Recommend correcting/backfilling affected areas.

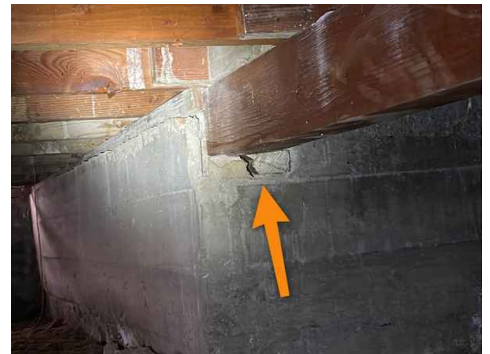
## 6.4.2 Floors (Structural)

**DAMAGED SUPPORT AT GIRDER BEAM**

FRONT RIGHT SIDE

Damaged support observed under girder beam. Recommend correcting.

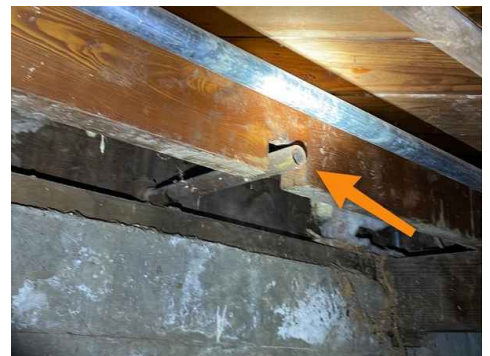
## 6.4.3 Floors (Structural)

**NOTCHED FLOOR JOIST**

Floor joist(s) is improperly notched. Recommend repair.

Contact a qualified general contractor.

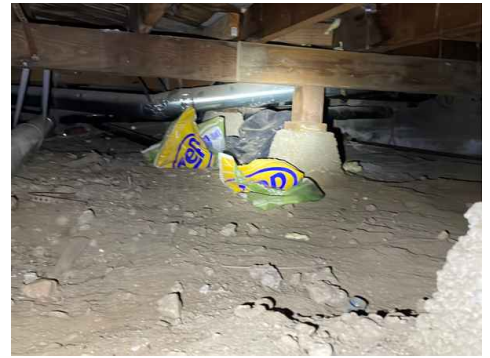
Debris observed in the crawlspace. Suggest removal.

Contact a qualified handyman.

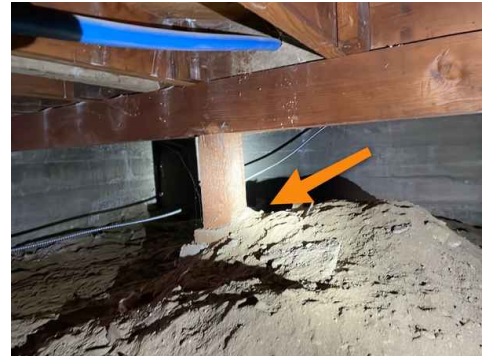
#### 6.5.3 Foundation Comments

### EARTH TO WOOD CONTACTS

Earth to wood contacts observed in the crawlspace. Recommend correcting for termite prevention.

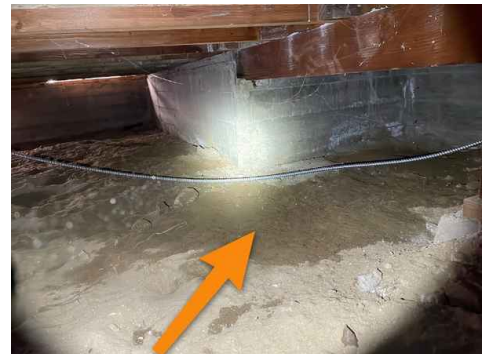
#### 6.5.4 Foundation Comments

### CRAWL SPACE DAMP

Damp soil observed at portions of the crawl space. Recommend correcting condition and further review by a qualified specialist.

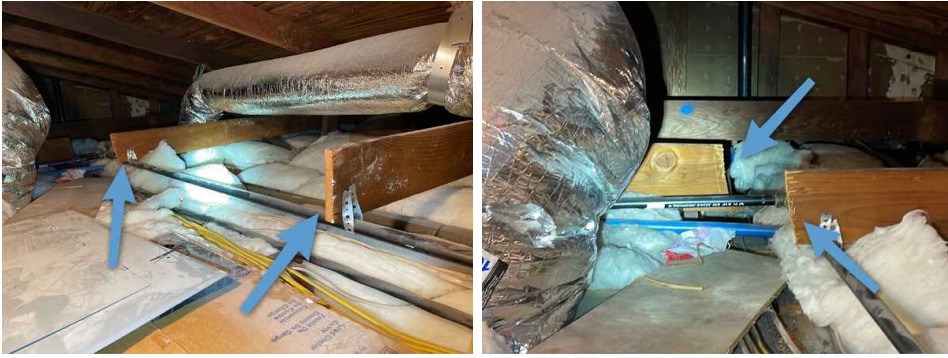
#### 6.7.1 Roof Structure and Attic

### FRAMING ALTERATIONS

Alterations and modifications observed at the attic framing members (cut or missing rafter ties). Suggest verifying condition by a qualified contractor or roofer.

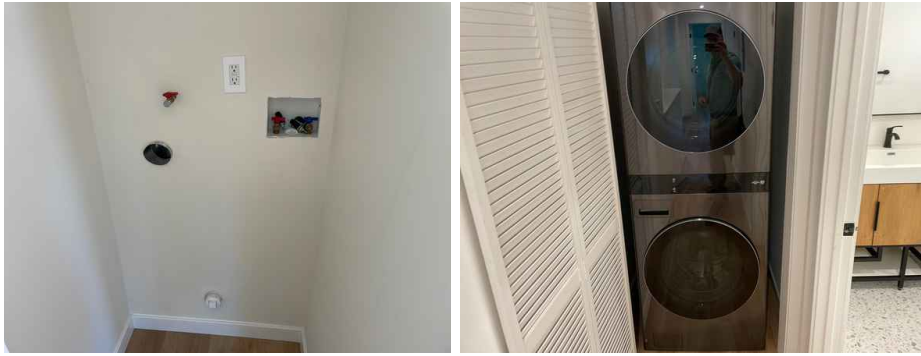
## Laundry Location: Laundry locations located

Washer connections located. The faucet and drain were not tested. Suggest verifying condition prior to the end of the inspection period.

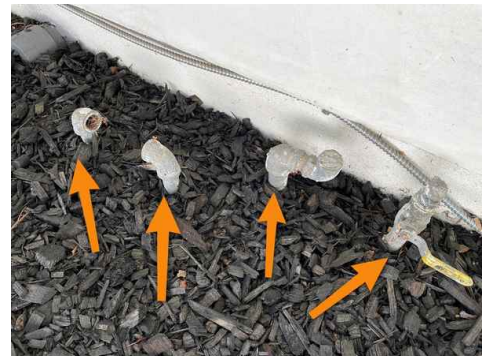
### ABANDONED GALVANIZED PIPING

Galvanized supply piping was observed. Although these pipes appear to be cut off/abandoned, we cannot determine if galvanized piping is still in use where not visible. Suggest verifying condition with a qualified plumber.

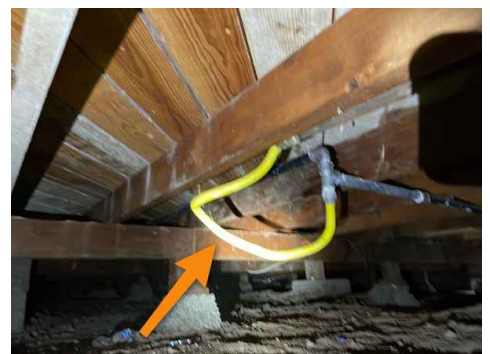
### YELLOW CCST (CORRUGATED STAINLESS STEEL TUBING)

Yellow CSST: Manufacturers believe the product is safer if properly bonded and grounded as required by the manufacturer's installation instructions. Proper bonding and grounding of the product can only be determined by a licensed electrical contractor.

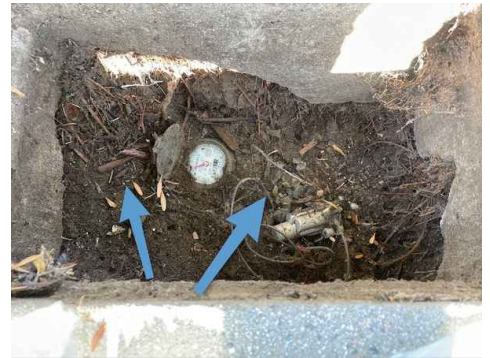
### 7.2.1 Main Water Supply/Shut Off Valve

#### **WATER METER COVERED**

The water meter at the curbside was partially buried. Suggest exposing and verifying condition.

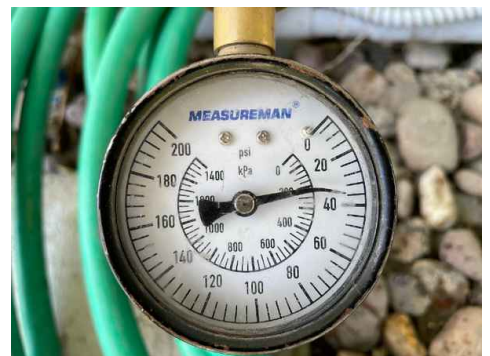
#### **WATER PRESSURE UNDER 40PSI**

The water pressure registered at 40 psi or under. It is acceptable to have the water pressure between 40 and 80 psi. This can be adjusted at the water pressure regulator that is installed at the main water shut off location.

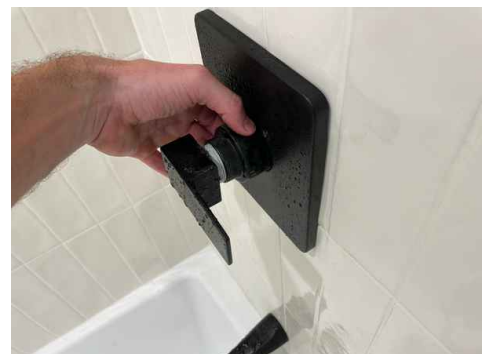
HALLWAY BATHROOM TUB/SHOWER FAUCET FITTING

Loose faucet(s) observed. Recommend correcting.

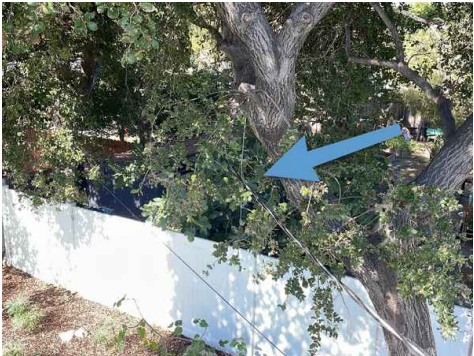
8.2.1 Service Entrance Conductors  
**SERVICE LINES IN CONTACT WITH VEGETATION**  
The main electrical service line is in contact with vegetation. Recommend correcting affected areas.  
Recommendation  
Contact your local utility company

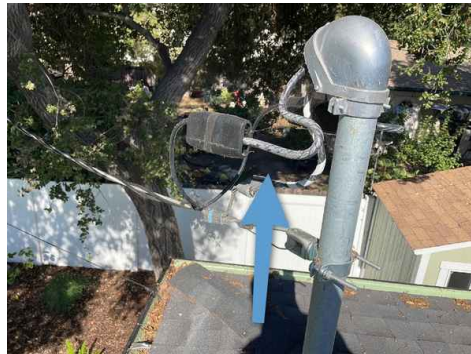
## 8.2.2 Service Entrance Conductors

**MISSING DRIP LOOP**

Drip Loop

Contact a qualified electrical contractor.

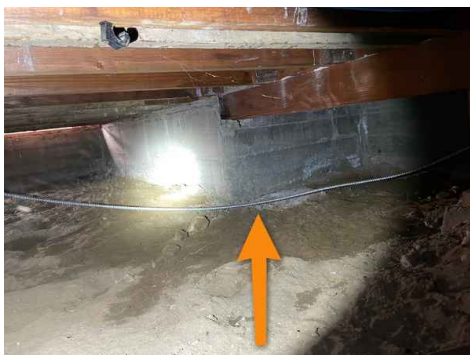
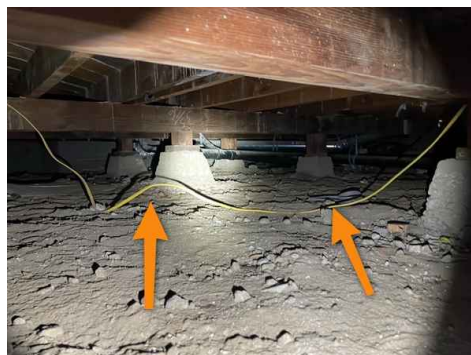
## 8.4.1 Branch Circuit Conductors, Overcurrent Devices and Compatibility of their Amperage and Voltage

**WIRING IMPROPERLY SECURED**

Contact a qualified professional.

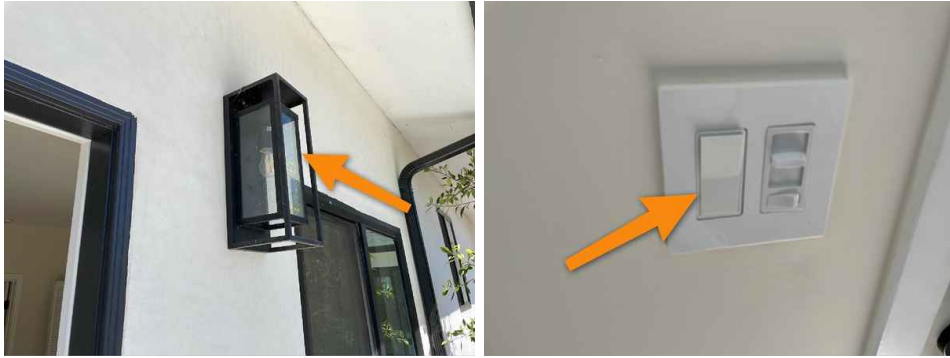
## 8.5.1 Light Switches/Light Fixtures and Ceiling Fans

**LIGHT/BULB(S) INOPERABLE**

Contact a qualified electrical contractor.

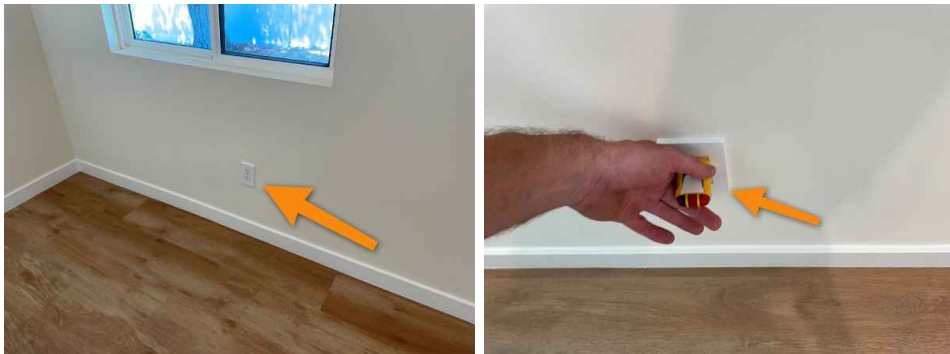
#### 8.6.1 Outlets

### INOPERABLE OUTLET

Contact a qualified electrical contractor.

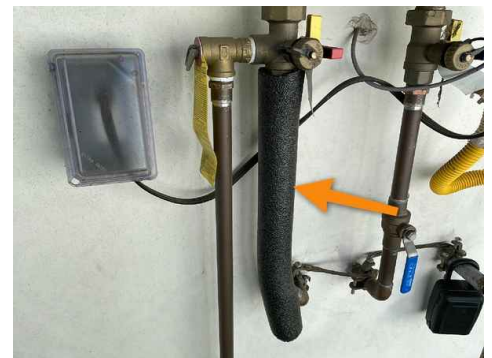
### INSULATION AT SUPPLY LINES

Limited review of supply lines due to insulation wrap.

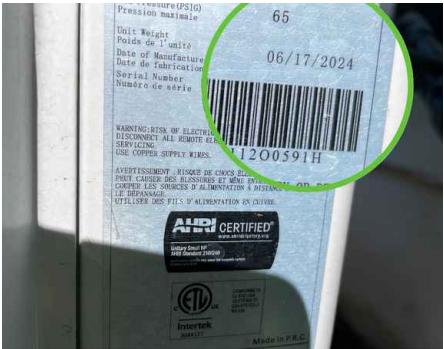
Operating a heat pump in heat mode when it's too warm outside (above 70 to 75 degrees) causes refrigerant over-pressurization. Because the system is designed to absorb heat from the outdoors and dump it inside, reversing this cycle when it's already hot creates extremely high pressures in the condenser, which can permanently damage the compressor. Due to the risk, the heater was not tested. Suggest verifying operation and condition in cooler temperatures.

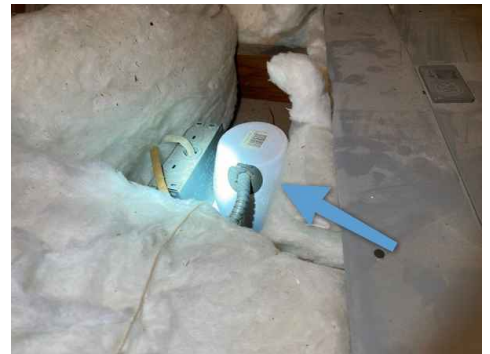
Insulation is in contact with lights in attic. Recommend correcting.

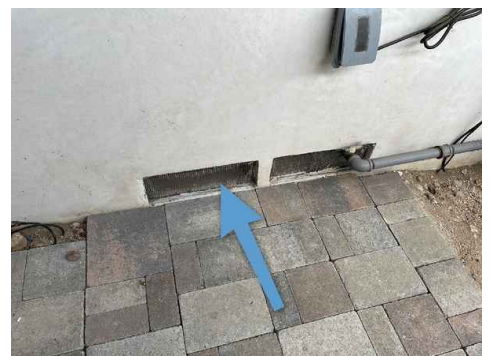
### 13.4.1 Ventilation of Attic and Foundation Areas

#### FOUNDATION VENTS BELOW GRADE

Foundation vents are installed below grade in areas. Recommend correcting to prevent moisture intrusion.

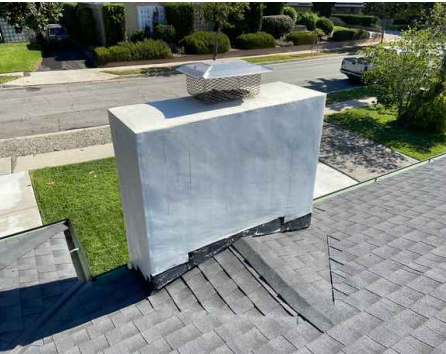
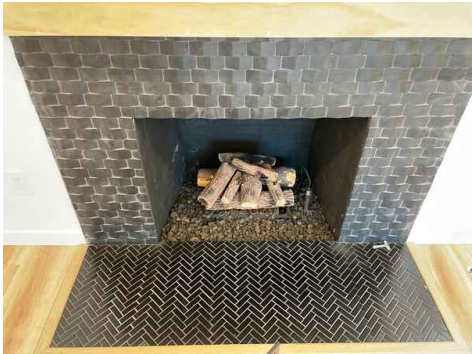
### General: Chimney/Fireplace Cover Pictures

**General: Chimneys (exterior)**  
Masonry Construction, Stucco Coated

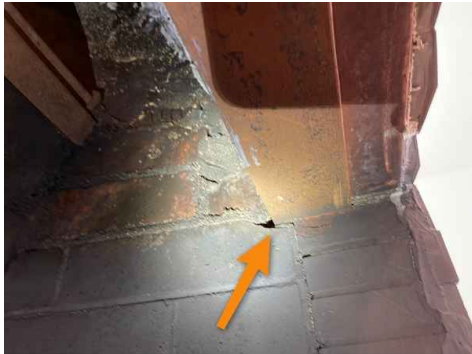
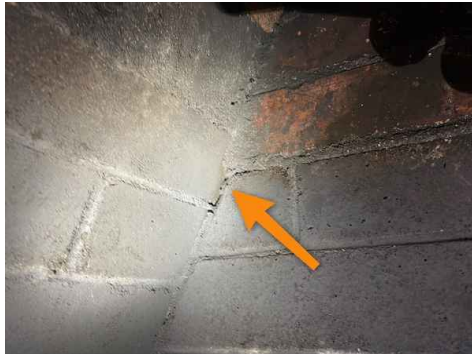
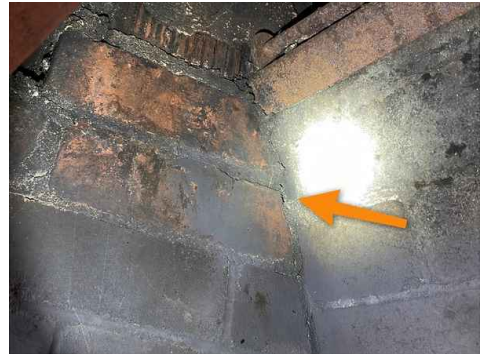
**DETERIORATION/GAPS/CRACKED FIREBRICK**

Cracked/deteriorated masonry and or gaps observed at firebox. Recommend verifying condition by a qualified fireplace specialist.

Contact a qualified fireplace contractor.

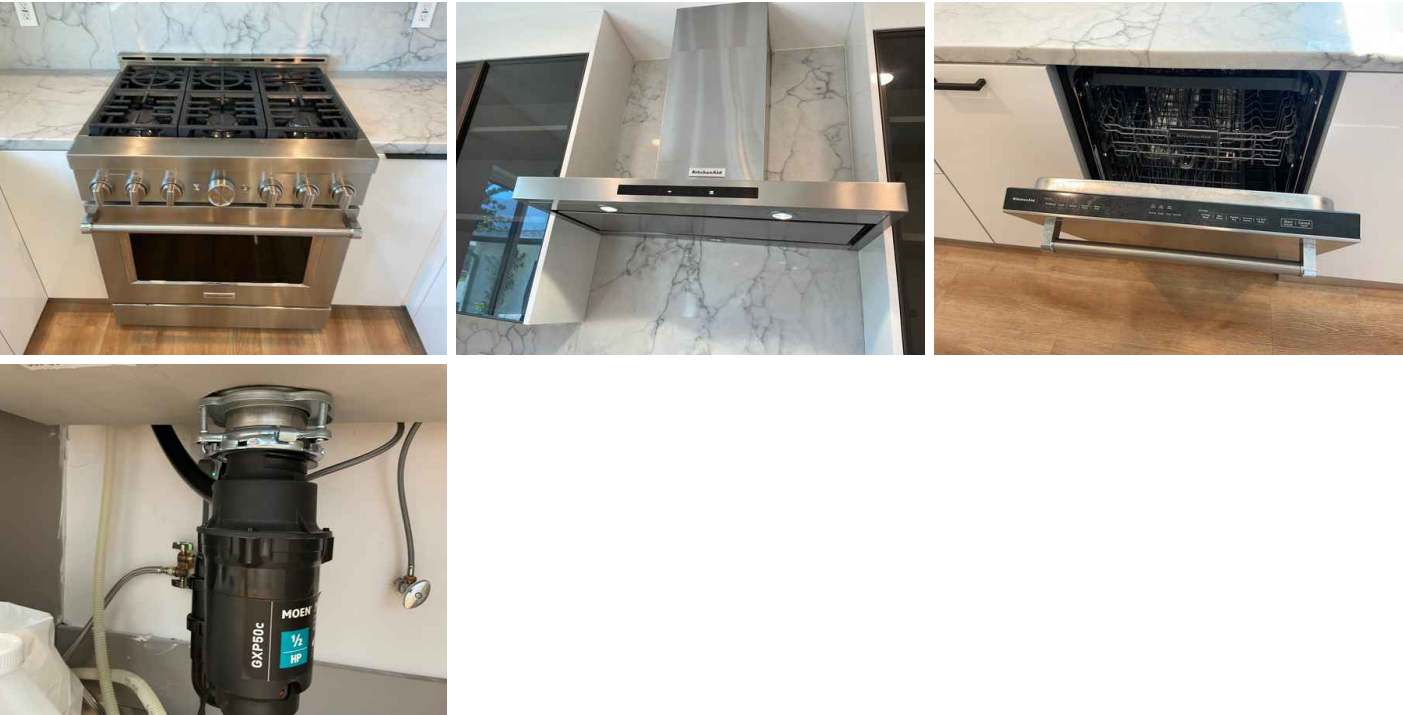
### Kitchen Appliances: Kitchen Appliance Pictures

**Kitchen Appliances: Dishwasher**  
**Brand**  
KITCHEN AIDE

**Kitchen Appliances: Range/Oven**  
KITCHEN AIDE

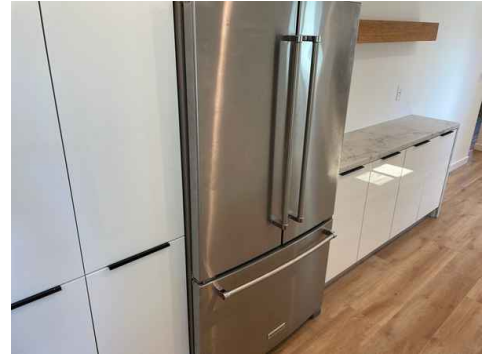
**KITCHEN APPLIANCES**

The kitchen appliances were tested in normal operating modes. Inspecting the refrigerator, ice makers/water lines, and appliance auxiliary features is beyond the scope of this inspection.

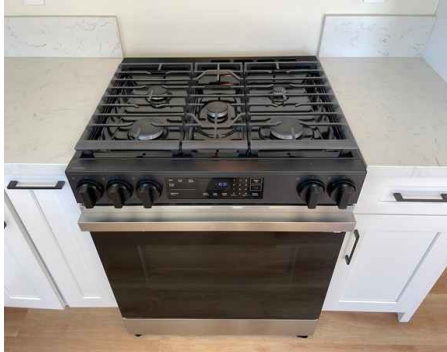
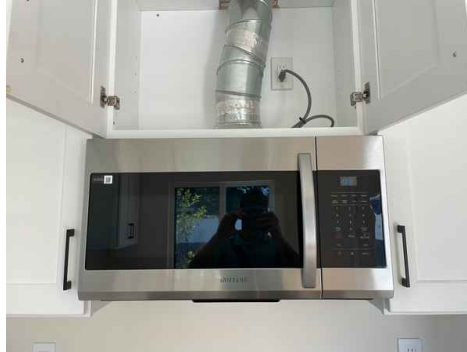
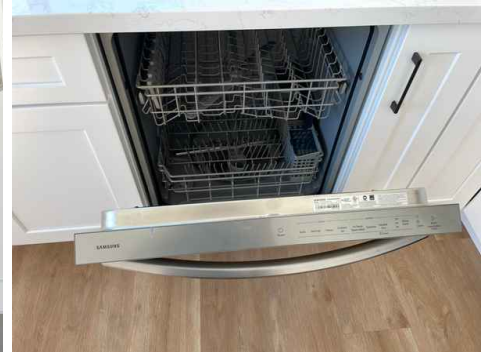
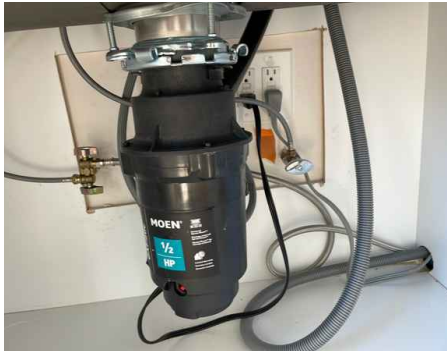
#### Kitchen Appliances: Kitchen Appliance Pictures

**Kitchen Appliances: Dishwasher**  
**Brand**  
Samsung

**Kitchen Appliances: Range/Oven**  
Samsung
