## PROPERTY INSPECTION REPORT

2115 N Baker St  
Santa Ana, CA 92706

Kim Skilling Steve Ranney  
JUNE 25, 2026

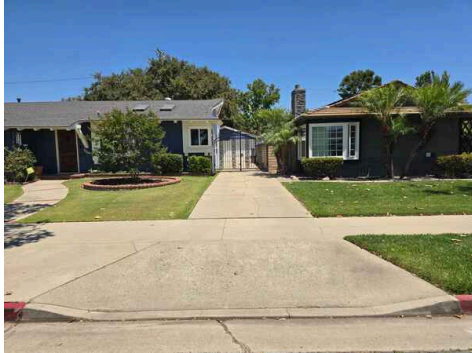
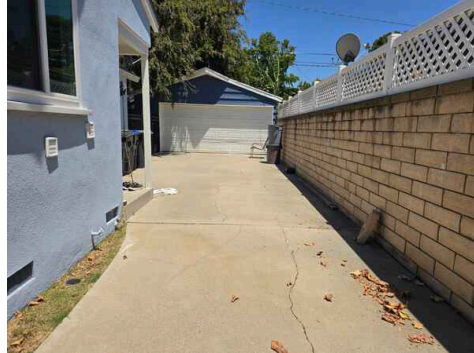
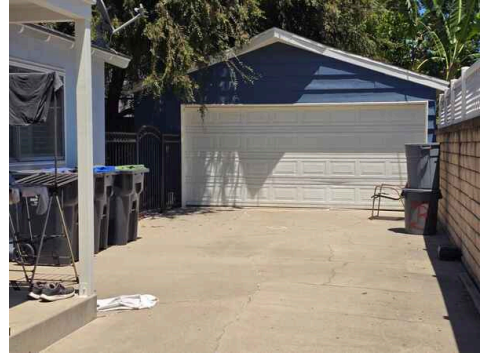
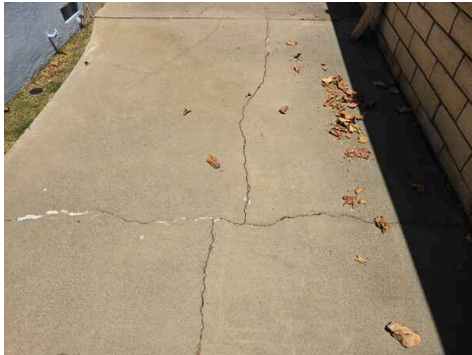
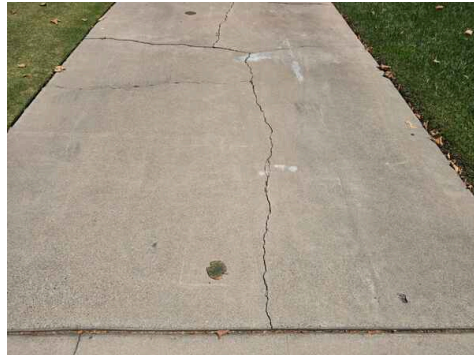
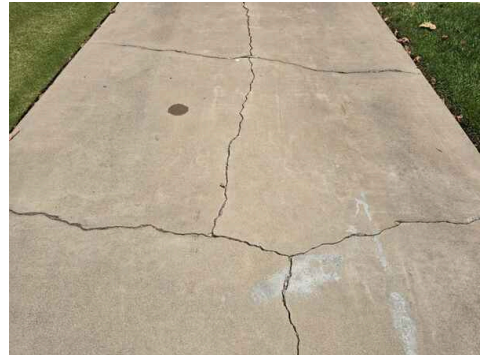
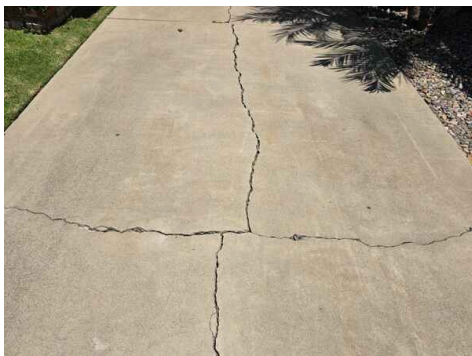
#### **CRACKING & HEAVING AT DRIVEWAY**

There is cracking and heaving at the driveway. I recommend evaluation by a licensed contractor.

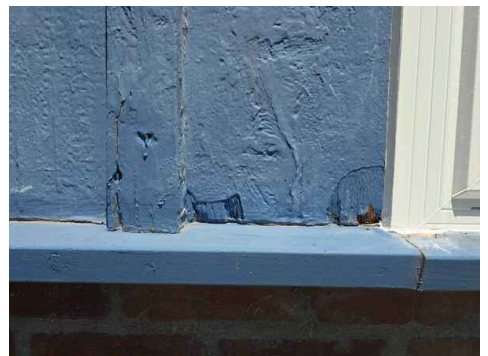
#### **MOISTURE/INSECT DAMAGED SIDING**

There is moisture and/or insect damaged siding at the front of the house. I recommend evaluation by a licensed contractor. Refer to a qualified structural pest control report for additional information.

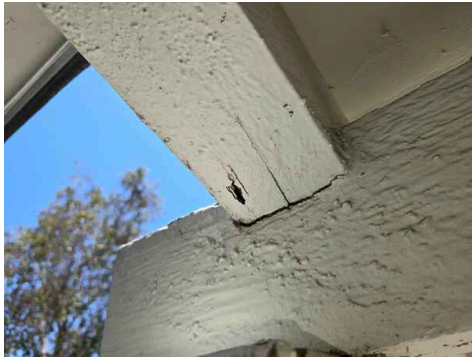
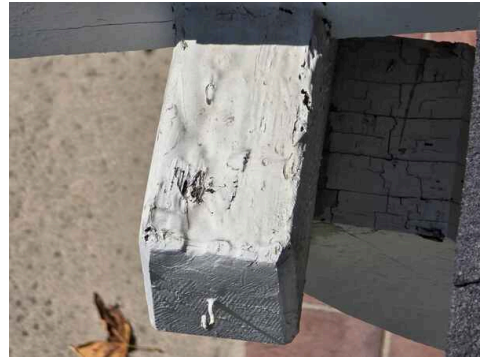
#### **MOISTURE/INSECT DAMAGE WOOD**

There is moisture and/or insect damaged trim at the exterior trim, rafter tails, and fascia. Refer to a qualified structural pest control report for additional information.

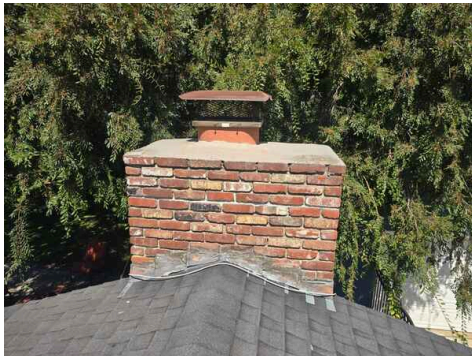
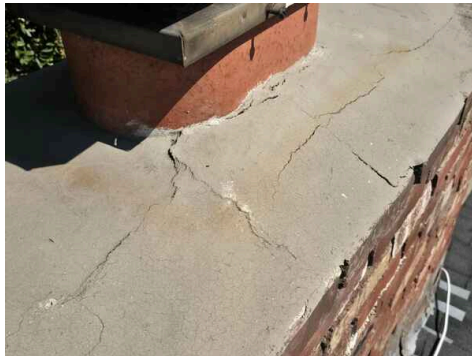
#### **CRACKING IN CHIMNEY CROWN**

There is cracking in the mortar cap at the top of the chimney. I recommend a level II inspection and evaluation by a certified chimney sweep.

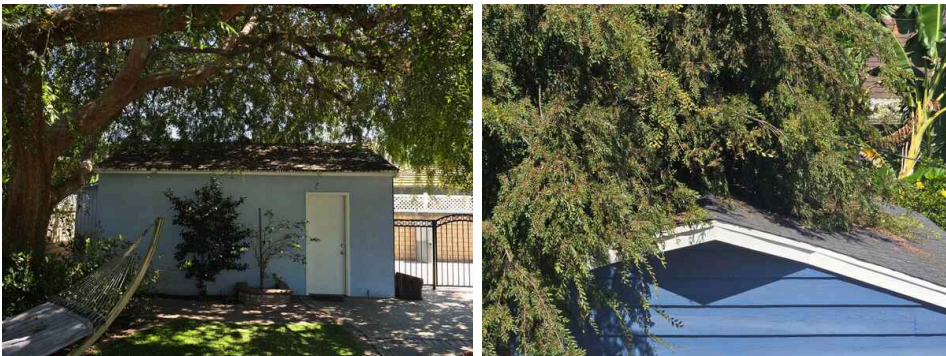
##### GARAGE

There are plant materials growing onto or over the garage roof. The plant materials should be cut back and removed from the roof. The roofing materials should be inspected for damage. I recommend evaluation by a qualified technician or licensed roofing contractor.

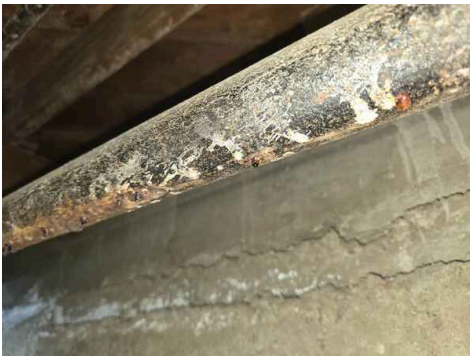
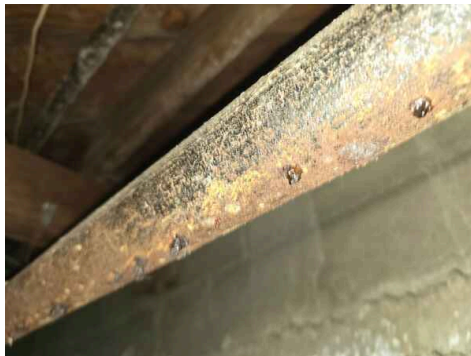
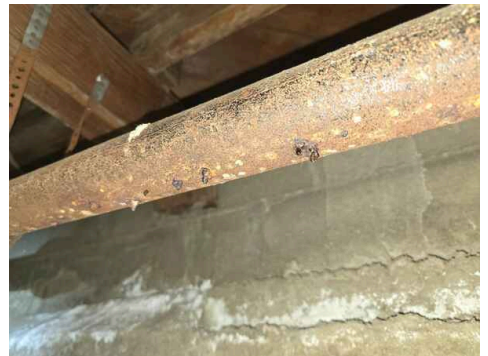
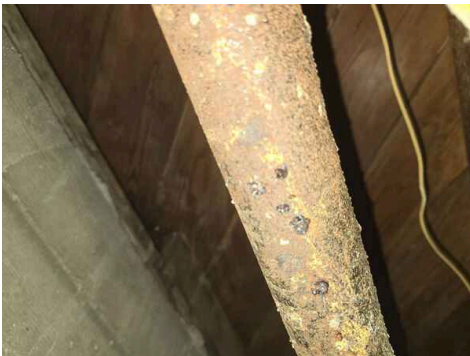
#### **RUST CYSTS ON CAST IRON WASTE PIPING**

There are rust cysts on portions of the cast iron waste piping in the crawl space. The damaged piping likely needs replacement. I recommend evaluation by a licensed plumbing contractor.

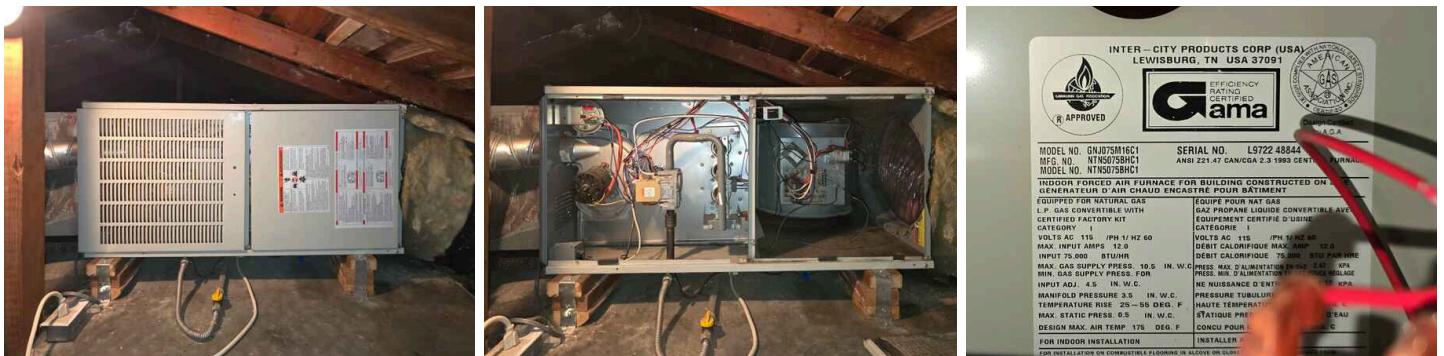
##### ATTIC

The furnace responded to the controls and appears to function at this time. However, the furnace is approximately 29 years old and in use beyond the manufacturer's life expectancy. The remaining lifespan of this system may be limited. The furnace does not appear to have been serviced recently. I recommend evaluation and service by a licensed heating contractor.

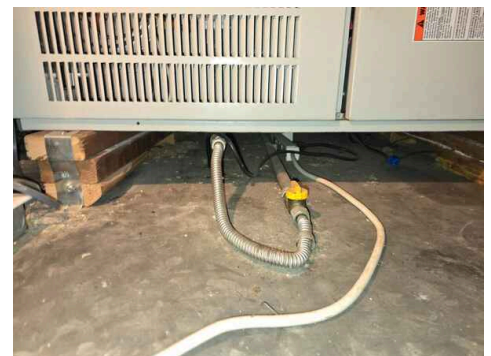
#### **SEDIMENT TRAP NOT INSTALLED AT FURNACE GAS SUPPLY**

A sediment trap has not been installed at the gas supply to the furnace. I recommend evaluation by a licensed plumbing contractor.

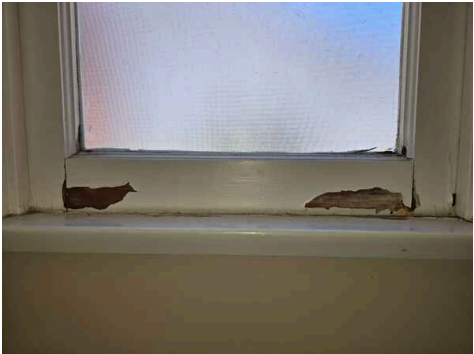
**PAINT FINISH DAMAGED**

The paint finish is damaged at the interior side of the master bathroom windows. I recommend evaluation by a licensed painting contractor.

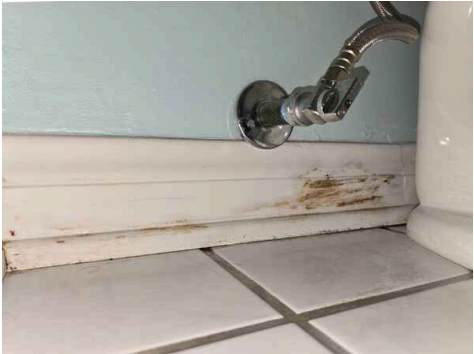
**MOISTURE STAINING ON BASEBOARD**

There is moisture staining on the baseboard behind the hallway bathroom toilet. I recommend evaluation by a licensed contractor.

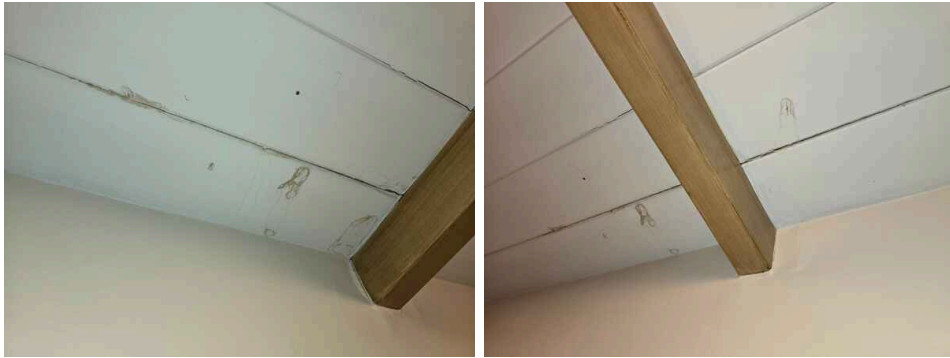
#### **MOISTURE STAINING ON CEILING**

There is moisture staining on the ceiling at the east side of the living room. I recommend evaluation by a licensed contractor.

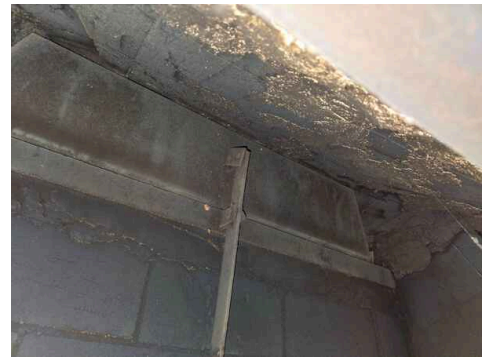
#### **DAMPER NOT PERMANENTLY OPEN**

Gas service is provided to the fireplace. The damper has not been blocked permanently open with a clamp, as required. I recommend evaluation and repair by a qualified technician.

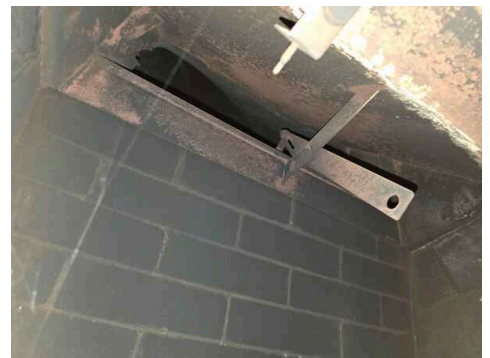
#### **DAMPER NOT PERMANENTLY OPEN**

Gas service is provided to the fireplace. The damper has not been blocked permanently open with a clamp, as required. I recommend evaluation and repair by a qualified technician.

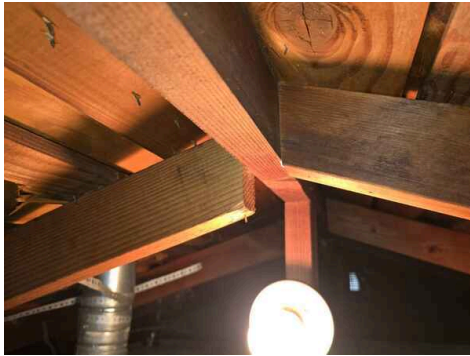
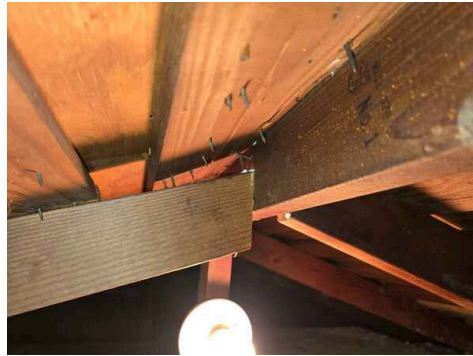
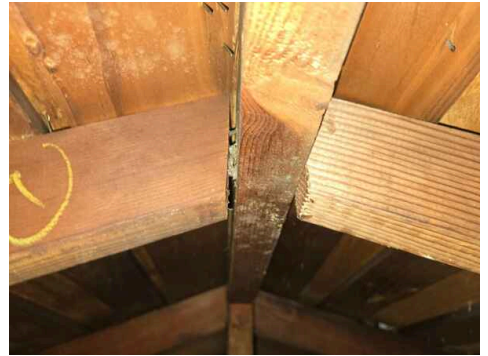
## ATTIC

Several of the roof rafters are separating from the ridge within the attic. The separating rafters should be secured to the ridge with metal framing connectors. I recommend evaluation by a licensed contractor.

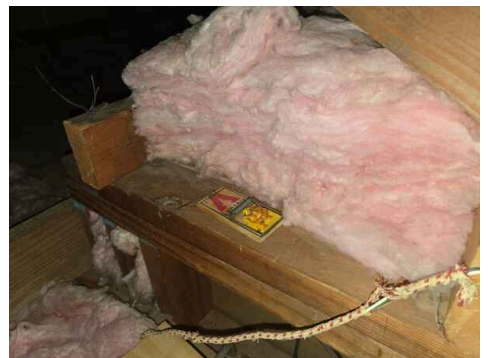
**RODENT TRAPS WITHIN ATTIC**

There are rodent traps within the attic. I recommend evaluation by a licensed pest control operator.

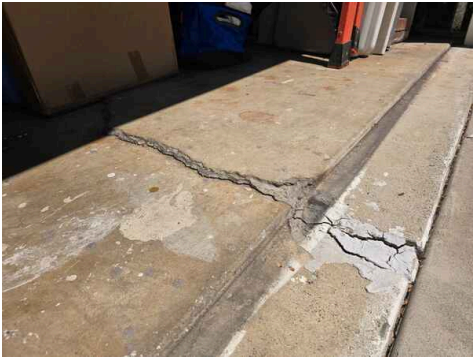
GARAGE

There is cracking and heaving at the garage floor concrete. I recommend evaluation by a licensed contractor.

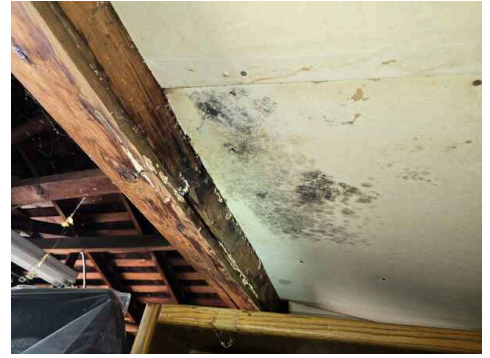
### MOISTURE STAINING AND DAMAGE

There is moisture staining and damage at the garage ceiling. I recommend evaluation by a licensed contractor. Refer to a qualified structural pest control report for additional information.

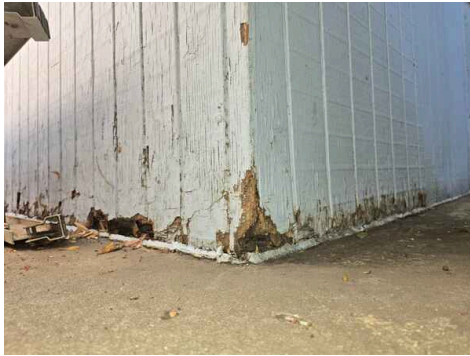
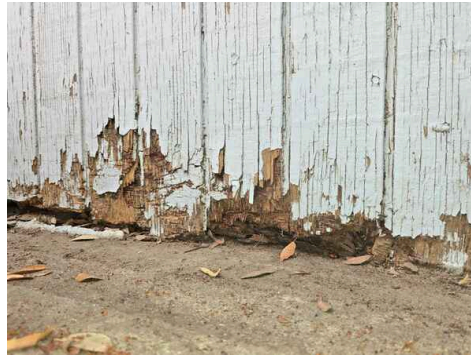
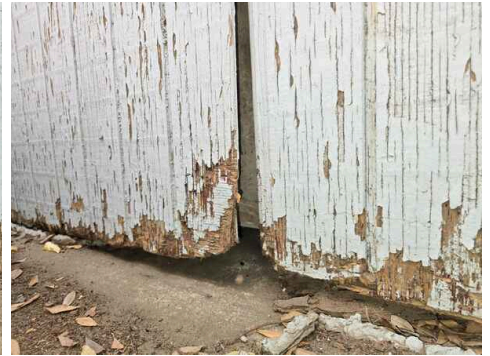
### MOISTURE DAMAGED SIDING

There is moisture damaged siding at the exterior east side of the garage. I recommend evaluation by a licensed contractor. Refer to a qualified structural pest control report for additional information.
