PROPERTY LOCATION: 1168 Knoll Dr Monterey Park, CA 91754

# INSPECTIONREPORT

Date of Inspection: 8/27/2026 at 12:30 PM

Year Built: 1931 Sq Ft: 803

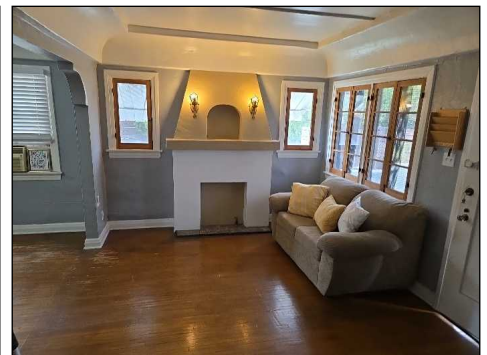
## 1. Wall Conditions

- Some areas not accessible or visible due to access limitations or personal items/furnishings
- No major visible defects observed at the time of inspection
- Small cracks/holes/chipped/dirty areas/cosmetic blemishes observed - typical for age of structure
- Peeling/blistered/cracking paint in areas
- **Peeling/blistered/cracking paint in areas**

**Peeling/blistered/cracking paint in areas**

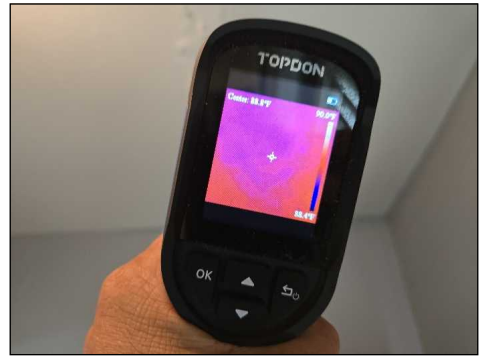
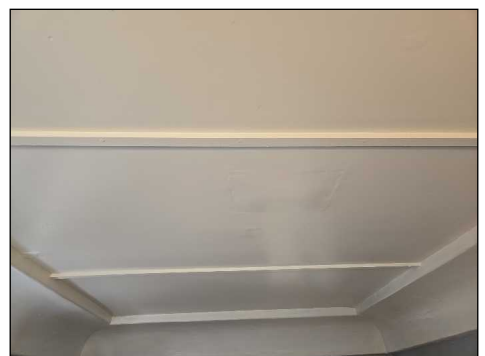
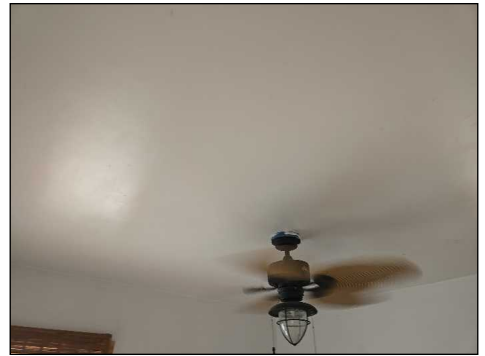
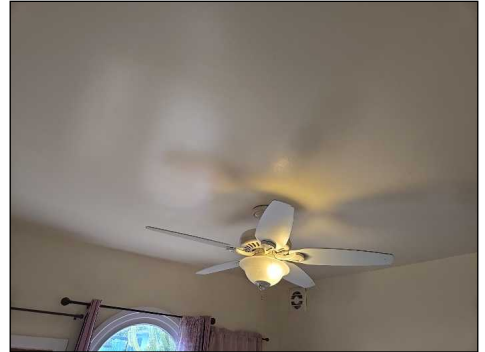
## 2. Ceiling Conditions

- Small cracks/holes/chipped/dirty areas/cosmetic blemishes observed - typical for age of structure
- Patched/partial painted areas present - consult seller regarding patched areas
- Large cracks or holes present – larger than typical - needs to be further evaluated/serviced
- Stains/blistered areas present - tested dry with moisture meter at time of inspection
- Evidence of past moisture problems - consult seller/disclosures for any past history of moisture issues
- Moisture damage- needs to be serviced; inquire with seller regarding cause and if repaired

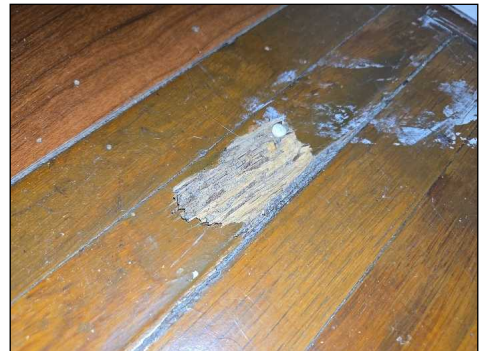
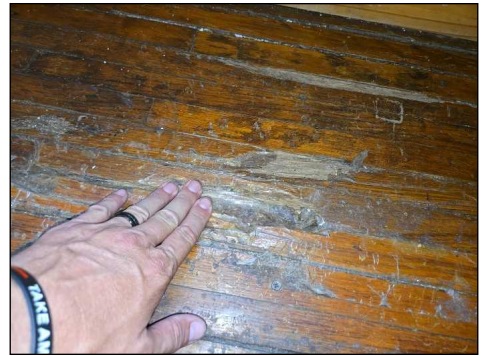
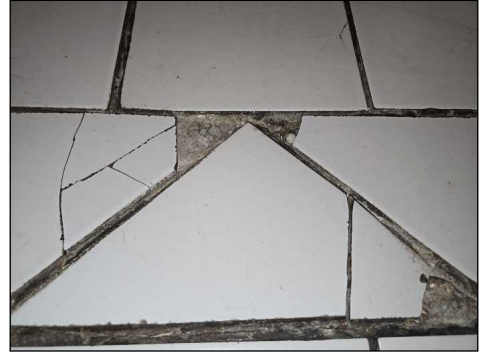
### 3. Floor Conditions

- Damaged flooring – service needed
- Damaged- needs to be serviced

**Damaged flooring – service needed**

**Damaged- needs to be serviced**

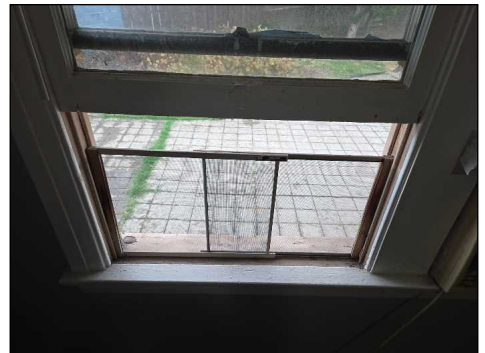
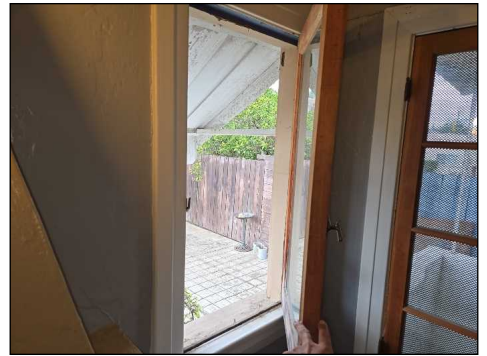
#### 4. Window Conditions

**Did not lock/latch properly - needs to be serviced**

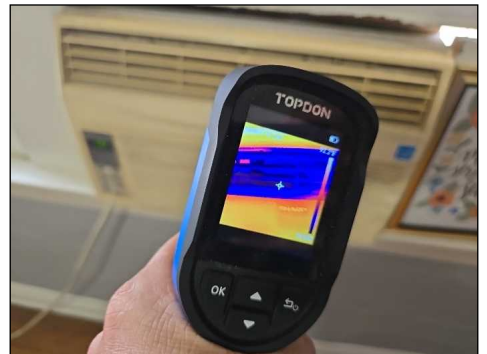
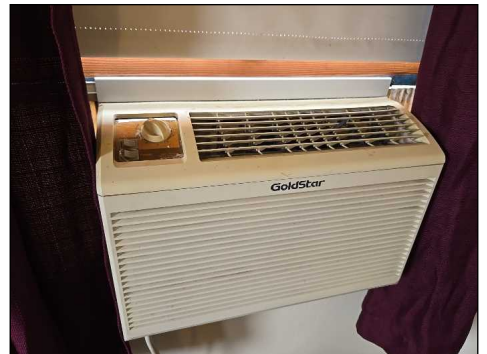
- Very old and worn unit - life expectancy limited
- Condensation/moisture damage observed - needs to be serviced/further evaluated

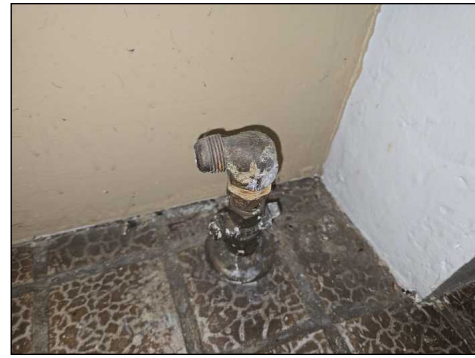
- Recommend further evaluation by CSIA certified chimney sweep
- Uncapped gas line - needs to be serviced

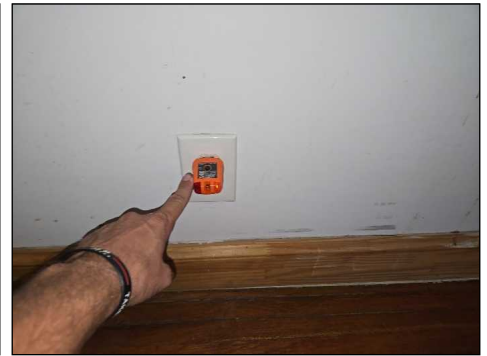
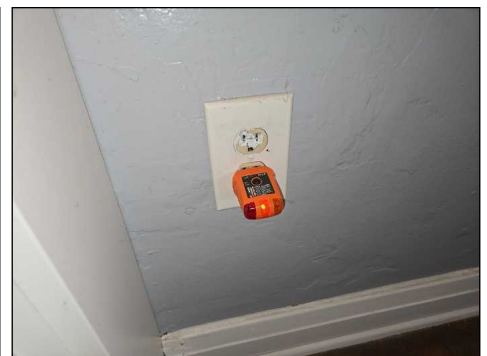
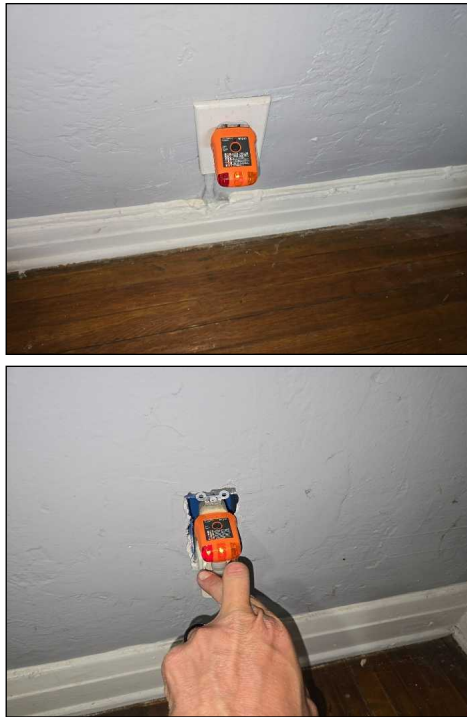
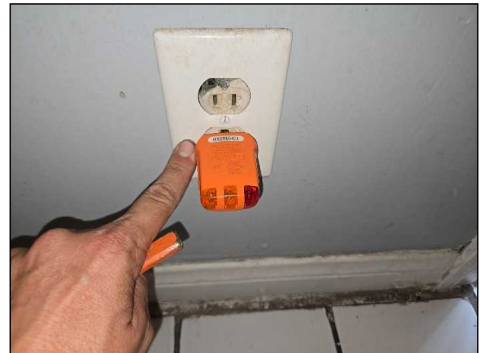
## 8. Electrical

Non-energized (dead) outlet(s) - needs to be serviced

**Outlet cover missing - needs to be serviced**

**Outlet hot wired in reverse with neutral - needs to be serviced**

**Broken outlet(s) - potential hazard - needs to be serviced**

**Non-energized (dead) outlet(s) - needs to be serviced**

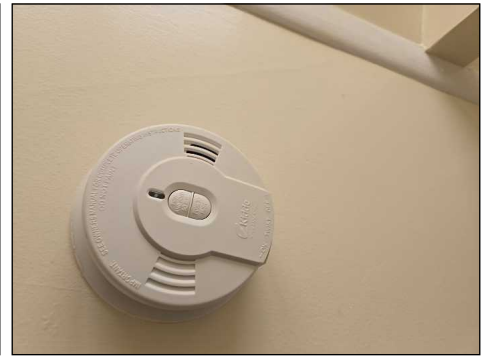
**Did not operate in bedroom- needs to be serviced or replaced**

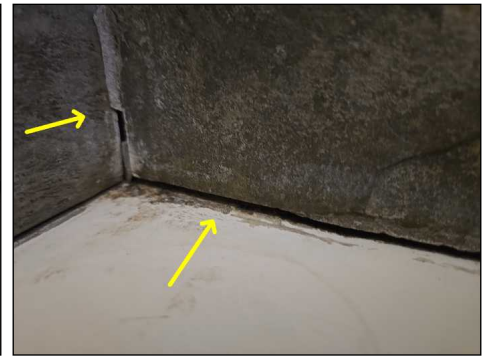
**Cracked/loose/missing grout in areas - recommend grout and sealer**

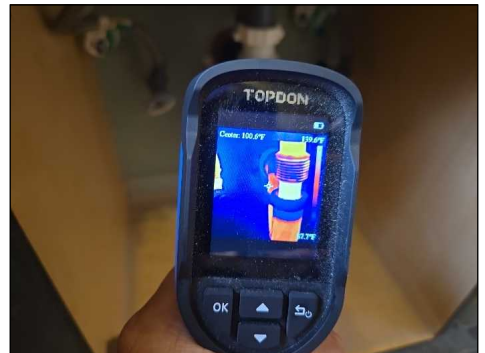
## 9. Plumbing

- The plumbing supply valves are visually inspected only and are not tested for functionality due to the potential for leakage - valves that are not used often will seize or freeze and are likely to leak when operated (opened/closed).
- Operational at time of inspection via normal fixture controls with no major visible defects
- Angle stops/hoses/drain pipes are worn/older - recommend upgrading these areas with new fixtures
- No visible leaks found at the time of the inspection after running water at fixtures
- Corrosion is present at plumbing areas - this is a sign of slow leaking and should be further evaluated by a plumber
- Plastic flex line used on bathroom sink drain - this material is considered weak and should be upgraded for optimum long term drainage

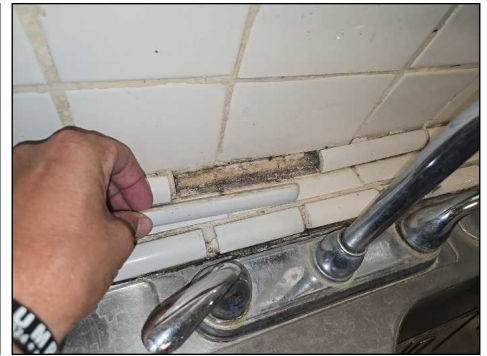
- Scratched/Worn/Chipped/Stained areas - signs of age and wear
- Cracked materials - needs to be serviced
- Cracked/loose materials - needs to be serviced

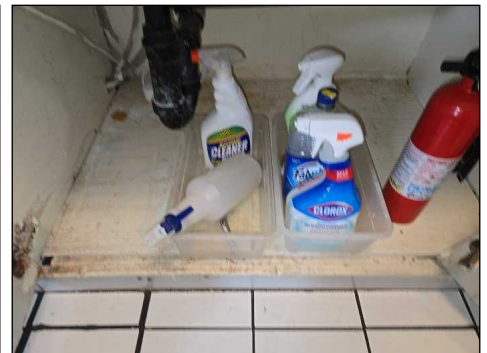
## 2. Cabinets

Damaged cabinet doors - needs to be serviced

Missing drawer/front - needs to be serviced

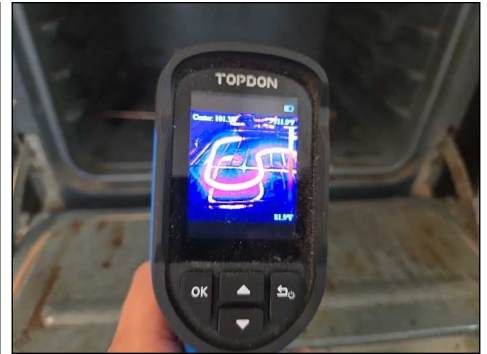
- Worn/older unit - replacement/repairs/maintenance will be required in the near future
- Glass in door damaged - needs to be serviced

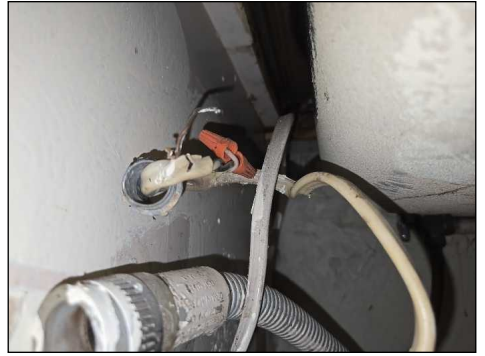
**Exposed wires - potential hazard - needs to be serviced**

**Exposed connections - potential hazard - needs to be serviced**

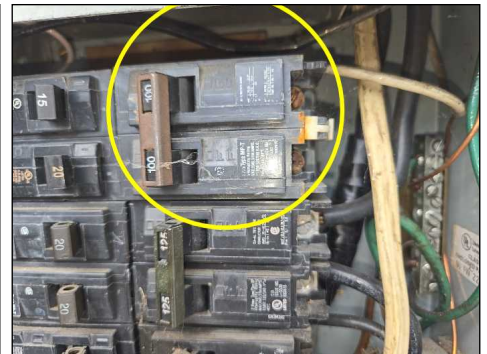
- Recommend upgrading services due to age of electrical system
- **Outer door missing/loose/damaged - needs to be serviced**
- **Improper modifications present at panel - needs to be serviced**

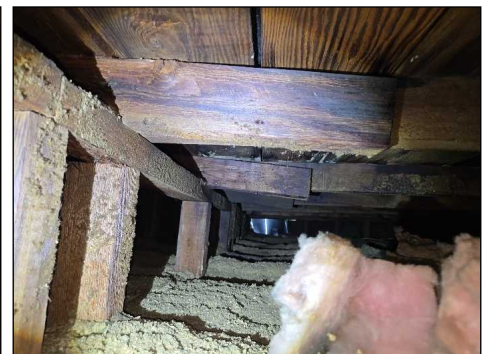
- **Consult termite report** for all wood areas in the attic
- Cracking small at wood members - typical for age
- *Could not access all areas of the attic due to limited space or insulation covering joist chords*
- **Deteriorated wood observed - consult termite report**
- **Large stains present on wood members of structure - needs to be serviced and further evaluated for possible leak**

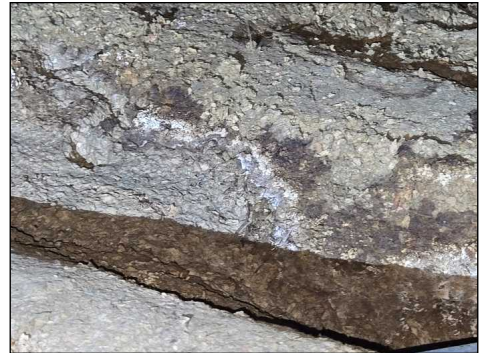
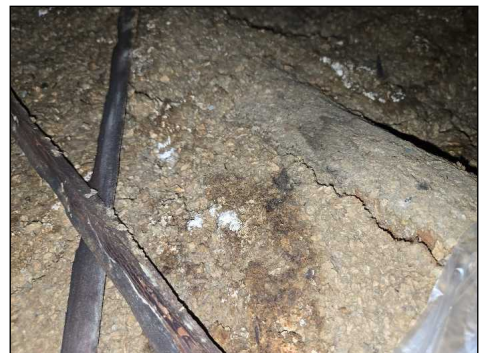
### 3. Insulation

- All visible insulation is worn/older/dirty - typical for the age of the structure
- This structure would benefit from new insulation
- Evidence of moisture entering structure- needs to be serviced - recommend further evaluation
- Irregular installation/workmanship- needs to be serviced

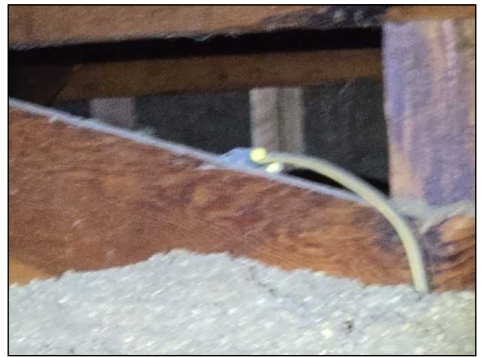
- Cover missing at junctions box(es) exposing connections - needs to be serviced
- Exposed connections (splices) not properly installed with a junction box - potential hazard - needs to be serviced

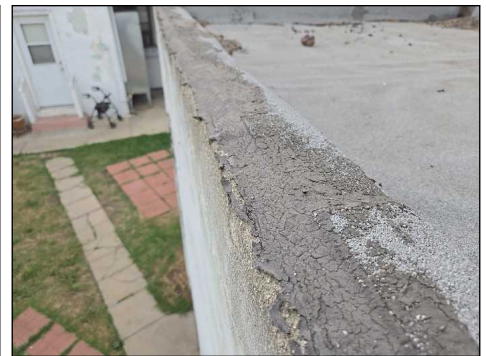
- Worn and weathered materials present - typical for age and weather exposure - **roof needs maintenance**
- Debris present on roof areas - recommend removal of all debris
- ***The inspector cannot determine if a roof (or any part of the roof system) leaks at any time or under any weather conditions, no water or hose testing is performed during this inspection. If there are concerns of possible roof leaks, please contact a licensed roofer to perform an additional inspection and/or roof certification. Remaining roof life can only be determined by a licensed roofer. This applies to all roof areas evaluated during this inspection.***
- **Damaged materials/areas - needs to be serviced**

**Damaged materials/areas - needs to be serviced**

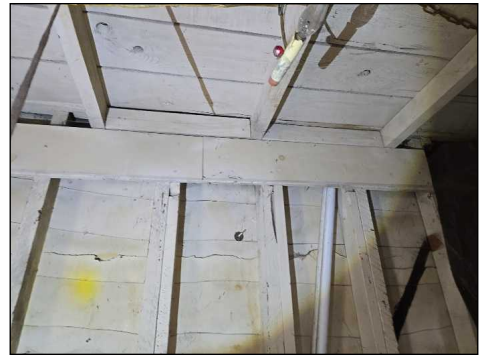
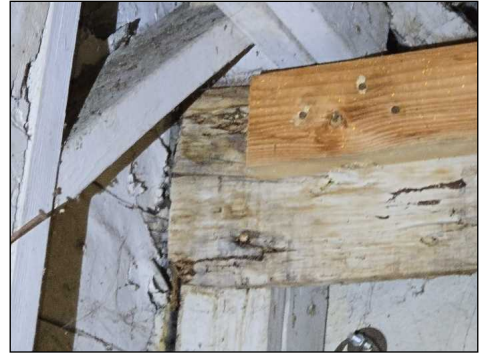
## 2. Rafters & Ceilings

- **Exposed wood rafters/joists - consult termite report** for all wood areas
- Cosmetic blemishes observed
- Cracking small - typical for age, recommend patching
- Patched areas observed - inquire with seller regarding reason for repairs
- **Evidence of moisture entering structure - hidden defects may exist; needs to be serviced**
- **Wood deterioration observed - consult termite report** for any wood areas in garage area

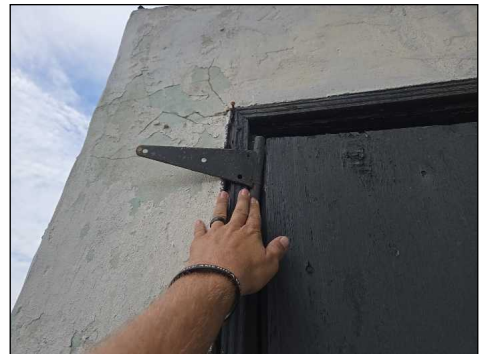
### 3. Main Automotive Doors

- Damaged/deteriorated - needs to be serviced
- Not functional - needs to be serviced
- Locked could not test

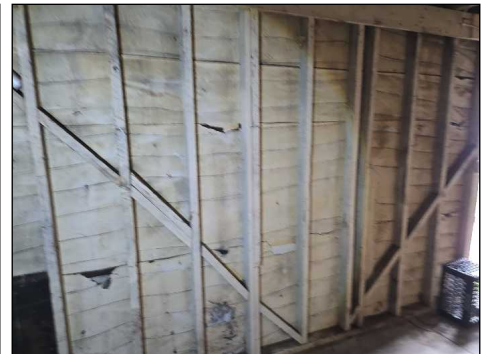
- **Consult termite report** for any wood areas in garage
- Small cracks/holes/chipped/dirty areas/cosmetic blemishes observed - typical for age of structure
- Torn building paper
- Stains present - tested dry for moisture at time of inspection
- Wood deterioration observed - consult the termite report for all wood in the garage
- Moisture damage at base - needs to be further evaluated

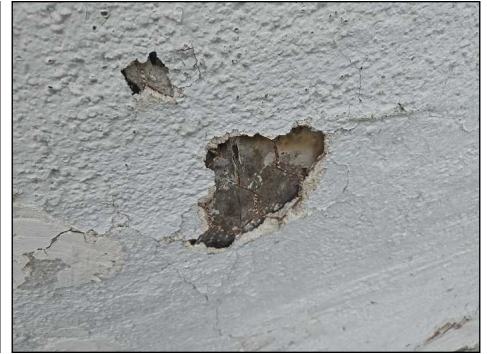
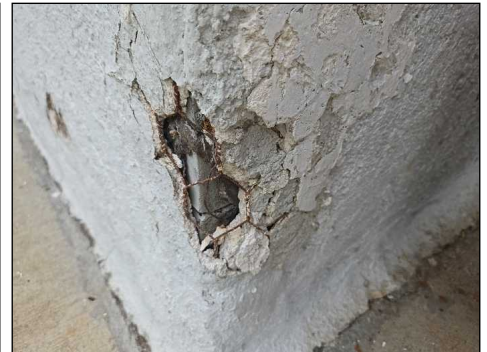
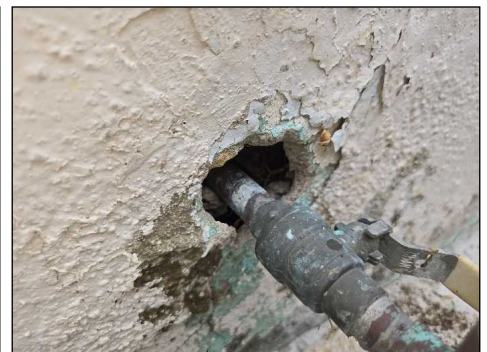
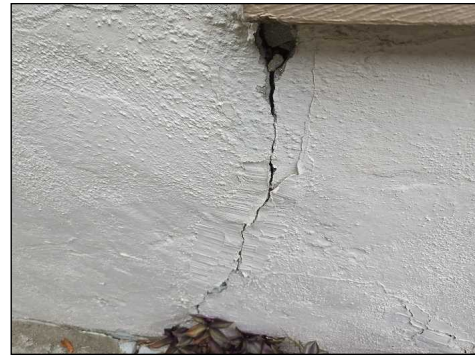
- Small cracking/chipping/holes present in areas - recommend stucco service/**maintenance**
- Patching present - consult seller for past repaired areas
- **Cracking/chipping/holes more than typical - needs to be serviced**
- **Cracking - more than normal - needs to be serviced**

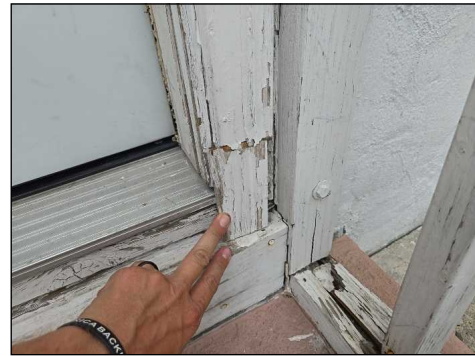
## 2. Wood Trim

- Recommend general trim **maintenance** and sealing any holes/gaps
- Worn/weathered at time of inspection where visible – recommend service and water tight **maintenance**
- **Damaged in areas - needs to be serviced**

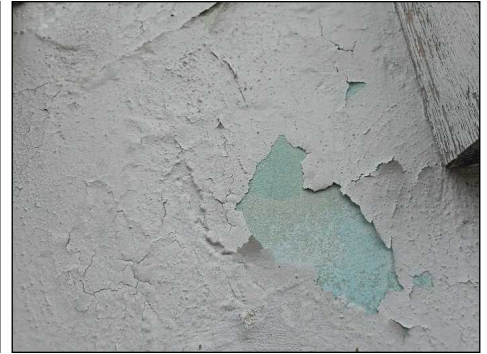
- Paint faded and typical for the age
- **Weathered and worn more than normal - needs to be serviced**
- **Blistered and peeling in areas - recommend servicing**

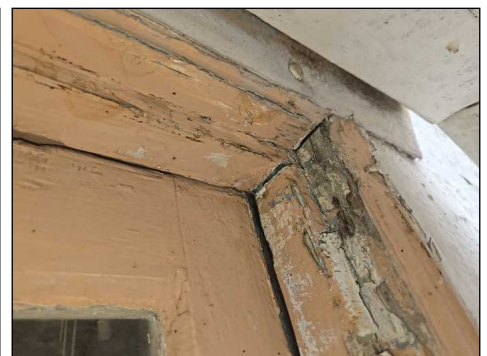
- ***Exterior windows require seasonal maintenance to extend lifespan and maintain weather tight seals***
- See interior section for additional information - some exterior window areas may not be visible due to height/limited access/vegetation/etc.
- **Consult the termite report for all wood windows/frames at this structure (if wood is present)**
- Worn windows/screens - typical for age
- Recommend weather tight service/maintenance
- Screens prevented complete inspection in areas
- **It appears that this structure has the original windows - consult a window contractor to evaluate these older windows, consider upgrading the windows at this structure**
- **Deteriorated frames - needs to be serviced**

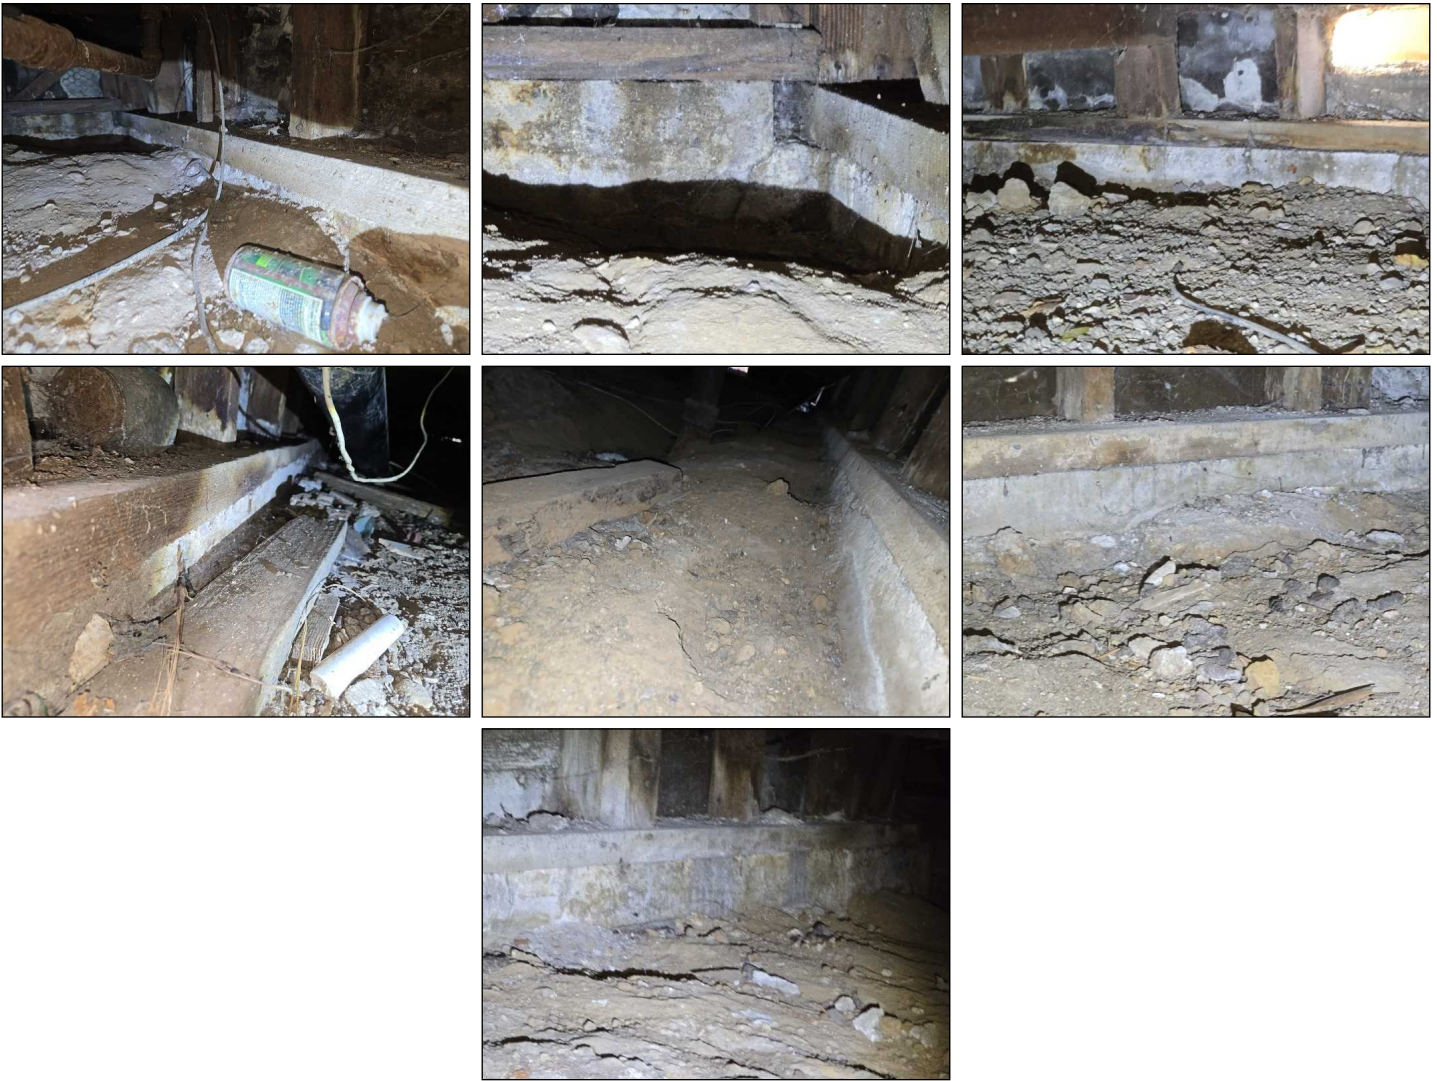
- Constructed of: concrete
- Visible foundation wall areas are worn and stained areas - typical for age of the structure and material
- Cracked areas present - typical for age of material
- Stained/worn areas - typical for age
- **All accessible areas of foundation walls were visibly inspected during this inspection (some areas may not be accessible due to limited space/plumbing piping/duct work obstructions)**
- **Efflorescence is excessive in areas - ongoing moisture or drainage problem may exist - needs to be serviced/further evaluated**
- **Recommend foundation contractor to evaluate this foundation due the age of the structure**

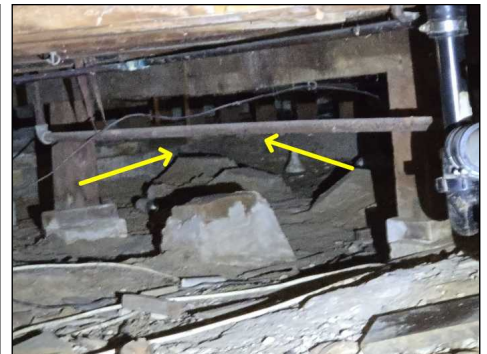
- Stained and worn areas - typical for age of structure
- Small cracking at wood members - typical for age of structure
- Brackets for all attachment points would benefit the structure
- **Damaged framing - needs to be serviced**
- **Recommend foundation contractor or structural engineer to further evaluate**

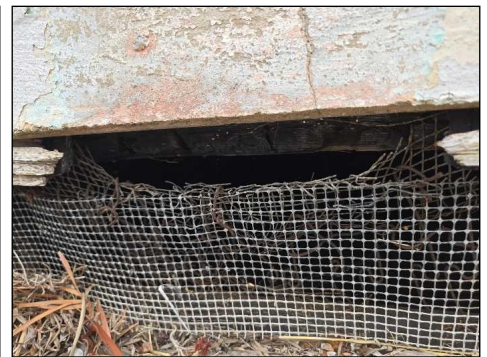
**Missing screens - recommend maintenance and repairs to prevent pest intrusion**

**Damaged screens - recommend maintenance and repairs to prevent pest intrusion**

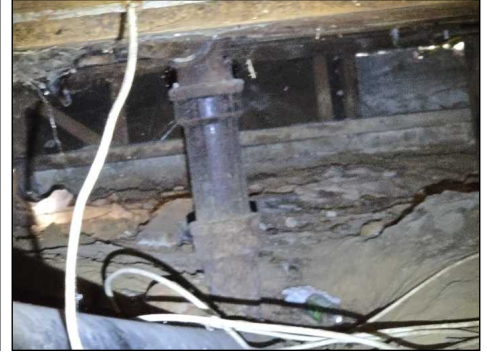
- Visibly leaking plumbing - recommend immediate evaluation by a licensed plumber to prevent unwanted moisture in crawl space
- **Galvanized** steel and cast iron plumbing drain piping present - we recommend that licensed plumber further evaluate due to the age of the materials present

- Corrosion/cysts at one or more locations of the metal drain lines or distribution piping - recommended further evaluation by a licensed plumber

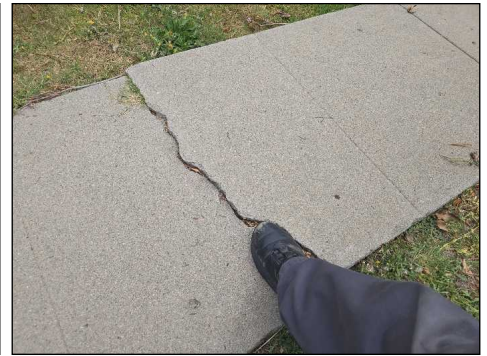
- Worn with common cracks/chips - typical for age of material
- Driveway stained in areas
- Walkways stained in areas
- **Moderate cracking in areas - recommend maintenance and patching as needed**
- **Cracking/chipping large - recommend servicing**

**Moderate cracking in areas -  
recommend maintenance and  
patching as needed**

**Cracking/chipping large -  
recommend servicing**

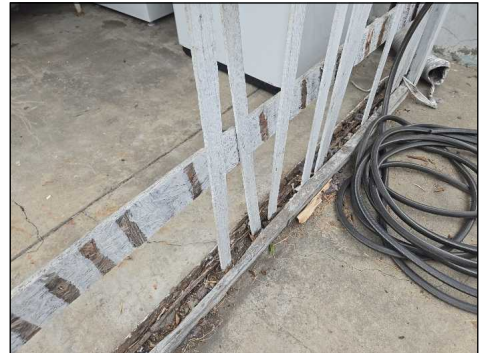
**Wood deterioration observed -  
**consult termite report****

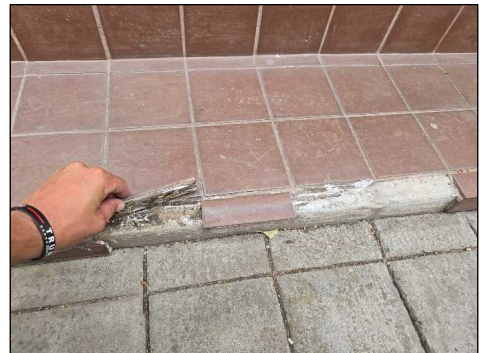
**Damaged rails - unsafe - needs to  
be serviced**

**Damaged steps - unsafe - needs to  
be serviced**

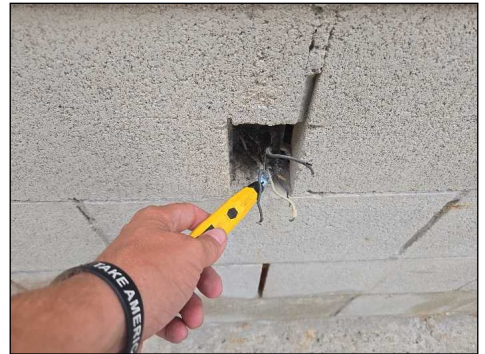
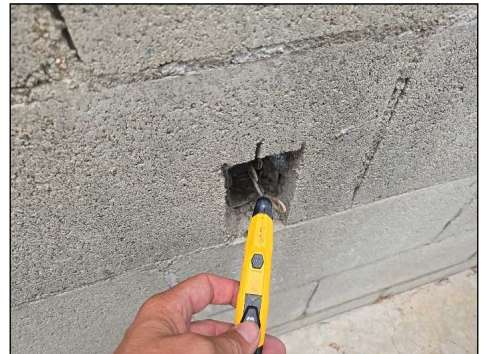
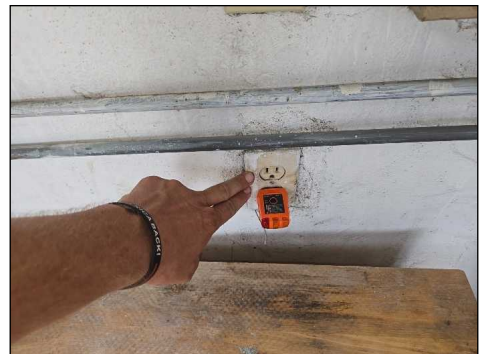
#### 4. Exterior Electrical

- The visible and tested fixtures/switches/outlets were in a loose/worn condition - typical for age
- Electrical fixtures need to be caulked/sealed to wall attachments to help prevent moisture entry
- Some light(s) did not function (some may be on sensors or timers) - check bulbs first, then consult an electrician to further evaluate as needed
- Exterior outlet/switch covers are missing or not of proper exterior weather proof type - needs to be serviced
- Exposed wires/connections - potential hazard - needs to be serviced
- Improper electrical installation - needs to be serviced

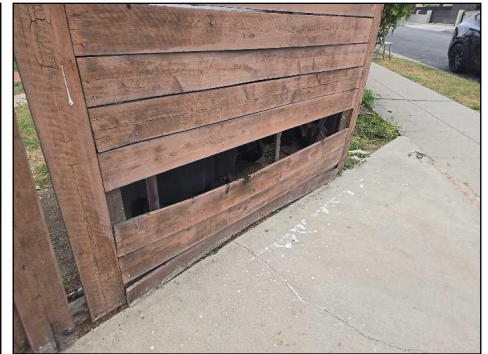
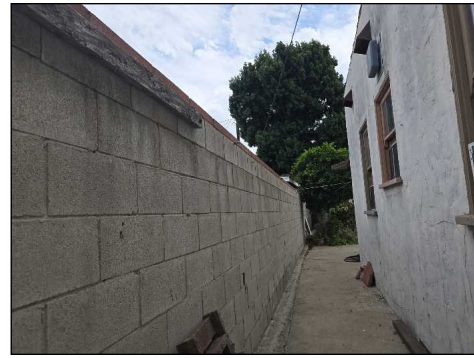
Damaged fencing/walls - needs to be serviced

Missing boards - recommend servicing

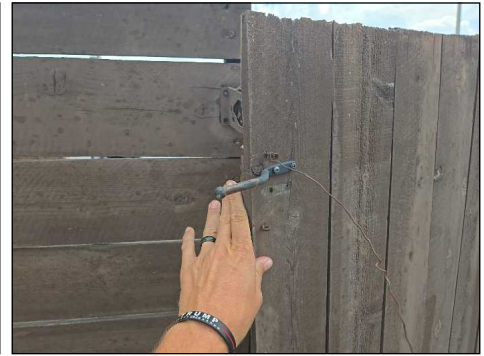
Damaged - needs to be serviced

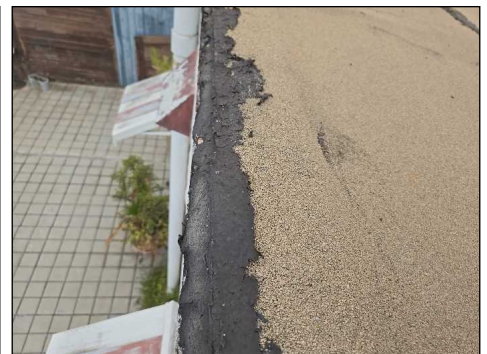
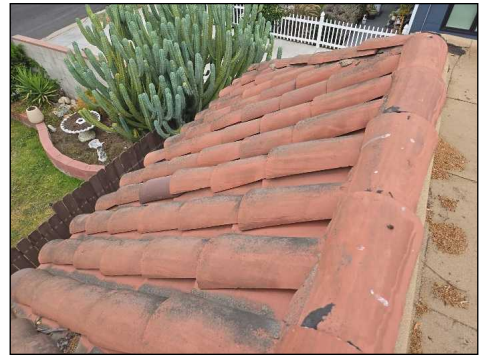
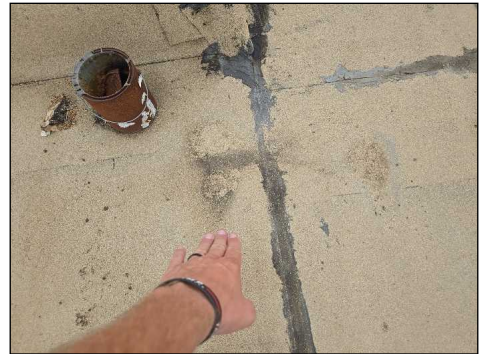
- Worn and weathered materials present - typical for age and weather exposure - roof needs maintenance
- Evidence of prior repair/patching observed - consult seller for all past repairs and roof service history
- Patching observed in areas on roof materials - inspector is unable to guarantee the adequacy of these repairs - recommend maintaining a continuous water tight seal in these areas
- Rolled composition roofing not considered a long-term material - regular maintenance is required
- **Broken tiles - needs to be serviced**
- **Missing/damaged shingles/tiles at ridge/hip - needs to be serviced**
- **Roof material not properly fastened - needs to be serviced**
- **Ponding or evidence of ponding in areas - needs to be serviced**

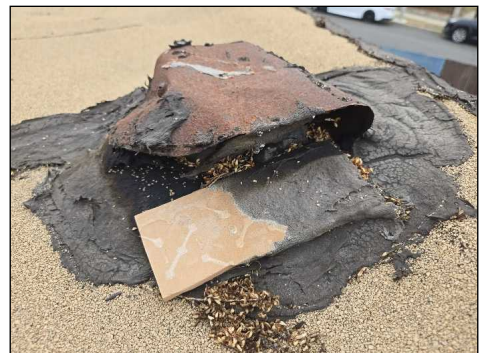
- Worn/weathered cap(s) – recommend seasonal maintenance to ensure that caps do not become loose or develop other defects
- Corroded - needs to be replaced
- Irregular materials/installation/workmanship used - needs to be serviced
- Mastic at vent(s) is weathered and cracked - needs to be serviced and resealed at all penetration points

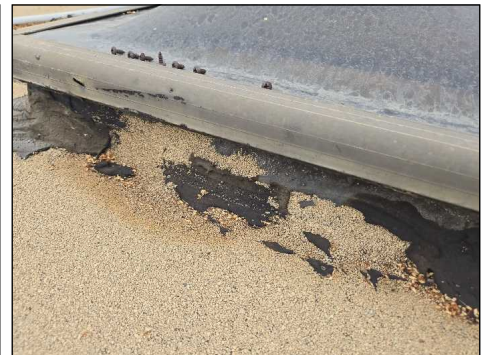
- Worn/weathered – recommend seasonal maintenance and sealing of all areas to ensure no water intrusion
- Excessive mastic/caulk repairs - signs of past moisture intrusion - needs to be serviced
