PROPERTY INSPECTION V 5.0

1919 Aspen Cir  
Fullerton, CA 92835

Allison Massenzio  
08/15/2026

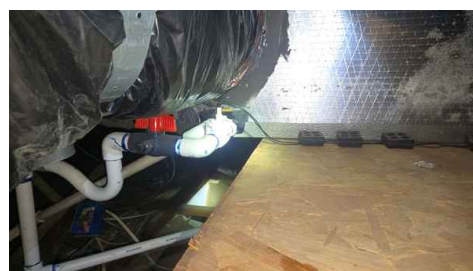
**Potential Issue:** Without a drip pan, condensate from the AC unit may leak onto surrounding materials, causing potential water damage, mold growth, or structural deterioration.

**Recommendation:** Have a licensed HVAC technician install a properly sized secondary drip pan beneath the AC unit to catch potential overflow and protect the area from water damage.

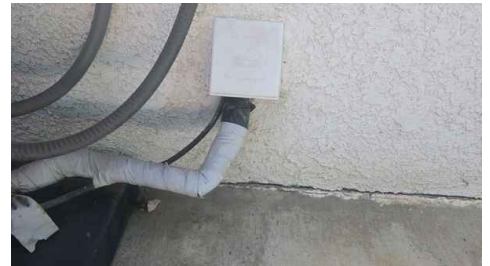
## 6.8.2 Cooling Equipment - 1919A

**AC THROUGH-WALL**

Moderate

Through-wall AC units are installed, creating potential points for moisture entry and damage. Recommend further evaluation by HVAC technician to ensure proper installation and sealing to prevent moisture-related issues and protect the building structure.

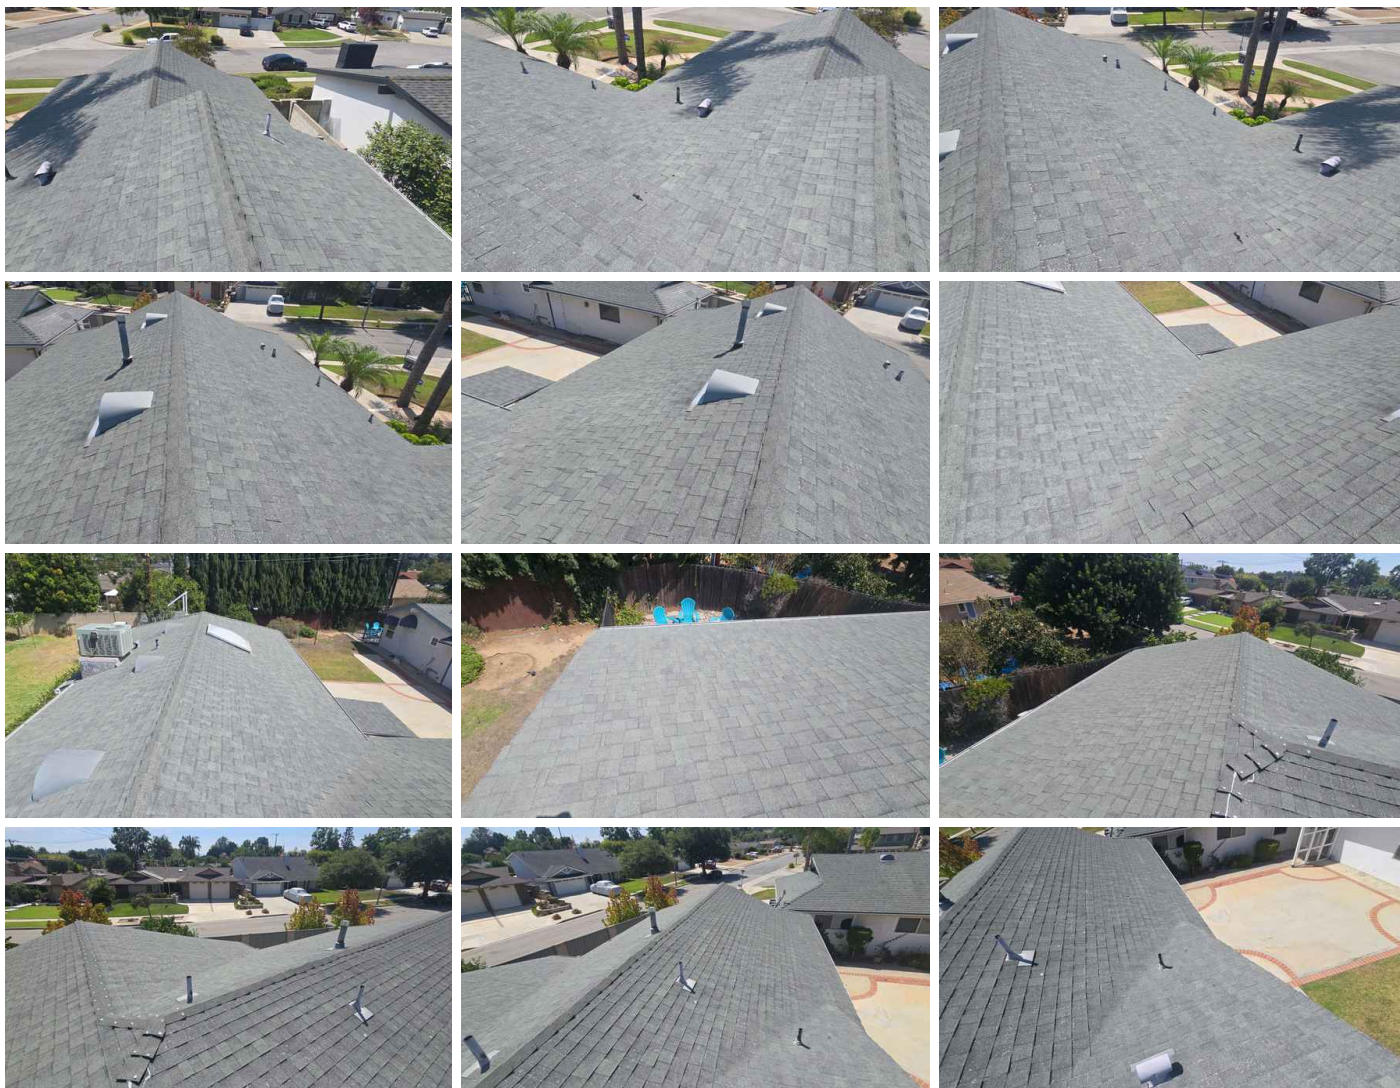
Walked Roof

Composition shingle roof system over the majority of the structure. This type shingle is composed of an asphalt impregnated fiberglass mat covered with a granular aggregate. Sloped construction. Periodic maintenance will extend the life of the roof for some time yet.

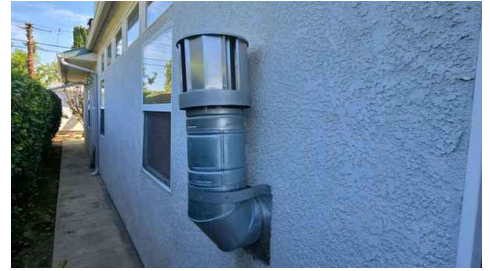
## 7.5.3 Chimneys / Skylights

**POTENTIAL BURN / SAFETY HAZARD**

The chimney/exhaust flue is installed at a low, accessible location adjacent to the walking area. During operation, the metal vent may become hot enough to create a potential burn or contact hazard for occupants, children, or service personnel. Recommend evaluation by a qualified HVAC or chimney contractor and modification, guarding, or relocation as necessary to reduce accidental contact and improve safety at this exterior area.

Recommendation

Contact a qualified professional.

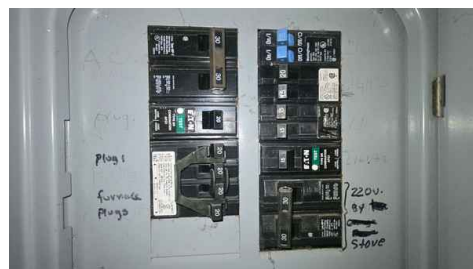
**Defect:** One or more AFCI breakers were present in the electrical panel but were not tested during the inspection.

**Potential Issue:** Testing AFCI breakers without knowing what is connected to the circuits could potentially disrupt or damage sensitive equipment.

**Recommendation:** Recommend consulting with a licensed electrician to test AFCI breakers under controlled conditions to verify proper functionality without risk to connected devices.

## Recommendation

Contact a qualified professional.

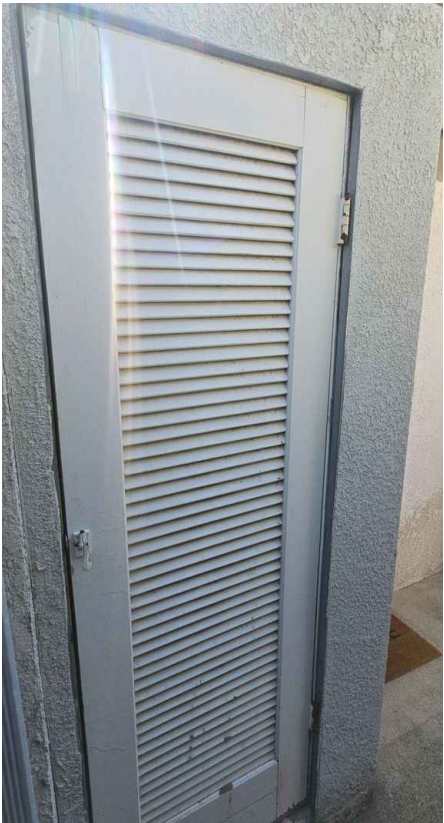
Water Heater, Controls, Flues & Vents: Location

Exterior Closet

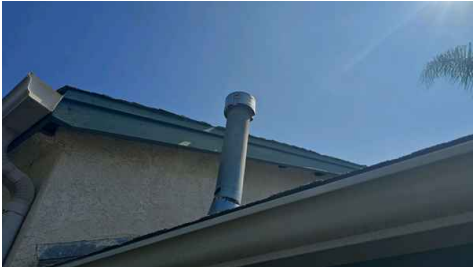
Moderate

The vent stack does not extend past the roof line. The vent stack should extend above the roof line. Suggest contacting a qualified professional for further review.

Recommendation  
Contact a qualified professional.

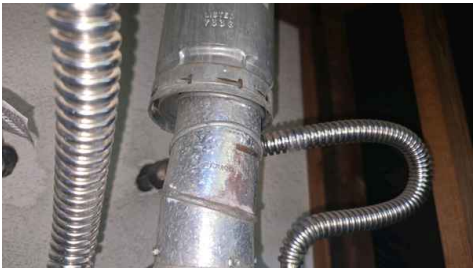
Health and Safety / Major

An unsecured connection was observed at the water heater exhaust flue where vent sections join. The connection appears inadequately fastened and may allow movement, separation, or leakage of combustion gases into the surrounding area. Improperly secured venting can create a potential carbon monoxide and fire safety hazard. Recommend evaluation and repair by a qualified plumbing or HVAC contractor, including fastening and verification of vent integrity.

Recommendation  
Contact a qualified professional.

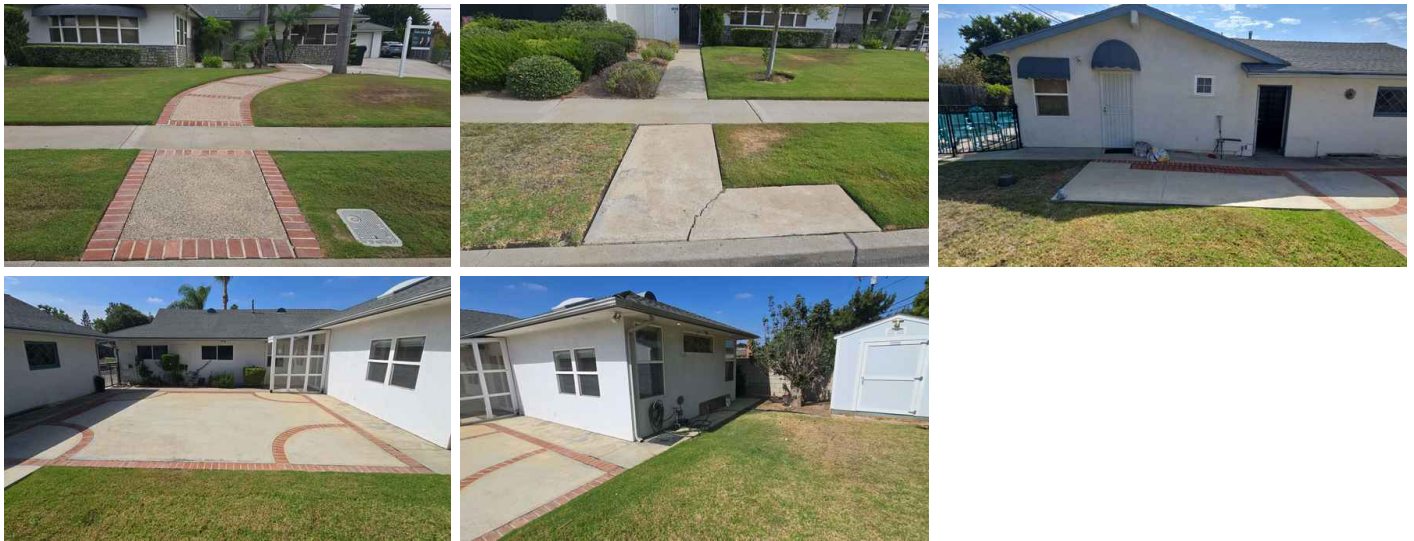
### Walkways : Walkway Material

Concrete, Pebblestone, Brick

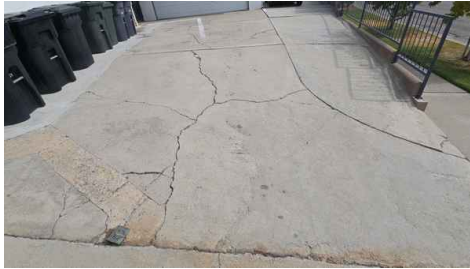
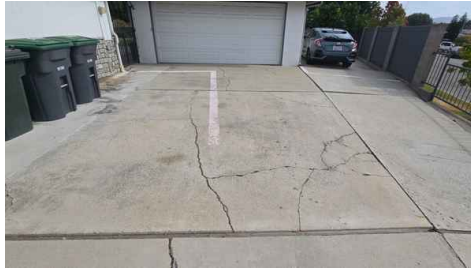
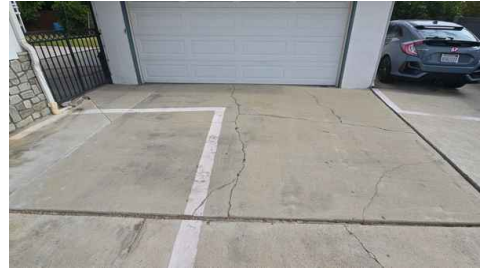
**DRIVEWAY CRACKING -**

Cracking observed at one or more locations. Recommend sealing all cracking as part of long term maintenance. If concerned recommend further review by a licensed general contractor for repairs prior to close.

Contact a qualified concrete contractor.

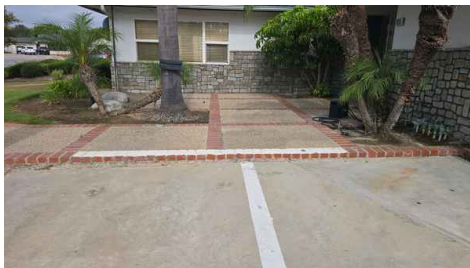
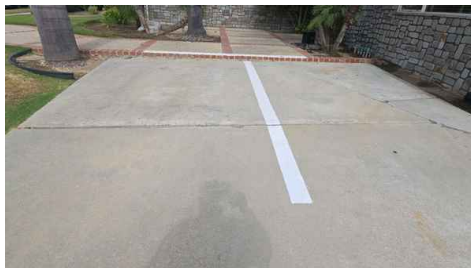
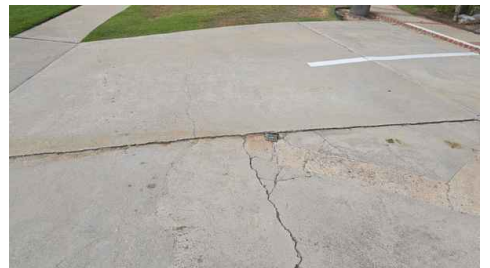
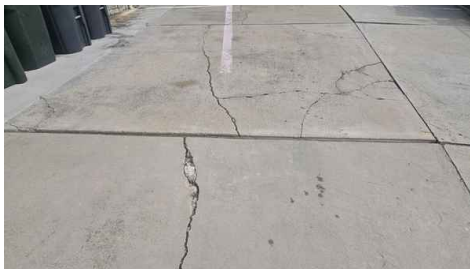
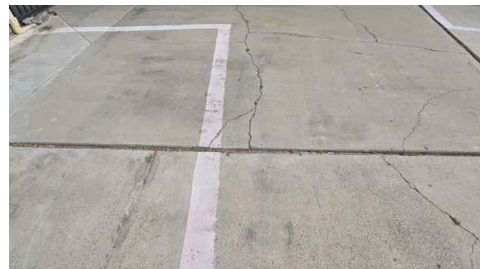
## 10.2.2 Driveways

**DRIVEWAY TRIP HAZARD**

Trip hazards observed on the driveway. This is a safety concern. Recommend further review by a licensed general contractor for repairs as necessary prior to close of escrow.

Contact a qualified concrete contractor.

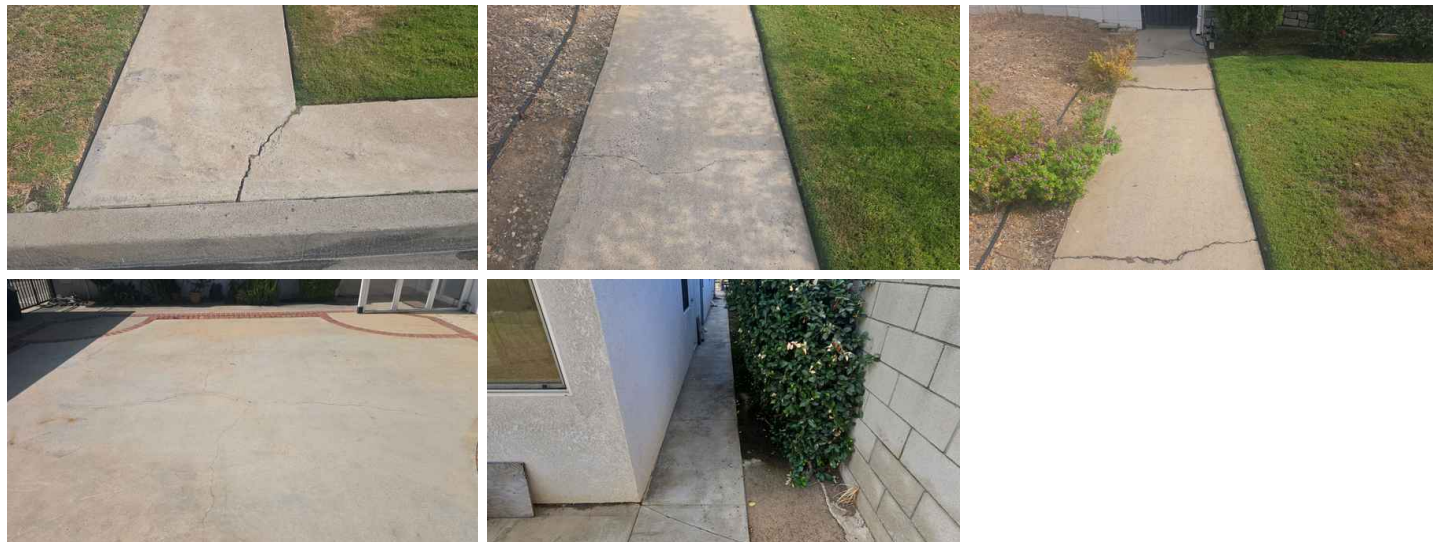
## 10.3.1 Walkways

**WALKWAY - CRACKING**

Cracking is observed at one or more locations. Recommend sealing to prevent further deterioration. If concerned, recommend further review by a licensed general contractor as necessary.

Contact a qualified concrete contractor.

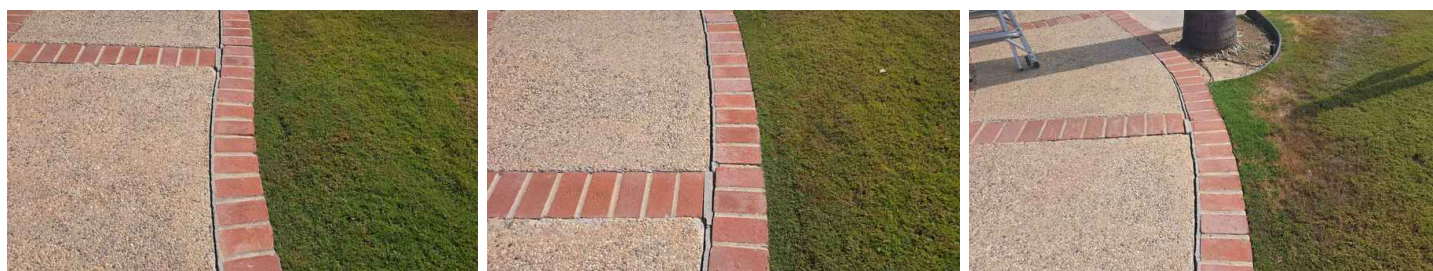
## 10.3.2 Walkways

**BRICK BORDER SEPARATION**

The brick border adjacent to the sidewalk was observed pulling away from the concrete walkway, creating a visible separation along the edge. This condition may be related to soil movement, settlement, moisture, or deterioration of the underlying support. Recommend evaluation and repair by a qualified masonry or concrete contractor to restore proper alignment, reduce further movement, and help minimize potential trip or maintenance concerns and issues.

Contact a qualified professional.

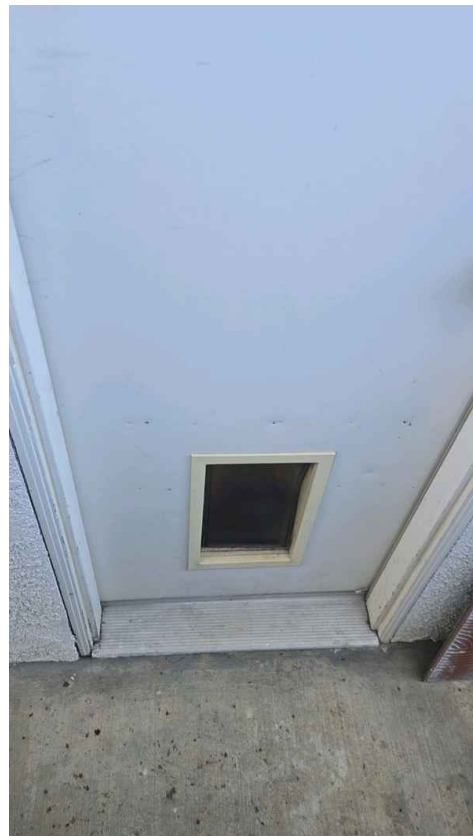
## 10.4.1 Exterior Doors

**DOG DOOR NOTED IN EXTERIOR SCREEN**

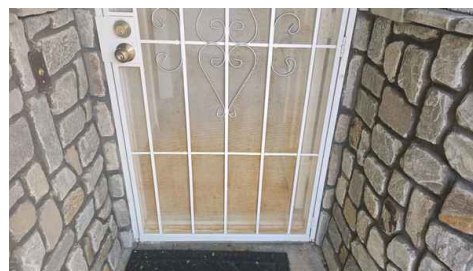
## 10.4.2 Exterior Doors

**SECURITY DOORS/GATES - CORROSION**

During the commercial property inspection, it was observed that the security gates at the entry doors exhibited signs of corrosion. This is a common occurrence with metal structures and can typically be addressed through proper maintenance and periodic cleaning. However, it is important to note that while the corrosion does not appear to be severe, it may require some level of repair or maintenance to prevent further degradation. It is recommended that a qualified professional evaluate the gates to determine the appropriate course of action.

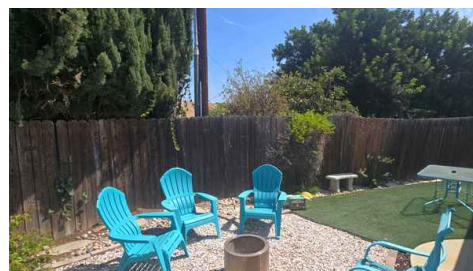
**LOOSE AND LEANING FENCE**

Fence is loose and leaning. This can be an indication of settling. Suggest consulting with specialist for further review prior to close of escrow.

Contact a qualified professional.

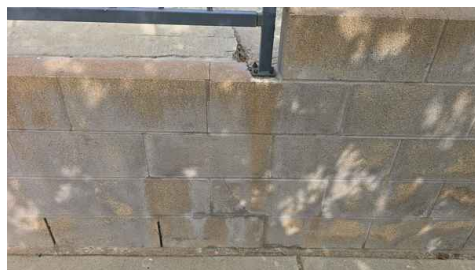
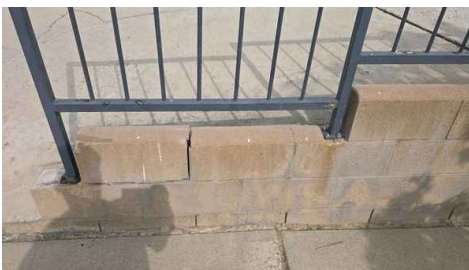
## 10.8.1 Retaining Wall

**RETAINING WALL - CRACKING NOTED**

Vertical crack observed on the retaining wall. It may be a result of natural settling or expansion of the building materials. No signs of significant movement or structural instability noted at this time. Recommend repair to prevent further deterioration/damage.

Contact a qualified professional.

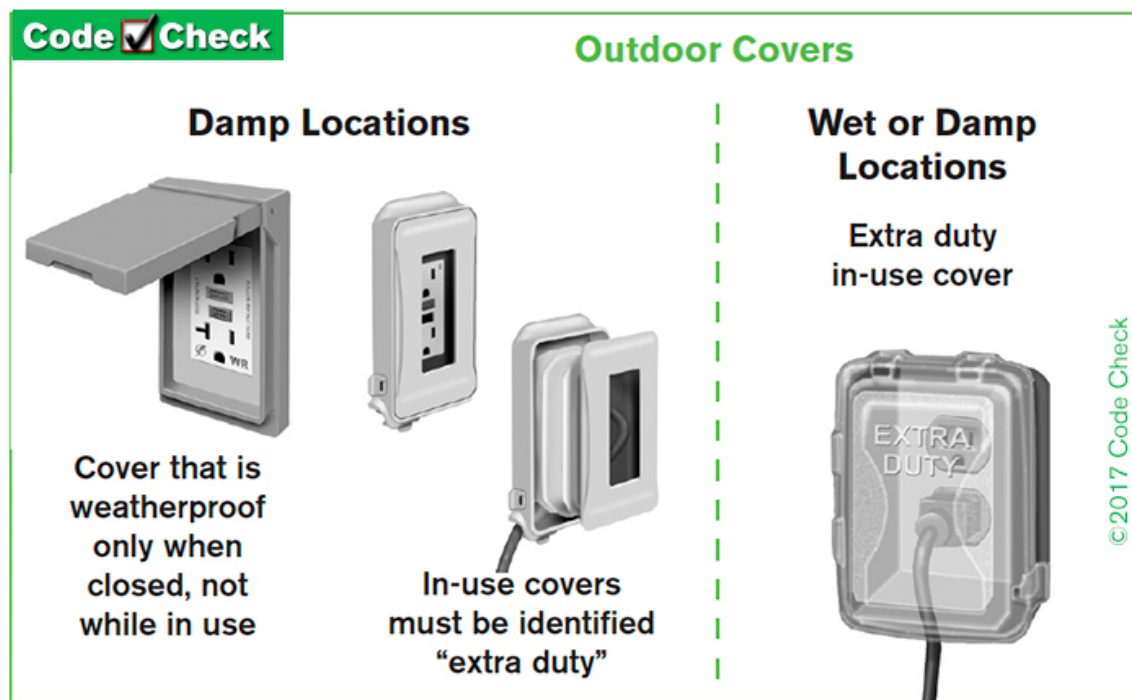
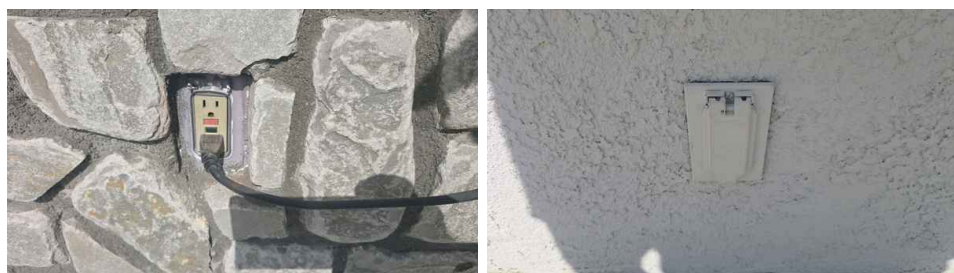
## 10.9.1 Exterior Electrical

**IMPROPER/MISSING/DAMAGED EXTERIOR WEATHER COVER**

Improper/Damaged/Missing weatherproof cover at exterior outlet. Suggest installing weatherproof cover to ensure safety.

Recommendation  
Contact a qualified professional.

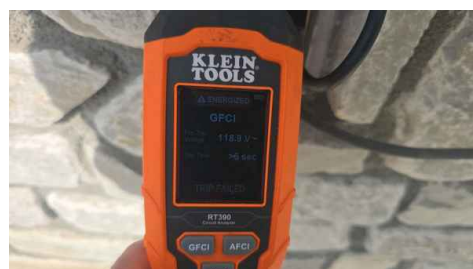
## 10.9.2 Exterior Electrical

**GFI INOPERABLE**

Ground fault interrupter provided for safety is inoperable. Recommend replacing.

Contact a qualified electrical contractor.

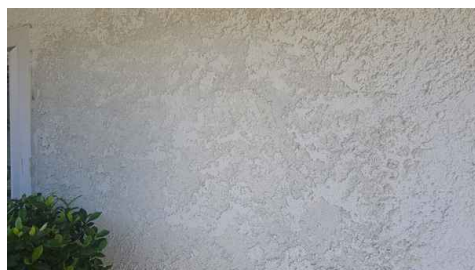
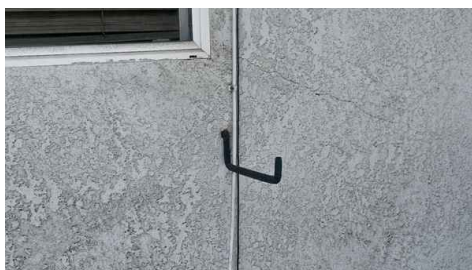
**CRACKING**

Cracking was observed at one or more points on the exterior. Recommend repair to prevent further deterioration

Contact a qualified professional.

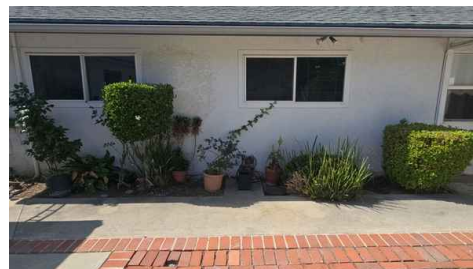
## 10.10.3 Siding

At time of inspection, one or more areas of the vegetation were observed to be against or close to the exterior walls. This should also be noted on your Termite report. Irrigated vegetation against house walls is conducive to Subterranean Termites. Recommend clearing 1- 3 feet

Contact a qualified professional.

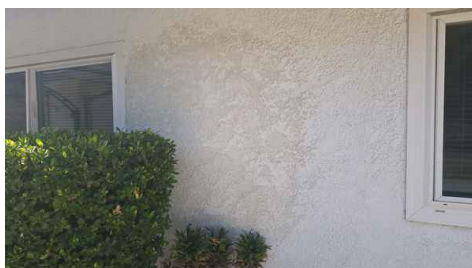
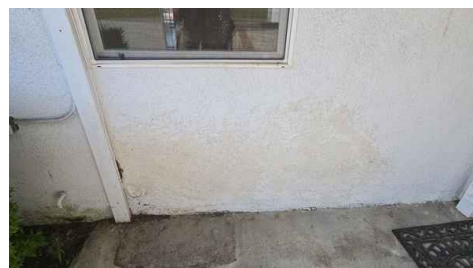
## 10.10.4 Siding

**PATCHING NOTED**

Contact a qualified professional.

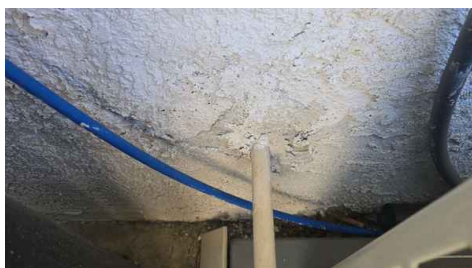
## 10.10.5 Siding

**STUCCO BLISTERING**

Contact a qualified professional.

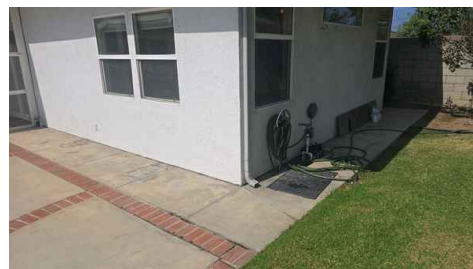
## 10.10.6 Siding

**WEEP SCREED RESTRICTED**

Contact a qualified professional.

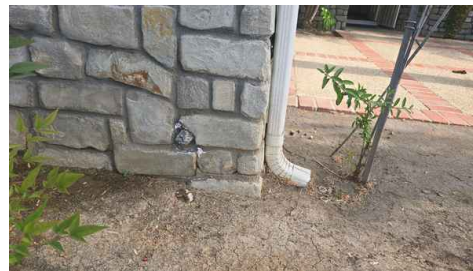
## 10.10.7 Siding

**STEP CRACKING IN VENEER**

Contact a qualified professional.

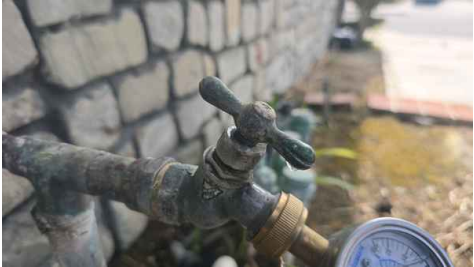
Stem packing leak observed at one or more locations of home exterior faucet, recommend review for repairs as needed.

Recommendation  
Contact a qualified professional.

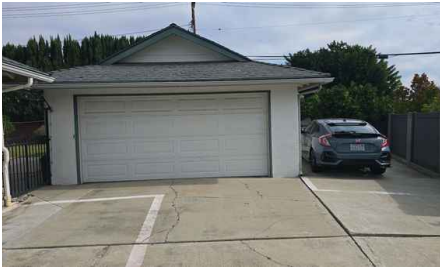
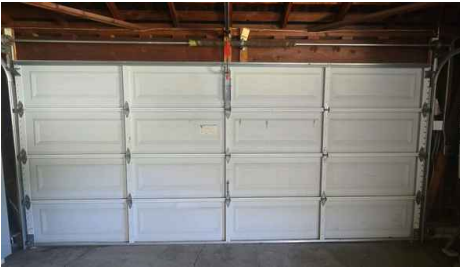
### **Garage Door: Material**

Metal, Non-insulated

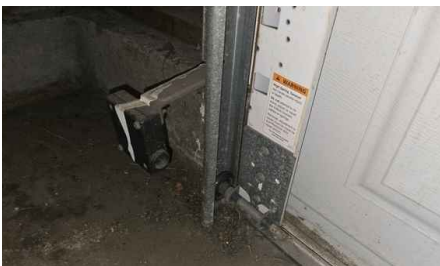
### **Garage Door Opener: Safety Reverse**

This garage door opener is equipped with a safety reverse device, which operated when tested at the time of our inspection. The U.S. Product and Safety Commission recommends that these devices be checked monthly.

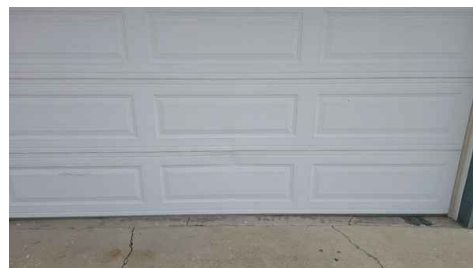
11.2.1 Garage Door

### PANEL DAMAGE

Garage door panel is damaged observed

Moderate

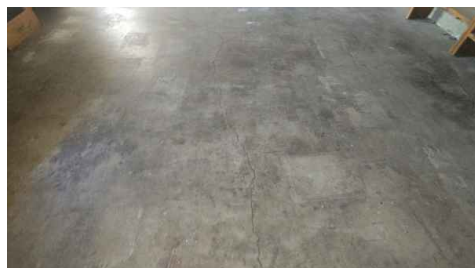
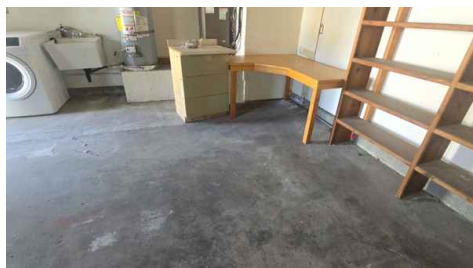
**CRACKING NOTED IN CONCRETE SLAB**

Inspection Note: Settling Cracking in Garage Floor

During our inspection, we observed minor settling cracks in the garage floor. These cracks appear to be superficial and not structurally concerning. They are typical in concrete surfaces over time and do not suggest any imminent issues. We recommend monitoring them for further progression but do not consider immediate action necessary.

Contact a qualified professional.

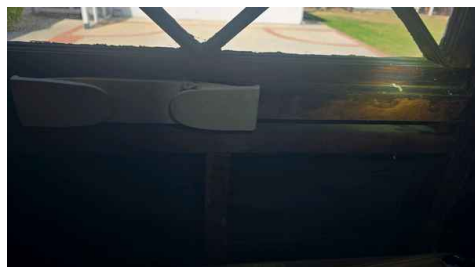
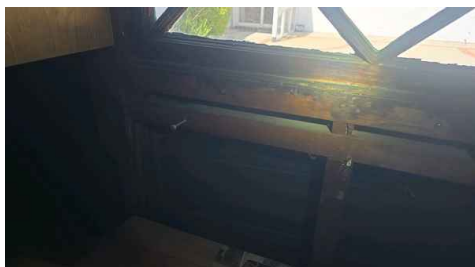
## 11.7.1 Window(s)

**WINDOW SILL - WATER STAINS**

Water staining observed on the window sill, indicating past or ongoing moisture intrusion. The affected area shows signs of discoloration and possible wood deterioration. Recommend further evaluation for potential leaks, sealing gaps or damaged areas, and refinishing or replacing affected wood as needed to prevent future issues.

Contact a qualified professional.

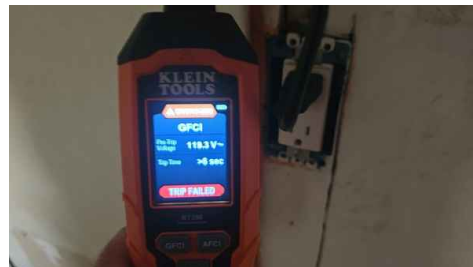
*A GFCI receptacle can provide protection for other receptacles downstream on the circuit. GFCI protection can be provided by GFCI breakers, blank face devices, or GFCI receptacles*

We recommend upgrading by installing GFCI receptacles in all locations required by present standards. This includes locations in bathrooms, garages, exteriors, basements and crawl spaces, kitchens and laundry within six feet of the sink. They are also commonly utilized for equipment such as sump pumps, whirlpools, spas and pool equipment. GFCI's have two different forms: receptacles with test/reset buttons, and panel breakers, and either form is effective in protecting appropriate outlets or fixtures.

Consider upgrading unprotected receptacles in areas where GFCI protection is presently required. A qualified electrician should do the work.

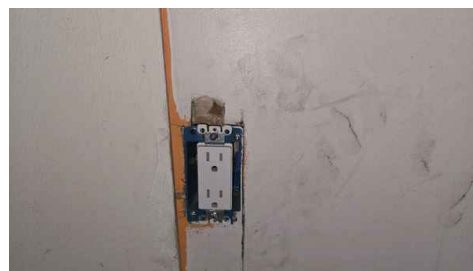
**COVER PLATE MISSING**

One or more outlets are missing faceplates. Recommend re-installing

Contact a qualified professional.

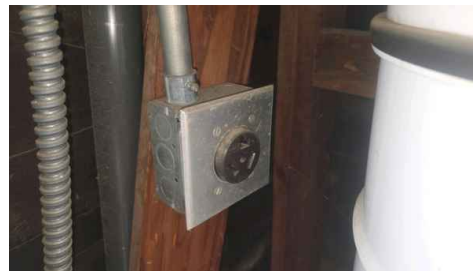
## 11.11.3 Electrical

**INOPERABLE OUTLET**

Contact a qualified professional.

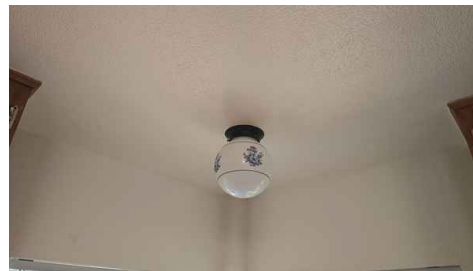
One or more lights are inoperable. Bulb may need to be replaced.

Contact a qualified professional.

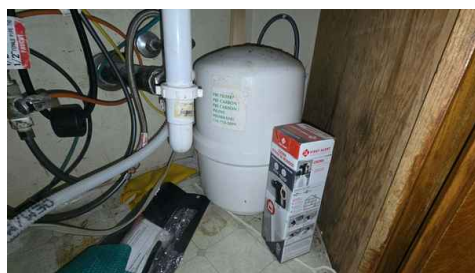
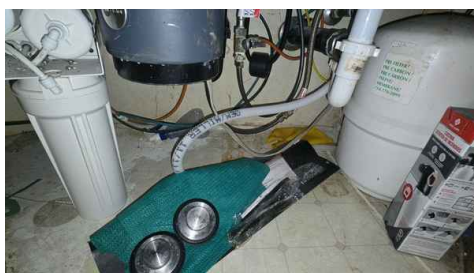
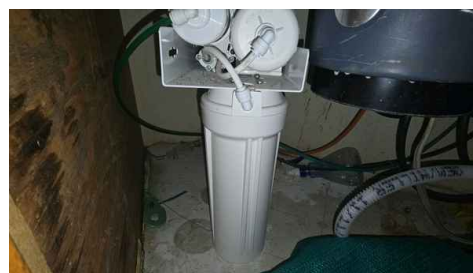
## 12.8.1 Cabinets

**WATER DAMAGE NOTED**

Water damage noted under kitchen sink.

Contact a qualified professional.

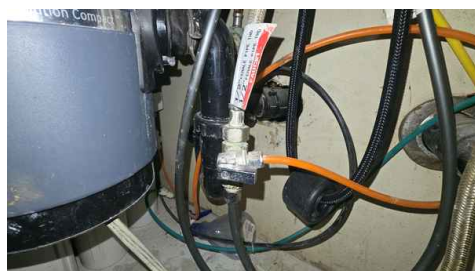
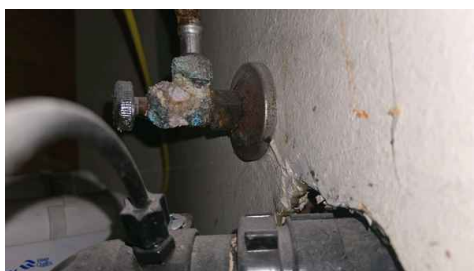
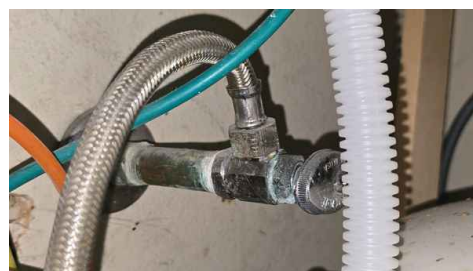
**ANGLE STOPS - CORROSION**

Corrosion noted at angle stops no evidence leak at time of inspection.

Contact a qualified professional.

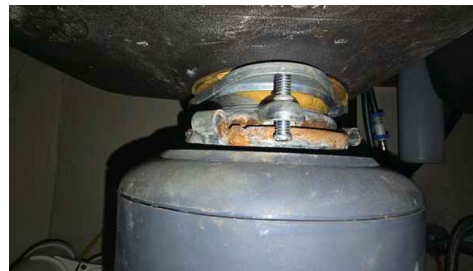
**GARBAGE DISPOSAL IS RUSTED**

Garbage disposal show signs of rust and corrosion. No signs of leak at time of inspection.

Contact a qualified professional.

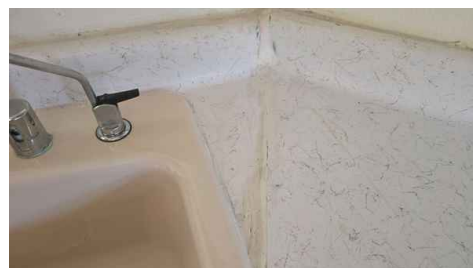
During the inspection of the kitchen area, it was observed that the countertop around the sink displayed noticeable sagging, likely due to water damage. Immediate attention is required to address the sagging countertop to prevent further damage and ensure safe usage

Contact a qualified professional.

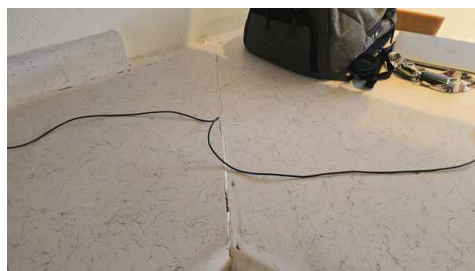
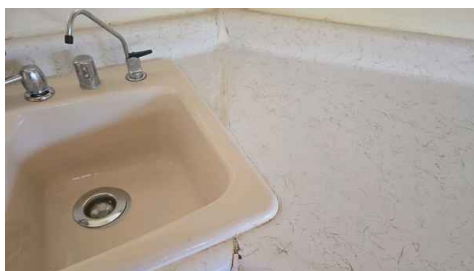
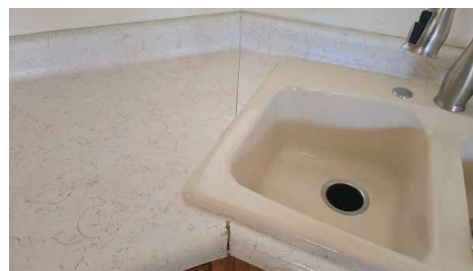
**COUNTERTOP PATCHING AND DAMAGE**

Patching, separation, and localized damage were observed at multiple areas of the countertop, including joints and near the sink. Previous repairs appear to have been performed, although the cause and effectiveness of those repairs could not be determined during the inspection. Recommend evaluation and repair by a qualified countertop or finish contractor to restore damaged areas and help prevent further deterioration or moisture intrusion.

Contact a qualified professional.

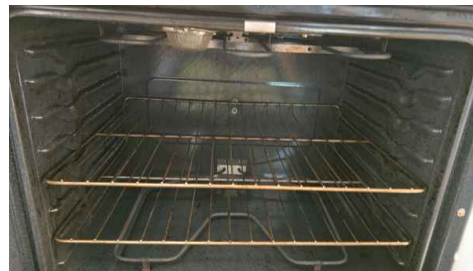
**OVEN LIGHT**

Oven light is not working. Recommend repair/replacement.

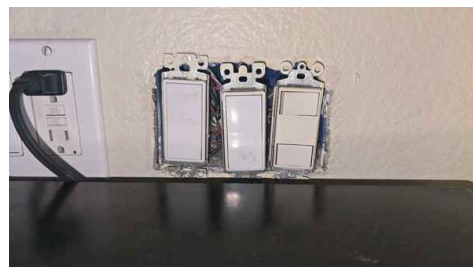
#### MISSING FACE PLATE NOTED

During the home inspection, it was observed that electrical outlets in one or more locations do not have a faceplate installed. It is recommended to have a qualified electrician install a faceplate for safety and aesthetic purpose

Contact a qualified professional.

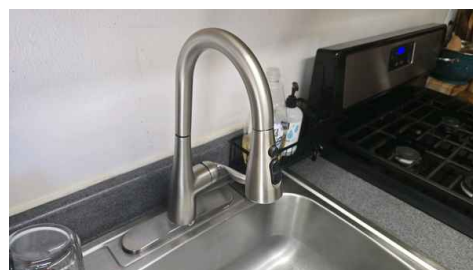
#### LOOSE FACUET

Loose Facuet recommend securing

Contact a qualified professional.

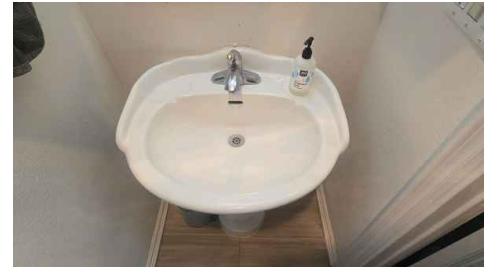
**LOOSE PEDESTAL SINK**

Loose Pedestal Sink observed. Recommend securing.

## Recommendation

Contact a qualified professional.

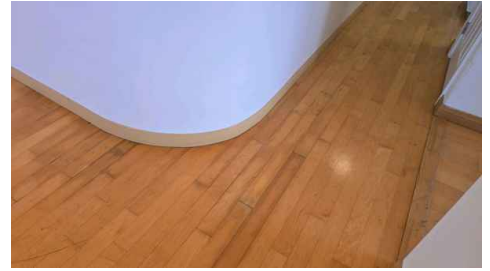
**MOISTURE DAMAGE**

Recommendation

Contact a qualified flooring contractor

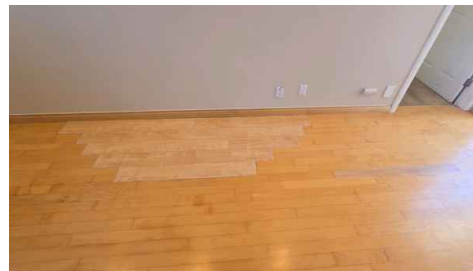
**FLOORING PATCHING AND REPAIRS**

Recommendation

Contact a qualified professional.

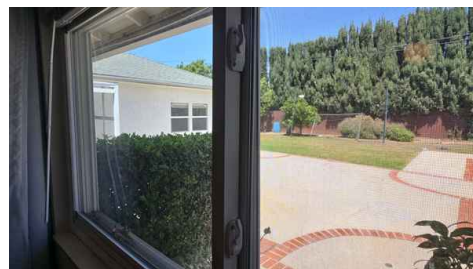
#### 27.5.2 Windows

##### **WINDOW LOCK DOES NOT CATCH**

Moderate

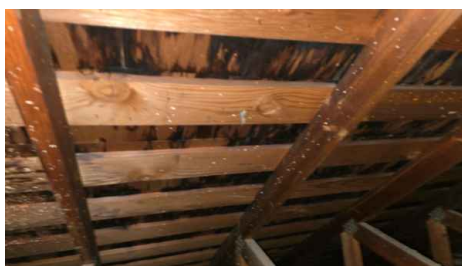
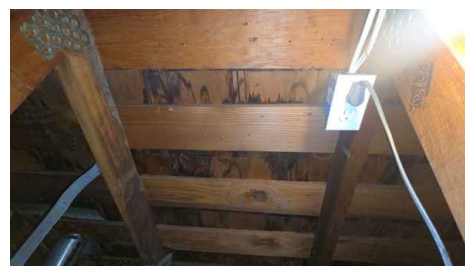
**Evidence of leakage: Leaking**  
Water stains

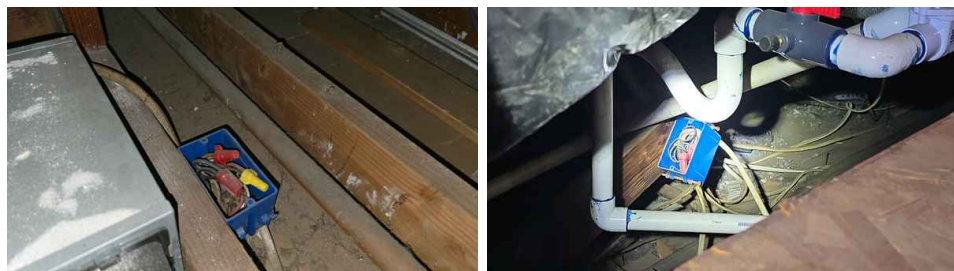
One or more loose or open junction boxes noted in the attic. Recommend correcting.

## Recommendation

Contact a qualified professional.
