# Real Estate Inspection Report

28th of August, 2026

## Home Inspection Experts

9433 Geyser Avenue  
Los Angeles, CA 91324

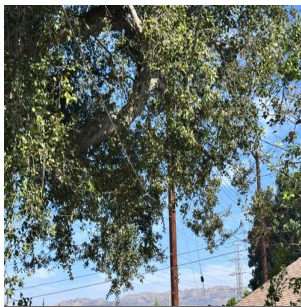
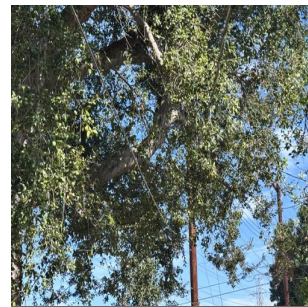
*trees in the back of the home need to be cut back-there are power lines running through the trees from the home to main pole*

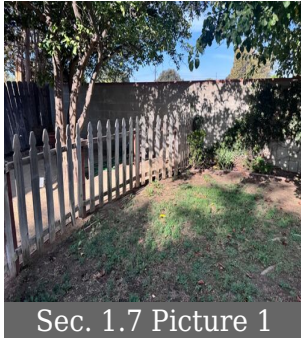
*wood fence on the left side of the home-has deteriorating post and fence is leaning away from the property  
recommend repairing and stabilizing the fence*

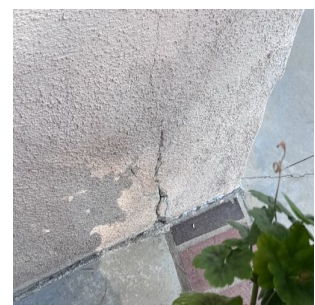
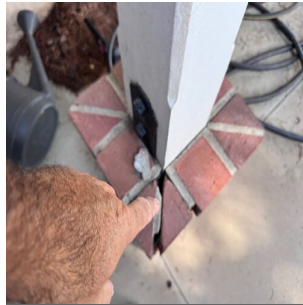
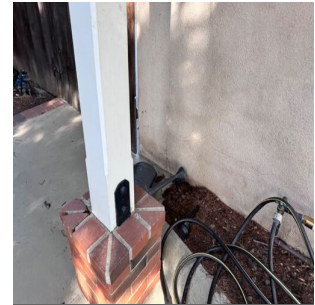
*there is breaking stucco around the perimeter of the home at the base of the house-recommend patching and painting the stucco*

*there is breaking stucco around the garage recommend repairing the stucco*

*brick footers in the front of the home are cracked in several areas recommend the cracks are repaired*

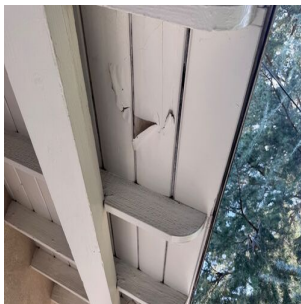
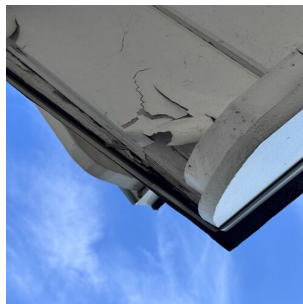
There is wood rot around the perimeter of the home recommend a termite inspector to inspect further

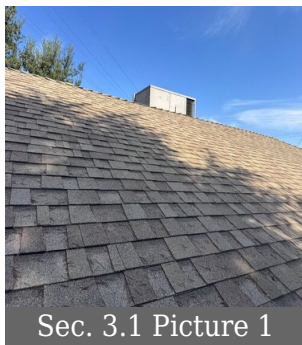
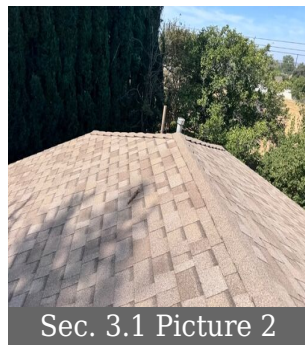
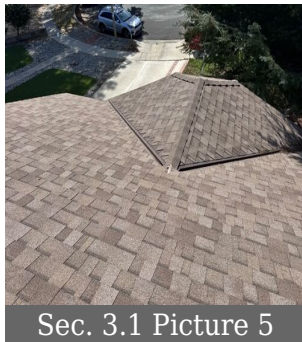
there is debris from the trees on the roof recommend blowing the debris off the roof

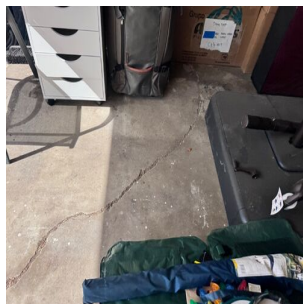
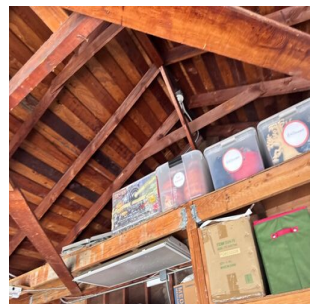
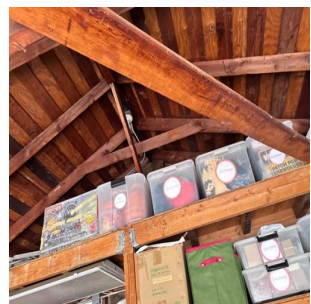
*there are several cracks in the garage flooring recommend the cement is repaired*

*the safety eyes are over 2 inches high recommend dropping these below 2 inches for safety*

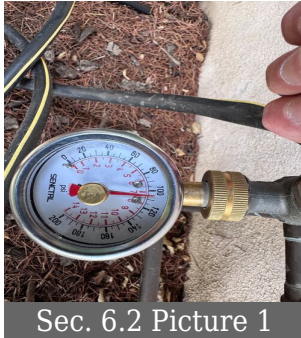
Sec. 6.2 Picture 1

**There are signs of rust / corrosion on the pipes.:** Yes

*the water pressure coming in the home is over 100 psi recommend adjusting the regulator to keep the pressure below 80 psi*

*there are signs of corrosion on the pipes under the home recommend monitoring the copper plumbing as there are signs of age and coming up on their lifespan*

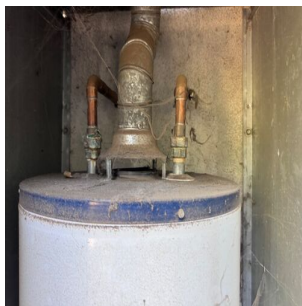
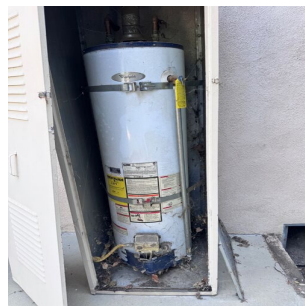
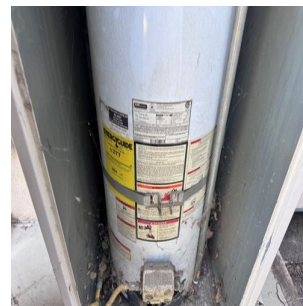
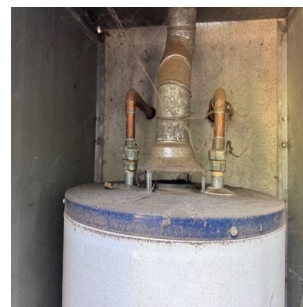
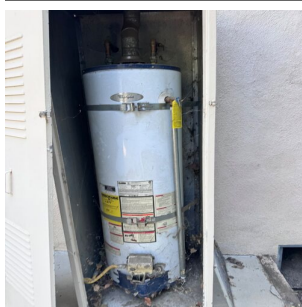
*the unit is making a crackling noise which can be an indication the unit is at its lifespan recommend monitoring the unit for replacement*

*the unit was manufactured in 2015*

*recommend installing a drain pan and a sediment trap*

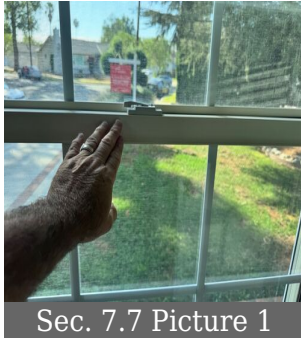
*vertical windows in the home (bedrooms) are difficult to open and close recommend servicing the tracks*

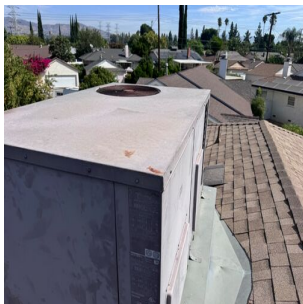
Sec. 12.1 Picture 1

**Condition:** Satisfactory  
**Type:** Forced air **Fuel Type:** Natural Gas  
**Location:** roof  
**Thermostat Location:** hallway  
**Furnace Brand at Property:** Other

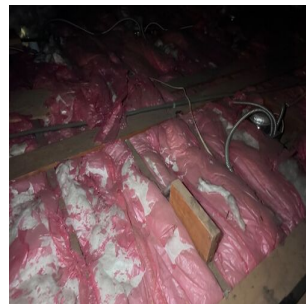
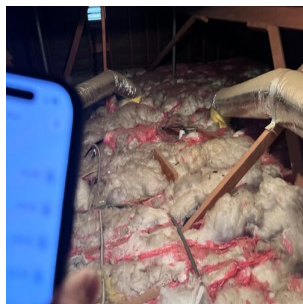
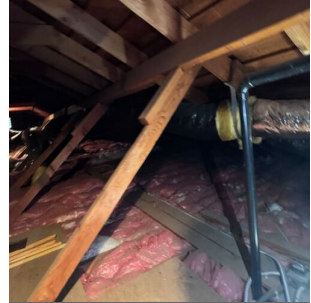
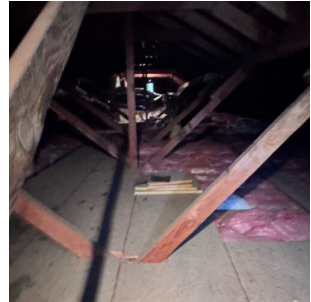
*there are rodent droppings in the attic recommend a pest control company inspects further*
