**Address:** 79 W VILLA ST  
**City:** Pasadena  
**Zip Code:** 91103  
**County Code:** 37

**District:** New Fair Oaks Historic District (designated)

# PRIMARY RECORD

**\*P10. Survey Type:** Survey - Intensive  
**Survey Title:** 2010 Late 19th/Early 20th Centuries

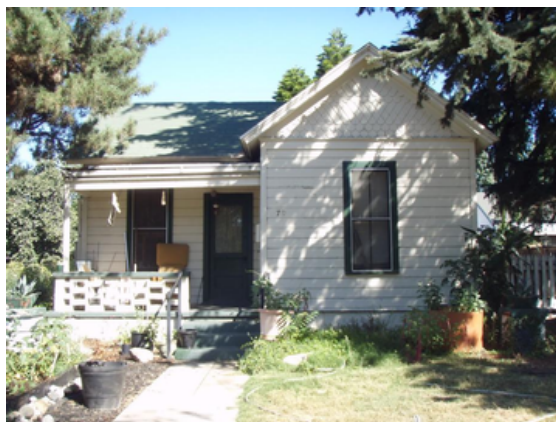
This one-story house is an example of the Vernacular Gabled Cottage subtype. It has a rectangular plan, a cross-gabled roof from and a projecting, flat roofed half-width front porch supported by a simple square wood post at the southwest corner. The masonry porch rail is non-original. The easterly bay of the south elevation has alternating bands of fish-scale and diamond shaped wood shingles in the gable end and the remainder of the exterior walls are clad in wood drop channel siding with corner boards. The house has a composition shingle roof, a concrete foundation, wood double-hung windows in a two-over-two configuration in wood-framed openings, and an original wood-paneled front door with a rectangular light in a wood-framed opening. The front yard, which is slightly elevated from the street by a concrete curb, is enclosed by a wood picket fence.

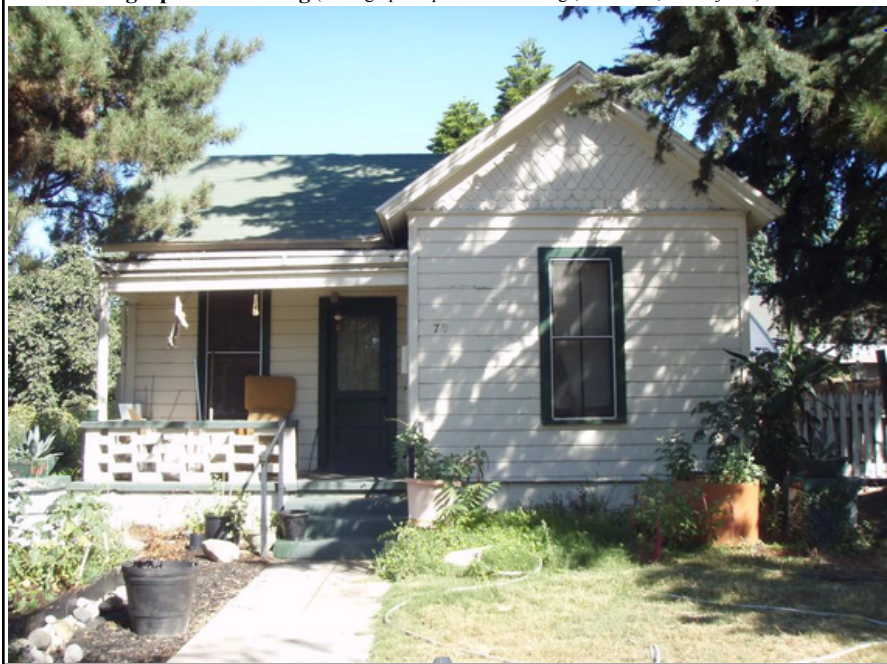
**P5a. Photograph or Drawing** (Photograph required for buildings, structures, and objects.)

This one-story house is an example of the Vernacular Gabled Cottage subtype. It has a rectangular plan, a cross-gabled roof from and a projecting, flat roofed half-width front porch supported by a simple square wood post at the southwest corner. The masonry porch rail is non-original. The easterly bay of the south elevation has alternating bands of fish-scale and diamond shaped wood shingles in the gable end and the remainder of the exterior walls are clad in wood drop channel siding with corner boards. The house has a composition shingle roof, a concrete foundation, wood double-hung windows in a two-over-two configuration in wood-framed openings, and an original wood-paneled front door with a rectangular light in a wood-framed opening. The front yard, which is slightly elevated from the street by a concrete curb, is enclosed by a wood picket fence.

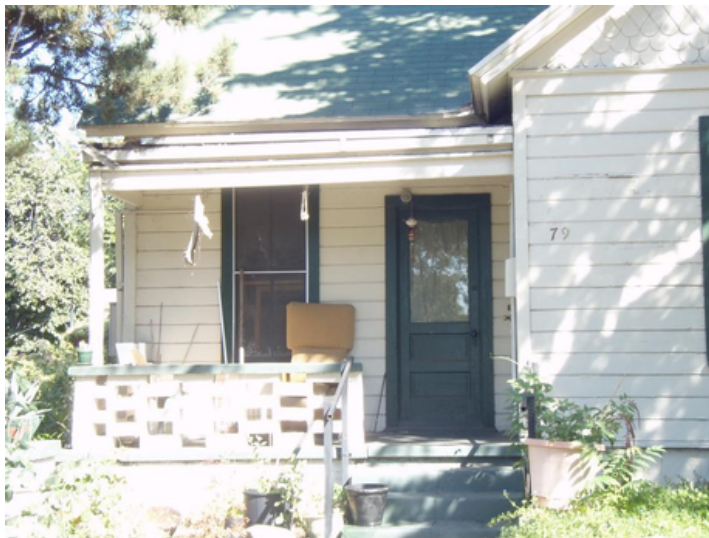
This one-story house is an example of the Vernacular Gabled Cottage subtype. It has a rectangular plan, a cross-gabled roof from and a projecting, flat roofed half-width front porch supported by a simple square wood post at the southwest corner. The masonry porch rail is non-original. The easterly bay of the south elevation has alternating bands of fish-scale and diamond shaped wood shingles in the gable end and the remainder of the exterior walls are clad in wood drop channel siding with corner boards. The house has a composition shingle roof, a concrete foundation, wood double-hung windows in a two-over-two configuration in wood-framed openings, and an original wood-paneled front door with a rectangular light in a wood-framed opening. The front yard, which is slightly elevated from the street by a concrete curb, is enclosed by a wood picket fence.
