# WOOD DESTROYING PESTS AND ORGANISMS INSPECTION REPORT

| Building No.<br><b>33</b> | Street<br><b>23rd St</b> | City<br><b>Cayucos</b> | Zip<br><b>93430-1409</b> | Date of Inspection<br><b>08/19/2026</b> | Number of Pages<br><b>1 of 6</b> |

**Report #: 114352**

| General Description:<br><b>Two story; Single family residence; Stucco exterior; Composition shingle roof; Furnished and occupied.</b> | Inspection Tag Posted:<br><b>GARAGE</b> |

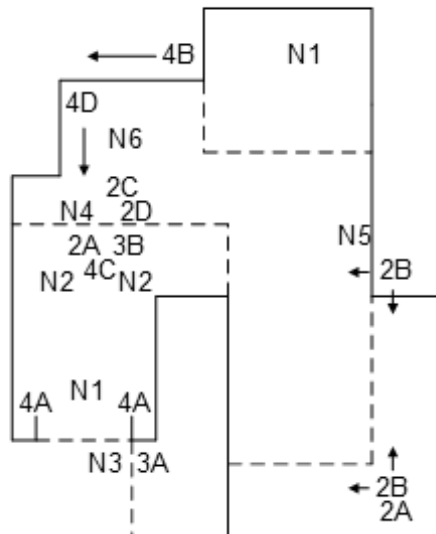
**\*\*\*Complete Inspection Report\*\*\***  
 Diagram not to scale-Finding locations approximate

Finding: 2A Evidence of Drywood Termite infestation was found at the exterior and appears to extend into inaccessible areas of the structure.

Finding: 2B Drywood Termite and Fungus damage was found at the 2nd level fascia.

Finding: 2C Drywood Termite damage was found at the door header jamb.

Finding: 2D Drywood Termite damage was found at the interior door casing.

Finding: 3A Fungus damage was found at the fascia of the eave area.

Finding: 3B Fungus damage was found at the exterior door frame.

- Finding: 4A      Moisture damage was noted at the interior garage baseboard and appears to have been caused by a previous moisture condition.  
Recommendation: Remove and replace the damaged portions of the baseboard as needed.  
Price: \$510.00

- Finding: 4B      A faulty grade condition exists where the soil grade extends above the weep screed at the base of the stucco. This condition may lead to infestation or infection.  
Recommendation: Lower the soil grade to allow 4" minimum clearance below the weep screed.  
Price: \$102.00

- Finding: 4C      An existing and/or potenial excessive moisture condition exists due to cracks to the deck coating and/or deteriorated of the deck flashing. The deck was not water tested at the time of this inspection.  
Recommendation: Consult a licensed deck coating specialist to inspect and to make any necessary repairs to the deck coating and/or flashings to eliminate the excessive moisture condition.  
Price: No Bid offered at this time. Owner should contact appropriate tradesman to complete recommended corrections.

- Finding: 4D      Moisture damage was noted at the interior bedroom baseboard and appears to have been caused by a previous moisture condition.  
Recommendation: Remove and replace the damaged portions of the baseboard as needed.  
Price: \$510.00

Recommendation: Seal the structure and fumigate with a gas lethal to Drywood Termites (Sulfuryl Fluoride). All occupants and pets must vacate the structure until the fumigation is complete. This company will exercise reasonable caution, but cannot be held responsible for damage to plants, TV antennas or roofing due to the fumigation. Further terms and instructions will be supplied upon request or upon scheduling of the fumigation. Information may also be obtained from the fumigation page on our website at [www.keytermite.com](http://www.keytermite.com)

Recommendation: Remove and replace the damaged portion of the fascia as needed.

Recommendation: Remove and replace the damaged portion of the door header jamb as needed.

Recommendation: Remove and replace the damaged portion of the door casing as needed.

Recommendation: Replace the fungus damaged portions of fascia as needed.

Recommendation: Replace the damaged portions of the door frame as necessary.
