INDIVIDUAL CONDO UNIT APPRAISAL REPORT

File No.: 2657

| SUBJECT | Property Address: 3131 Laurel Ave | | Unit #: 9 | City: Fullerton | State: CA | | | | | |
| Project Name: Mauna Loa Hidden Village | | Phase: 1 | | | | | | | | |

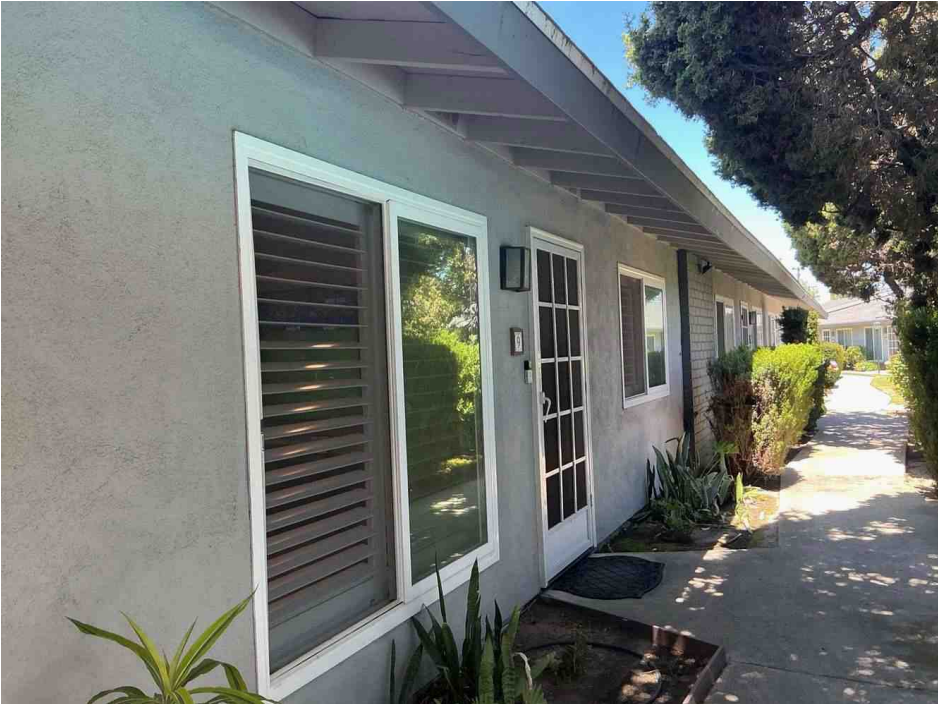
Subject Front

3131 Laurel Ave  
Sales Price  
Gross Living Area 1,073  
Total Rooms 5  
Total Bedrooms 2  
Total Bathrooms 2.0  
Location Interior lot/Neutral  
View Residential/Typical  
Site  
Quality Q4  
Age 56

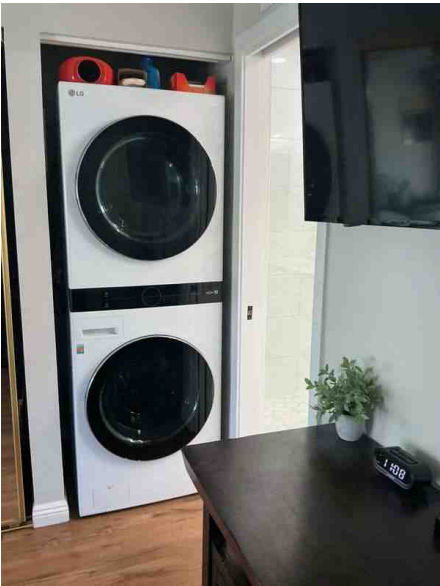
Laundry

The subject has 2 bedrooms, 2 bathrooms, kitchen, dining & living rooms. The laundry is in a bedroom and is reported to be 1 of only 4 units grandfathered in, with no permission to add to other units going forward. Luxury vinyl plank (LVP) flooring in all rooms but the bathrooms which have porcelain tile flooring, quartz slab countertops and ceramic or porcelain tile wainscoting. Refaced kitchen cabinets with quartz slab countertops & stainless steel appliances. Newer paint throughout, along with newer trim and crown molding. Besides listed above, there is a FAU, CAC, stucco exterior, a private patio surrounded by vinyl fencing with a cloth awning, 2-car covered carports with storage and open guest parking spaces in close proximity. Typical neighborhood-typical depreciation was observed at the time of the appraisal inspection. C3 exterior condition and appeal being neighborhood-conforming.
