# WOOD DESTROYING PESTS AND ORGANISMS INSPECTION REPORT

| 1475 | Spencer Street | Cambria | 93428 | 09/08/2026 | 1 of 6 |

**Report #: 114583**

| General Description:<br>Two story; Single family residence; Hardie exterior; Composition shingle roof; Furnished and occupied. | Inspection Tag Posted:<br><div style="border: 1px solid black; padding: 5px; text-align: center;">SUBSTRUCTURE</div> |

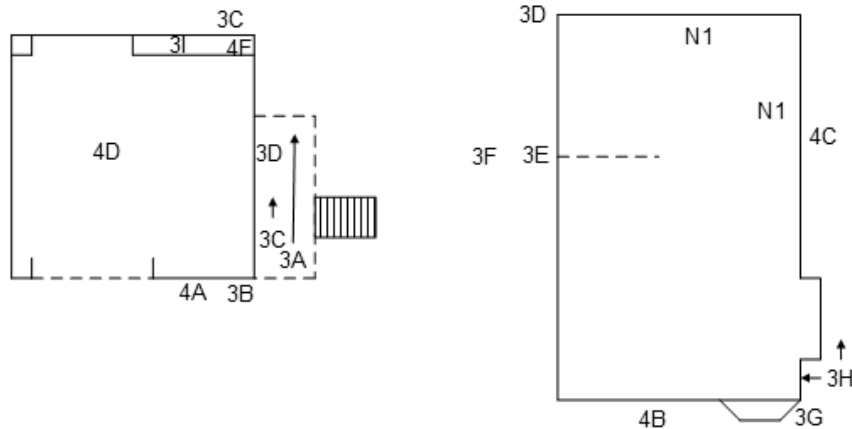
Diagram not to scale-Finding locations approximate

| Finding: | 3A | Fungus infection, Beetle and Dampwood damage were found in the wood deck throughout the decking and framing. |
| Finding: | 3B | Fungus damage was found at the roof sheathing, fascia, and sleeper of the eave area. |
| Finding: | 3C | Fungus damage was found at the roof sheathing of the eave area. |
| Finding: | 3D | Fungus damage was found at the exterior wood trim. |
| Finding: | 3E | Fungus damage was found at the 2nd level fascia of the eave area. |
| Finding: | 3F | Minor fungus damage was found at the siding. Replacement of the wood member appears to be impractical. |
| Finding: | 3G | Fungus damage was found at the fascia of the eave area. |
| Finding: | 3H | Minor fungus damage was found at the belly band. Replacement of the wood member appears to be impractical. |
| Finding: | 3I | Fungus infection has occurred to the attic framing due to leakage at the roof. |

Finding: 4A An excessive moisture condition exists due to the base of the wood siding which is embedded in asphalt. Moisture may be trapped at the base of the wood siding and may lead to infestation, infection and damage.

Finding: 4B An excessive moisture condition exists due to the base of the wood trim extending into the concrete.

Finding: 4C An excessive moisture condition exists due to the base of the belly band which is embedded in stone. Moisture may be trapped at the base of the wood siding and may lead to infestation, infection and damage.

Finding: 4D Moisture stains were noted at the wood members of the attic around the vent pipe and indicate leakage.

| Recommendation: | | Remove and replace the damaged wood members of the deck. This will most likely involve complete replacement of the wood deck. In areas where a sound wood member is not replaced and VERY MINOR surface fungus growth is present but no detectable deterioration has occurred, scrape away the surface growth with a wire brush and chemically treat the wood member with disodium octaborate tetrahydrate or copper naphthenate. Repair includes replacement with nailed con-common redwood decking and doug-fir framing. Additional costs for upgrades to deck screws, con-heart, deck-heart, synthetic decking or pressure treated framing will be quoted upon request. |
| Recommendation: | | Replace the fungus damaged portions of roof sheathing, fascia, and sleeper as needed. |
| Recommendation: | | Replace the fungus damaged portions of roof sheathing as needed. |
| Recommendation: | | Replace the damaged portions of the trim as necessary. |
| Recommendation: | | Replace the fungus damaged portions of fascia as needed. |
| Recommendation: | | Remove the minor damage with a wood chisel. Fill the void with an exterior wood filler. |

Recommendation: Remove surface fungus with a wire brush at the attic framing as needed. Chemically treat the affected wood members with disodium octaborate tetrahydrate or copper naphthenate for control of the fungus infection. Make necessary corrections to the roof to eliminate the excessive moisture condition.

Recommendation: Seal the base of the wood siding with a durable exterior sealant. This seal must be maintained to remain effective.

Recommendation: Cut the base of the wood trim and remove the embedded portions of wood. Fill the void with a concrete patch if necessary.

Recommendation: Seal around vent flashing at the roof level to eliminate the leakage.
