# HomePro Inspections

Residential Pre-Listing Inspection Address:  
1701 Clinton Street Apt. #321  
Los Angeles CA 90026

*Report Prepared for: Craig Swift*

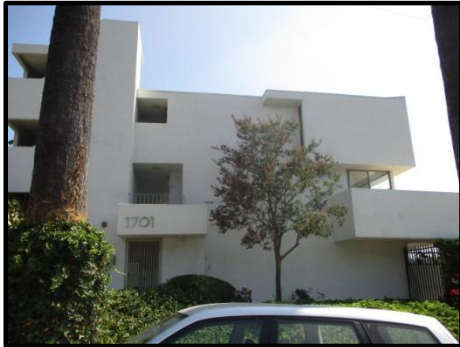
The stucco cladding has cracks at various locations. The Stucco Manufacturing Association doesn't recommend trying to reseal cracks that are thinner than the thickness of a quarter, because the crack is too thin to hold repair material and will detract from the appearance of the finished surface. Cracks wider than the thickness of a quarter can be repaired with the same stucco formulation used to apply the cladding. However, if cracks return and are suspected to be caused by expansion/contraction of structural components, it may be necessary to use an elastomeric-type of sealant. Recommendation is to monitor the cracking and repair when appropriate.

The stucco siding at one or more locations exhibits blisters and peeling. This type of damage is due to age, exposure and neglect. The damage is cosmetic in scope but will expand over time. Recommendation: Repair as appropriate at this time.

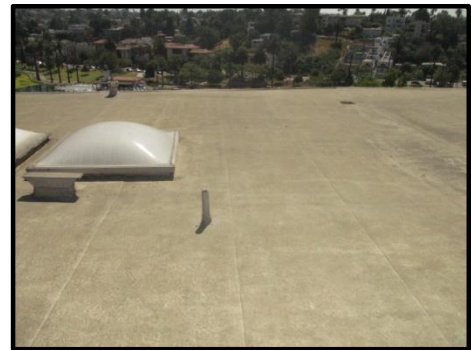
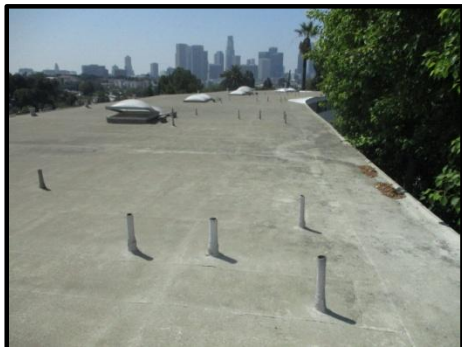
**Roofing Materials:** rolled roofing

**Material Condition:** appears satisfactory

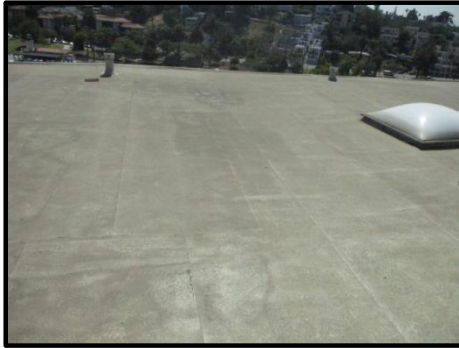
*NEEDS SERVICING: The roof has sections that are covered with debris and some of the scuppers are plugged with debris. Recommendation: Cleaning of all foreign material from the roof surface.*

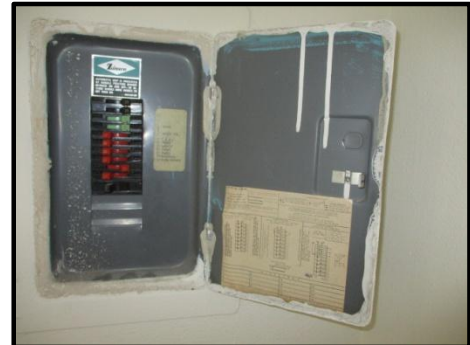
*IMPORTANT: The electrical service panel in this home is a Zinsco brand panel and is cause for concern. Many professional electricians contend that Zinsco brand breakers are potentially hazardous because they have a high failure rate. Recommendation: Immediate evaluation by a licensed electrical contractor for remedies as appropriate.*

**Sub Panel Type:** Zinsco Load Center

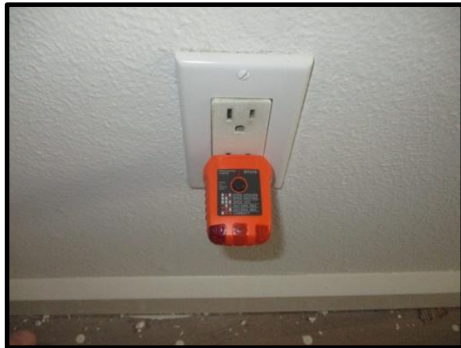
*NEEDS SERVICING: There are electrical wires at fixtures and electrical J-Boxes that have been spliced and not contained in approved junction boxes. Recommendation: Have all splices installed inside required junction boxes as necessary.*

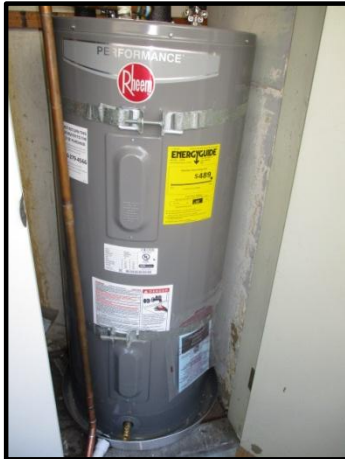
**Water Heater Energy Source:** electricity

**Capacity:** 40 Gallons

**Date of Manufacture:** 2025

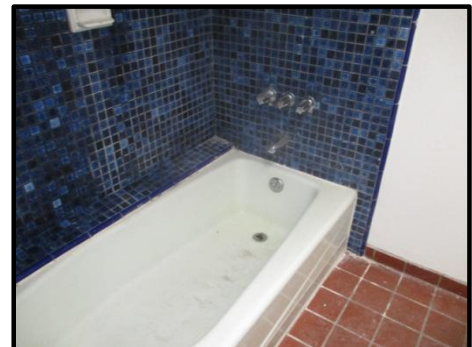
*NEEDS SERVICING: One or more of the shower surround has small screw holes located inside the surround itself. These small screws appear to be for some shower fixture that is no longer present. These small holes are considered improper as they allow water to seep into the holes where the water can eventually cause damage. Recommend that the small screw holes be water-proofed as necessary at this time.*

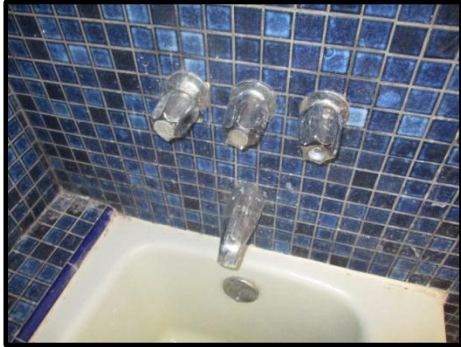
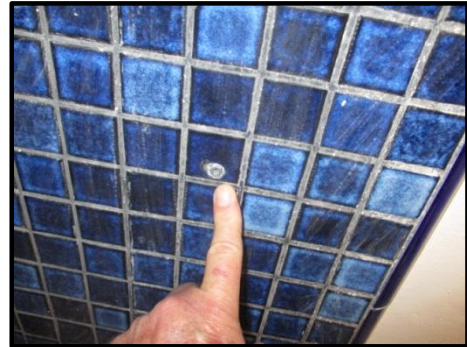
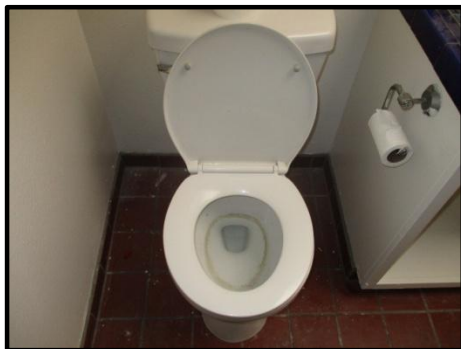
**NEEDS SERVICING:** One or more of the supply pipes older angle-stops are seized or are very difficult to turn on and off. Angle-stops are the water fixtures turn-off valves located below sinks and toilets. These fixtures do wear out

*over time and replacement is common. Recommend that the affected angle-stops be serviced as necessary at this time.*

*NEEDS SERVICING: One or more of the tub/showers drains slowly. Recommendation: Service the drain as necessary at this time. I would start by using a drain cleaner first as this should improve the draining as necessary.*

*NEEDS SERVICING: One or more of the diverters at the tub/showers leaks or will not function properly and needs to be repaired or replaced.*

*NEEDS SERVICING: One or more of the tub/shower faucets leaks at the handle when operated. Recommendation: Repair as appropriate by a qualified professional as necessary.*

*NEEDS SERVICING: One or more of the tub stops are missing or damaged and non-functional. Recommendation: Replacement, repair or service tub-stops as necessary at this time.*

*NEEDS SERVICING: One or more of the bathroom vanity sink-stops are missing, damaged or non-functional. Recommend that all sink-stops be serviced, repaired or replaced as necessary at this time.*

*NEEDS SERVICING: One or more of the toilets are loose at the floor. Loose toilet pedestals can ruin the wax seal between the pedestal and the soil pipe, resulting in leaks and often rotting flooring (if wood) beneath the toilet. Recommendation: Removal of toilet, inspection and repair if appropriate of the soil pipe collar, replacement of wax seal and re-installing the fixture.*

*NEEDS SERVICING: One or more of the sinks drain slowly. Recommendation: Repair/service as appropriate by a licensed plumbing contractor.*

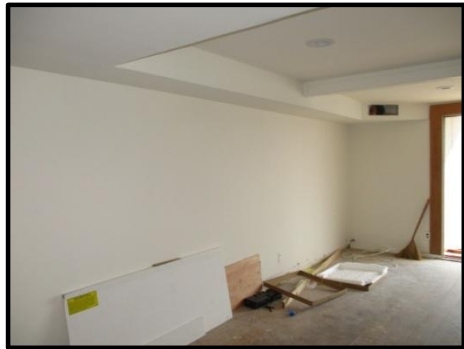
Drywall cracks were noted in several areas of the home. None of the cracks observed appeared serious in nature. Recommendation: Patch cracks before painting again.

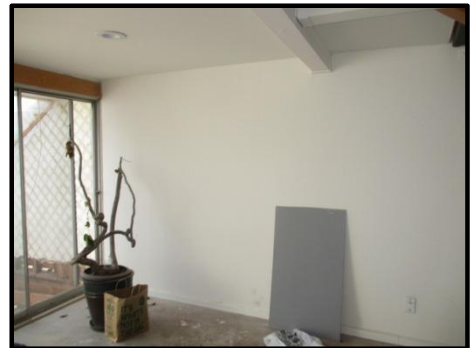
There are wood or wood laminate floors applied over the concrete slab in this home. On the surface, these appear to be in good condition. However, it is impossible to predict future performance of the flooring, as there is no way to determine visually whether proper underlayments have been used to prevent moisture from wicking into the underside of the floor from the slab.

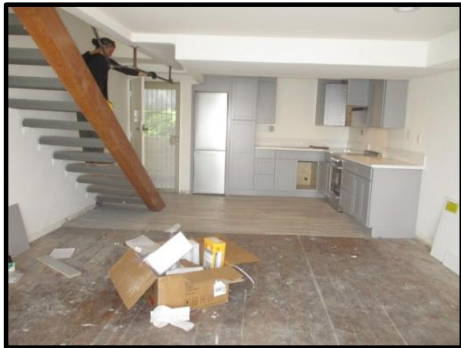
The flooring has compression (gaps between the cover and the floor sub-structure - floor joists). This softness is a condition known as 'compression set' which is very common with raised floor or multi-level structures. Correction

of this condition involves filling the gaps with epoxy filler, re-sanding and refinishing the floor or simply replacing the section of floor that exhibits this condition. Recommendation: No repairs or remediation is recommended at this time. Compression set is common and since it is overall minor in scope no action is recommended at this time.

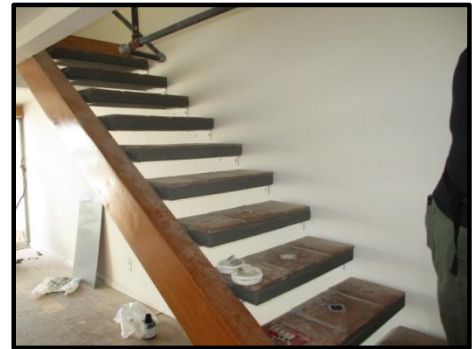
*IMPORTANT: The staircase is missing hand rails. Hand rails are required at all staircase systems that include three or more steps to a landing. Recommend that hand railing be installed as necessary at this time for safety considerations.*

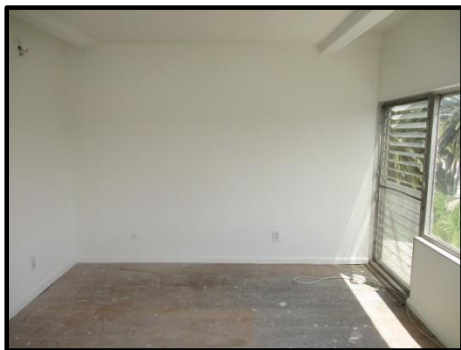
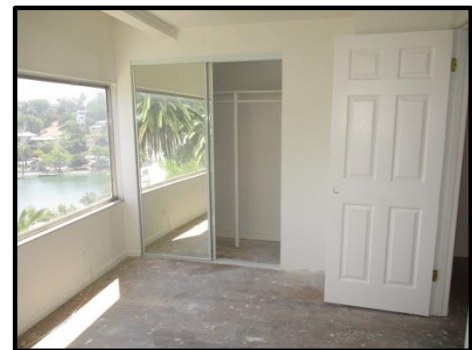
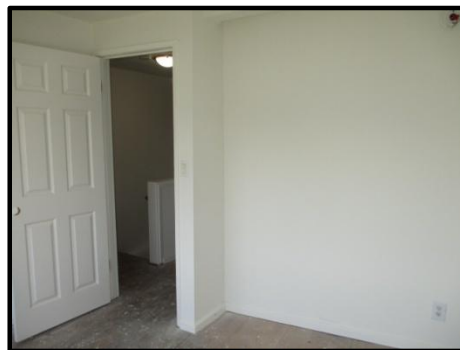
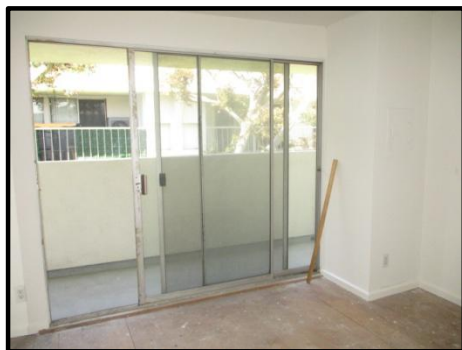
Areas of the drywall and trim within the home have been blue taped for touch up or have been repaired and not yet painted.

The walls and ceilings throughout the home exhibit extensive modification, patching and texturing. Recommendation: Refinish all walls and ceilings in order to have uniformity.

**IMPORTANT: East Bedroom Flooring - There is evidence of moisture damage to some of the wood flooring in the home. The cause of the damage is unknown. Recommendation: Evaluation and repair or replacement by a licensed flooring contractor.**

One or more of the installed windows are single pane types. Single pane windows are not as energy efficient and allow heat loss through a process known as "convection". Single pane windows also provide limited noise reduction performance.

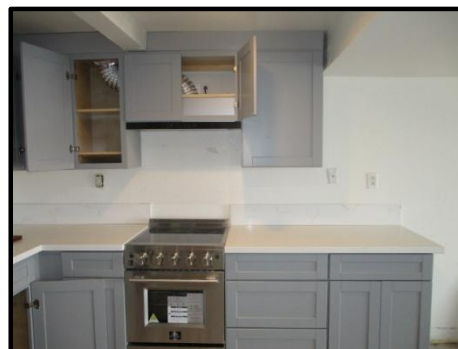
**Range Style:** Free standing, self-contained cook top and oven

**Fuel:** Electric

**Make:** Forno
