**Corrective Work Completed After Pre-Listing Inspection**  
**30645 Ganado Drive**

# Confidential Inspection Report

LOCATED AT:  
30645 Ganado Dr  
Rancho Palos Verdes, California 90275

INSPECTED ON:  
Tuesday, May 12, 2026

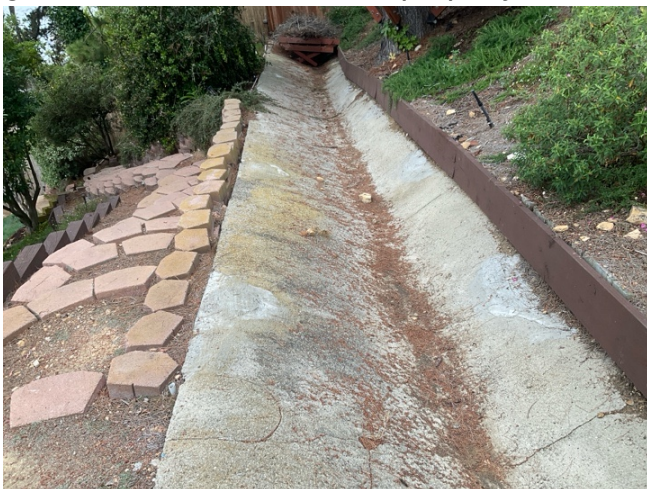
**10:** The drainage swales on the site are clear and clean. They should be kept clean for the general maintenance of the property.

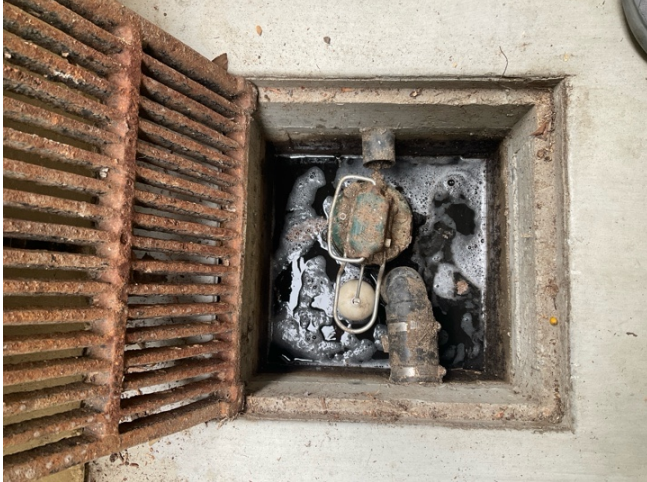
**11:** The yard drainage system includes a float-activated sump pump. Sump pumps are outside the scope of our inspection and are not evaluated. As a courtesy the pump was tested and appeared to function properly. It is important that the sump pit and pump be kept clean and monitored periodically, as drainage problems could result if this system malfunctions. Please consult the seller regarding past drainage issues.

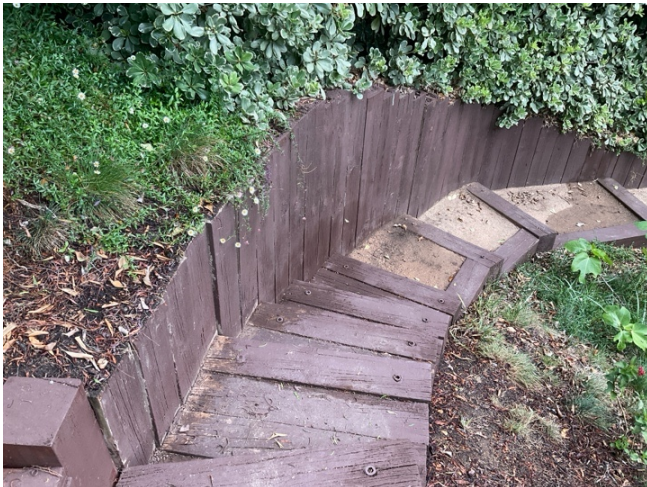
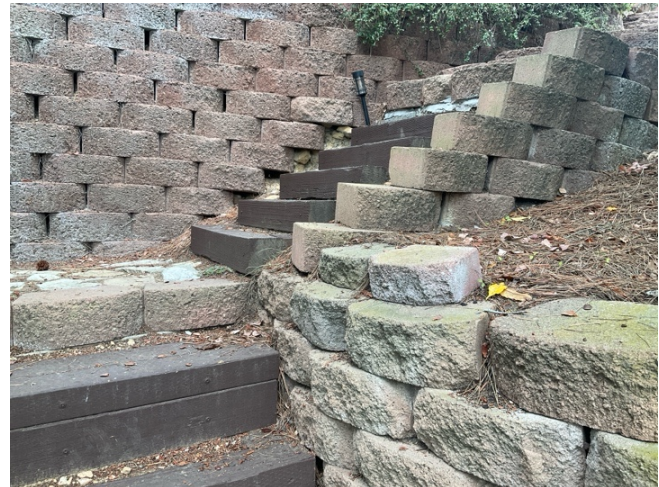
**15:** The railroad-tie and stacked block yard walls, though functional, have limited structural value as retaining walls and will need to be periodically monitored for movement.

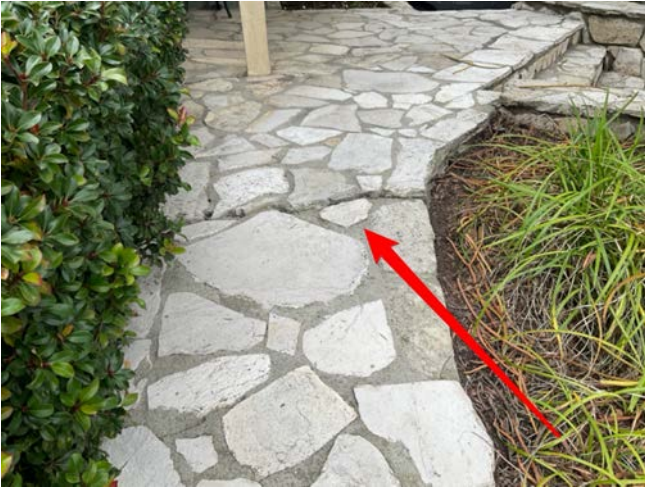
**17:** There are offsets in the walkways that could be considered a trip potential.

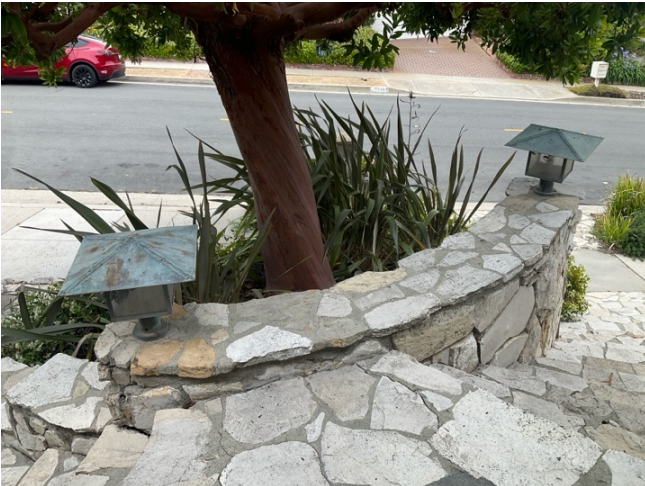
**18:** There are overlooks at the property that may not have proper guardrails. Installation of proper guardrails is recommended.

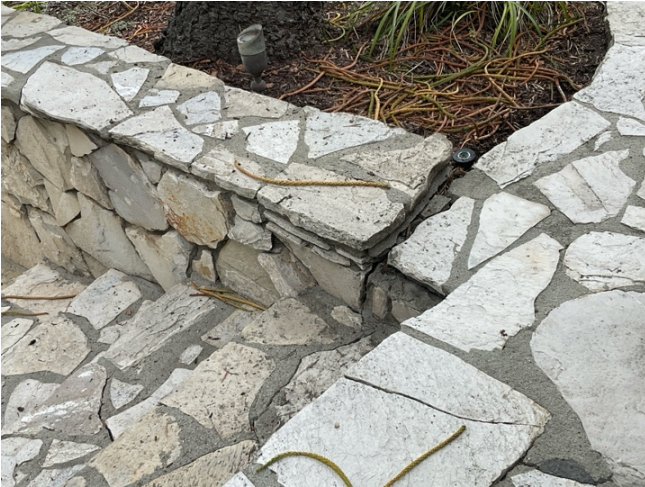
**19:** The yard planters have typical cosmetic damage. Repairs could be performed but would not be considered necessary.

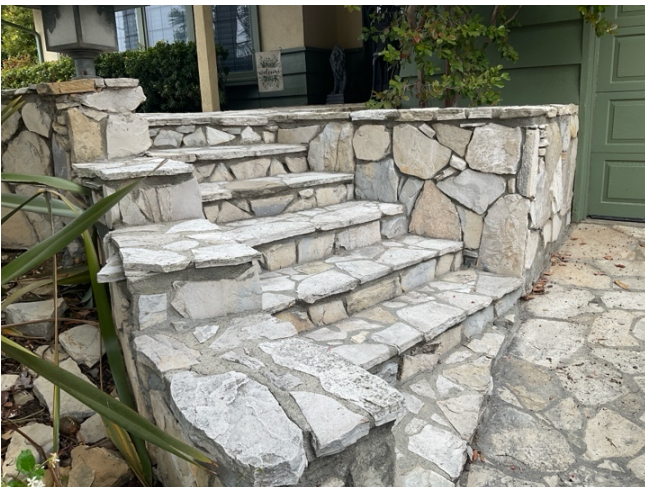
**21:** We recommend installing handrails on steps that have three or more risers, particularly if children or the elderly visit or occupy the property.

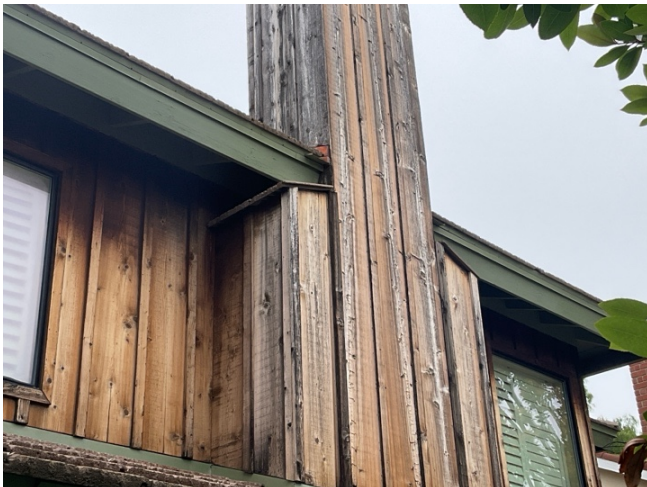
**26:** The upper siding may need refinishing for cosmetic purposes.

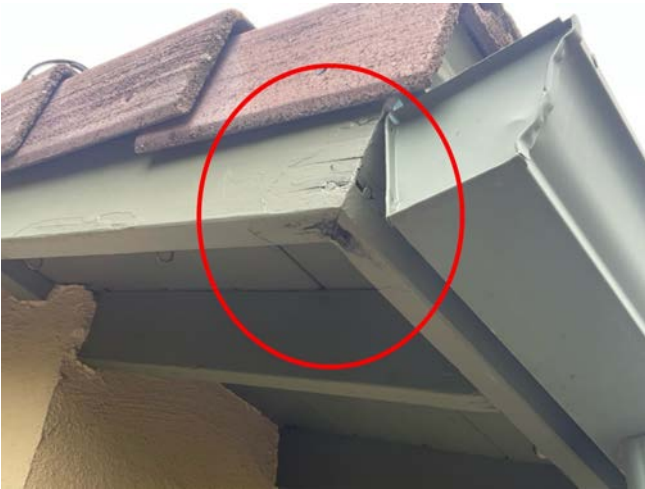
**28:** Degraded wood was observed at some areas of the fascia boards. A termite inspector should evaluate this further as we are not qualified.

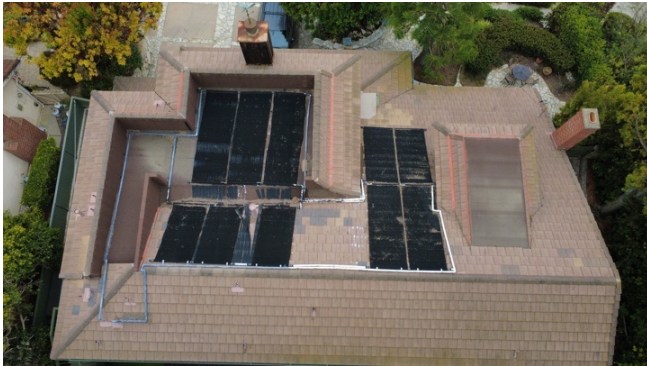
**46:** The subject property has both pitched and flat roof areas.

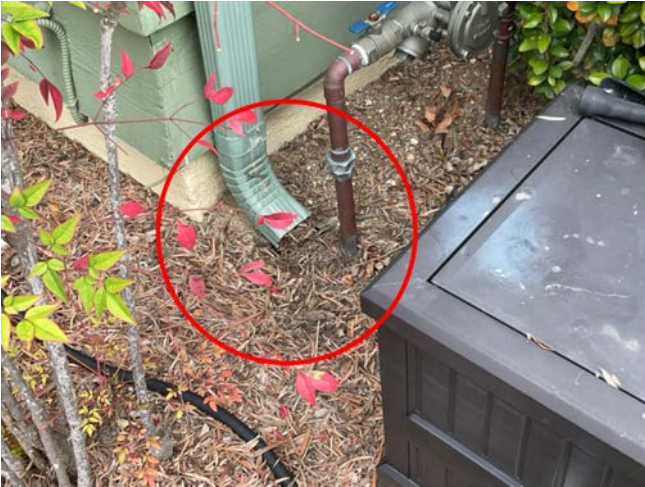
**48:** The roof gutter downspouts should be extended away from the home to prevent water from ponding against the buildings foundation.

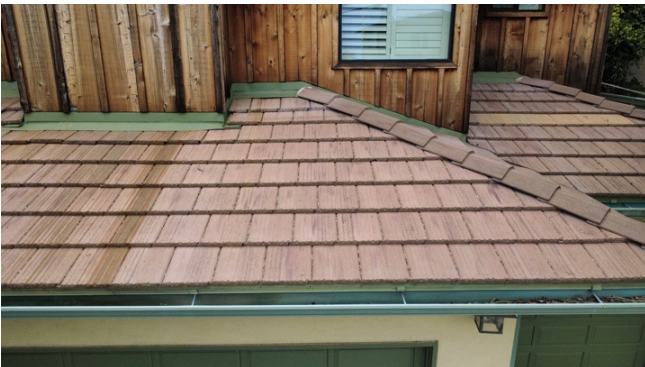
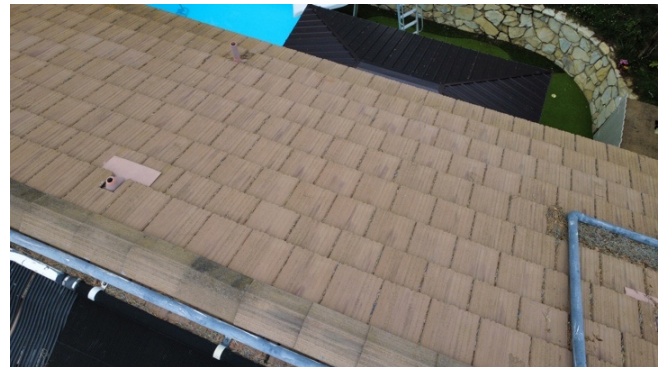
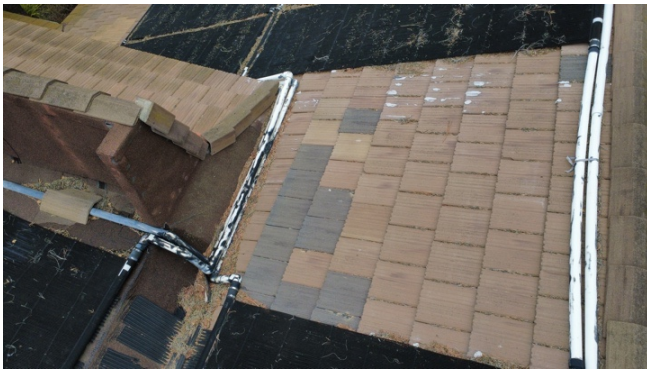
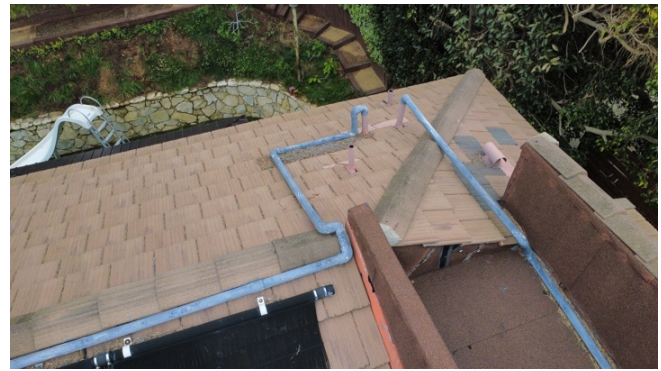
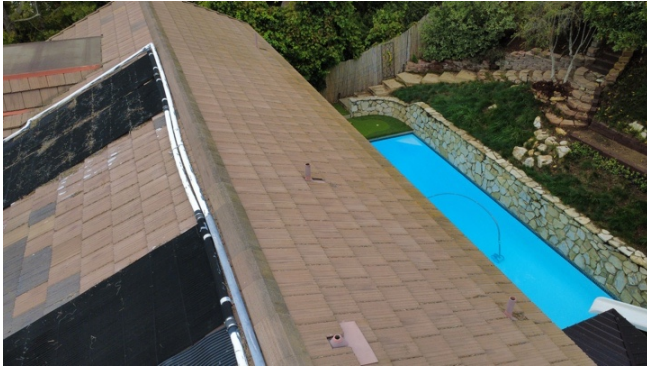
**49:** Concrete tiles are used as a roof covering at the pitched areas. Concrete tile roofs are among the most expensive and durable of all roofs. They are typically warranted by the manufacturer to last for forty years or more. These roofs are dependant on the integrity of the waterproof membrane beneath them which cannot be seen without removing the tiles. The majority of leaks at concrete tile roofs result when a roof has not been well maintained or kept clean. We therefore recommend servicing the roof regularly. Our service does not include any guarantee against leaks. For a guarantee, you will need to have a roofing company perform a water test and issue a roof certification.

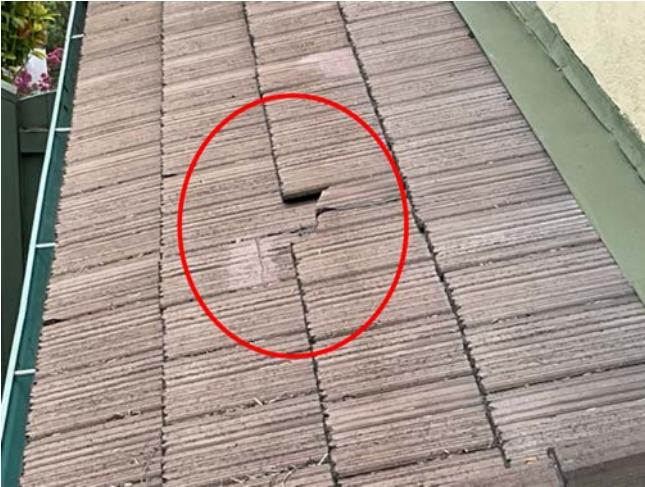
**52:** Some of the concrete tiles are broken, cracked or chipped but not separated. This is not uncommon and the tiles do not necessarily need to be serviced. It would be prudent, however, to have a roofer comment on this. If they are not repaired, the tiles should be monitored to make sure that they do not become displaced and expose the waterproofing membrane, which would cause deterioration to the membrane from the ultra-violet rays of the sun and cause leaks that would not otherwise occur.

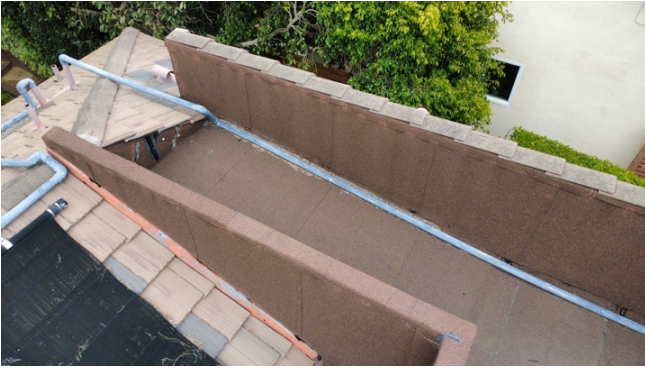
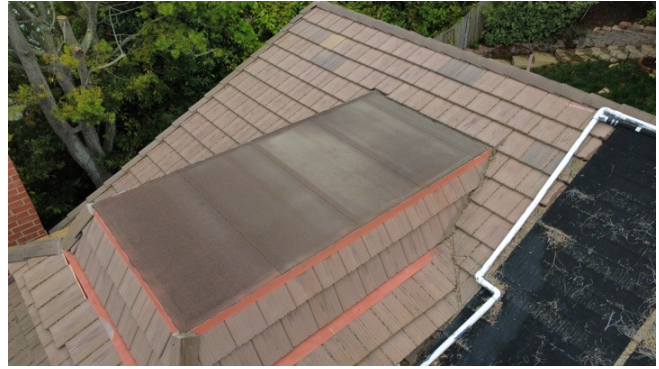
**56:** The cap sheet is functional and appears in acceptable condition. Regular maintenance yearly is recommended.

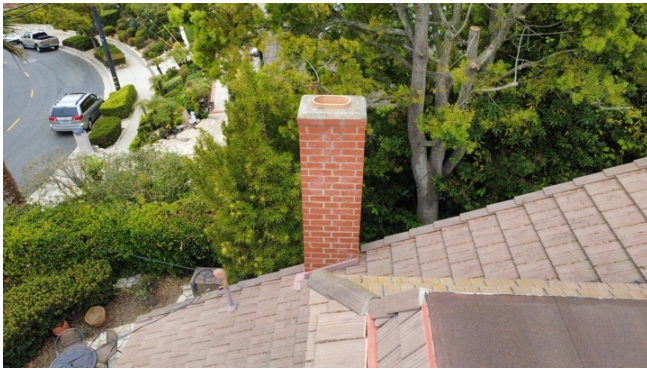
**77:** There is no spark arrestor on the chimney which is required by current standards, and should be installed.

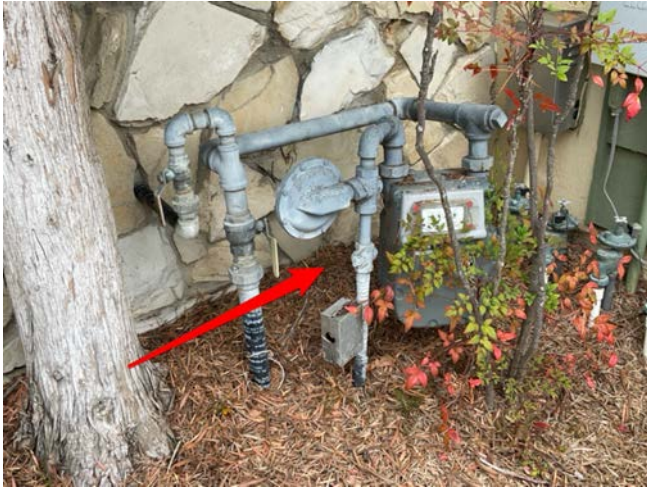
**97:** The gas main shut-off is located at the front of the residence.

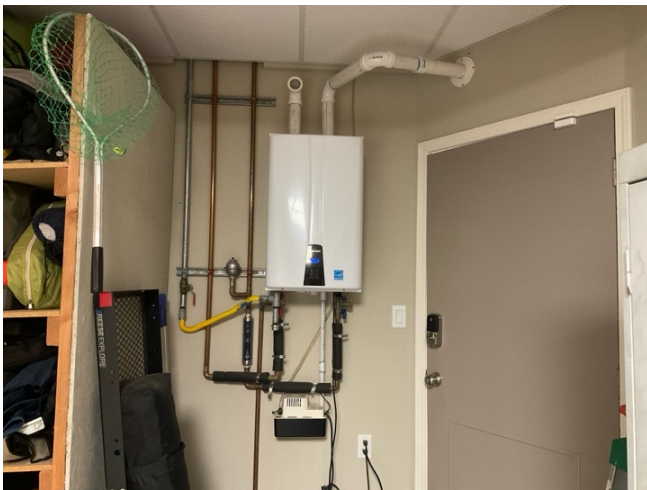
**101:** The water heater is a 'tankless' system that uses natural gas for fuel. This on demand, or "use it as you need it", water-heating technology is more energy efficient than conventional water heaters which use a tank to store heated water. Tankless water heaters produce an endless supply of hot water by rapidly heating water the moment it is needed. Because there is a limit to how much water can pass through the system at a time, it is important that you organize your hot water tasks one after another as a tankless water heater is not as effective when more than two tasks draw from it at one time. You should question the sellers about the water heater and its ability to provide sufficient hot water for the home, as this determination is beyond the scope of our inspection for this type of system.

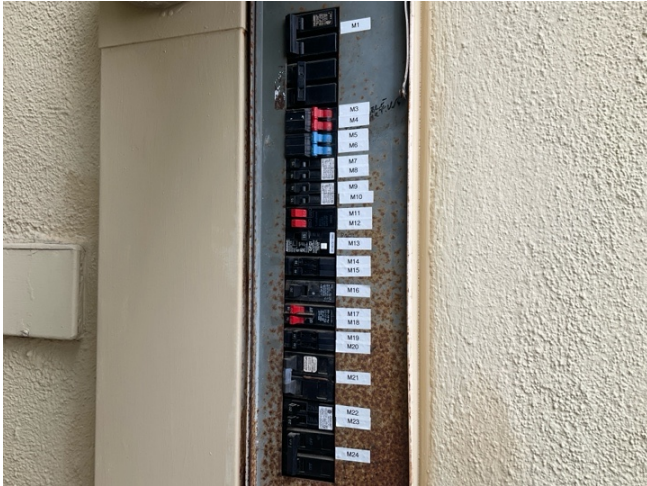
**119:** The main panel and its components appear functional and in serviceable condition.

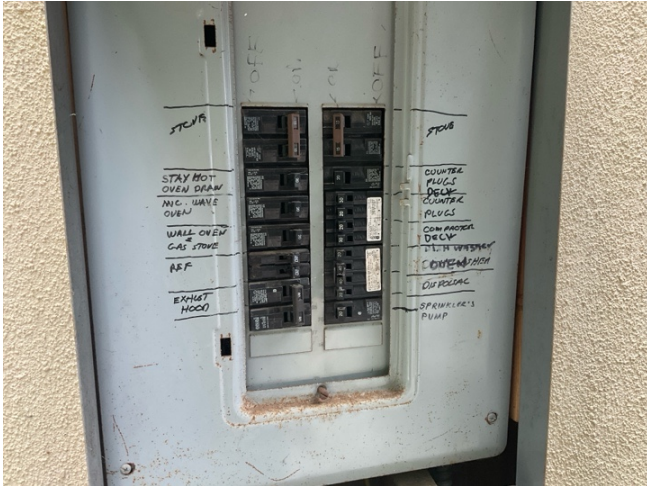
**127:** The electrical subpanel has no visible deficiencies.

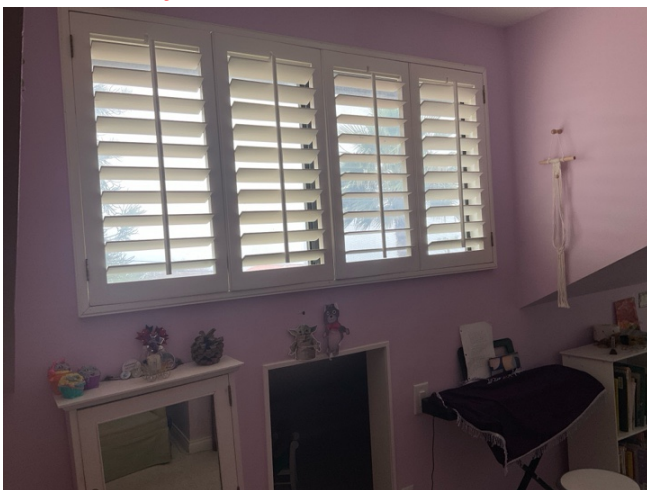
**194:** The dual-glazed window in the front upstairs bedroom has a broken hermetic seal. As a result, condensation can be seen between the glass. Although cosmetic, replacement of the window may be desired.

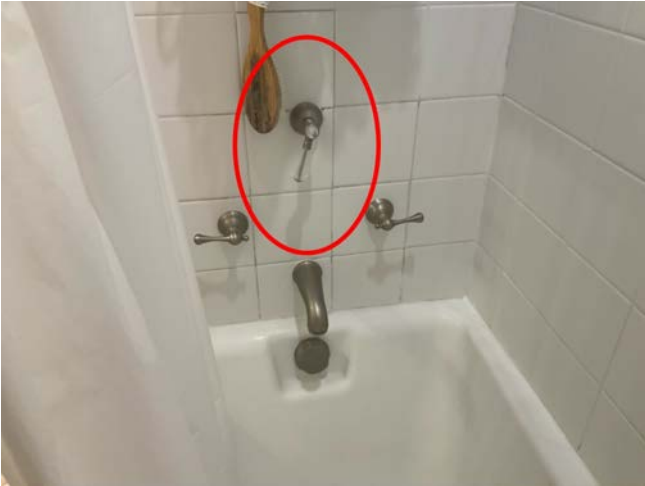
**235:** The shower diverter valve in the tub-shower is defective (repair or replacement needed).

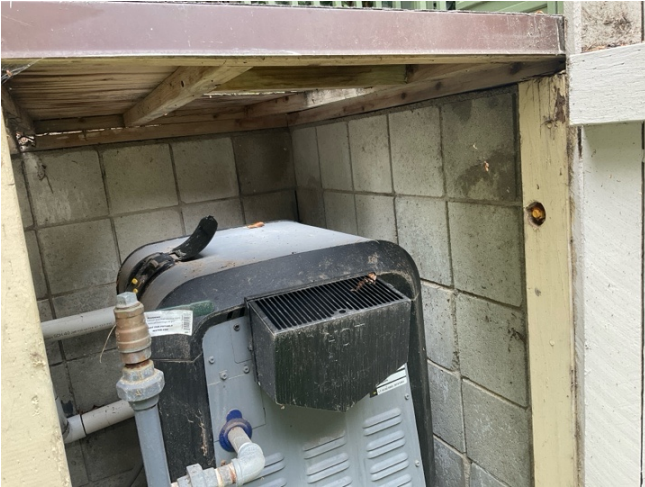
**310:** There should be a minimum clearance of 36" above the top of the heater to dissipate heat. The heater may require an exhaust vent stack.

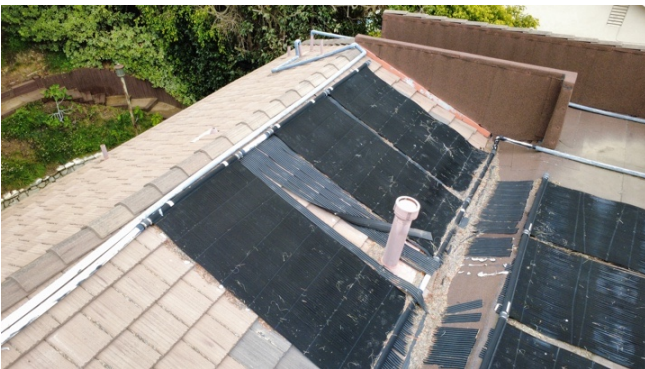
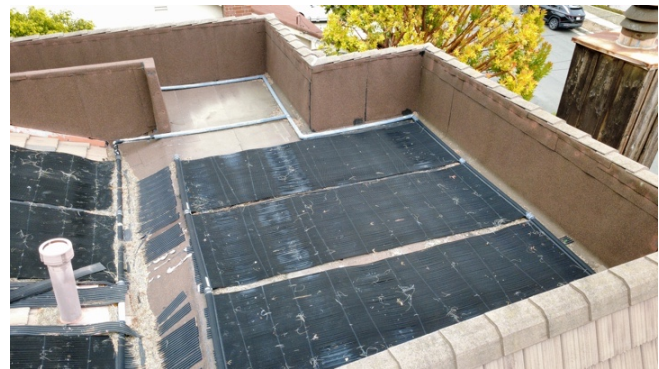
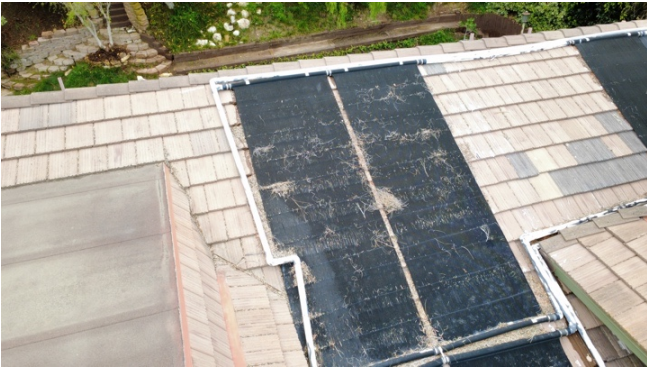
**315:** The plumbing includes a solar system for which we do not have the expertise to evaluate. You may therefore wish to have a specialist evaluate this system as it is outside the scope of our inspection.

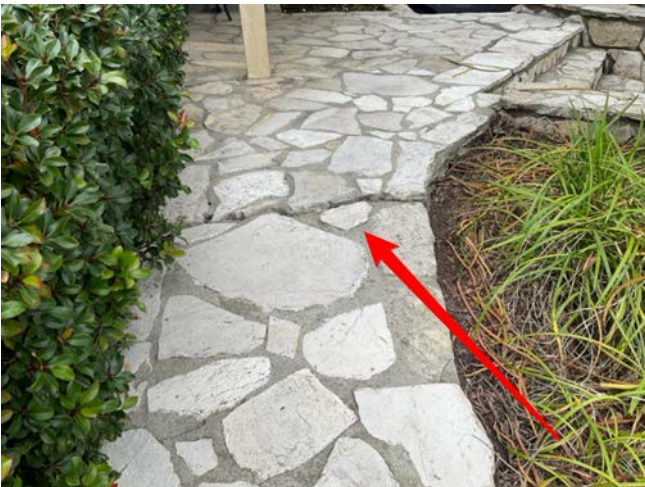
**s-17:** There are offsets in the walkways that could be considered a trip potential.

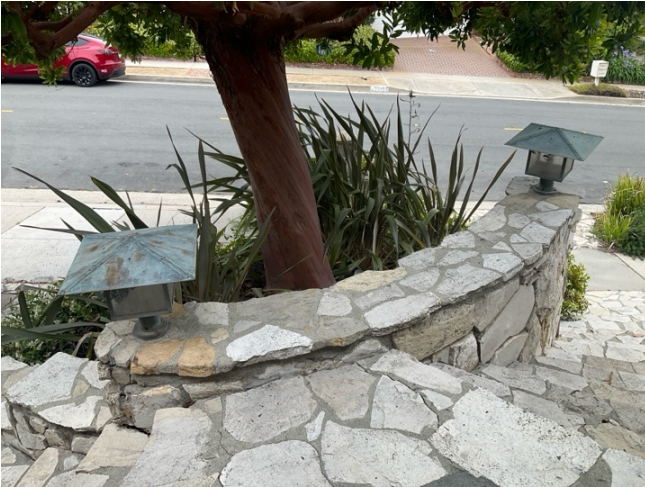
**s-18:** There are overlooks at the property that may not have proper guardrails. Installation of proper guardrails is recommended.

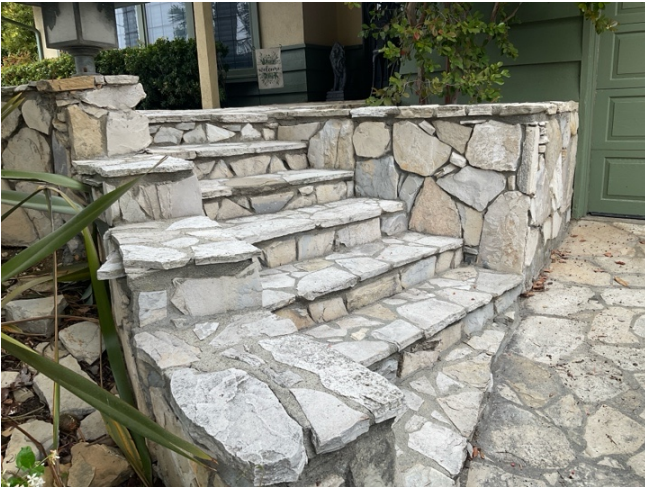
**s-21:** We recommend installing handrails on steps that have three or more risers, particularly if children or the elderly visit or occupy the property.

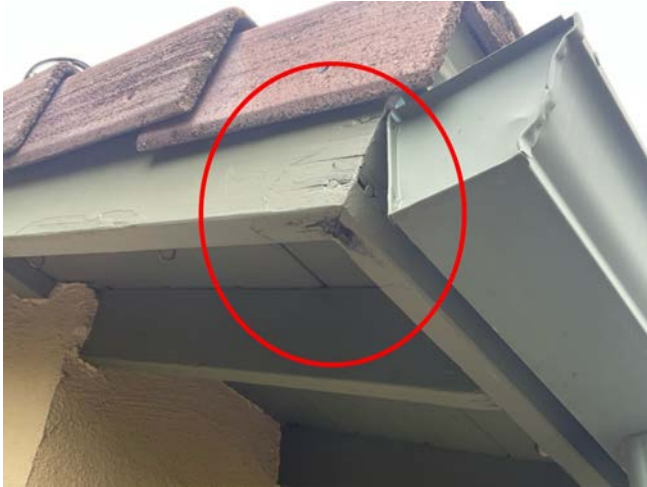
**s-28:** Degraded wood was observed at some areas of the fascia boards. A termite inspector should evaluate this further as we are not qualified.

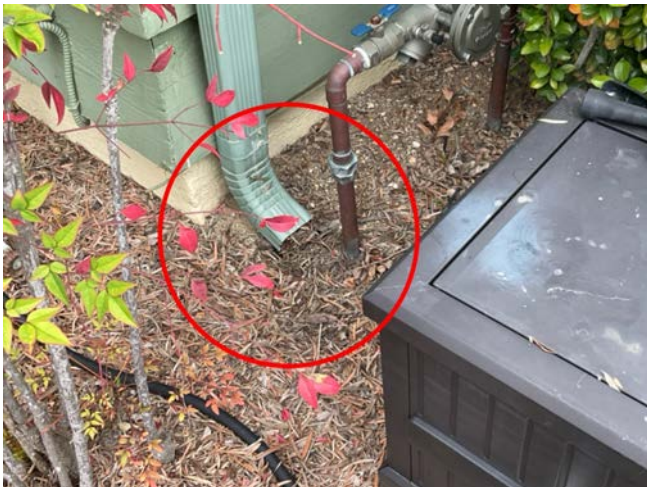
**s-48:** The roof gutter downspouts should be extended away from the home to prevent water from ponding against the buildings foundation.

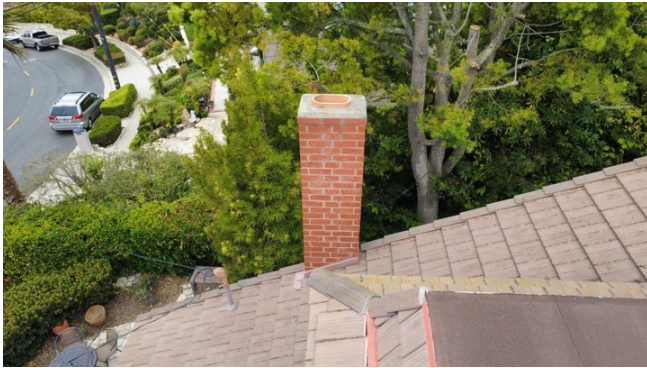
**s-77:** There is no spark arrestor on the chimney which is required by current standards, and should be installed.

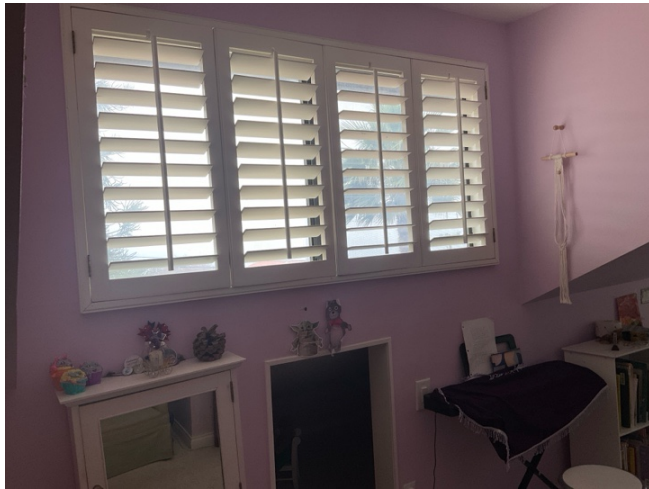
**s-194:** The dual-glazed window in the front upstairs bedroom has a broken hermetic seal. As a result, condensation can be seen between the glass. Although cosmetic, replacement of the window may be desired.

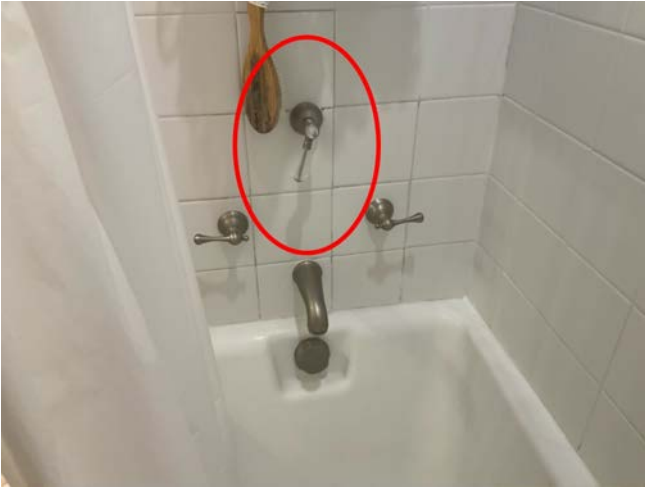
**s-235:** The shower diverter valve in the tub-shower is defective (repair or replacement needed).

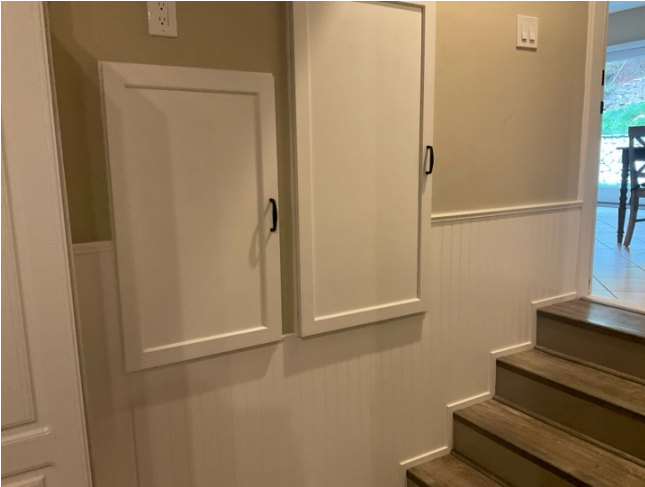
**s-297:** The cabinets in the garage firewall must be repaired with approved 1-hour fire rated material in order to maintain the necessary firewall separation between the garage and the living quarters.

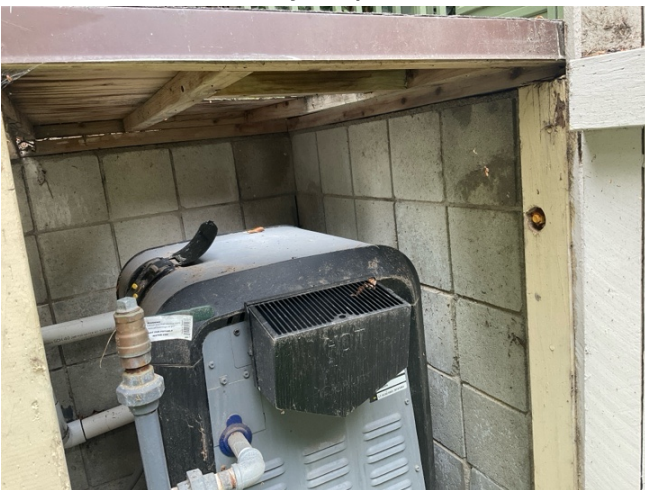
**s-310:** There should be a minimum clearance of 36" above the top of the heater to dissipate heat. The heater may require an exhaust vent stack.
