INSPECTION REPORT  
3549 Esplanade Space 249,  
Chico CA 95973

INSPECTED BY  
Carlos Pasillas  
Cpasillas LLC

INSPECTION DATE  
📅 9/24/2026  
🕒 10:00 AM

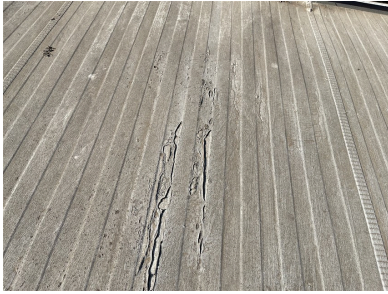
1.0 Item 1 (Picture)

Multiple repair noted at roof covering. Consult with seller regarding damage and repair history. Suggest sealing coating cracks now and annual evaluation/servicing as needed to prevent water penetration.

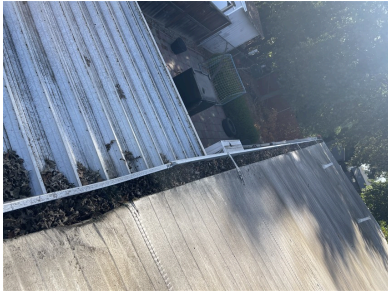
1.6 Item 1 (Picture)

(1) Heavy leaf buildup noted in rain gutters. Suggest cleaning and flushing now and on an annual basis for proper drainage. Consider upgrade of gutter guards to prevent leaf buildup.

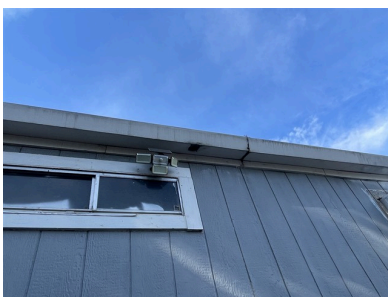
1.6 Item 2 (Picture)

(2) Gutters leak at seams. Recommend cleaning and applying gutter sealant. Replacement may be required if leakage is chronic.

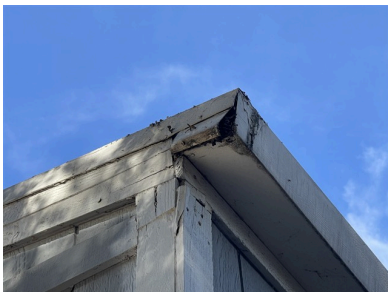
1.8 Item 1 (Picture)

Wood damage noted at fascia/eaves/soffit members. Anticipate repairs. Consult pest control company for evaluation and repair cost estimate for damaged wood.

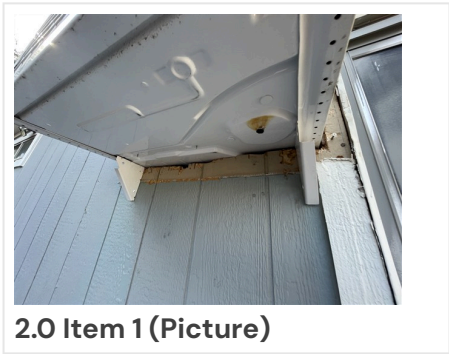
2.0 Item 1 (Picture)

(1) Suggest sealing at any gaps, cracks, around light fixtures, window AC units, doors,trim, etc...to aide in preventing water penetration and pest intrusion.

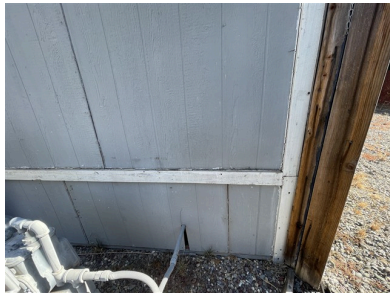
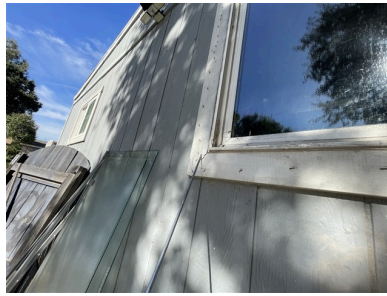
2.0 Item 2 (Picture)

(2) Wood damage noted at siding and trim. Anticipate repairs. Consult pest control company for evaluation and repair cost estimate for damaged wood.

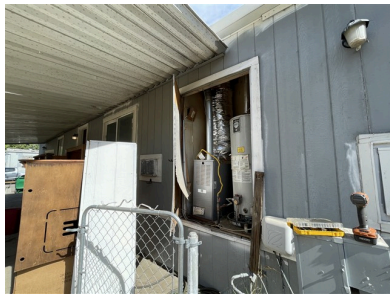
2.0 Item 4 (Picture)

(3) Anticipate repairing damage/loose utility room for proper operation.

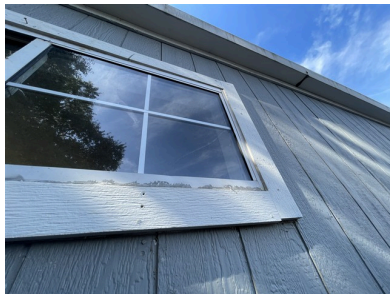
2.1 Item 1 (Picture)

Broken window glass was observed, compromising the window's weather-tight seal. Recommend having a qualified window contractor or glazier replace the damaged glass.

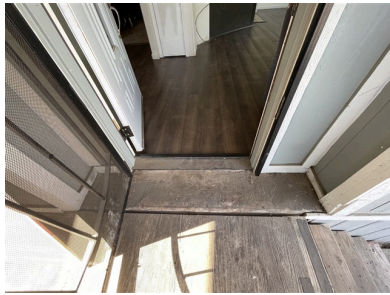
2.2 Item 1 (Picture)

The exterior entry threshold area is missing the required subfloor and finished walking surface, leaving the framing exposed. While metal flashing may be present, it is non-structural and cannot support foot traffic or protect against wear and damage. Recommend a qualified contractor properly install a structural subfloor, durable finished flooring, and a weather-tight threshold over the flashing to eliminate trip hazards, prevent damage.

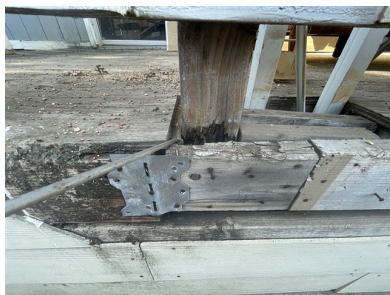
2.3 Item 1 (Picture)

Wood damage noted at deck post, decking. Anticipate repairs. Consult pest control company for evaluation and repair cost estimate for damaged wood. Have wood properly sealed for protection and enhanced lifespan.

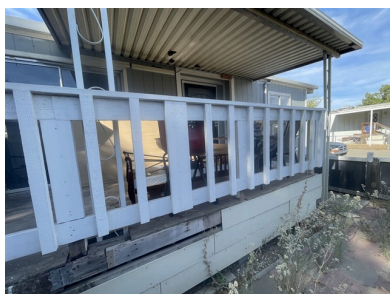
2.4 Item 1 (Picture)

The porch railing features excessive gaps between the balusters and is below standard height requirements, posing a fall and safety hazard. Recommend consulting qualified professional for upgrade options for added safety.

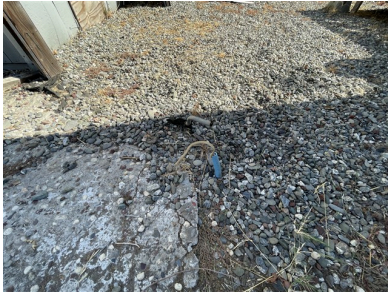
2.5 Item 1 (Picture)

Fragmented pipe and conduit materials were observed lying loose on the ground surface, creating a physical trip hazard. While verification indicates the existing wiring is currently inactive (dead), the surface-level materials require remediation for safety.

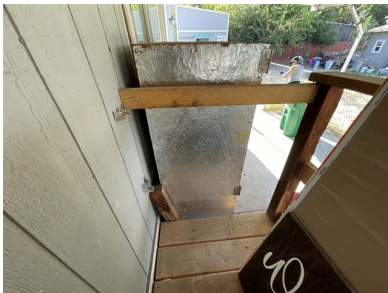
2.6 Item 1 (Picture)

The back entry stairs exhibit missing guardrails and balusters along the open side, creating a fall hazard. Recommendation: Install code-compliant guardrails and balusters (with spacing of less than 4 inches) along all open sides of the landing and stairs to prevent falls.

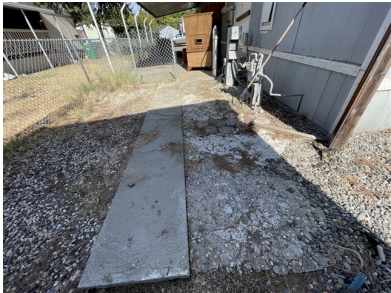
3.0 Item 1 (Picture)

Unlevel surfaces with trip concerns noted. Suggest repairs for safety.

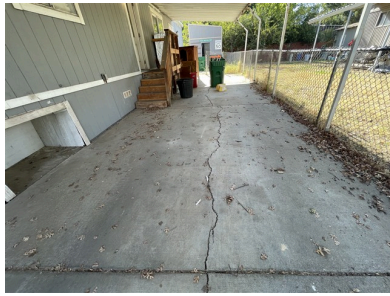
3.1 Item 1 (Picture)

Cracking/ settlement/ displacement noted at driveway. Consult contractor for further evaluation and repairs as desired.

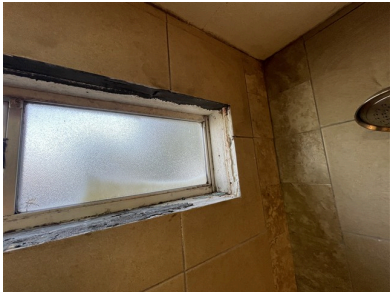
5.2.A Item 1 (Picture)

(1) Missing tile or weatherproofing around the shower/bathtub window frame. Window jambs and sill located directly within the shower spray zone, creating a high risk for moisture intrusion behind the wall finishes. Recommend consulting a qualified tile or waterproofing professional to install proper waterproof tile trim, flashing, and flexible silicone sealant around the entire perimeter of the window to prevent water damage and mold growth.

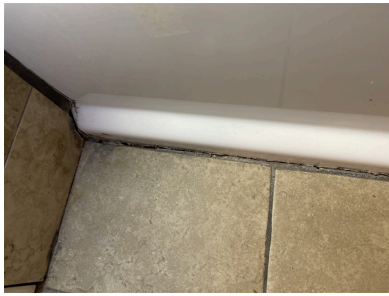
5.2.A Item 2 (Picture)

(2) Caulking/ grout repair is recommended as part of routine maintenance at tub/shower and flooring areas on a regular basis to help prevent moisture intrusion, damage and mold build-up.

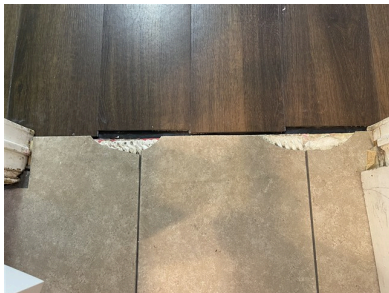
5.4.A Item 1 (Picture)

Crack damage tiles noted near bathroom entry. Anticipate repair/replacement.

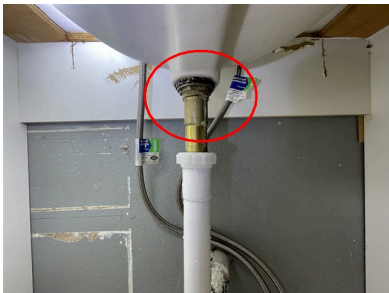
5.0.B Item 1 (Picture)

Leak at plumbing under sink noted. Consult plumber for further evaluation and repairs.

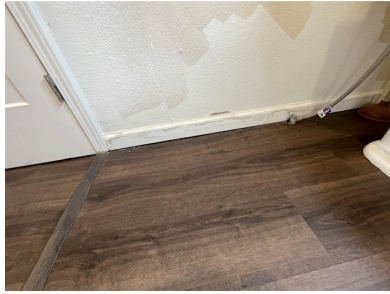
5.3.B Item 1 (Picture)

Staining and discoloration at main bathroom baseboard and/or painting noted at wall. Possible leakage from toilet and/or shower. Consult seller regarding prior water penetration. Check for hidden damage.

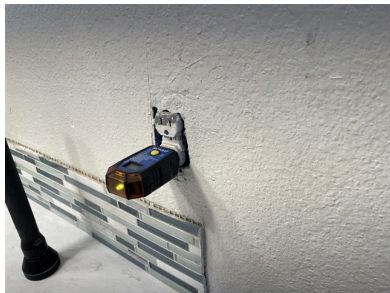
5.5.B Item 1 (Picture)

Missing cover plates noted. Install covers at all outlets and switches for safety.

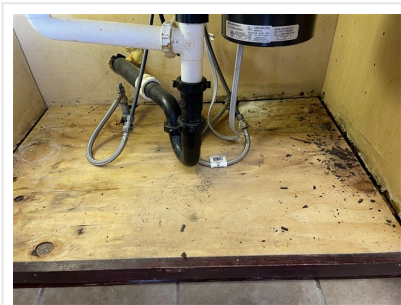
6.0 Item 1 (Picture)

Stains/moisture damage noted under kitchen sink. Consult seller on history of water leaks. Unable to determine condition behind concealed areas. Look for hidden damage behind materials.

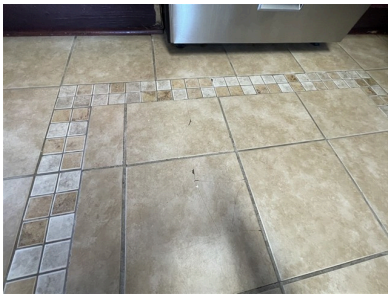
6.1 Item 1 (Picture)

Crack tiles noted at kitchen floor. Repair/replace as desired.

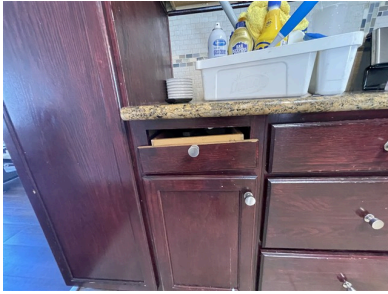
**6.9 Item 1 (Picture)**

The upper drawer beneath the countertop is broken. Anticipate repair/replacement

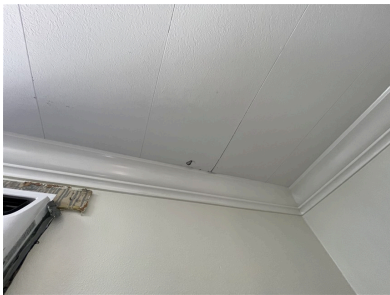
7.0 Item 1 (Picture)

Staining and patching and painting noted at ceiling(s). Possible leakage from exterior and/or roof cover. Consult seller regarding prior water penetration. Check for hidden damage. See roof section.

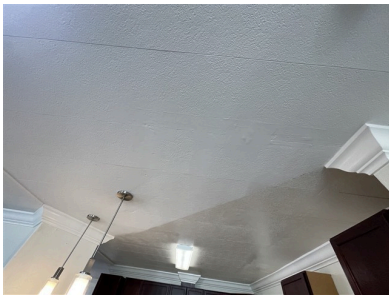
7.0 Item 2 (Picture)

Staining and patching and painting noted at ceiling(s). Possible leakage from exterior and/or roof cover. Consult seller regarding prior water penetration. Check for hidden damage. See roof section.

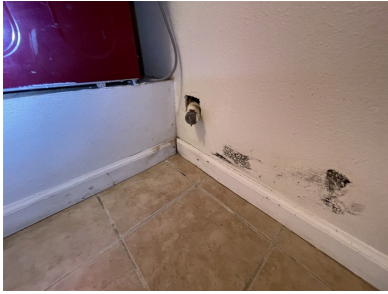
7.1 Item 1 (Picture)

Mold/mildew growth noted at laundry room wall and baseboard. Consult seller regarding prior water penetration. Check for hidden damage.

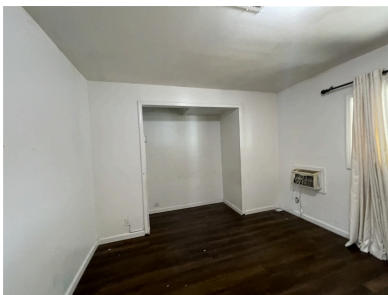
7.6 Item 1 (Picture)

Missing closet doors noted. Install as desired.

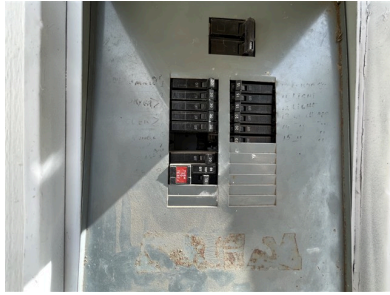
8.4 Item 1 (Picture)

Panel missing knockouts covers. Recommend installing covers for safety.

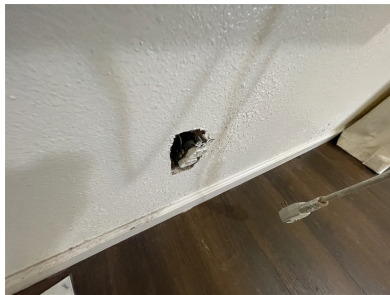
8.5 Item 1 (Picture)

(1) Missing and multiple loose outlet noted. Anticipate installing/repairing missing and loose outlet for safety.

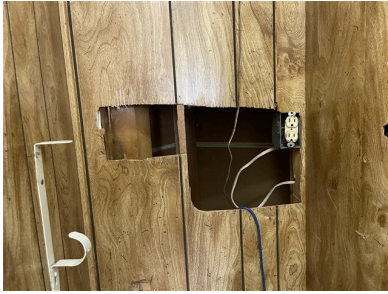
**8.6 Item 1 (Picture)**

Exposed wiring in living room closet can be subject to damage. Enclose wiring in conduit for safety. Consult electrician for proper installation.

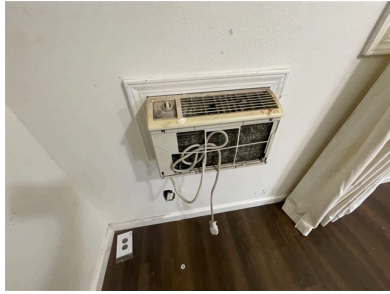
9.1 Item 1 (Picture)

Wall/window Air Conditioning: Unit operated properly, however due to age, wear and condition it is downgraded to fair. Wall/window units are not part of a standard inspection.

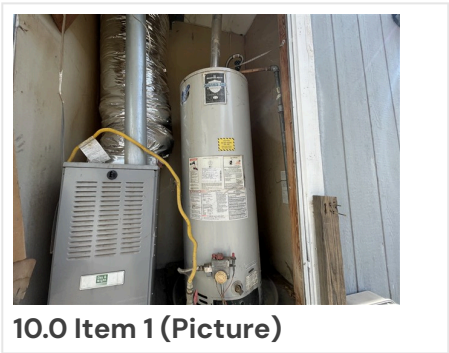
Missing seismic straps. Seismic straps should be installed at the upper one–third of the unit and the lower one–third per local building standard requirements. Repair for safety.

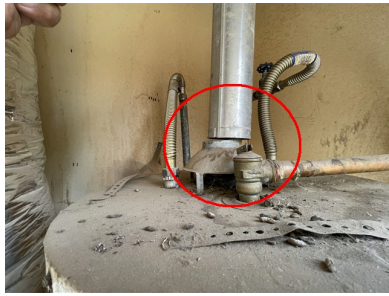
10.1 Item 1 (Picture)

Draft hood/ Vent pipe is not properly installed attached and poses a safety concern. Consult a plumber for proper installation of vent pipe prior to lighting water heater for occupant safety.

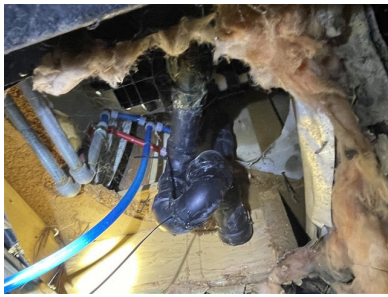
11.3 Item 1 (Picture)

(1) Leak noted at shower drain in crawlspace beneath hallway bathroom. Consult a plumber for repairs.

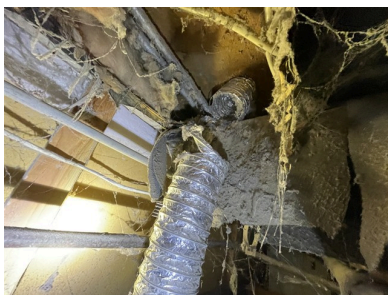
11.6 Item 1 (Picture)

Damage/disconnected dryer vent is discharging directly into the crawlspace. Recommend Having a qualified contractor or handyman properly reconnect, mechanically secure, and seal the dryer exhaust duct with approved metal clamps and foil tape, ensuring the entire system terminates safely to the exterior of the structure

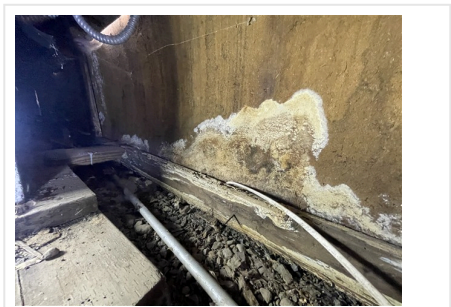
12.0 Item 1 (Picture)

Fungal growth and wood decay were observed on the underfloor framing and skirting. Recommendation: Have a licensed contractor or pest control specialist evaluate and repair/replace damaged wood components, and correct any underlying moisture or ventilation issues.

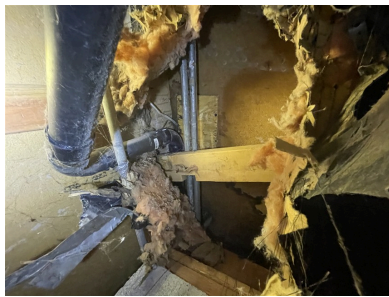
12.1 Item 1 (Picture)

Damage underbelly and missing loose insulation noted at several areas in crawlspace. Recommend repair by a qualified crawlspace or insulation contractor to replace missing insulation, secure loose materials, and properly patch/seal the underbelly membrane to prevent heat loss, moisture intrusion, and pest activity.

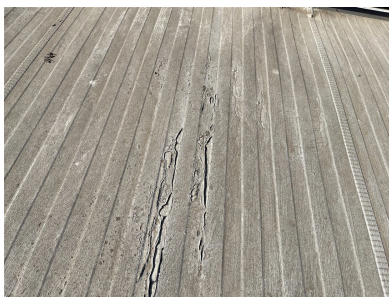
1.0 Item 1 (Picture)

Multiple repair noted at roof covering. Consult with seller regarding damage and repair history. Suggest sealing coating cracks now and annual evaluation/servicing as needed to prevent water penetration.

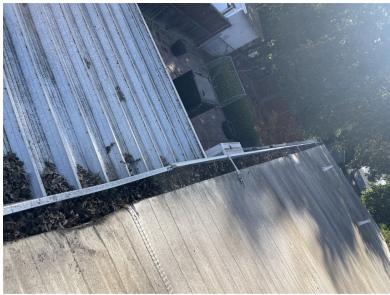
1.6 Item 1 (Picture)

(1) Heavy leaf buildup noted in rain gutters. Suggest cleaning and flushing now and on an annual basis for proper drainage. Consider upgrade of gutter guards to prevent leaf buildup.

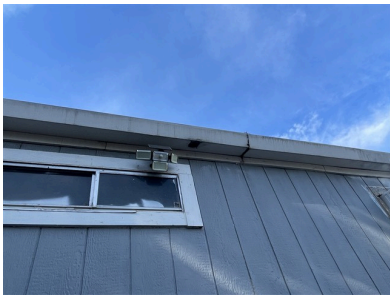
1.6 Item 2 (Picture)

(2) Gutters leak at seams. Recommend cleaning and applying gutter sealant. Replacement may be required if leakage is chronic.

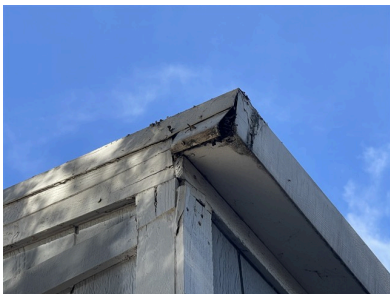
1.8 Item 1 (Picture)

Wood damage noted at fascia/eaves/soffit members. Anticipate repairs. Consult pest control company for evaluation and repair cost estimate for damaged wood.

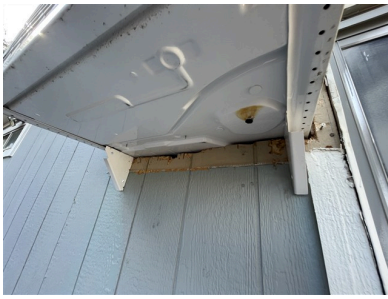
**2.0 Item 1 (Picture)**

(1) Suggest sealing at any gaps, cracks, around light fixtures, window AC units, doors,trim, etc...to aide in preventing water penetration and pest intrusion.

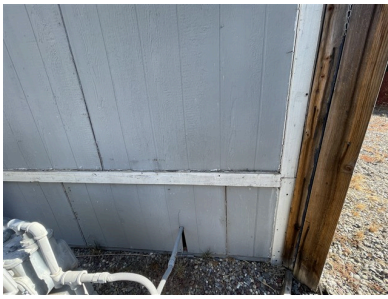
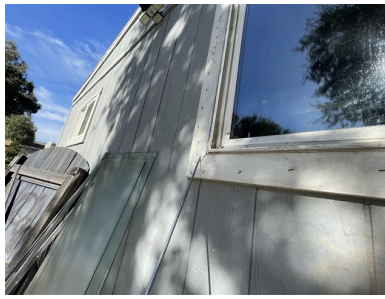
**2.0 Item 2 (Picture)**

(2) Wood damage noted at siding and trim. Anticipate repairs. Consult pest control company for evaluation and repair cost estimate for damaged wood.

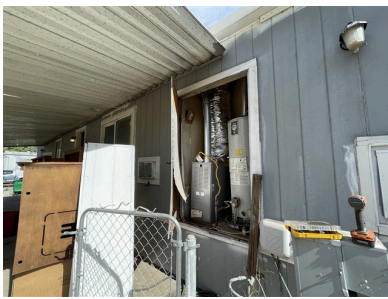
**2.0 Item 4 (Picture)**

(3) Anticipate repairing damage/loose utility room for proper operation.

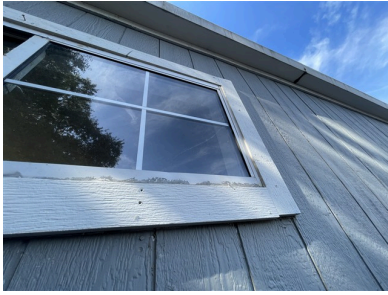
2.1 Item 1 (Picture)

Broken window glass was observed, compromising the window's weather-tight seal. Recommend having a qualified window contractor or glazier replace the damaged glass.

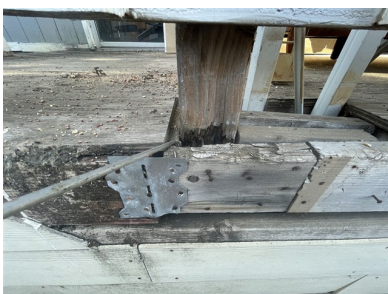
2.3 Item 1 (Picture)

Wood damage noted at deck post, decking. Anticipate repairs. Consult pest control company for evaluation and repair cost estimate for damaged wood. Have wood properly sealed for protection and enhanced lifespan.

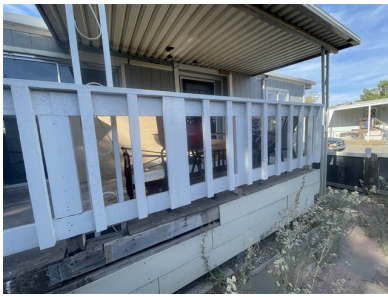
2.4 Item 1 (Picture)

The porch railing features excessive gaps between the balusters and is below standard height requirements, posing a fall and safety hazard. Recommend consulting qualified professional for upgrade options for added safety.

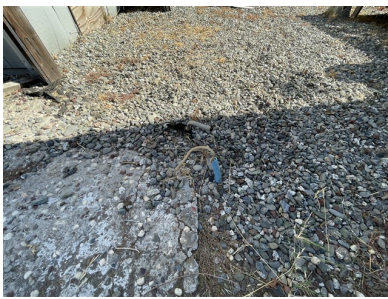
2.5 Item 1 (Picture)

Fragmented pipe and conduit materials were observed lying loose on the ground surface, creating a physical trip hazard. While verification indicates the existing wiring is currently inactive (dead), the surface-level materials require remediation for safety.

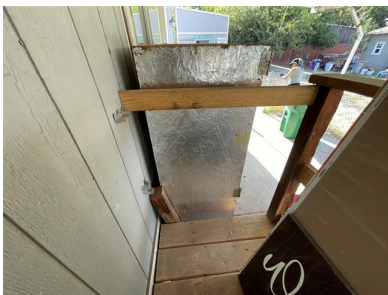
2.6 Item 1 (Picture)

The back entry stairs exhibit missing guardrails and balusters along the open side, creating a fall hazard. Recommendation: Install code-compliant guardrails and balusters (with spacing of less than 4 inches) along all open sides of the landing and stairs to prevent falls.

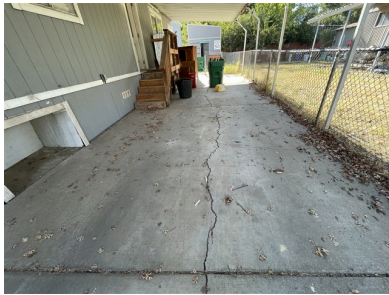
3.1 Item 1 (Picture)

Cracking/ settlement/ displacement noted at driveway. Consult contractor for further evaluation and repairs as desired.

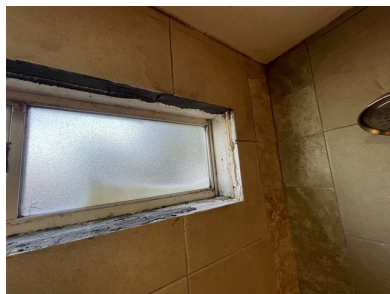
5.2.A Item 1 (Picture)

(1) Missing tile or weatherproofing around the shower/bathtub window frame. Window jambs and sill located directly within the shower spray zone, creating a high risk for moisture intrusion behind the wall finishes. Recommend consulting a qualified tile or waterproofing professional to install proper waterproof tile trim, flashing, and flexible silicone sealant around the entire perimeter of the window to prevent water damage and mold growth.

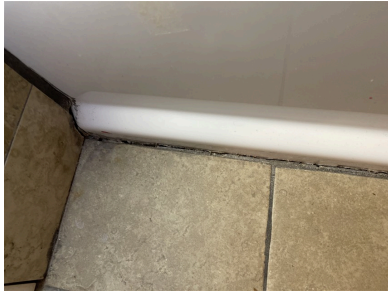
5.2.A Item 2 (Picture)

(2) Caulking/ grout repair is recommended as part of routine maintenance at tub/shower and flooring areas on a regular basis to help prevent moisture intrusion, damage and mold build-up.

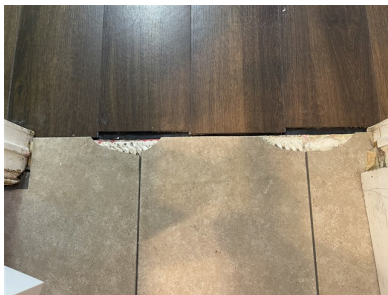
5.4.A Item 1 (Picture)

Crack damage tiles noted near bathroom entry. Anticipate repair/replacement.

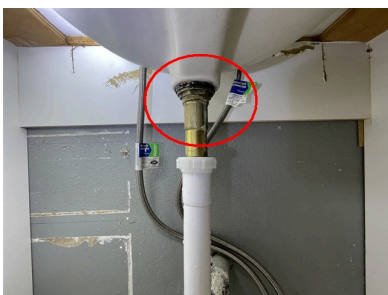
5.0.B Item 1 (Picture)

Leak at plumbing under sink noted. Consult plumber for further evaluation and repairs.

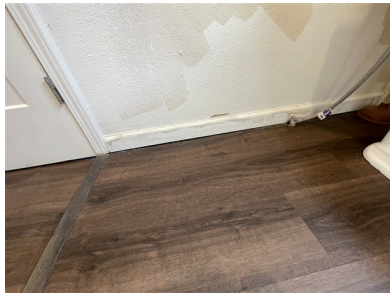
5.3.B Item 1 (Picture)

Staining and discoloration at main bathroom baseboard and/or painting noted at wall. Possible leakage from toilet and/or shower. Consult seller regarding prior water penetration. Check for hidden damage.

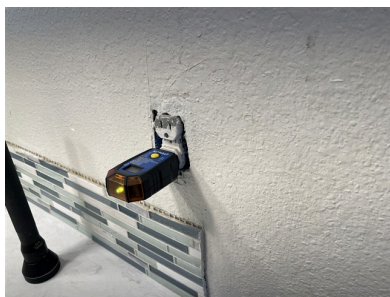
5.5.B Item 1 (Picture)

Missing cover plates noted. Install covers at all outlets and switches for safety.

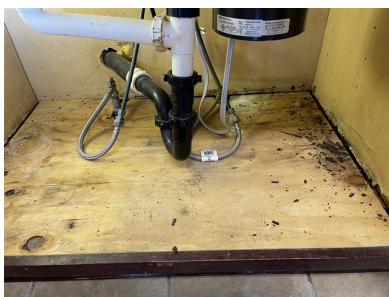
6.0 Item 1 (Picture)

Stains/moisture damage noted under kitchen sink. Consult seller on history of water leaks. Unable to determine condition behind concealed areas. Look for hidden damage behind materials.

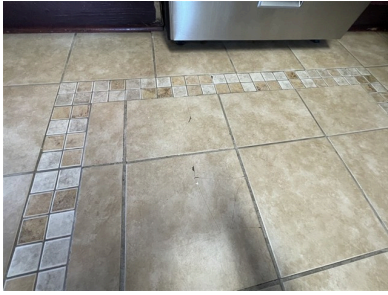
**6.1 Item 1 (Picture)**

Crack tiles noted at kitchen floor. Repair/replace as desired.

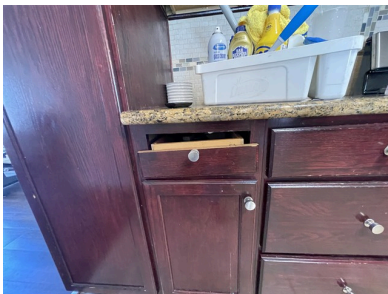
**6.9 Item 1 (Picture)**

The upper drawer beneath the countertop is broken. Anticipate repair/replacement

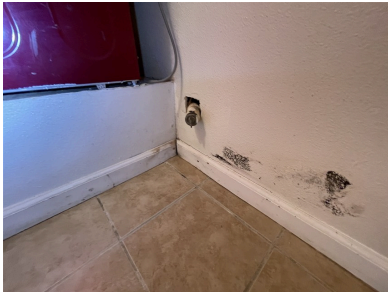
7.1 Item 1 (Picture)

Mold/mildew growth noted at laundry room wall and baseboard. Consult seller regarding prior water penetration. Check for hidden damage.

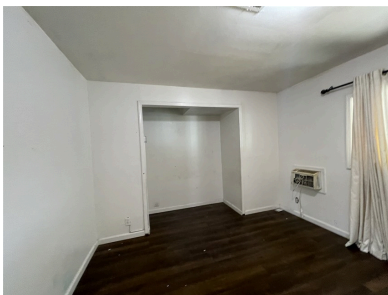
7.6 Item 1 (Picture)

Missing closet doors noted. Install as desired.

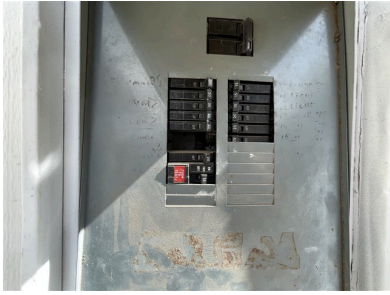
**8.4 Item 1 (Picture)**

Panel missing knockouts covers. Recommend installing covers for safety.

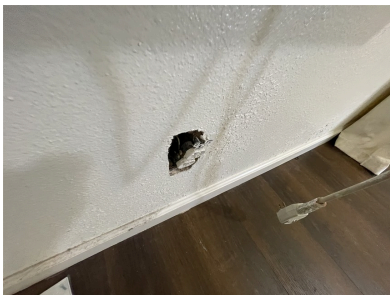
**8.5 Item 1 (Picture)**

(1) Missing and multiple loose outlet noted. Anticipate installing/repairing missing and loose outlet for safety.

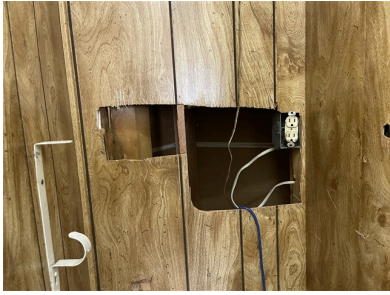
**8.6 Item 1 (Picture)**

Exposed wiring in living room closet can be subject to damage. Enclose wiring in conduit for safety. Consult electrician for proper installation.

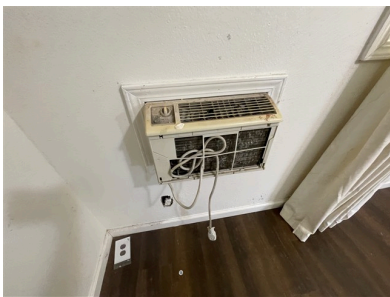
**9.1 Item 1 (Picture)**

Wall/window Air Conditioning: Unit operated properly, however due to age, wear and condition it is downgraded to fair. Wall/window units are not part of a standard inspection.

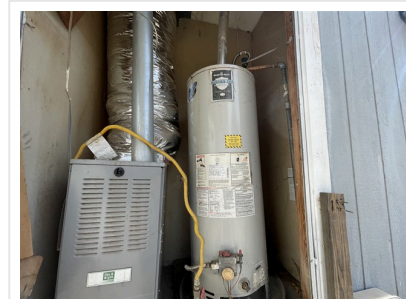
**10.0 Item 1 (Picture)**

Missing seismic straps. Seismic straps should be installed at the upper one-third of the unit and the lower one-third per local building standard requirements. Repair for safety.

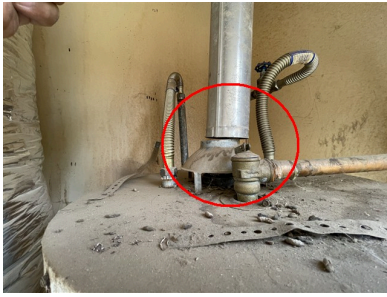
10.1 Item 1 (Picture)

Draft hood/ Vent pipe is not properly installed attached and poses a safety concern. Consult a plumber for proper installation of vent pipe prior to lighting water heater for occupant safety.

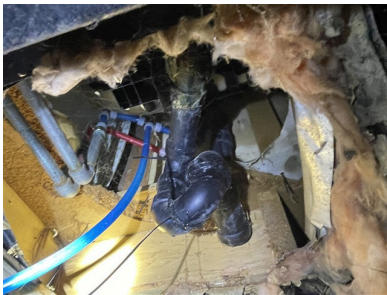
11.3 Item 1 (Picture)

(1) Leak noted at shower drain in crawlspace beneath hallway bathroom. Consult a plumber for repairs.

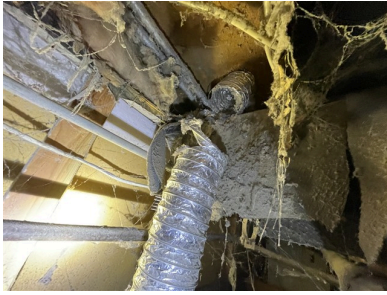
11.6 Item 1 (Picture)

Damage/disconnected dryer vent is discharging directly into the crawlspace. Recommend Having a qualified contractor or handyman properly reconnect, mechanically secure, and seal the dryer exhaust duct with approved metal clamps and foil tape, ensuring the entire system terminates safely to the exterior of the structure

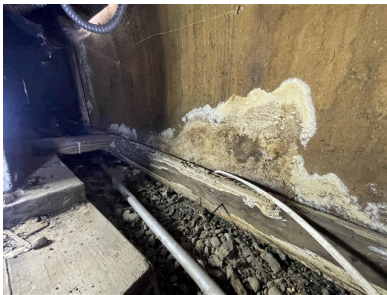
12.0 Item 1 (Picture)

Fungal growth and wood decay were observed on the underfloor framing and skirting. Recommendation: Have a licensed contractor or pest control specialist evaluate and repair/replace damaged wood components, and correct any underlying moisture or ventilation issues.

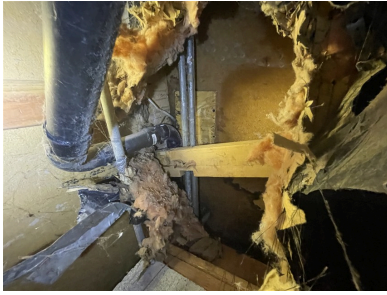
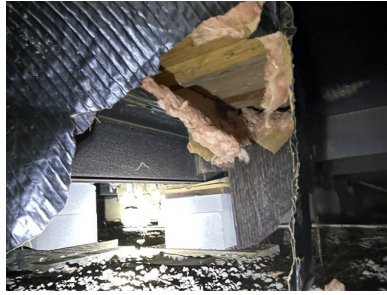
**12.1 Item 1 (Picture)**

Damage underbelly and missing loose insulation noted at several areas in crawlspace. Recommend repair by a qualified crawlspace or insulation contractor to replace missing insulation, secure loose materials, and properly patch/seal the underbelly membrane to prevent heat loss, moisture intrusion, and pest activity.
