## YOUR INSPECTION REPORT

**4465 Ocean Boulevard #4  
San Diego, CA 92109**

**Report ID: 1110100**

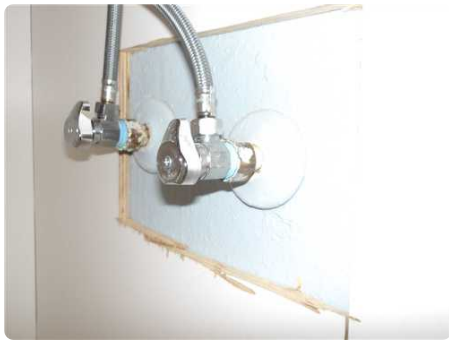
2.1 - Water Supply & Distribution System

There is surface corrosion in the visible supply and/or waste piping at several valves, fixture and drains in the home. We observed no signs of active leaks at the time of the inspection but leaks can develop anytime without warning. All valves and fixtures should be evaluated during your final walk through and before close of escrow to verify that no new leaks have developed.
  - This piping should be evaluated for leaks on a regular basis and repaired by a qualified technician when necessary.

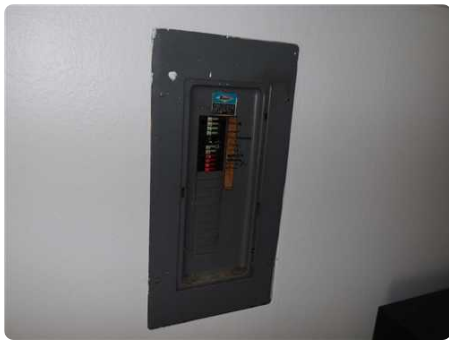
### 3.3 - Main Electric Panel and Sub Panels

- 🔑 The sub panel was manufactured by Zinsco. Zinsco panels and circuit breakers have not been manufactured for some time, and some higher-rated Zinsco circuit breakers have been known to fail to trip at their rated amperage. Breakers that do not trip are a fire hazard.

We recommend that the sub panel be evaluated by a qualified electrician to determine if upgrading the panel is

- warranted.

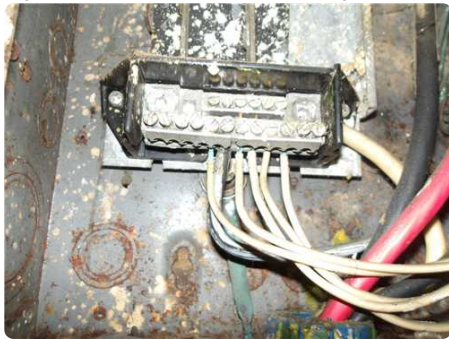
Corrosion was noted in several areas of the main electric panel and components. Corrosion on electrical components can compromise their ability to properly perform. The panel should be evaluated and repaired as needed by a licensed, qualified electrician to avoid potential overheating of components.

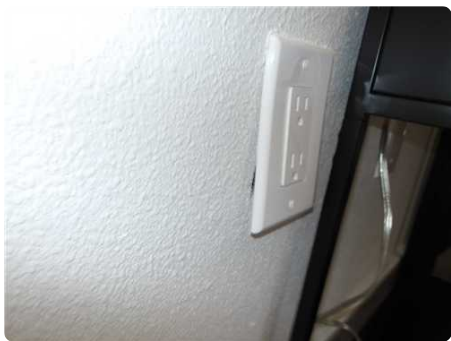
#### Location: multiple throughout condo

One or more outlets are damaged in several rooms of the home. The outlets still work and have power but the damaged outlet often make a loose connection when plugged in. A qualified electrician should make any needed repairs.

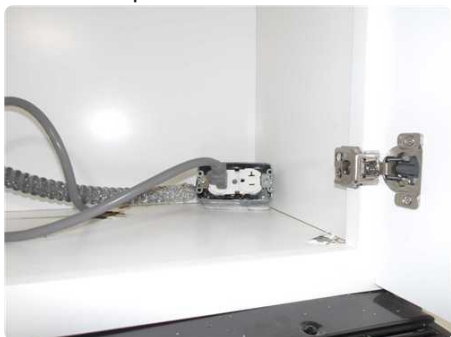
Outlet above the microwave is not installed properly and is missing a cover. A qualified electrician should make any needed repairs.

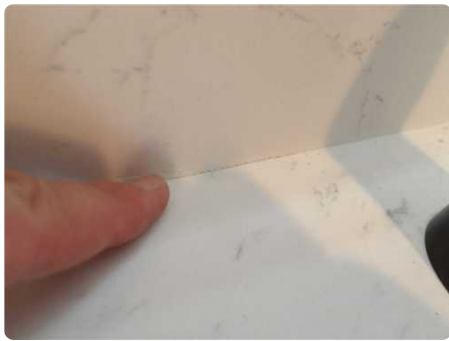
#### Location: bathroom

The joint between the backsplash and wall at the sink is open and subject to moisture damage from water penetration.

- Check for damage behind the cabinet base. Re-caulking is advised.

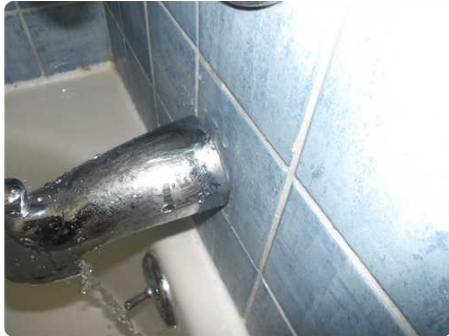
- 🔑 There is a gap between the shower wall and the base of the tub spout. Water can enter the wall cavity and cause hidden damage. A qualified plumber could make required repairs.

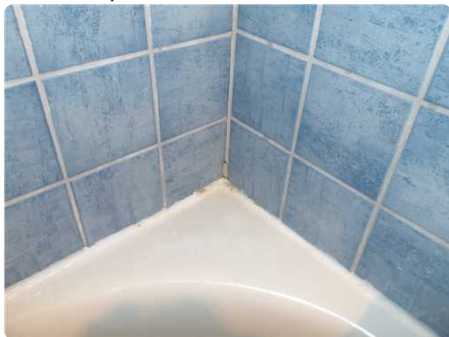
- 🔑 There are loose tiles on the tub deck or walls. Loose tile can allow water to enter behind the tile surface, leading to significant damage to surrounding structural features and any wood floor system or ceiling below. Depending on the extent of any hidden damage, repair can be as simple as re-grouting loose tile, or can prove expensive if structural repairs are required. Loose tiles should be removed and the underlying conditions investigated and repaired as necessary before new tiles are reinstalled. Have a qualified, experienced tile contractor evaluate the damage and make repairs.
