# Inspection Report

**Property Address:**  
3517 Cameo Dr #87  
Oceanside CA 92056

**Foresight Building Inspection**

| <b>Date:</b> 8/27/2026 | <b>Time:</b> 11:00 AM | <b>Report ID:</b> 3815 |

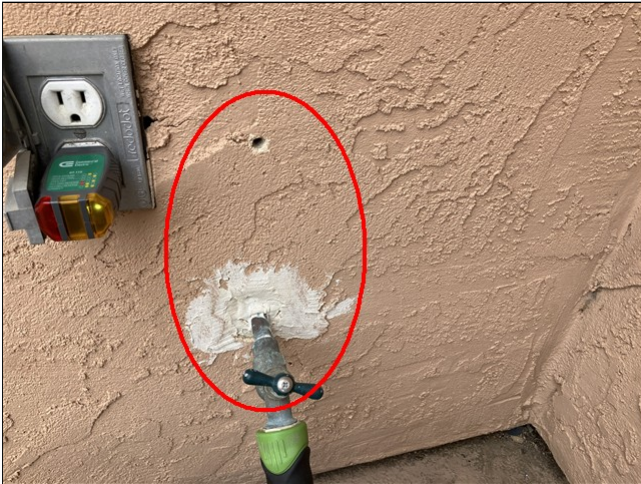
There were damages, deterioration, or other visible defects observed at areas of the exterior wall cladding system or components. It is recommended to have this evaluated by an appropriate licensed contractor or tradesman and repaired/ replaced as needed.

2.0 Item 1(Picture) patio: stucco maintenance/repairs needed

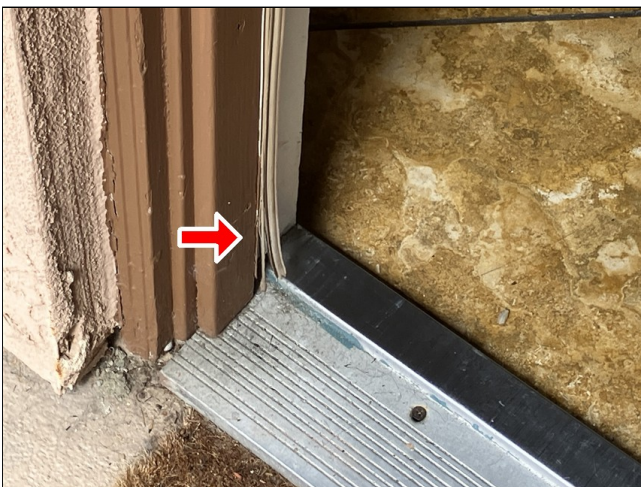
(1) Some of the exterior door weather stripping was missing, damaged, or had other observable defect that should be repaired or replaced as needed.

2.1 Item 1(Picture) front door: weather stripping maintenance/repairs needed

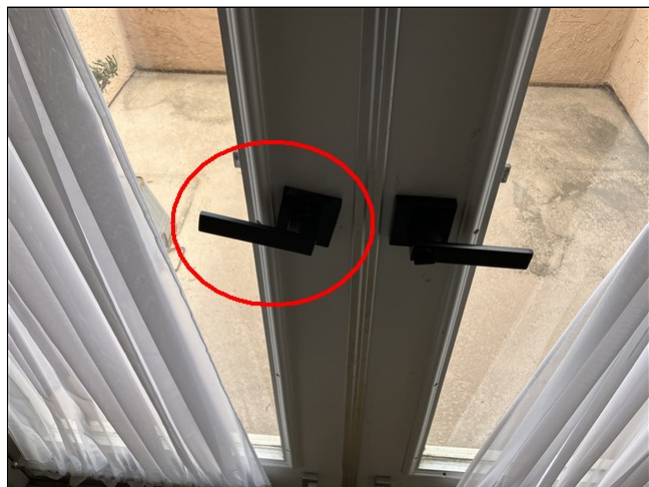
2.1 Item 2(Picture) dining area patio: loose door handle

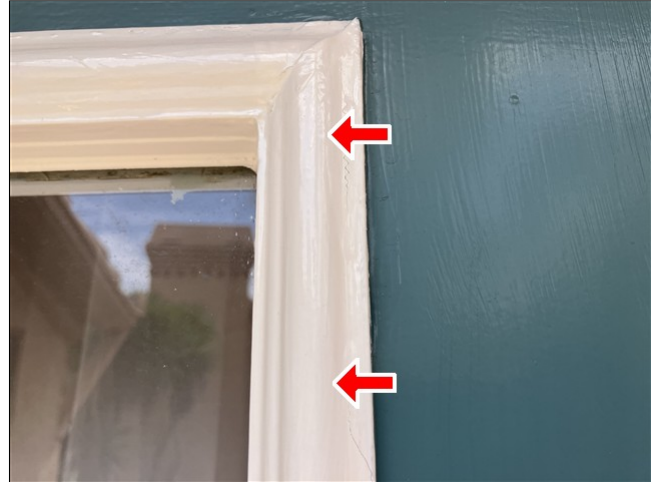
(2) Repairs are recommended at the exterior doors where caulking, sealant, or paint was missing, deteriorated, or had other observable defect.

2.1 Item 4(Picture) front patio: door paint maintenance/repairs needed

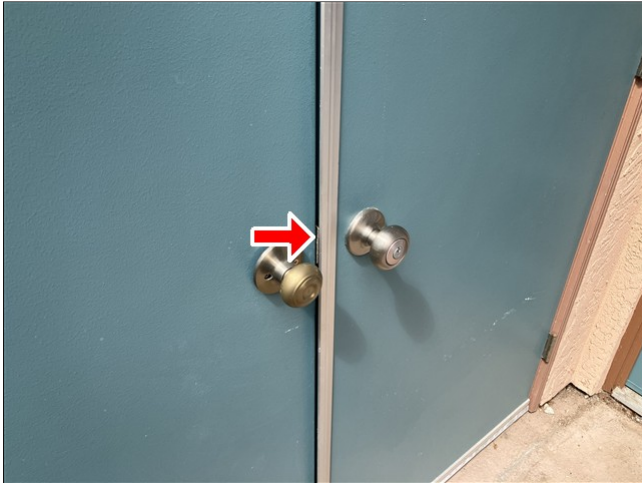
(3) One or more of the exterior door components had visible damage, did not function properly, or had other observable defect. It is recommended to have the doors evaluated by a qualified tradesman and repaired/replaced as needed.

2.1 Item 5(Picture) front patio closet door did not latch when tested

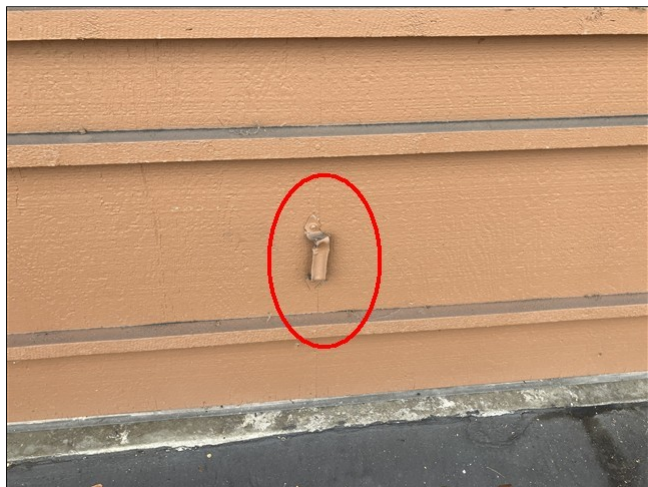
One or more of the garage door systems or components was damaged, did not operate properly when tested, or had other observable defect. It is recommended to have the door system evaluated by a qualified contractor and repaired/ replaced as needed.

3.4 Item 1(Picture) handle damage visible

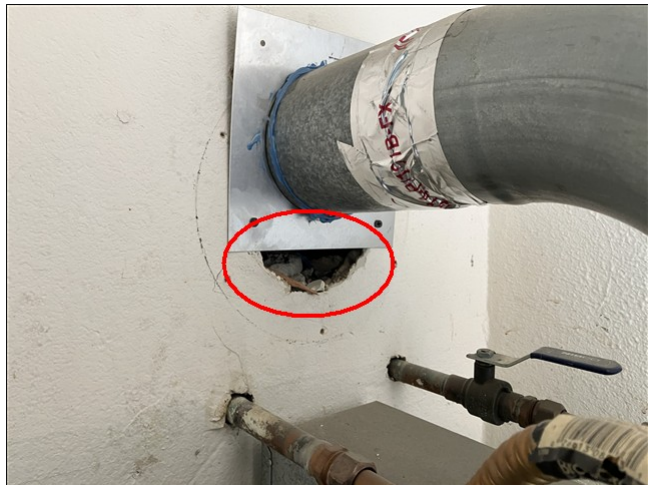
**Comments:** Further Evaluation, Repair or Replace  
(1) Damages, missing drywall, or other defects to the walls or ceilings were observed. It is recommended to have these walls and ceilings evaluated by a qualified tradesman and repaired/replaced as needed.

4.0 Item 1(Picture) front patio closet: hole in drywall observed

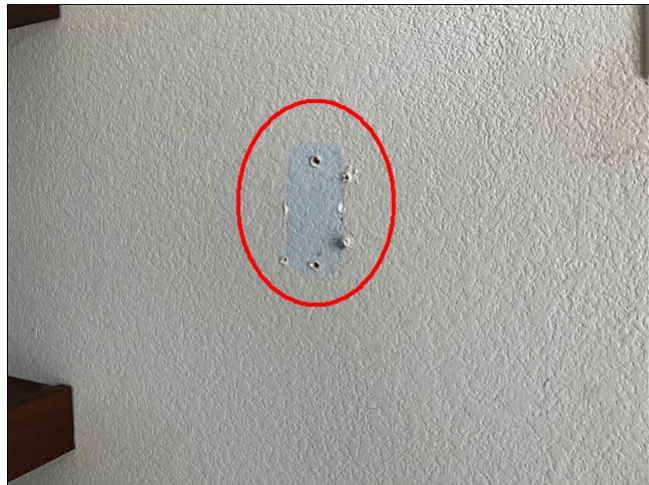
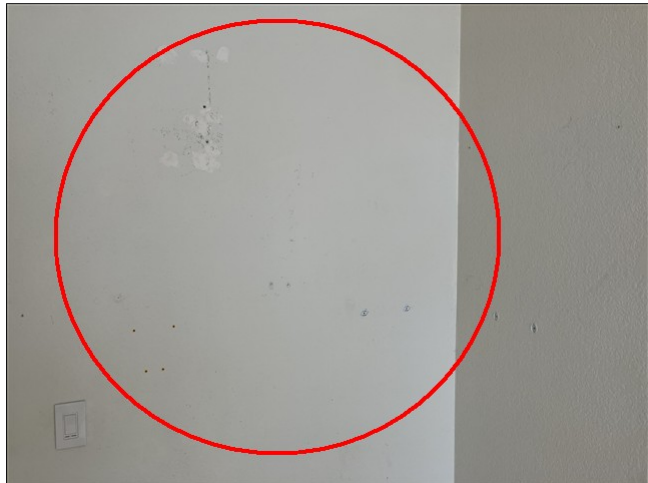
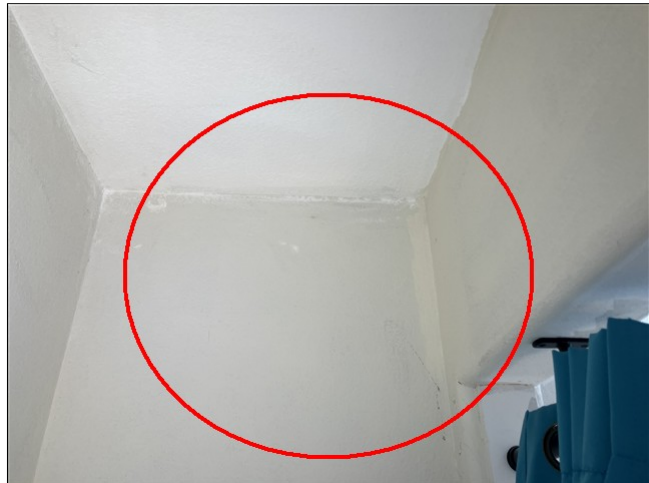
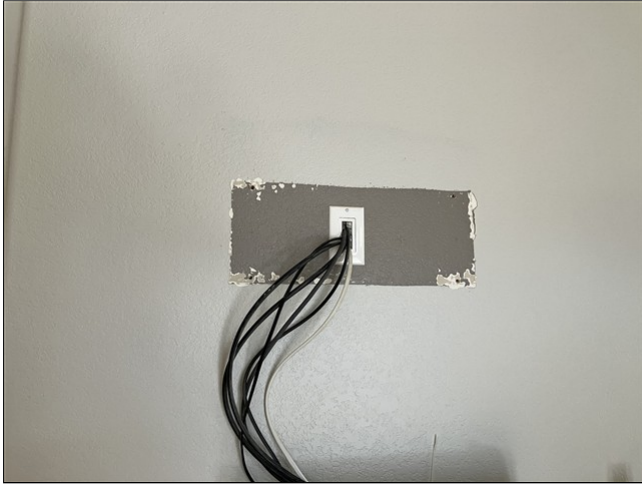
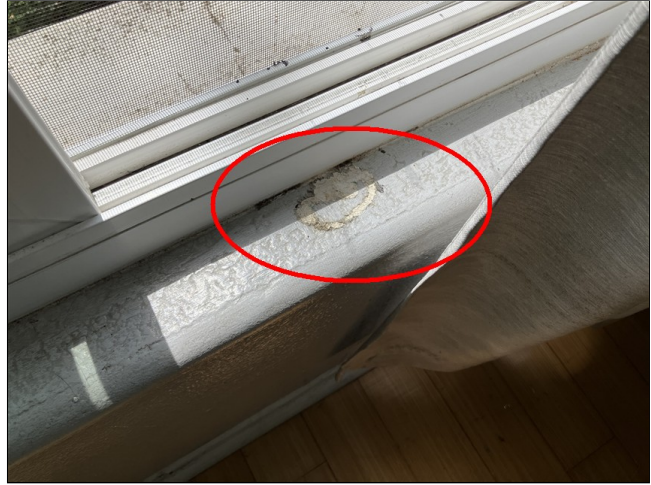
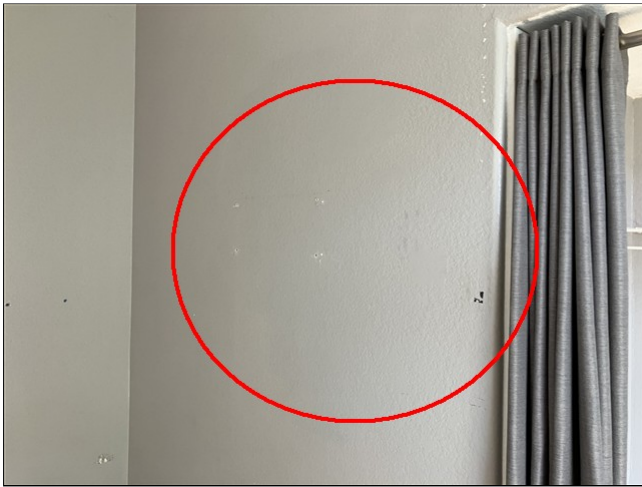
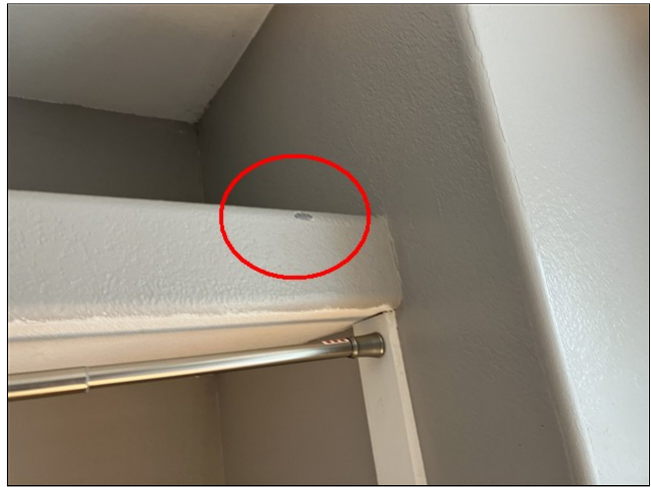
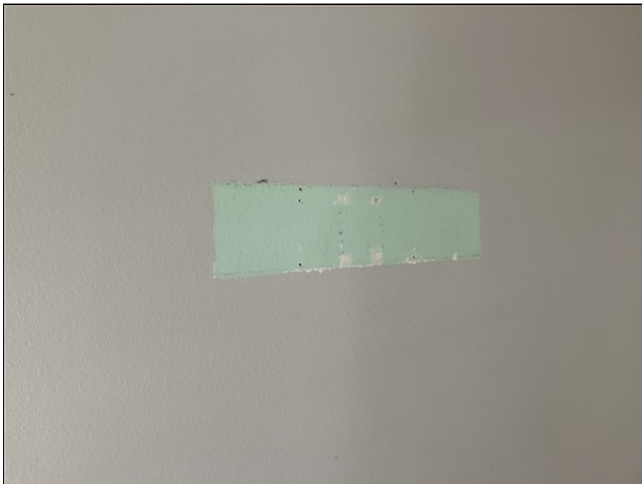
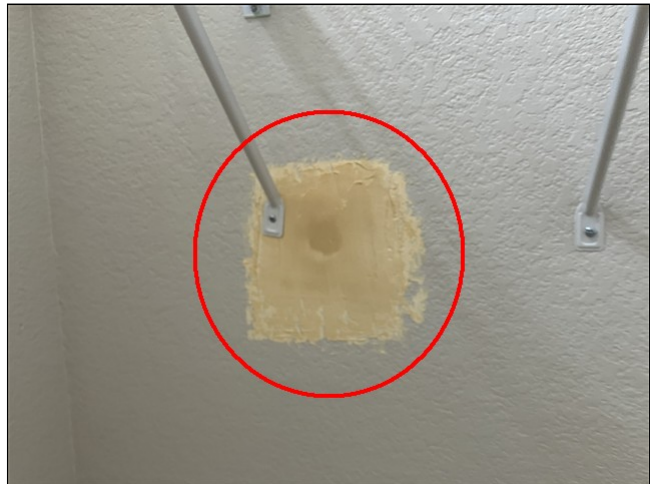
4.0 Item 2(Picture) interior: wall surface maintenance/repairs needed

4.0 Item 3(Picture) interior: wall surface maintenance/repairs needed

4.0 Item 4(Picture) interior: wall surface maintenance/repairs needed

4.0 Item 5(Picture) interior: wall surface maintenance/ repairs needed

4.0 Item 6(Picture) interior: wall surface maintenance/ repairs needed

4.0 Item 7(Picture) interior: wall surface maintenance/ repairs needed

4.0 Item 8(Picture) interior: wall surface maintenance/ repairs needed

4.0 Item 9(Picture) interior: wall surface maintenance/ repairs needed

4.0 Item 10(Picture) interior: wall surface maintenance/ repairs needed

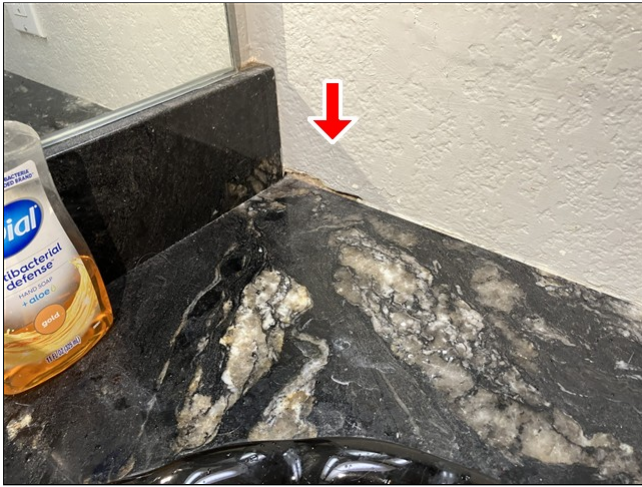
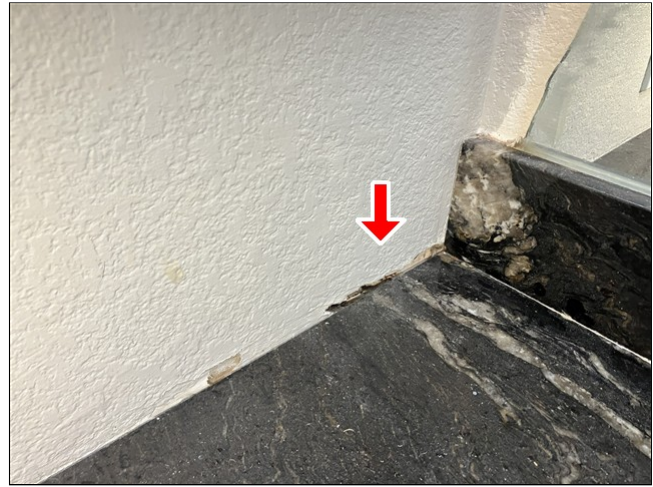
4.0 Item 11(Picture) primary bedroom bath: wall damage visible

4.0 Item 12(Picture) primary bedroom bath: wall damage visible

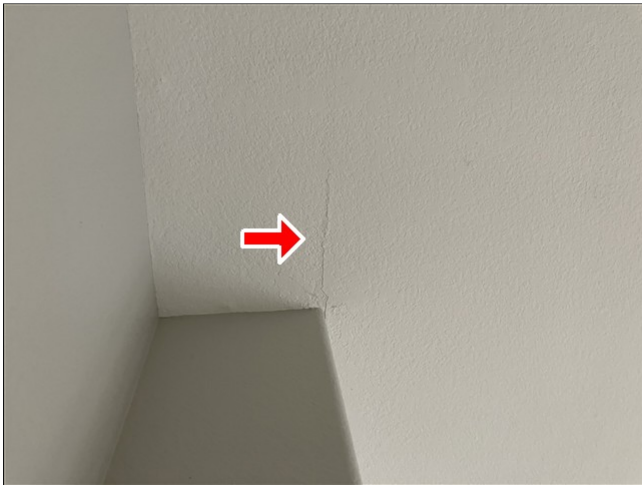
(2) Disclaimer: Cracks in the ceiling and/or walls may be a result from possible settling, movement, or defect that has occurred. This inspection is not meant to be a structural evaluation but an observation of visible physical defects. Only further evaluation and investigation from a qualified person can determine if non-visible defects are present and corrections as needed.

4.0 Item 13(Picture) primary bedroom: crack in ceiling observed

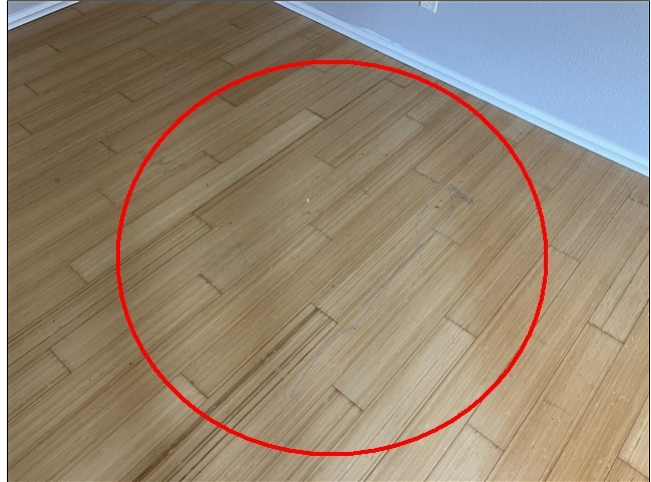
Floor covering damages or defects were observed at areas of the interior. It is recommended to have the floor coverings evaluated and repaired/replaced as needed.

4.1 Item 2(Picture) primary bedroom: floor scratches observed

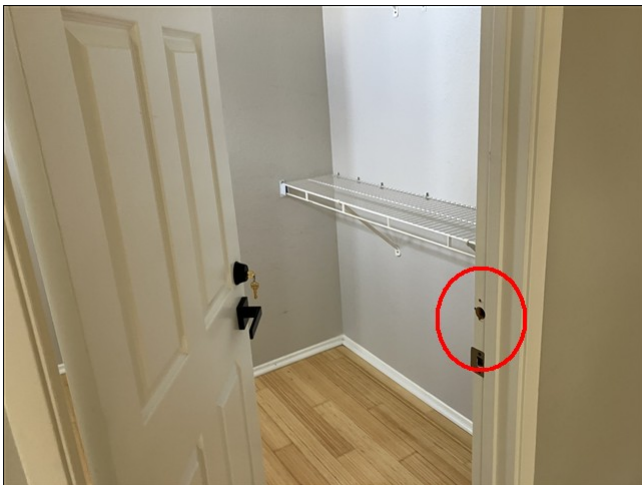
A representative number of doors was tested. One or more of the tested doors or hardware had signs of damage, defect, or did not operate properly when tested. It is recommended to have all doors and hardware defects evaluated and repaired/replaced as needed.

4.3 Item 1(Picture) primary bedroom closet: missing dead bolt latch receiver

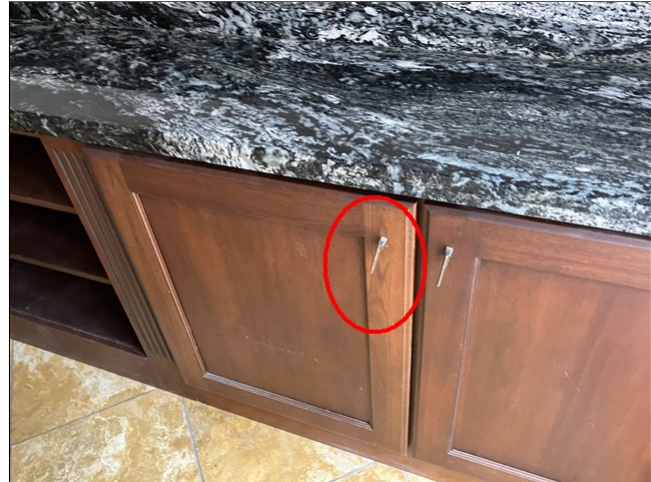
(1) Damages, hardware defects, or other visible defects were observed at areas of the interior cabinetry or countertops. It is recommended to have cabinetry and countertop defects evaluated by a qualified tradesman and repaired/replaced as needed.

4.4 Item 2(Picture) dining area: loose handle

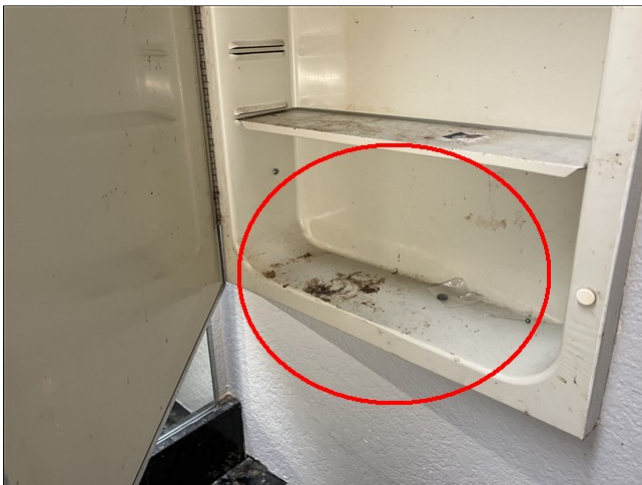
4.4 Item 3(Picture) primary bedroom bath: medicine cabinet oxidation visible

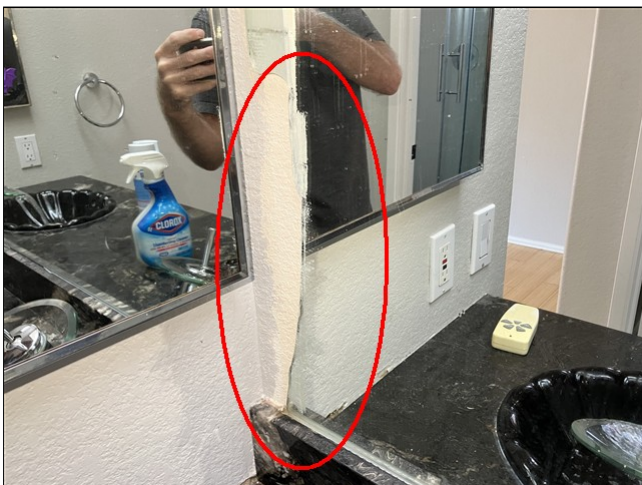
4.4 Item 5(Picture) primary bedroom bath: broken mirror observed

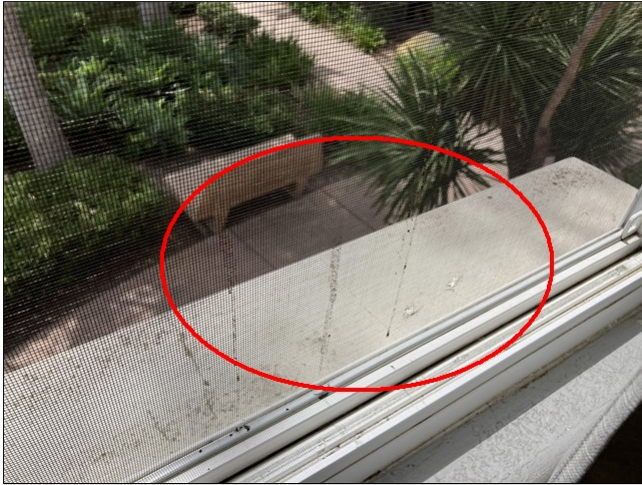
4.5 Item 1(Picture) bedroom window: screen damage visible

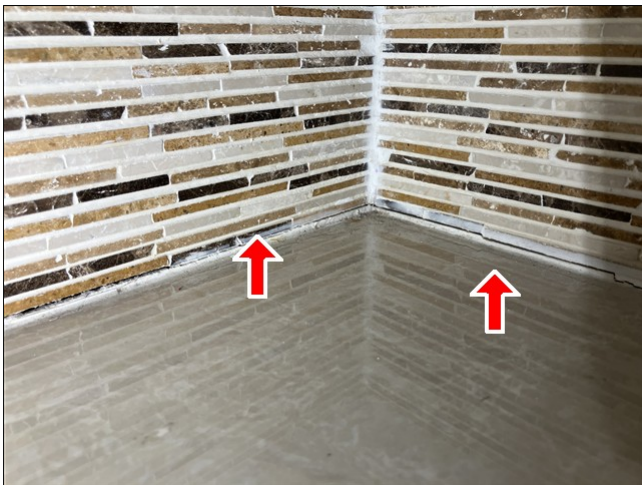
The caulking or grout was missing, separated, or had other observable defect at areas of one or more of the tub/shower wall or floor systems. It is recommended to have these evaluated and repaired as needed.

4.6 Item 1(Picture) hall bath: caulking or appropriate sealant maintenance/repairs needed

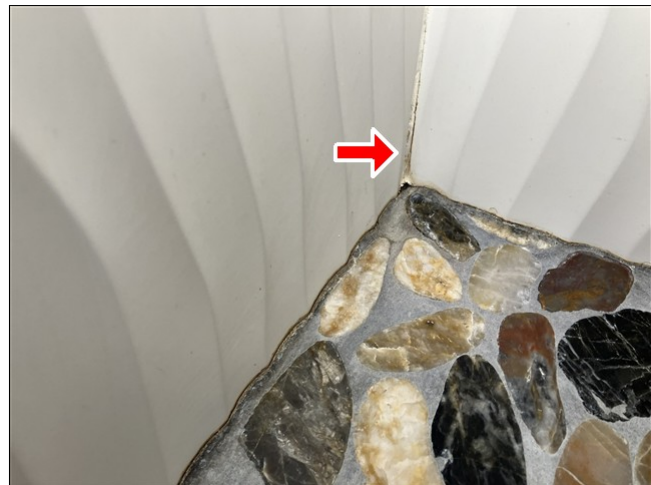
4.6 Item 2(Picture) primary bedroom bath: caulking or appropriate sealant maintenance/repairs needed

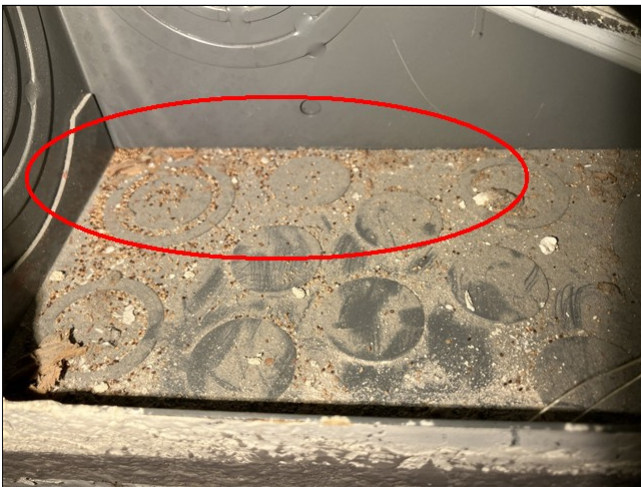
Possible WDO (wood destroying organisms) damage or evidence was observed at areas of the interior. It is recommended to have a licensed pest control company evaluate all WDO related defects and remediate as needed.

4.8 Item 1(Picture) inside electrical panel: possible WDO evidence or damage observed

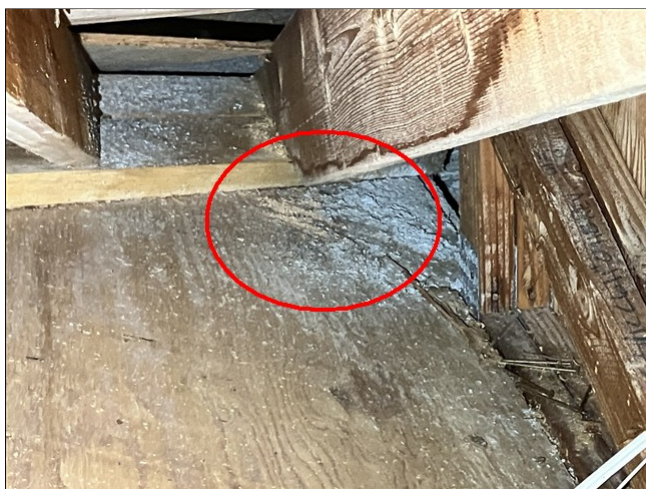
(1) Evidence of possible wood-destroying organism (WDO) activity and/or damage was observed at the time of inspection. Conditions such as damaged wood, staining, debris, or other indicators may be consistent with current or previous WDO activity; however, this inspection is not a pest inspection and no determination is made regarding whether the activity is active or past. Concealed damage may also exist in inaccessible areas. Further evaluation by a licensed structural pest control or WDO specialist is recommended for identification, treatment recommendations, and determination of the extent of any damage or necessary repairs.

5.4 Item 1(Picture) possible WDO evidence or damage observed

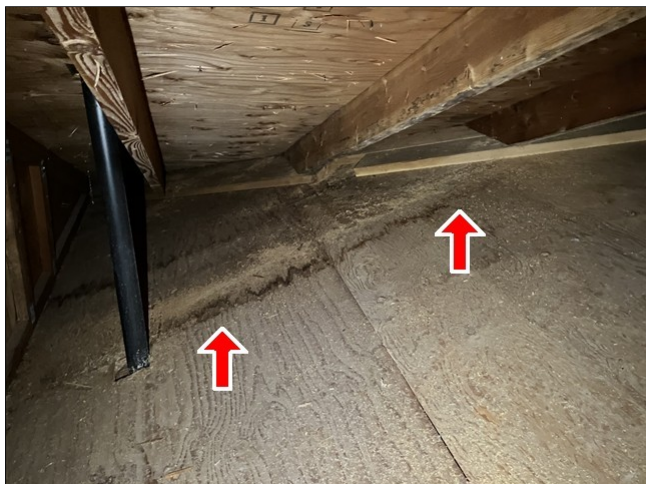
(2) Evidence of past moisture penetration was visible in areas of the attic. No moisture was observed at the time of the inspection. Because the scope of this inspection is limited to the condition of the property at the time of the inspection and defects may not be visible, further evaluation is recommended from a licensed roofer to determine the cause of the stains and correction as needed.

5.4 Item 2(Picture) attic: stains visible

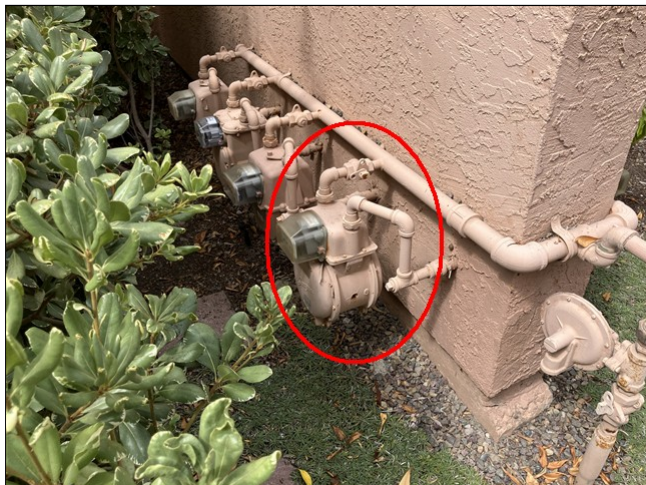
6.1 Item 1(Picture) gas meter and shut-off valve for unit 87

Because determining if the fuel system is free of leaks, it is recommended to have SDG&E (San Diego Gas and Electric) perform a routine service check up. Please contact SDG&E for more information:

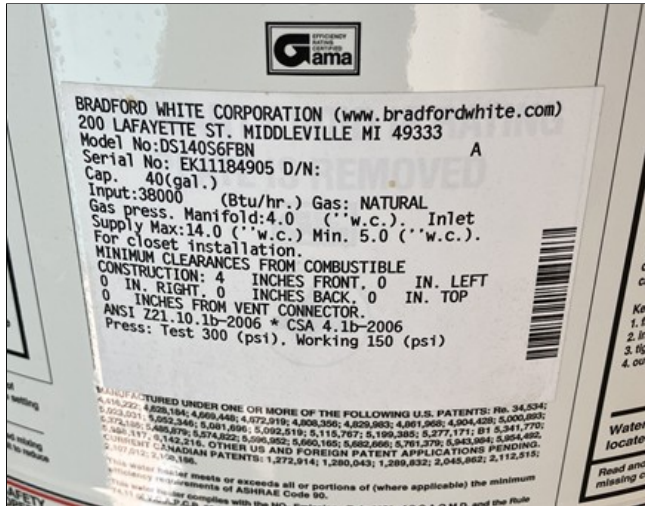
The water heater was operational at the time of the inspection but one or more components may have exceeded or are near to exceeding their expected serviceable life. Further evaluation from a qualified plumber is recommended to determine current servicing, maintenance, and safety upgrade needs and the remaining life expectancy.

6.2 Item 1(Picture) possible mfg date: 2008

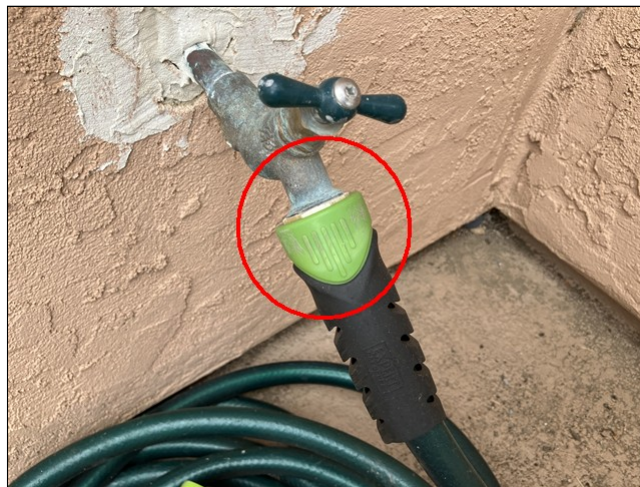
One or more of the exterior spigots were missing an anti-siphon device (vacuum breaker). These prevent water intended for irrigation from siphoning back into the potable water system. It is recommended to have these installed.

6.4 Item 2(Picture) vacuum breaker (anti-siphon device) upgrade recommended at exterior spigot(s)

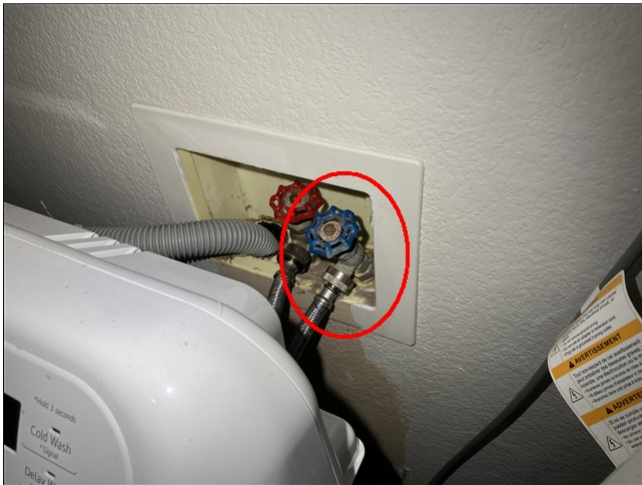
(2) Inadequate or improper water supply strapping was observed. It is recommended to have the water supply strapping evaluated by a licensed plumber and repaired/replaced as needed.

6.4 Item 3(Picture) laundry hook up was loose / recommend further evaluation and correction as needed

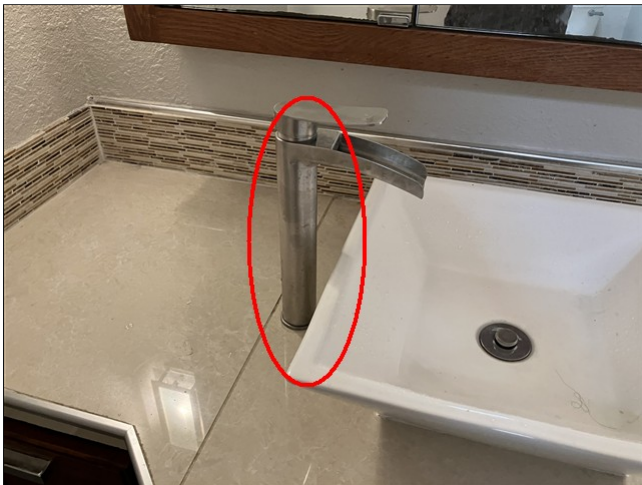
One or more of the plumbing fixtures (toilets, sinks, faucets, tub/shower valves, etc.) were loose, leaked during operation, or had other observable defect. It is recommended to have the fixtures evaluated by a licensed plumber and repaired/replaced as needed.

6.5 Item 1(Picture) hall bath: loose faucet fixture

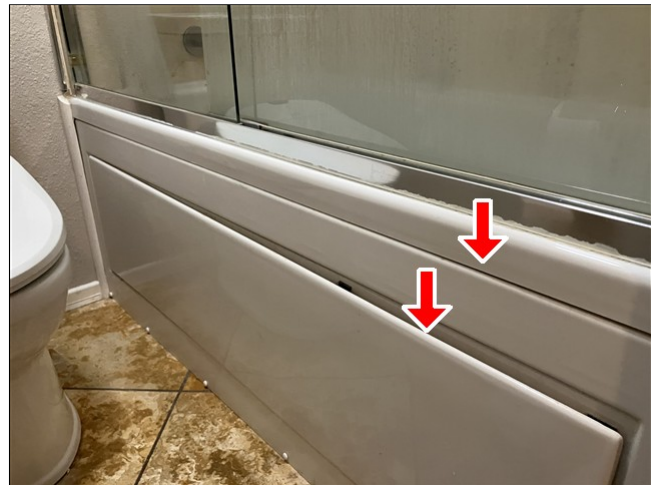
6.5 Item 2(Picture) hall bath: tub spa access cover was loose / recommend further evaluation and correction as needed

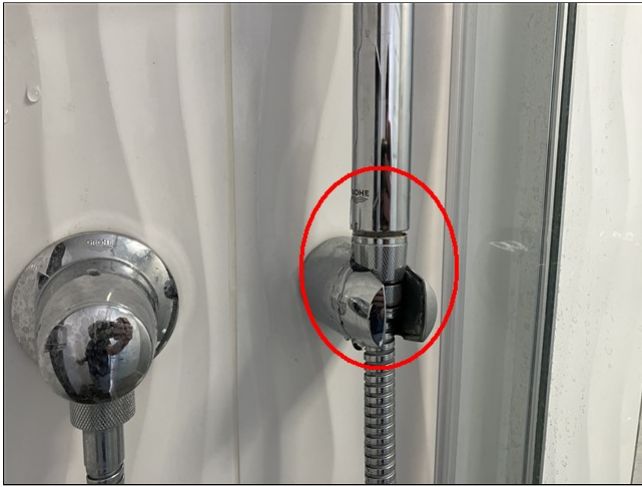
6.5 Item 3(Picture) primary bedroom bath: leaked when tested

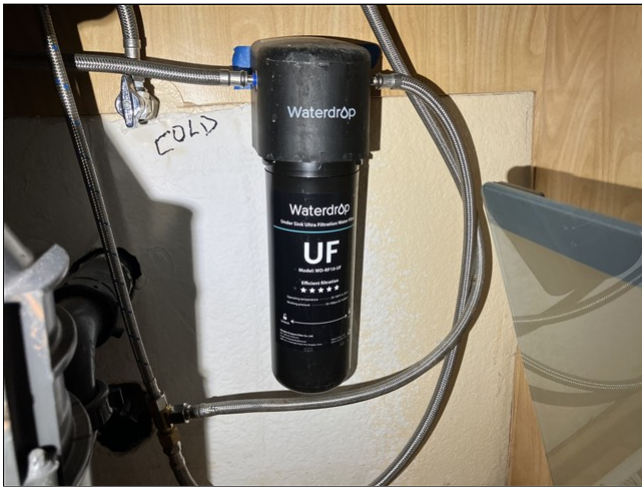
One or more plumbing auxiliary systems or features were observed that were not tested or inspected as part of the scope of this inspection. These systems and components may require servicing or maintenance that only specialized technicians can determine after evaluation. It is advised to consult with the appropriate service technician for further evaluation.

6.8 Item 1(Picture) kitchen: water filter was not inspected or tested as part of the scope of this inspection

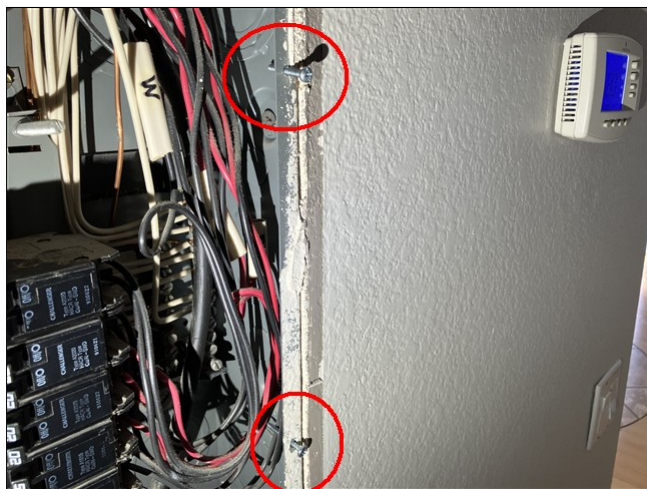
One or more defects were observed at the electrical panel components. It is recommended to have this evaluated by a licensed electrician and repaired/replaced as needed.

7.3 Item 1(Picture) improper/inadequate panel cover screws / maintenance/repairs needed

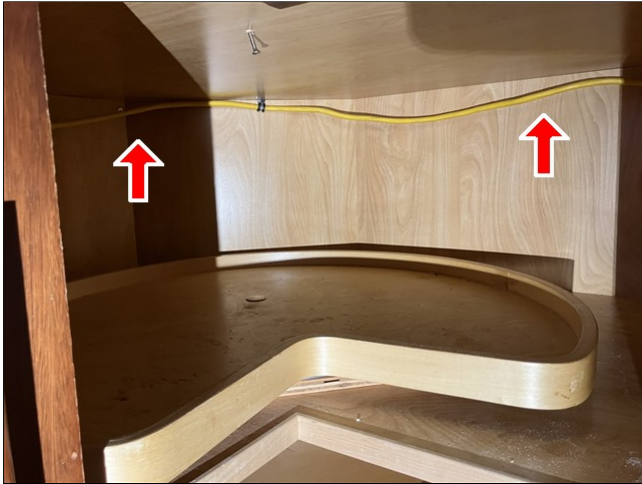
Improper wiring method, damages, or other defects were observed at areas of the branch circuit wiring or breaker system. All electrical system and component defects should be considered safety hazards. It is recommended to have the systems evaluated by a licensed electrician and repaired/replaced as needed.

7.4 Item 1(Picture) kitchen: exposed wiring appeared susceptible to damage / recommend further evaluation

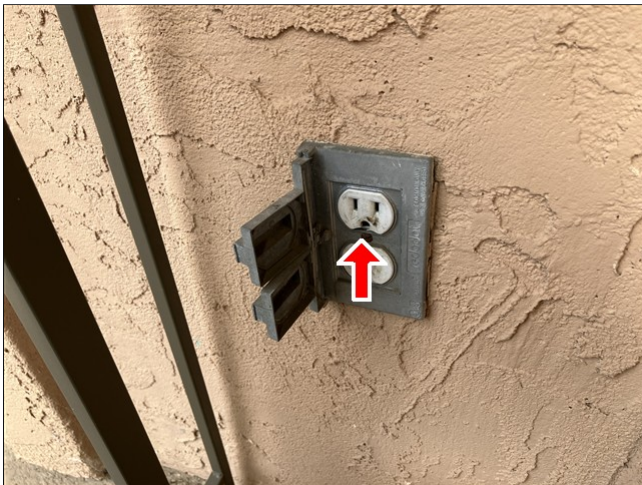
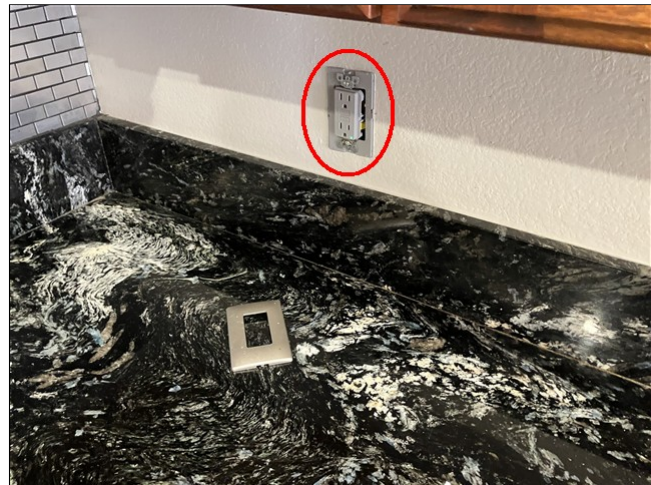
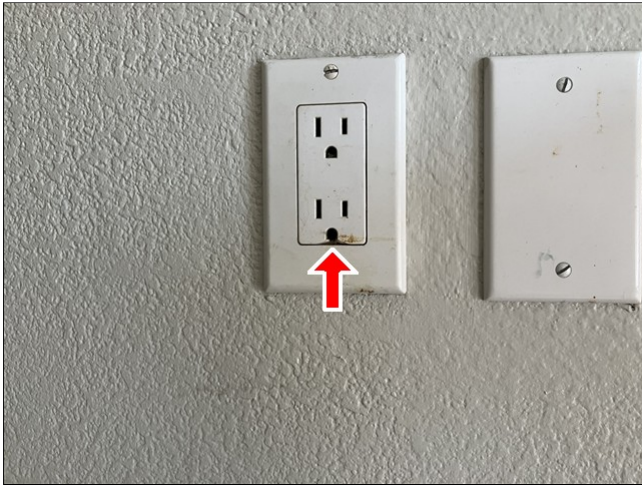
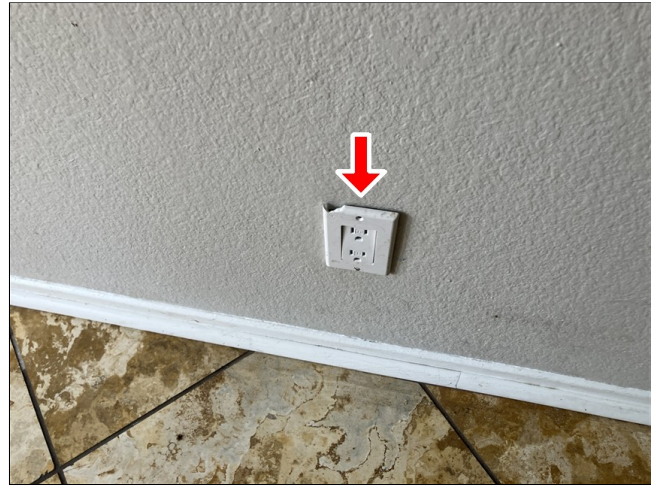
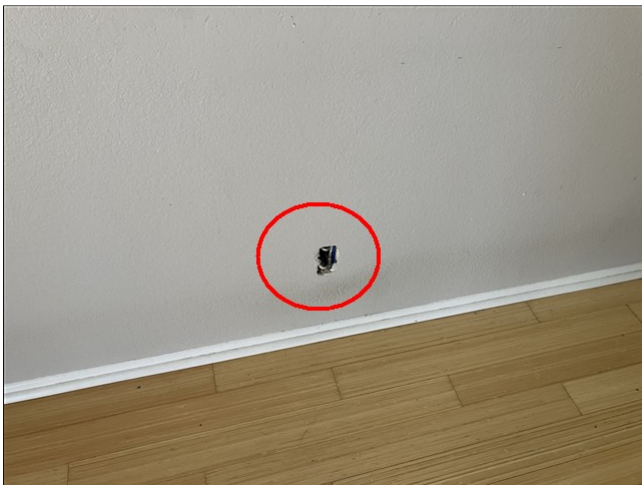
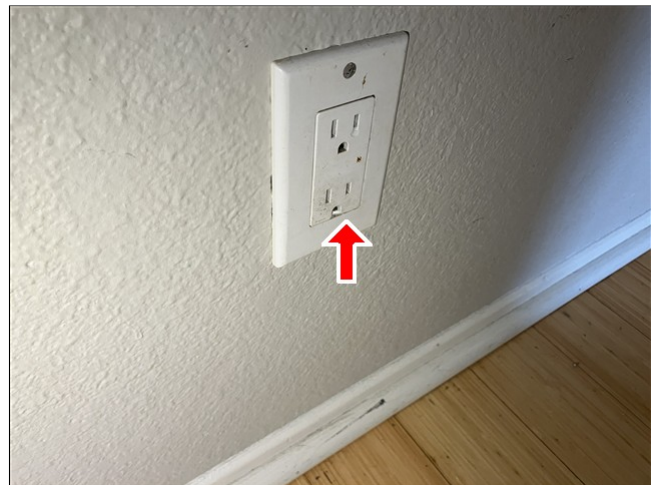
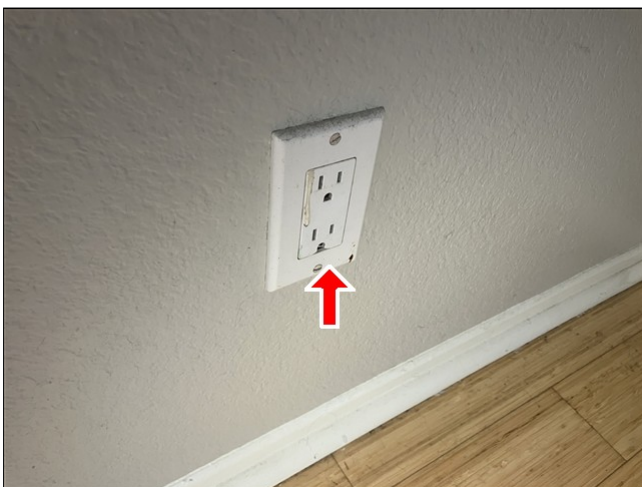
(1) Defects were observed at one or more of the outlets, switches, or fixtures. All electrical system and component defects should be considered safety hazards. It is recommended to have a licensed electrician evaluate all outlets, switches, and fixtures and repair/replace as needed.

7.5 Item 1(Picture) exterior: damage outlet

7.5 Item 2(Picture) kitchen : outlet cover maintenance/ repairs needed

7.5 Item 3(Picture) multiple damaged outlets observed

7.5 Item 4(Picture) damaged outlet cover

7.5 Item 5(Picture) missing cover

7.5 Item 6(Picture) damaged outlet

7.5 Item 7(Picture) damaged outlet

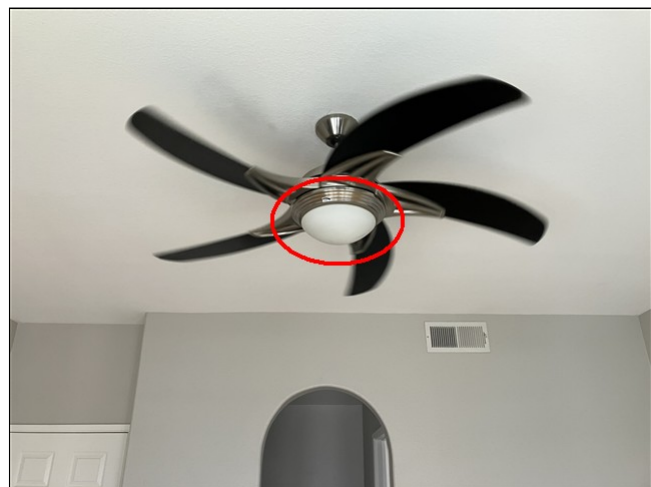
7.5 Item 8(Picture) primary bedroom fan light did not turn on when tested

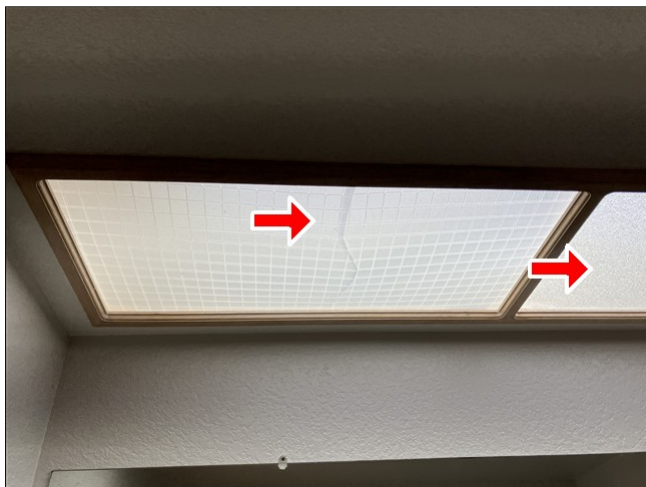
7.5 Item 9(Picture) bedroom bath: cracked ceiling fixture cover / mismatched covers observed

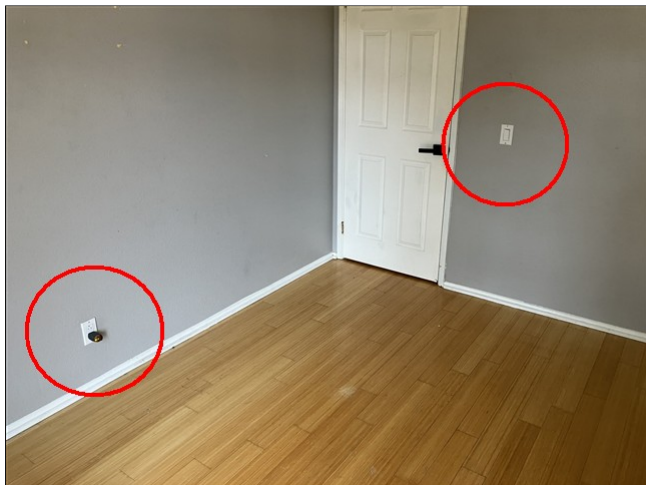
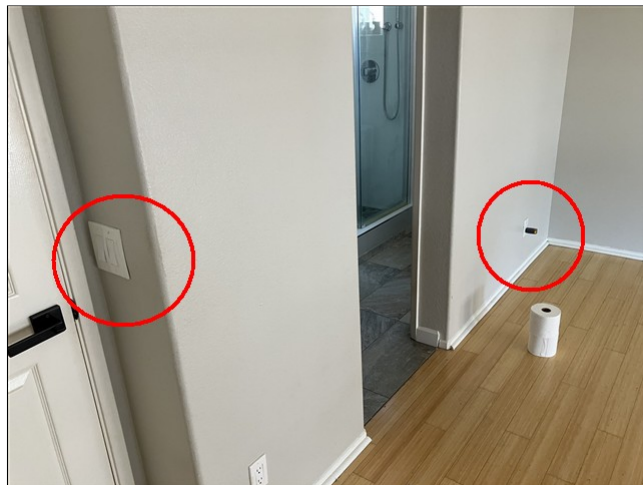
(2) While the inspector makes every effort to identify switches and their corresponding fixtures or receptacles, one or more were not identifiable. Further evaluation is recommended to identify and evaluate the corresponding fixture or outlet.

7.5 Item 10(Picture) bedroom: switch and corresponding outlet were not identified / recommend further evaluation

7.5 Item 11(Picture) primary bedroom: switch and corresponding outlet were not identified / recommend further evaluation

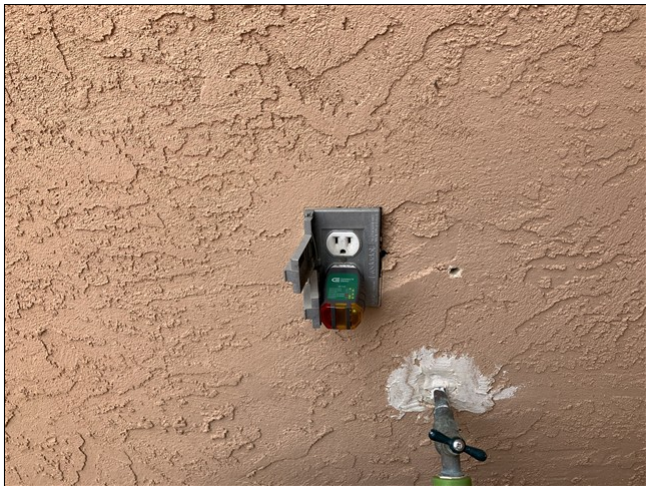
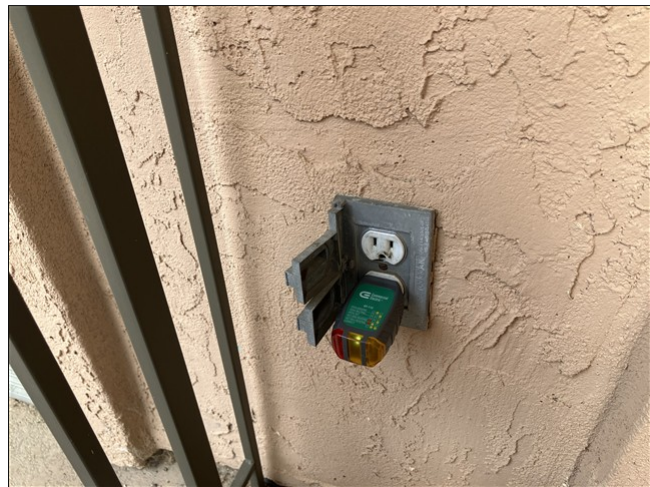
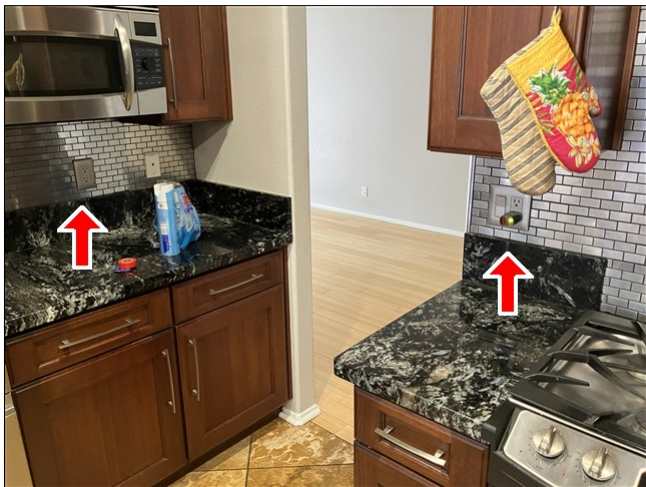
One or more outlets observed in the kitchen, bathroom, exterior, or garage did not appear to be GFCI protected. While this may have been acceptable at the time of construction, current standards require that all kitchen countertop outlets, bathroom outlets, exterior outlets, and garage outlets must be GFCI. Other auxiliary systems may also require GFCI outlets such as pool pumps, sumps, and jacuzzi jet motors. It is recommended to have a licensed electrician evaluate the appropriate GFCI locations and upgrade as needed.

7.6 Item 2(Picture) exterior: recommend evaluation and upgrade of any non-GFCI outlets

7.6 Item 3(Picture) exterior: recommend evaluation and upgrade of any non-GFCI outlets

7.6 Item 4(Picture) kitchen: recommend evaluation and upgrade of any non-GFCI outlets

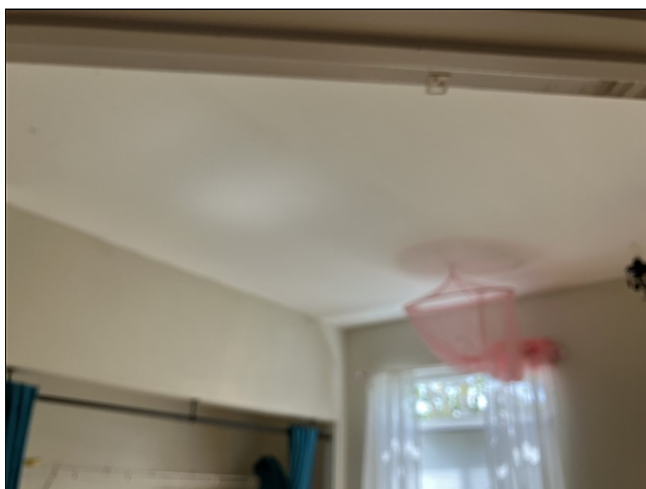
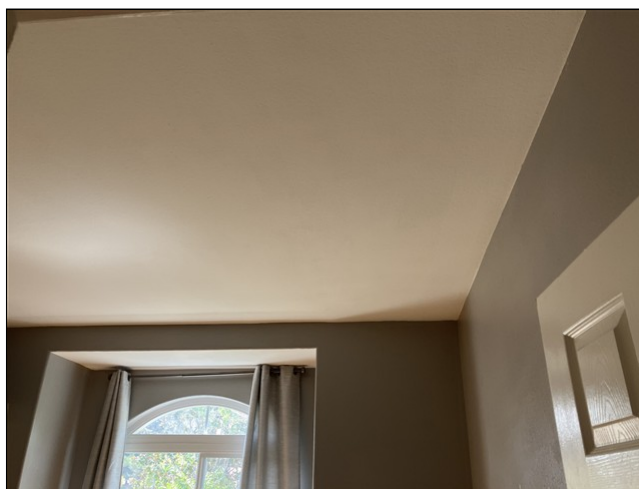
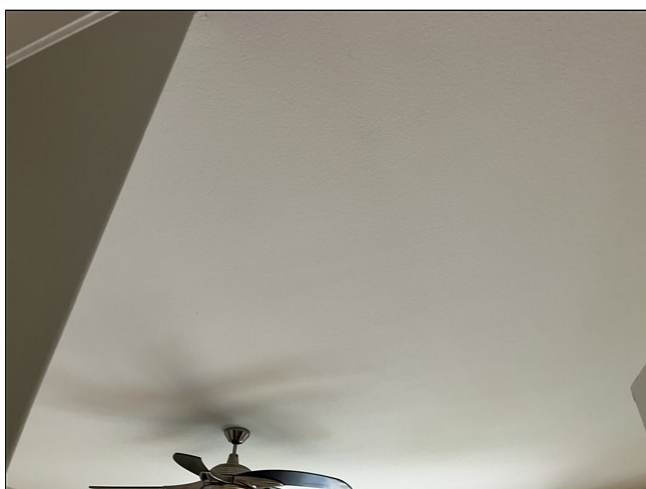
7.7 Item 1(Picture) bedroom: missing smoke detector

7.7 Item 2(Picture) bedroom: missing smoke detector

7.7 Item 3(Picture) primary bedroom: missing smoke detector

If there is no visible installation date or the age cannot be verified, it is recommended to install a new detector with a visible date to facilitate future replacement. It is recommended to test detectors according to the manufacturers specifications. Consult with the local fire department for tips and other useful information on smoke alarm installation and maintenance.

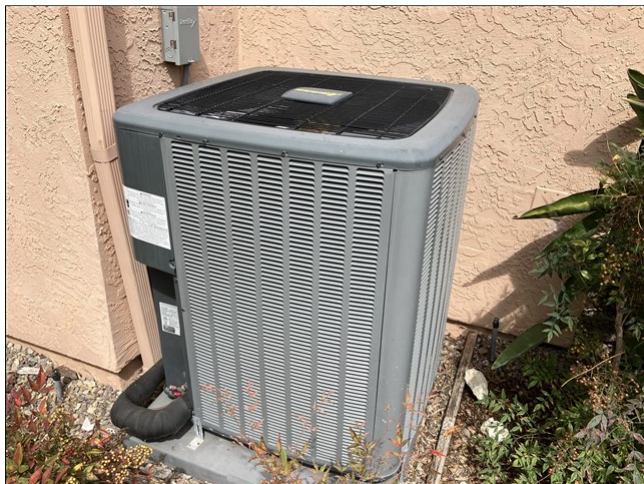
8.4 Item 1(Picture) a/c condenser: no visible maintenance record observed

Because no visible maintenance and service record was observed, a routine maintenance inspection by a qualified HVAC technician is recommended. An annual maintenance inspection by a technician can report any defects outside the scope of this inspection and provide an estimated life expectancy for the system and components.

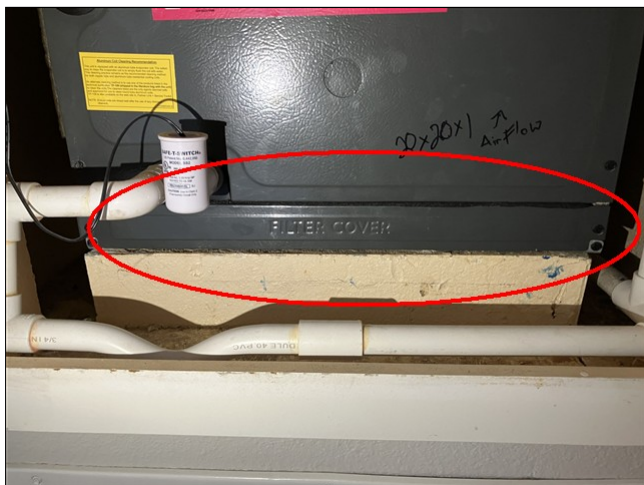
(1) One or more of the return air filters are missing, damaged, or dirty and should be cleaned or replaced. Filters should be cleaned/replaced at least two times a year depending on usage.

8.7 Item 1(Picture) air filter replacement needed

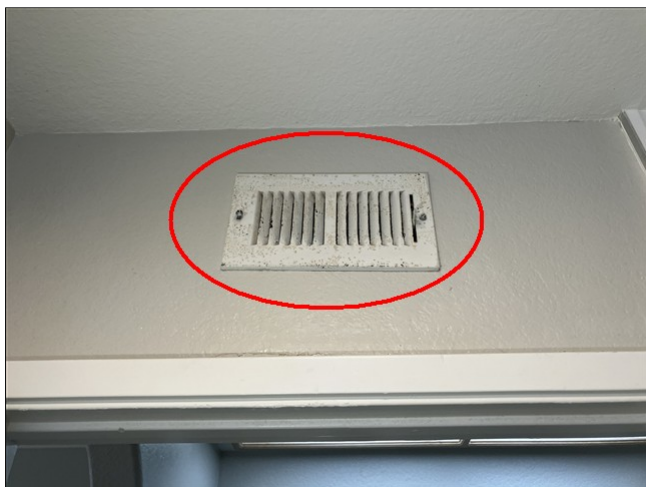
(2) One or more of the registers were missing, loose, or had other visible defect that should be evaluated by a qualified tradesman and repaired/replaced as needed.

8.7 Item 2(Picture) bedroom bath: oxidation visible at register

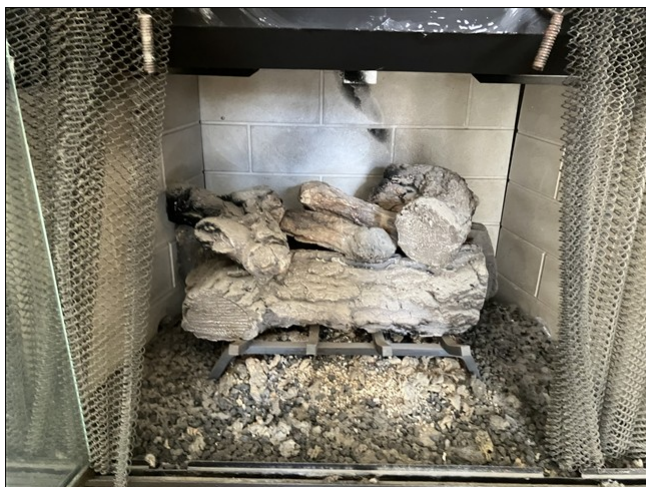
8.9 Item 1(Picture) a fireplace and chimney flue performance and safety inspection by a qualified person is recommended

**Disclaimer:** It is outside the scope of this inspection to determine if the fireplace or chimney systems are functional and safe for use. A safety and performance inspection is recommended from a licensed or certified fireplace/chimney specialist.
