# Inspection Report

**Property Address:**  
3517 Cameo Dr #87  
Oceanside CA 92056

**Foresight Building Inspection**

| <b>Date:</b> 8/27/2026 | <b>Time:</b> 11:00 AM | <b>Report ID:</b> 3815 |

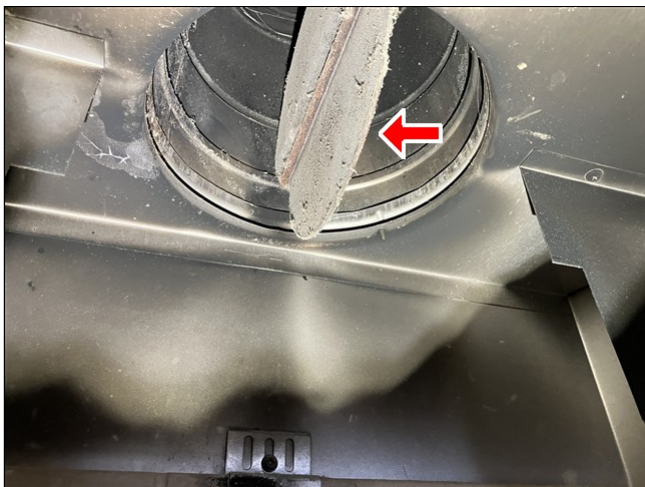
The damper clamp at one or more fireplaces with a gas firelog insert was missing, not properly installed, or had other observable defect. A damper clamp prevents the flue damper from ever being completely closed and creating a carbon monoxide hazard.

8.10 Item 2(Picture) missing damper clamp

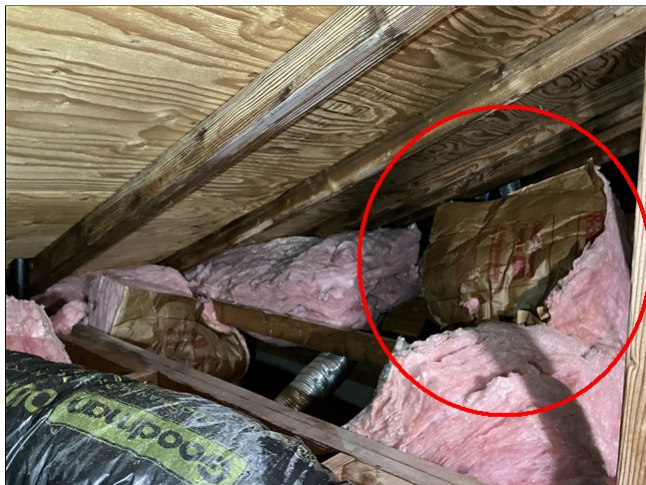
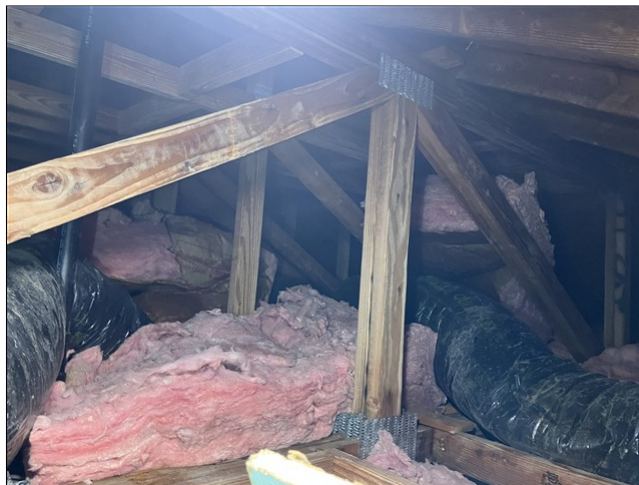
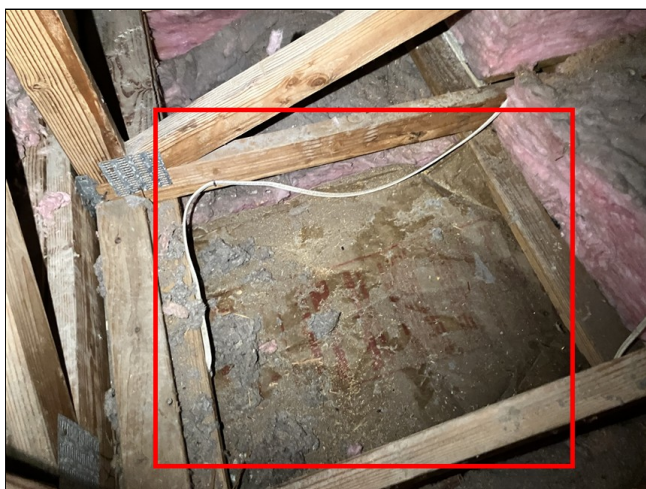
Areas of the insulation system or components were missing, not properly installed, or had other observable defect. It is recommended to have the insulation evaluated by a qualified insulation contractor and repair/replace as needed.

9.0 Item 1(Picture) displaced insulation observed (paper backing should not be exposed)

9.0 Item 2(Picture) displaced insulation observed

9.0 Item 3(Picture) paper backing should not be exposed

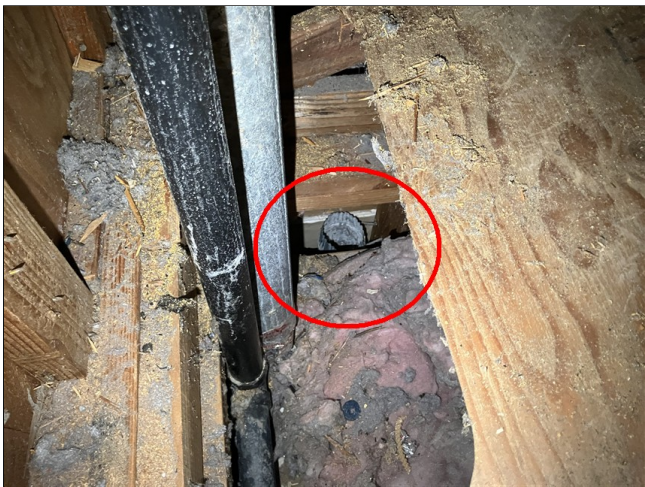
9.1 Item 1(Picture) recommend evaluation and proper removal of abandoned dryer ducting materials

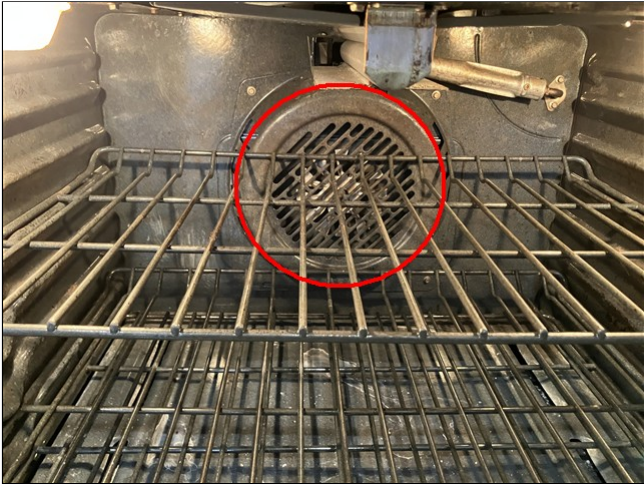
One or more of the oven functions or components did not operate properly when tested or had other observable defect. It is recommended to have the unit evaluated by a qualified appliance technician and repaired/replaced as needed.

10.1 Item 1(Picture) convection fan did not turn on when tested

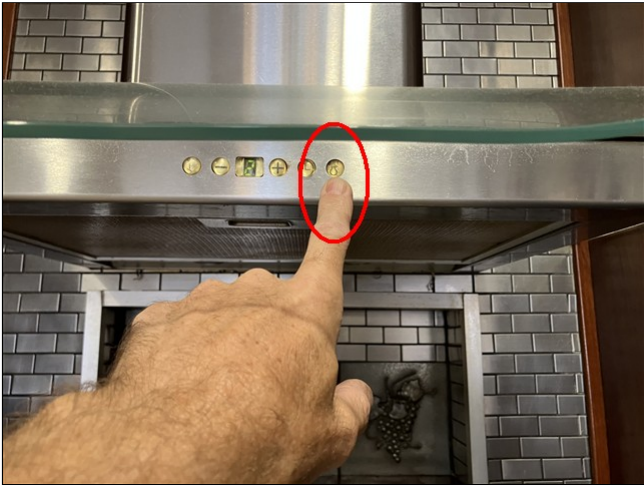
The range hood did not operate properly when tested or had another observable defect. It is recommended to have this evaluated by an appropriate licensed contractor and repaired/replaced as needed.

10.2 Item 1(Picture) hood light did not turn on when tested

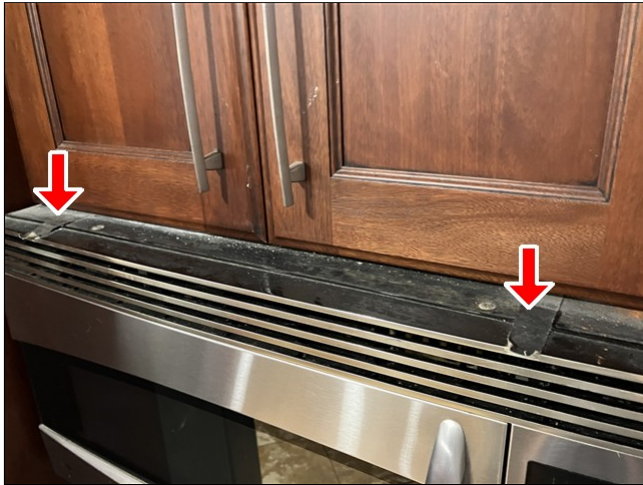
One or more of the microwave functions or components did not operate properly when tested or had other observable defect. It is recommended to have the unit evaluated by a qualified appliance technician and repaired/replaced as needed.

10.4 Item 1(Picture) microwave cover appeared loose (tape observed)
