**ELITE GROUP**  
INSPECTION PROFESSIONALS

PROPERTY LOCATION: 153 Calle Redondel San Clemente, CA 92672

# INSPECTIONREPORT

Date of Inspection: 5/15/2026 at 10:00 AM

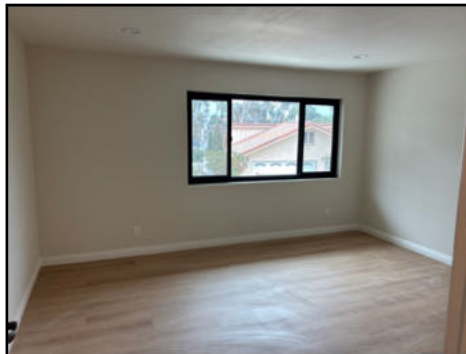
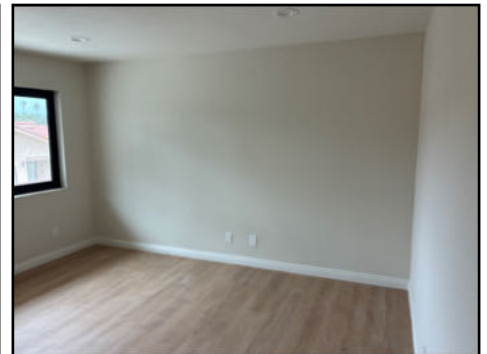
## 2. Wall Conditions

- Recently painted throughout structure
- No major visible defects observed at the time of inspection

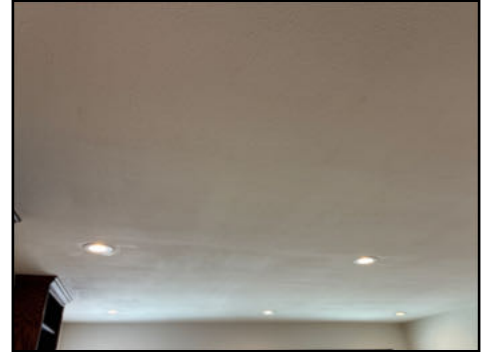
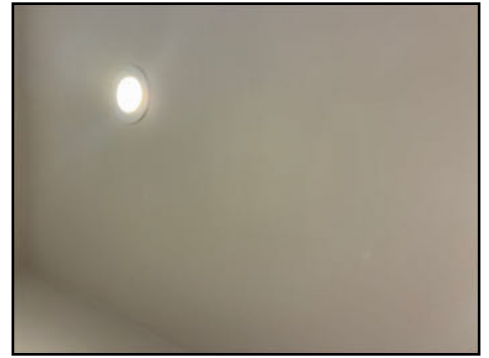
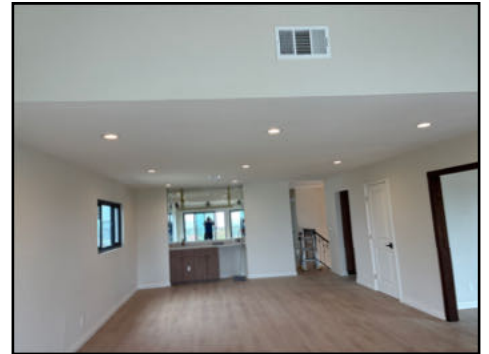
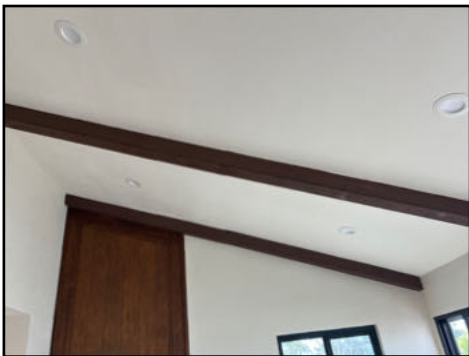
### 3. Ceiling Conditions

- Recently painted throughout structure
- No major visible defects observed at the time of inspection

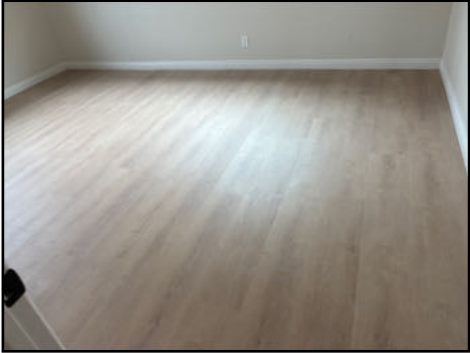
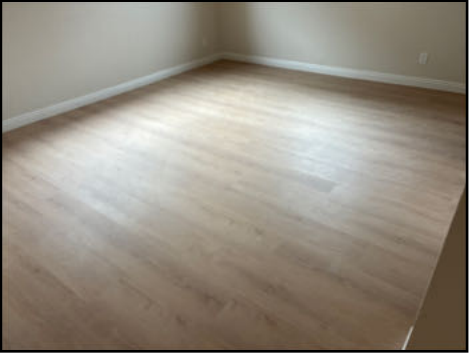
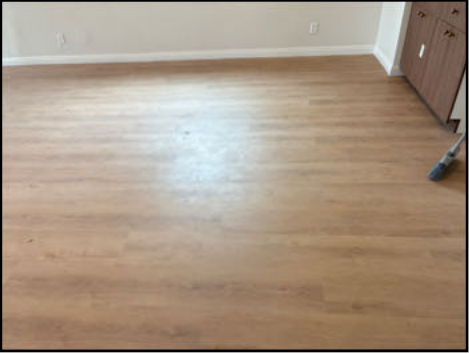
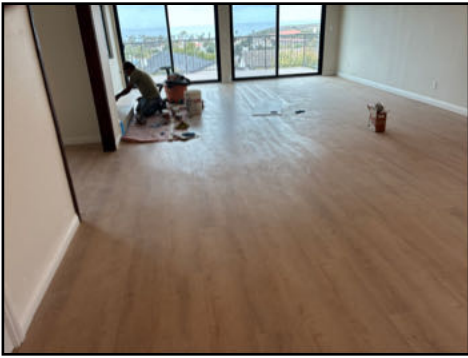
#### 4. Floor Conditions

- New/newer materials are present
- Normal wear for age - no major visible defects at the time of the inspection
- Flooring not level in areas, cause could not be determined, recommend further evaluation by a licensed contractor

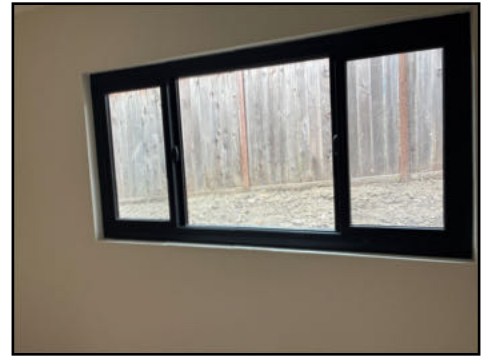
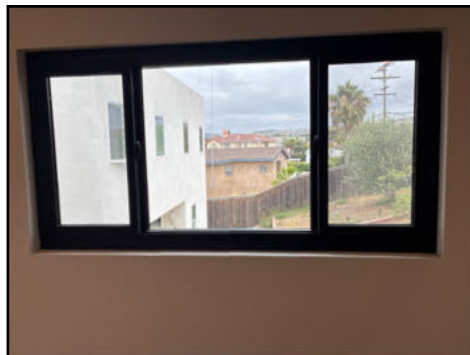
## 5. Window Conditions

- Accessible windows were tested and operated at time of inspection
- Visible/accessible windows show signs of normal wear for age with no major visible defects at the time of the inspection

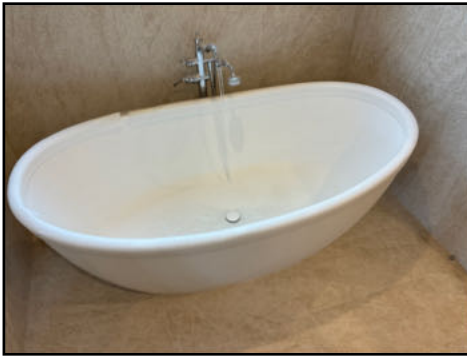
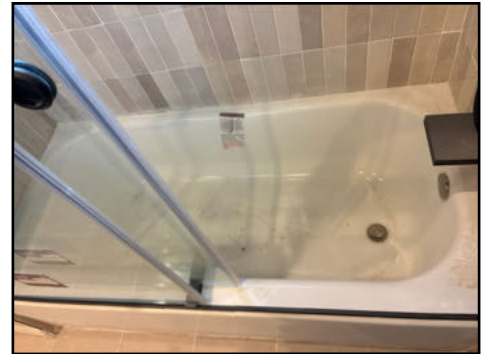
- Fixture was tested and operating at the time of the inspection
- Fixture had normal wear for age at the time of the inspection - no major visible defects
- Tub has normal wear for age at the time of the inspection - no major visible defects
- Drain stopper operated at the time of the inspection
- Bathtubs are not filled to overflow opening to test
- Hot and cold reversed at fixture - needs to be serviced/evaluated by a licensed plumber at downstairs master bathroom

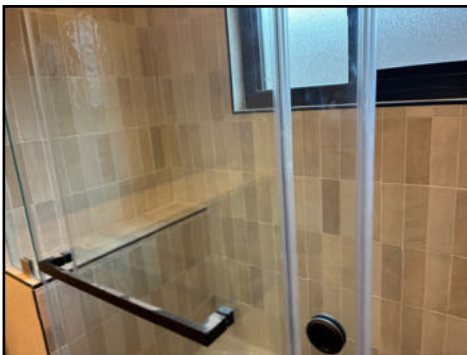
- Shower pans are not long-term water tested for leaking - consult the termite report
- Tile and grout present
- Stone
- Shower walls have normal wear for age at the time of the inspection - no major visible defects - recommend routine grout and sealer maintenance
- Shower pan has normal wear for age at the time of the inspection - no major visible defects - recommend routine grout and sealer maintenance

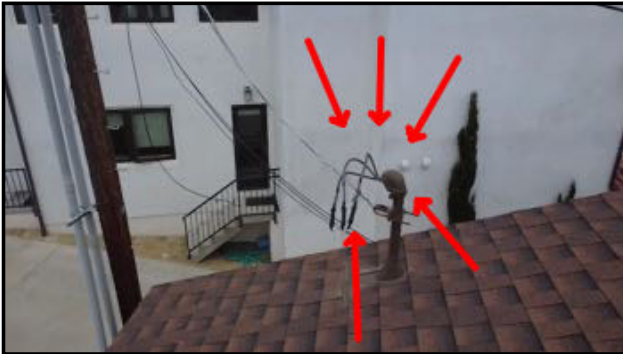
- Overhead - normal wear for the age on day of the inspection - no major visible defects
- **Drip loop not proper configuration - needs to be serviced**

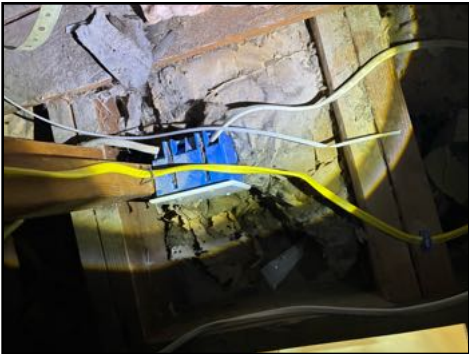
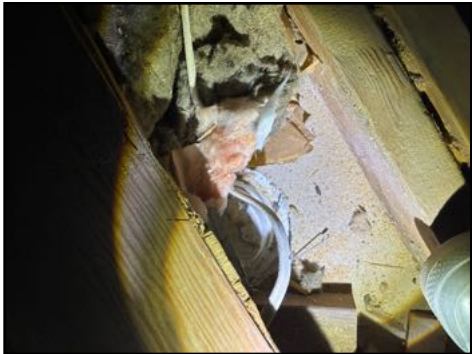
- **Consult termite report for all wood areas in the attic**
- Conventional framing present, normal wear at time of inspection - no major visible defects
- Cracking small at wood members - typical for age
- **Stains present on wood members of structure - evidence of past moisture entering structure- monitor for future moisture intrusion**
- *Limited attic inspection - many areas are not accessible to to limited space, lack of proper walk boards, electrical, plumbing, ductwork, etc.*
- *Could not access all areas of the attic due to limited space or insulation covering joist chords*
- *Structure inspection limited due to access hindrances such as insulation/ductwork/pipes/wires*

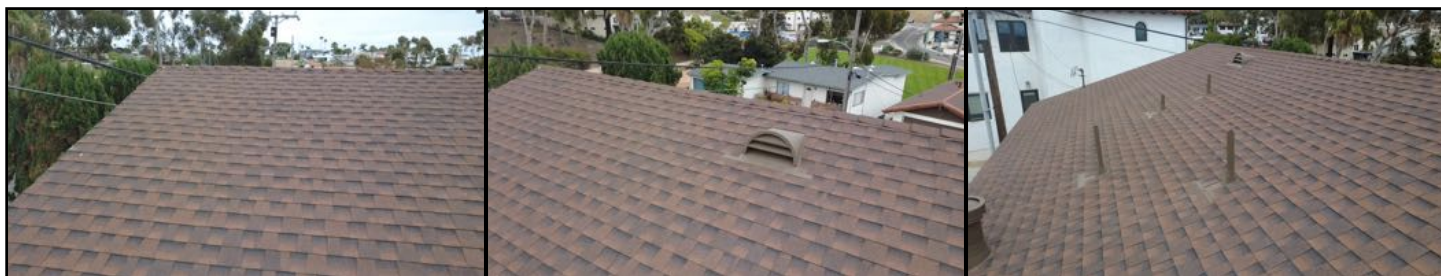
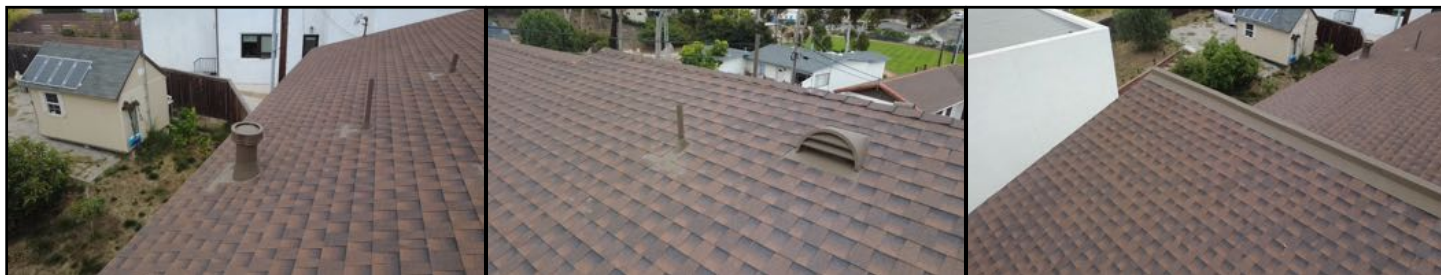
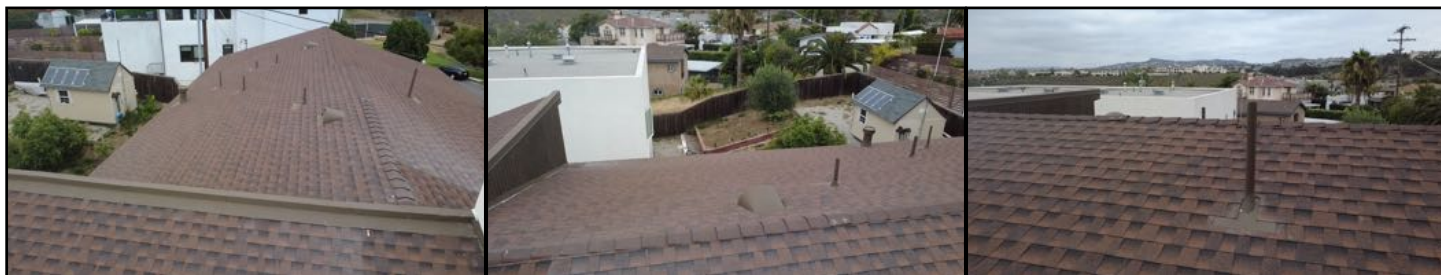
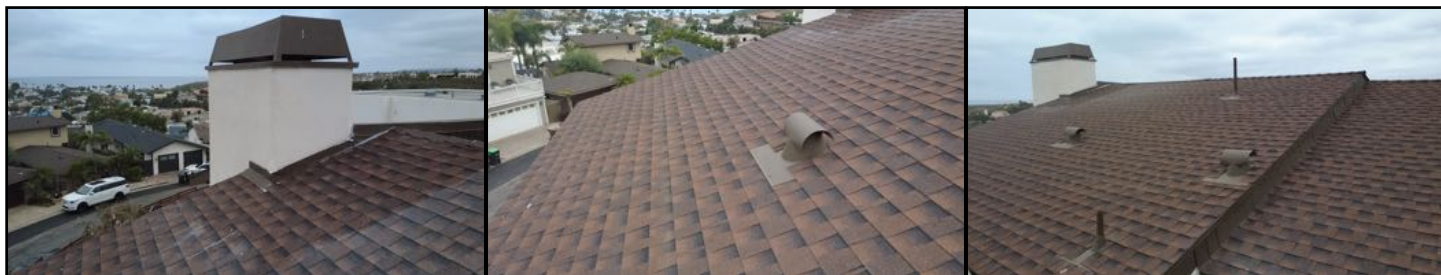
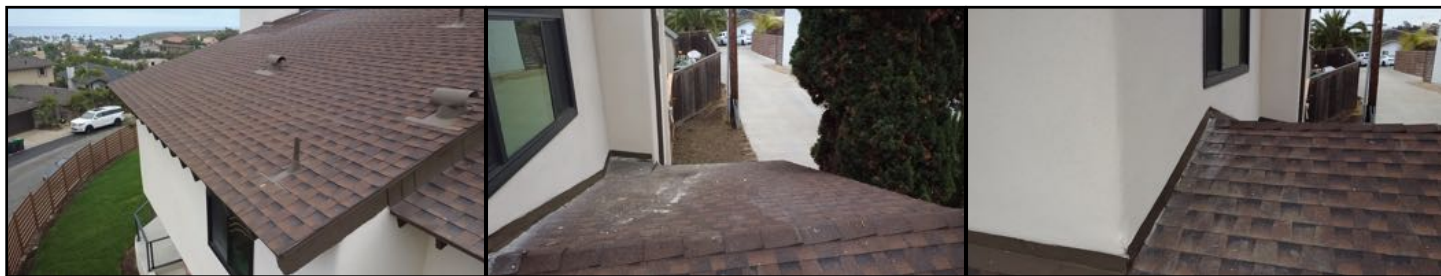
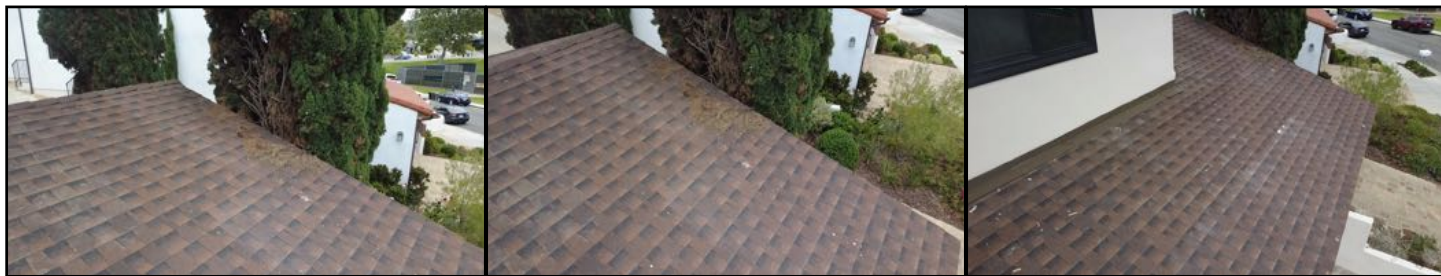
- Visible materials show signs of normal wear for the age of the materials at time of inspection - no major visible defects - Regular seasonal maintenance is recommended to extend the life of the roof

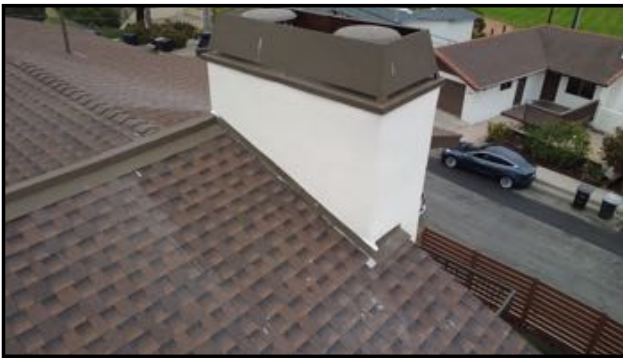
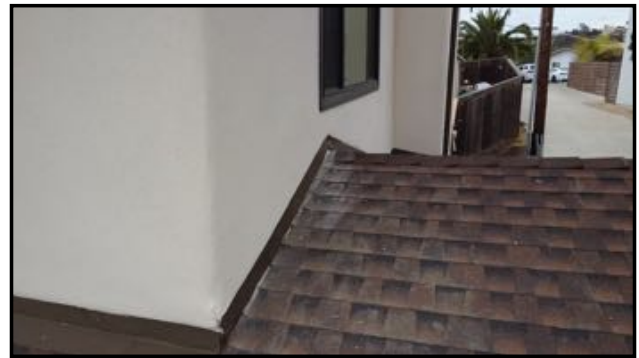
## 2. Flashings

- Some areas not visible - N/A
- Normal wear at time of inspection - no major visible defects - recommend seasonal mastic maintenance to prevent moisture intrusion

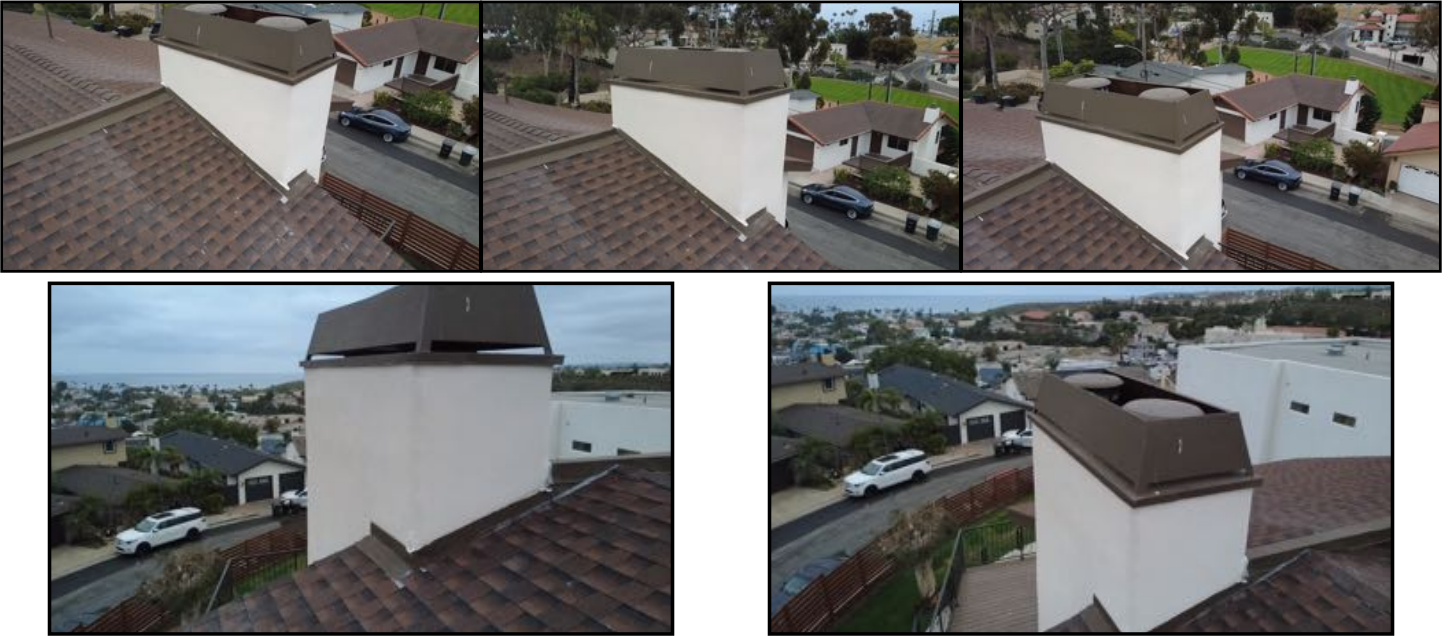
## 5. Chimneys

- Vent type chimney present
- Normal wear at the time of inspection - no major visible defects
- ***Chimney inspection includes all exterior accessible areas of chimney - interior cavity/flue is not inspected, consult a licensed chimney sweep contractor for further investigation and inspection of the internal areas of the chimney.***
