# WOOD DESTROYING PESTS AND ORGANISMS INSPECTION REPORT

| Building No.<br>13940 | Street<br>Morro Road | City<br>Atascadero | Zip<br>93422 | Date of Inspection<br>09/14/2026 | Number of Pages<br>1 of 7 |

## \*\*\*Complete Inspection Report\*\*\*

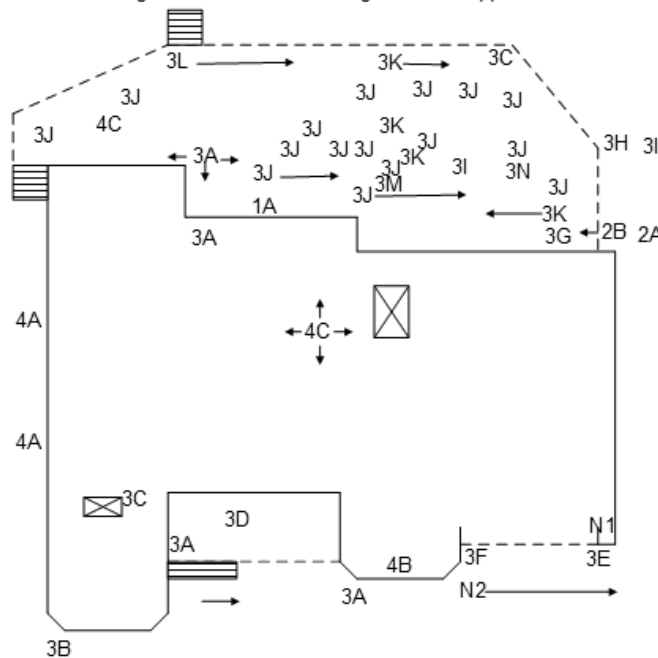
Diagram not to scale-Finding locations approximate

Finding: 1A Evidence of Subterranean Termites was found in the substructure area in the form/stake boards.

Finding: 2A Evidence of Drywood Termite infestation was found at the exterior and appears to extend into inaccessible areas of the structure.

Finding: 2B Minor Drywood Termite damage was found at the deck ledger.  
Recommendation: Repair the minor damage of the wood member with a wood filler.  
Price: \$102.00

Finding: 3A Fungus damage was found at the fascia of the eave area.  
Recommendation: Replace the fungus damaged portions of fascia as needed.  
Price: \$1,122.00

Finding: 3B Minor fungus damage was found at the fascia. Replacement of the wood member appears to be impractical.  
Recommendation: Remove the minor damage with a wood chisel. Fill the void with an exterior wood filler.  
Price: \$153.00

Finding: 3C Fungus damage was found at the chimney chase fascia.  
Recommendation: Remove and replace the damaged portions of the chimney chase fascia as needed to eliminate the fungus infection and damage.

Finding: 3D Fungus growth was found at the deck framing.  
Recommendation: Remove the surface growth with a wire brush. Chemically treat the infected wood members with disodium octaborate tetrahydrate.  
Price: \$685.00

Finding: 3E Fungus damage was found at the garage jamb.  
Recommendation: Remove and replace the damaged portions of the garage jamb as needed to eliminate the fungus infection and damage.  
Price: \$204.00

Finding: 3F Minor fungus damage was found at the garage jamb. Replacement of the wood member appears to be impractical.  
Recommendation: Remove the minor damage with a wood chisel. Fill the void with an exterior wood filler.  
Price: \$102.00

Finding: 3G Minor fungus damage was found at the door spine. Replacement of the wood member appears to be impractical.  
Recommendation: Remove the minor damage with a wood chisel. Fill the void with an exterior wood filler.  
Price: \$102.00

Finding: 3H Fungus damage was found at the deck girder and deck fascia.  
Recommendation: Remove and replace the entire deck girder and deck fascia to eliminate the fungus infection and damage.  
Price: \$6,018.00

Finding: 3I Fungus damage was found at the deck support post.  
Recommendation: Remove and replace the entire deck support post to eliminate the fungus infection and damage.  
Price: \$1,020.00

Finding: 3J Fungus damage was found at the deck joist.  
Recommendation: Remove and replace the entire deck joist to eliminate the fungus infection and damage.  
Price: \$5,610.00

Finding: 3K Fungus growth was found at the deck.  
Recommendation: Remove the surface growth with a wire brush. Chemically treat the infected wood members with disodium octaborate tetrahydrate.

Finding: 3L Fungus damage was found at the deck girder, joist, and blocking.  
Recommendation: Remove and replace the entire deck girder, joist, and blocking to eliminate the fungus infection and damage.

Finding: 3M Fungus damage was found at the blocking.  
Recommendation: Remove and replace the damaged portions of the blocking as needed to eliminate the fungus infection and damage.

Finding: 3N Minor fungus damage was found at the deck support post. Replacement of the wood member appears to be impractical.  
Recommendation: Remove the minor damage with a wood chisel. Fill the void with an exterior wood filler.  
Price: \$102.00

Finding: 4A An excessive moisture condition exists due to cracks or holes in the exterior stucco boxed eave that may allow leakage into the interior of the wall spaces.  
Recommendation: Patch the holes or cracks in the exterior stucco box eave to eliminate the excessive moisture condition.  
Price: \$459.00

Finding: 4B An excessive moisture condition exists due to an inadequate seal at the kitchen sink backsplash.  
Recommendation: Seal the edge of the kitchen sink where it meets the backsplash with a durable waterproof sealant.  
Price: \$102.00

Finding: 4C Loose cellulose debris (wood scraps/paper) were found in the substructure and deck area. This may lead to Subterranean termite infestation.  
Recommendation: Remove and dispose of all loose cellulose debris from under the dwelling of such size that it will not pass through an ordinary garden rake.  
Price: \$450.00

Recommendation: Remove and dispose of the form stakes/boards in all accessible areas. Spot treat the substructure soil with Taurus SC (fipronil) in the areas of termite activity. Chemically treat the embedded portions of the form/stakes boards which were not practical to remove. Remove accessible evidence of the Subterranean Termite infestation. In addition, an application will be made to the soil adjacent to the exterior wall around the complete perimeter of the structure. Holes may be drilled through concrete, paving or masonry adjacent to the foundation in areas such as, but not limited to; patios, sidewalks, porches and driveways, to allow for chemical treatment of the soil below. We will exercise reasonable caution when drilling but assume no liability for damage to hidden plumbing, electrical, or other utility below these areas. The location of such utilities should be identified prior to our arrival. Regardless of locations of Subterranean Termite infestation found, control of the entire structure is guaranteed. Control is guaranteed by Key Termite and Pest Control for a period of 5 years from the date of treatment. NOTE: Any exterior storage must be moved away at least 3 feet from the perimeter of the structure prior to our arrival.

Recommendation: Seal the structure and fumigate with a gas lethal to Drywood Termites (Sulfuryl Fluoride). All occupants and pets must vacate the structure until the fumigation is complete. This company will exercise reasonable caution, but cannot be held responsible for damage to plants, TV antennas or roofing due to the fumigation. Further terms and instructions will be supplied upon request or upon scheduling of the fumigation. Information may also be obtained from the fumigation page on our website at [www.keytermite.com](http://www.keytermite.com)  
**\*\*\*Fumigations are guaranteed for 5 years from the date completed\*\*\***
