# PACIFIC CREST HOME INSPECTIONS

## INSPECTION REPORT BY PACIFIC CREST INSPECTIONS

701 Kettner Blvd 154  
San Diego, CA 92101

08/13/2026

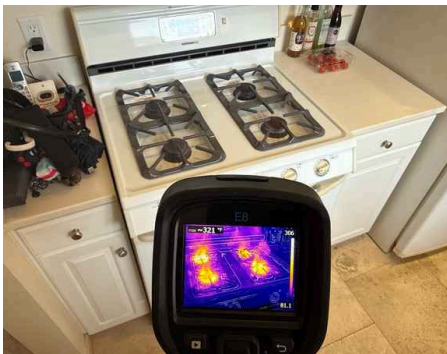
##### Ranges and Cooktops: Thermal Image Showing Operation

Infrared picture of range/cooktop in operation. This image shows function of the operable range burners.

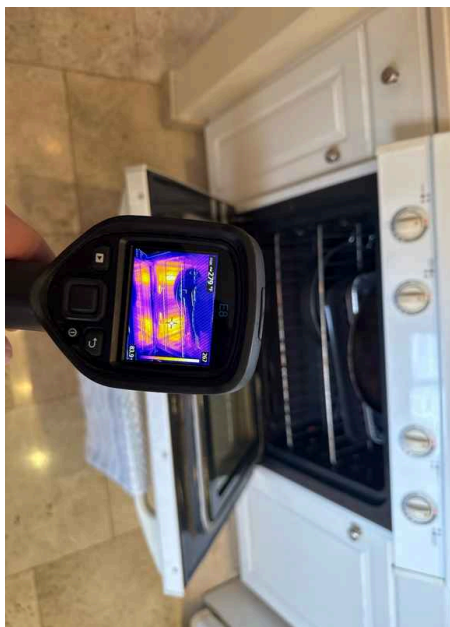
## Wall Oven: Thermal Image Showing Operation

Infrared picture of oven in operation. This image shows function of the operable oven heat source.

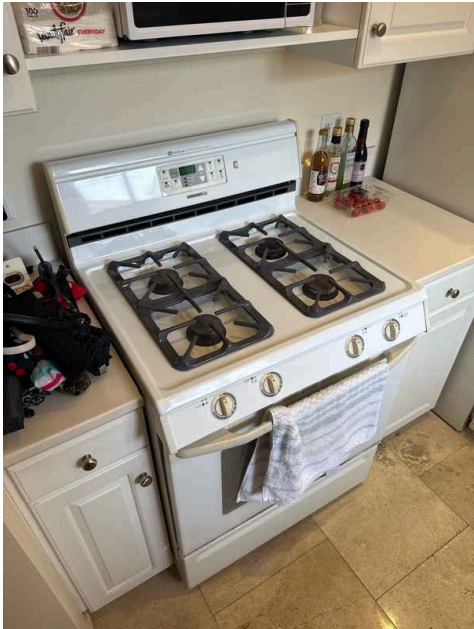
**ANTI-TIP BRACKET MISSING**

The range does not appear to be equipped with a functional anti-tip bracket. This bracket is designed to prevent the oven from falling forward in the event weight is applied to the oven door or a child climbs up the front of the appliance. Recommend installation of an approved anti-tip bracket by a qualified professional.

Contact a qualified professional.

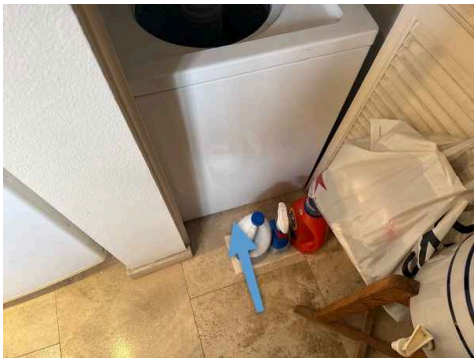
3.7.1 Washer/Dryer

**LEAK PAN NOT PRESENT**

A lack of adequate catch pan was noted installed at the laundry area. Recommend installation by a qualified professional to prevent damage in the event of a leak.

Contact a qualified professional.

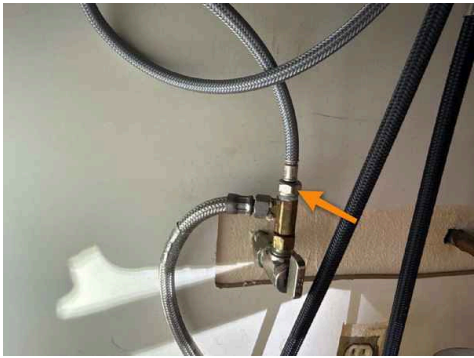
### CORROSION AT SUPPLY HOSES

Corrosion was noted at the supply houses at one or more fixture location. This may be indicative of previous possible leaks. Advise consulting a licensed plumbing contractor to determine if maintenance or repair is necessary.

Contact a qualified plumbing contractor.

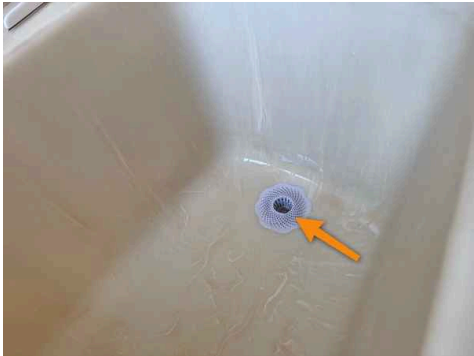
4.4.1 Tub/Shower Fixtures

**TUB STOP MISSING**

The tub stop was noted removed or missing. Recommend installation of a permanent tub stop.

Contact a qualified plumbing contractor.

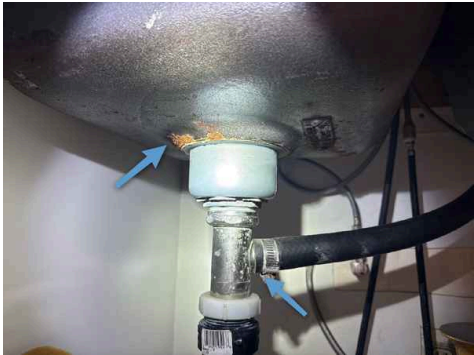
4.5.1 Plumbing Drain, Waste and Vent Systems

**PREVIOUS LEAK**

Evidence of previous possible leaks were noted at the drain line below the sink. Area appeared dry at the time of the inspection. Advise monitoring and repair by a licensed plumbing contractor.

Contact a qualified plumbing contractor.

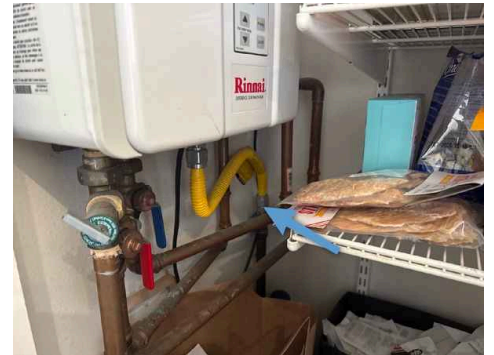
#### 4.6.2 Water Heaters, Controls, Flues and Vents

A lack of sediment trap was noted present at the water heater gas supply. This would be standard for water heaters installed 2007 or prior. However, this is recommended for retrofitting with older appliances and is required for any water heater installed after 2008. Advise correction by a licensed plumbing contractor.

Contact a qualified plumbing contractor.

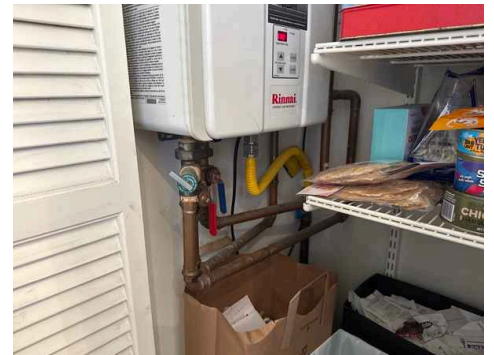
#### 4.6.3 Water Heaters, Controls, Flues and Vents

An expansion tank is not installed at the water heater. This may not have been a required fixture at the time of construction. However, most water heater manufacturers recommend installation when the home's water system is a "closed" system. Recommend consulting a licensed plumbing contractor to determine if corrections are needed at this time.

Contact a qualified plumbing contractor.

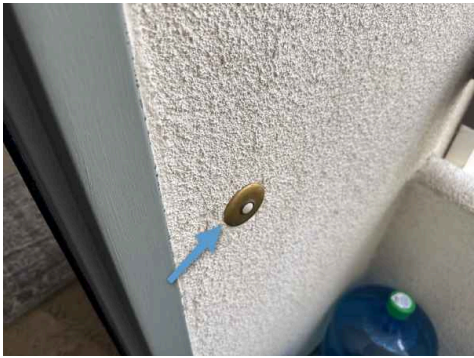
#### 5.5.2 Connected Devices and Fixtures

##### **DOOR BELL – BUTTON DAMAGED**

The doorbell button was noted damaged at the time of the inspection. This does not appear to impact operation. Advise repair as necessary.

Recommendation  
Contact a qualified professional.

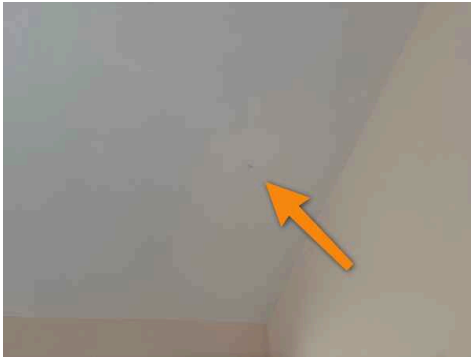
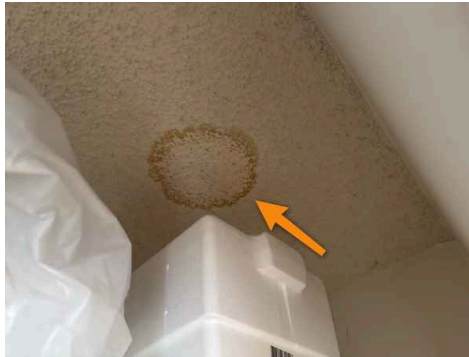
#### **WATER STAINING**

Contact a qualified plumbing contractor.

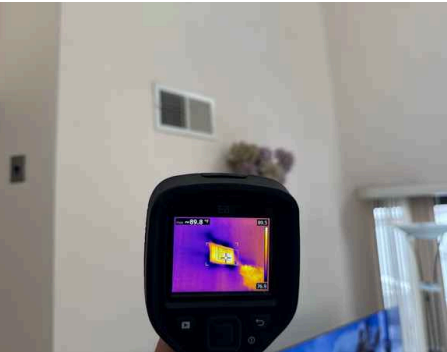
## Heating Equipment : Thermal Image Showing Operation

The furnace turned on and produced heat at the time of the inspection.

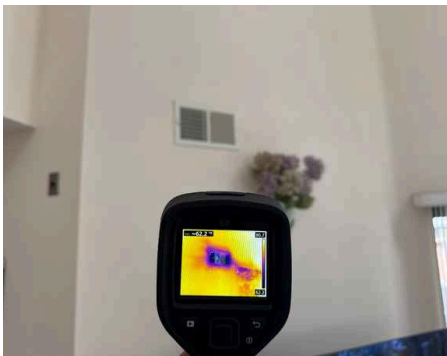
### Cooling and Air Handler Equipment: Thermal Image Showing Operation

The AC appeared to turn on and produce cold air at the time of the inspection.
