# **Cantor Property Inspection**

### **CONFIDENTIAL INSPECTION REPORT**

12845 Stone Canyon Road, Poway, CA 92064

9/30/2026 1:00 pm to 3:30 pm

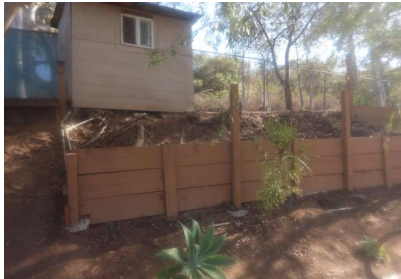
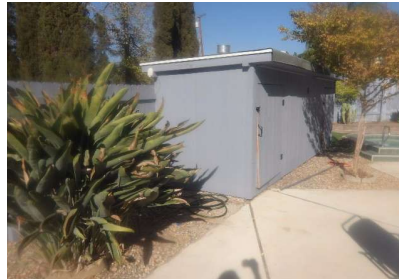
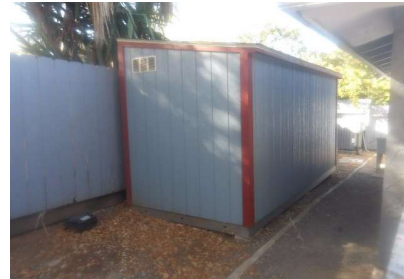
2.2 - We do not evaluate auxiliary structures as part of our service. However, you should obtain the necessary permits because we do not tacitly endorse any structure that was installed or built without permits, and latent defects could exist.

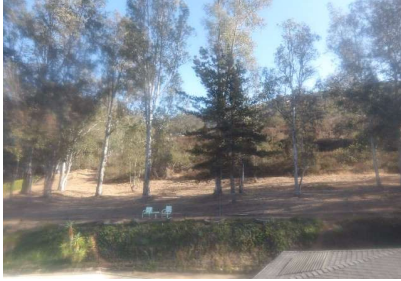
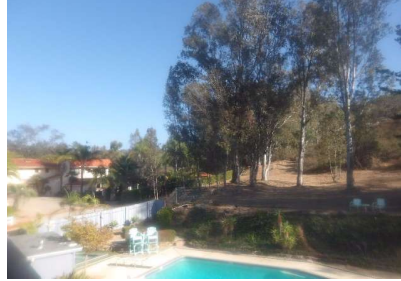
2.8 - There are several new laws requiring home owners to maintain a proper defensible space around their properties to prevent wildfires from destroying homes. An inspection by the local fire marshal is advised, to confirm if there is proper defensible space around the property.

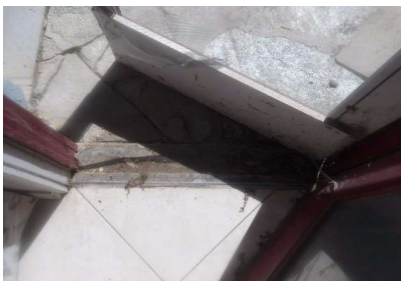
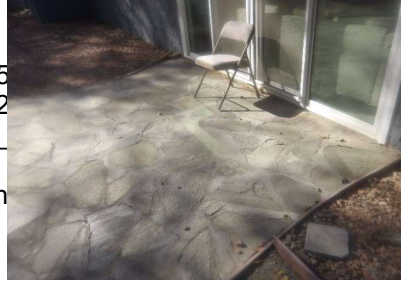
2.11 - At points around the residence, there are similar elevations between the exterior grade and the interior floors. Such conditions are obviously not ideal, and moisture intrusion could result. The door thresholds must be kept sealed and the base of the walls monitored, and particularly during prolonged rains.

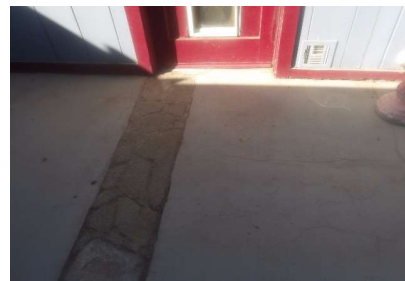
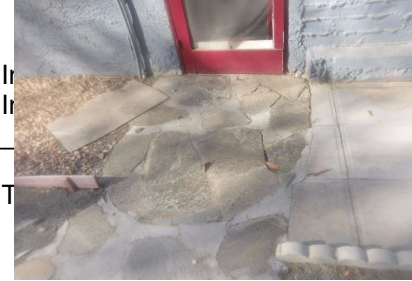
r floors which is not ideal - *Continued*

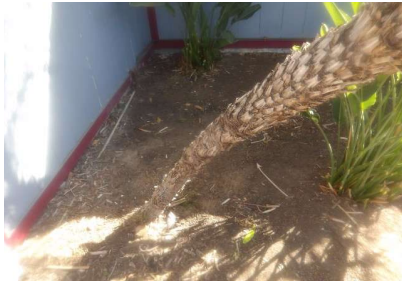
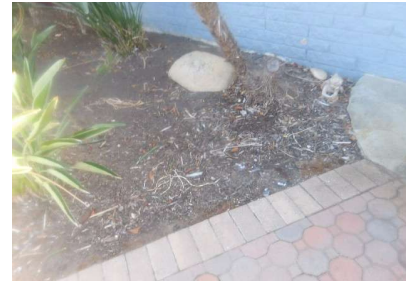
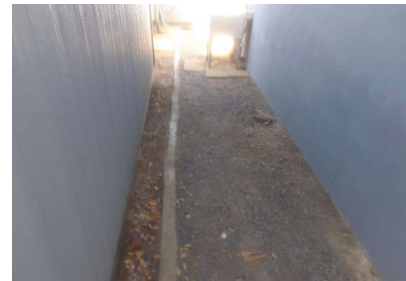
2.15 - There are areas where water will be directed toward the foundation instead of away from it, as recommended. This not only allows for the possibility of moisture intrusion, but also differential settling, et cetera. Further evaluation and repair by a licensed foundation-drainage contractor is advised.

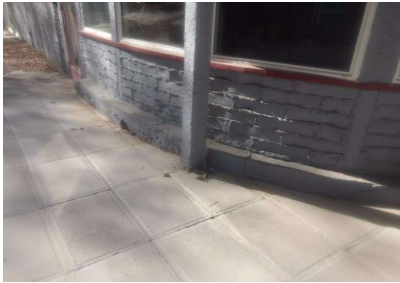
2.16 - Flash walls have been installed in various locations around the perimeter of the home to try and correct or improve faulty drainage conditions. There are gaps and separations in the flash walls and drainage concerns still exist. Further evaluation by a licensed drainage contractor is advised.

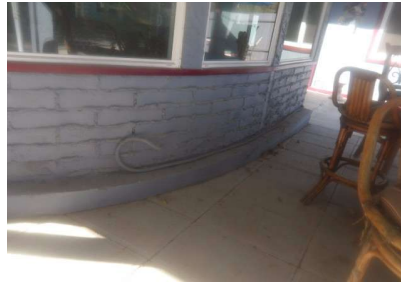
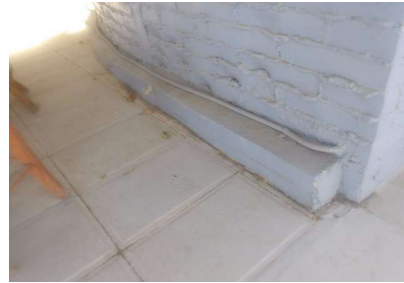
Flash walls have been installed in various locations around the perimeter of the home - *Continued*

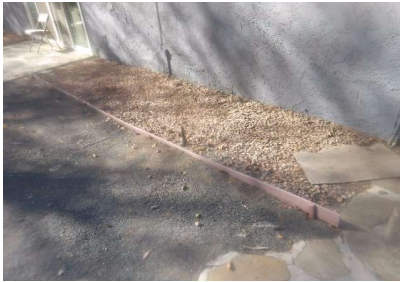
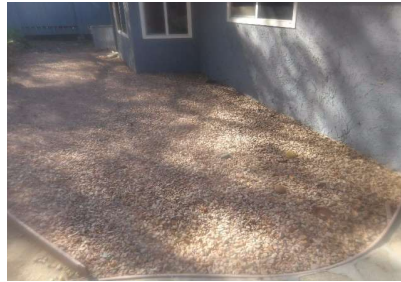
2.19 - The planter areas around the perimeter of the home are a moisture intrusion concern. Further evaluation and repair by a licensed contractor is advised during the contingency period of the escrow.

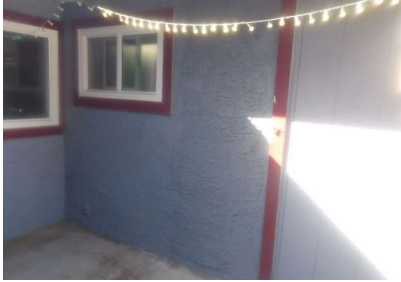
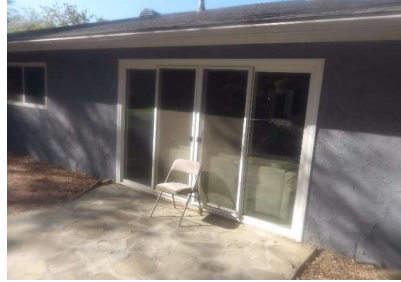
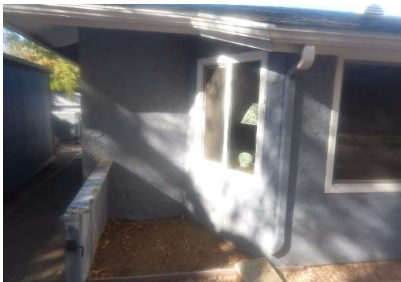
2.26 - Patching was noted in the stucco at various locations throughout the building. Further evaluation and repair by a licensed stucco contractor is advised.

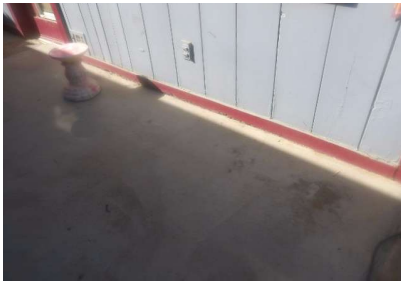
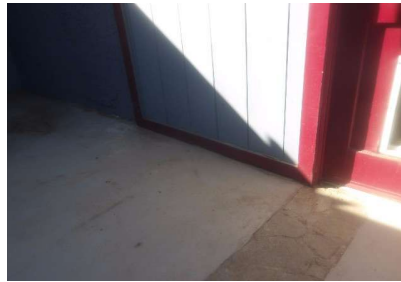
2.27 - Earth to wood contact was noted at the base of the walls at various locations around the home. Further evaluation and repair by a licensed contractor and or termite inspector is advised.

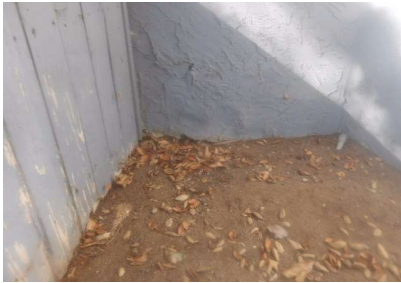
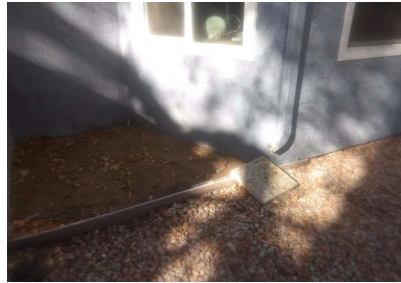
There are moisture stains and or damage in the stucco at the base of the walls - *Continued*

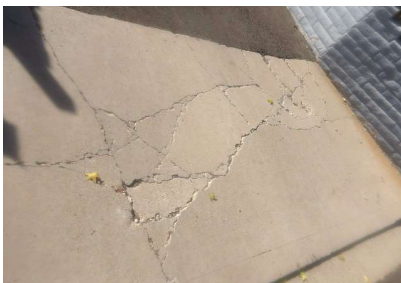
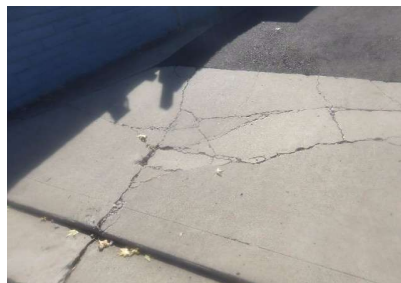
2.32 - There are cracks and offsets in the driveway that could prove to be trip-hazards, particularly for children or the elderly, which you may wish to evaluate for yourself.

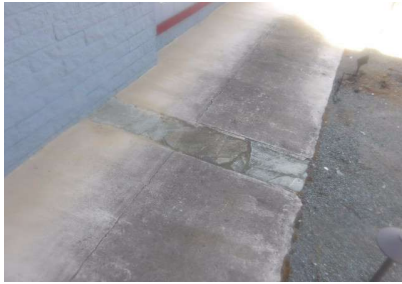
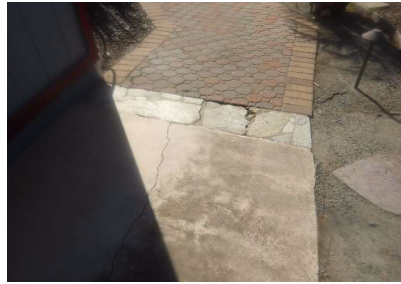
2.34 - There are several cracks and or offsets in the walkways that could prove to be trip-hazards.

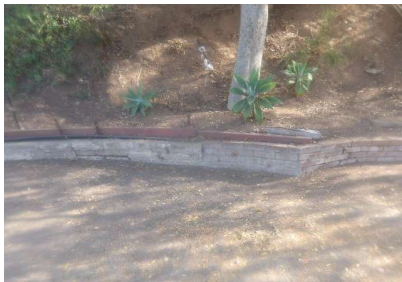
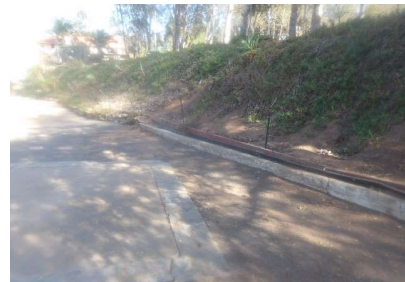
2.37 - The retaining wall at the rear of the residence is cracked, displaced, and has been compromised. Further evaluation and repair by a licensed masonry contractor is advised.

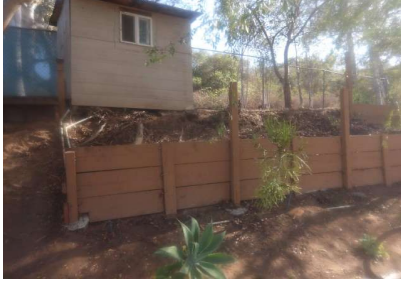
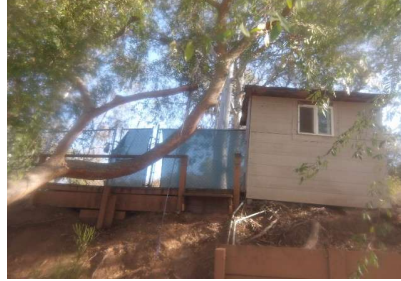
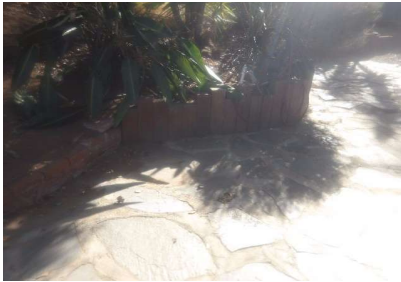
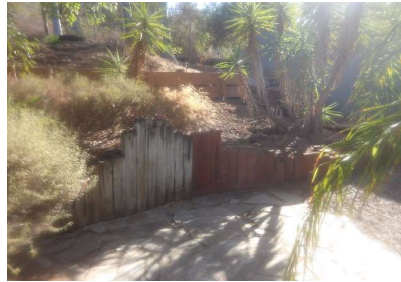
2.38 - The wooden yard walls terracing the rear slope have no structural value, and are intended to inhibit surface soil movement, and should be periodically monitored for damage or stability. The wooden yard walls are damaged, displaced, and in poor condition. Further evaluation and repair by a licensed contractor is advised.

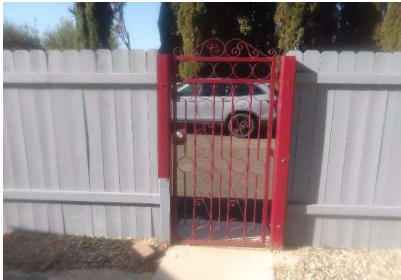
2.43 - The double cylinder keyed deadbolt on the exterior fence could prevent or impede an emergency exit, and should be replaced with a safer latch type.

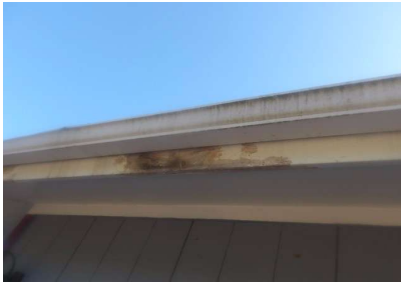
There are signs of possible moisture and or termite damage noted in the wood trim - *Continued*

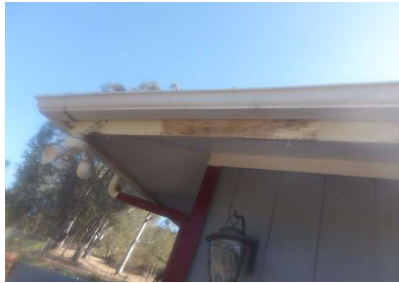
2.45 - There are signs of possible moisture and or termite damage noted in the wood trim, fascia boards, and eaves at various locations throughout the building. Further evaluation and repair by a licensed Pest Control Operator is advised.

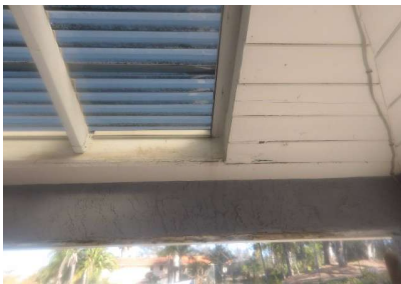
2.49 - There is possible termite and or moisture damage to the rear patio cover, that should be further evaluated and repaired by a licensed Pest Control Operator.

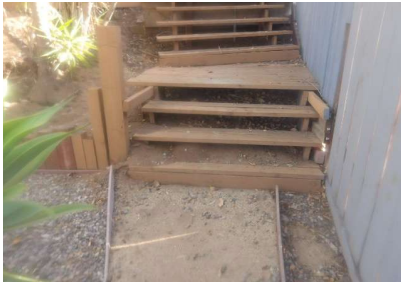
Moisture and or termite damage was noted in the wood steps - *Continued*

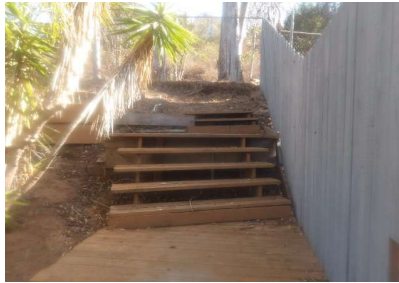
2.52 - Moisture and or termite damage was noted in the wood steps. Further evaluation by a licensed Pest Control Operator is advised.

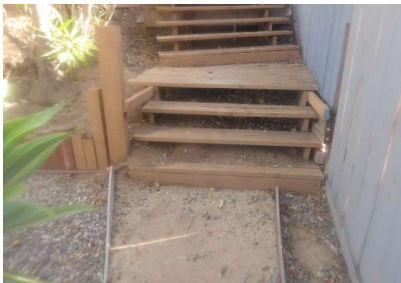
2.53 - The risers are unequal in height, which could prove to be a trip-hazard. The rise should not be less than 4 inches, nor greater than 7 inches. In addition, the dimensions of the risers should not exceed 3/8 of an inch from the smallest dimension on the entire run of the stairs.

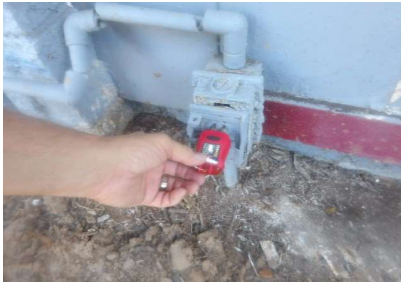
2.59 - One or more exterior outlets on the exterior of the home did not appear to be functional, which should be serviced by a licensed electrician.

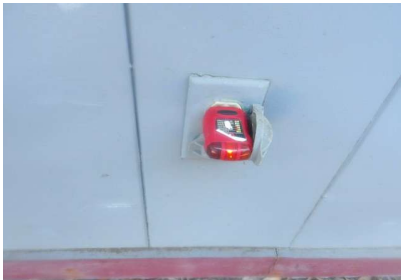
2.61 - One outlet or more have an open ground, which should be serviced by a licensed electrician.

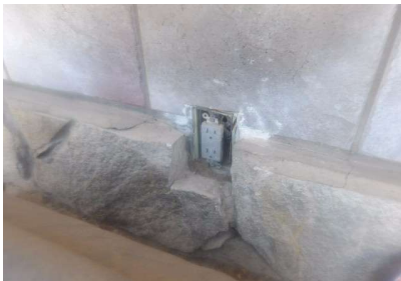
2.63 - One or more outlets are missing waterproof cover plates, which should be installed.

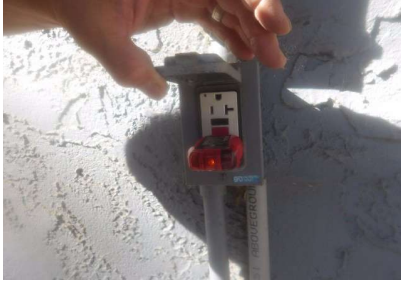
2.65 - The rear exterior outlet has an open-ground, however, for safety reasons has had ground fault protection added. You may wish to have the outlet properly grounded by a licensed electrician.

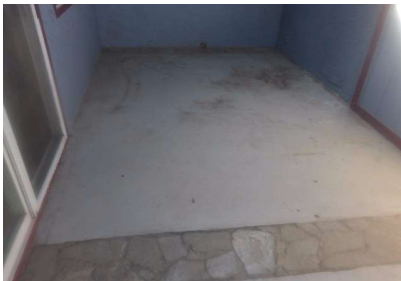
2.73 - The concrete patio at the rear is poured too high against the foundation. There should be a two inch separation from the top of the slab to the bottom of the stucco drip screed. This allows for proper drainage to occur. Although, there is currently no signs of any issue, this could be a moisture intrusion concern.

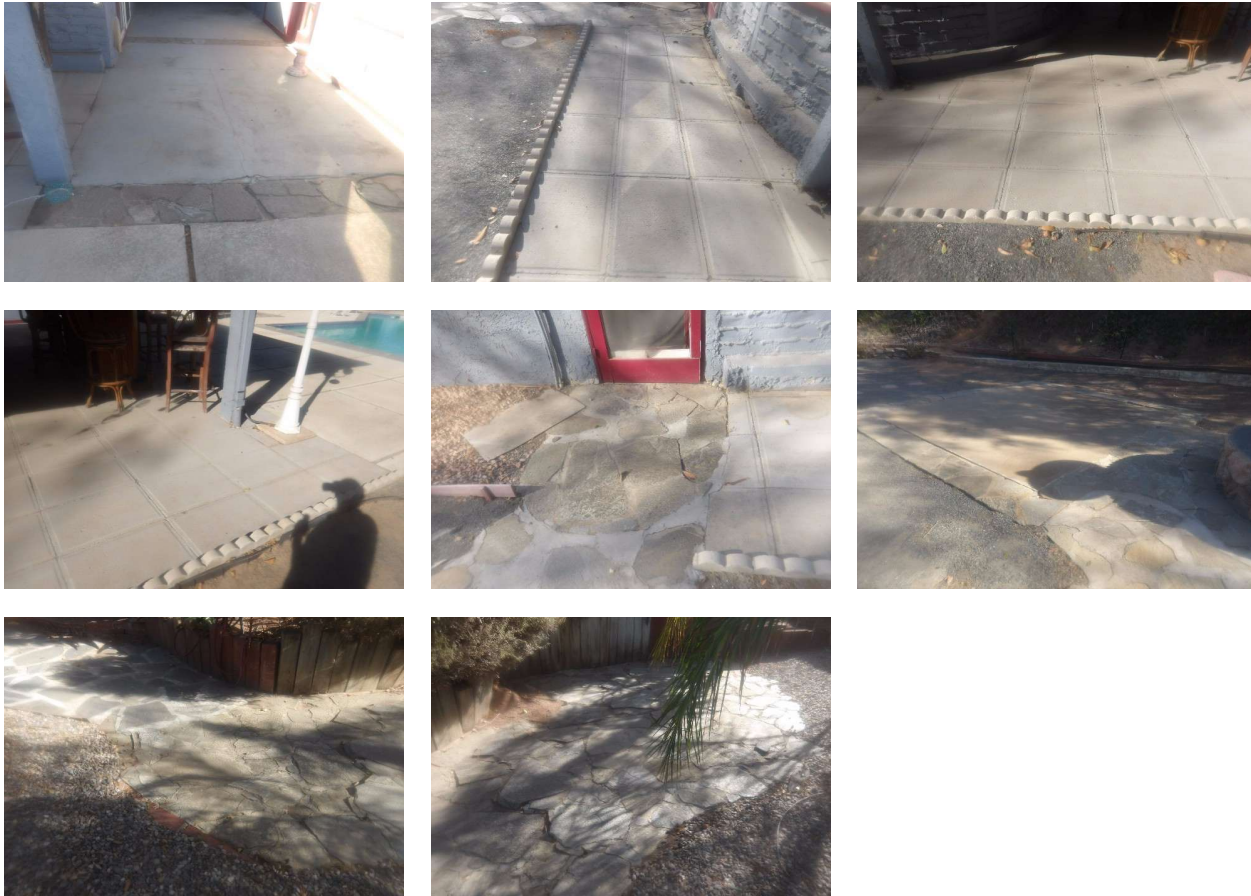
The brick and stone style patios at the rear of the home are functional - *Continued*

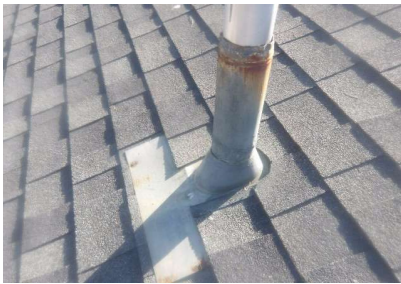
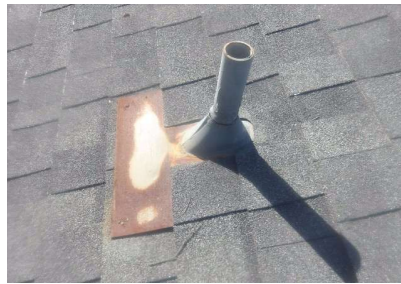
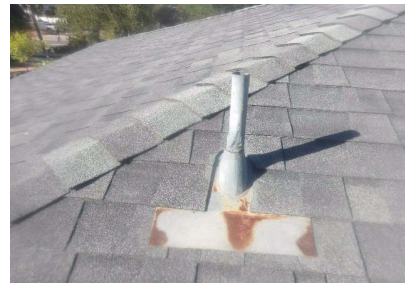
3.6 - One or more flashing's are separated and need to be resealed. Further evaluation and repair by a licensed roofer is advised.

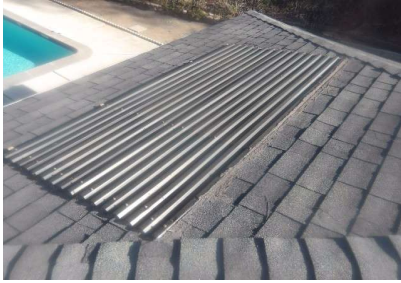
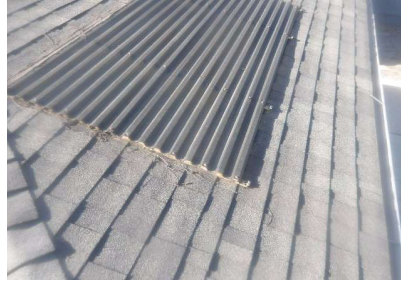
Mastic has been applied around the skylight - *Continued*

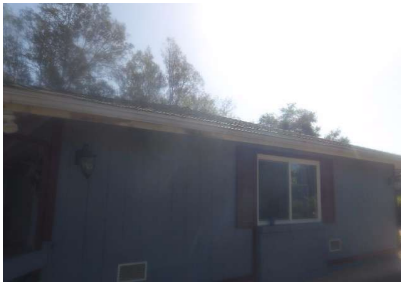
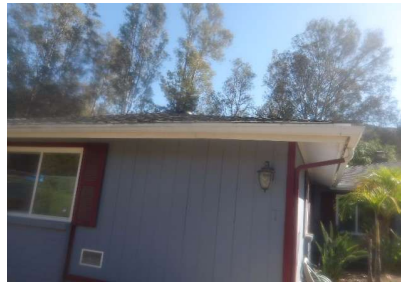
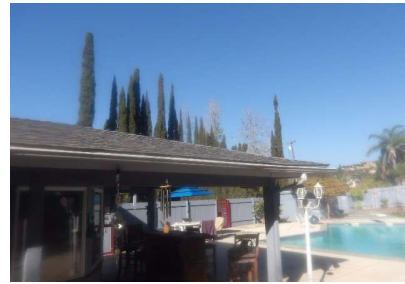
3.9 - The gutters are full of debris, and need to be cleaned and serviced to drain properly.

3.10 - The gutters needs to be serviced, such as resealing them, sealing seams, and making sure they slope to drain, etc.

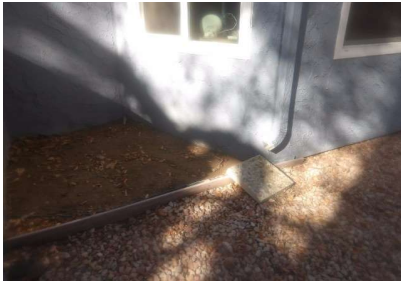
3.11 - It would be prudent to add leaders and or splash blocks at the bottom of the downspouts to promote positive drainage and divert water away from the perimeter footings.

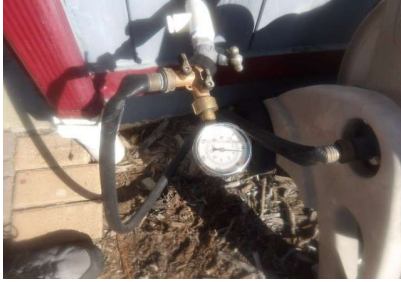
4.2 - A functional pressure regulator is in place on the plumbing system.

4.3 - The water pressure was 45 to 50 PSI when tested.

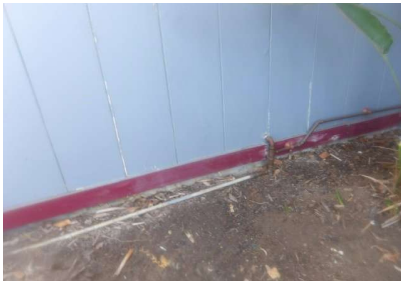
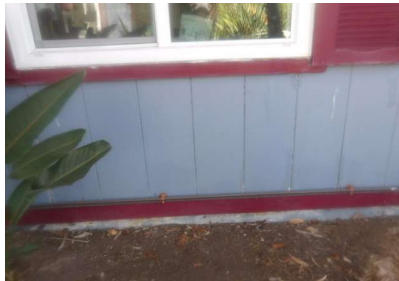
4.7 - There exposed copper water pipes run on the ground on the North side of the building, which are subject to damage. Proper repair by a licensed contractor is advised.

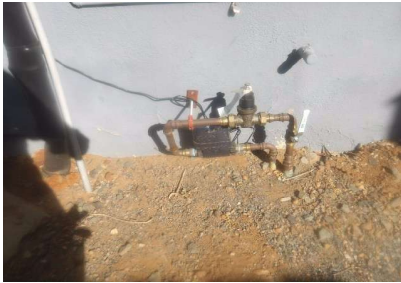
A Moen leak detector shutoff device has been added to the water main at the right side of the home - *Continued*

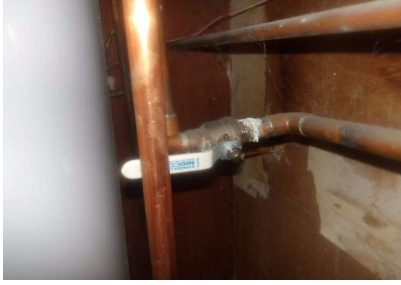
4.17 - There is corrosion noted on the supply line connectors and or shut-off valve, which should be serviced.

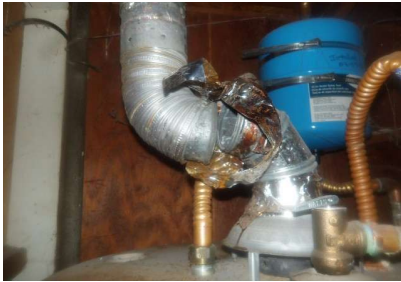
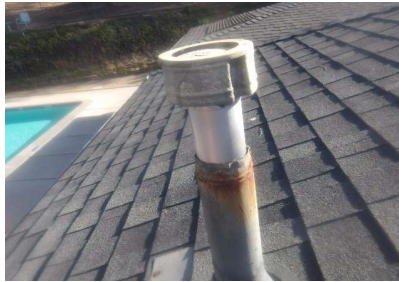
4.19 - The vent pipe is disconnected and will not effectively draft the bi-products of combustion beyond the residence and the vent pipe is improperly installed, which should be serviced by a licensed plumber.

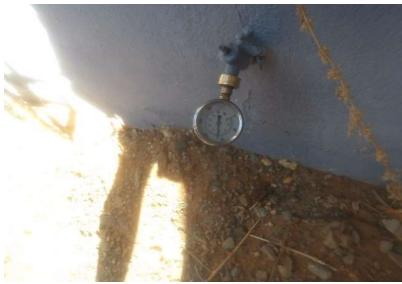
4.30 - A hose bib at the right side is missing a handle, which should be replaced. However, we may not have located and tested every hose bib on the property.

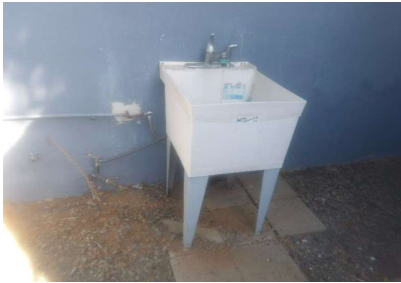
There is an improperly installed sink added at the right side of the home - *Continued*

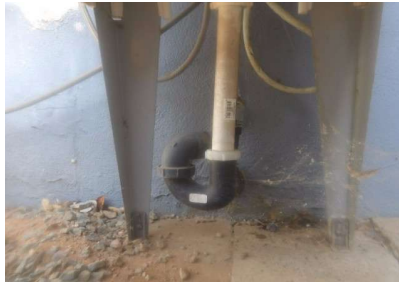
4.32 - There is an improperly installed sink added at the right side of the home. Additionally, there is a leak at the sink faucet. Proper repair or removal of the sink is advised by a licensed plumber.

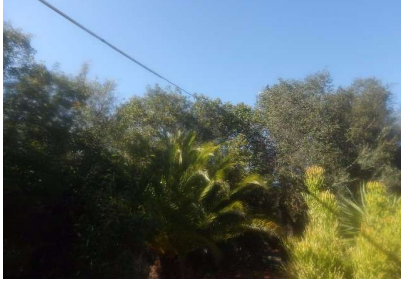
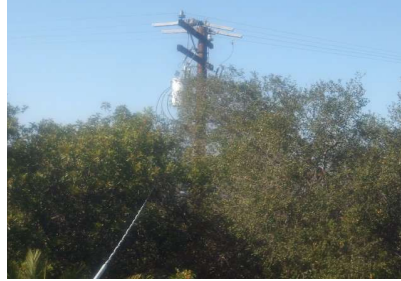
5.3 - The utility company's overhead conductor lines are running through tree limbs that should be trimmed.

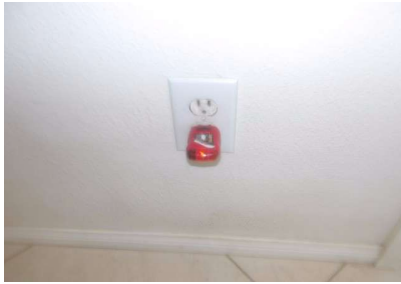
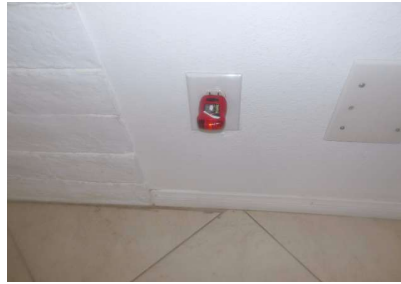
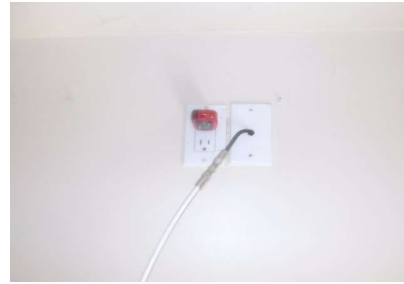
5.11 - The home was original wired with a two wire non-grounded electrical system. Many of the outlets throughout the home have been replaced to three prong grounded style, however, remain ungrounded. Further evaluation and repair by a licensed electrician is advised during the contingency period of the escrow.

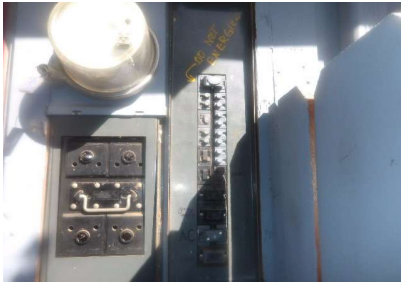
The sub panel is the original Bulldog Electrical Company panel - *Continued*

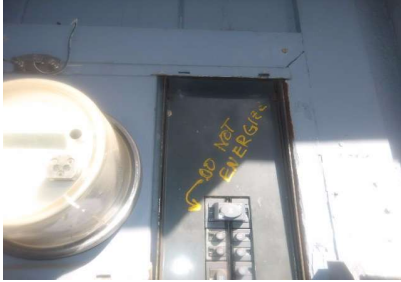
5.28 - There is a 40 amp circuit breaker at the very top of the panel that has a written notice to not use, however, it appears that the circuit breaker is currently still in use. Further evaluation and repair by a licensed electrician is advised.

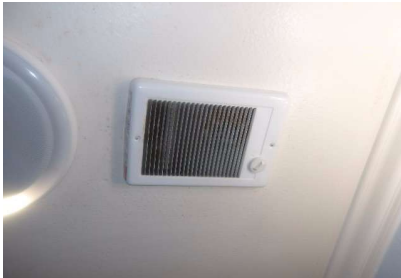
6.1 - There an improperly installed electric wall heater that has been installed on the ceiling. Proper repair by a licensed contractor is advised.

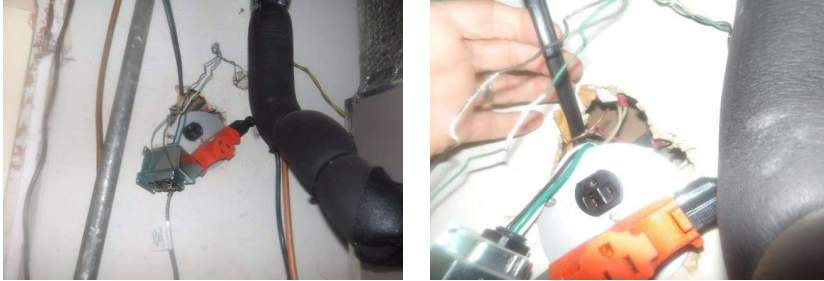
7.4 - There are one or more electrical connections that have been incorrectly made outside of a junction box, which is a potential fire-hazard. All such connections should be made inside a junction box, in order to contain any arcing or sparking within the box. Additionally, there is extension cord or lamp cord wiring. Proper repair by a licensed electrician is advised.

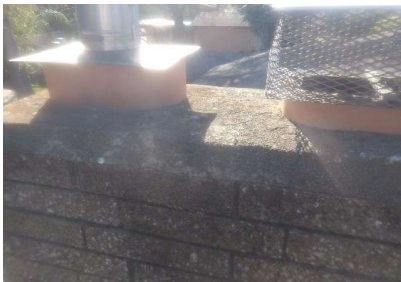
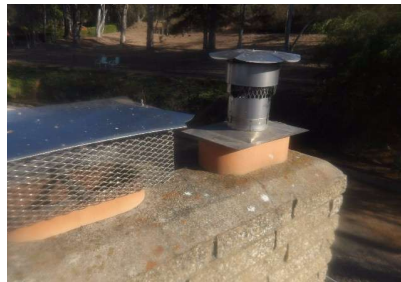
8.5 - The crown, which is designed to seal the chimney wall and shed rainwater, is cracked and or damaged and should be sealed or replaced by a licensed masonry contractor or certified chimney sweep.

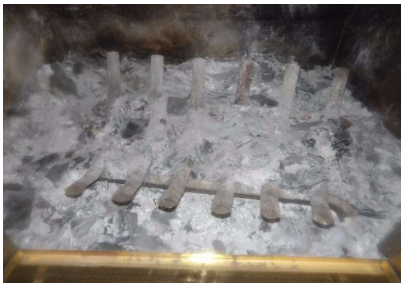
8.12 - The firebox is full of ash, which limited the inspection. Further evaluation when the firebox is cleaned out and before the close of escrow is advised.

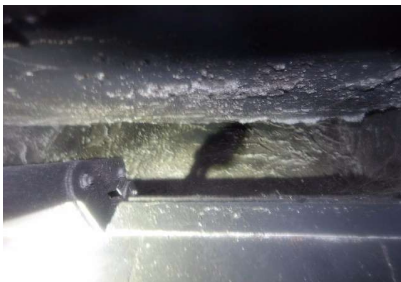
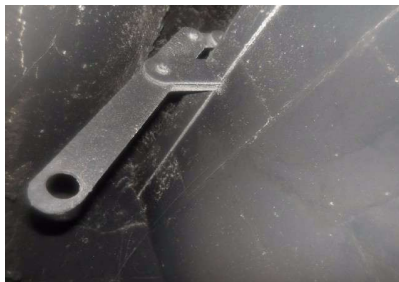
8.13 - The damper is stuck, either by rust or thermal warping, and should be repaired or replaced by a licensed fireplace specialty contractor.

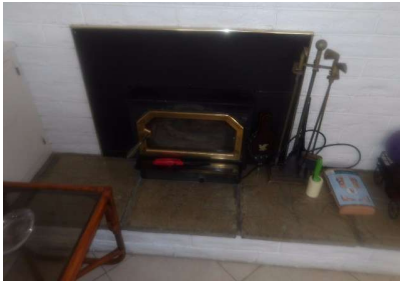
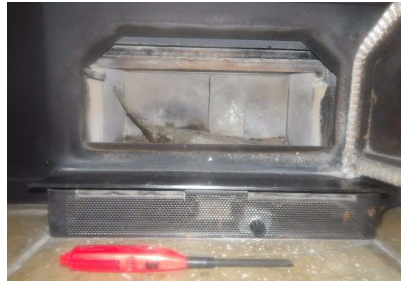
8.22 - An insert has been installed inside the original prefabricated fireplace. Our services do not include the inspection of such modification. Further evaluation by a licensed fireplace contractor who specializes in this type of installation.

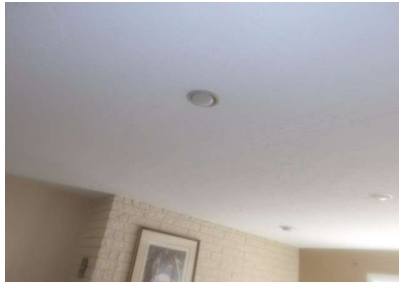
9.22 - There are patched areas in the walls and or ceiling, which you should question the seller about, or have further evaluated by a licensed contractor.

There are patched areas in the walls and or ceiling - *Continued*

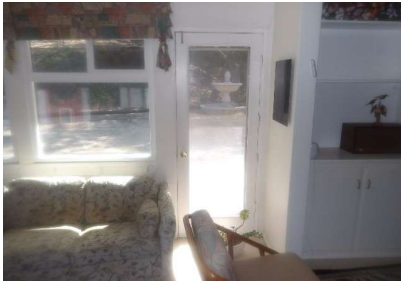
9.38 - One or more doors have a broken hermetic seal, and should be replaced. This is evident from fogging, or condensation forming between the panes of glass, that confirm that the seal has failed.

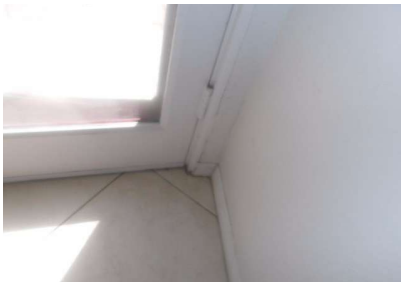
9.39 - There is moisture and or termite damage noted in the French doors. Further evaluation and repair by a licensed termite inspector or contractor is advised.

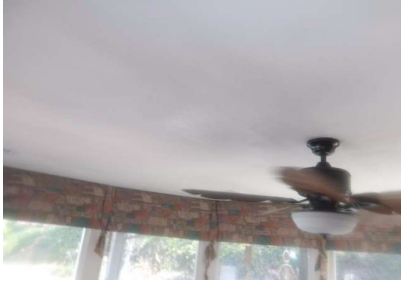
There are moisture stains and or patched areas in the walls and or ceiling - *Continued*

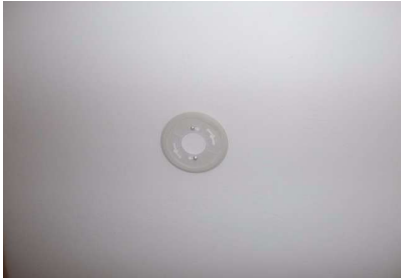
10.54 - There is no smoke detector, which is mandated in this jurisdiction and should be installed.

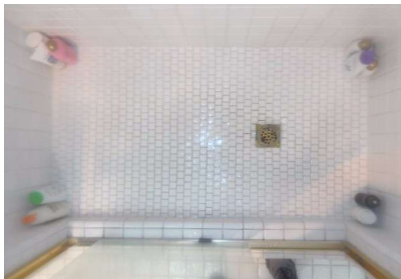
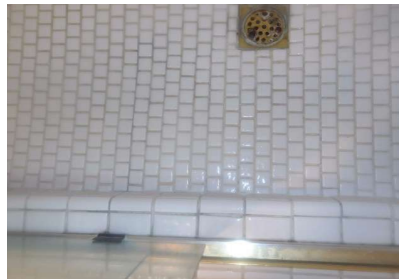
11.14 - There are cracked tiles in the stall shower area that should be monitored to forestall moisture intrusion.

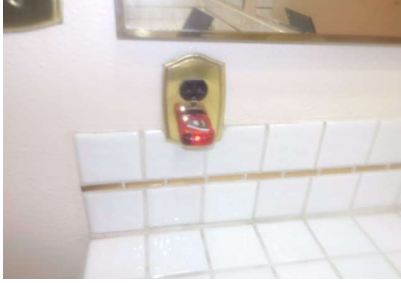
11.18 - The outlet is functional, however, does not include ground-fault protection, which should be installed by a licensed electrician.

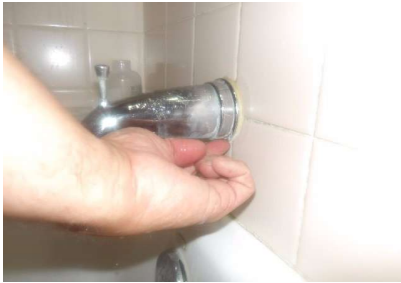
The tub and shower valve and or spout leak - *Continued*

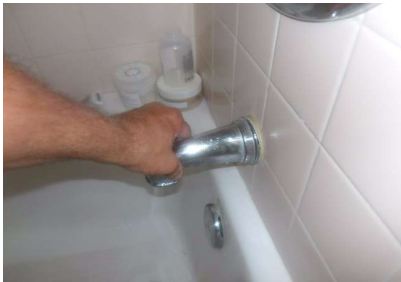
- 11.32 - The tub stopper is missing or incomplete and should be repaired or replaced.  
11.33 - The tub spout, valve, and or shower head are loose, which should be serviced.

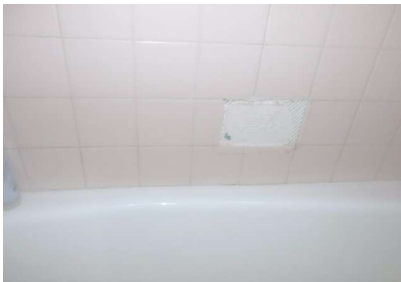
- 11.34 - The soap dish is missing in the tiled shower wall, which should be serviced by a licensed contractor.

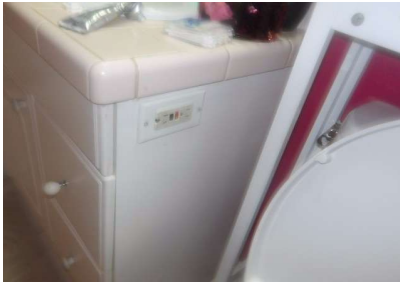
- 11.38 - The outlet is functional and include ground-fault protection, however, is improperly located on the side of the cabinet and has exposed Romex wiring under the counter top. Proper repair by a licensed electrician is advised.

The outlets are functional and include ground-fault protection - *Continued*

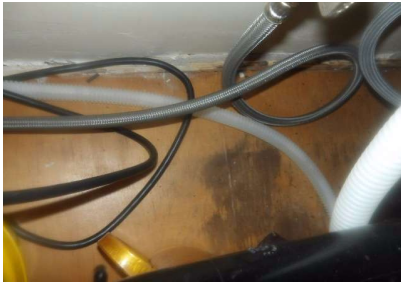
The floor of the sink cabinet and or wall is functional but moisture stained and or damaged - *Continued*

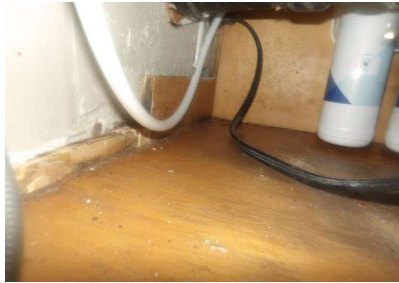
12.9 - The floor of the sink cabinet and or wall is functional, but moisture stained and or damaged. Further evaluation and repair by a licensed termite inspector is advised.

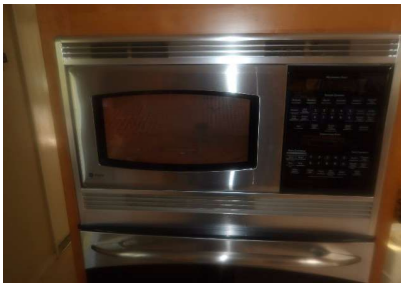
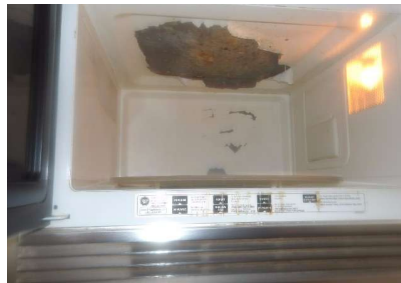
12.25 - The built-in microwave does not respond. Further evaluation and repair by a licensed appliance repair contractor is advised.

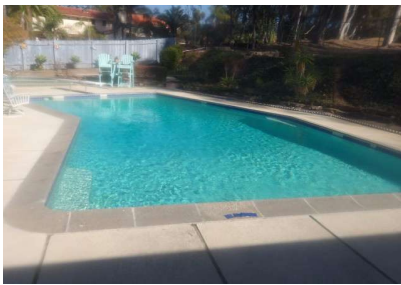
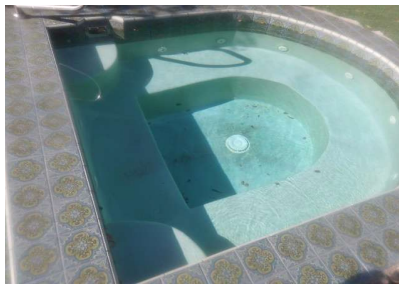
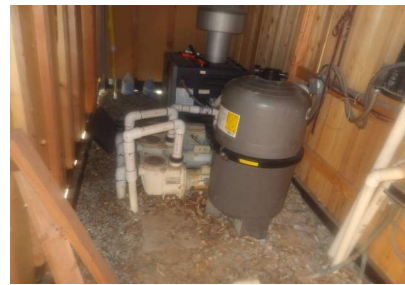
13.2 - We do not evaluate pools or spas as part of our inspection service. It is recommended that a licensed pool specialist evaluate them during the contingency period of the escrow. You should also be aware of local ordinances governing pool and spa safety.

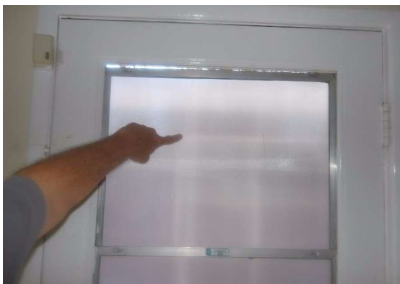
16.2 - There are cracks in the glass panels of the exterior door, which should be repaired.

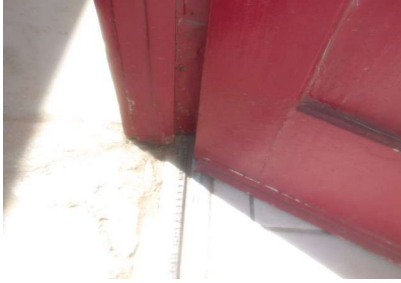
16.3 - There is possible moisture and or termite damage in the exterior door and or jamb. Further evaluation and repair by licensed termite inspector is advised.

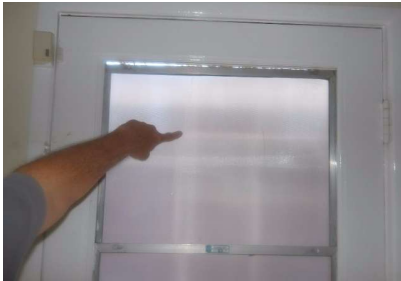
16.4 - The glass in the exterior door does not appear to be tempered safety glass, as required by building standards. Upgrades for safety enhancement is advised.

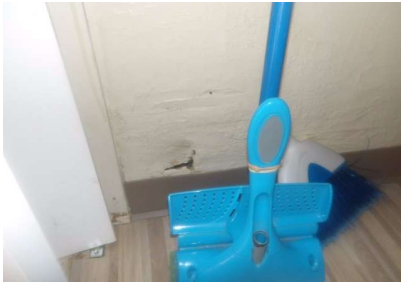
There are patched and or damaged areas in the walls and or ceiling - *Continued*

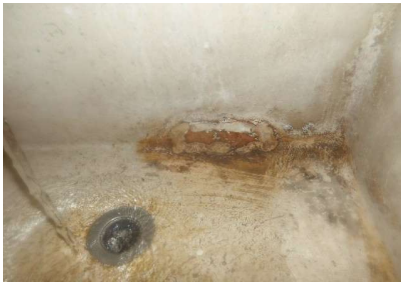
16.16 - The laundry sink is functional, however, appears to have a patched area on the bottom or side wall of the sink. Further evaluation and repair by a licensed plumber is advised.

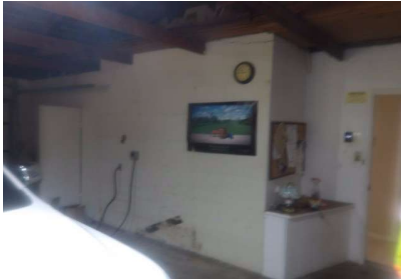
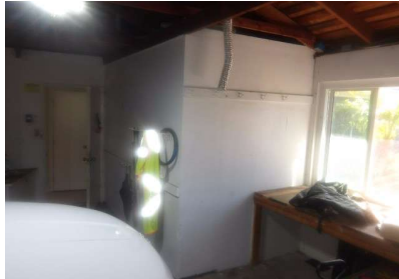
17.1 - A portion of the garage has been converted into living space (The laundry room and kitchen pantry closet), we recommend that you verify the required building permit and certificate of occupancy. This is important because our inspection does not tacitly approve, endorse, or guarantee the integrity of any work that was done without a building permit, and latent defects may exist.

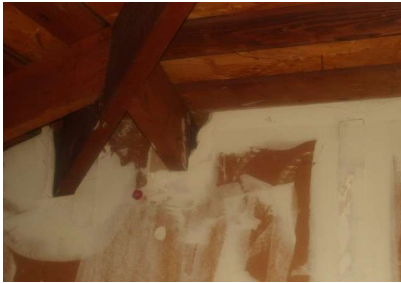
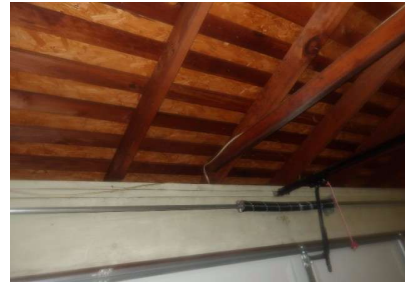
There are moisture stains and or damage on the walls and or ceilings - *Continued*

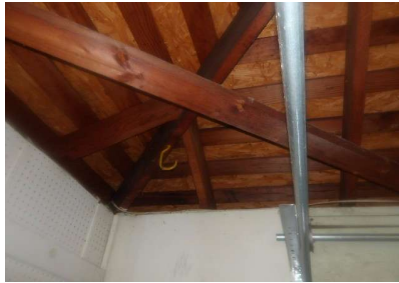
17.5 - There are moisture stains and or damage on the walls and or ceilings, the cause of which should be explained or explored further by licensed roofer.

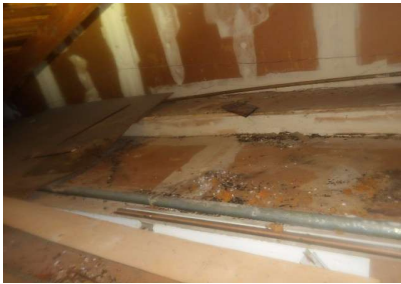
17.8 - Rodent activity was noted throughout the garage. Further evaluation and repair by a licensed Pest Control Operator is advised.

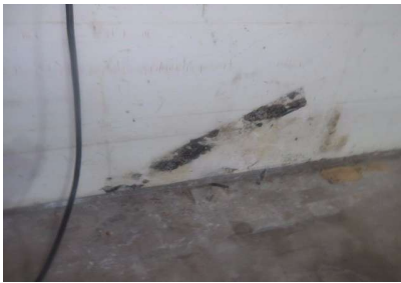
17.9 - There appears to be a fungus like growth on the wall in the garage. Further evaluation and repair by a licensed and qualified mold specialist is advised.

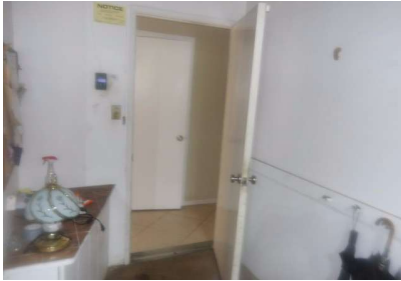
17.15 - The house entry door is not self-closing and is required to be, to maintain the necessary firewall separation between a garage and living quarters, and will need to be serviced.

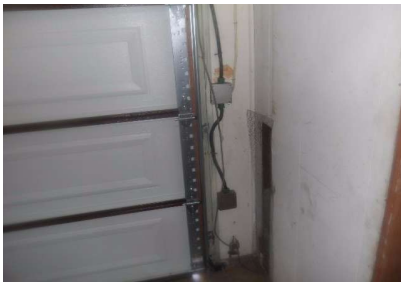
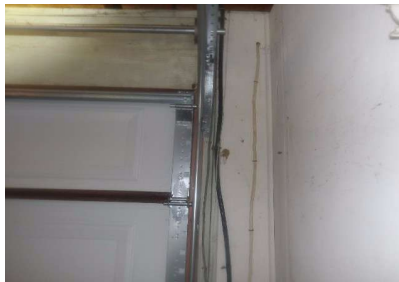
17.18 - There is exposed Romex wiring noted on the walls and or ceiling of the garage. Further evaluation and repair by a licensed electrician is advised.

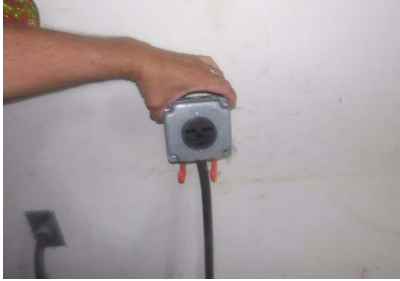
17.19 - The 220 volt outlet that was tested is functional, however, the outlet is not properly secured to the wall, which should be repaired by a licensed electrician.

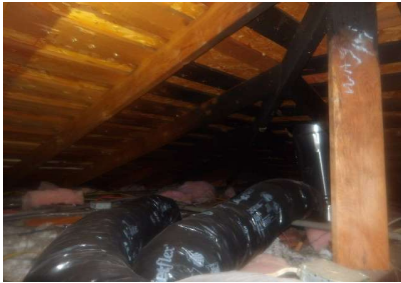
Components of the roof framing are scorched or charred and should be further evaluated - *Continued*

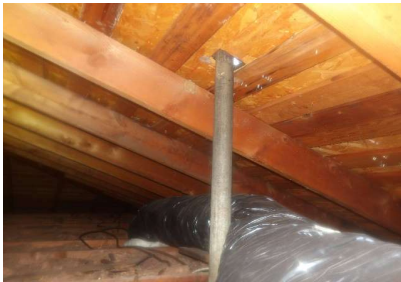
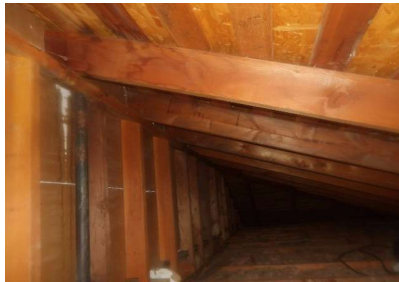
18.8 - There is evidence that the roof has leaked in various locations, which should be reasonably explained, or the roof should be further evaluated by a licensed roofer.

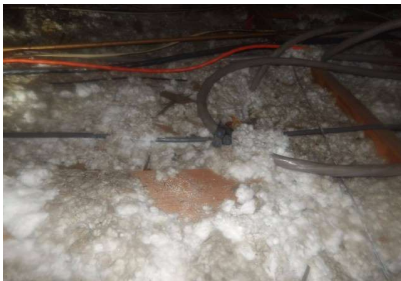
18.11 - There are one or more electrical connections that have been incorrectly made outside of a junction box, which is a potential fire-hazard. All such connections should be made inside a junction box, in order to contain any arcing or sparking within the box.

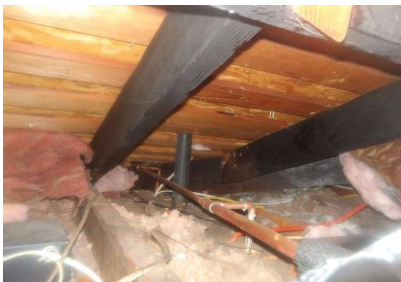
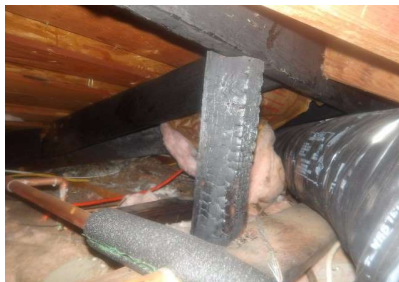
18.21 - Components of the roof framing have been scorched or charred by a previous fire. You should request information about this from the sellers, and if the charred framing has not been evaluated by an engineer it should be.
