## KEEN EYE HOME INSPECTION REPORT

2251 Chicago St  
San Diego, CA 92110

Shaylie Fraser  
10/03/2026

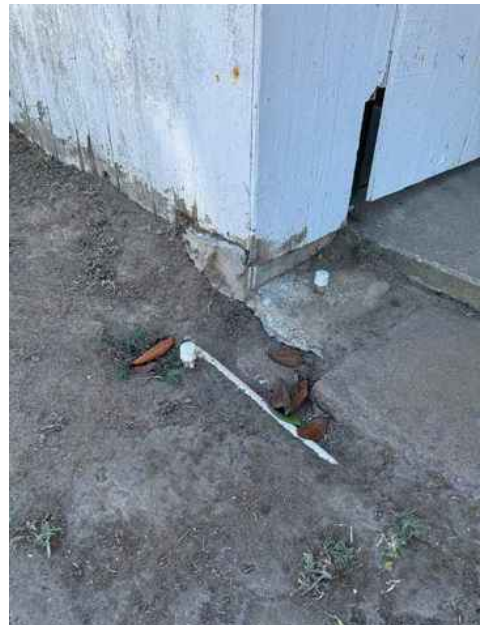
#### 4.1.2 Driveways, Sidewalks, Patios

### TRIPPING HAZARD - OBJECT

Defective/Safety Hazard

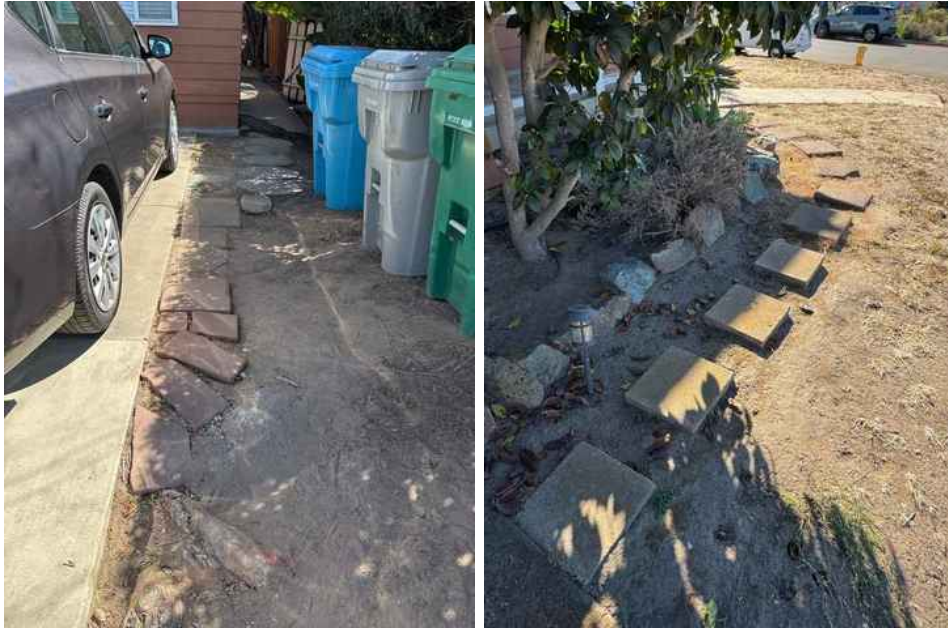
## 4.1.3 Driveways, Sidewalks, Patios

**LOOSE / SETTLED / SEPARATING PAVERS**

Recommendation

Contact a qualified professional.

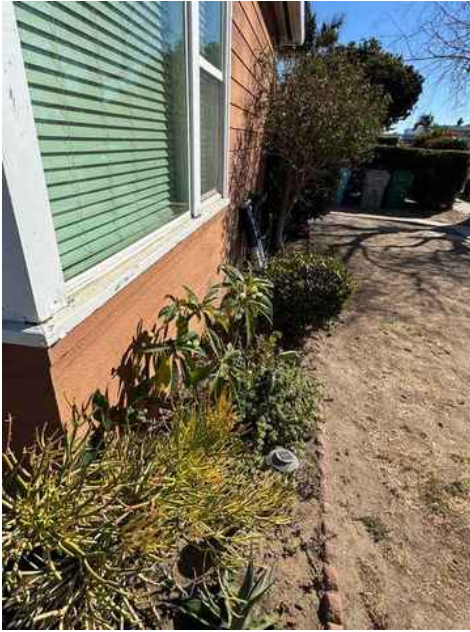
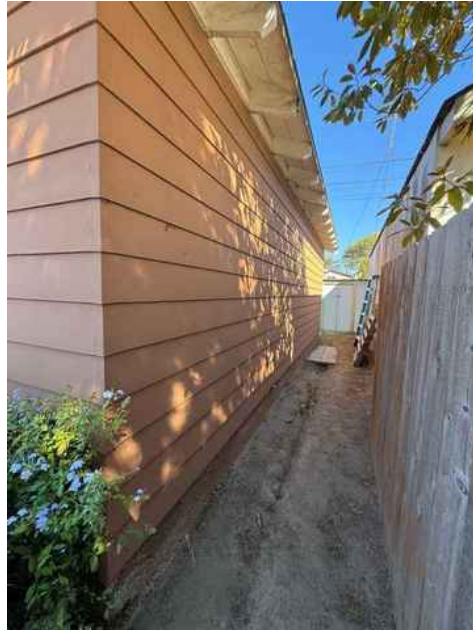
## 4.2.1 Drainage or Grading

**IMPROPER GRADING / DRAINAGE AWAY FROM STRUCTURE**

Recommendation

Contact a qualified professional.

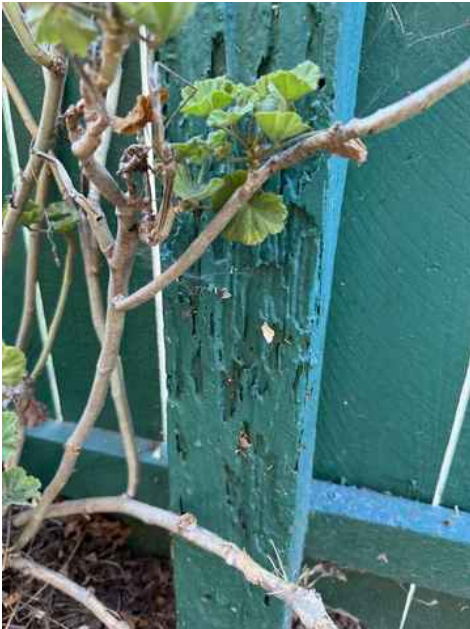
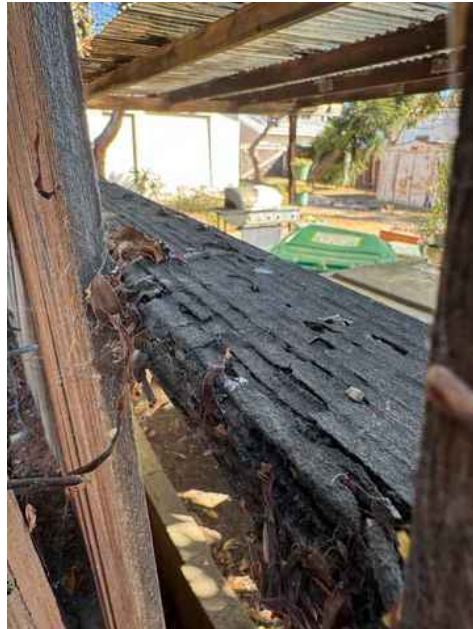
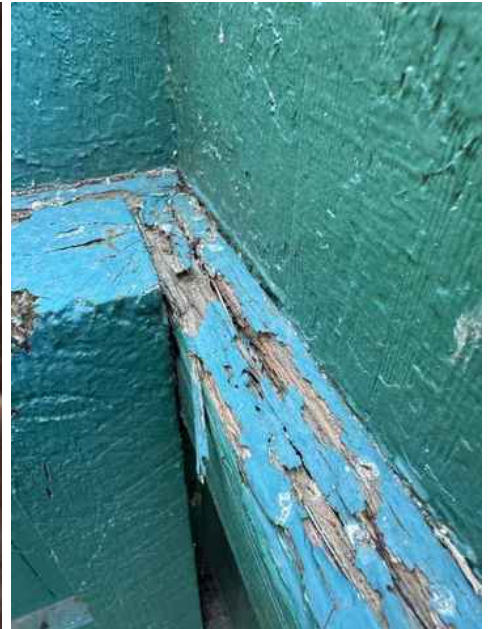
#### 4.3.1 Fences / Gates

### WOOD DAMAGE - TERMITE INSPECTION RECOMMENDED

#### Recommendation

Contact a qualified pest control specialist.

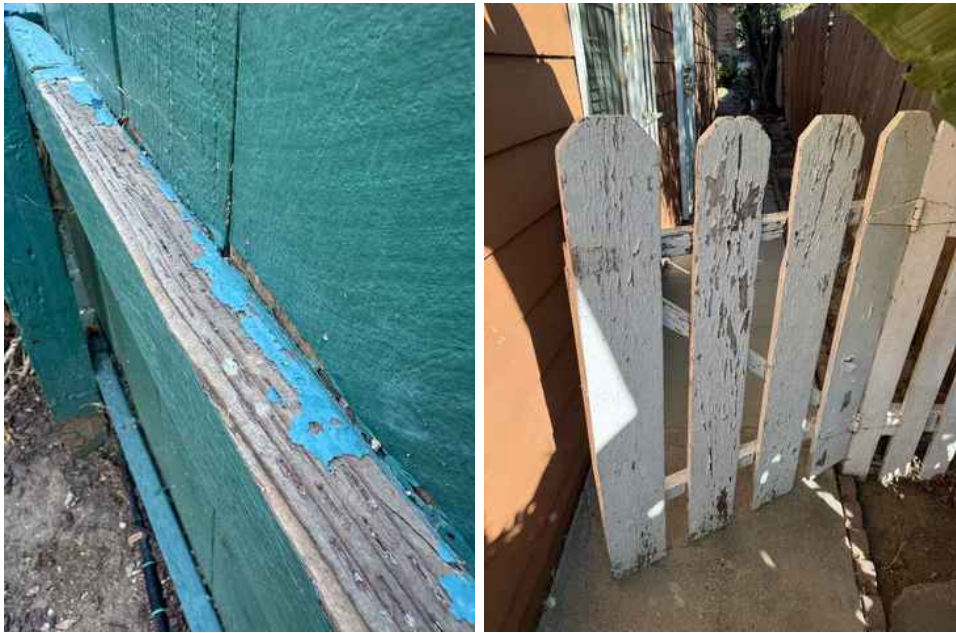
#### 4.3.2 Fences / Gates

### PAINT / FINISH NEEDED

Unfinished wood or deteriorated finish was noted in one or more areas. Contacting a qualified tradesperson for repairs is recommended.

Recommendation  
Contact a qualified professional.

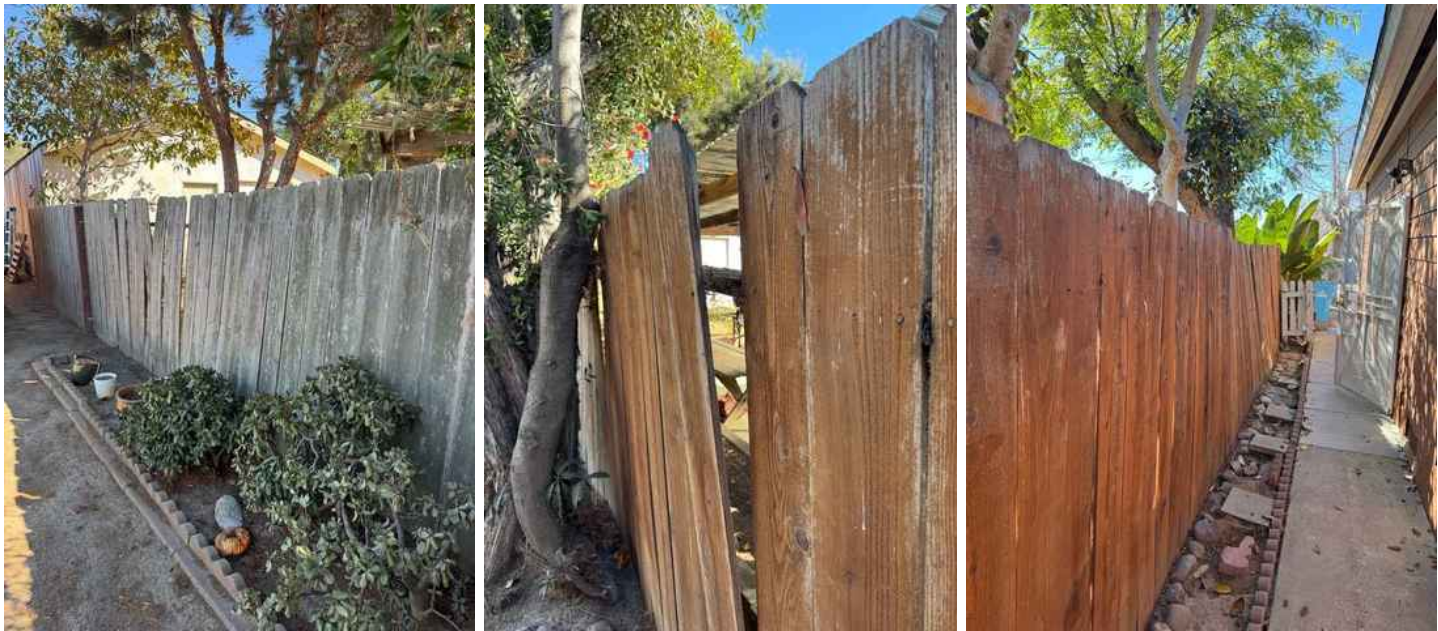
4.3.3 Fences / Gates

**LOOSE, LEANING AND/OR DAMAGED**

Fencing was loose, leaning and/or damaged in one or more areas. A qualified professional should evaluate and make repairs or replace sections as necessary.

Recommendation  
Contact a qualified professional.

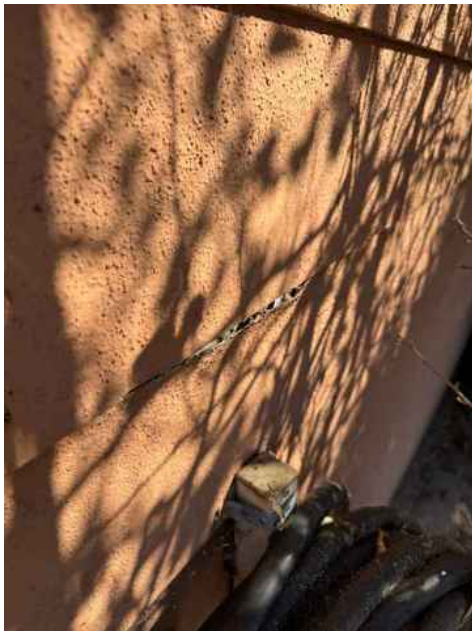
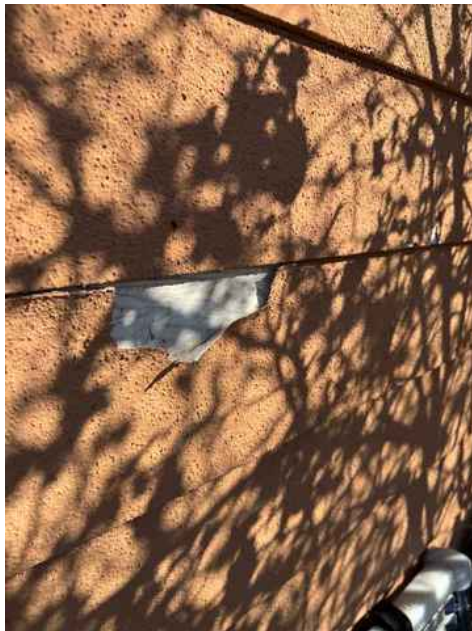
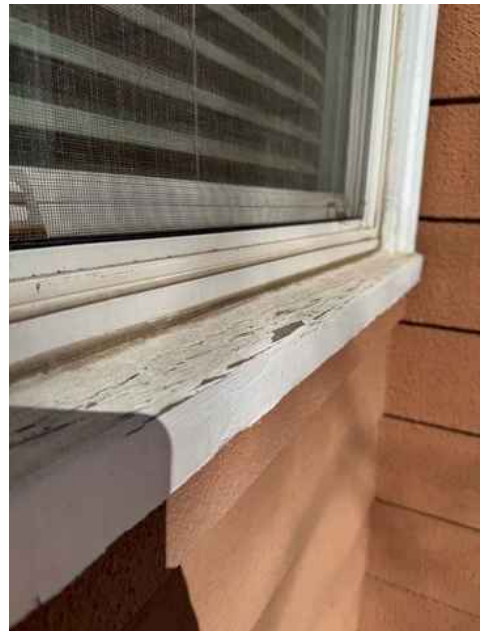
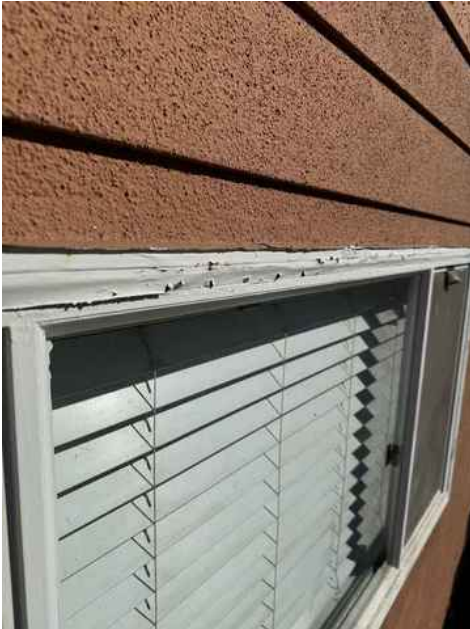
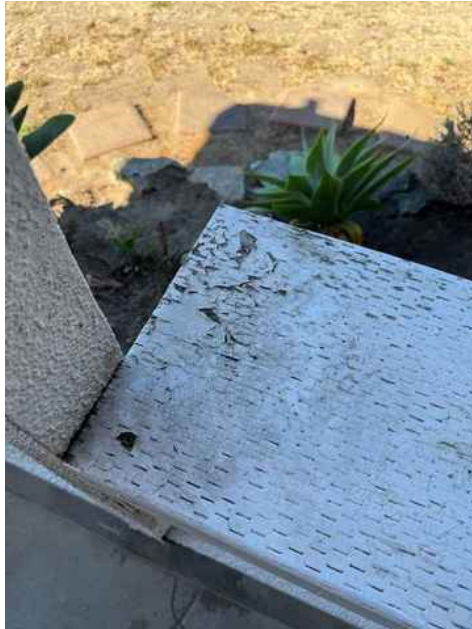
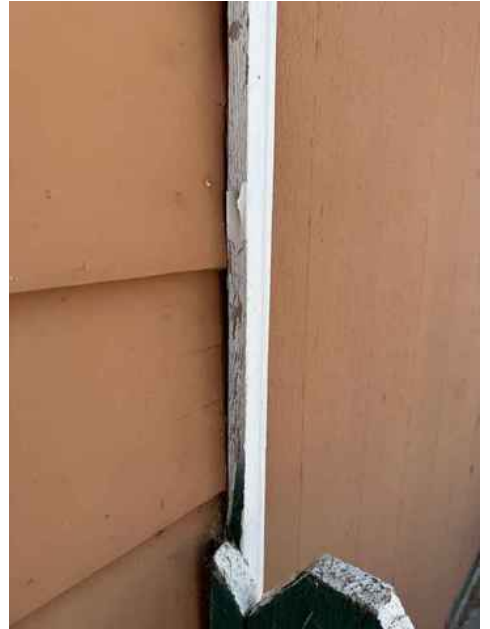
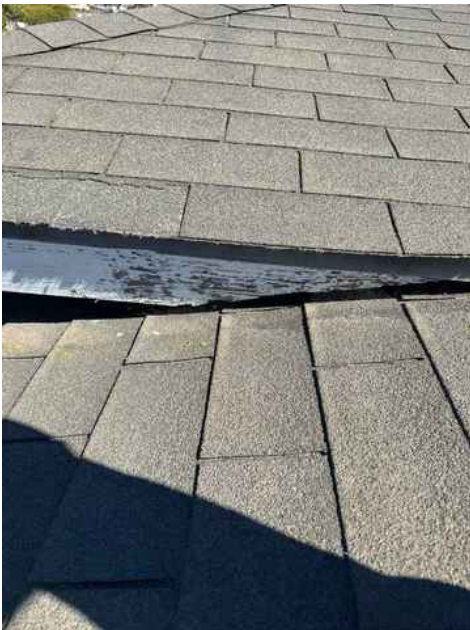
#### 4.4.1 Exterior Walls / Trim

##### **PAINT / STAIN FAILING**

Attention Required

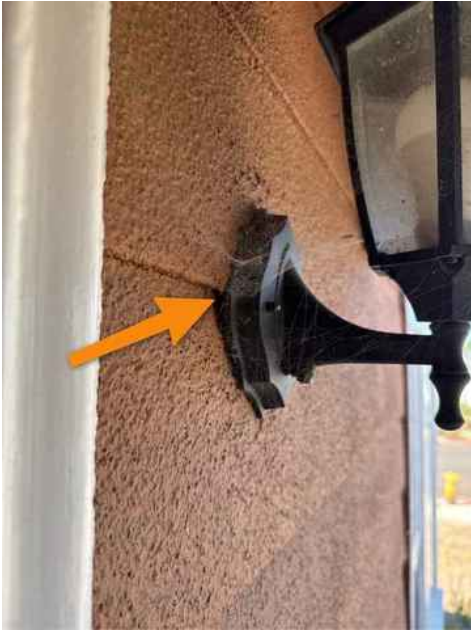
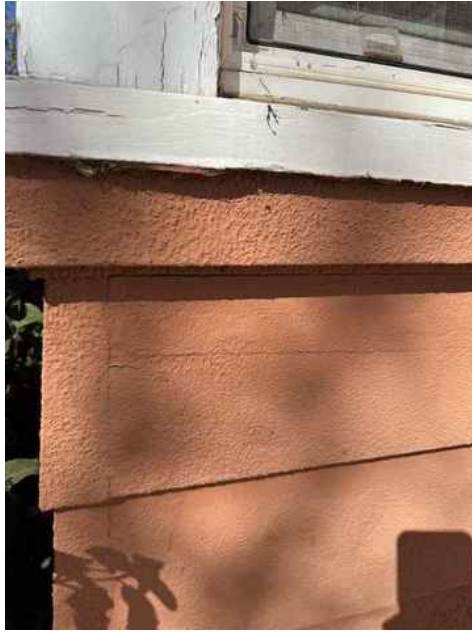
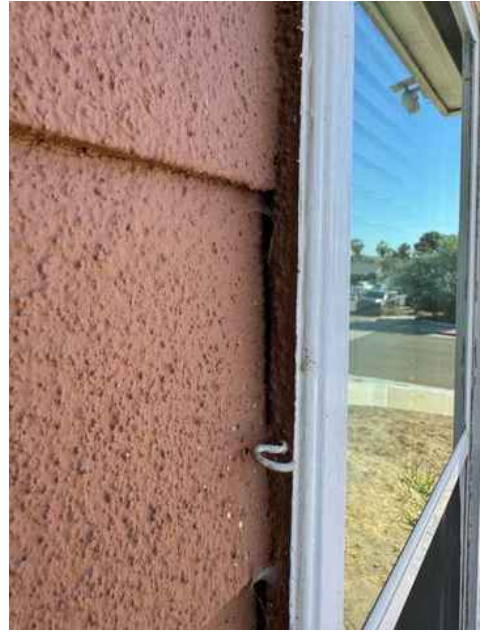
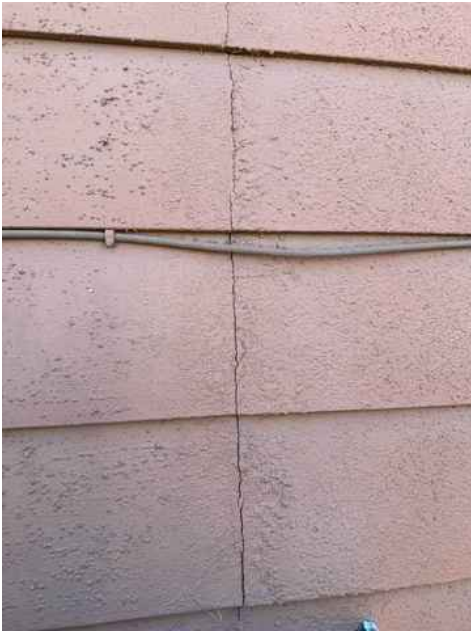
#### 4.4.2 Exterior Walls / Trim

### CAULKING/SEALANT NEEDED

#### Recommendation

Contact a handyman or DIY project

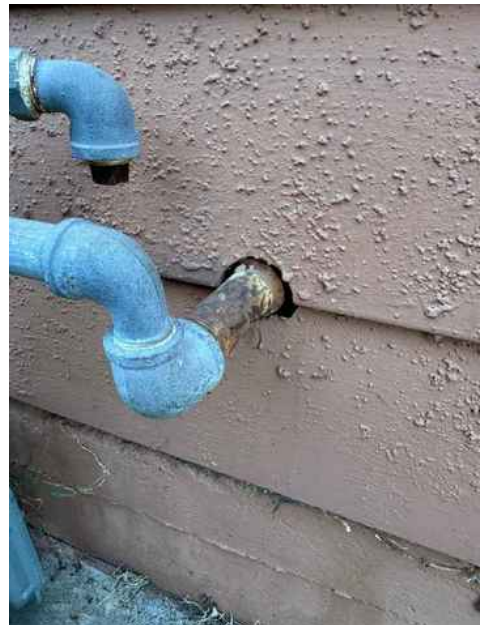
#### 4.4.3 Exterior Walls / Trim

##### **HOLES / GAPS**

Attention Required

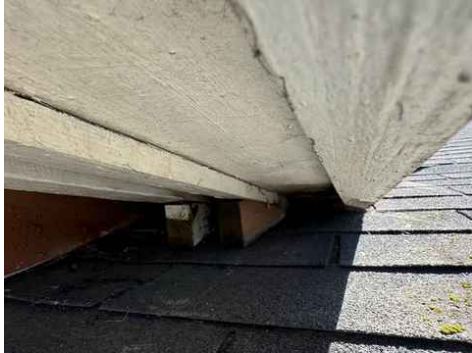
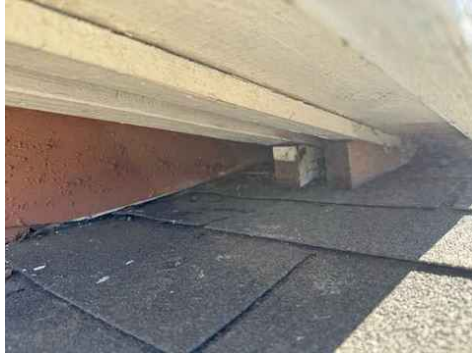
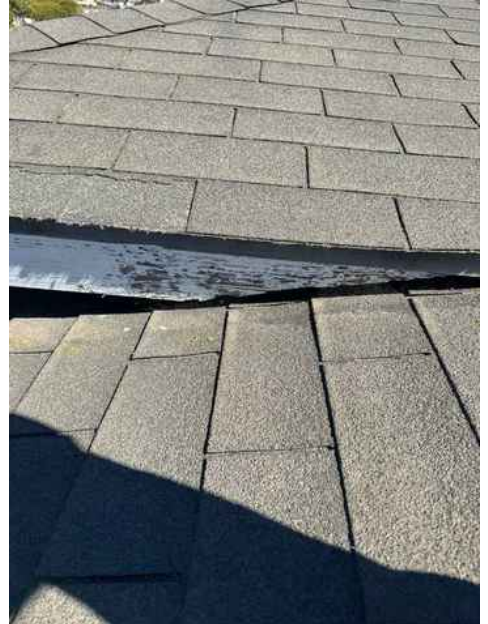
## 4.4.4 Exterior Walls / Trim

**UNFINISHED WOOD NOTED**

**Attention Required**

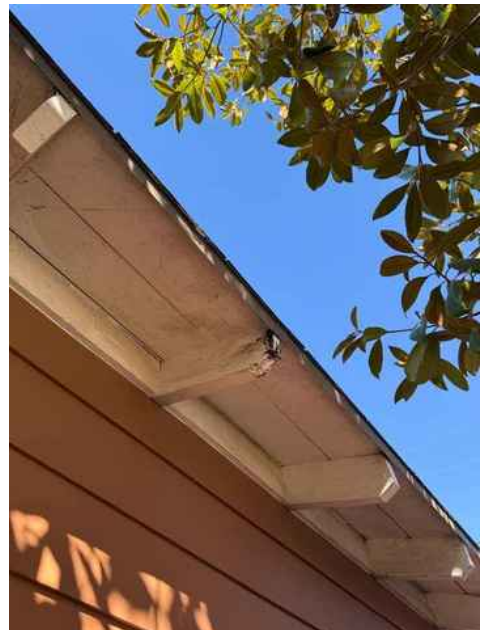
## 4.5.1 Eaves / Soffits

**TERMITE DAMAGE**

**Attention Required**

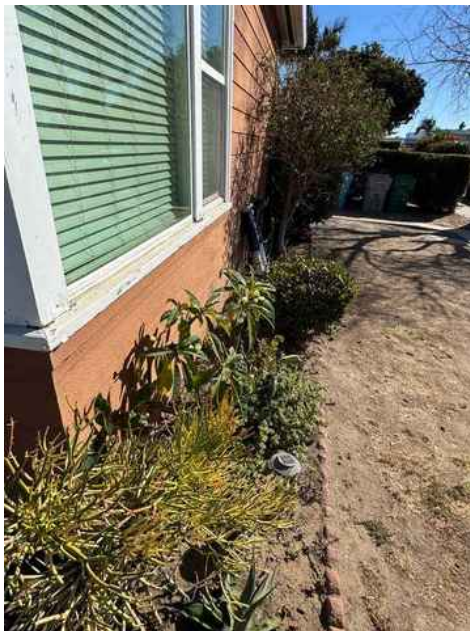
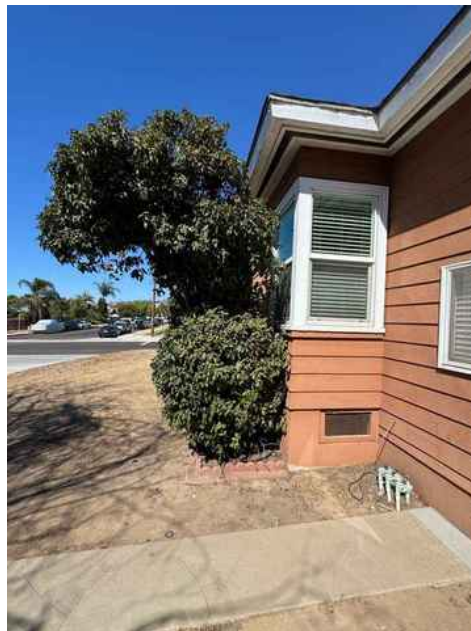
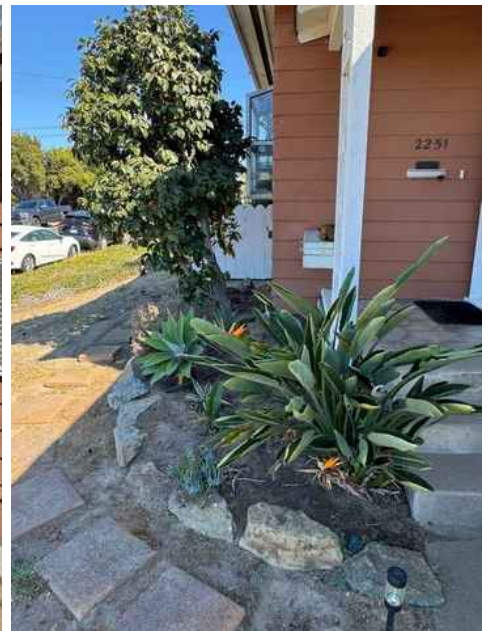
## 4.6.1 Vegetation

**TREE NEAR FOUNDATION**

## Recommendation

Contact a handyman or DIY project

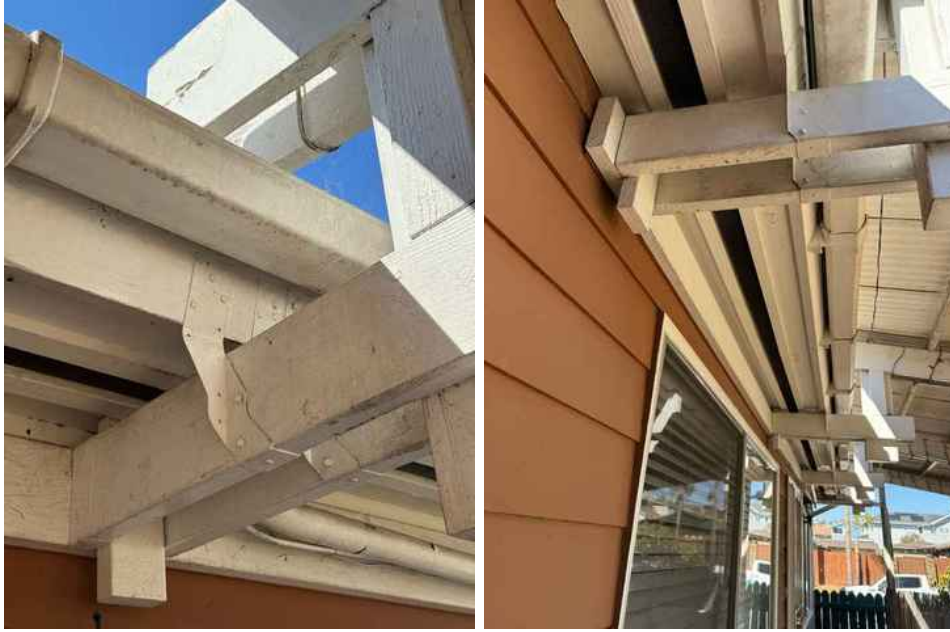
## 4.7.1 Patio Cover(s) / Trellis(es)

**IMPROPER ATTACHMENT**

## Recommendation

Contact a qualified professional.

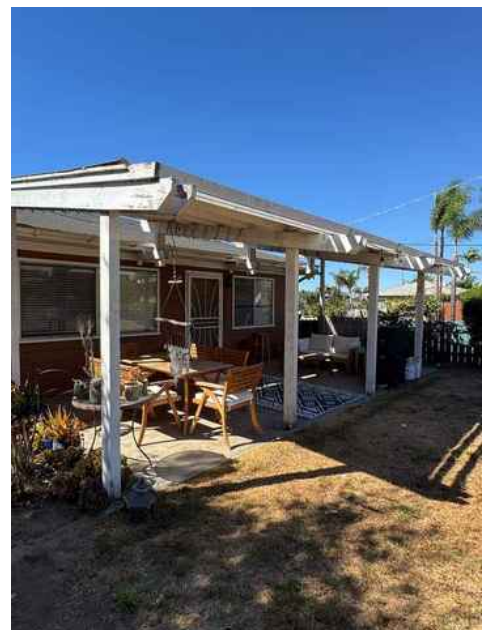
## 4.7.2 Patio Cover(s) / Trellis(es)

**NO METAL FLASHING VISIBLE**

Defective/Safety Hazard

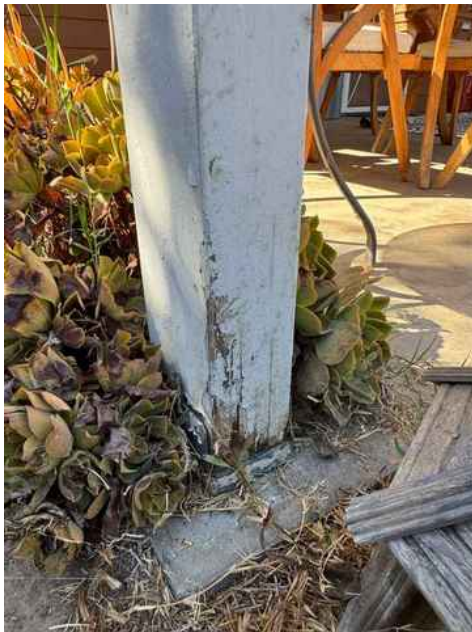
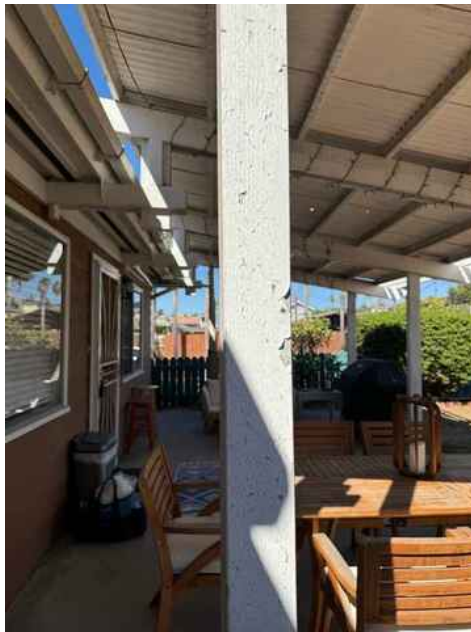
**NEEDS PAINTING / MAINTENANCE**

Patio cover surfaces were overdue for normal painting / maintenance. A qualified professional is recommended to clean and preserve as necessary.

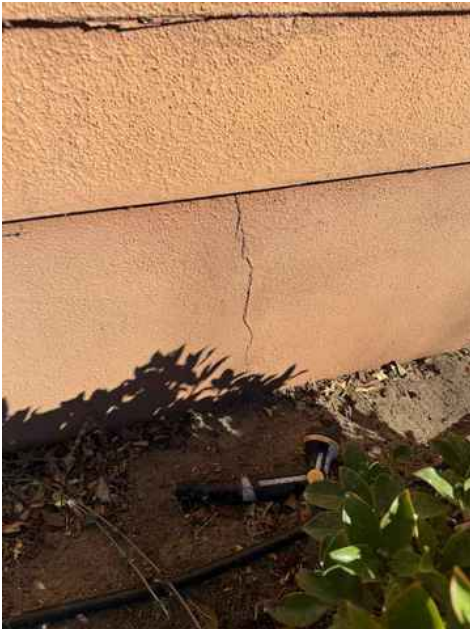
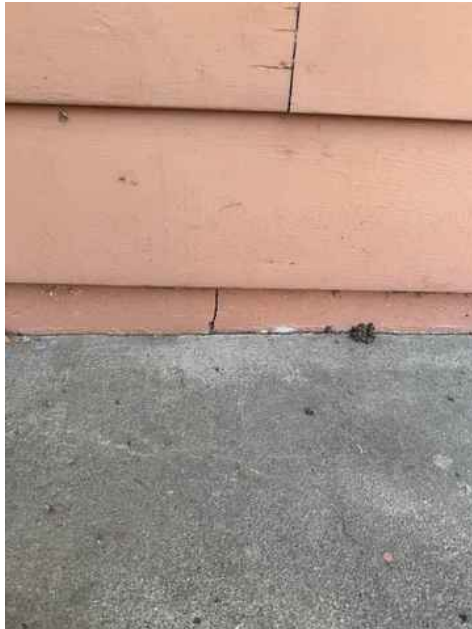
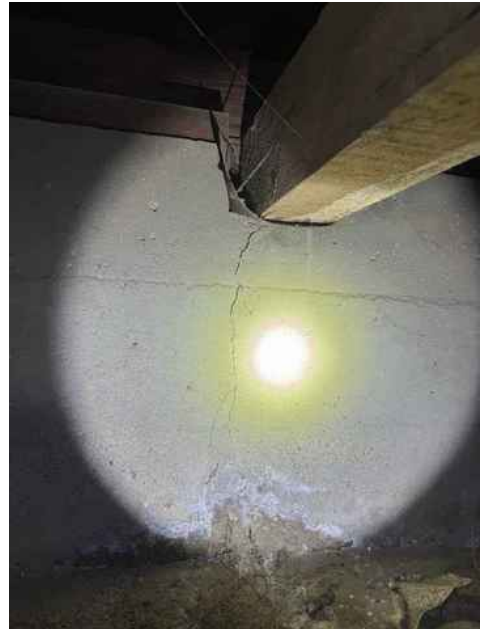
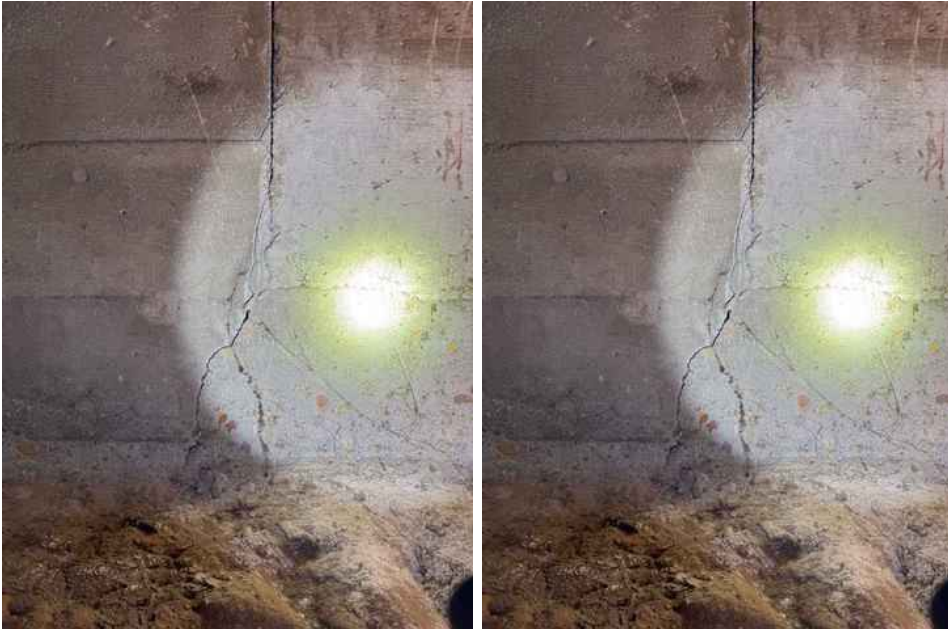
### 5.2.2 Foundation

#### **SPALLING/DETERIORATION**

Spalling/deterioration was noted at the foundation stem walls in one or more location. This is often indicative of age or prolonged moisture issues. Recommend further evaluation by a licensed foundation contractor prior to the end of your contingency period to determine if corrections are needed at this time.

Contact a qualified professional.

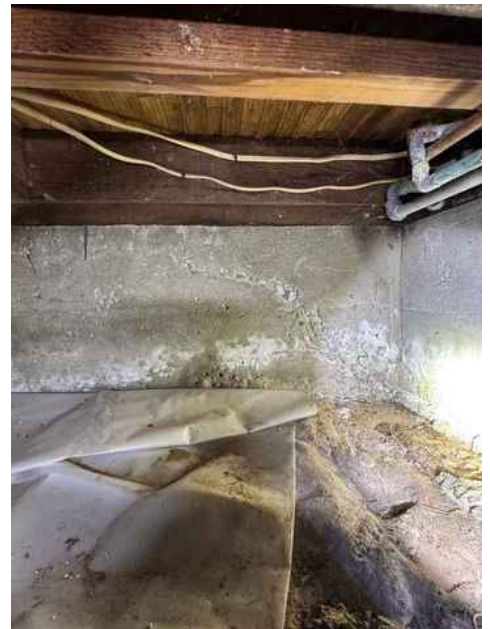
### 5.2.3 Foundation

#### **PIERS/POSTS NOT STRAPPED**

The posts and piers are not strapped or braced. While this condition may have been acceptable at the time of original construction, it does not meet current building standards. Installing metal straps or connectors to secure the posts to the piers could improve the overall stability and longevity of the foundation. Evaluation by a qualified foundation contractor is recommended to review this condition and discuss potential repairs or upgrades.

Contact a foundation contractor.

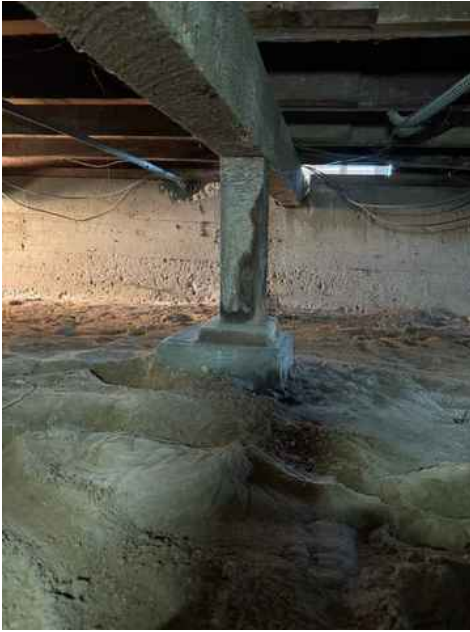
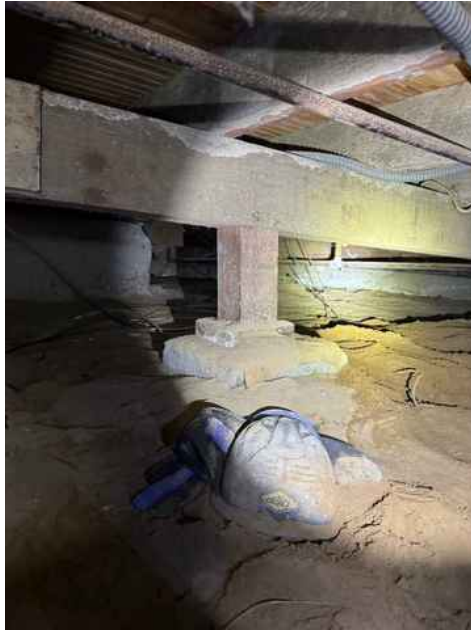
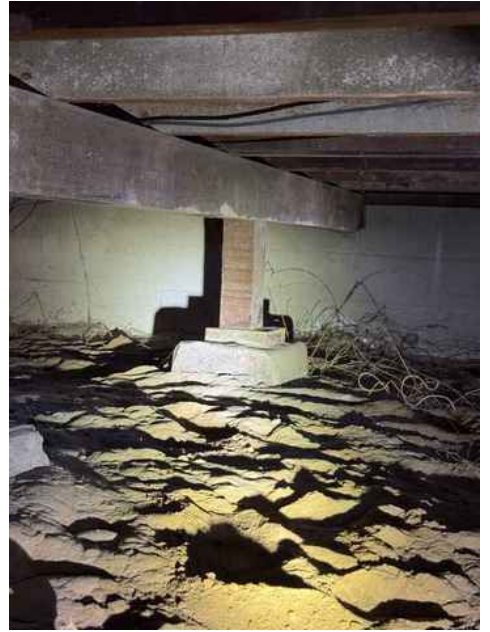
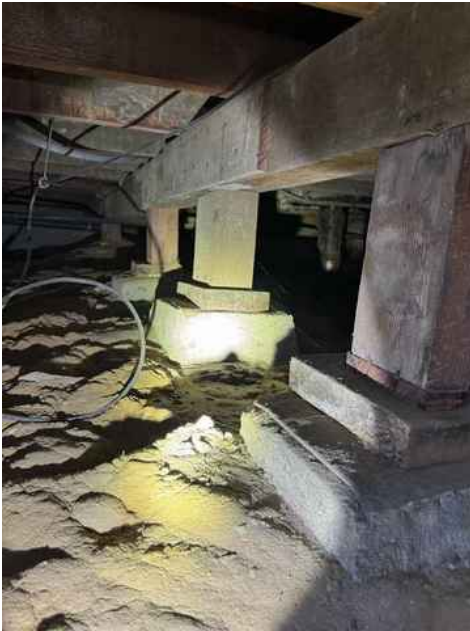
#### 5.2.4 Foundation

##### **PIER/POST SHIFTED**

One or more concrete pier appeared to be shifted beneath it's wood post. A qualified foundation contractor is recommended for further evaluation and repair. Adding metal straps to the pier and post may improve the overall stability and longevity of the home's foundation.

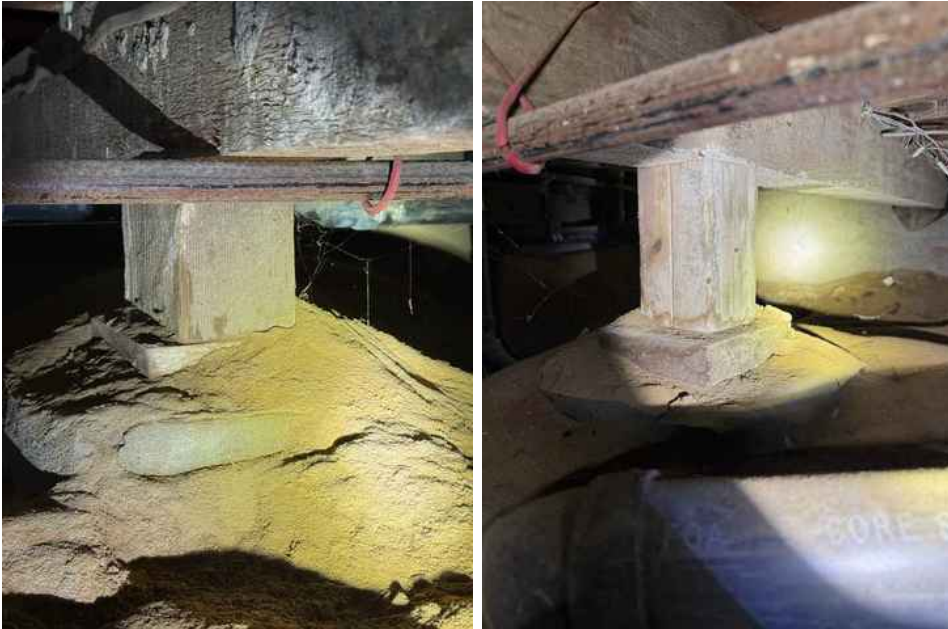
#### 5.2.6 Foundation

### STAINING ON POST

Moisture stains noted at one or more wood post. This is indicative of the crawlspace flooding. Moisture in the crawlspace can cause damage to the structure, attract wood destroying organisms and encourage mold growths. Recommend further evaluation by a licensed grading and drainage contractor and/or a licensed foundation contractor to determine repairs necessary at this time.

Contact a qualified professional.

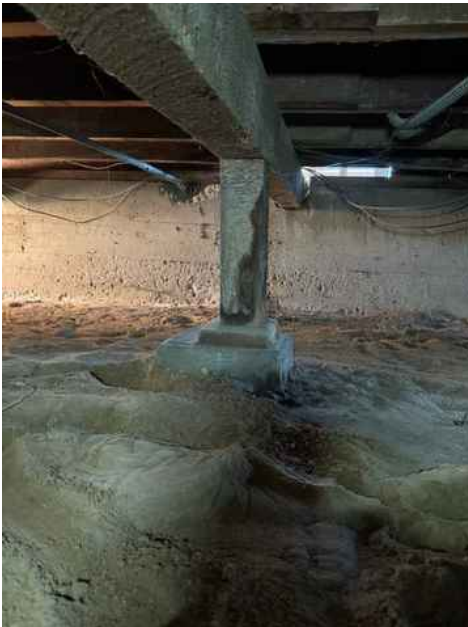
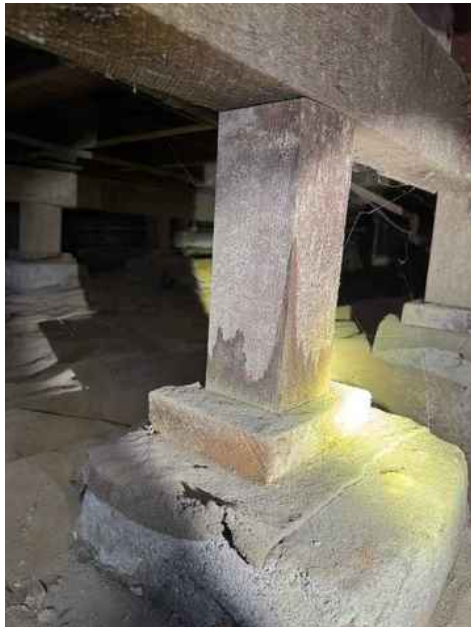
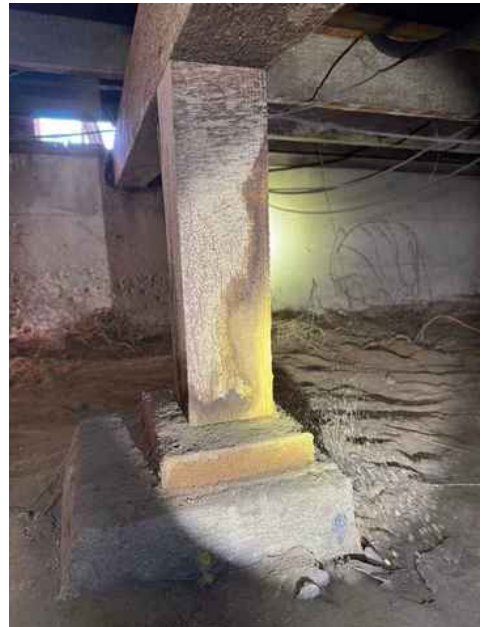
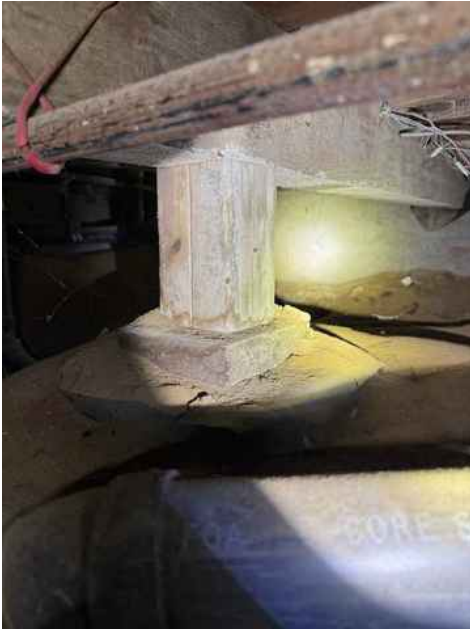
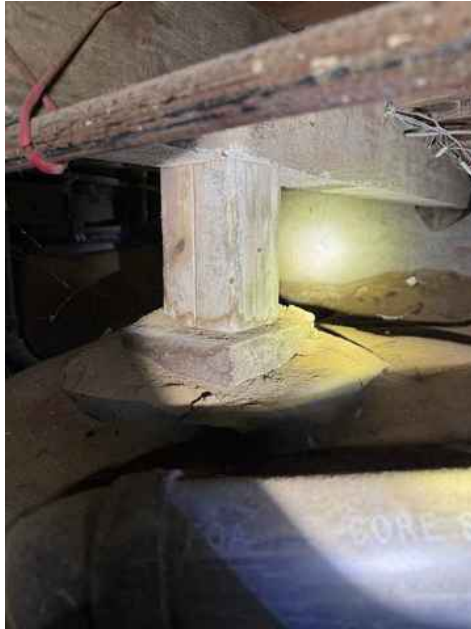
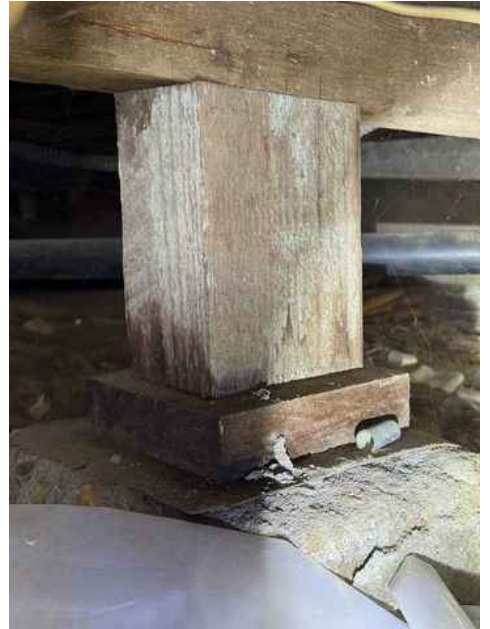
#### 5.2.7 Foundation

#### **DETERIORATION / CRACKS NOTED**

Cracks and or deterioration were noted in one or more areas. Determining the significance of this is beyond the scope of this inspection. Further evaluation is recommended by a qualified contractor.

Contact a foundation contractor.

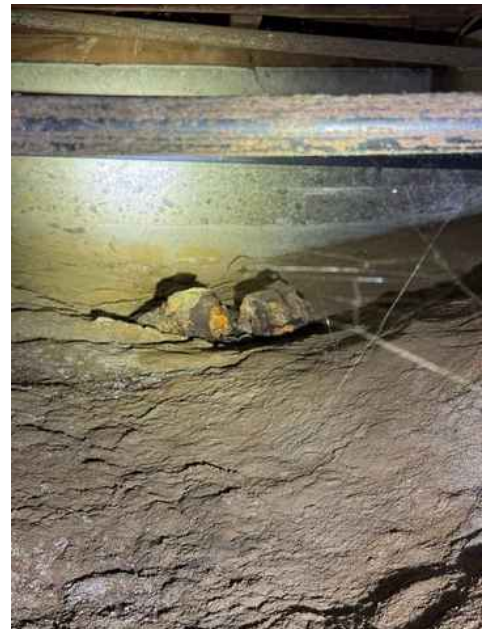
#### 5.3.1 Substructure / Framing

### ASK OWNER ABOUT REPAIRS

Evidence of prior repairs were found in the crawl space. Recommend asking the property owner about the repairs (e.g. why necessary, whether prior leaks have occurred).

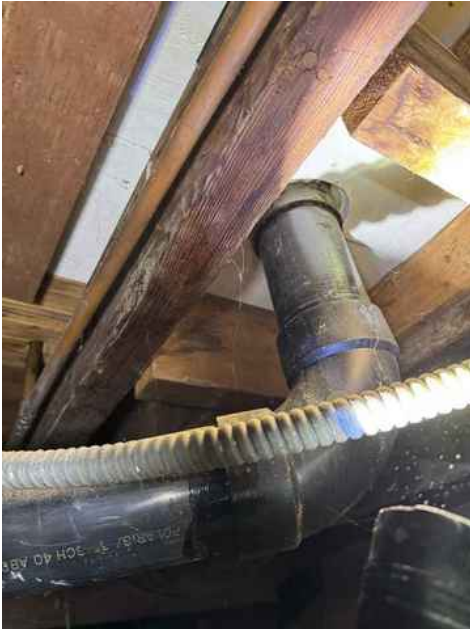
### 5.3.2 Substructure / Framing

#### **MOISTURE STAINS NOTED - DRY**

Stains were noted in one or more areas. These should be checked by a pest control professional to see if any damage is present which should be repaired. The area tested dry at the time of the inspection and appears to be from a past issue. Monitoring this area appears necessary to ensure no leaks are present.

Recommend monitoring.

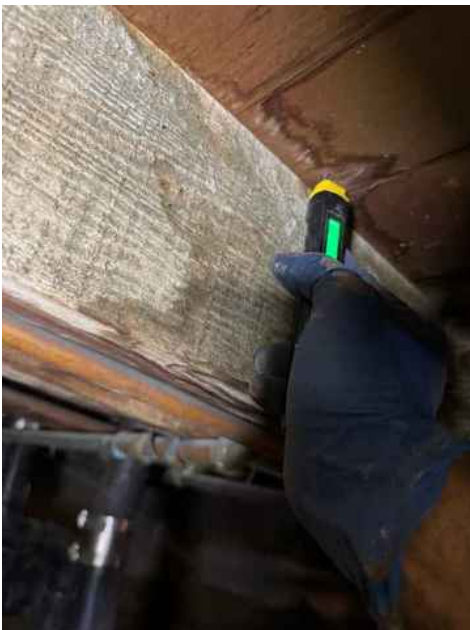
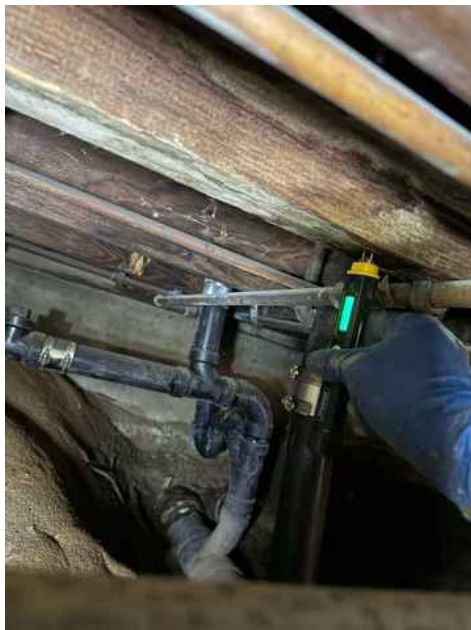
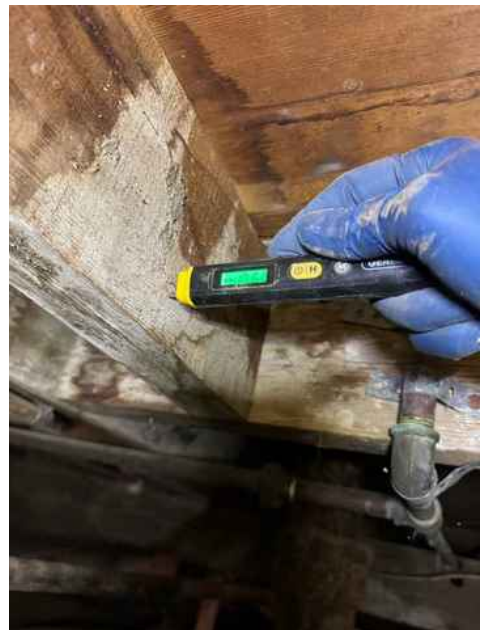
### 5.3.3 Substructure / Framing

#### **SHIMS NOTED**

Shims were noted in one or more areas. Some shimming is typical but excessive shims are sometimes used to improve poor workmanship. Further evaluation may be desired.

Contact a qualified professional.

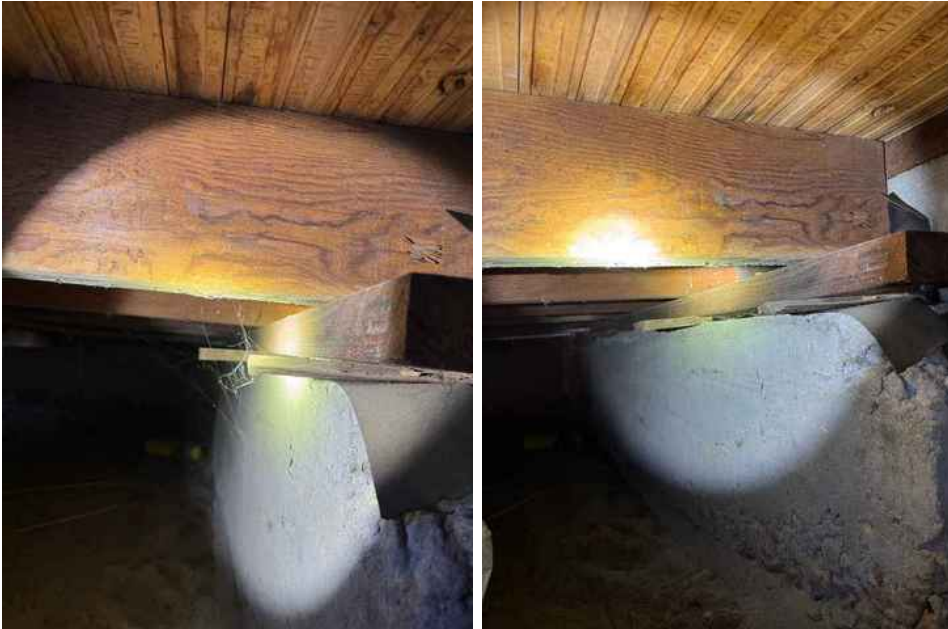
#### 5.4.1 Insulation/Ventilation

### **NO INSULATION UNDER FLOOR**

No insulation was installed under the floor in the crawl space. A qualified professional is recommended to install insulation for improved energy efficiency and per today's standards. Typically this is R-19 rated fiberglass blanket with the attached facing installed against the warm side (towards living space).

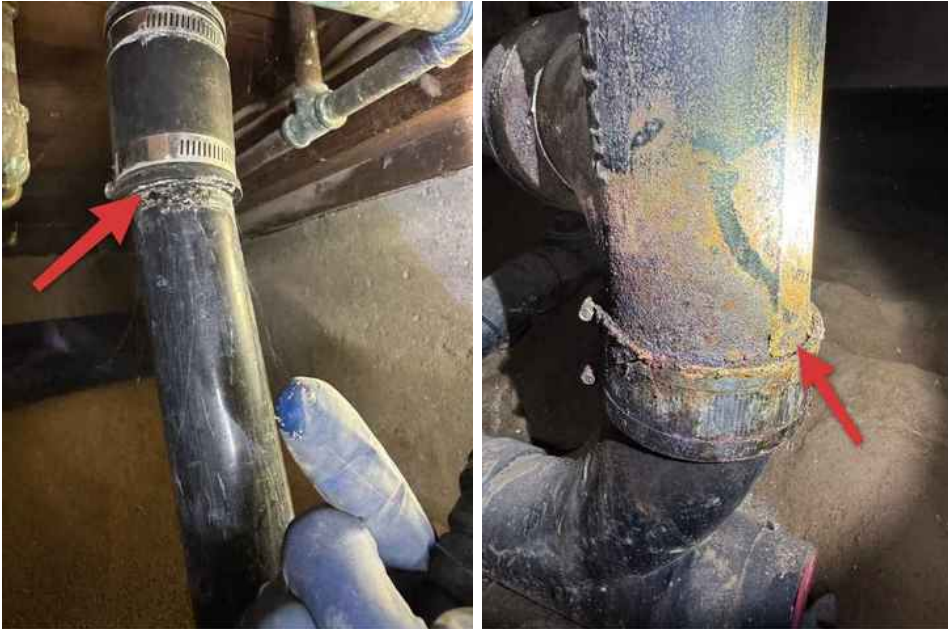
#### 5.5.2 Moisture Intrusion

##### **EFFLORESCENCE NOTED**

White efflorescence (powder substance) on concrete wall indicates moisture is in contact with the masonry. This does not necessarily indicate that intrusion will occur. Efflorescence is found on many homes without water intrusion occurring inside the home. But, it should alert you to the possibility that future steps may be needed. This is typically a result of over watering, poor downspout termination points or improper site drainage. Advise further evaluation and repairs as needed by a qualified foundation contractor, landscape contractor, waterproofing contractor and/or grading and drainage contractor to determine repairs necessary at this time. I also recommend installing gutters if this home is not currently equipped with them.

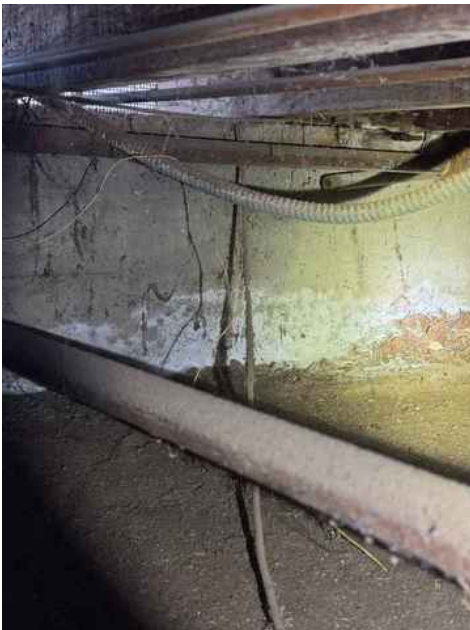
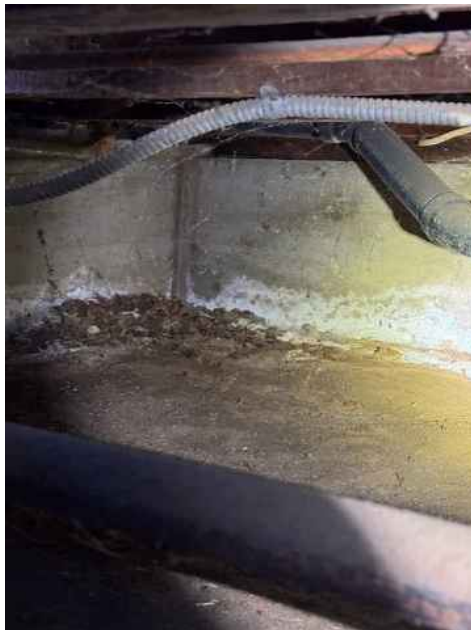
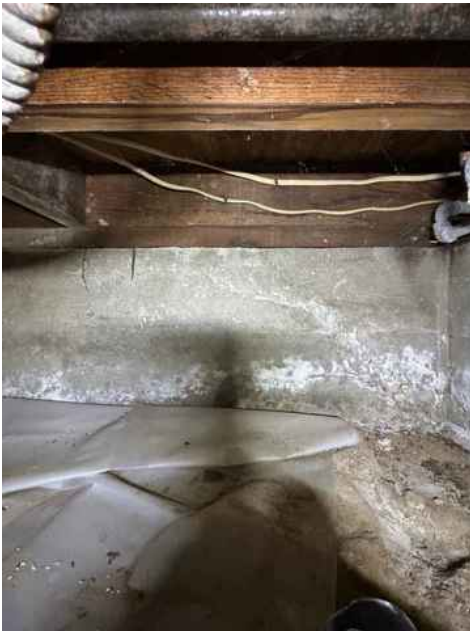
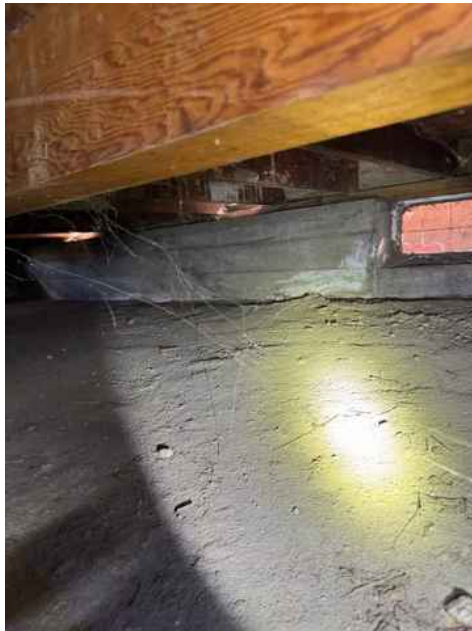
### 5.5.3 Moisture Intrusion

#### **CRACKED SOIL NOTED**

Cracks were noted in the soil under the house which can be an indication of expansive soil (clay based). This makes it extremely important to get the water away from the structure and further evaluation may be desired.

Contact a qualified professional.
