## KEEN EYE HOME INSPECTION REPORT

2251 Chicago St  
San Diego, CA 92110

Shaylie Fraser  
10/03/2026

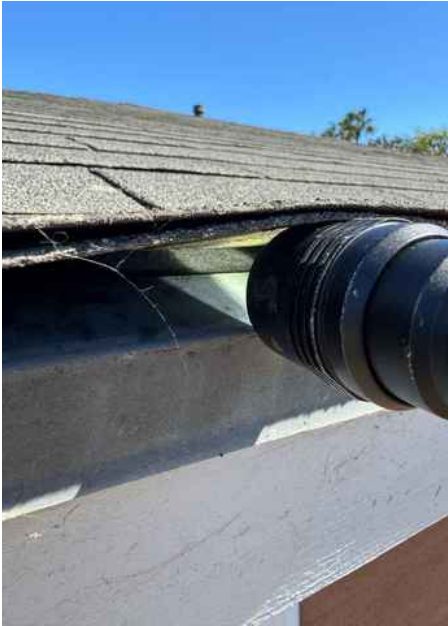
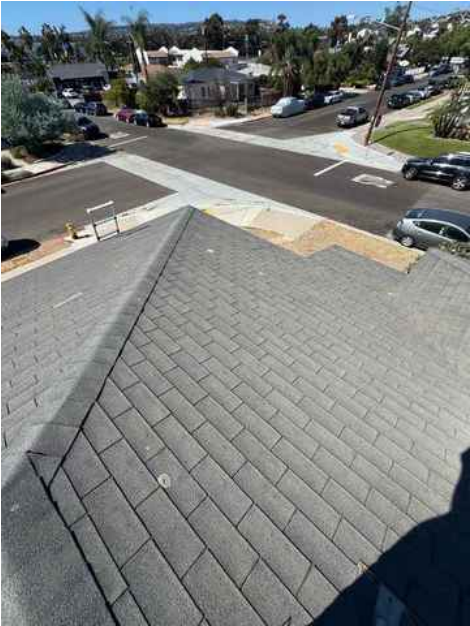
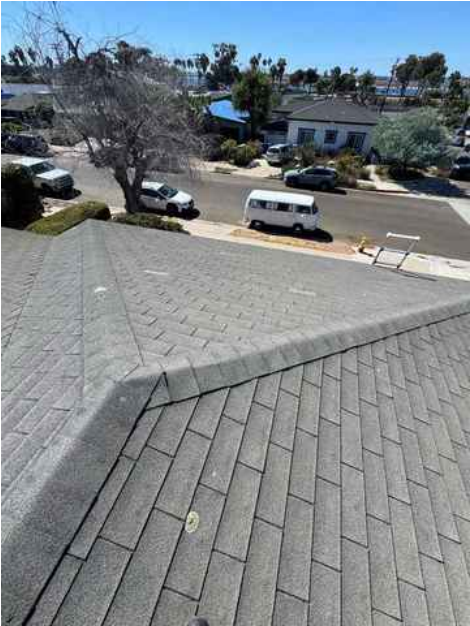
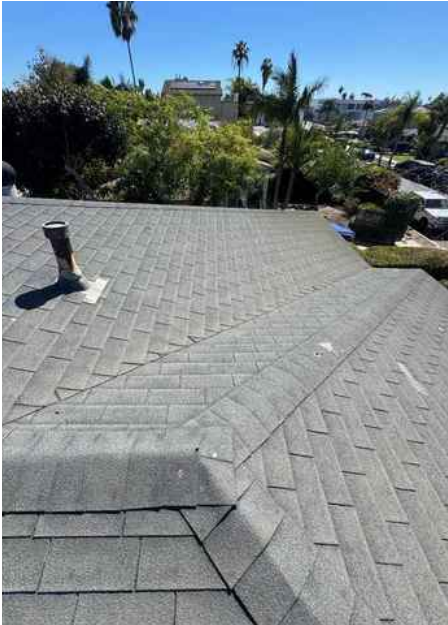
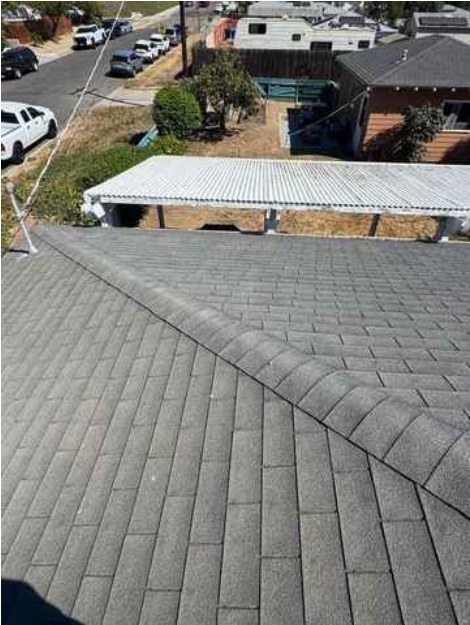
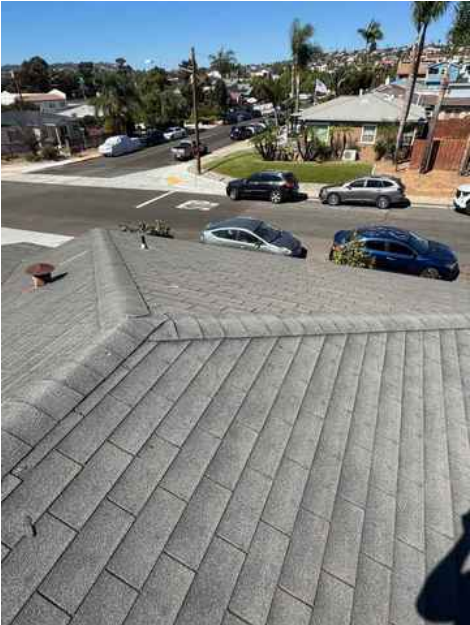
**General: View of Roof**  
View of roof.

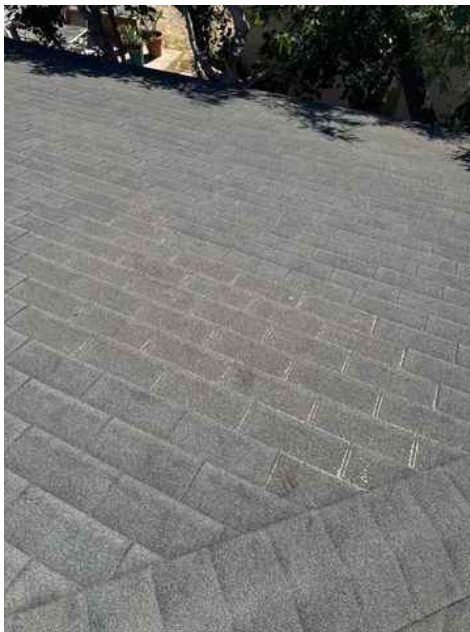
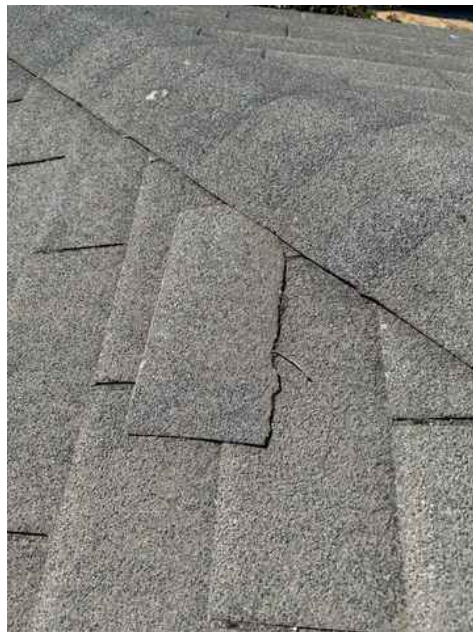
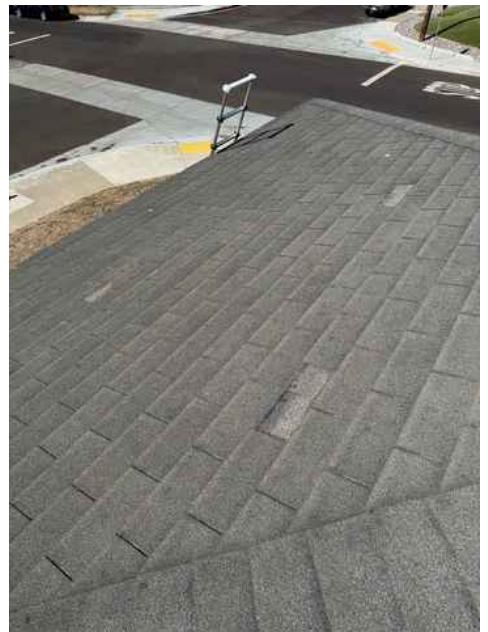
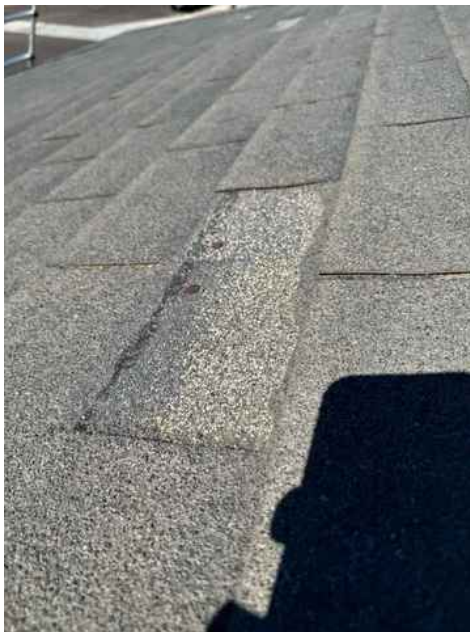
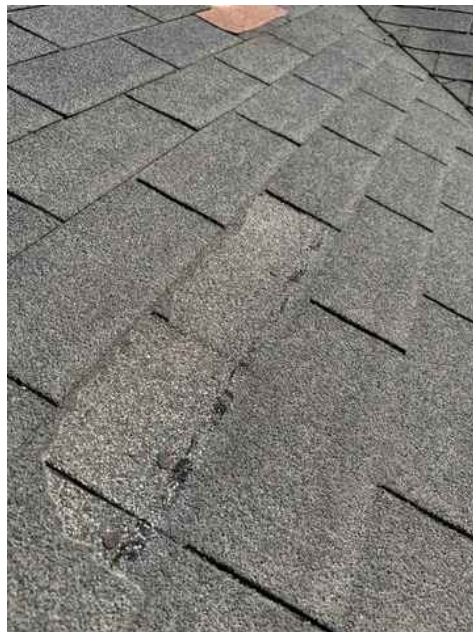
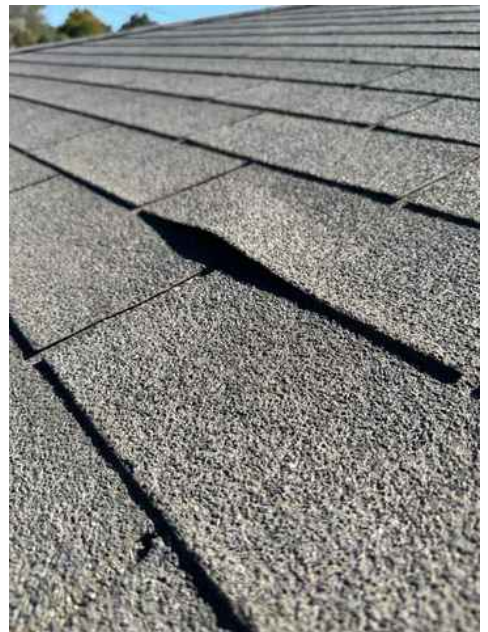
### MULTIPLE ISSUES NOTED

Multiple issues were noted on the roof. A qualified tradesperson is recommended for further evaluation of the entire roof and to make repairs as needed. The inspector noted the following issues that need repair.

1. Damaged and lifted shingles noted at multiple areas of the roof.
2. Improper roof penetrations and exposed fasteners throughout.
3. Roof penetrations in need of maintenance. Soft spots near one or more roof penetrations.
4. Flashing not properly installed at roof to wall. Lifted and rusting flashing.
5. Vinyl gutters in need of maintenance. Heavily back up.
6. Trees / vegetation in proximity of roof. Routine maintenance is advised.
7. Moss growth of roof.
8. Leaves / debris on roof.
9. Partial Gutters noted for roofing system.

Contact a qualified professional.

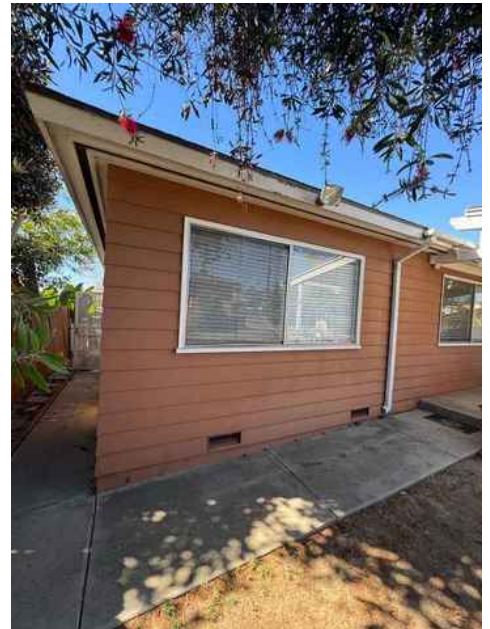
**PARTIAL GUTTERS NOTED**

A partial gutter system was noted. A qualified professional is recommended to add full gutters for improved drainage.

Contact a qualified professional.

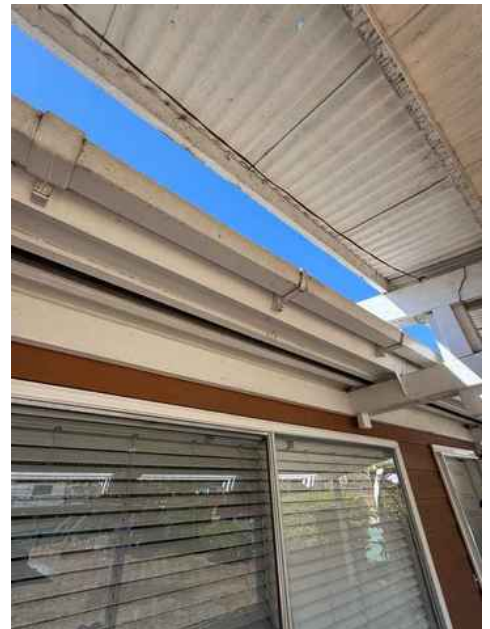
## 6.5.2 Roof Drainage Systems

Plastic or vinyl gutters are not recommended because they have a short life span. The gutters were damaged, separated and/or substandard.

Contact a handyman or DIY project

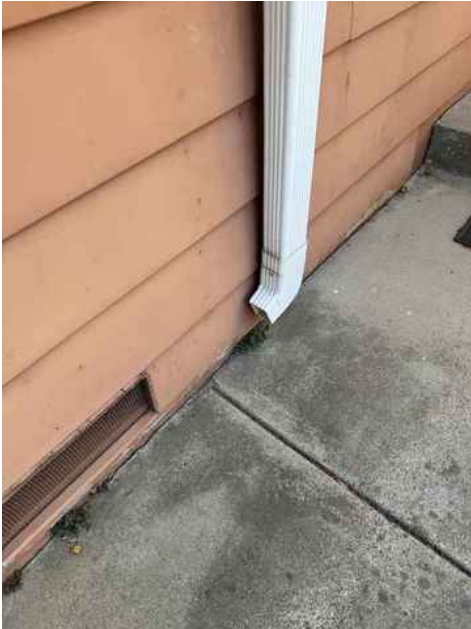
## 6.5.3 Roof Drainage Systems

The routing of the gutter drains appears to be assisting in the dampness noted in the front unit crawl space. A qualified licensed contractor is recommended to evaluate and estimate repairs.

Contact a qualified professional.

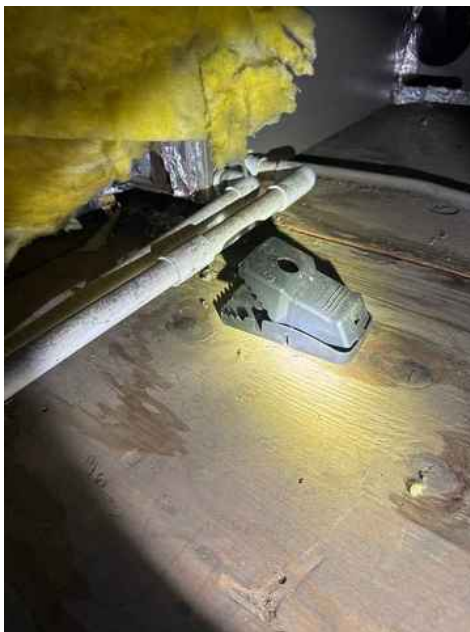
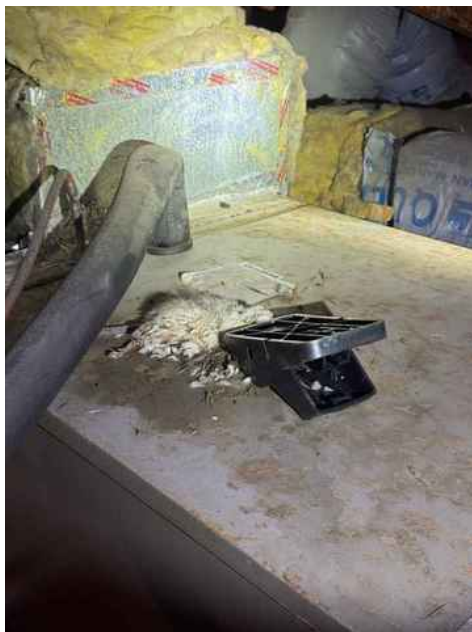
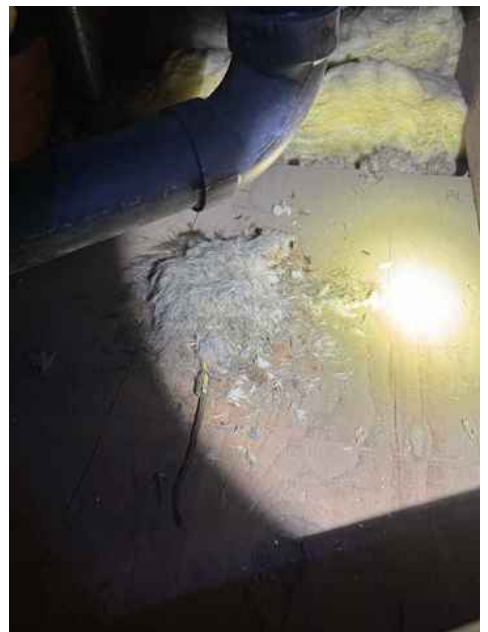
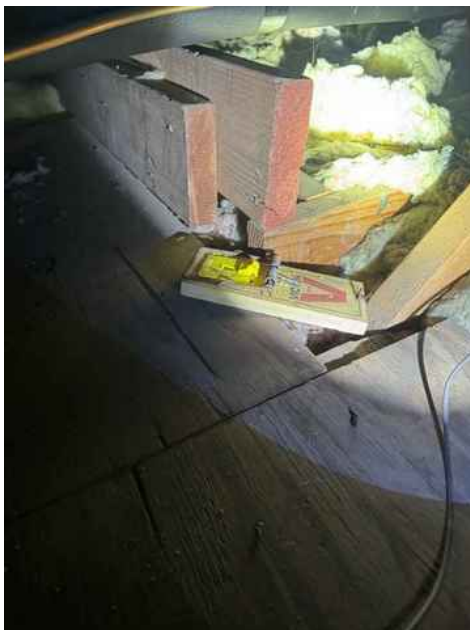
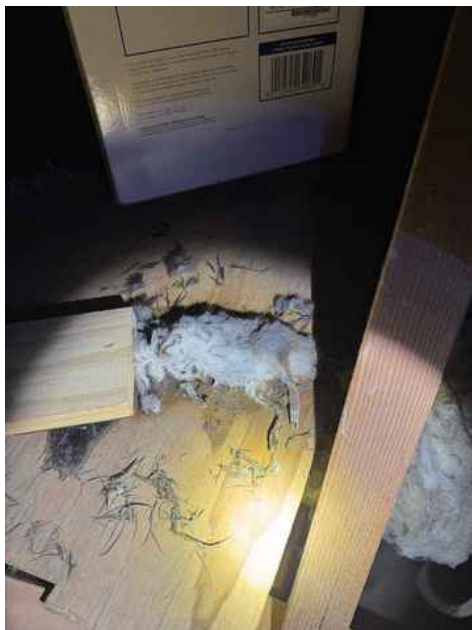
#### RODENT ACTIVITY NOTED

Evidence of rodent activity (traps and/or droppings) was found in one or more locations. If present, pests may chew, damage or contaminate insulation, wiring and/or ductwork. Repairs may be needed to seal openings around exterior to prevent pest intrusion. A qualified pest control professional is recommended for further evaluation and removal of any pests or waste material; setting traps and sealing openings as needed.

Contact a qualified pest control specialist.

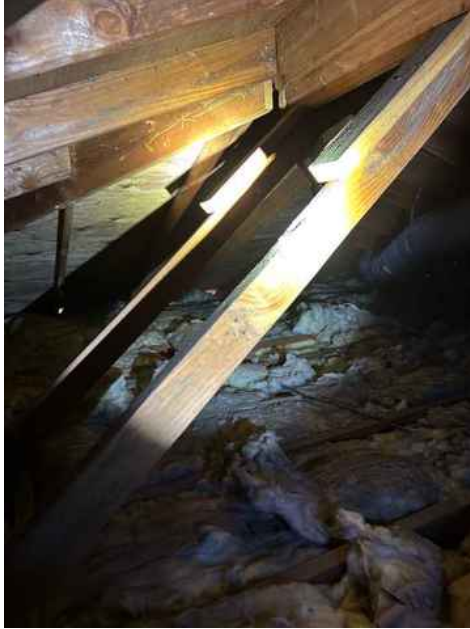
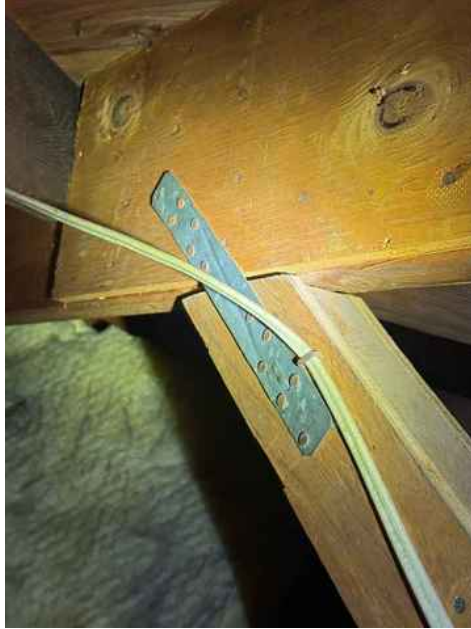
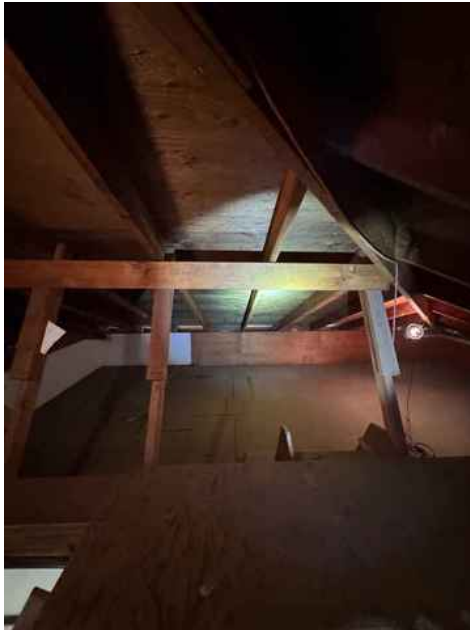
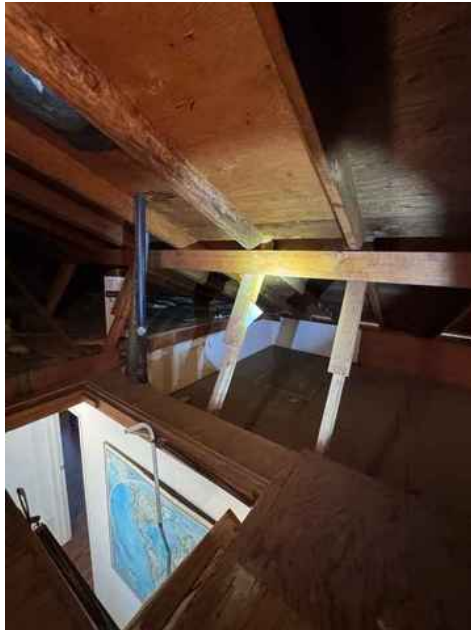
**ADDED FRAMING NOTED**

Added/altered framing was noted in one or more areas. It is unknown if these alterations were permitted and inspected. Inquire with the seller for more information. A qualified professional should be considered for further evaluation.

Contact a qualified professional.

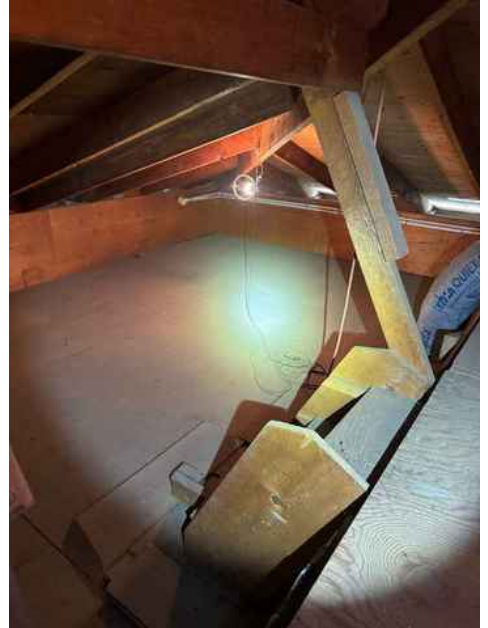
**INSULATION MISSING**

Attic insulation at one or more areas was missing. HVAC costs will likely be higher due to reduced energy efficiency. A qualified professional is recommended for installation and/or replacement of insulation as needed.

Contact a qualified insulation contractor.

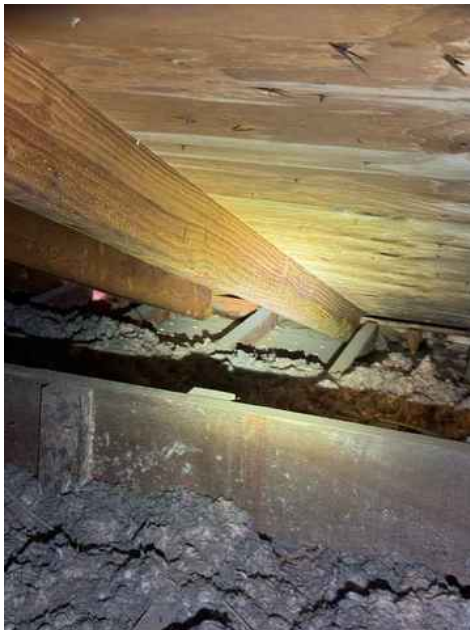
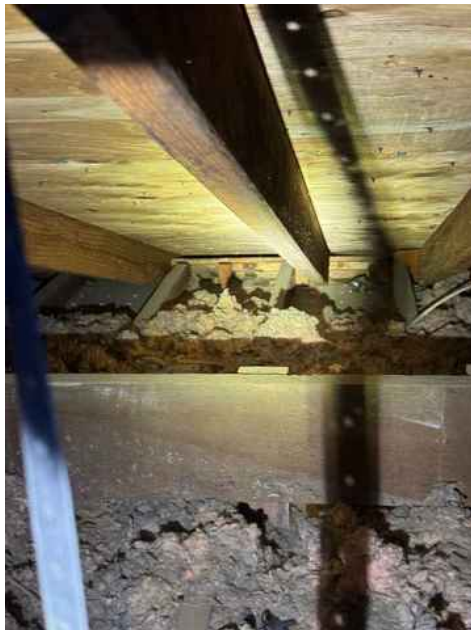
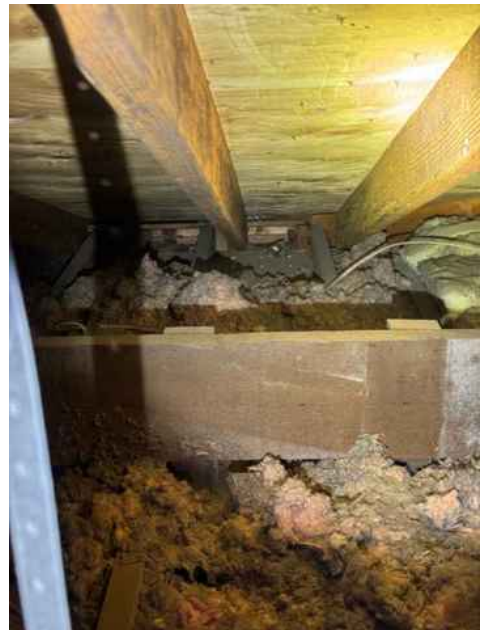
**SUBSTANDARD AND MISSING INSULATION**

## Recommendation

Contact a qualified insulation contractor.

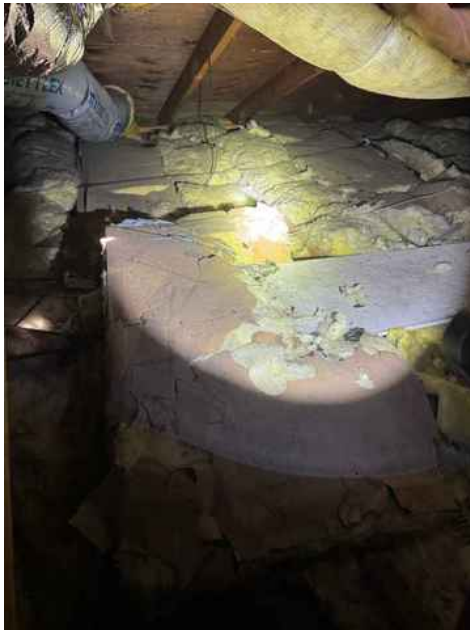
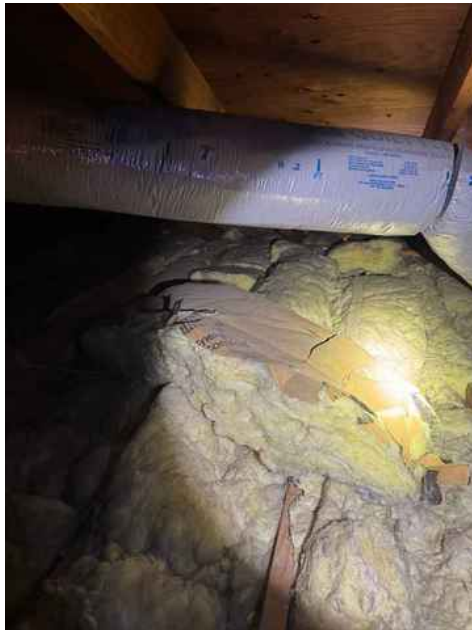
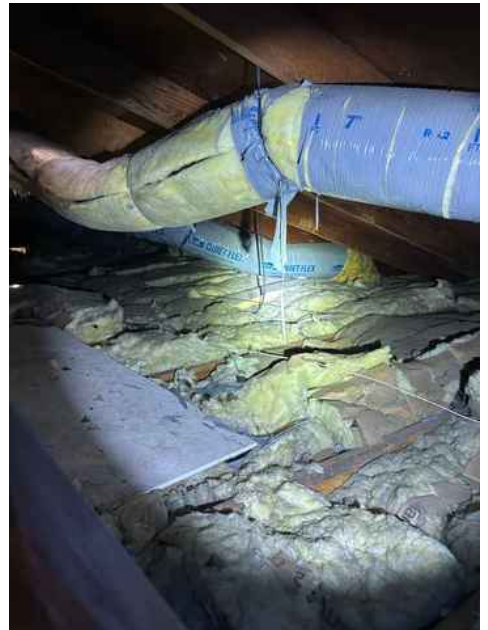
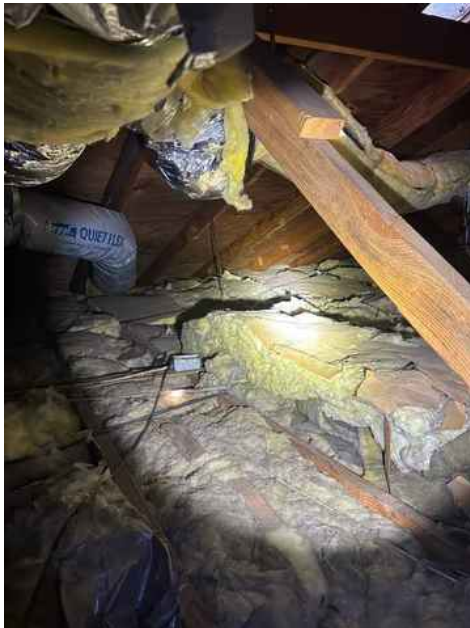
**INSULATION FACING EXPOSED**

The facing is generally flammable and is intended to be covered. It also acts as a vapour retarder, and on this side it can hold moisture in the assembly rather than letting it dry, which over time can support fungal growth or insect activity.

Recommendation: have a qualified insulation contractor reinstall the batts to the manufacturer's instructions, with the facing toward the conditioned space.

Contact a qualified professional.

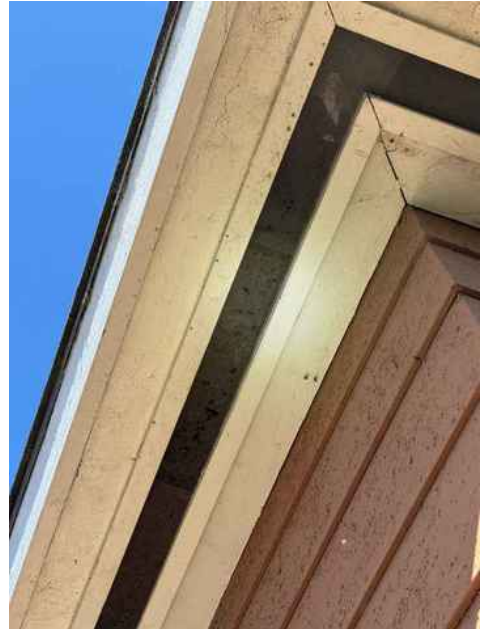
**VENT SCREENS DAMAGED**

One or more vent screens over attic vents and/or mechanical vents designed to keep rodents out were damaged. A qualified person is recommended to repair as needed.

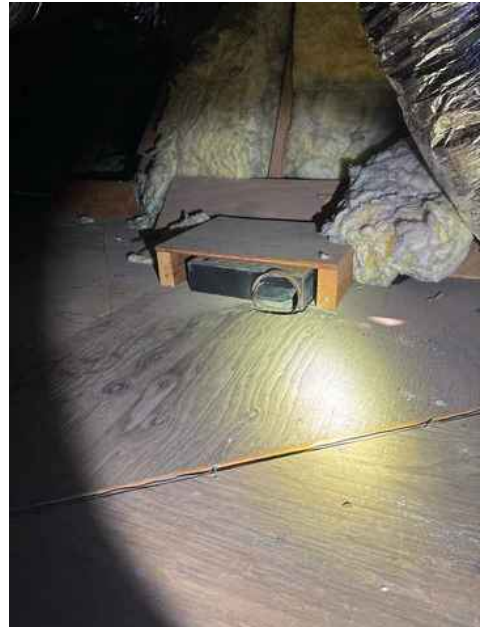
**BATHROOM VENT IMPROPER TERMINATION**

Bathroom fan vents into the attic at a roof vent at one or more areas. This condition can cause moisture issues. A qualified professional is recommended to make repairs to terminate exhaust fan at the exterior (roof/sidewall) to a dedicated vent assembly.

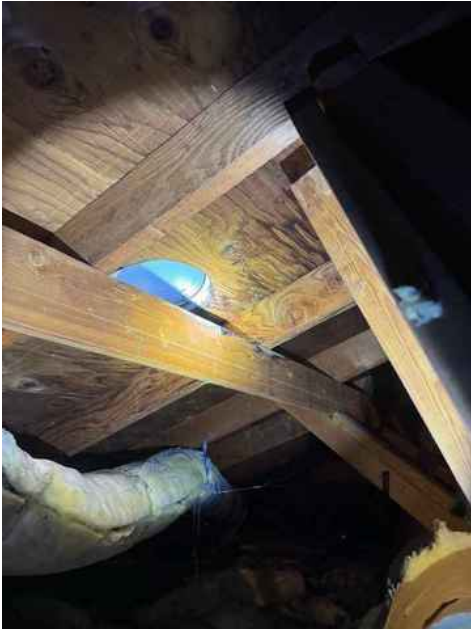
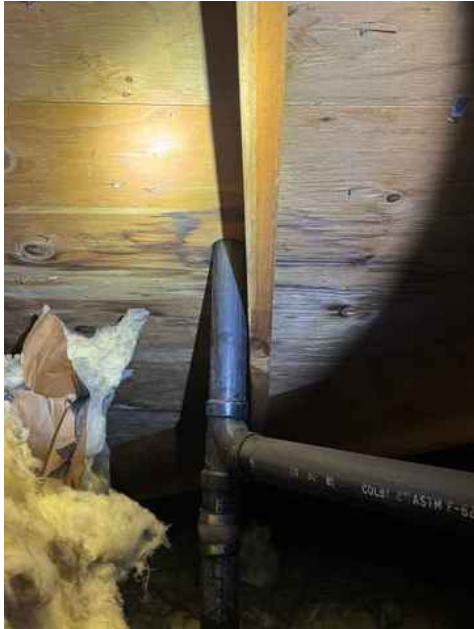
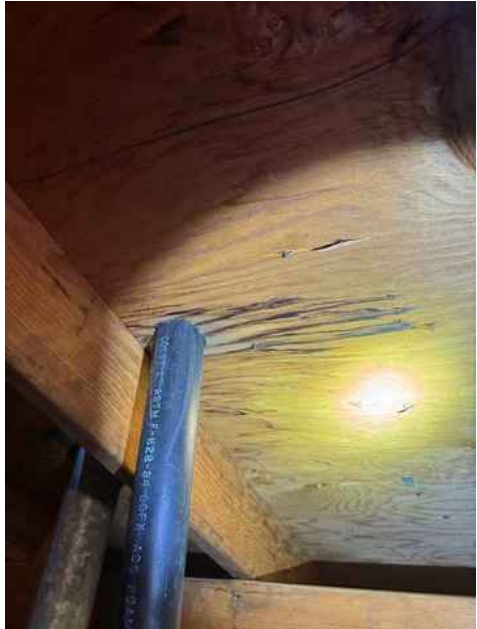
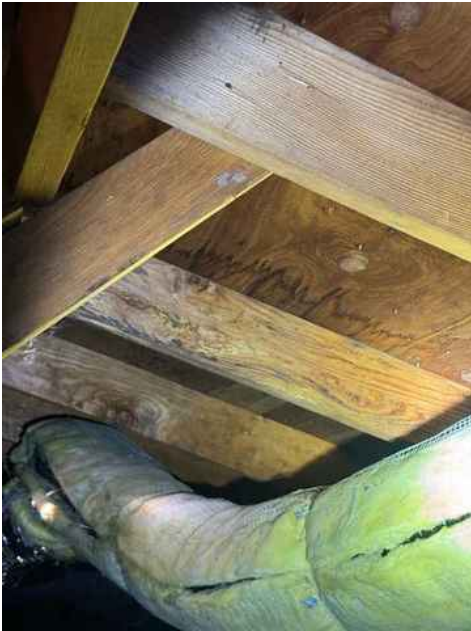
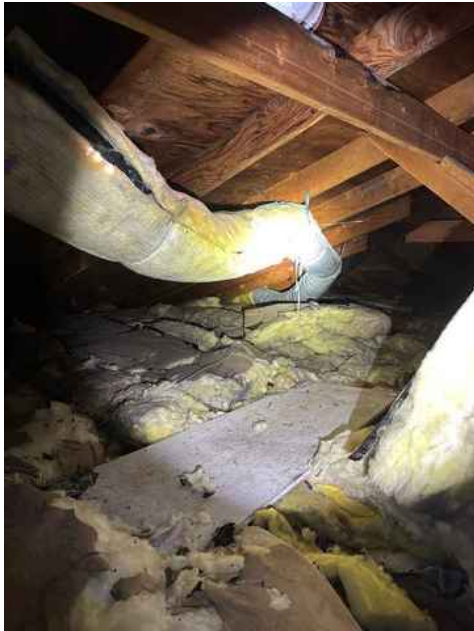
**STAINS NOTED**

Due to the age of the house and it having undergone roof surface change, stains were observed in the attic. It is not possible to determine which, if any, may be active roofing leaks. The consultation with a roofing contractor may be desired to verify that the roof is not actively leaking. It is beyond the scope of a visual inspection to determine if each individual area is watertight.

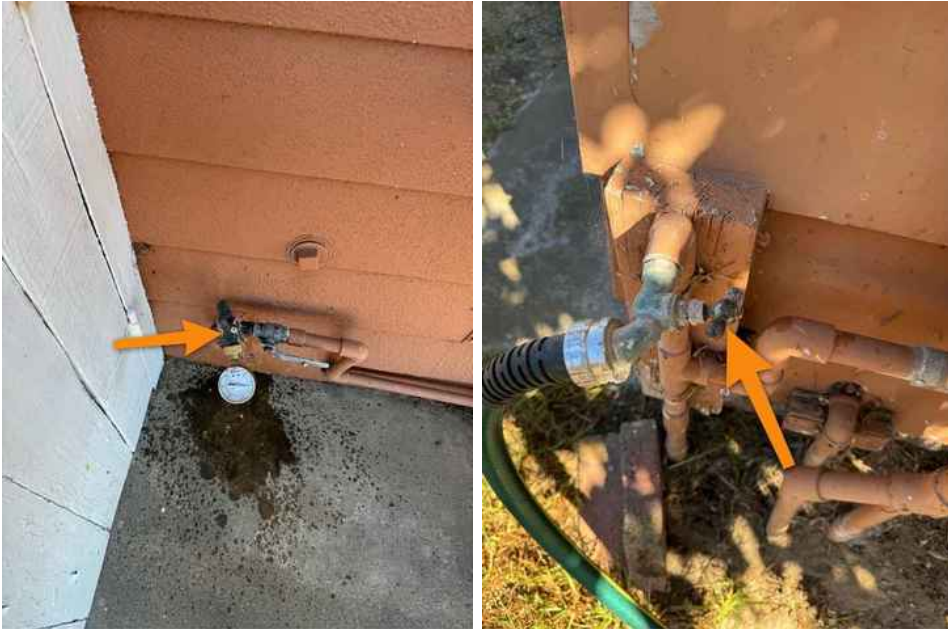
**HOSE BIB LEAKED WHILE ON**

One or more hose bibs (outside faucets) leaked while on. When hose bibs leak while turned on, it may be due to worn "packing" around the stem or a defective backflow prevention device. A qualified plumber is recommended to make repair as necessary.

Contact a qualified plumbing contractor.

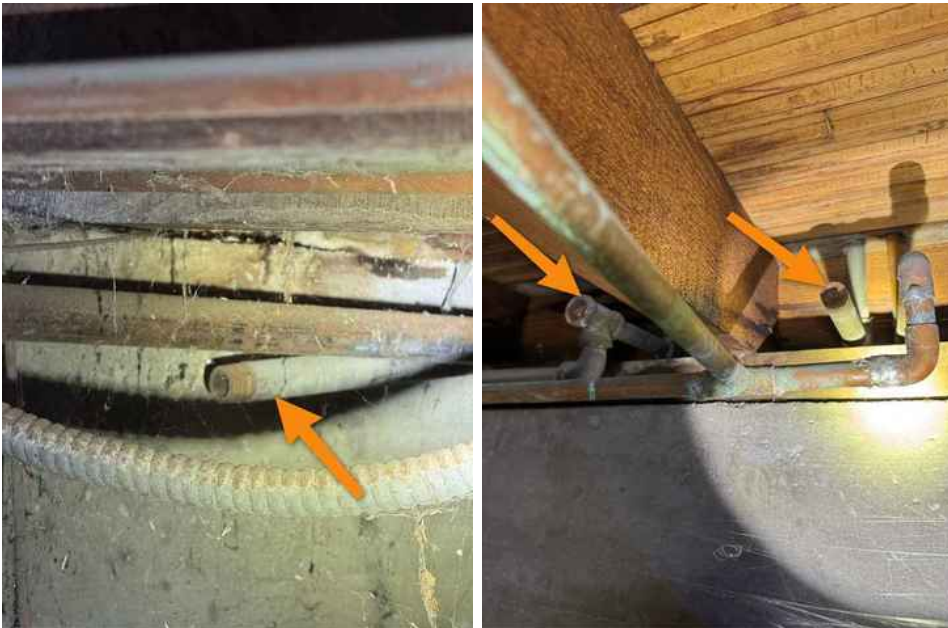
#### REPIPE NOTED

There is evidence that portions of the plumbing system have been replaced. However, it could not be determined whether the entire water supply system has been updated, as much of the piping is concealed within walls and ceilings. Buyers are encouraged to request documentation or receipts for any plumbing work performed from the seller, if available. In addition, reviewing city or county permit records may provide more detailed information regarding the extent of the plumbing modifications.

Contact a qualified plumbing contractor.

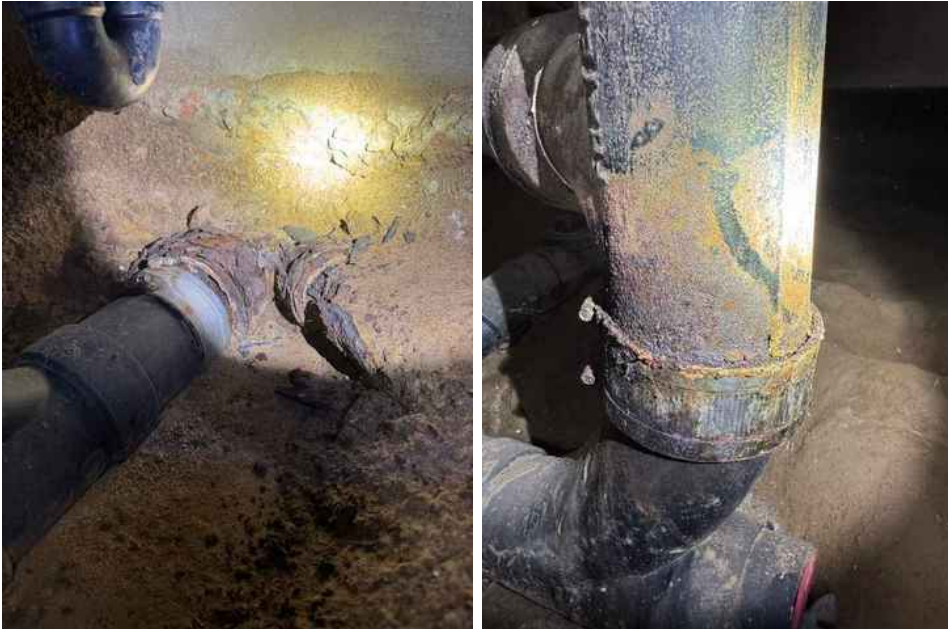
### CAST IRON CORRODED

Cast iron pipes are showing rust and corrosion due to age. They appear to be at the end of their useful life. A qualified plumbing contractor is recommended to determine repairs necessary at this time.

Contact a qualified professional.

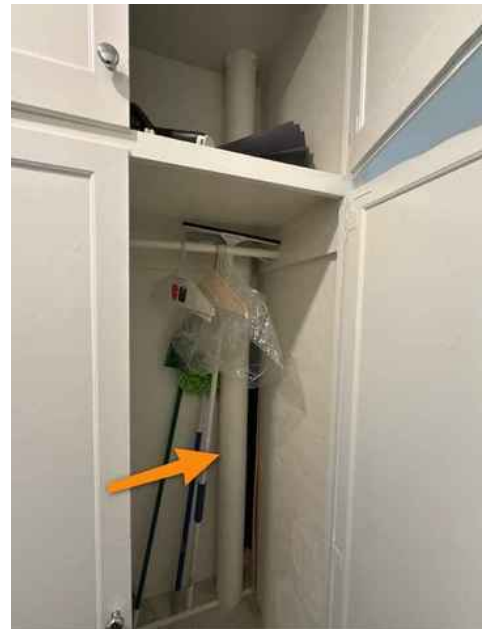
##### **TRANSITE VENT (KNOWN TO CONTAIN ASBESTOS)**

A Transite vent pipe was noted. Transite is a brand name of a vent which is known to contain asbestos but is fine in its current state. Removal of the Transite is recommended for added safety. A vent cap was missing which can let water into the structure. Correction is recommended.

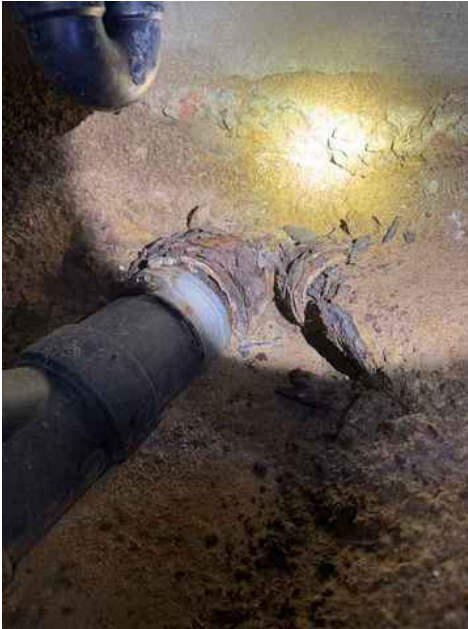
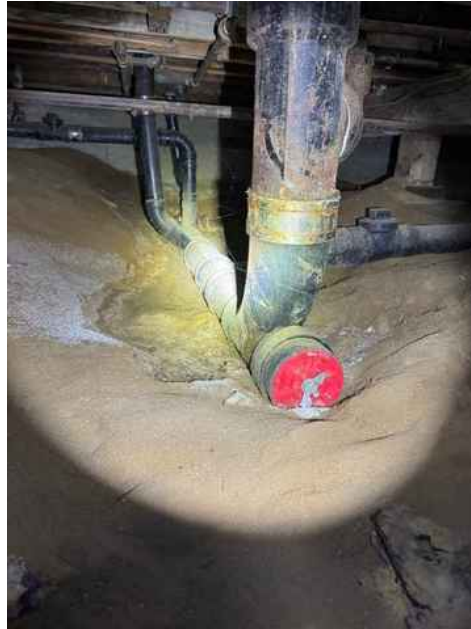
##### **RE-PIPED DRAIN NOTED**

There is evidence that part of the plumbing drain system was re-piped (newer lines noted or capped lines). Asking seller about this and/or have further evaluated by a qualified plumber to determine if any corrections are needed at this time is recommended.

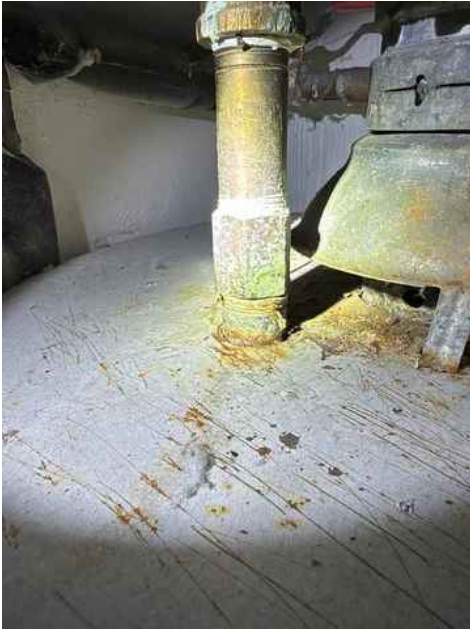
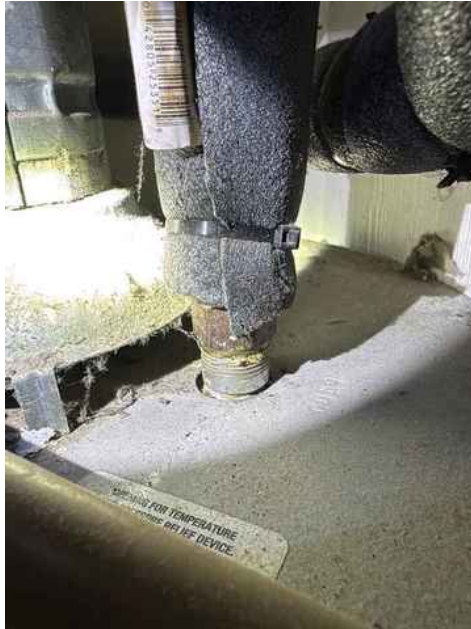
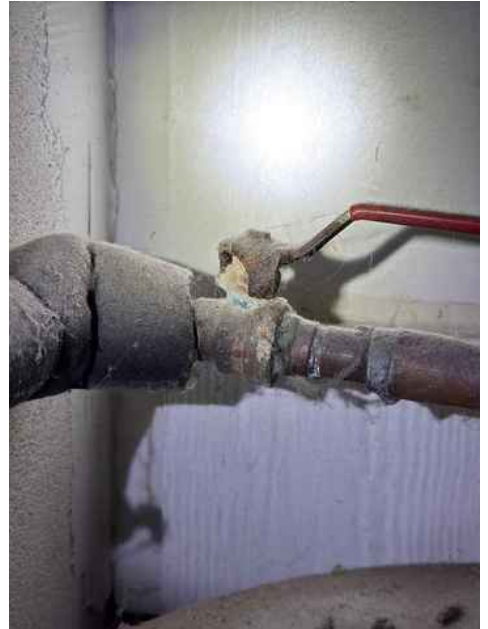
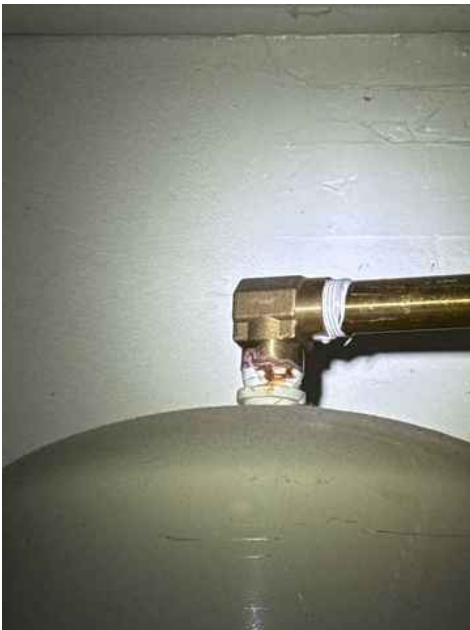
### FITTING CORROSION

One or more fittings on the water heater were corroded or rusted. This can indicate past leaks, or that leaks are likely to occur in the future. A qualified plumber is recommended for repair.

Contact a qualified plumbing contractor.

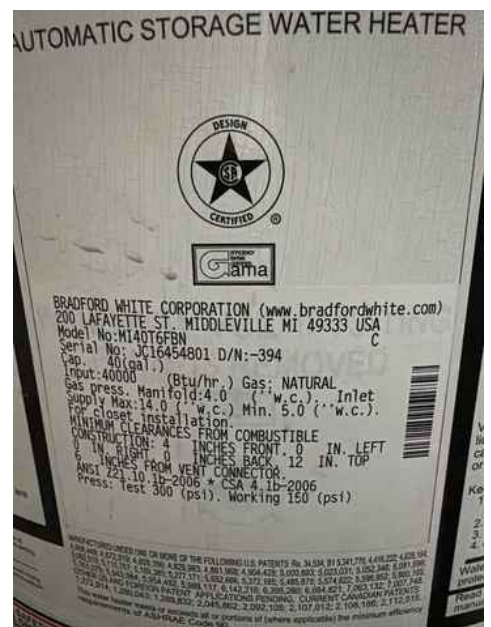
#### **LIFESPAN (8-12 YEARS)**

The water heater appeared to be nearing the end of its expected lifespan (8-12 years). Budgeting for replacement of the water heater is recommended.

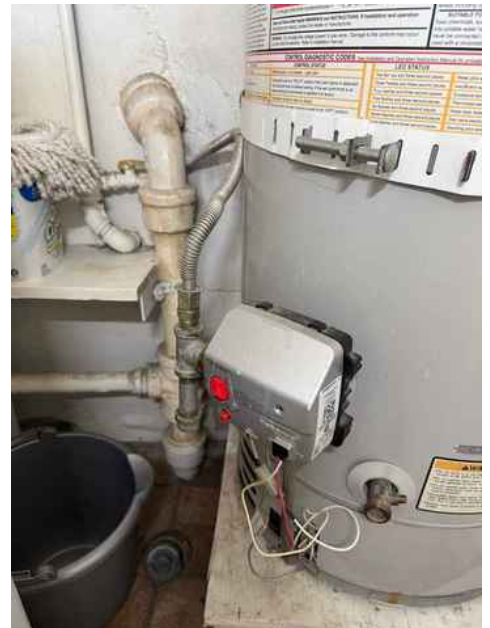
**GAS SMELL NOTED**

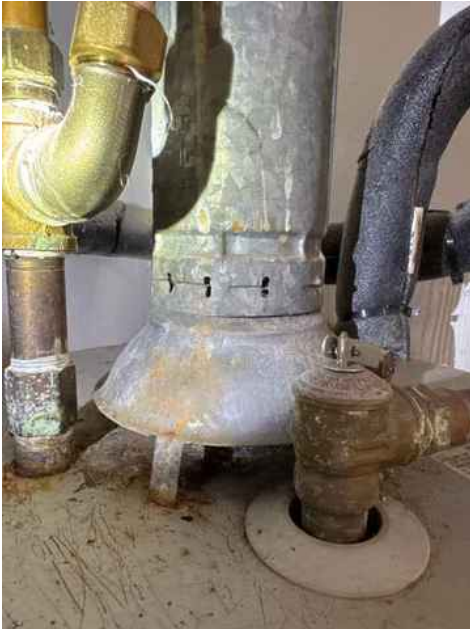
**VENT PIPE NOT PROPERLY SECURED**

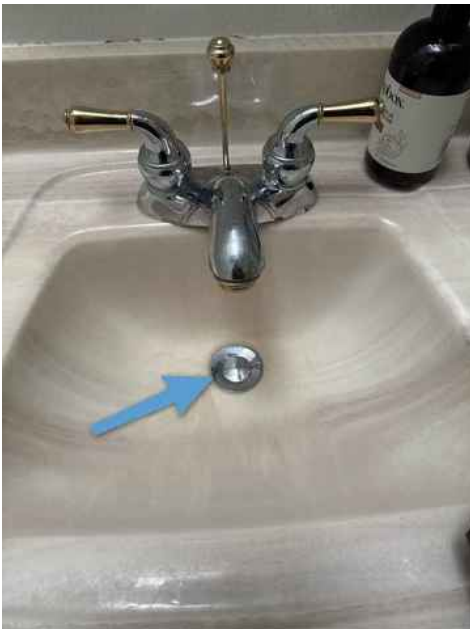
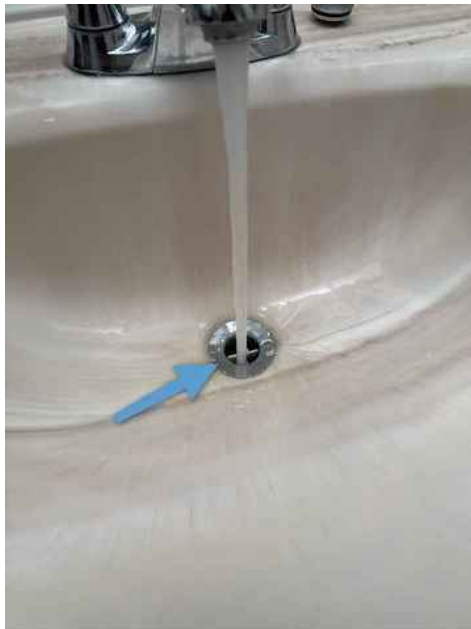
One or more sink drain stops were inoperable, missing, difficult to operate and/or ineffective. A qualified handyperson is recommended for repair.

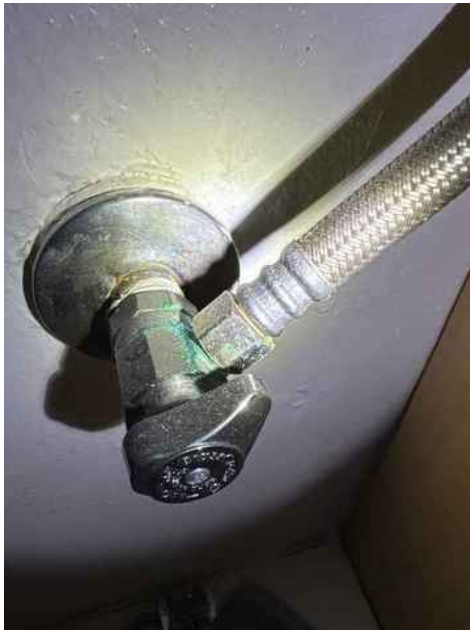
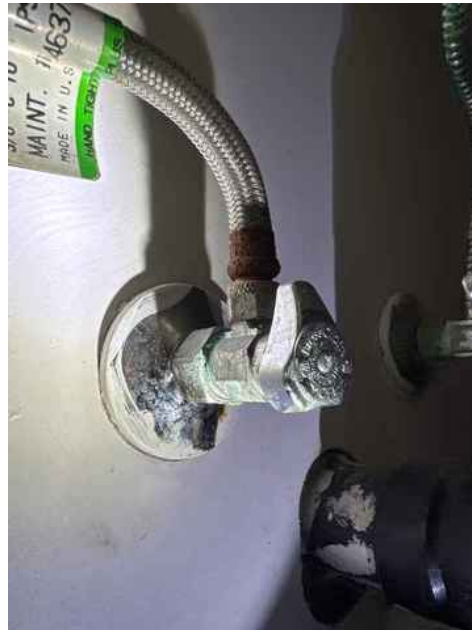
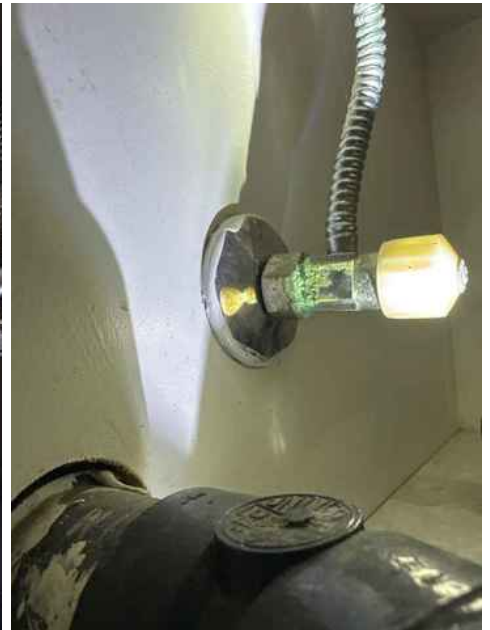
#### 8.6.2 Sinks / Fixtures

### **CORROSION / DAMAGE - ANGLE STOPS**

Some of the angle stops, shut off valves or supply lines under the sinks or behind the toilets appear to be corroding, damaged, or have mineral deposits or rust. This is indicative of a previous leak that has sealed itself. Monitoring this situation is recommended. A qualified plumbing contractor is recommended for further evaluation and repairs.

Contact a qualified professional.

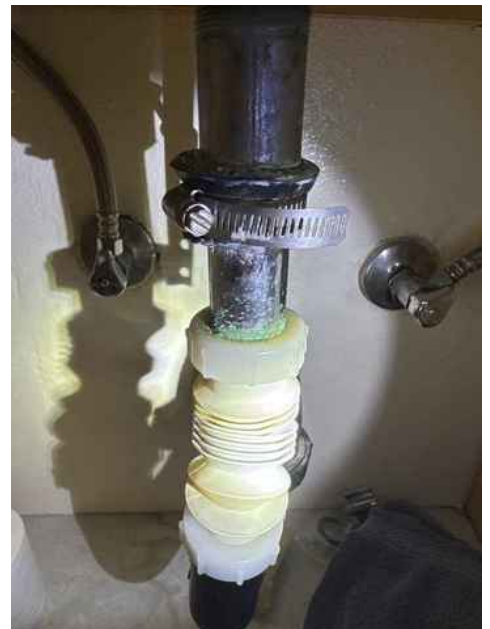
#### 8.6.3 Sinks / Fixtures

### **CORROSION / DAMAGE - DRAIN LINES**

Corrosion and/or damage was found at drain lines and/or fittings under one or more sinks. This can indicate past leaks, or that leaks are likely to occur in the future. A qualified plumbing contractor is recommended for repairs.

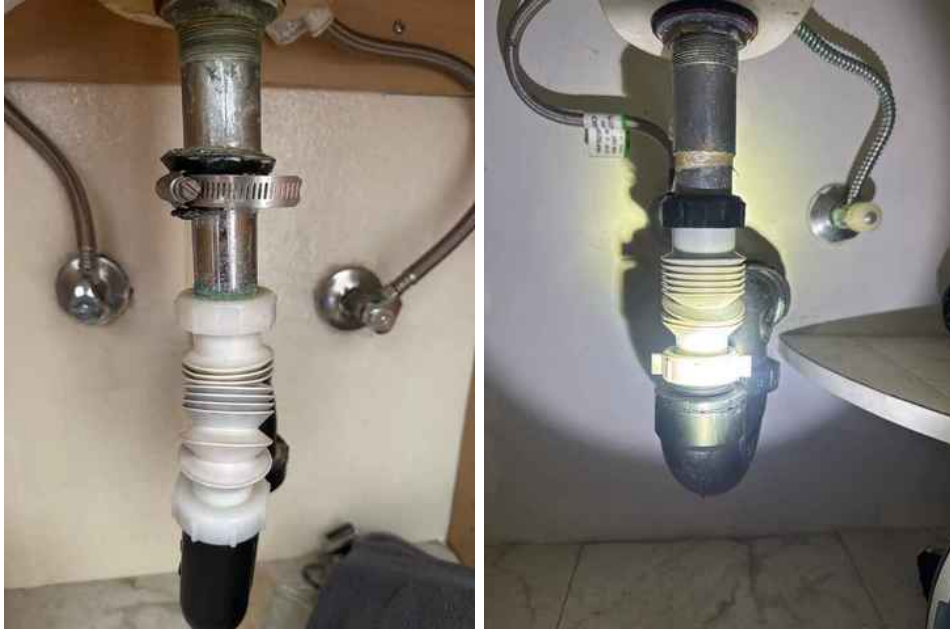
#### 8.6.4 Sinks / Fixtures

### **FLEXIBLE PIPE**

Ribbed, flexible drain piping was noted in one or more locations. This type of pipe is used as a temporary fix and is prone to clogging/trapping debris. A qualified plumbing contractor is recommended to replace these flexible pipes with smooth wall pipes as needed.

Contact a qualified plumbing contractor.

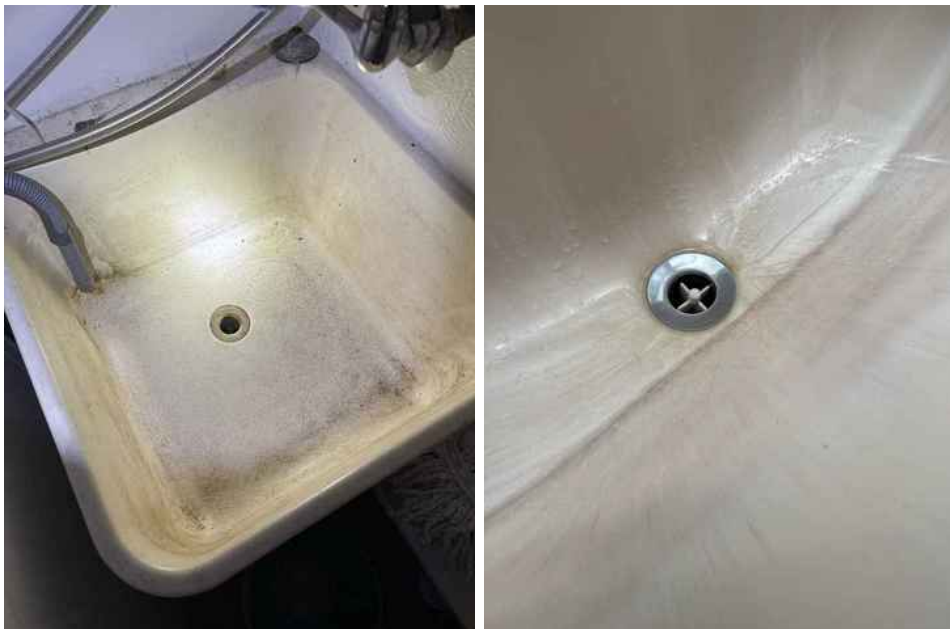
## 8.6.5 Sinks / Fixtures

**WORN / BLEMISHED / DETERIORATED**

The sink was worn, blemished and/or deteriorated. A qualified professional is recommended for repairs.

Contact a qualified professional.

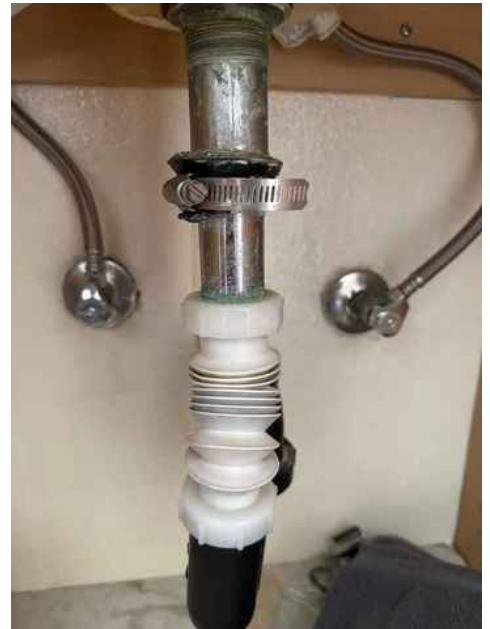
## 8.6.6 Sinks / Fixtures

**SUBSTANDARD DRAIN REPAIR**

Substandard repairs were noted at the sink drains in one or more locations (tape, sealant, or other non-standard components). A qualified plumber is recommended to make repairs according to standard building practices.

Contact a qualified plumbing contractor.

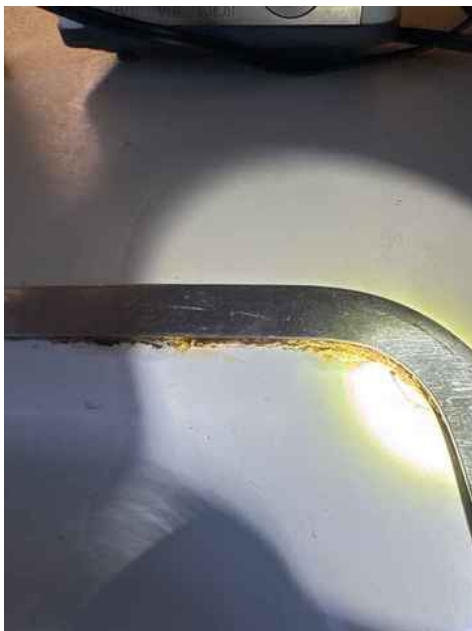
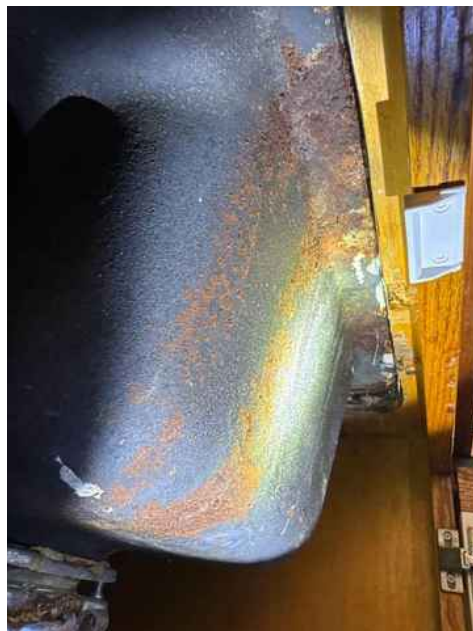
### 8.6.7 Sinks / Fixtures

#### **RUSTED SINK(S)**

Rust noted at one or more sinks. This is indicative of age, use and/or previous leaks. A qualified professional is recommended to make repairs as needed.

Contact a qualified professional.

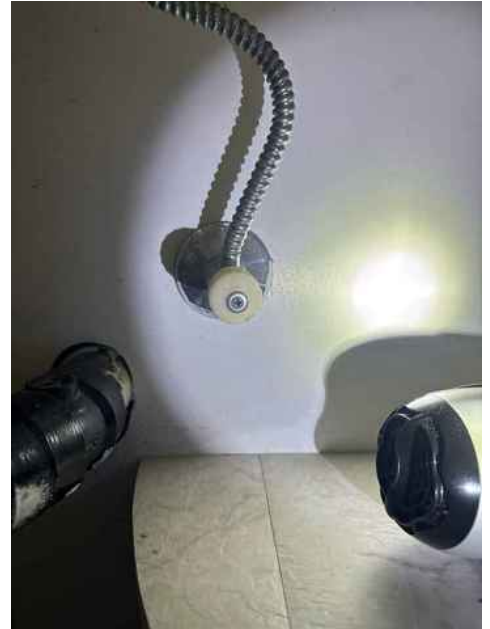
### 8.6.8 Sinks / Fixtures

#### **OLD ANGLE STOP(S)**

Old or original angle stops are installed at some or all sinks and toilets. We recommend replacing all of these older angle stop valves with new valves and braided steel supply lines to avoid leaks.

Contact a qualified plumbing contractor.
