## KEEN EYE HOME INSPECTION REPORT

2251 Chicago St  
San Diego, CA 92110

Shaylie Fraser  
10/03/2026

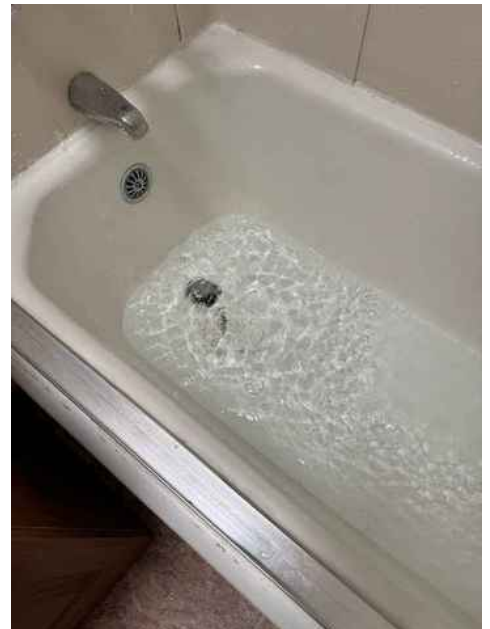
## 8.7.1 Bathtubs / Showers

**DRAINED SLOWLY / CLOGGED -  
BATHTUB**

The bathtub drained slowly or was clogged. A qualified professional is recommended to clear the drain and/or make repairs as necessary.

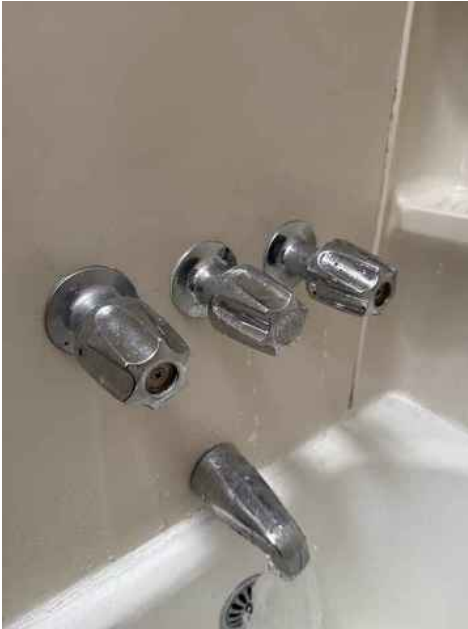
## 8.7.2 Bathtubs / Showers

**VALVE LEAK**

A shower handle/valve was leaking. A qualified contractor is recommended to evaluate and make repairs.

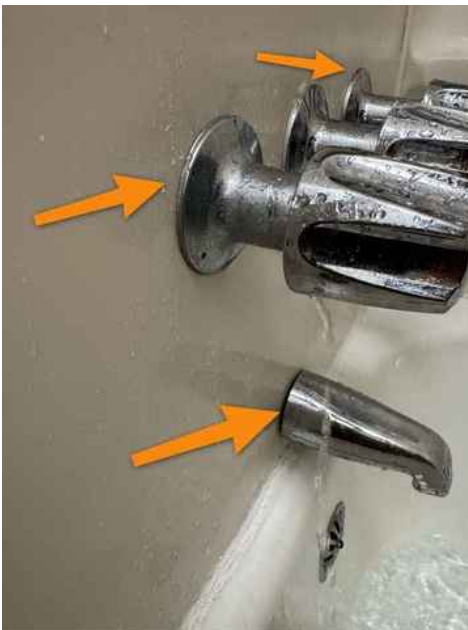
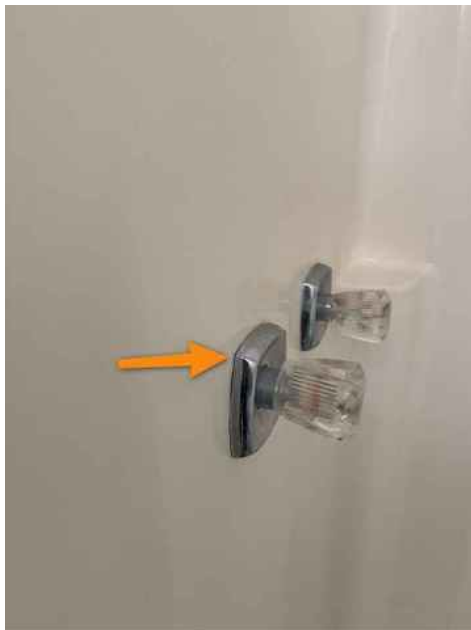
### 8.7.3 Bathtubs / Showers

#### **GAP OR NO CAULK BEHIND SPOUT / HANDLES / MIXING VALVE**

A gap and/or missing caulking was noted around the bathtub spout and/or showerhead. This gap poses a risk of water entering the wall structure behind the wall. A qualified professional is recommended to make repairs to seal gap(s) as needed.

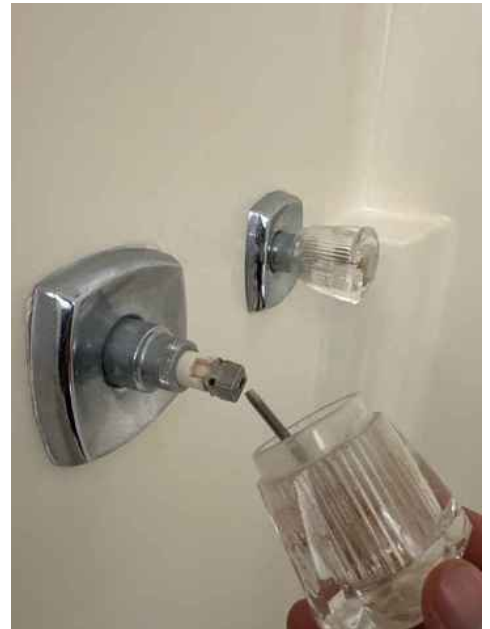
### 8.7.4 Bathtubs / Showers

#### **VALVE HANDLE COVER SUBSTANDARD**

One or more bathtub and/or shower valve handle covers were loose, damaged and/or missing. A qualified handyperson is recommended for repair or replacement.

Contact a handyman or DIY project

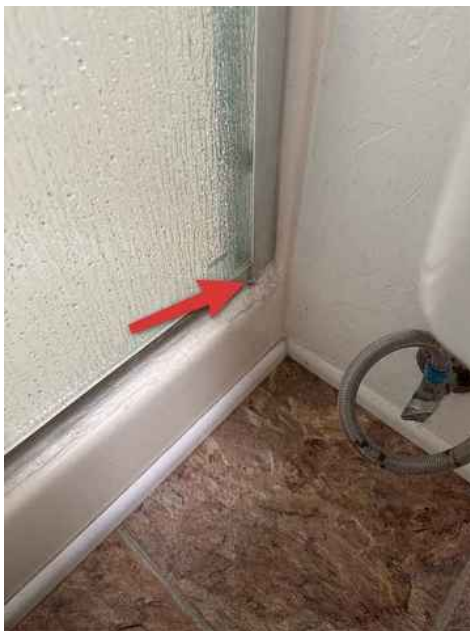
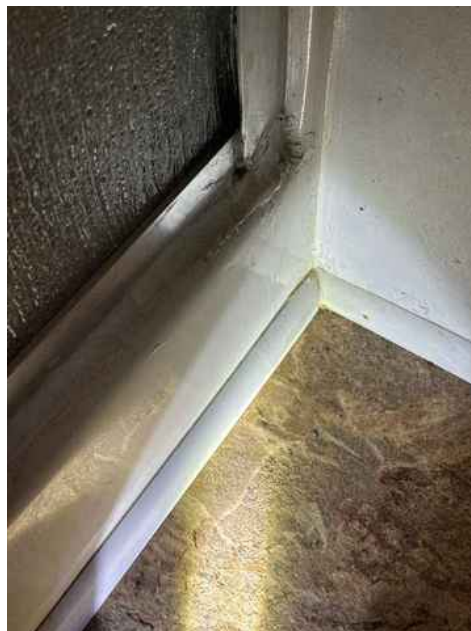
#### 8.7.5 Bathtubs / Showers

##### **ENCLOSURE LEAKS**

The shower enclosure appears to leak when the water supply is turned on. A qualified professional is recommended for further evaluation and repairs/modifications.

Contact a qualified general contractor.

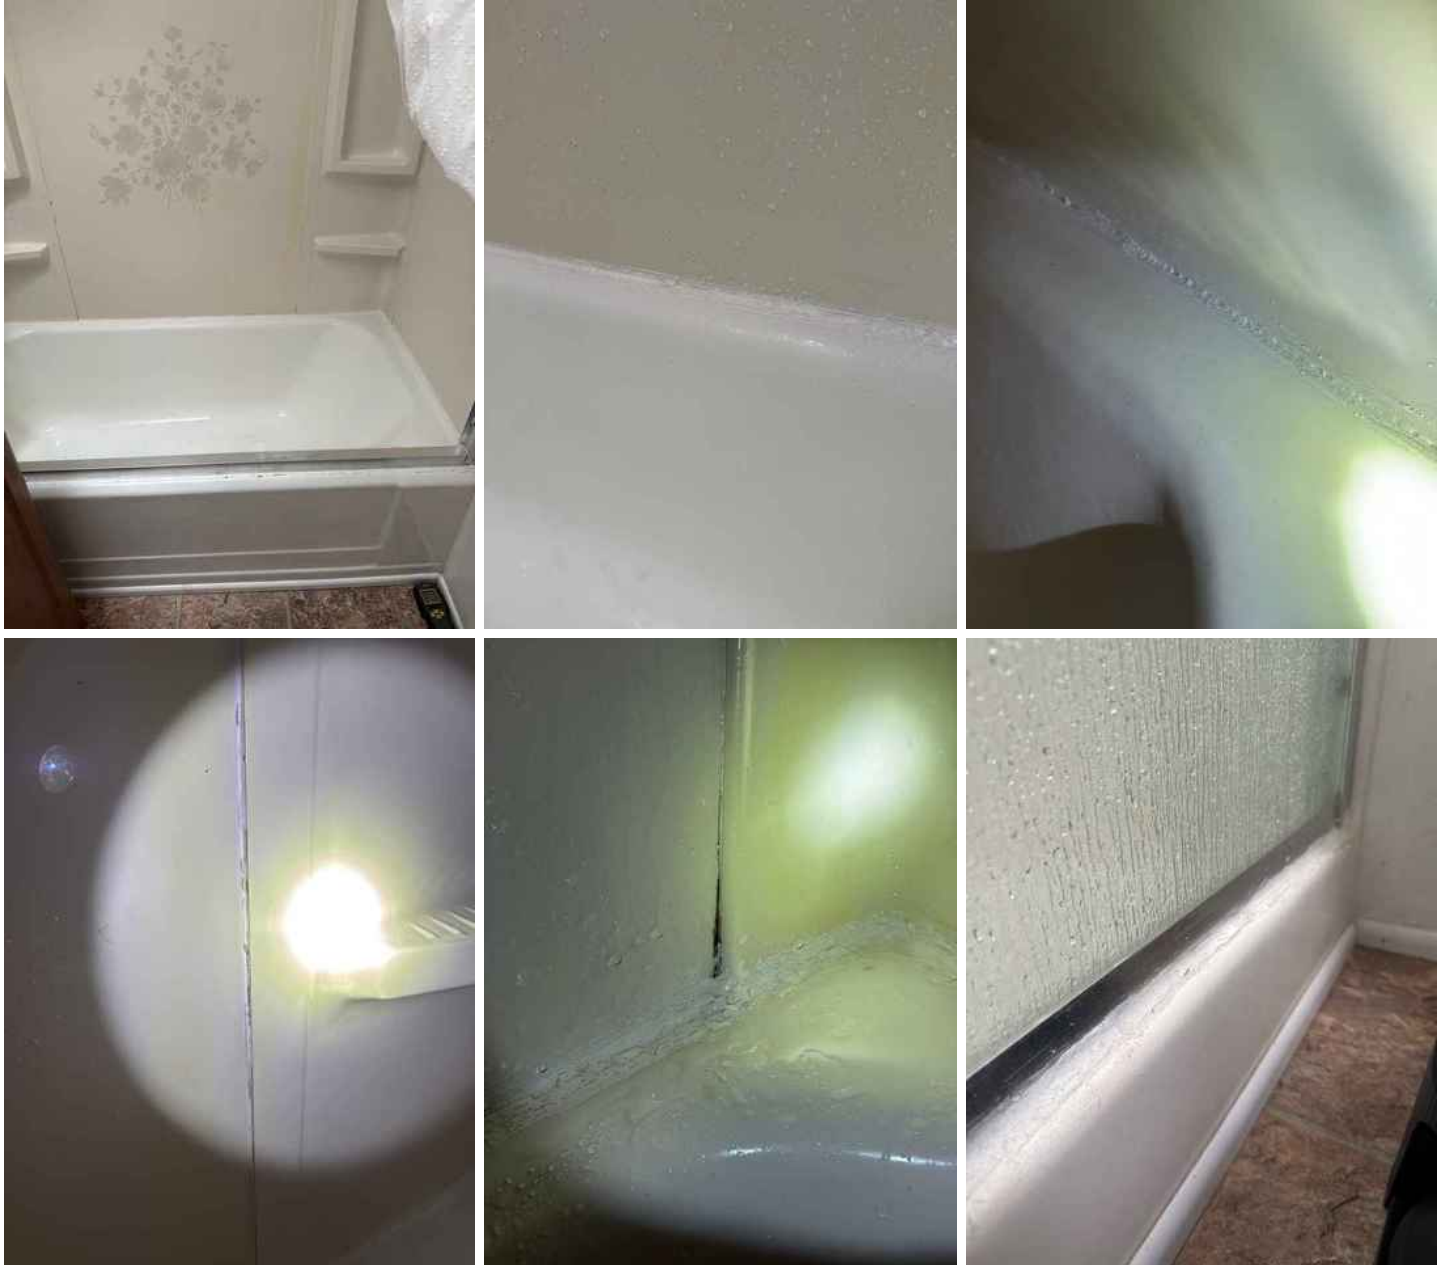
#### 8.7.6 Bathtubs / Showers

##### **RE-CAULK SHOWER/TUB ENCLOSURE**

The tub/shower enclosures need to be cleaned and re-caulked to prevent moisture intrusion beyond the shower enclosure walls.

Contact a qualified professional.

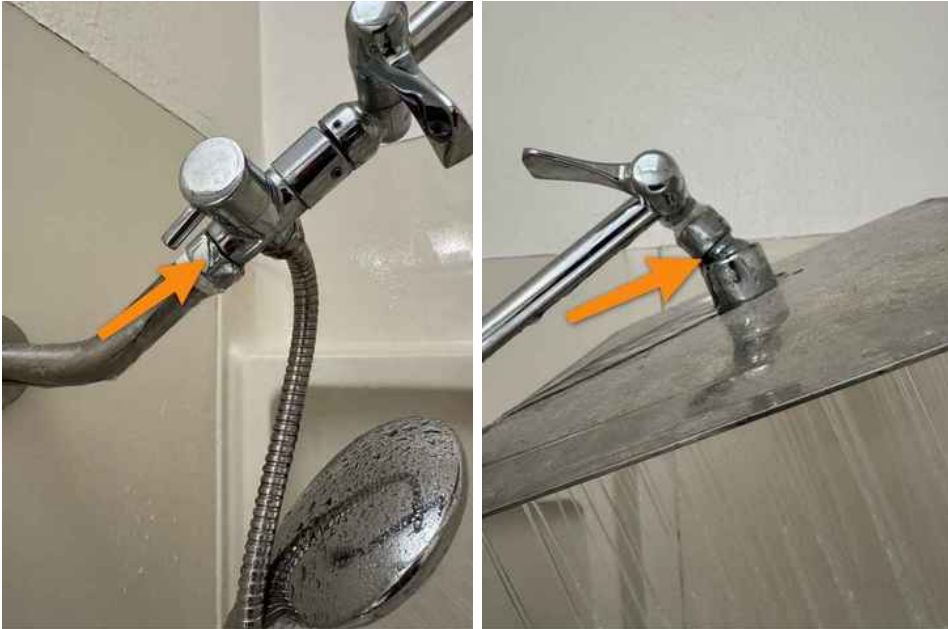
## 8.7.7 Bathtubs / Showers

**SHOWER HEAD CONNECTION LEAKS**

The shower head was leaking at a connection. A qualified professional is recommended to make repairs.

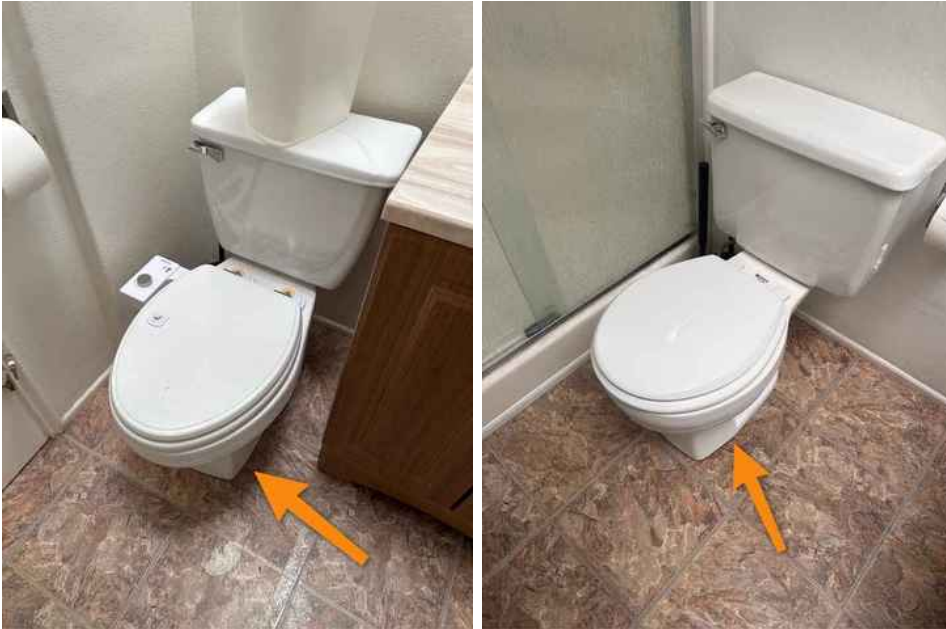
#### 8.8.1 Toilets

##### **TOILET LOOSE**

Toilet was noted as being loose where it attached to the floor. Leaks can occur. As the inspector cannot determine the condition of the wax ring underneath which seals the toilet, it is recommended that a qualified contractor remove the toilet(s) for further evaluation and repair if deemed necessary. A new wax ring should be installed and toilet(s) should be securely anchored to the floor to prevent movement and leaking.

Contact a qualified plumbing contractor.

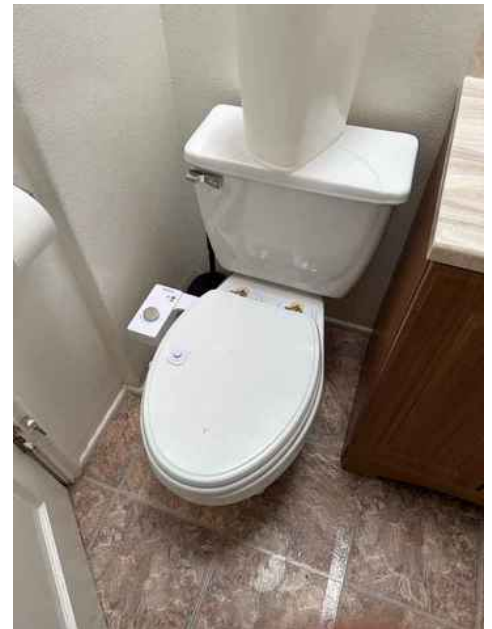
### 8.8.2 Toilets

#### **CLEARANCE UNUSUALLY TIGHT**

Contact a qualified professional.

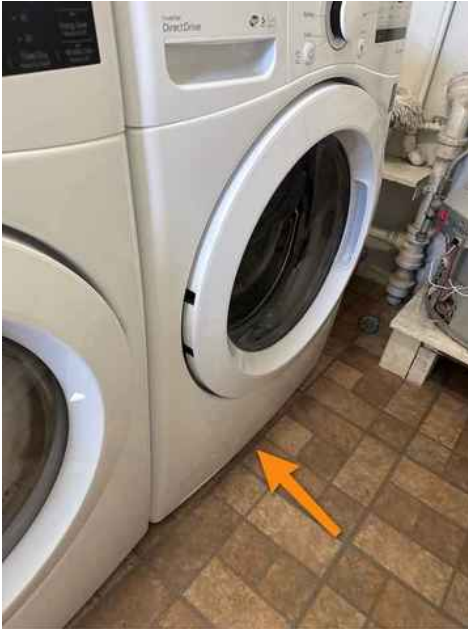
### 8.9.1 Laundry

#### **NO CATCH PAN**

The laundry connection sits above finished living space, or somewhere an overflow would reach finished areas, and there is no pan or pan drain underneath. A pan catches water from a leaking hose, an overflow, or a drain backup and directs it away from the finished space below.

Recommendation: ask a qualified contractor about fitting a pan. A dedicated drain line to the exterior is not always practical depending on the layout; where it is not, a battery-powered water alarm placed in the pan is an inexpensive alternative.

Contact a qualified professional.

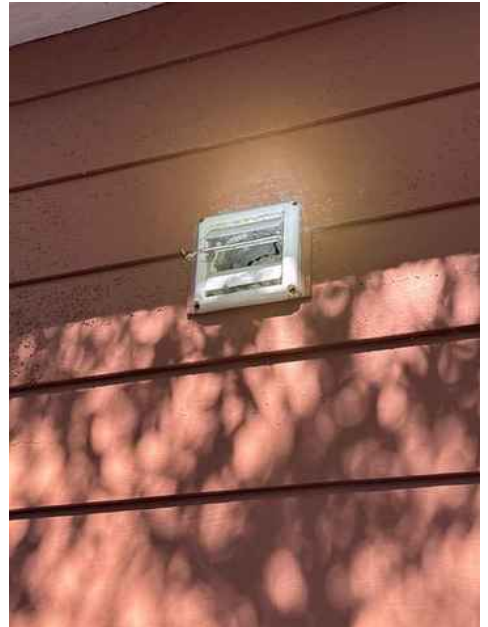
### 8.9.2 Laundry

#### **DRYER DUCT AND/OR VENT NEEDS CLEANING**

The dryer exhaust duct and/or vent assembly appeared to be in the need of cleaning. This condition may reduce air flow which could become a fire hazard. A qualified professional is recommended for cleaning this duct now and as necessary in the future.

Contact a qualified professional.

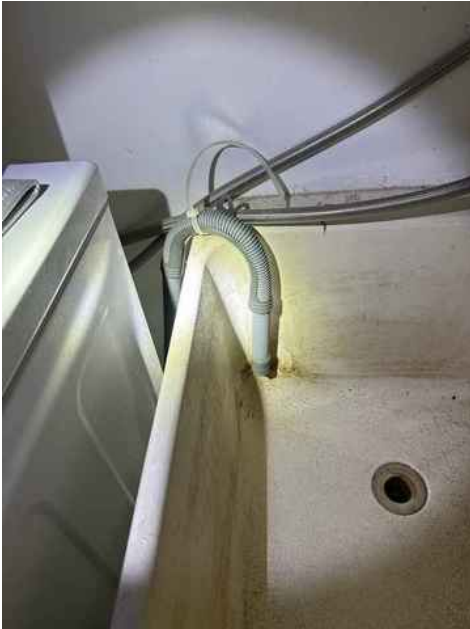
### 8.9.3 Laundry

#### **DRAINS TO SINK**

The clothes washing machine did not have a standpipe and drained to the laundry sink. This is sometimes typical in older homes, however, modern building standards require a 2 inch standpipe to discharge into. Client should evaluate their needs and repair as needed.

Contact a qualified plumbing contractor.

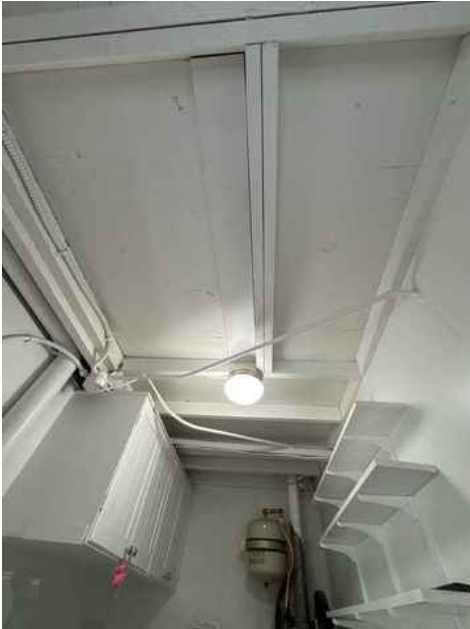
### EXHAUST FAN MISSING

One or more exhaust fans were missing. Today's building standards require exhaust fans in all wet locations. Consideration should be given to having qualified professional install fans where needed.

Contact a qualified professional.

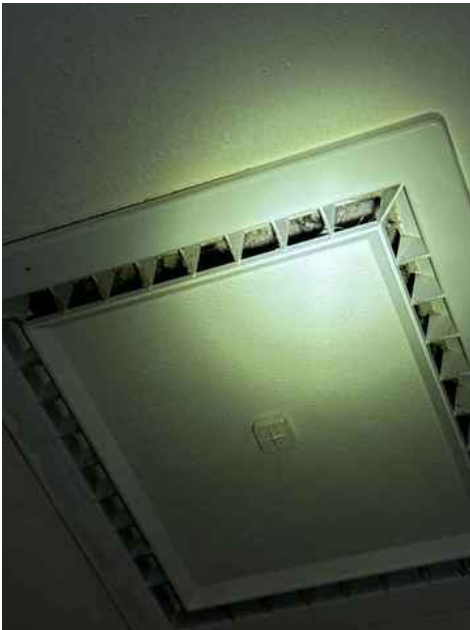
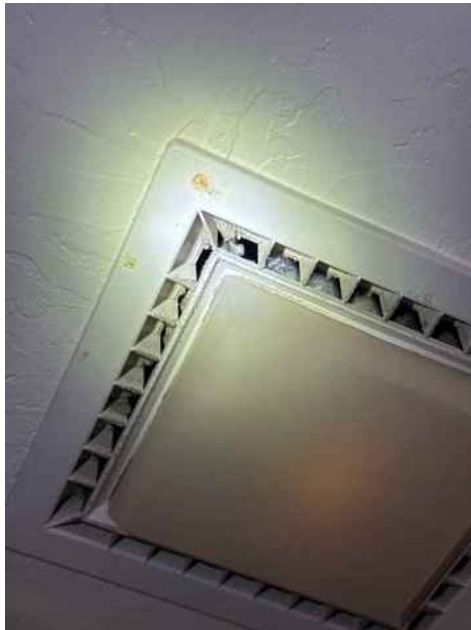
### 8.10.3 Exhaust Fans / Ventilation

#### **CLEAN BATHROOM VENT**

Exhaust vent cover grill was dirty. This condition can result in restricted air flow. A qualified handyperson is recommended to clean vent covers as needed.

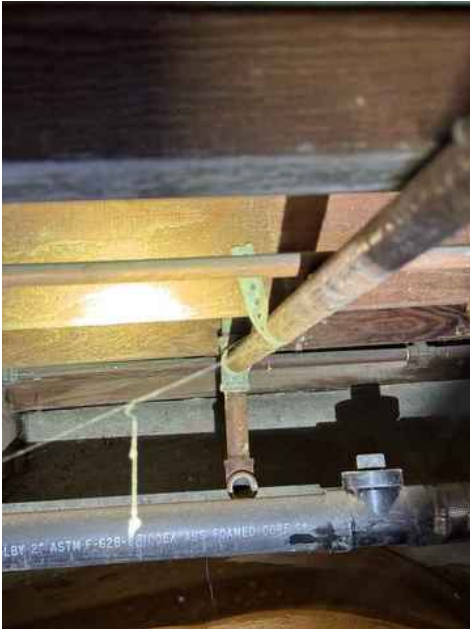
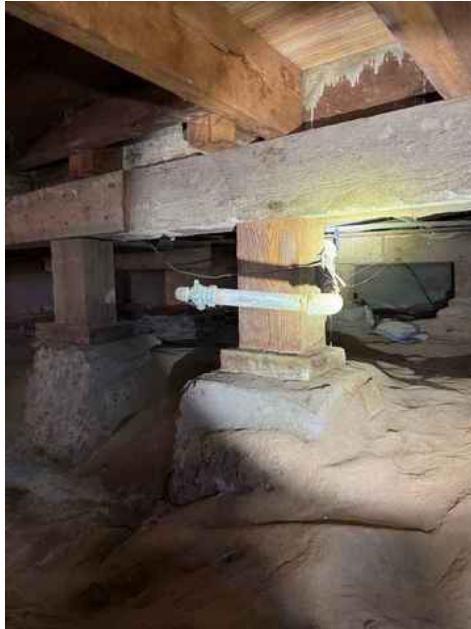
### 8.11.1 Fuel Systems

#### **RE PIPING NOTED**

A re-pipe or alterations of the gas lines were noted. Inquire with the seller for more information.

Contact a qualified professional.

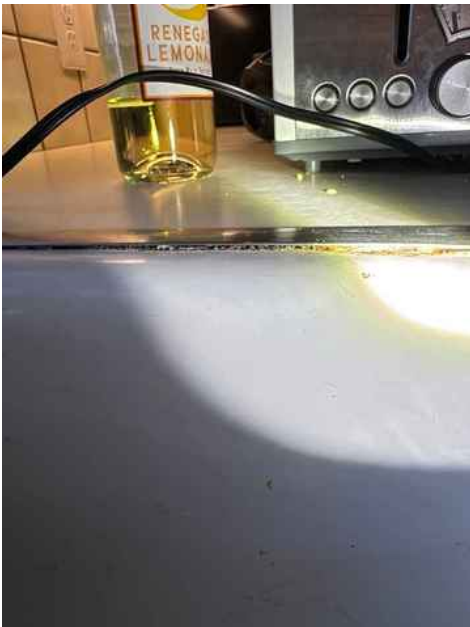
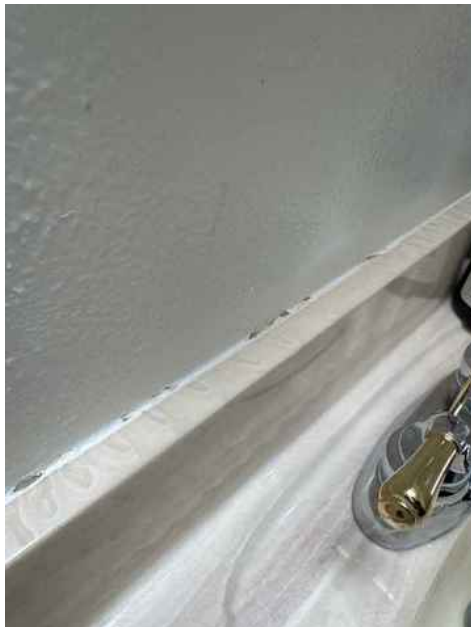
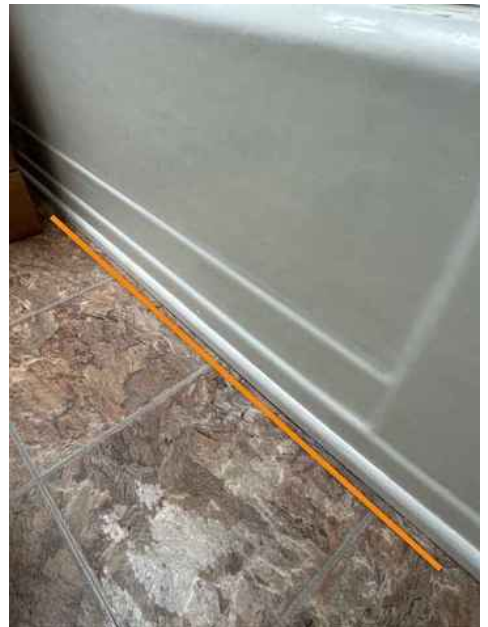
### 8.13.1 Caulking

## **SILICONE SEALANT NEEDED**

Sealant around one or more sinks, counter tops, shower/tub areas is aged, deteriorating, and/or shows signs of mildew buildup. Recommend resealing by a qualified handyperson to help prevent moisture intrusion and maintain a sanitary condition.

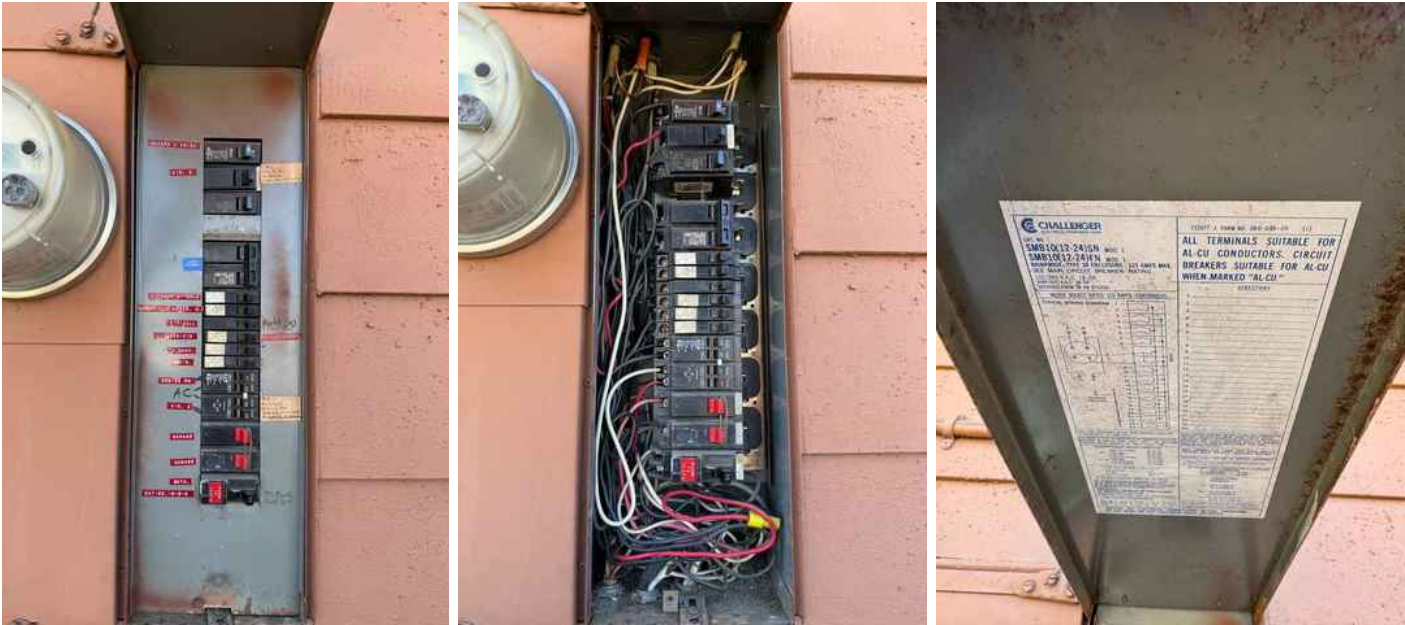
This electric panel appears older. Aside from any visual deficiencies noted elsewhere in this report, it may be prudent to consider updating this panel to a more modern panel that allows room for expansion and modern breaker (GFCI/AFCI) protection. Client should consult with a qualified electrician regarding cost.

Electrical Panel(s): Panel Equipment Photographs

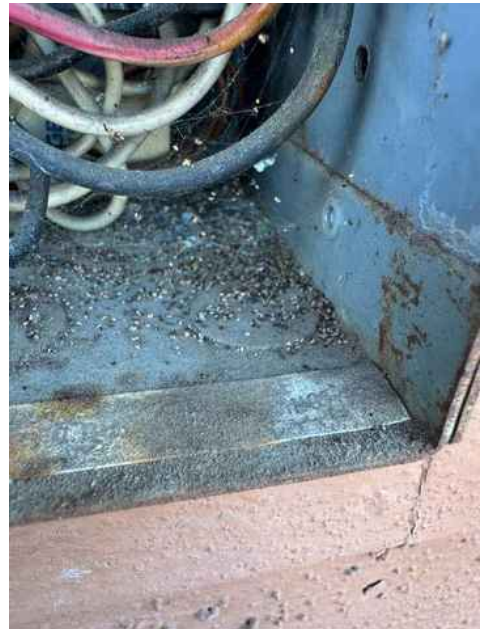
**TERMITE DROPPINGS NOTED**

What appeared to be termite droppings were noted in one or more areas. These could be from prior activity. A qualified pest control professional is recommended for further evaluation.

Contact a qualified professional.

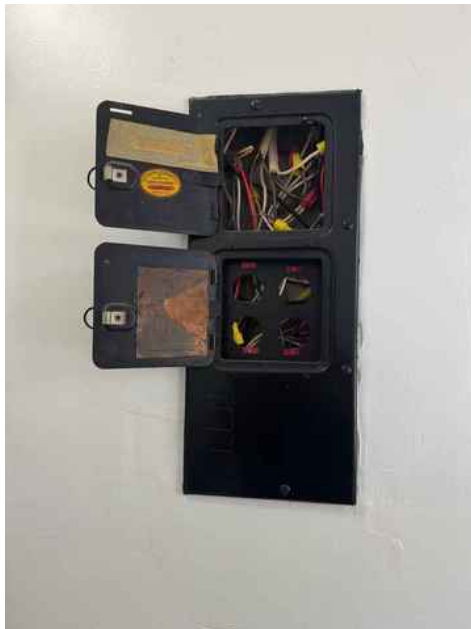
Wire splices in older panel. Recommend further evaluation and needed repairs by a qualified licensed contractor.

Contact a qualified electrical contractor.

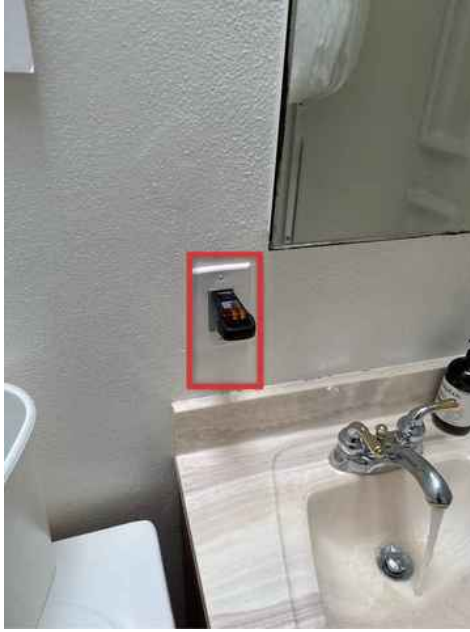
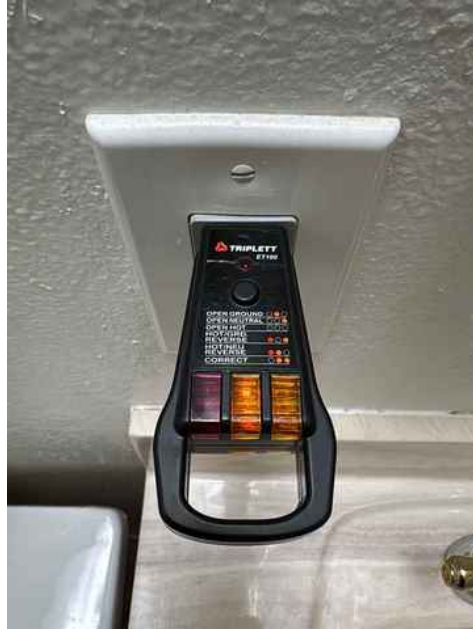
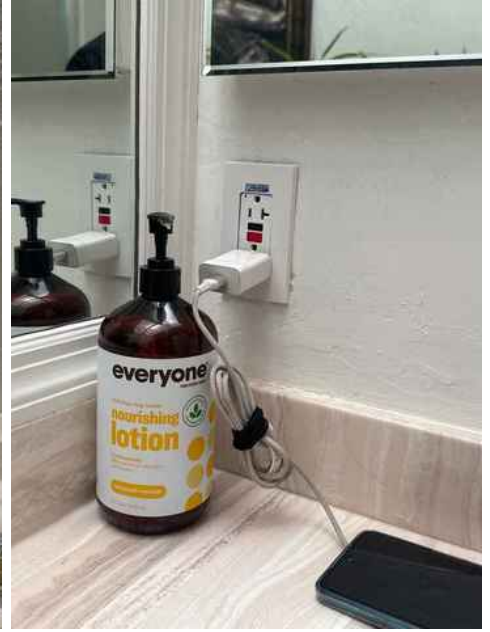
One or more ground fault circuit interrupter (GFCI) receptacles (outlets) were not functioning properly (would not trip / would not reset / still energized when tripped). A qualified electrician is recommended to replace GFCI receptacle(s) as needed.

Contact a qualified electrical contractor.

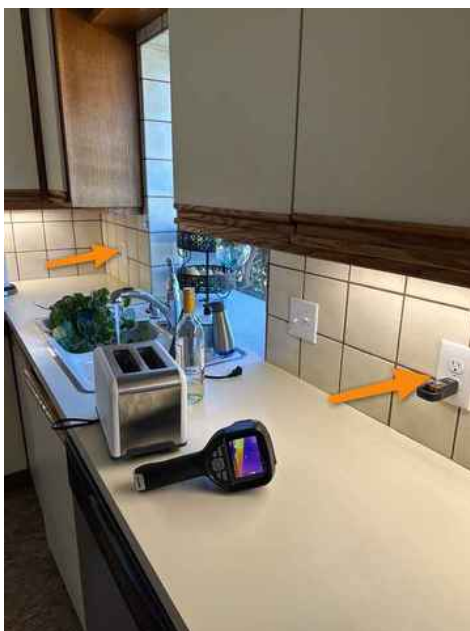
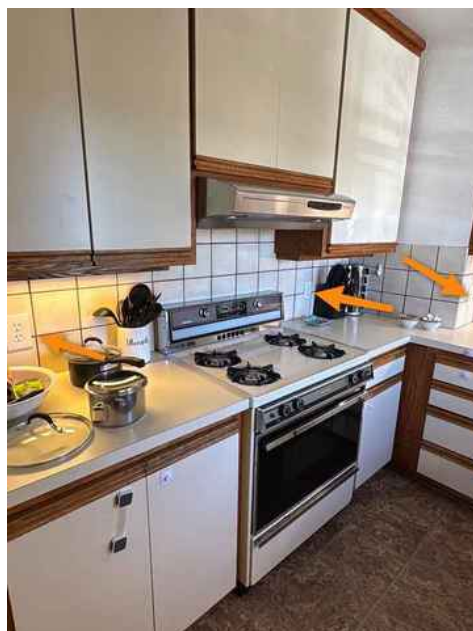
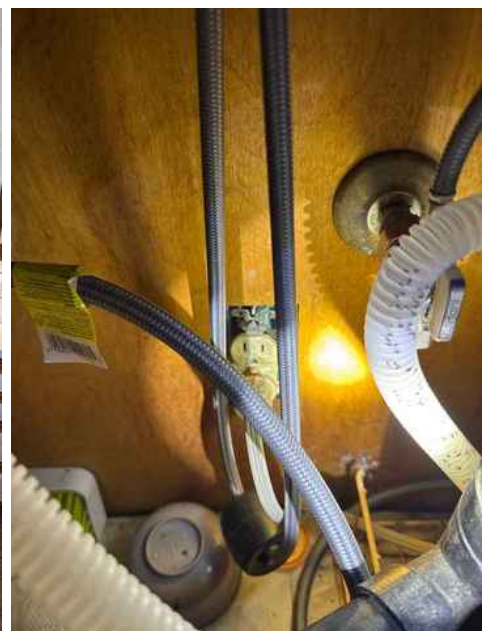
## 9.5.2 GFCI / AFCI Protection

**RECOMMEND GFCI UPGRADE**

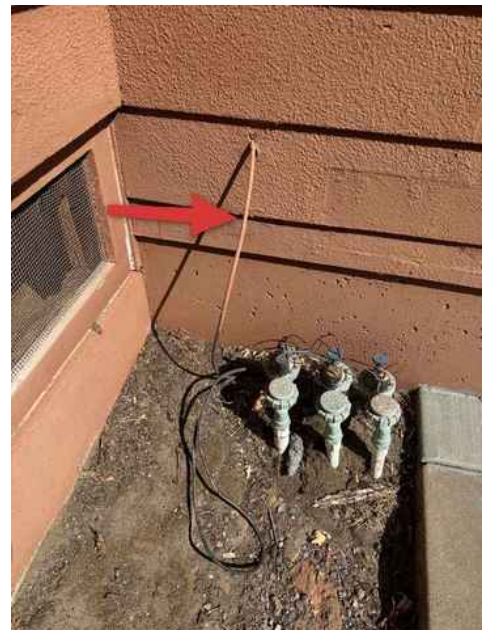
**EXPOSED WIRING - SUBJECT TO DAMAGE**

Exposed wiring was noted. This is a safety concern if used where it could be subject to physical damage (below 7ft). Exposed wire is normally installed in conduit for protection. A qualified professional is recommended for repairs to protect wire as needed.

Contact a qualified professional.

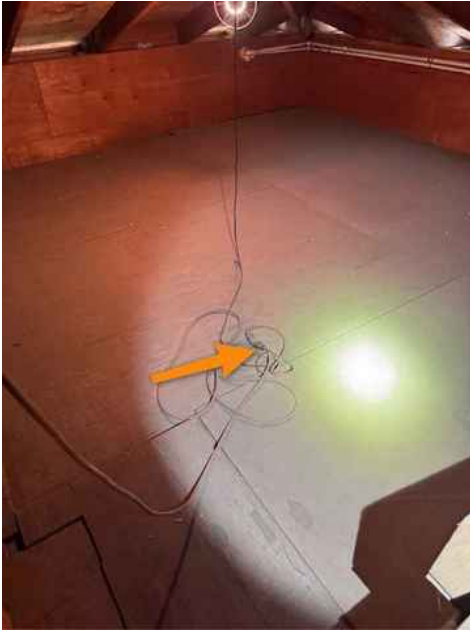
Extension cords are being used as permanent wiring. Extension cords are considered temporary. Recommend further evaluation by a licensed electrical contractor before the end of your contingency period to determine repairs possible at this time for safety.

Contact a qualified professional.

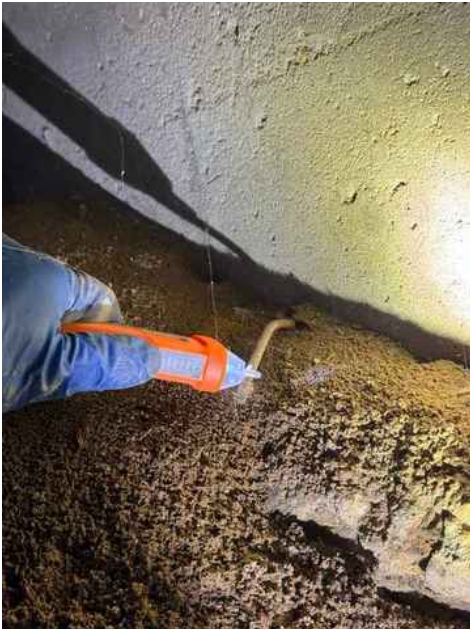
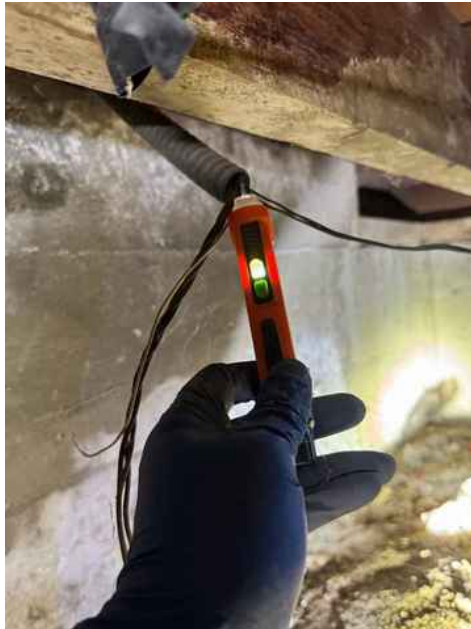
#### **IMPROPER WIRE TERMINATION - NOT LIVE**

Improperly terminated wires were noted in one or more areas, however, these wires did not appear to be live when tested. This is a potential safety concern if they could be switched on. A qualified electrical contractor is recommended for repairs.

Contact a qualified electrical contractor.

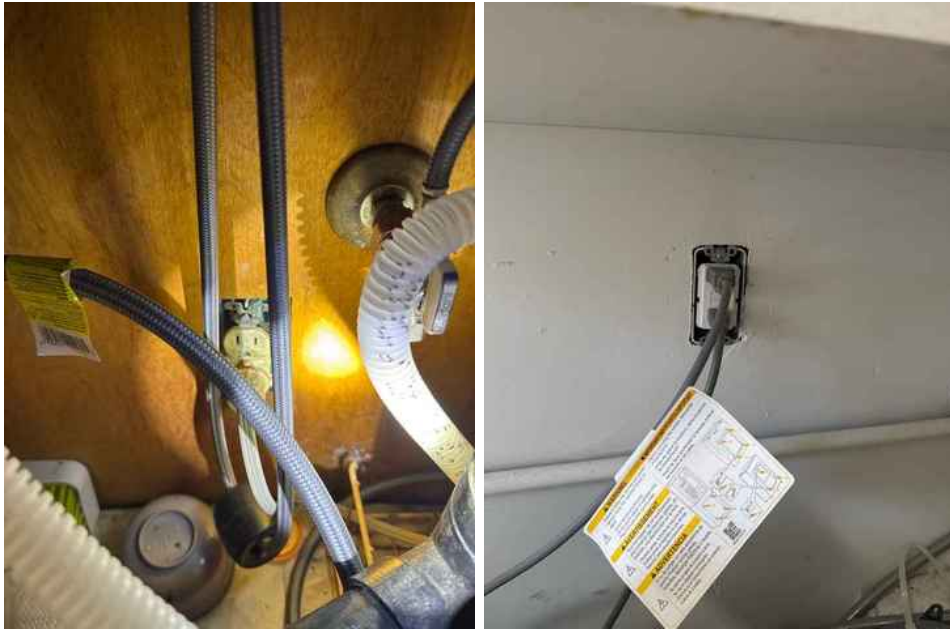
#### **COVER PLATE(S) MISSING, LOOSE OR DAMAGED**

Cover plate(s) were missing, loose and/or damaged in one or more areas. These plates are intended to contain fire and prevent electric shock from occurring due to exposed wires. A qualified person is recommended to replace or install cover plates where necessary.

Contact a qualified electrical contractor.

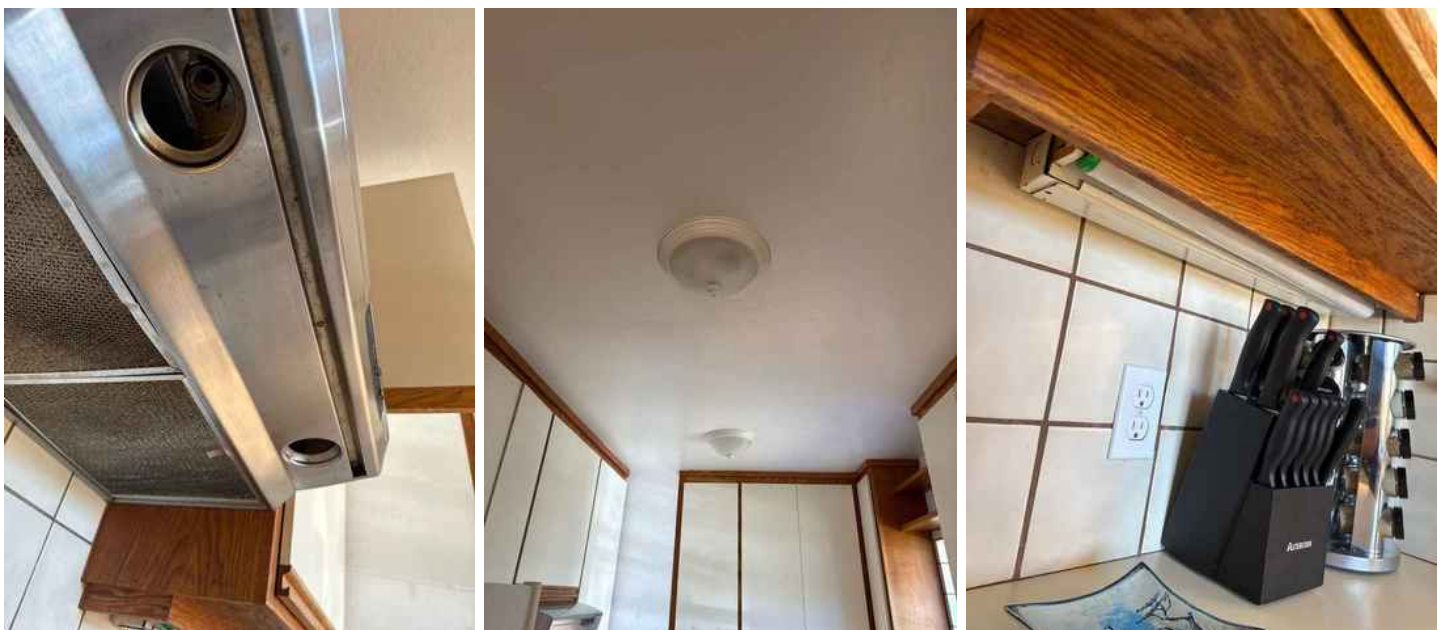
**BULB(S) INOPERABLE AND/OR MISSING**

A bulb was not functioning or not installed at one or more fixtures. The repair could be as simple as bulb replacement or further repair may be necessary. A qualified professional is recommended to further evaluate as needed.

Contact a qualified professional.

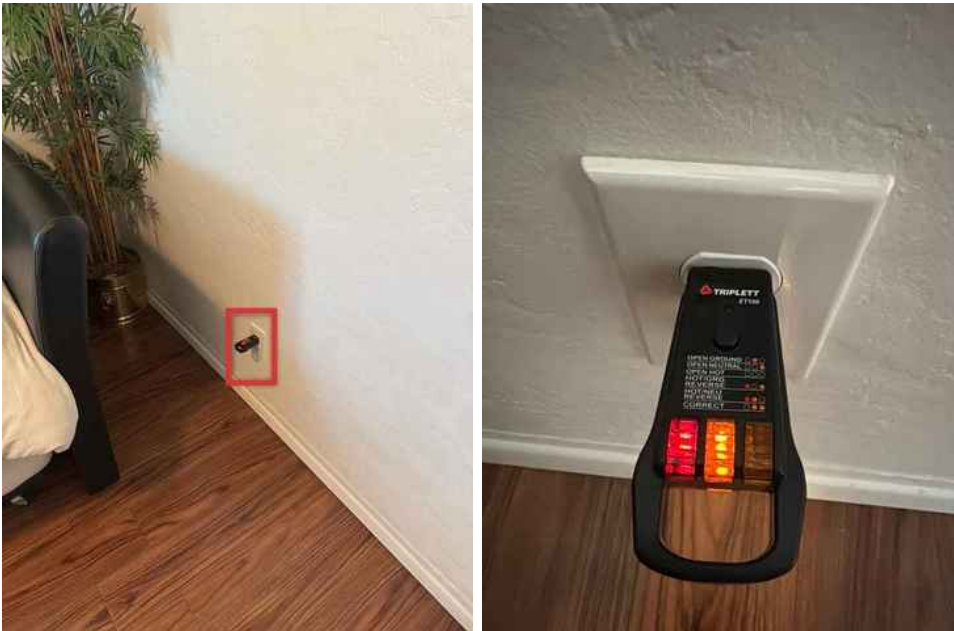
An outlet was reading hot/neutral reversed when tested with an outlet tester at one or more areas. This is a potential safety hazard. A qualified electrician is recommended to repair outlets where needed.

Contact a qualified electrical contractor.

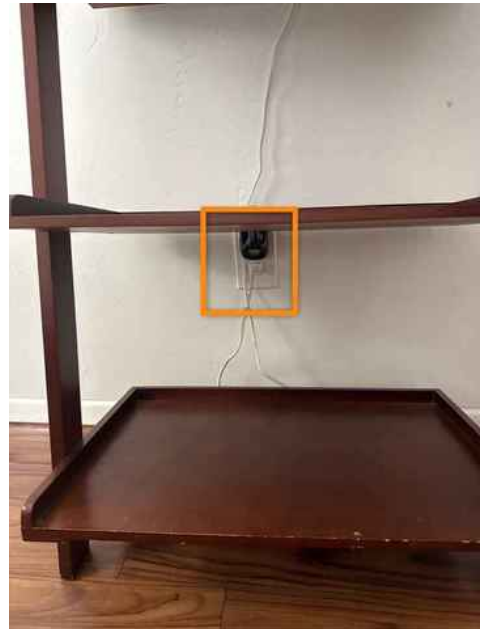
**LOOSE RECEPTACLE**

Junction box for receptacle appeared to be loose in the wall. This can put stress on the circuit wires which should not be moved. A qualified electrician is recommended to secure receptacles where needed.

Contact a qualified professional.

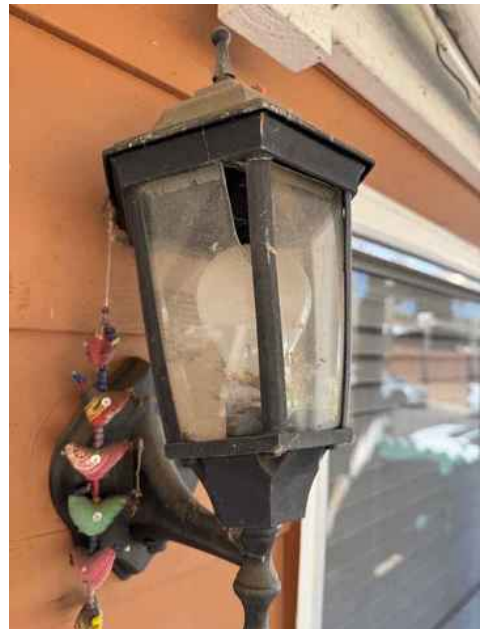
**LIGHT FIXTURE DAMAGED**

Light fixtures were damaged at one or more areas. A qualified electrician is recommended for repair or replacement as needed.

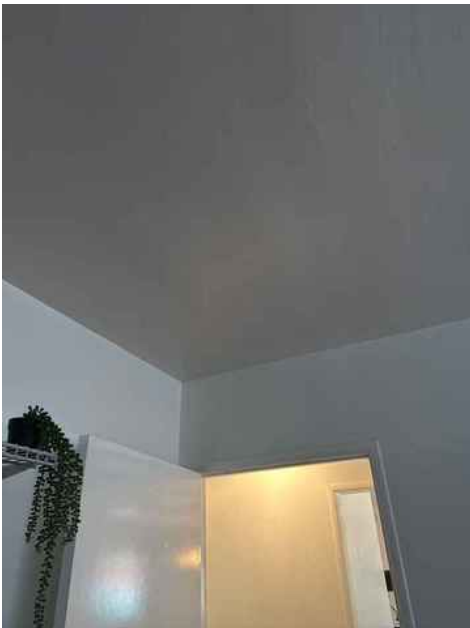
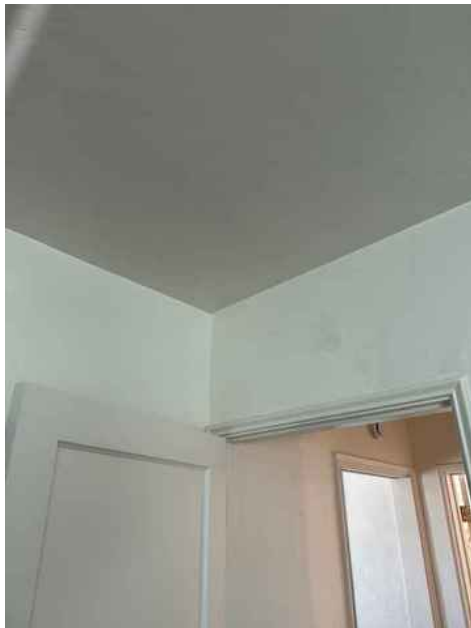
### **SMOKE DETECTOR(S) MISSING**

Smoke alarms were missing and/or not installed in one or more recommended locations. Smoke alarms should be replaced as necessary and installed per standard building practices (e.g. in each hallway leading to bedrooms, in each bedroom, and on each floor). Installing photoelectric-type smoke detectors / alarms is recommended.

Contact a handyman or DIY project

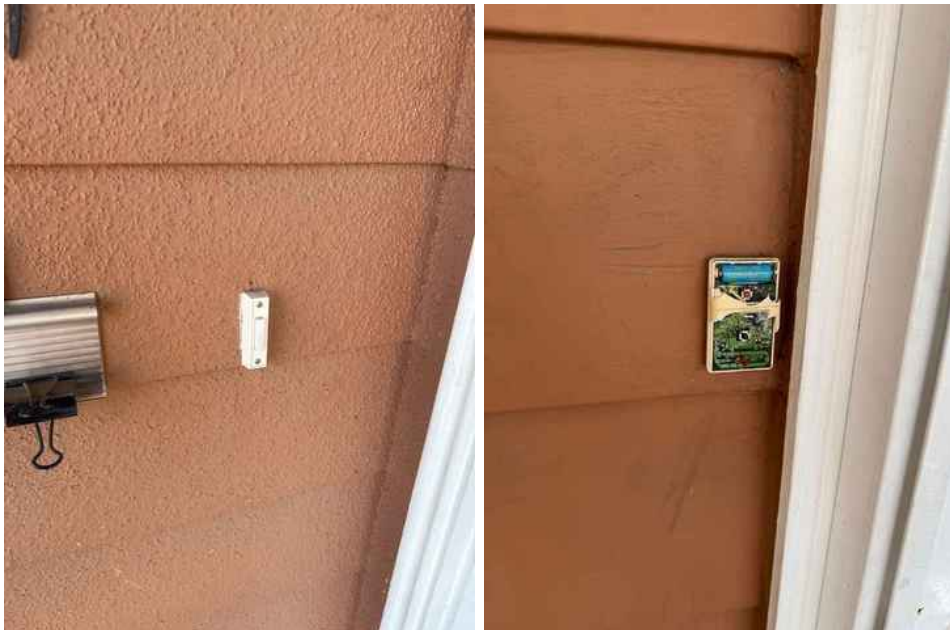
The doorbell was loose, damaged and/or inoperable. A qualified handyperson is recommended for repair or replacement.

Contact a qualified handyman.

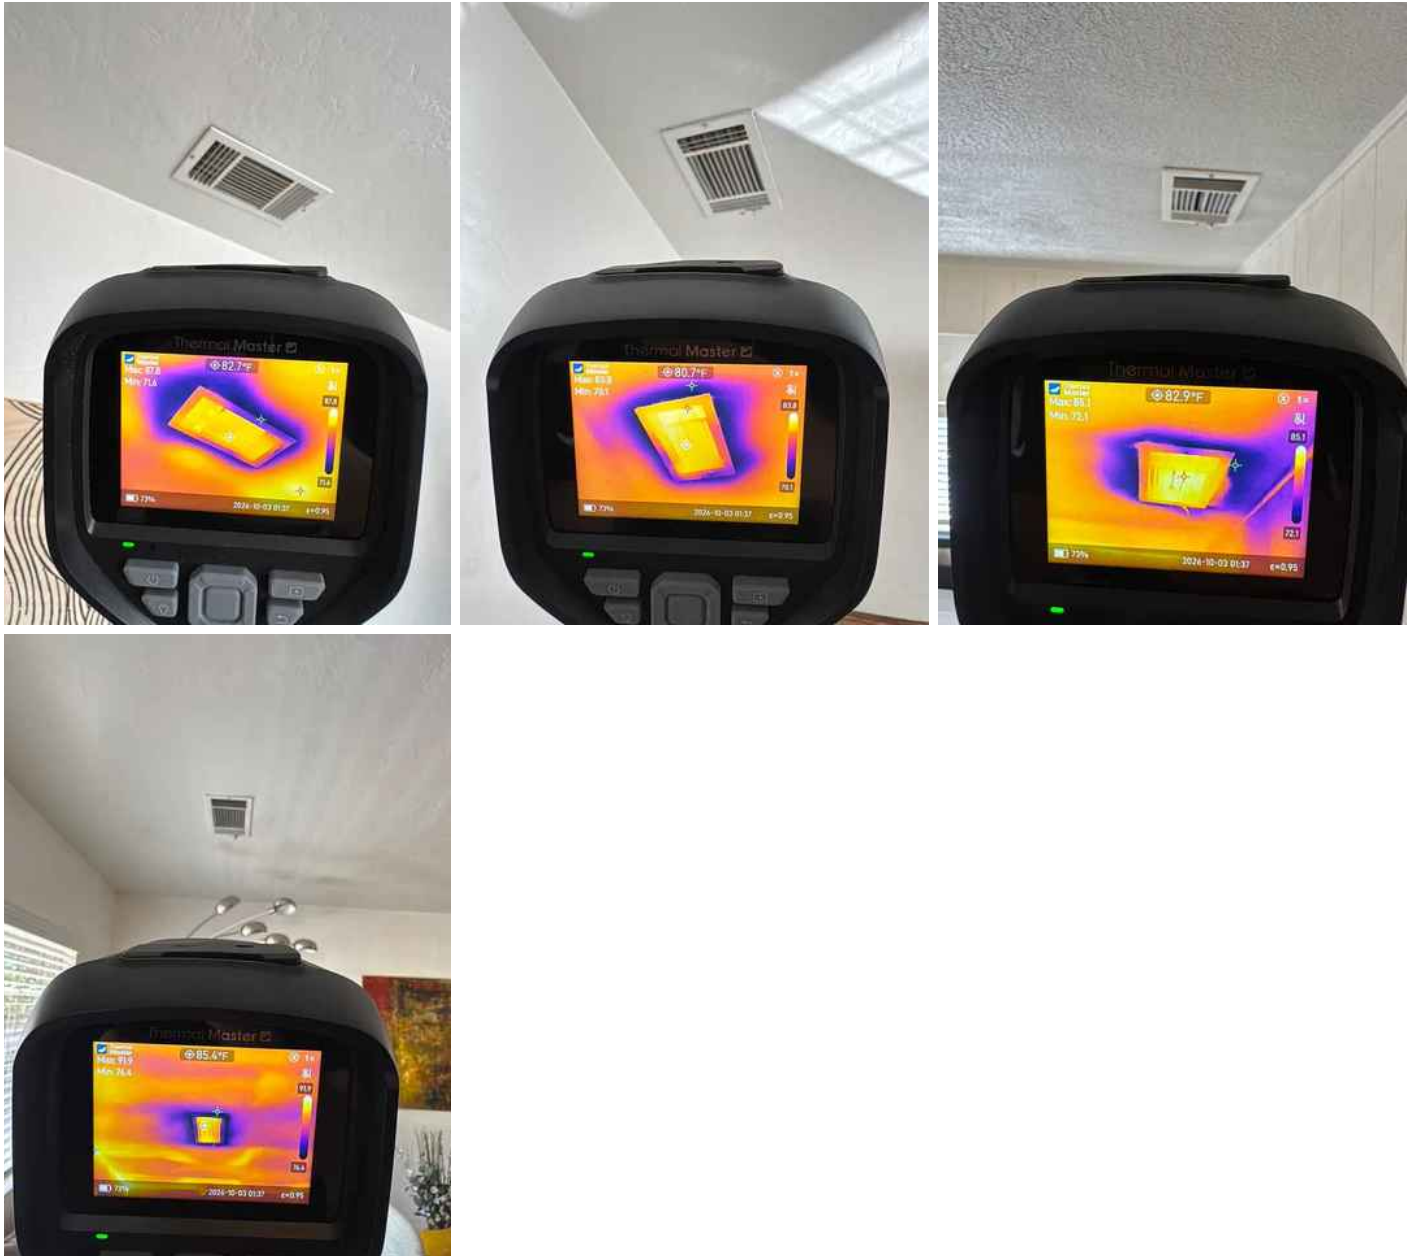
## Heating (Forced Air): Appears Functional - Thermal Image(s) During Operation

Heat system appears to be in working order.

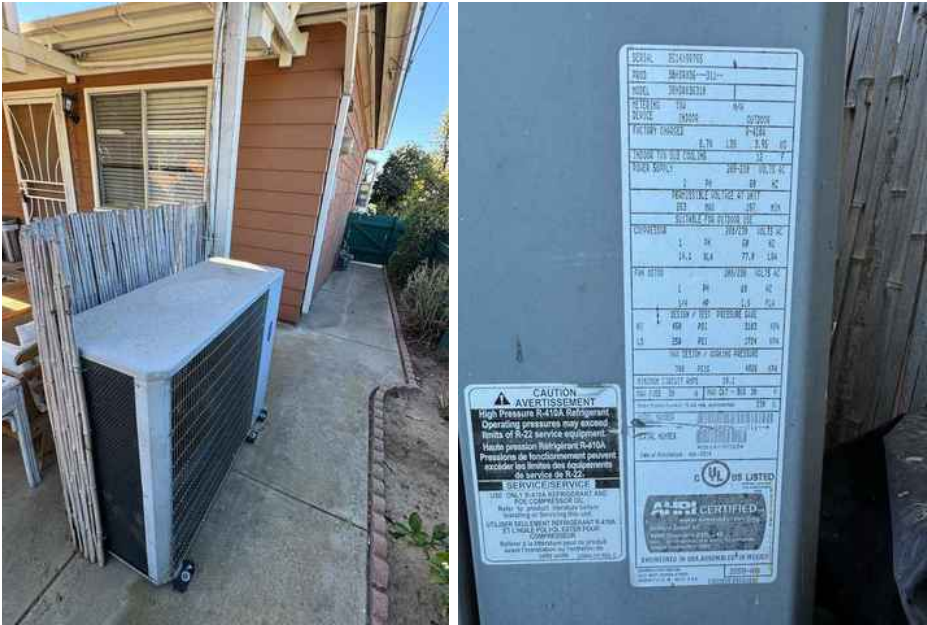
Air Conditioning: Equipment Photos
