## KEEN EYE HOME INSPECTION REPORT

2251 Chicago St  
San Diego, CA 92110

Shaylie Fraser  
10/03/2026

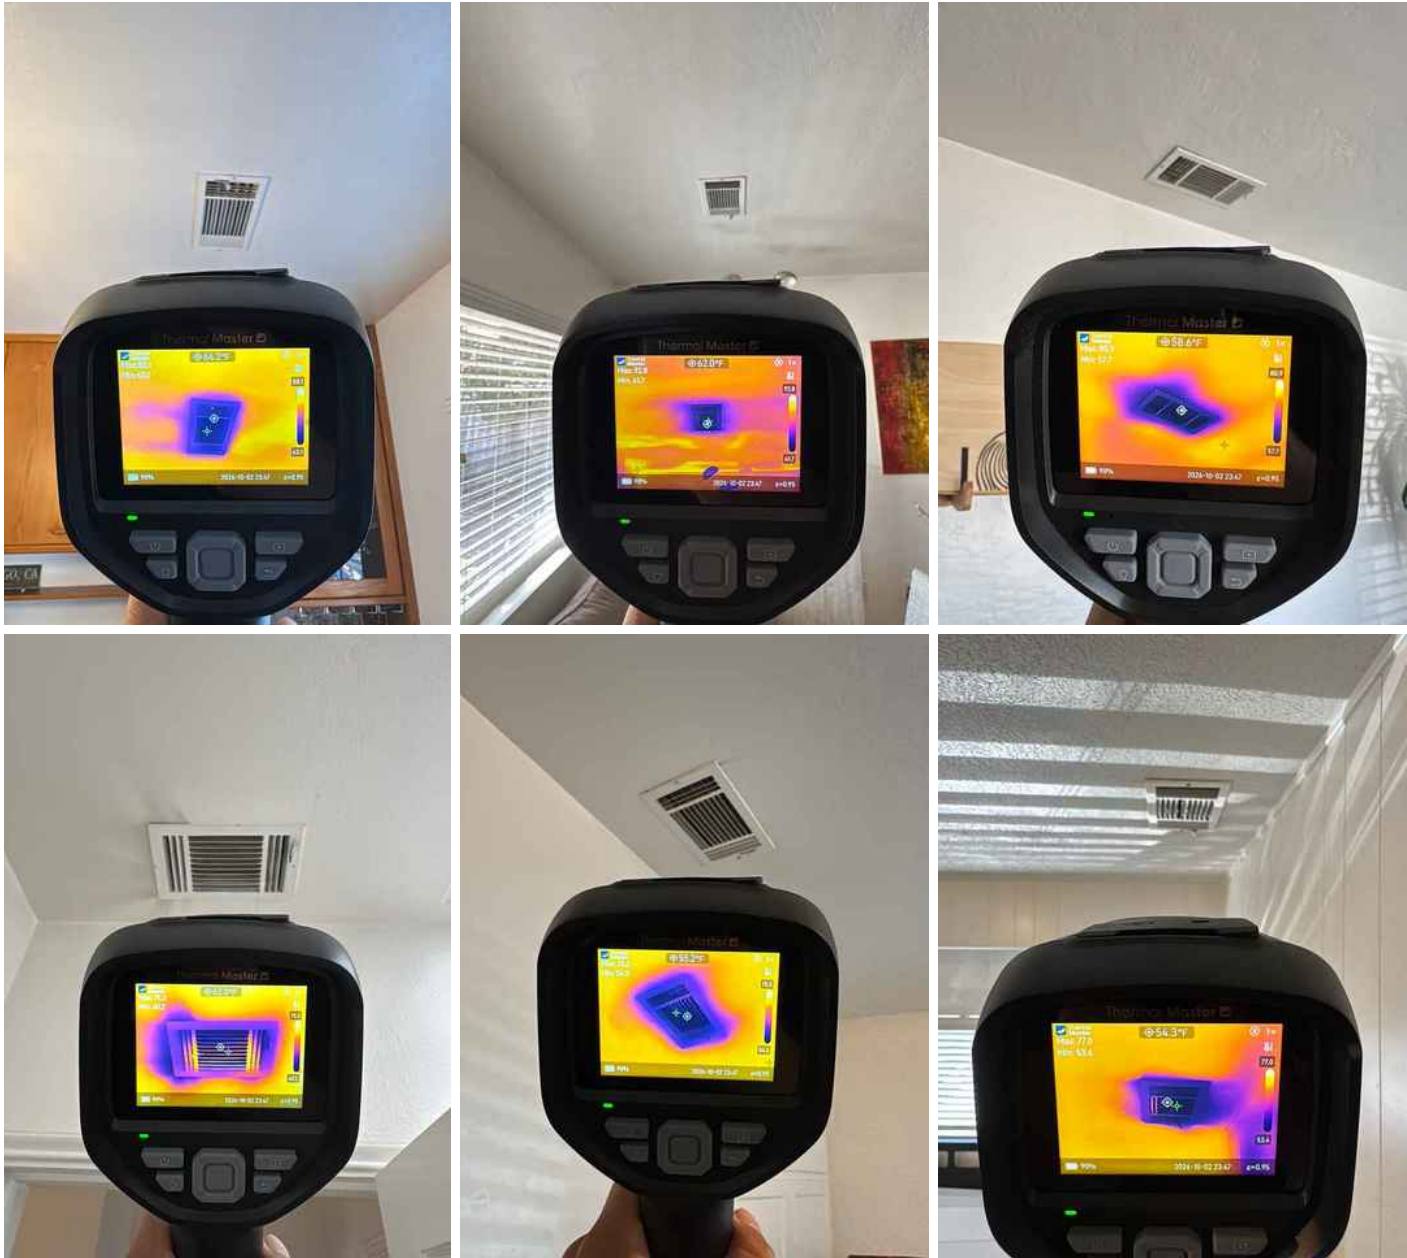
Air Conditioning: Appears Functional

AC unit appears functional.

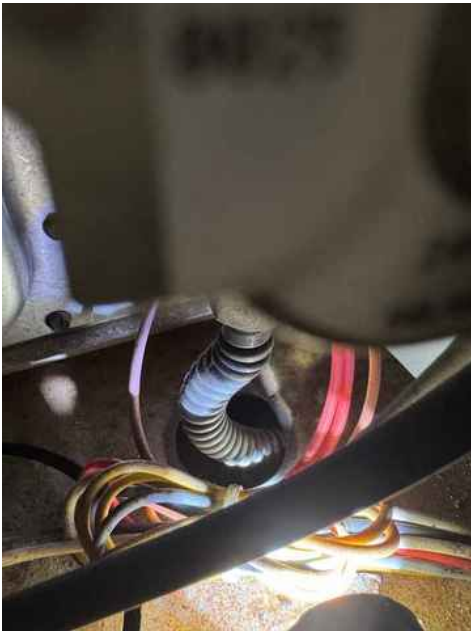
**FLEXIBLE GAS LINE INTO UNIT**

Contact a qualified HVAC professional.

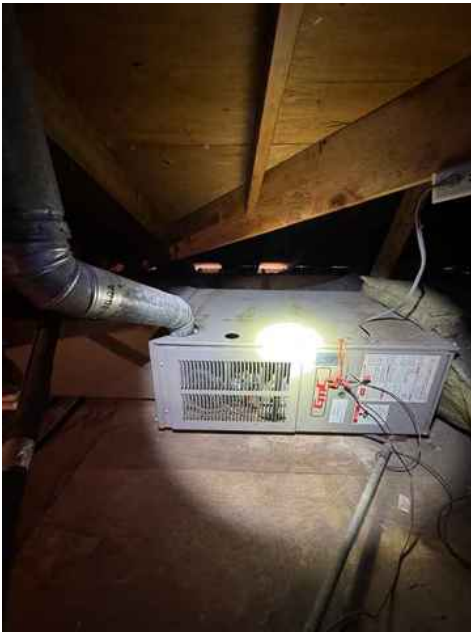
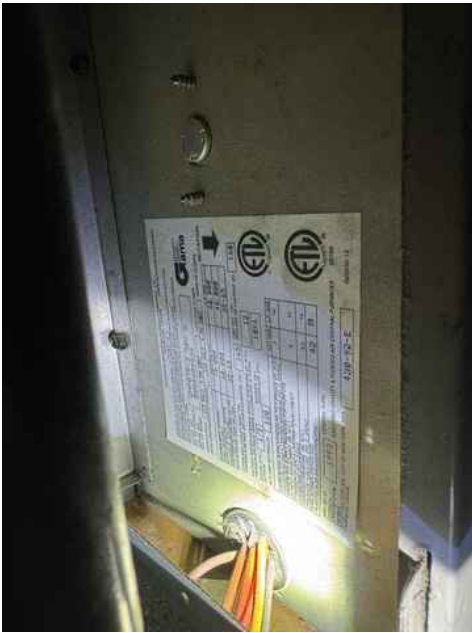
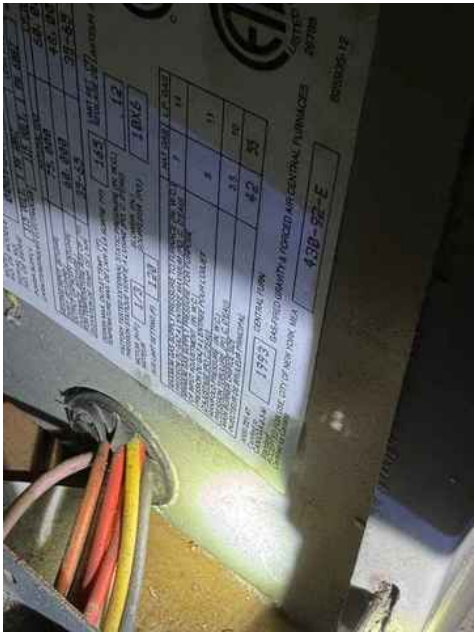
**HORIZONTAL FURNACE - POSSIBLE RECALL**

Regardless of recall status, the unit observed is beyond its intended lifespan and is considered obsolete. Replacement or upgrade is strongly recommended. Further evaluation by a qualified HVAC contractor is recommended to verify recall information, assess the system’s condition, and provide recommendations for repair or replacement.

Recommendation  
Contact a qualified HVAC professional.

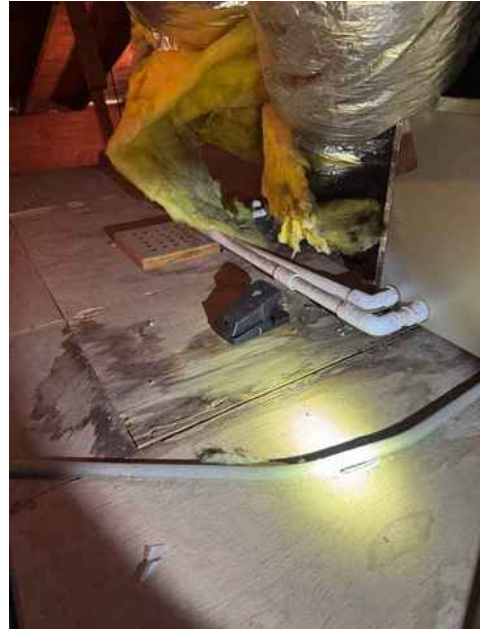
**WATER STAINS NOTED**

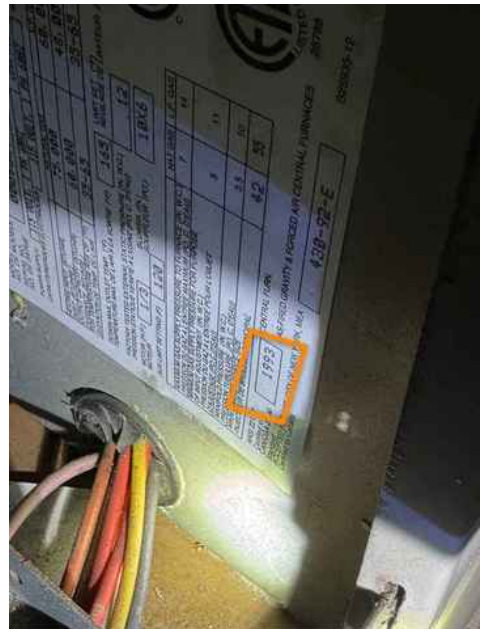
**NEAR OR AT LIFESPAN (FORCED AIR)**

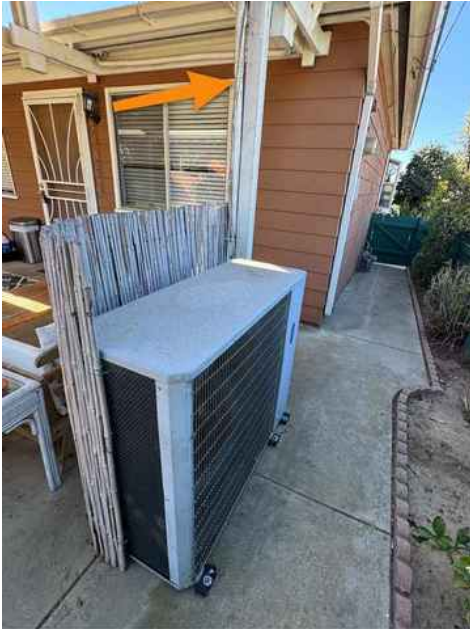
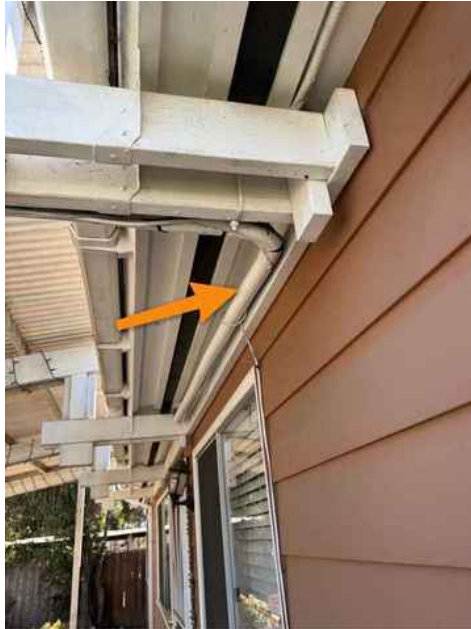
**NO SHROUD (METAL AT WALL)**

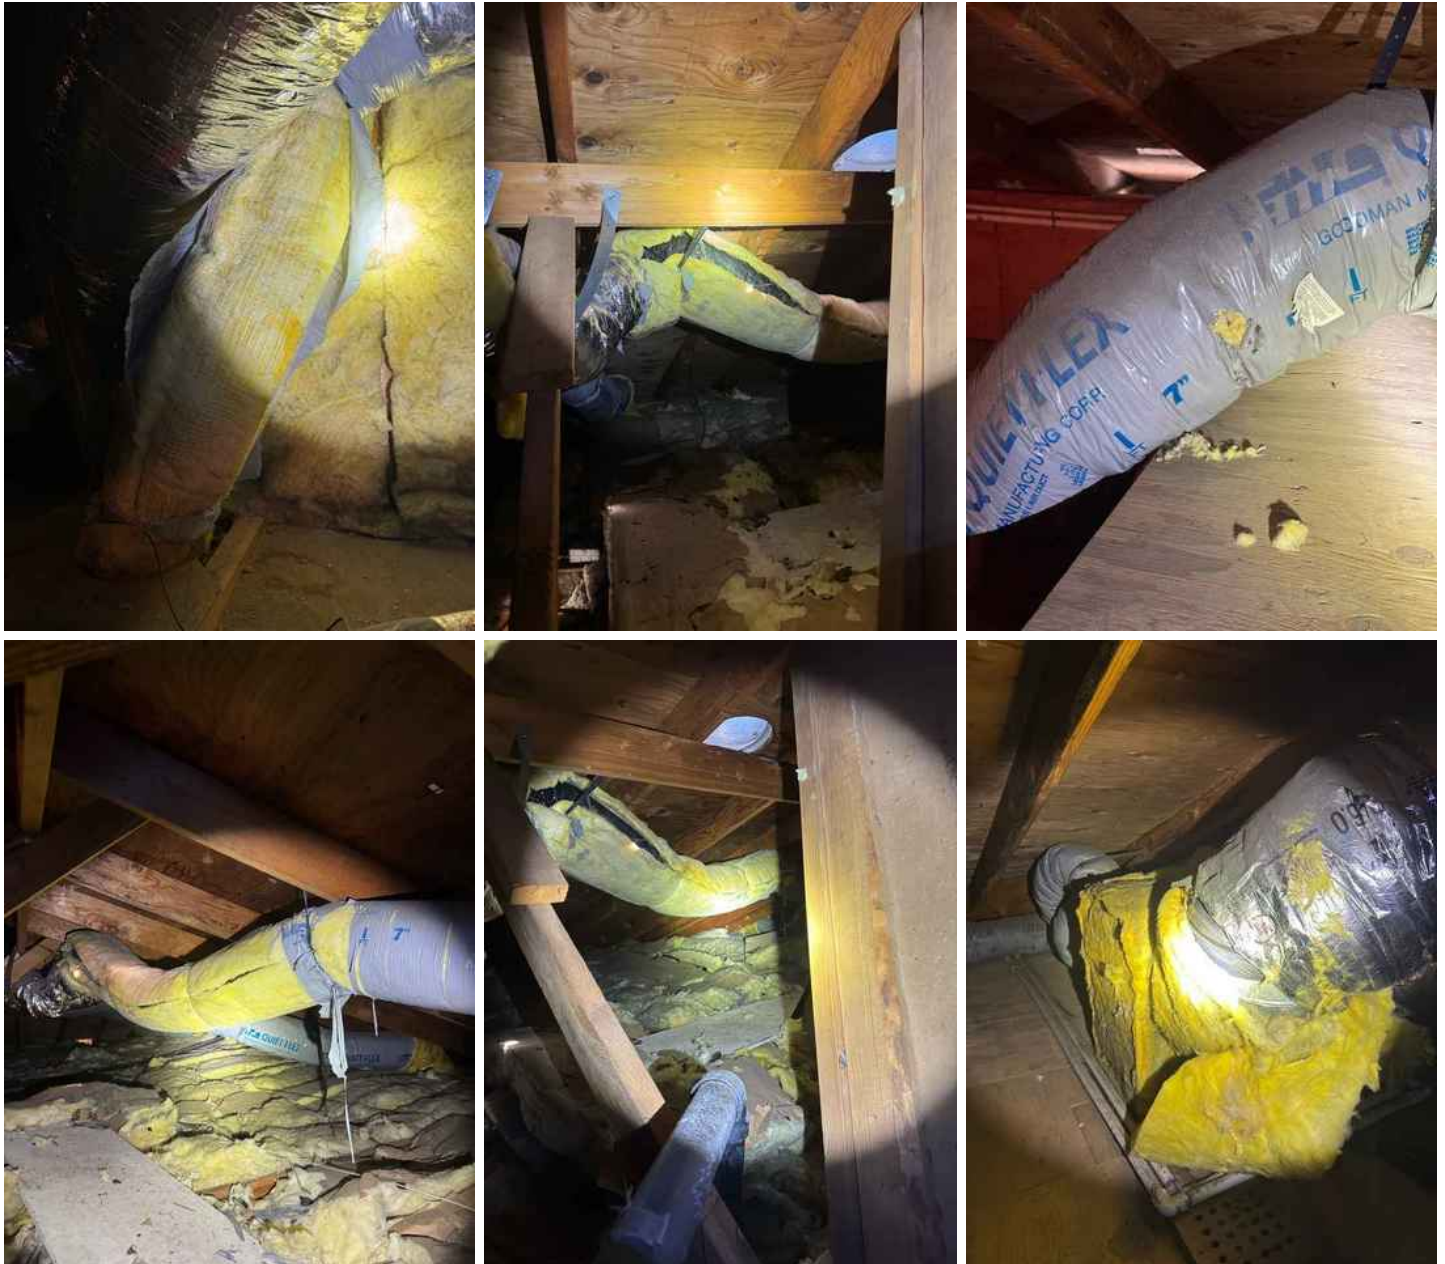
### 10.4.1 Ducts and Registers

#### **INSULATION MISSING / DAMAGED**

Insulation at the ducting appear to be missing, damaged or deteriorated. This can result in reduced energy efficiency. A qualified HVAC professional is recommended to make repairs.

Contact a qualified HVAC professional.

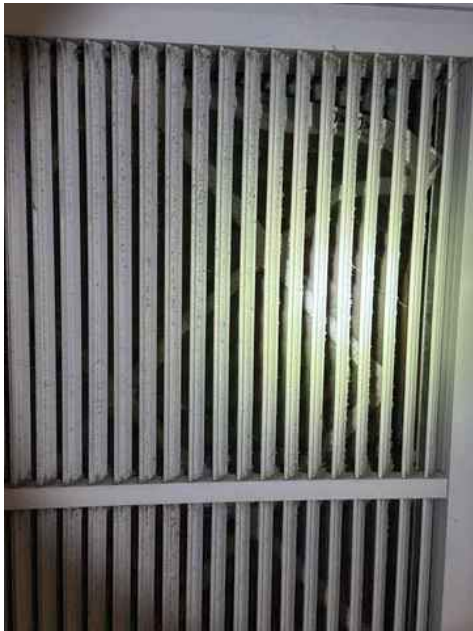
10.5.1 Filter(s) & Thermostat(s)

The heating and/or cooling system's air filters were found dirty at one or more locations. To ensure efficiency, they should be cleaned and/or replaced and appropriately sized. Recommend addressing this by cleaning, repairing, or replacing the filters as necessary.

Recommended DIY Project

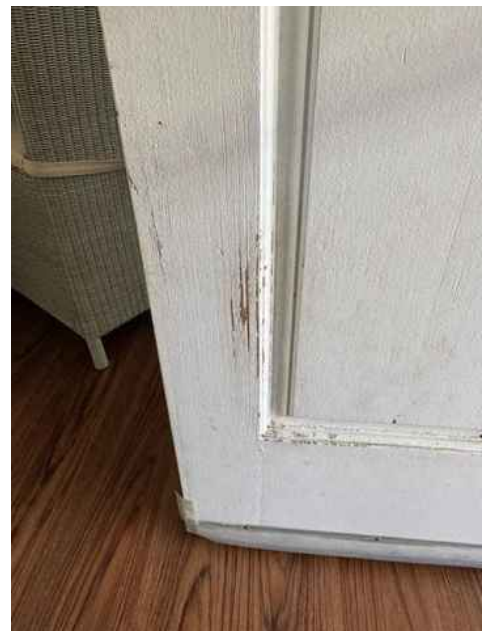
An exterior door is in need of refinishing or painting. A qualified person is recommended to refinish door as needed.

Contact a qualified painting contractor.

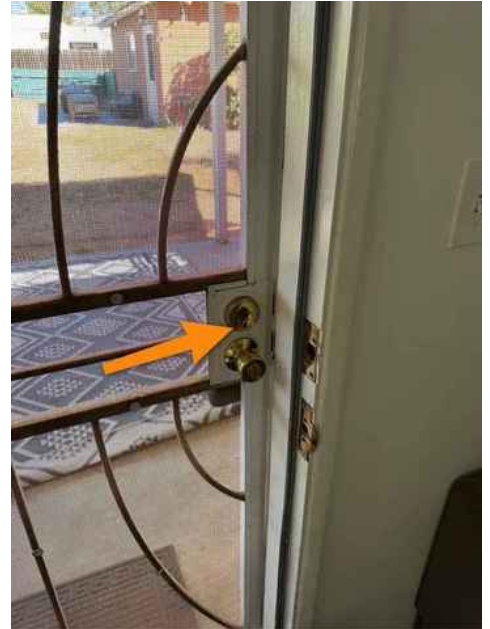
## 11.2.2 Exterior Doors

Locking and/or latching hardware was difficult to operate and/or damaged in one or more areas. A qualified handyperson is recommended to make adjustments or repairs as needed.

Contact a qualified professional.

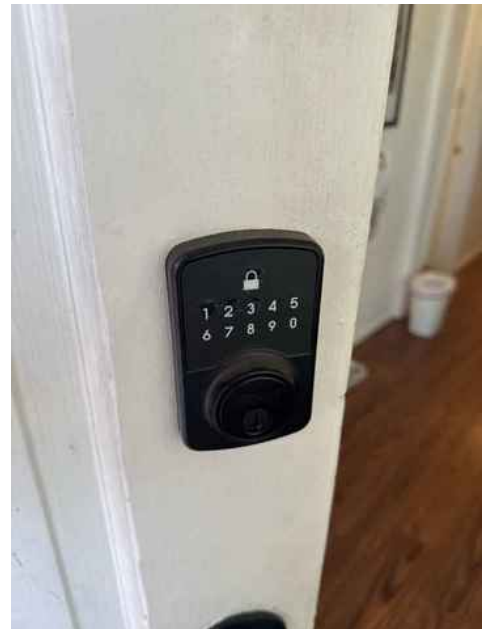
## 11.2.3 Exterior Doors

**KEYLESS ENTRY NOTED**

Keyless entry pad was noted at one or more exterior doors. If available, inquire with the seller regarding this hardware or have a qualified professional further evaluate as needed.

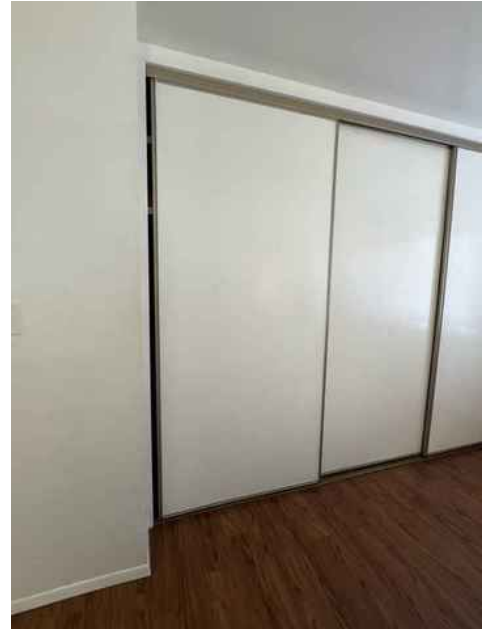
Interior door(s) were difficult to open or close in one or more areas. A qualified handyperson is recommended to make repairs as needed.

Contact a qualified door repair/installation contractor.

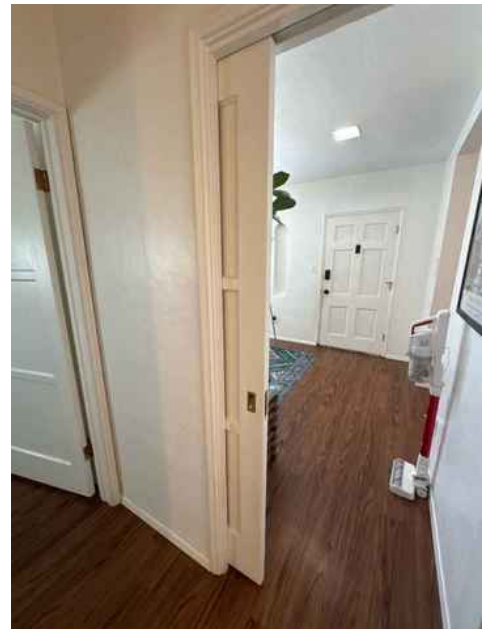
### 11.3.2 Interior Doors

#### **BINDS IN / DRAGS JAMB**

Interior door(s) binded/dragged at the jamb, adjacent door and/or the flooring in one or more areas. The hinge(s) may be loose and need tightening or further repair may be necessary. A qualified professional is recommended for repairs.

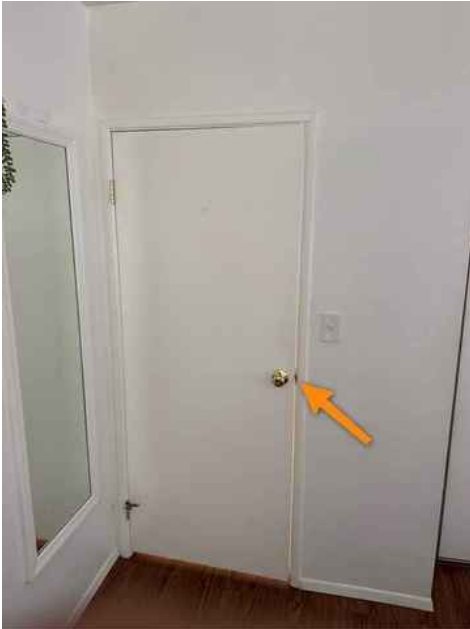
### 11.3.3 Interior Doors

#### **DOOR(S) MISALIGNED / BARELY LATCH**

One or more interior doors were misaligned, barely latched and/or had gaps at jambs. Recommend repairs be made by a qualified contractor.

Contact a qualified door repair/installation contractor.

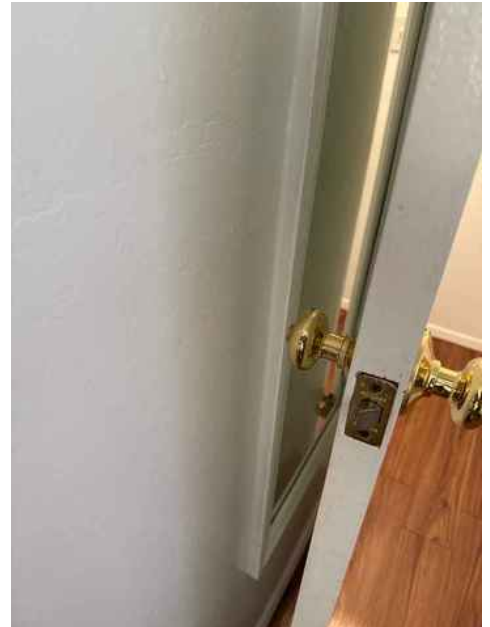
#### 11.3.4 Interior Doors

### DOORSTOP(S) MISSING

Doorstops were missing at one or more areas. A qualified handyperson is recommended to install doorstops where needed.

Contact a handyman or DIY project

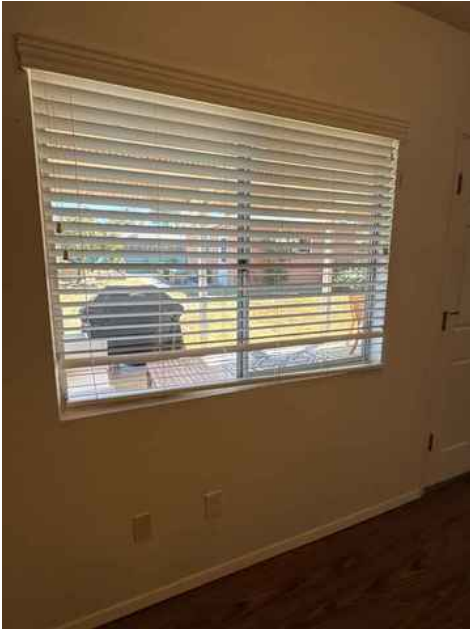
#### 11.4.1 Windows

### TEMPERED GLASS NOT VERIFIED

Tempered glass could not be verified at one or more windows (this is sometimes difficult to view). Recommend confirming that the glass is tempered. If not then upgrades are recommended for added safety.

Contact a qualified professional.

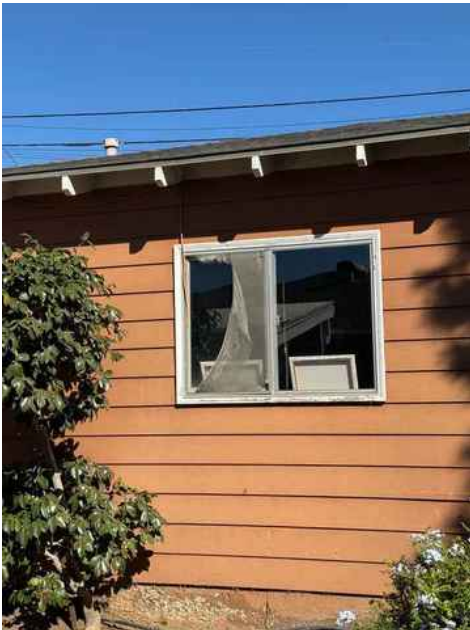
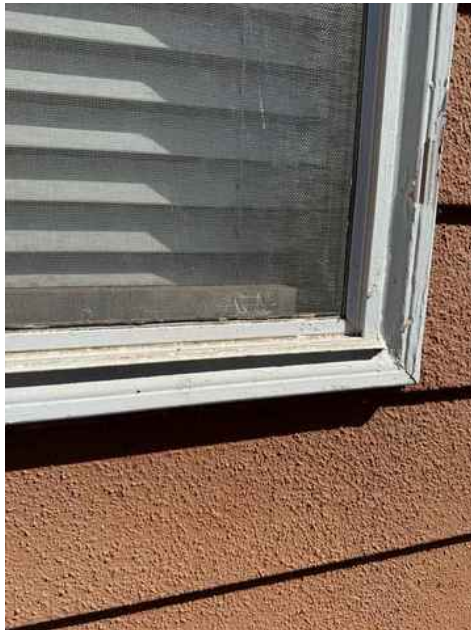
#### 11.4.2 Windows

##### **SCREEN(S) DAMAGED**

Window screens were damaged at one or more areas. A qualified handyperson is recommended to repair or replace screens as needed.

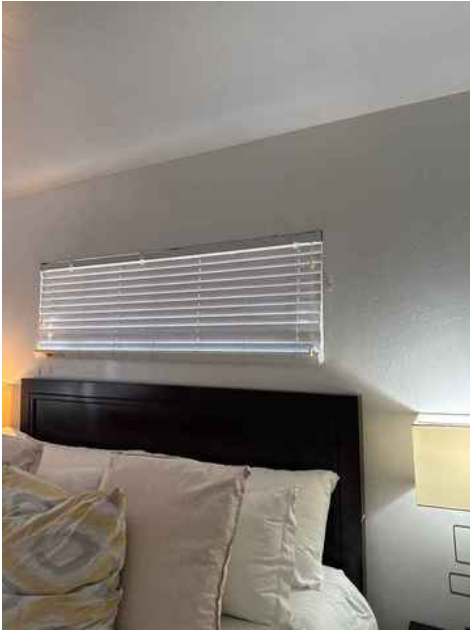
#### 11.4.3 Windows

##### **SCREEN(S) MISSING**

Window screens were missing in one more areas. Installation of windows screens where needed is recommended.

Contact a qualified professional.

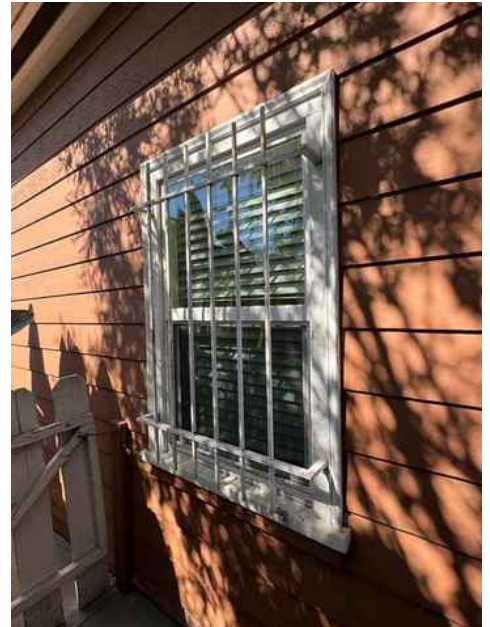
#### 11.4.4 Windows

##### **SECURITY BAR WARNING**

Security bars were present. These may be an emergency escape hazard if not functioning properly or locked when needing to escape from the dwelling. Guests who may not be familiar with their operation may not know how to use these. Client should evaluate their comfort level with these and take whatever action they deem necessary such as removal, etc.

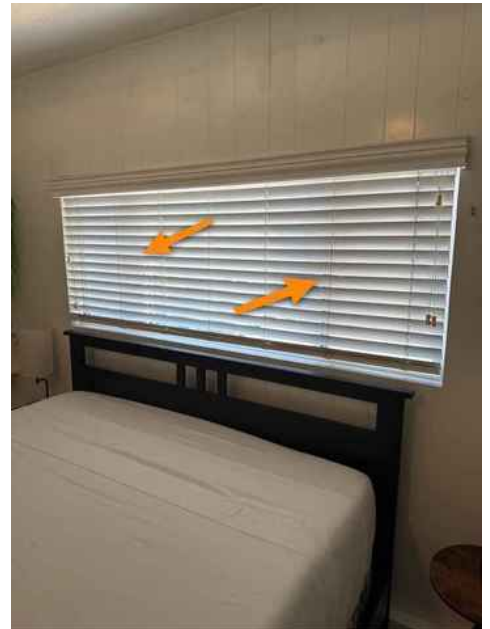
A window lock was difficult to operate at one or more areas. A qualified professional is recommended for repair or replacement of the locks as needed.

Contact a qualified professional.

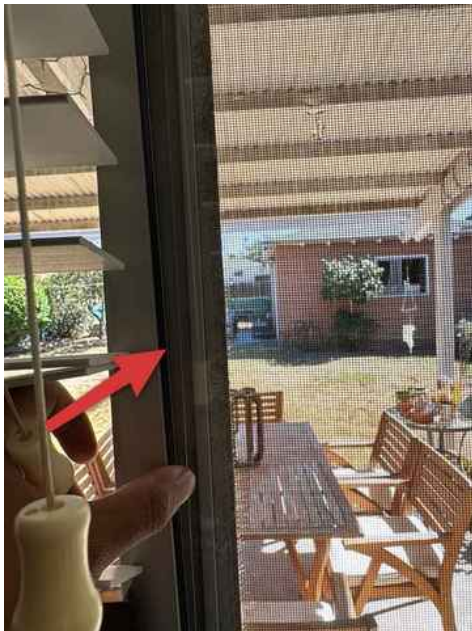
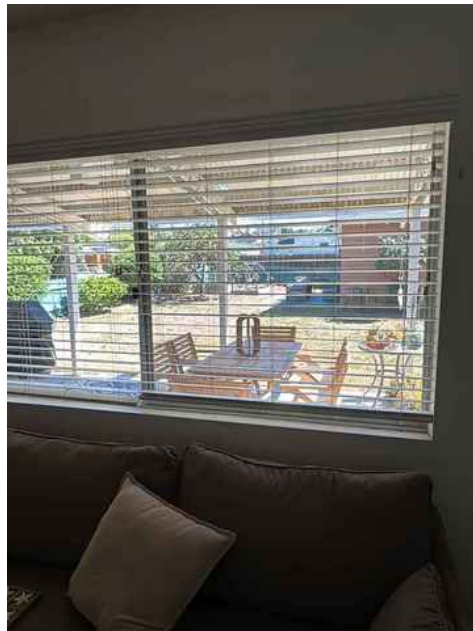
#### 11.4.7 Windows

### INTERIOR WINDOW TRIM LOOSE

The interior trim / casing for the glazing is loose one or more windows. A qualified window contractor is recommended to evaluate and estimate repairs.

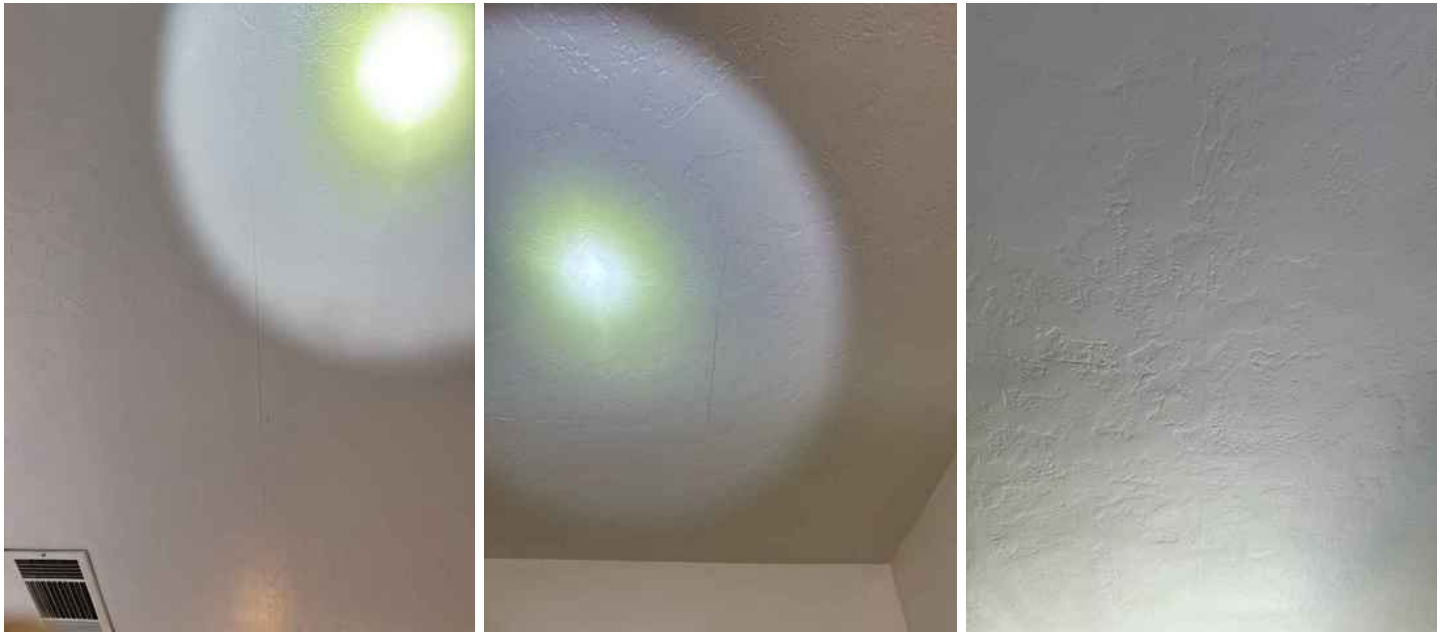
#### 11.5.1 Ceiling

### COMMON CRACKS/DETERIORATION NOTED

Common to moderate cracks were present in one or more areas (typical cosmetic damage). A qualified handyperson is recommended to patch, paint and/or make repairs as needed.

Contact a qualified professional.

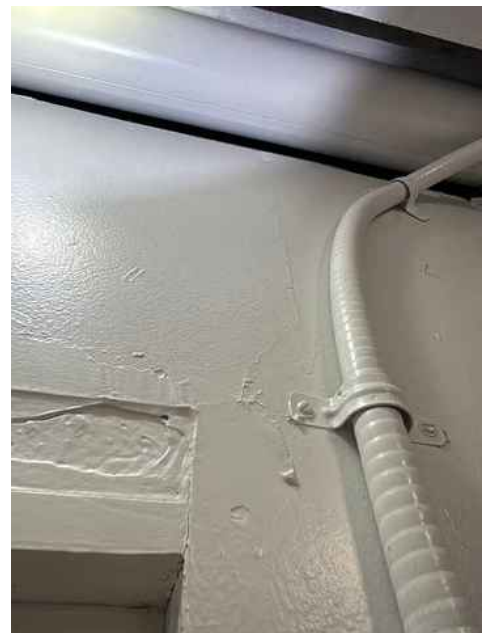
## 11.6.1 Walls

**COMMON CRACKS / DETERIORATION NOTED**

Common to moderate cracks were present in one or more wall and/or ceiling areas (typical cosmetic damage). A qualified professional is recommended for paint and/or repairs as needed. Monitoring cracks for signs of further movement and repair as needed.

Contact a handyman or DIY project

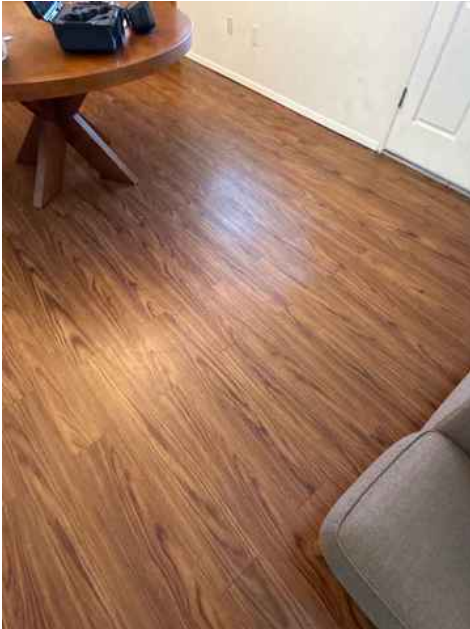
## 11.7.1 Floors

**FLOORS NOT LEVEL / SLOPED**

Floors in one or more areas were not level. Repairs may be needed to make floors level. A qualified contractor is recommended for further evaluation and repairs to make floor level.

Contact a qualified general contractor.

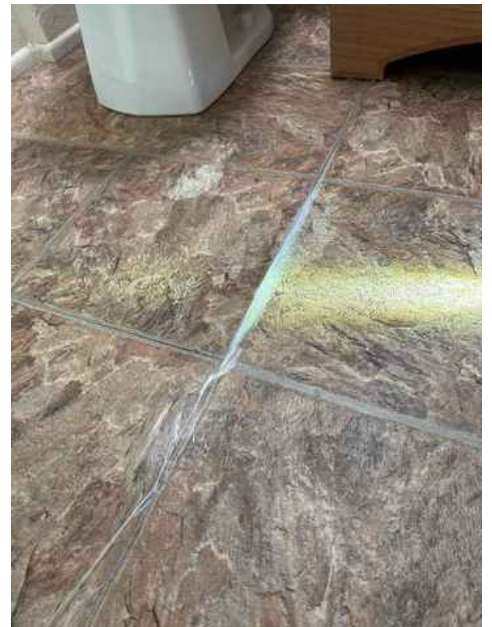
##### **VINYL FLOOR DAMAGE / LIFTING / FAULTY**

Vinyl/linoleum flooring in one or more areas was damaged, lifting and/or faulty. Recommend that a qualified contractor replace or repair flooring as necessary.

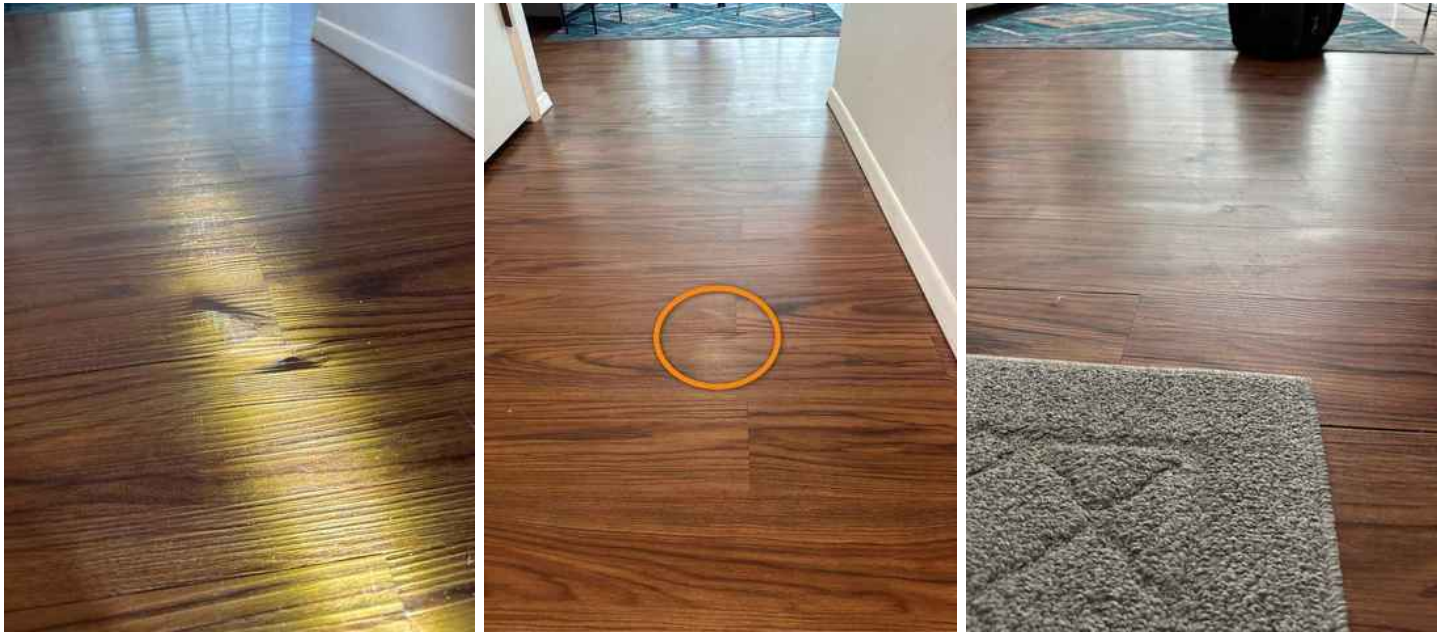
#### 11.7.4 Floors

##### **WOOD FLOOR DAMAGED**

Wood flooring in one or more areas was deteriorated, worn and/or damaged. A qualified professional may be desired for further evaluation and to discuss refinishing or replacement of the floor cover as needed.

Contact a qualified flooring contractor

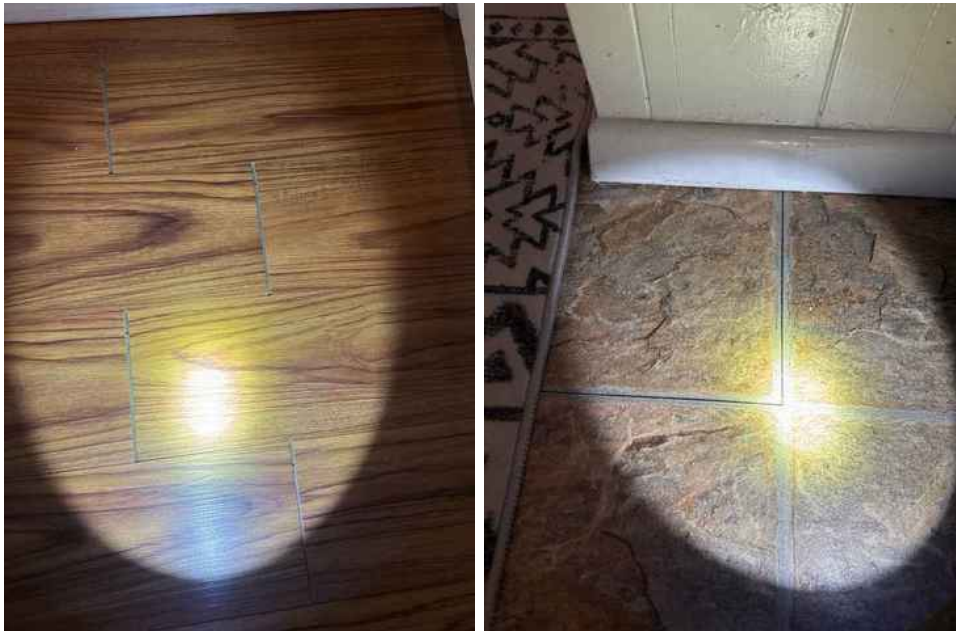
The wood and/or laminate floor had gaps at one or more locations. Recommend repairs be made by a qualified flooring contractor.

Contact a qualified flooring contractor

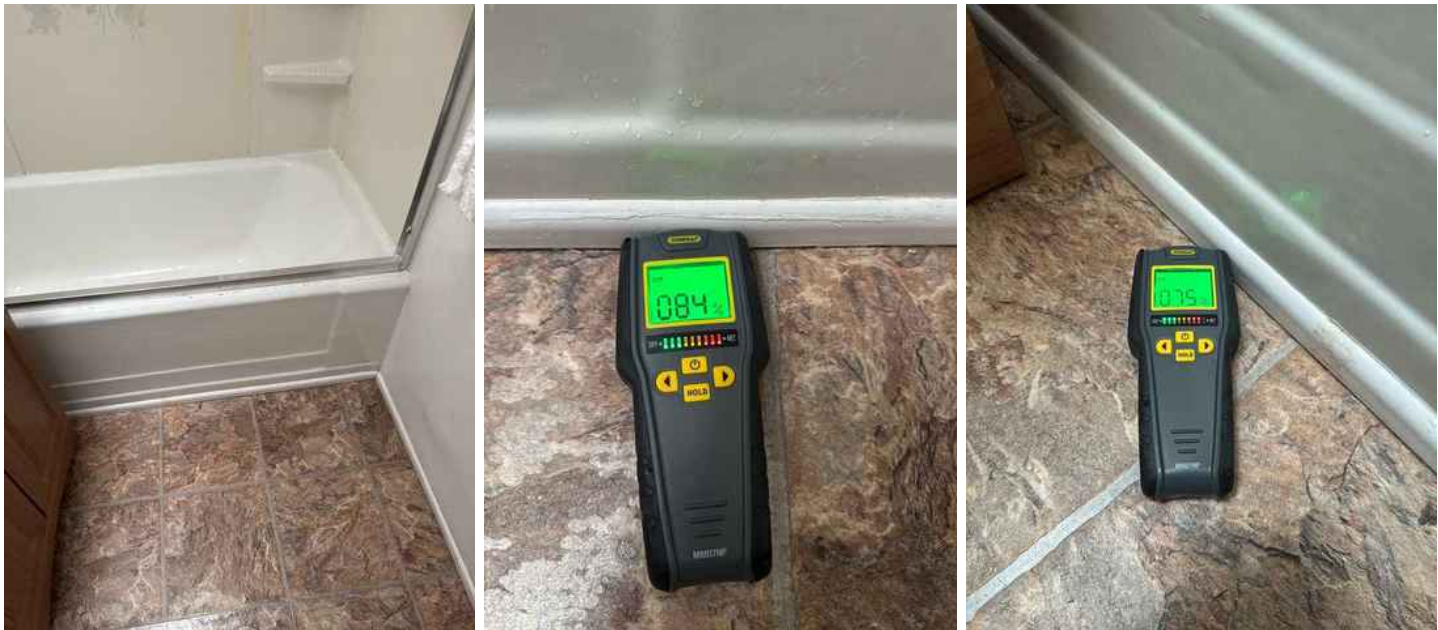
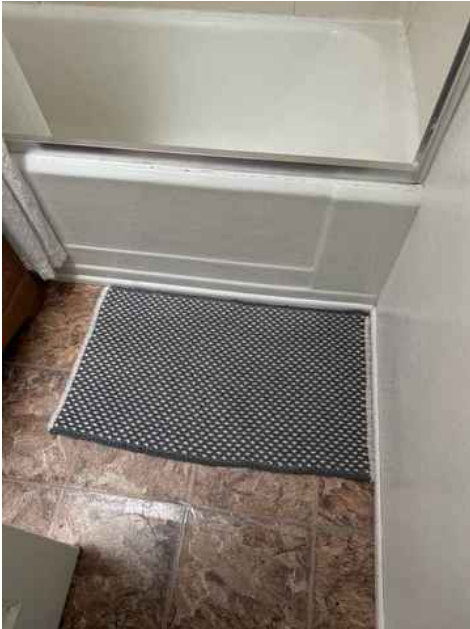
11.7.7 Floors

ACTIVE MOISTURE INTRUSION NOTED

\*The property was being used as an Airbnb. There were professional cleaners present and the shower mat may have contributed to the elevated reading. Monitor conditions.

Contact a qualified professional.

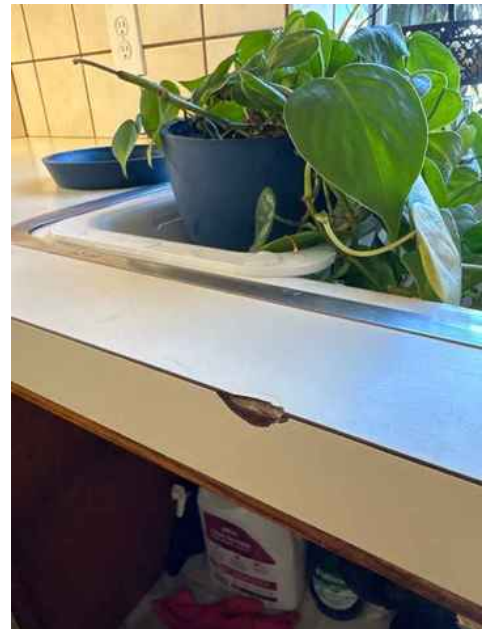
#### 11.8.1 Countertops & Cabinets

### COUNTERTOP DAMAGED

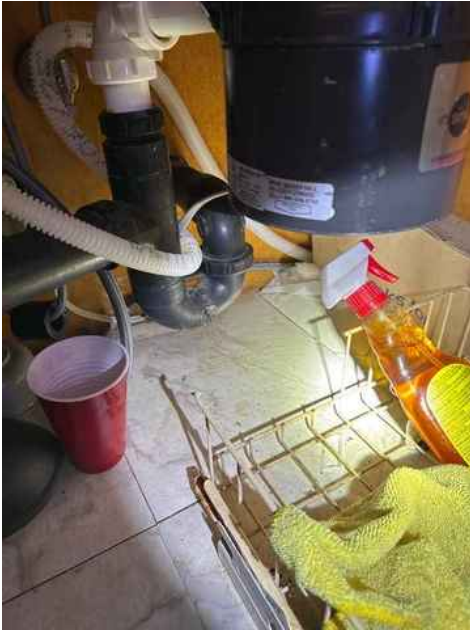
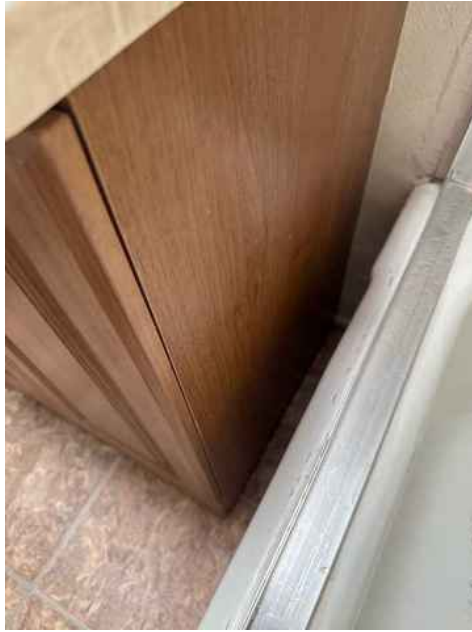
#### 11.8.2 Countertops & Cabinets

### WATER DAMAGE BELOW SINK

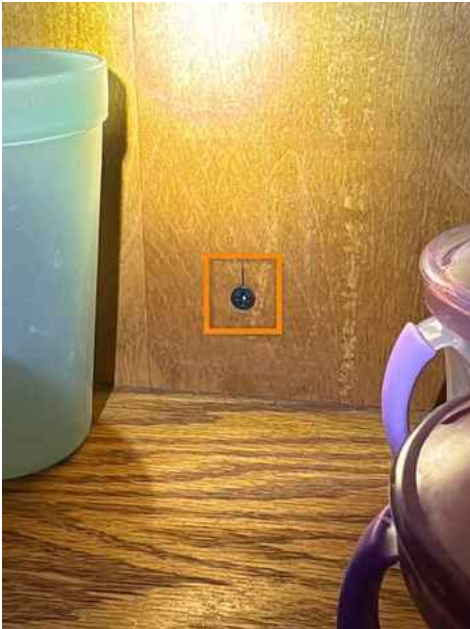
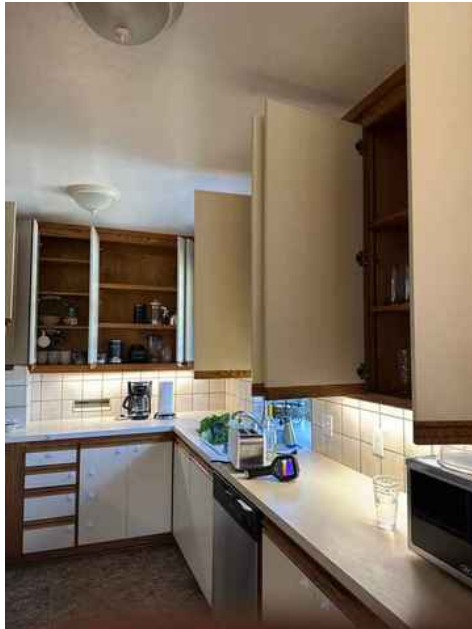
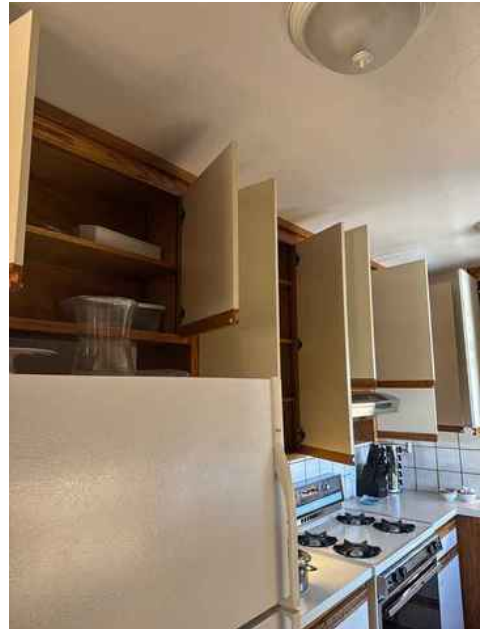
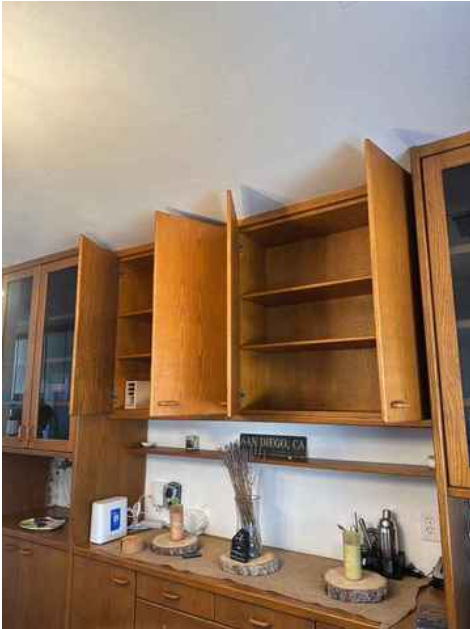
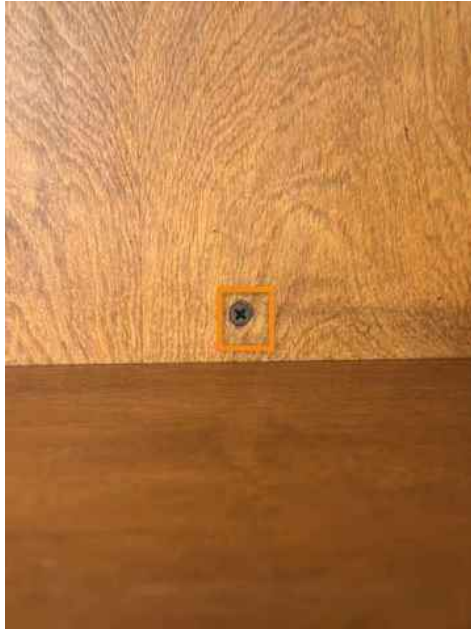
### 11.8.3 Countertops & Cabinets

#### **CABINETS / HARDWARE SUBSTANDARD**

Contact a handyman or DIY project

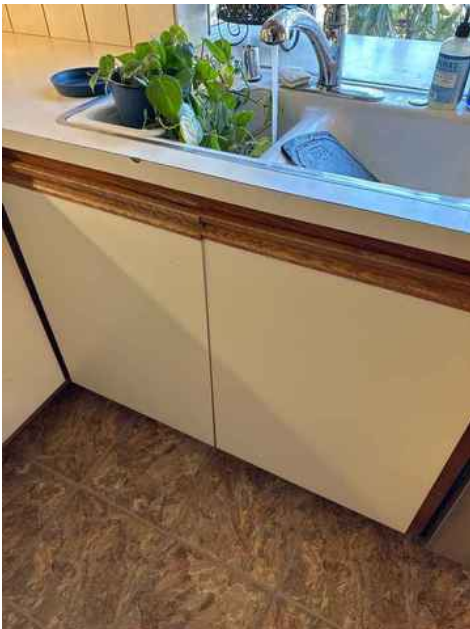
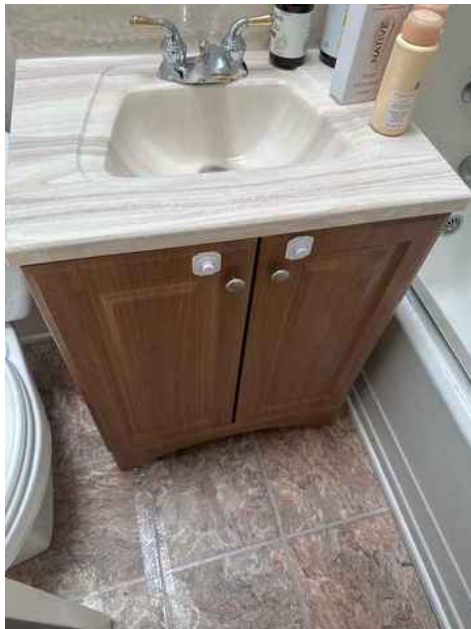
#### 11.8.4 Countertops & Cabinets

### ADJUST CABINET DOOR(S) OR DRAWER(S)

Contact a handyman or DIY project

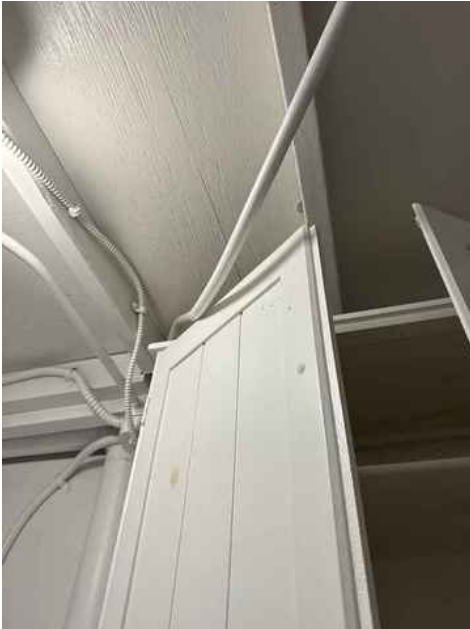
#### 11.8.5 Countertops & Cabinets

### CABINET CLEARANCE UNUSUALLY TIGHT

The clearances around one or more cabinets were unusually tight. Alterations may be desired.

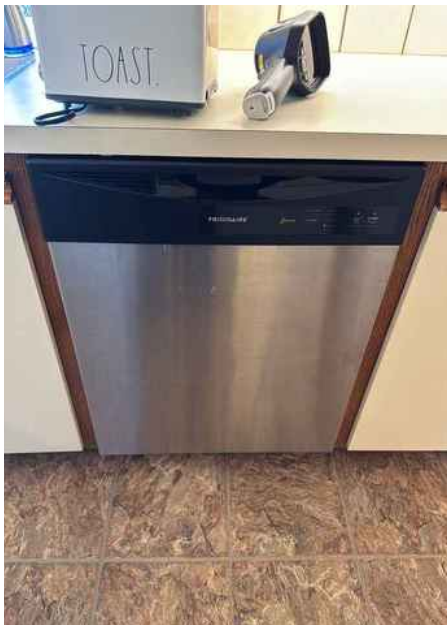
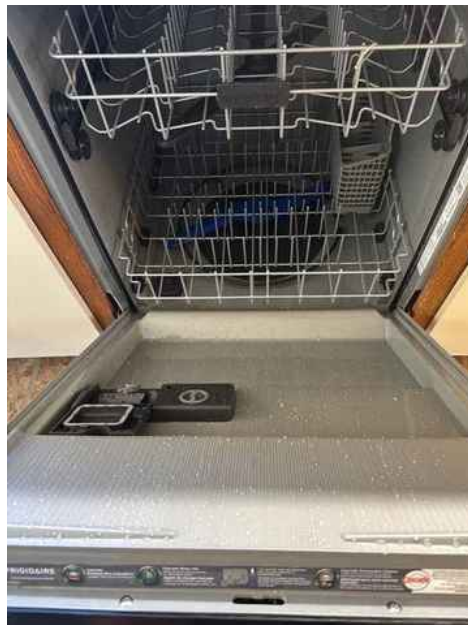
**Dishwasher: Dishwasher Functional**

The dishwasher turned on and appeared to complete a wash cycle at the time of the inspection. However, this is not a guarantee that this unit will not leak at some time in the future. We recommend purchasing a home warranty to cover the unit an possible damages that may result from a leak.

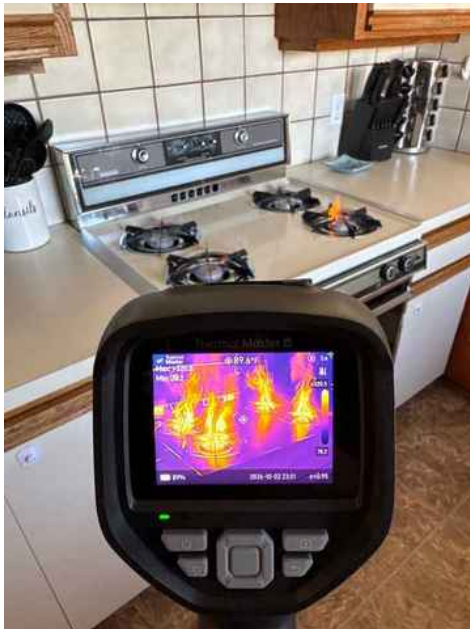
Infrared picture of range/cooktop in operation. This unit appeared operational.

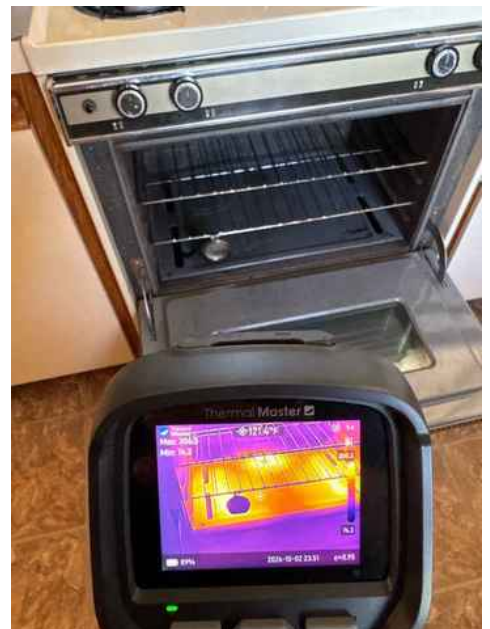
#### **THERMAL IMAGE OF OVEN WORKING**

Thermal image of the oven working. This unit appeared functional.

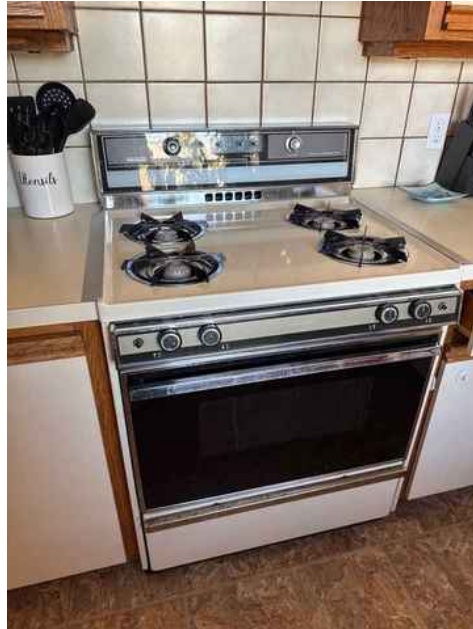
#### **ANTI - TIP BRACKET NOT INSTALLED / INEFFECTIVE**

The range did not appear to have an anti-tip bracket installed. These brackets have been sold with all free-standing ranges since 1985. This could pose a safety hazard since the range can tip forward when weight is applied to the open door, such as when a child climbs on it or if heavy objects are dropped on it. Installation of an anti-tip bracket is recommended for added safety.

Contact a qualified professional.

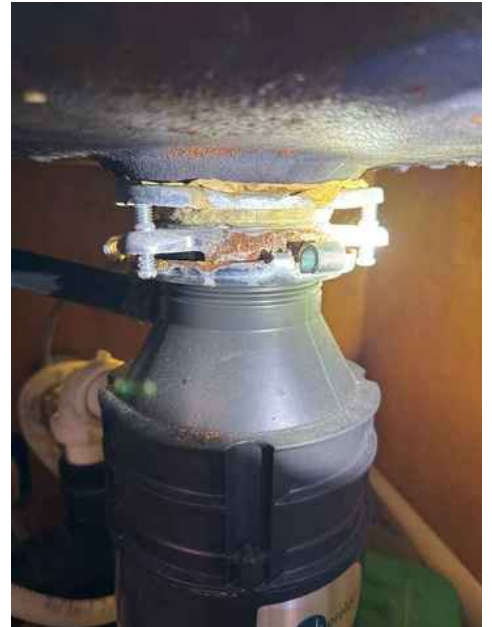
### **RUST AT DISPOSAL**

Rust was present. This is indicative of past leaks. No leaks were noted at the time of inspection. Monitoring this installation and/or have a qualified appliance repair professional further evaluate and repair/replace for preventative maintenance reasons.

Contact a qualified professional.

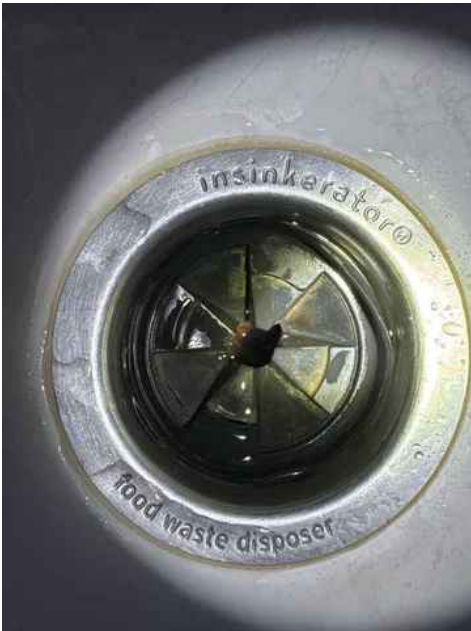
### **RUST IN UNIT**

Significant rust was noted inside one or more units. Upgrades and or monitoring is recommended.

Contact a handyman or DIY project
