## KEEN EYE HOME INSPECTION REPORT

2251 Chicago St  
San Diego, CA 92110

Shaylie Fraser  
10/03/2026

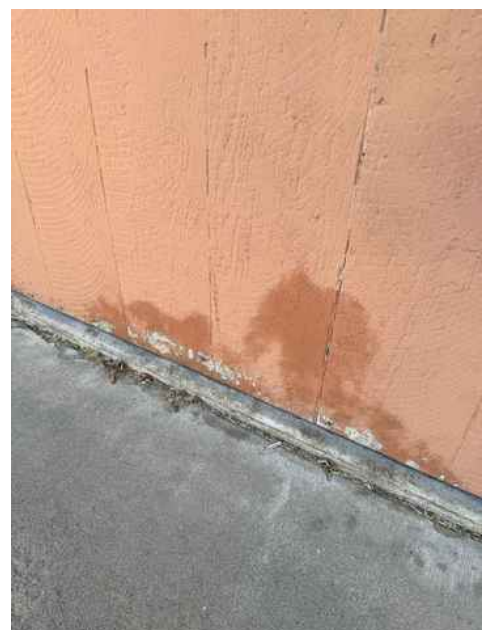
The garage door is in need of refinishing or painting. A qualified professional is recommended to refinish or paint as needed to prevent deterioration.

Contact a qualified professional.

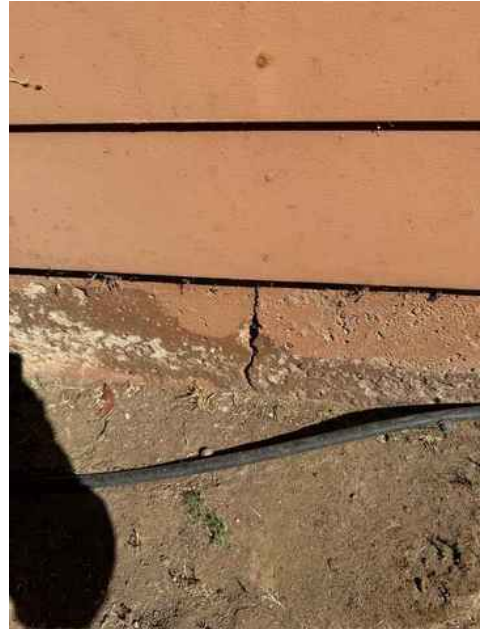
**CRACKING NOTED - PATCH AND REPAIR**

One or more patched cracks were observed in the concrete slab. These do not currently appear to pose a structural concern. Inquire with the seller regarding cracks and need for maintenance. Continued monitoring is advised, and further evaluation and repair by a qualified professional is recommended if widening is noted.

Contact a qualified professional.
