# **Confidential Pre-Listing Inspection Report**

## **7890 E. Sprint St. Unit #15E Long Beach, CA**

### **February 4, 2026**

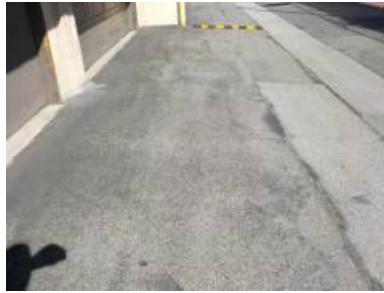
Cracks and stains observed are typical.

Probable HOA maintained.

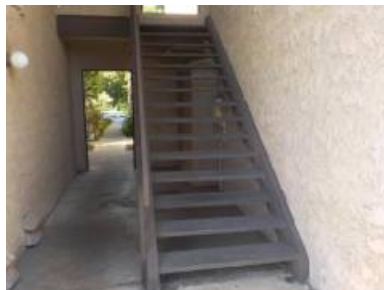
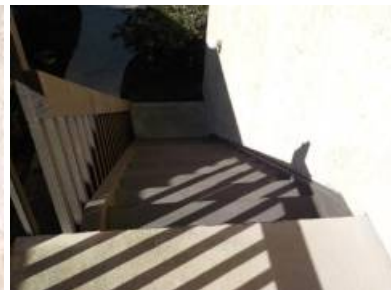
*Exterior Steps / Stoops:*

Appear serviceable.

Probable HOA maintained.

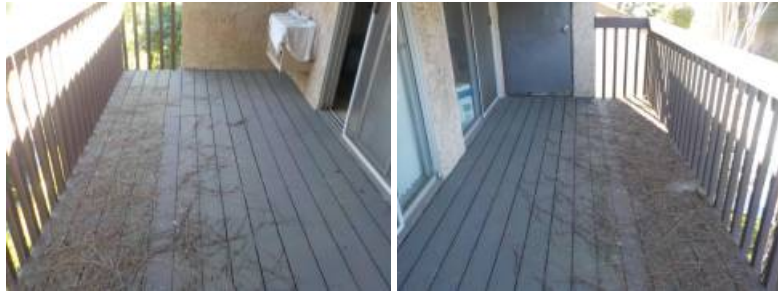
**Patio / Porch:**

Condition: Appears serviceable  
Handrail system appears serviceable

Probable HOA maintained

**Please Note: review the termite inspection report for more information including recommended remediation.**

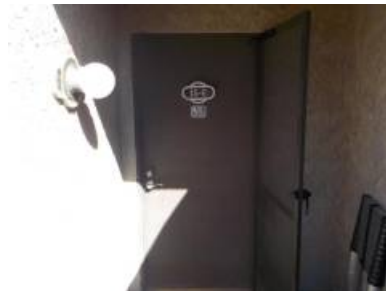
**There is no doorbell**

Recommend installation.

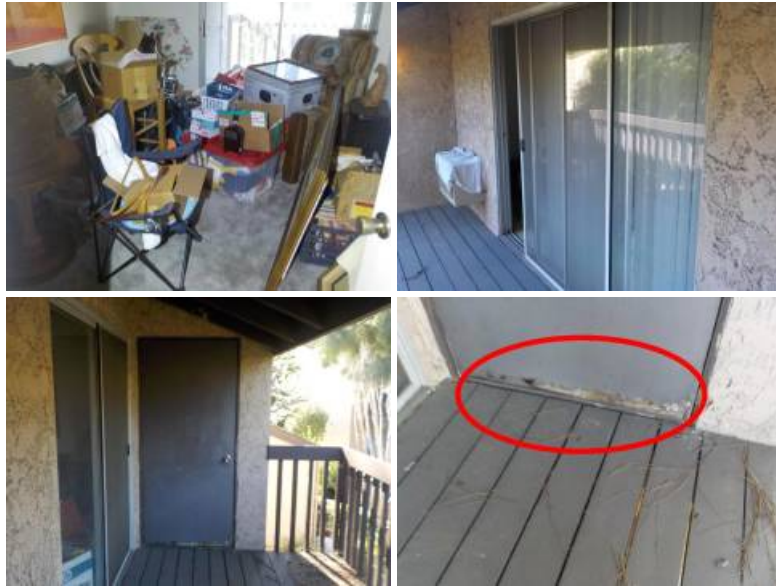
Please Note:  
Unable to fully inspect due to stored personal items.

Deck:  
**Door is damaged on the bottom**  
Recommend remediation.

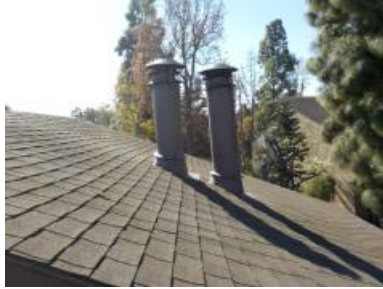
*Flue:*

The inspection is limited to the visible portions of the fireplace flue. Drop light, mirrors, and smoke testing are not a part of the inspection. Visibility is limited to as little as 5% of the flue. If further investigation is recommended, the services of a qualified professional chimney sweep should be obtained.

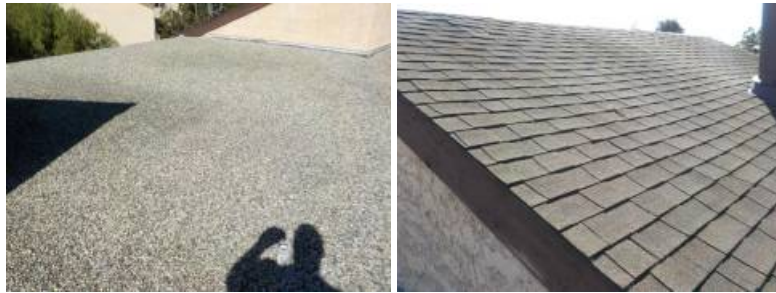
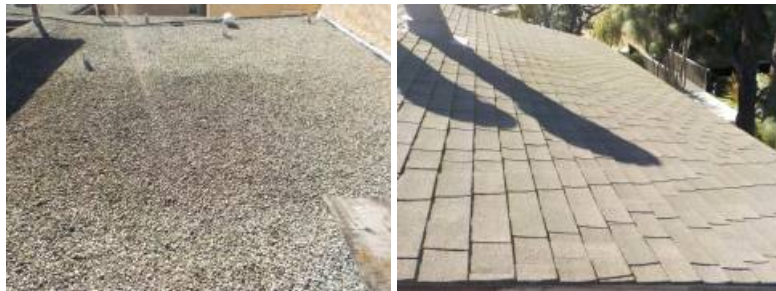
### Roof:

Style: Combo (Flat & Shed)  
 Roof Access: Mounted (walked on roof)  
 Roof Covering: Asphalt shingles & Rock over Tar.

Roof Covering Condition: General condition appears serviceable with signs of weathering and aging. Regular maintenance and inspections are advised.

Probable HOA maintained

**Please Note: in no way can inspector determine if there will be any roof leaks. If client seeks that kind of certainty they should hire a licensed roofing contractor to perform a comprehensive inspection and "leak free certification" of the entire roof structure.**

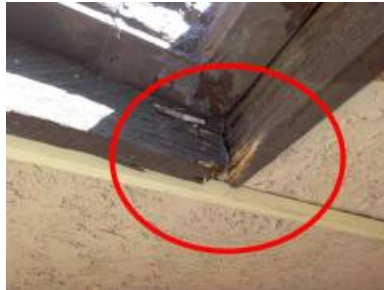
**Please Note: review the termite inspection report for more information including recommended remediation.**

**Probable HOA maintained.**

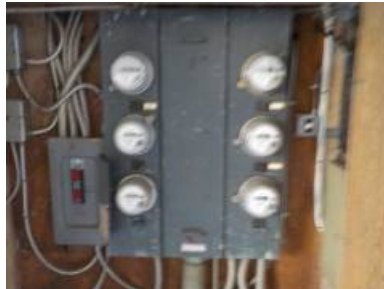
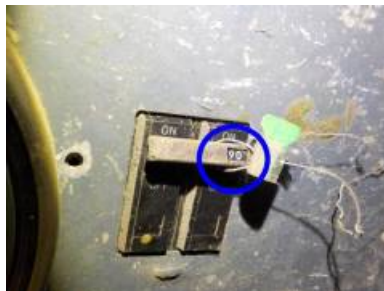
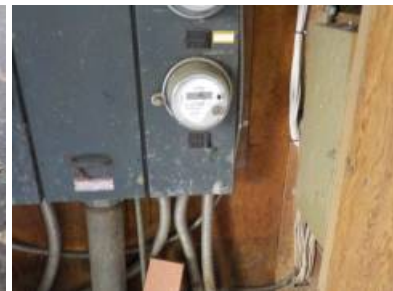
### Electrical Distribution Panels:

**This is a "Zinsco" panel (potential safety hazard)**

Main Panel Location:                      Exterior of house in HOA maintained area.

Main Circuit Rating:                      100 amps.

**Recommend further inspection and deemed necessary repairs by a licensed electrician**

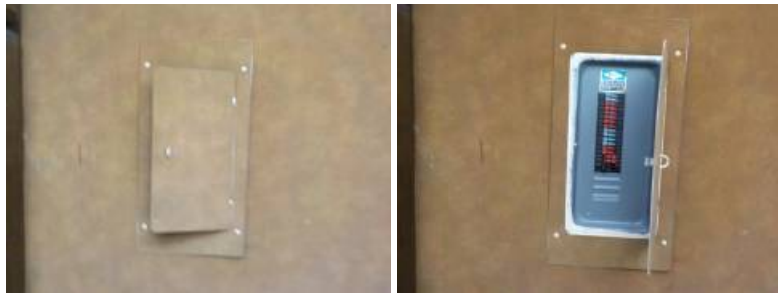
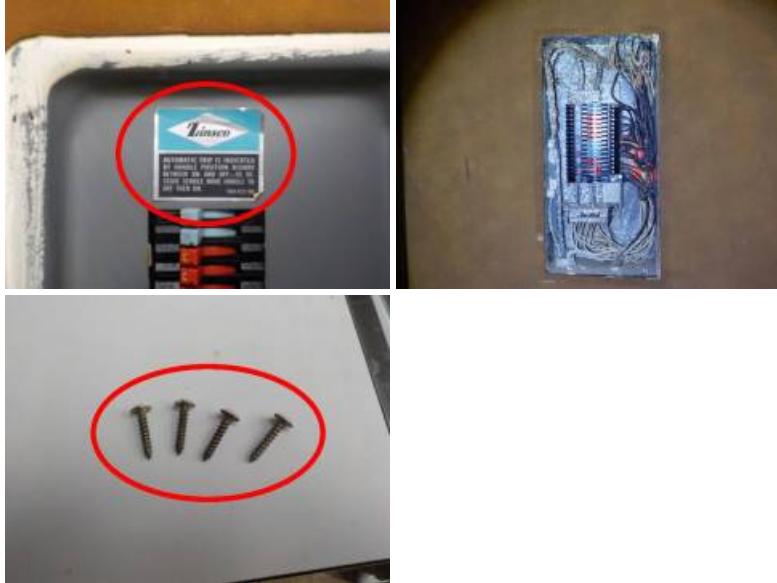
Subpanels-location:

**This is a "Zinsco" panel (potential safety hazard)**

Interior.

**Recommend further inspection and deemed necessary repairs by a licensed electrician**

Recommend installation of blunt tipped screws.

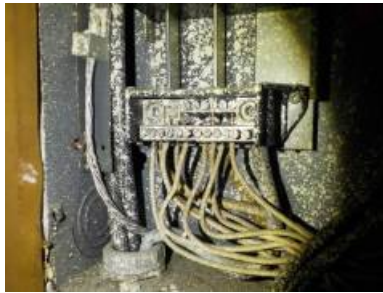
Branch Wiring:

Copper

Please Note: the determination of the type of branch wiring is primarily determined by the visual inspection of the main panel.  
We do not remove outlet covers to evaluate the type(s) of branch wiring.

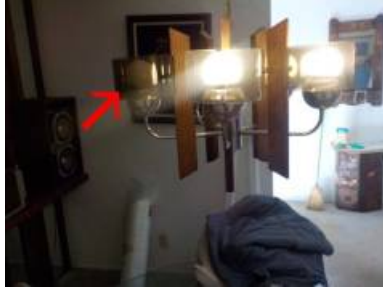
A representative sampling of switches was tested.  
As a whole, switches throughout the house are in serviceable condition with the following observed:  
Dining Room: **multiple bulbs are not functioning**  
Recommend remediation.

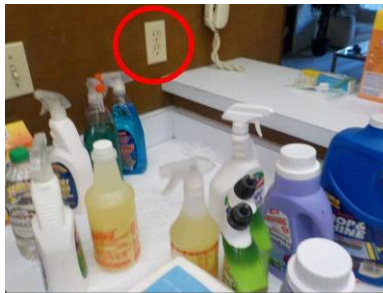
**6 receptacles within 6' of the water source (sink) are not GFCI (Ground Fault Circuit Interrupter) protected - improper**

**Not GFCI protected - improper**

Installation of GFCI receptacles at all outlets within 6' of the water source (sink) are required to restore to safe and compliant conditions.

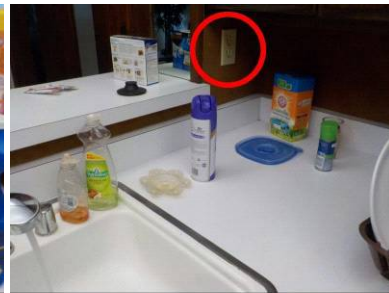
**Not GFCI protected - improper**

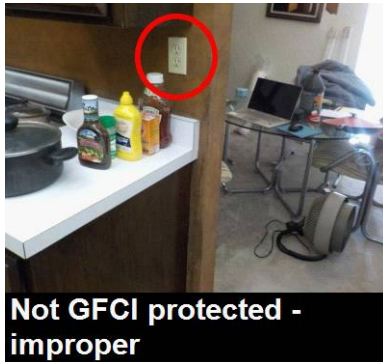
**Not GFCI protected - improper**

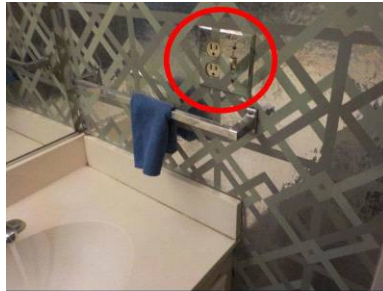
**4 receptacles within 6' of the water source (sink) are not GFCI (Ground Fault Circuit Interrupter) protected - improper**  
**This is a safety and compliance issue.**

**Not GFCI protected - improper**

Installation of GFCI receptacles at all outlets within 6' of the water source (sink) are required to restore to safe and compliant conditions.

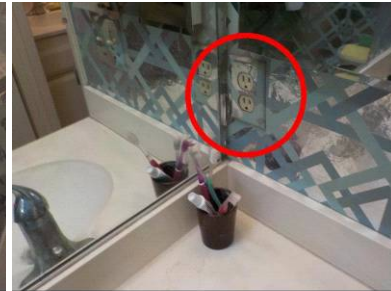
**Not GFCI protected - improper**

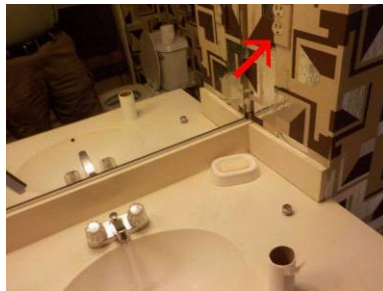
**2 receptacles within 6' of the water source (sink) are not GFCI (Ground Fault Circuit Interrupter) protected - improper**  
**This is a safety and compliance issue.**

**Not GFCI protected - improper**

Installation of GFCI receptacles at all outlets within 6' of the water source (sink) are required to restore to safe and compliant conditions.

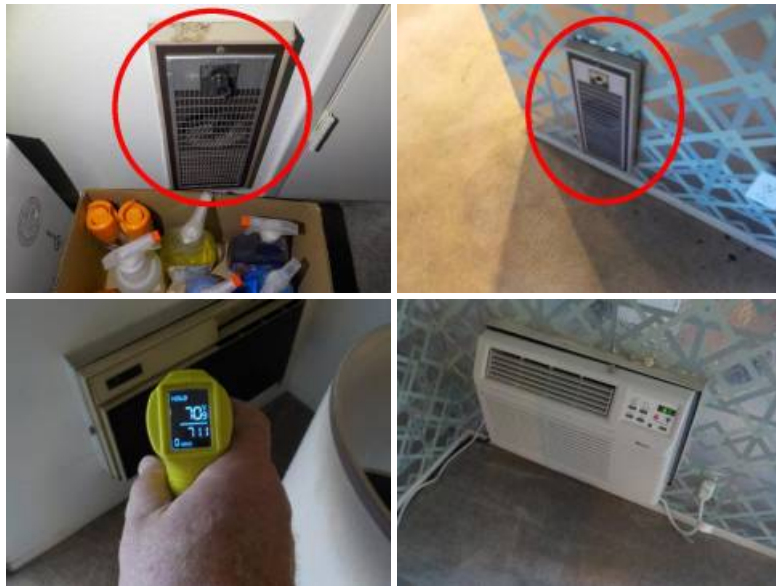
Appear serviceable with the following observed:

Both Bedrooms: **original units are not functioning - improper.**

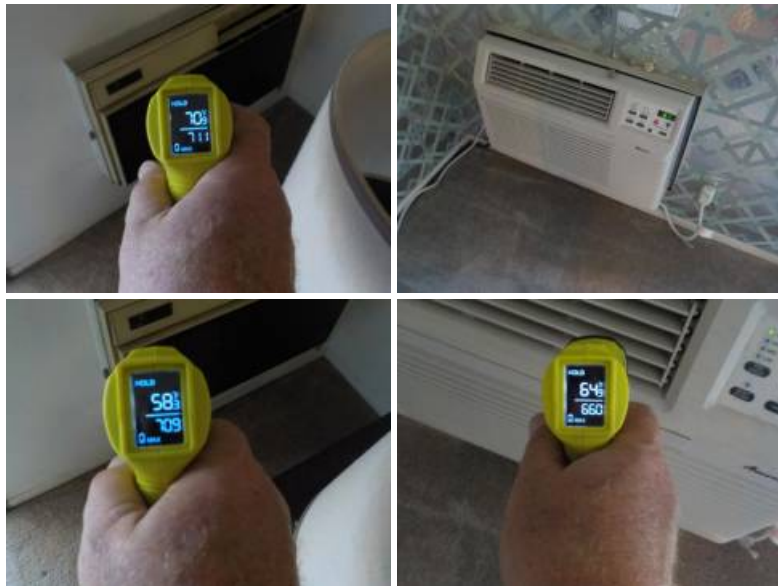
### Air Conditioning:

Window/Wall Units only  
No forced AC is provided.

Both:  
Appear to be older.

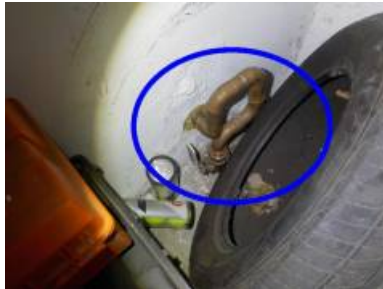
Material:

Copper is the primary visible material being used.

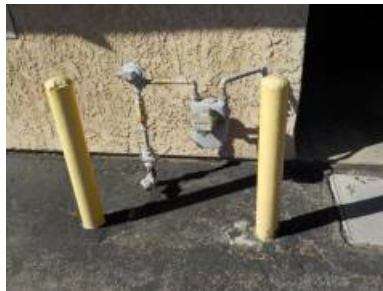
Please Note: there is no emergency gas shut-off valve wrench - improper

Please Note: recommend the installation of a seismic shut-off valve.

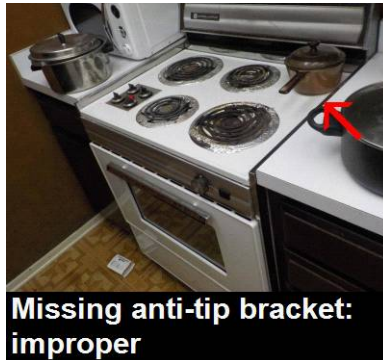
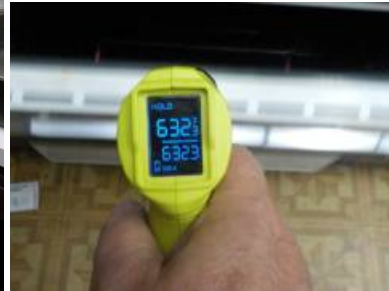
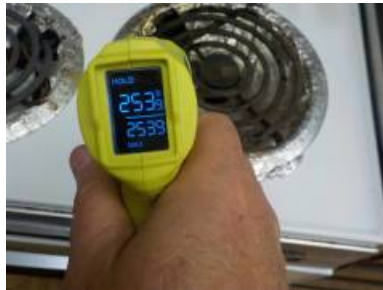
**Missing anti-tip bracket - improper**

Recommend installation of an anti-tip bracket to restore to safe conditions

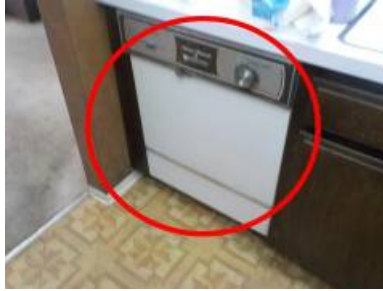
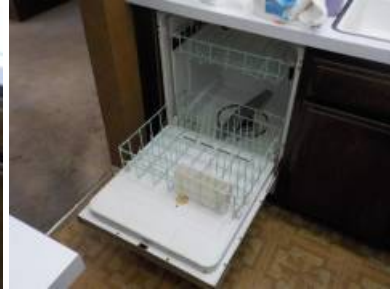
**Not functioning (not responding to control panel) - improper**  
Recommend further inspection and deemed necessary repairs by a licensed plumber or qualified service provider to restore to normal operating condition.

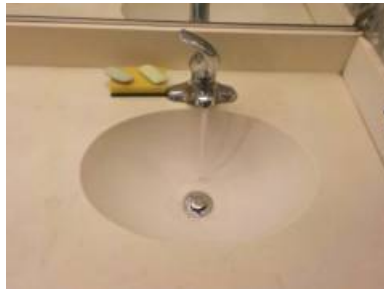
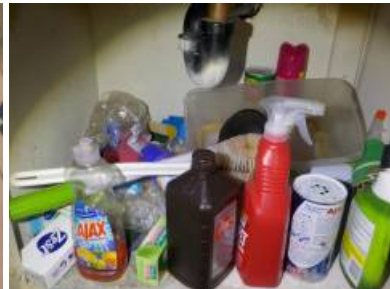
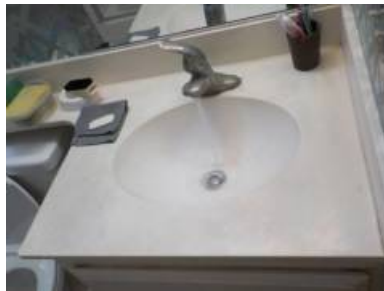
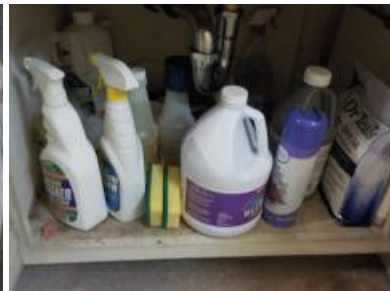
Failure of aging angle stops could result in serious water damage.

Due to the age and as a matter of preventative maintenance it is highly recommended to replace the angle stops

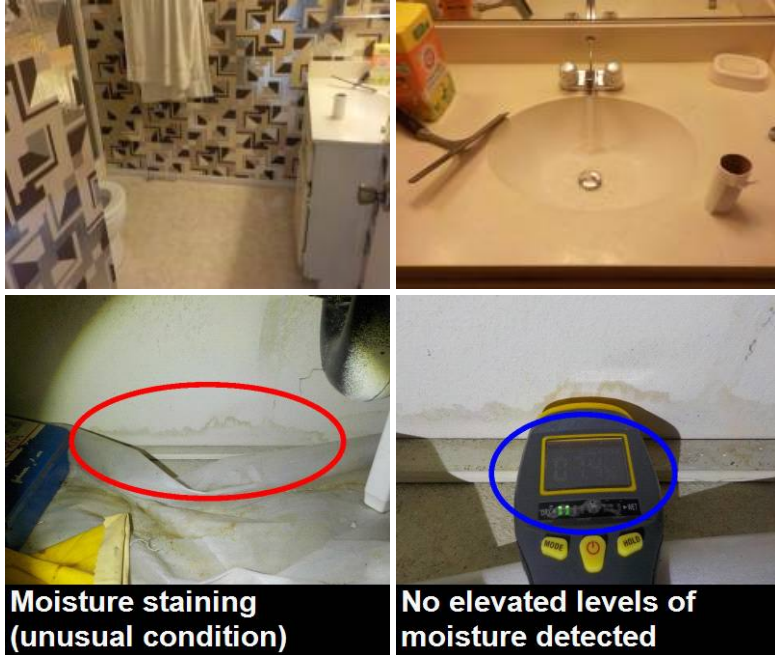
**Moisture staining  
(unusual condition)**

**No elevated levels of  
moisture detected**

Recommend further inspection and deemed necessary repairs by a qualified service provider

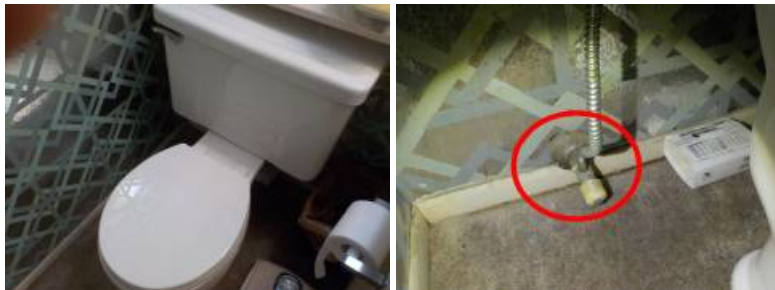
*Jr. Master Bath:*

Due to the age and as a matter of preventative maintenance it is highly recommended to replace the angle stop  
Failure of aging angle stops could result in serious water damage.

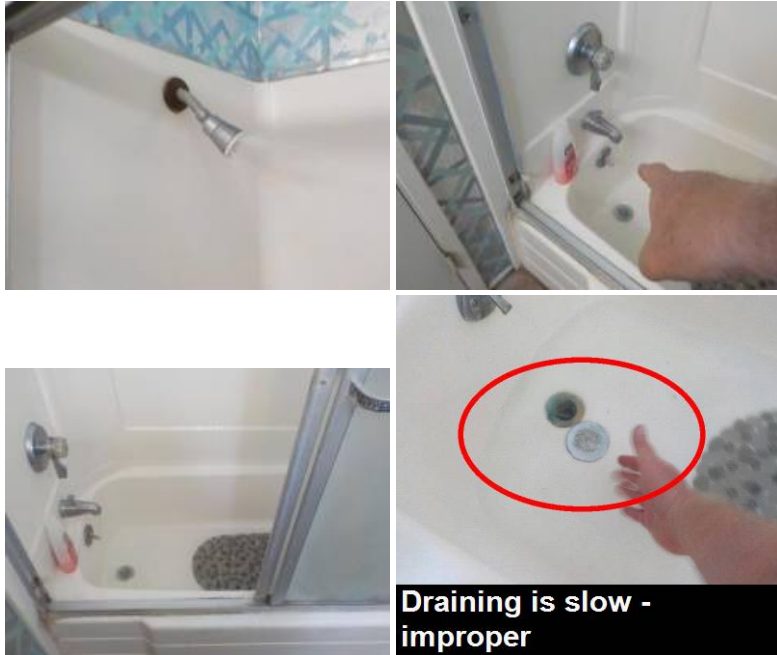
Master Bath:

**Draining is very slow - improper**

Recommend further inspection and deemed necessary repairs by a licensed plumber or qualified service provider to restore to normal conditions.

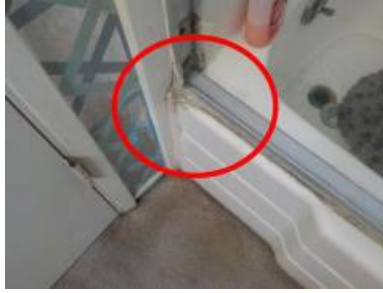
*Jr. Master Bath:*

Appear serviceable

Please Note: Caulk and seal all tub and shower fixtures to wall to help prevent possible moisture intrusion.

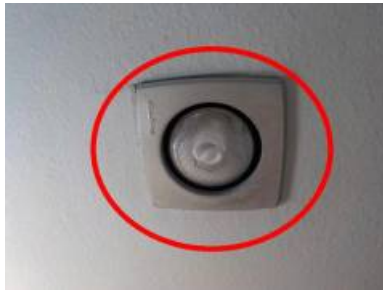
**Exhaust fan did not operate - improper**

**Please Note: this is the only method of venting in this bathroom (no window)**

**Recommend repairs by a qualified service provider**

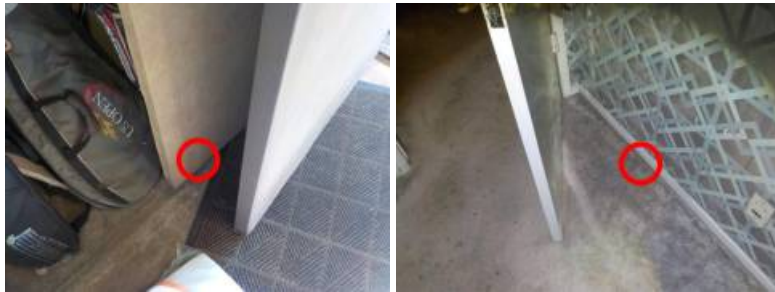
Appears serviceable with the following noted:  
**Missing stops at one or more doors**  
 Recommend installation of stops at affected doors.

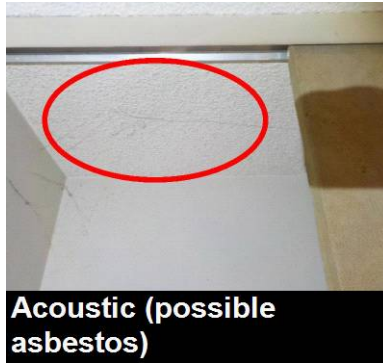
**Acoustic (possible asbestos)****Floors:***General:*OK   MM   RR  
☐   ☐   ☒**Appears serviceable with the following observed:**  
**Carpet: multiple stains are viewed - improper**  
**Recommend cleaning/remediation**

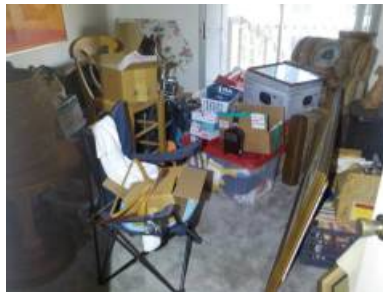
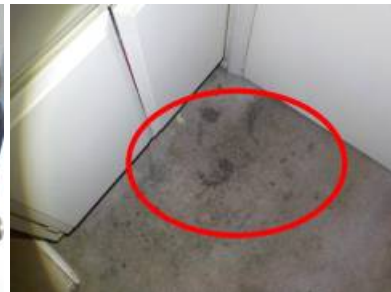
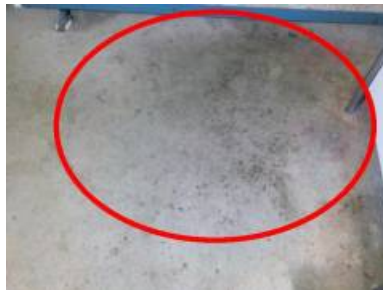
Unable to fully inspect due to stored personal belongings.

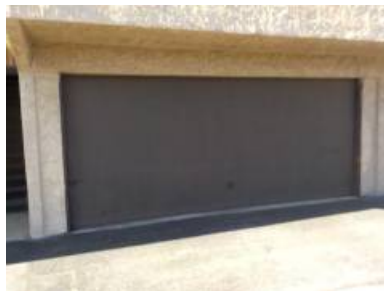
Door Opener:

Automatic door opener(s) is operational  
 Automatic reverse feature is functioning

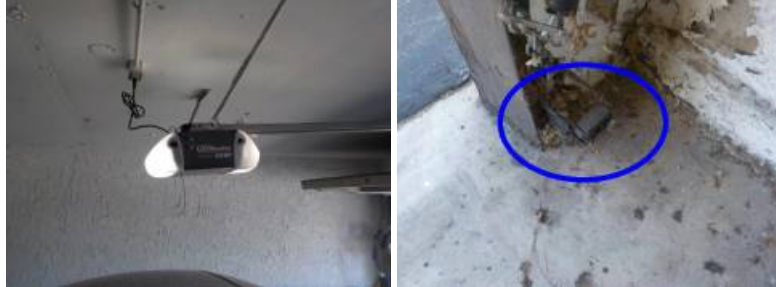
Please Note: **there is no manually operated door release (in case of power outage)**  
Recommend remediation.

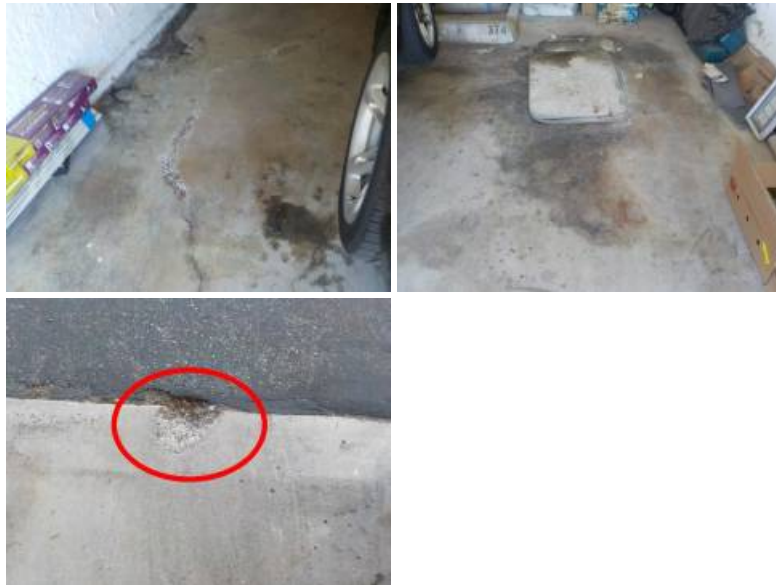
Concrete  
Typical cracks and stains observed
