**Dewey Pest Control**

295 S San Anselmo Ave  
San Bernardino, CA 92410

Page 2 of 24 inspection report

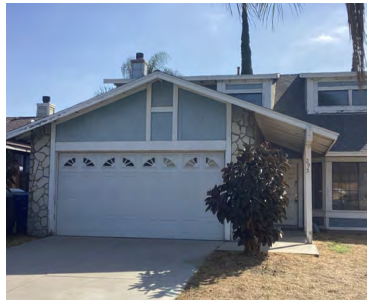
### 2A - Section I

**FINDING** - Evidence of Drywood termites noted in the front left corner of the garage trim boards

**RECOMMENDATION** - Fumigate the structure for the control of Drywood termites. Remove or cover evidence of infestation in accessible areas. Owner/agent to prepare the structure for fumigation as per occupants notice to be furnished by this company. The structure must be vacated until released for re-entry by the licensed fumigator. The fumigant to be used on your structure and the active ingredients are: VIKANE (active ingredients) sulfuryl fluoride and chloropicrin. 2 year guarantee

**RECOMMENDATION** -Repair, Remove and replace infected/damaged wood. Unless colored paint is supplied by the owner, (Painting is not included in estimate. Prime coat only). Damage or infections found to extend into interior of wall void or other currently inaccessible areas will be reported on supplemental report. Estimate for additional repairs will be given at that time. No opinion is rendered concerning the conditions in these areas at this time.

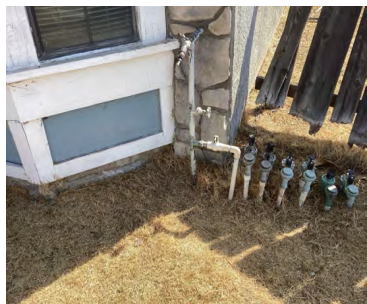
### 2B - Section I

**FINDING** - Evidence of Drywood termites noted in the garages man doors framework, jambs, and trim boards

**RECOMMENDATION** - Fumigate the structure for the control of Drywood termites. Remove or cover evidence of infestation in accessible areas. Owner/agent to prepare the structure for fumigation as per occupants notice to be furnished by this company. The structure must be vacated until released for re-entry by the licensed fumigator. The fumigant to be used on your structure and the active ingredients are: VIKANE (active ingredients) sulfuryl fluoride and chloropicrin. 2 year guarantee

**RECOMMENDATION** -Repair, Remove and replace infected/damaged wood. Unless colored paint is supplied by the owner, (Painting is not included in estimate. Prime coat only). Damage or infections found to extend into interior of wall void or other currently inaccessible areas will be reported on supplemental report. Estimate for additional repairs will be given at that time. No opinion is rendered concerning the conditions in these areas at this time.

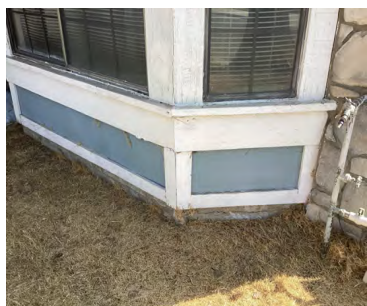
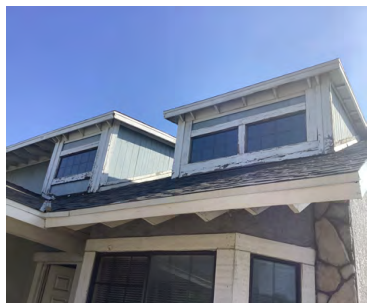
### 2C - Section I

**FINDING** - Evidence of Drywood termites noted in the wooden trim boards, and composition wooden siding of the left side exterior fireplace

**RECOMMENDATION** - Fumigate the structure for the control of Drywood termites. Remove or cover evidence of infestation in accessible areas. Owner/agent to prepare the structure for fumigation as per occupants notice to be furnished by this company. The structure must be vacated until released for re-entry by the licensed fumigator. The fumigant to be used on your structure and the active ingredients are: VIKANE (active ingredients) sulfuryl fluoride and chloropicrin. 2 year guarantee

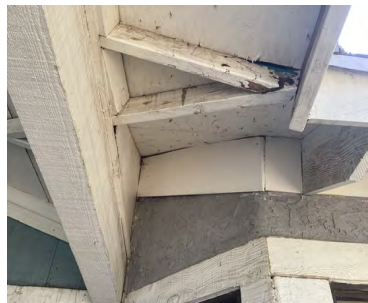
## 2D - Section I

**FINDING** - Evidence of Drywood termites noted in the most of the portions of the garage where the interior walls are opened framed and are exposed. These areas of evidence included on top of mudsills, fire blocks, and wall studs, These wood members are also leading into the finished drywalled portions of the garage and are structurally tied into the main overall wooden framework of the garage and the wooden framework of overall home

**RECOMMENDATION** - Fumigate the structure for the control of Drywood termites. Remove or cover evidence of infestation in accessible areas. Owner/agent to prepare the structure for fumigation as per occupants notice to be furnished by this company. The structure must be vacated until released for re-entry by the licensed fumigator. The fumigant to be used on your structure and the active ingredients are: VIKANE (active ingredients) sulfuryl fluoride and chloropicrin. 2 year guarantee

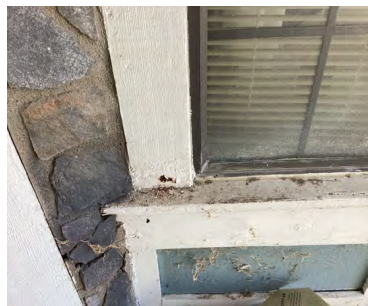
## 2E - Section I

**FINDING** - Evidence of Drywood termites noted in the upper levels far rear right corner bedroom of the home, coming from the interior walls, windowpane and baseboards

**RECOMMENDATION** - Fumigate the structure for the control of Drywood termites. Remove or cover evidence of infestation in accessible areas. Owner/agent to prepare the structure for fumigation as per occupants notice to be furnished by this company. The structure must be vacated until released for re-entry by the licensed fumigator. The fumigant to be used on your structure and the active ingredients are: VIKANE (active ingredients) sulfuryl fluoride and chloropicrin. 2 year guarantee

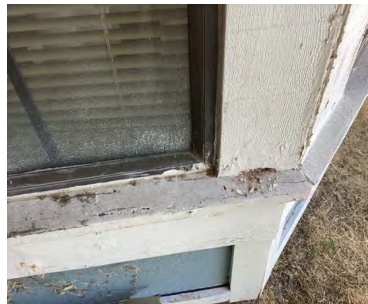
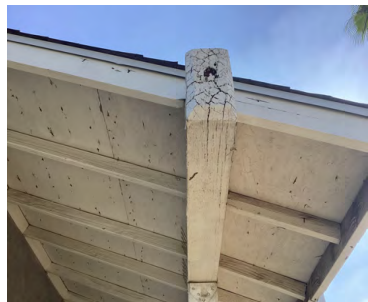
### 3A - Section I

**FINDING** - Evidence of Dry Rot / Fungus damage noted in the trim boards of the front entrance pop-out windows, that were previously poorly repaired and/or patched, may also contain other possible hidden damages

**RECOMMENDATION** -Repair, Remove and replace infected/damaged wood. Unless colored paint is supplied by the owner, (Painting is not included in estimate. Prime coat only). Damage or infections found to extend into interior of wall void or other currently inaccessible areas will be reported on supplemental report. Estimate for additional repairs will be given at that time. No opinion is rendered concerning the conditions in these areas at this time.

**RECOMMENDATION** - Fumigate the structure for the control of Drywood termites. Remove or cover evidence of infestation in accessible areas. Owner/agent to prepare the structure for fumigation as per occupants notice to be furnished by this company. The structure must be vacated until released for re-entry by the licensed fumigator. The fumigant to be used on your structure and the active ingredients are: VIKANE (active ingredients) sulfuryl fluoride and chloropicrin. 2 year guarantee

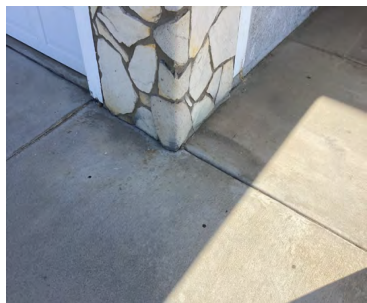
### 3B - Section I

Evidence of Dry Rot / Fungus damage noted in the front entrances patio covers header beams edge closest to and pointing at the street

RECOMMENDATION -Repair, Remove and replace infected/damaged wood. Unless colored paint is supplied by the owner, (Painting is not included in estimate. Prime coat only). Damage or infections found to extend into interior of wall void or other currently inaccessible areas will be reported on supplemental report. Estimate for additional repairs will be given at that time. No opinion is rendered concerning the conditions in these areas at this time.

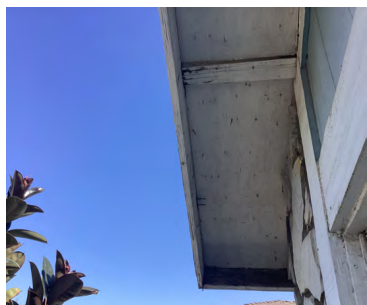
## 3C - Section I

Evidence of Dry Rot / Fungus damage noted in the trim boards, and composition wooden siding of the left side exterior fireplace

RECOMMENDATION -Repair, Remove and replace infected/damaged wood. Unless colored paint is supplied by the owner, (Painting is not included in estimate. Prime coat only). Damage or infections found to extend into interior of wall void or other currently inaccessible areas will be reported on supplemental report. Estimate for additional repairs will be given at that time. No opinion is rendered concerning the conditions in these areas at this time.

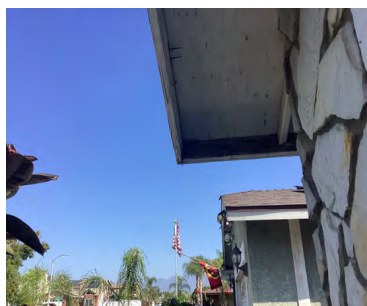
## 3D - Section I

Evidence of Dry Rot / Fungus damage noted in the garages man doors framework, jambs, and trim boards

RECOMMENDATION -Repair, Remove and replace infected/damaged wood. Unless colored paint is supplied by the owner, (Painting is not included in estimate. Prime coat only). Damage or infections found to extend into interior of wall void or other currently inaccessible areas will be reported on supplemental report. Estimate for additional repairs will be given at that time. No opinion is rendered concerning the conditions in these areas at this time.

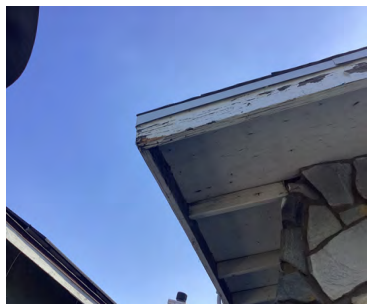
## 3E - Section I

Evidence of Dry Rot / Fungus damage noted in the lower levels fascia boards, and possibly the edges of the starter board directly above these fascia board(s)

RECOMMENDATION -Repair, Remove and replace infected/damaged wood. Unless colored paint is supplied by the owner, (Painting is not included in estimate. Prime coat only). Damage or infections found to extend into interior of wall void or other currently inaccessible areas will be reported on supplemental report. Estimate for additional repairs will be given at that time. No opinion is rendered concerning the conditions in these areas at this time.

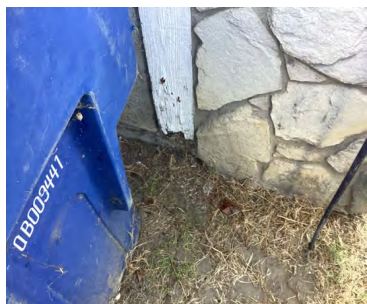
## 3F - Section I

Evidence of Dry Rot / Fungus damage noted in the upper levels rear corners plywood sheathing

RECOMMENDATION -Repair, Remove and replace infected/damaged wood. Unless colored paint is supplied by the owner, (Painting is not included in estimate. Prime coat only). Damage or infections found to extend into interior of wall void or other currently inaccessible areas will be reported on supplemental report. Estimate for additional repairs will be given at that time. No opinion is rendered concerning the conditions in these areas at this time.

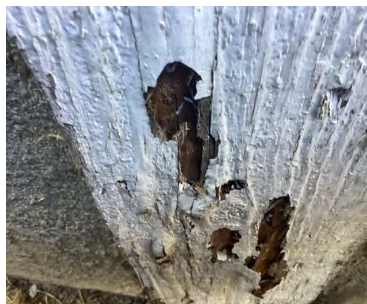
## 4E - Section II

FINDING - Weathering and/or peeling paint noted at exterior wood surfaces of the home and garage

RECOMMENDATION - Owner/agent should engage the services of a licensed contractor to perform the work necessary to correct the finding listed above, at owner's expense.

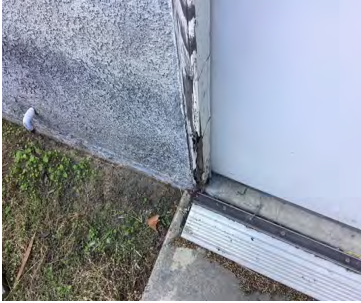
## 4I - Other

FINDING - Possible concealed damage noted at the exterior patched trim boards of the

front entrance pop-out windows

RECOMMENDATION - Owner/agent should engage the services of a licensed contractor to perform the work necessary to correct the finding listed above, at owner's expense.
