CALI INSPECT  
+18588886202  
matt@caliinspect.com  
<http://www.caliinspect.com>

## RESIDENTIAL INSPECTION

9092 Terrace Dr  
La Mesa, CA 91941

Steve Presley & Felice Presley  
08/14/2026

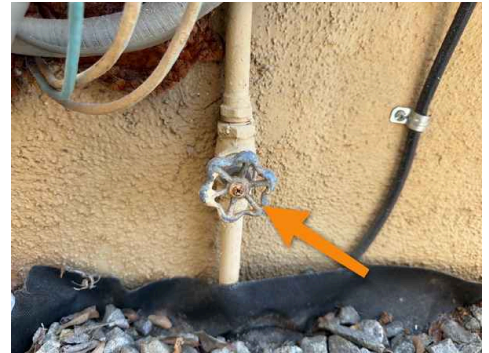
Front Left Exterior

Attention Item

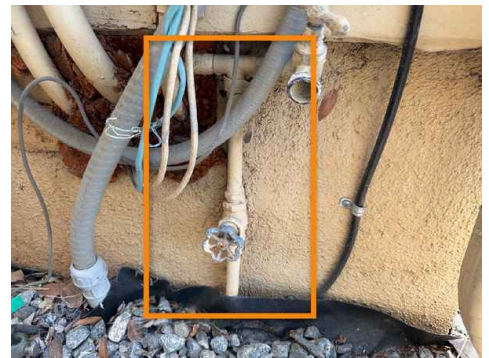
Front Left Exterior

### 2.1.2 Main Water Shut-Off

Attention Item

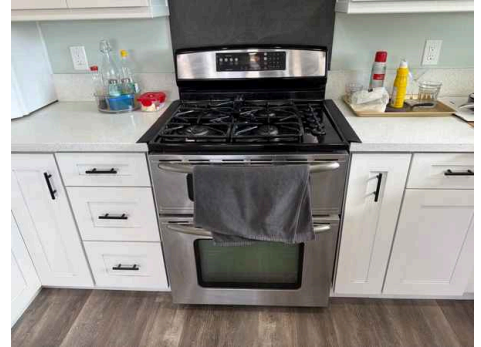
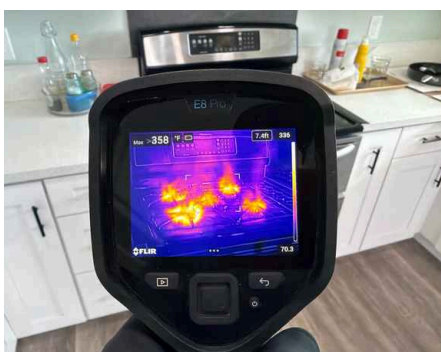
**Range/Oven/Cooktop: Thermal Image Showing Operation**

Infrared picture of range/cooktop in operation.

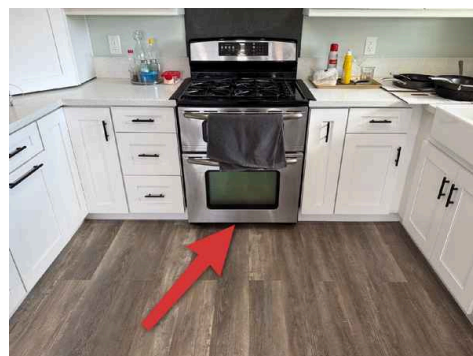
**ANTI-TIP BRACKET MISSING**

Range was not fastened to the floor with an anti-tip bracket. This poses a safety hazard to children. Recommend a qualified contractor secure range so it can't tip.

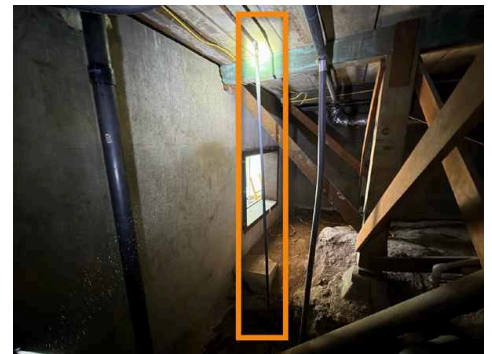
Crawlspace

#### PIPING NOT SECURE

Portions of the plumbing distribution system were not properly secured. This condition can promote damage and possible leaks. Advise consulting a licensed plumbing contractor for necessary repairs.

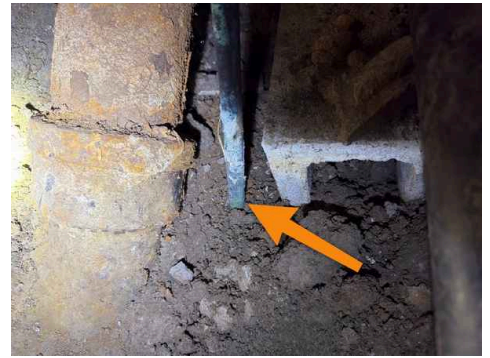
Crawlspace

## 4.1.2 Water Supply and Distribution Systems

Attention Item

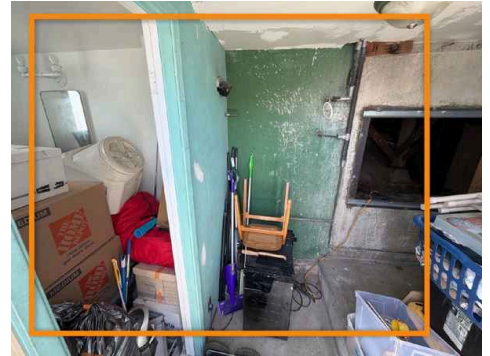
Downstairs

## 4.2.1 Fixtures and Connected Devices

Attention Item

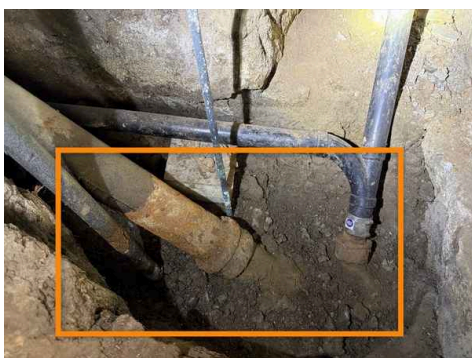
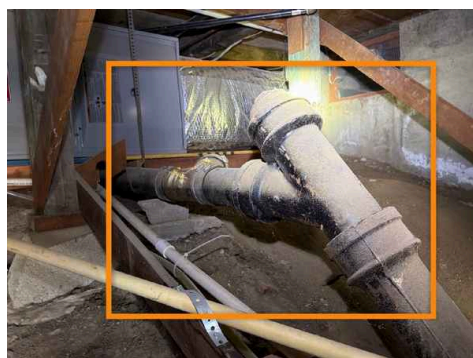
Crawlspace

## 4.4.1 Drain, Waste, &amp; Vent Systems

Attention Item

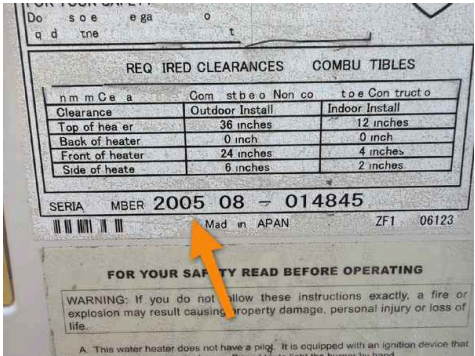
2005 MFD

Water heater appeared to be near or past the end of its expected life. Recommend monitoring or replace for preventative measures by a licensed plumbing contractor.

Attention Item

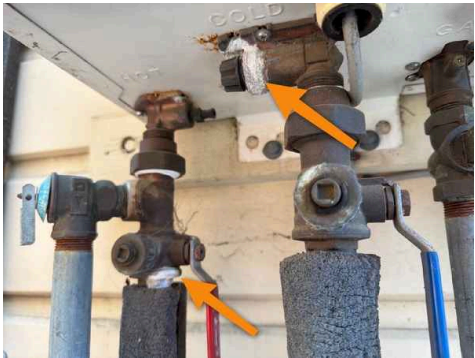
4.5.3 Hot Water Systems, Controls, Flues & Vents

CORROSION

Corrosion was noted at the shut-off and/or fittings. Recommend a qualified plumber evaluate for repair/replacement.

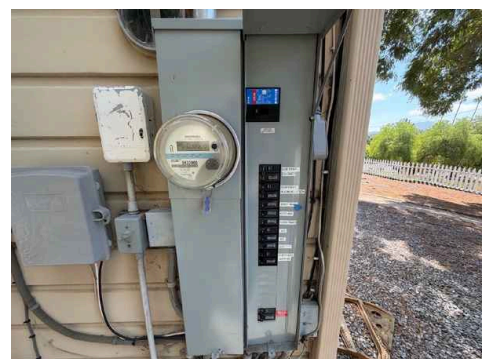
Main Panel

**NEW PANEL(S)**

One or more electrical panels appeared to be recently installed. This usually requires permits. Recommend asking the seller for documentation showing the panels were installed by a licensed electrician. If documentation cannot be produced, we recommend having the panel(s) evaluated by a licensed electrical contractor to determine if latent defects exist.

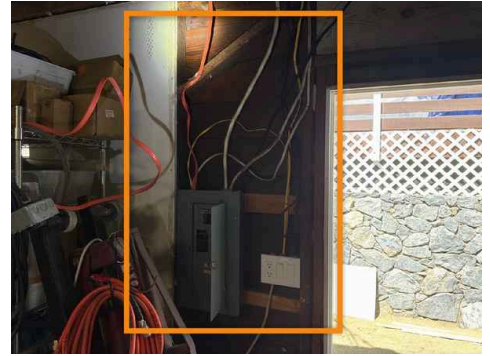
Garage Various Locations

**EXPOSED ROMEX**

Exposed/unprotected romex(wiring) noted at one or more locations. This wiring should be in a conduit or protected. Recommend evaluation by a licensed electrical contractor.

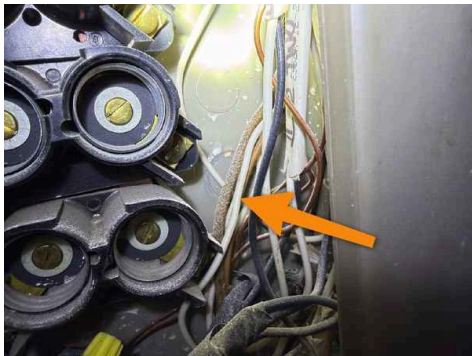
Hallway Closet

**ORIGINAL/OLDER WIRING**

Portions of the original or older cloth coated wiring noted in use. We recommend having a safety check be performed of the entire electrical system by a licensed electrical contractor to determine if any repairs are needed and for safety.

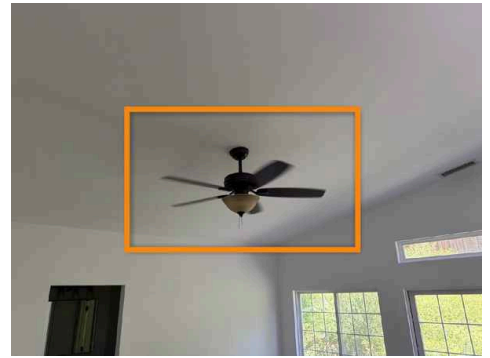
Primary Bedroom

**FAN ROCKS**

One or more fan(s) appeared to rock while in motion. Recommend balancing to ensure proper function and for safety.

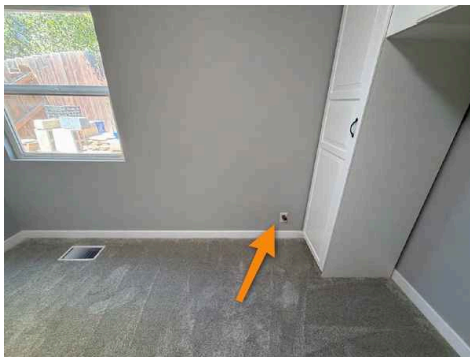
3rd Bedroom

One or more outlet(s) did not appear to be grounded. Recommend further evaluation by a licensed electrical contractor to determine repairs needed at this time.

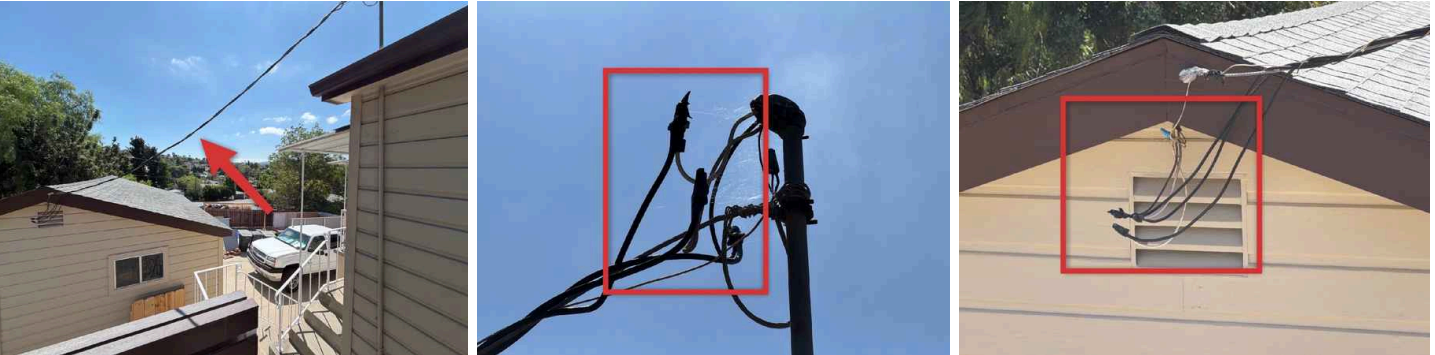
Garage Feed

**POOR CLEARANCE/CONNECTIONS**

Garage electric overhead feed wires appeared too low, not giving enough clearance above the deck. Exposed/unprotected splicing is present. Recommend further evaluation by a licensed electrician to determine if upgrades or repairs are needed at this time and to prevent possible safety related concerns.

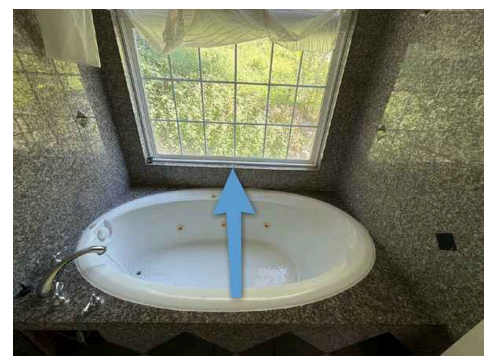
Primary Bathroom

**MISSING SCREEN(S)**

Observation Item

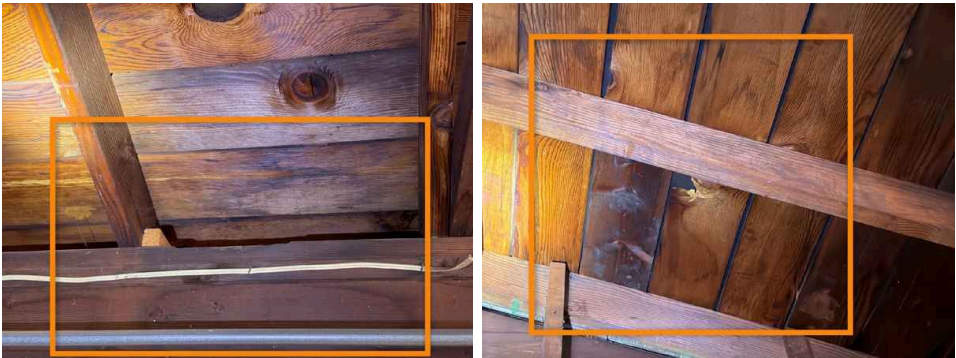
Moisture staining noted at the garage ceiling. Unable to determine exact cause. Area appeared dry at the time of inspection. Recommend further evaluation by a licensed roofing contractor to determine if corrections are needed at this time.

Attention Item

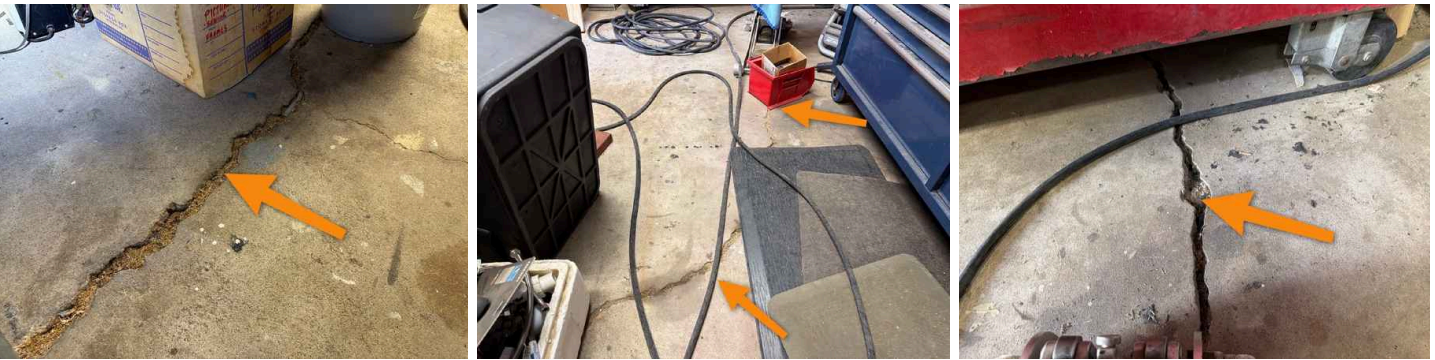
7.5.1 Floor

SETTLING/MOVEMENT

Garage floor shows signs of settling in the soil beneath the slab. Recommend a structural engineer evaluate for potential repairs.

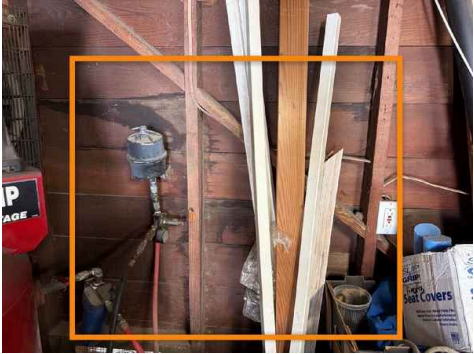
MOISTURE STAINING

Moisture staining noted at one ore more locations in the garage. This an indication of previous possible leaks or moisture intrusion. Unable to determine the cause. Recommend asking the seller about this and have further evaluations as needed by a licensed restoration contractor.

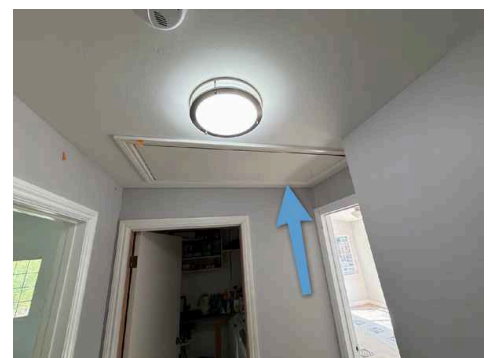
Shared Bathroom Hallway

Pull down ladder for attic present. These ladders are known to be problematic if not properly installed.

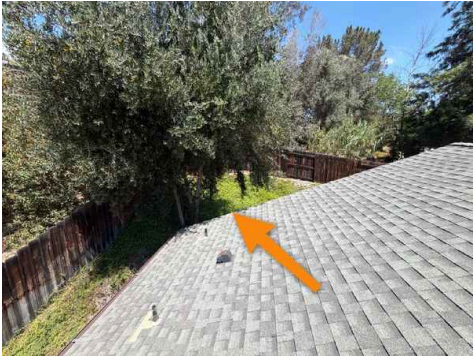
Rear Left

TREES/VEGETATION

Trees/Vegetation noted in contact or overhanging the roof. This can lead to possible pest activity, conceal defects and hold moisture in these areas. recommend clearing of all vegetation that can be problematic to the roof components.

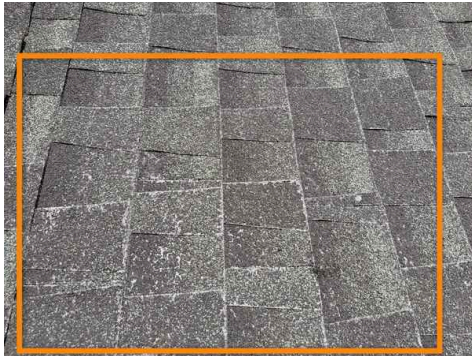
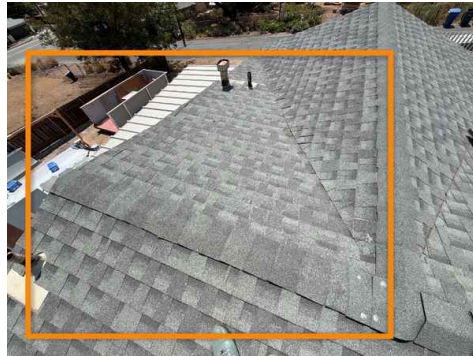
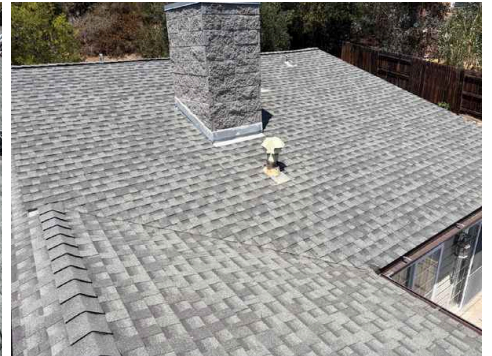
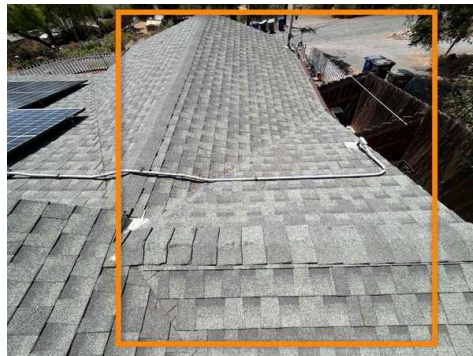
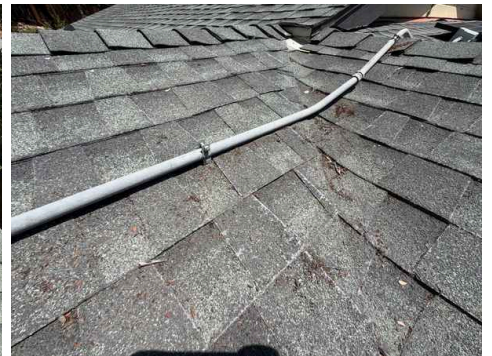
## 9.1.2 Coverings

Portions of the roof appeared to be approaching or beyond its expected service life. Recommend further evaluation by a licensed roofing contractor to determine if repairs or possible replacement are needed at this time.

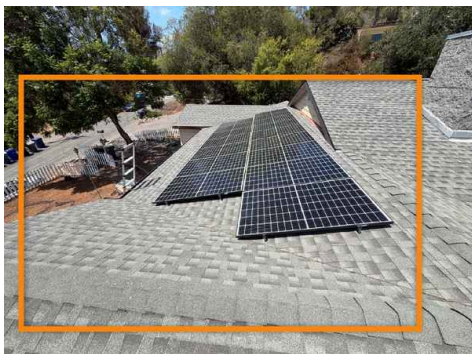
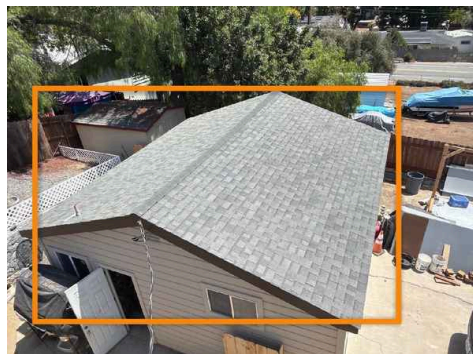
Garage

**PREVIOUS REPAIRS**

Previous repairs noted at portions of the roof. Recommend asking the seller about this and have further evaluations by a licensed roofing contractor.

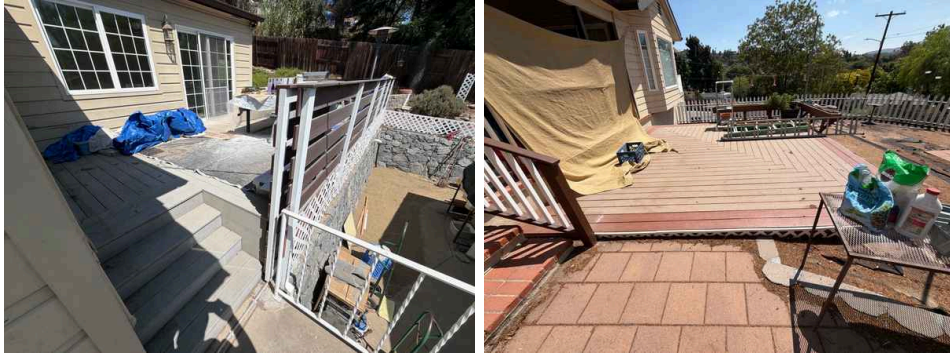
**NOT VISIBLE**

Portions of the deck/structure were not visible. Recommend further evaluation as needed to ensure latent defects don't exist.

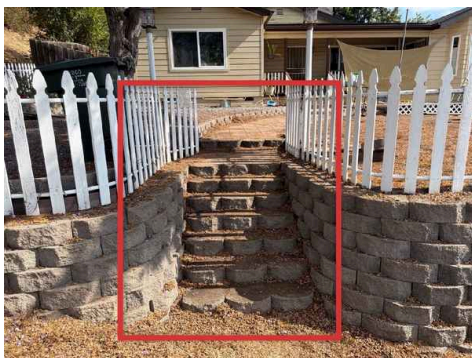
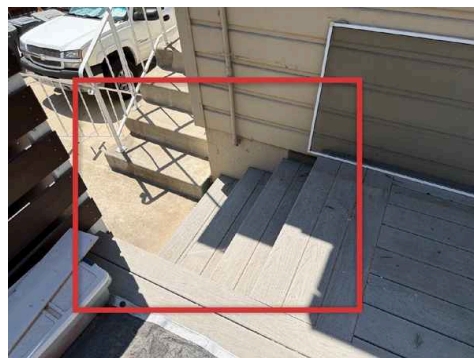
## 10.4.1 Decks, Balconies, Porches &amp; Steps

Missing handrails/guardrails noted at one or more locations of the exterior. Recommend adding handrails and guardrails for safety at all steps and steep drop offs.

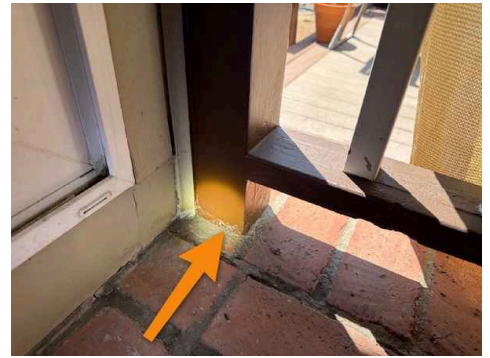
Front Exterior

## 10.4.2 Decks, Balconies, Porches &amp; Steps

Attention Item

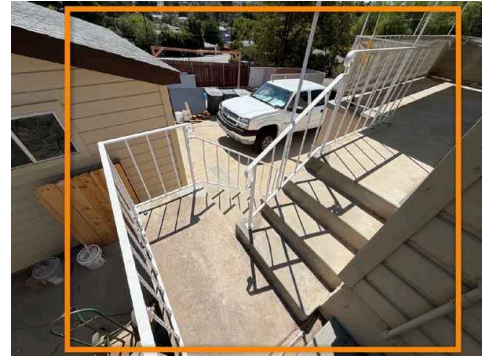
Right Exterior

## 10.4.3 Decks, Balconies, Porches &amp; Steps

Attention Item

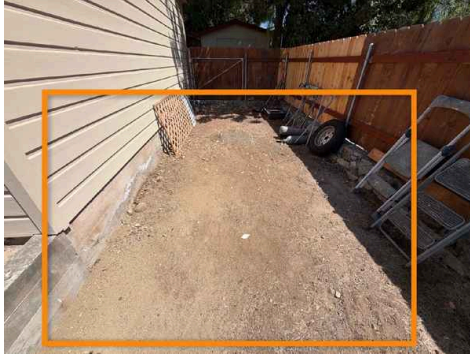
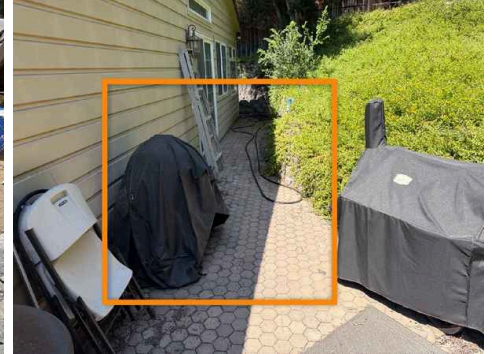
## 10.6.1 Vegetation, Grading, Drainage &amp; Retaining Walls

Low areas and/or poor drainage noted at one or more locations at the exterior. This can create issues with moisture intrusion and possible structural damage. Recommend further evaluation by a licensed grading and drainage contractor to determine necessary repairs to ensure proper drainage.

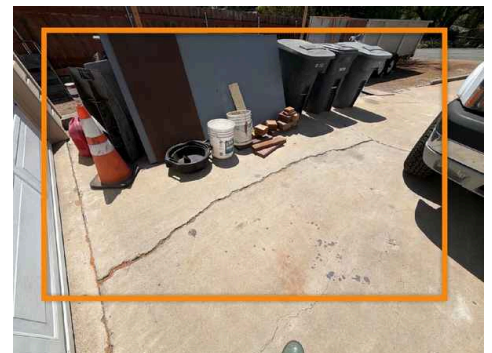
Front Front Garage Exterior

**MOVEMENT/DAMAGE AT HARDSCAPE**

Movement/damage noted at the hardscape at one or more locations. Possible moisture related and/or tree root activity. Recommend further evaluation by a licensed grading and drainage contractor to determine repairs needed at this time.

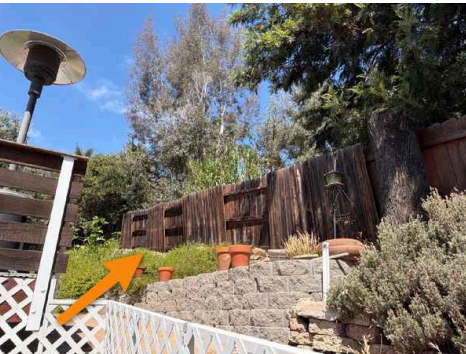
Rear Exterior

Portions of the fencing noted leaning and/or damaged. Recommend repair by a licensed fencing contractor.

Attention Item

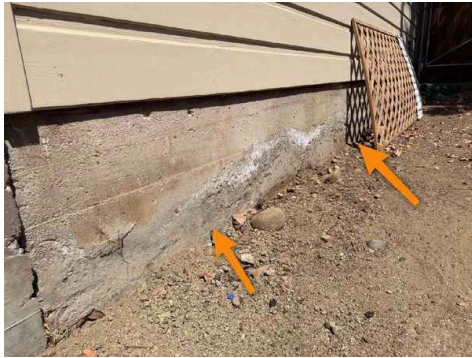
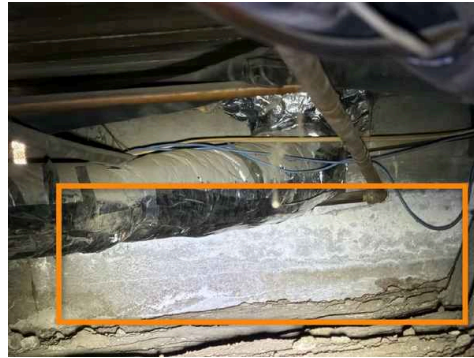
Spalling and/or deterioration noted at portions of the concrete. This is most likely caused by prolonged moisture contact. Recommend further evaluation by a licensed foundation contractor to determine repairs needed at this time.

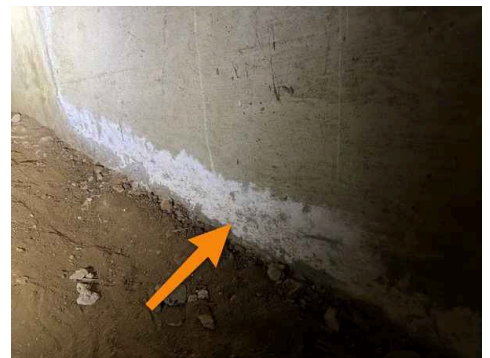
Rear Right Crawlspace

White efflorescence powder substance noted at the foundation walls. This is common whenever there is previous moisture contact. Recommend monitoring and have evaluated by a licensed foundation and grading contractor to determine if repairs are needed at this time.

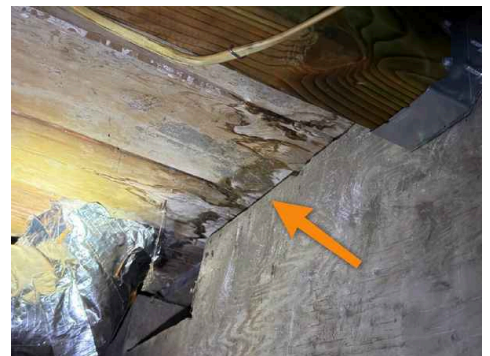
Rear Right Crawlspace

## 11.2.1 Floor Structure

There were signs of possible previous water issues in the underlying floor structure. Recommend identifying source of moisture and repairing as needed by a licensed structural contractor.

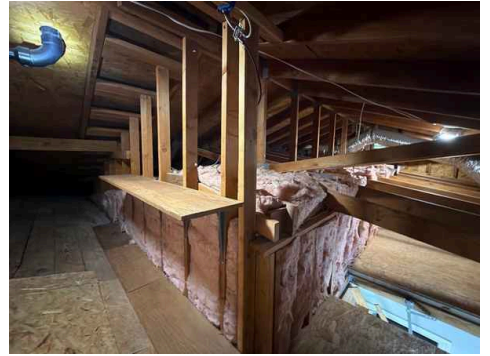
## 11.4.1 Roof Structure &amp; Attic

Attention Item

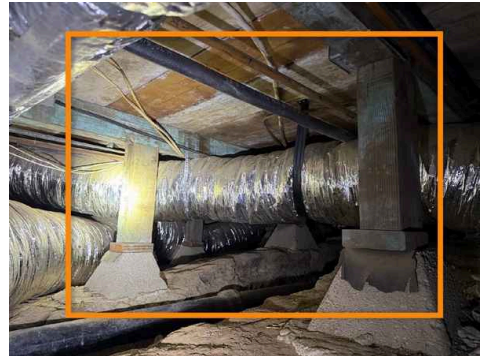
Various Locations Crawlspace

**SEISMIC RETROFITTING INCOMPLETE**

Attention Item

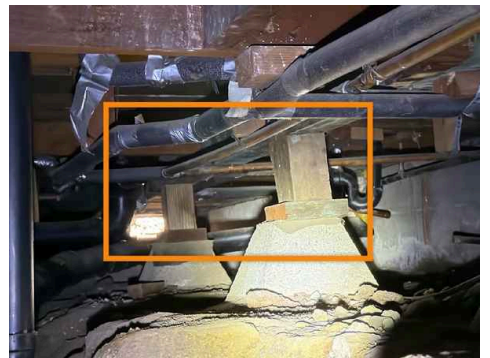
Various Locations Crawlspace

## 11.5.2 Post and Piers

Attention Item

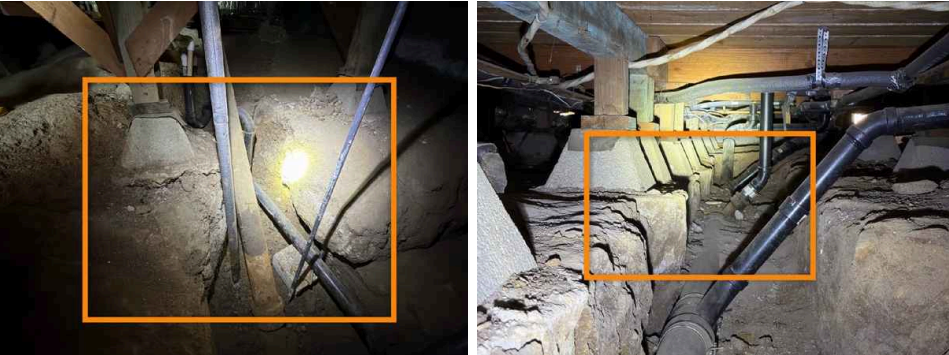
Crawlspace

11.5.3 Post and Piers

Undermining noted at one or more piers in the crawlspace. This can cause movement of the structure due to instability of the pier(s). Recommend further evaluation by a licensed structural contractor to determine repairs needed at this time.

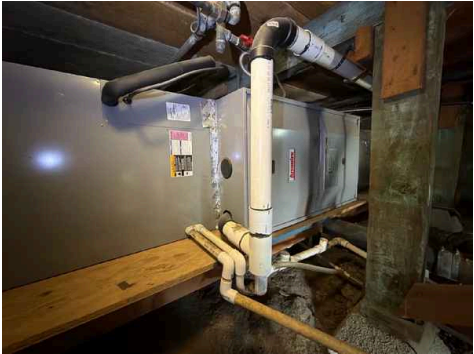
Crawlspace

Heater appeared functional/serviceable at the time of inspection. However, due to the many components not visible, such as the heat exchanger, we recommend having the unit serviced and evaluated by a licensed HVAC contractor to determine if latent defect exists.

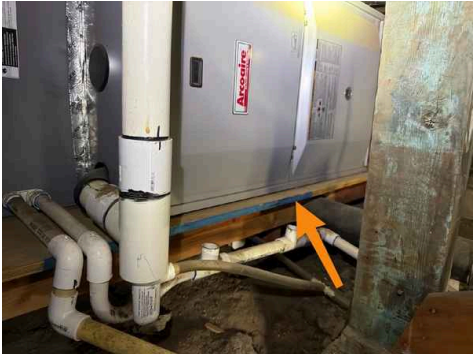
Crawlspace

The furnace was noted installed on combustibile/wood blocking or platforms. This is typically not in accordance with today's standards. Recommend further evaluation by a licensed HVAC contractor to determine if repairs/replacement of the blocks is needed at this time.

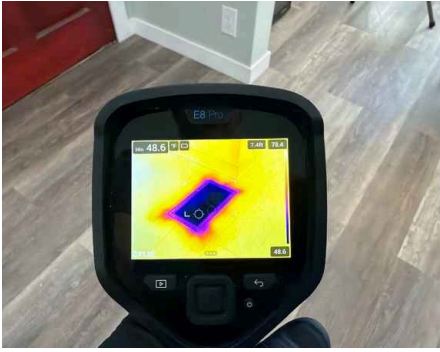
Cooling Equipment: Thermal  
Image A/C

Thermal image showing A/C  
during operation. (Operable)

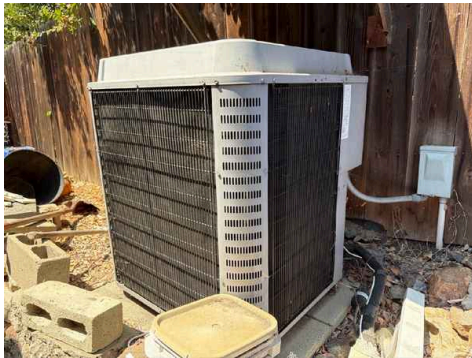
Left Exterior

The A/C noted aged and limited life may remain. The A/C was operable and produced cold air at the time of inspection. Recommend further evaluation by a licensed HVAC contractor to determine any repairs/maintenance needed at this time.

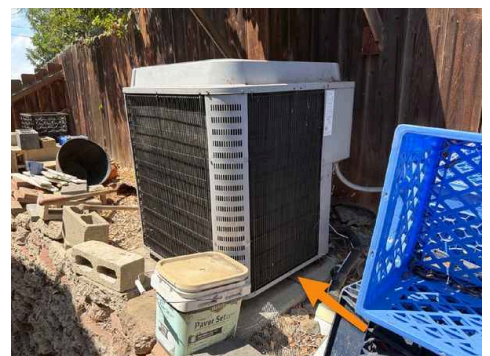
Left

The exterior condenser was not properly secured to the platform/concrete. Recommend securing to prevent possible damage in the event of seismic activity or physical contact.

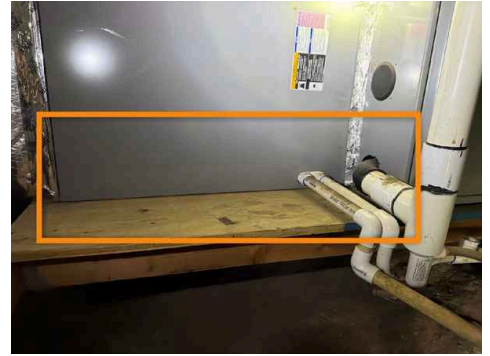
Crawlspace

No leak pan was present under the evaporative coil in the attic. This can lead to excess moisture in this space. Recommend further evaluation by a licensed HVAC contractor to determine upgrades needed at this time.

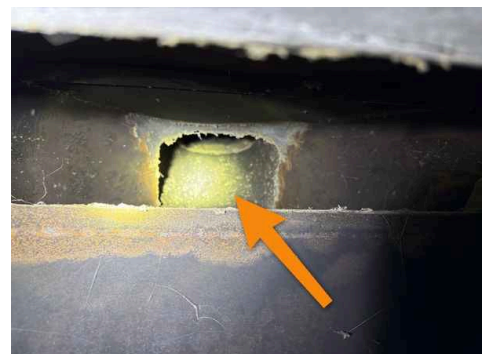
Chimney had layer of creosote dust, so underlying structure couldn't be inspected for cracks. Recommend qualified chimney sweep company inspect and/or clean.
