## RESIDENTIAL INSPECTION REPORT

2520 Avenue L  
Galveston, TX 77550

# PROPERTY INSPECTION REPORT FORM

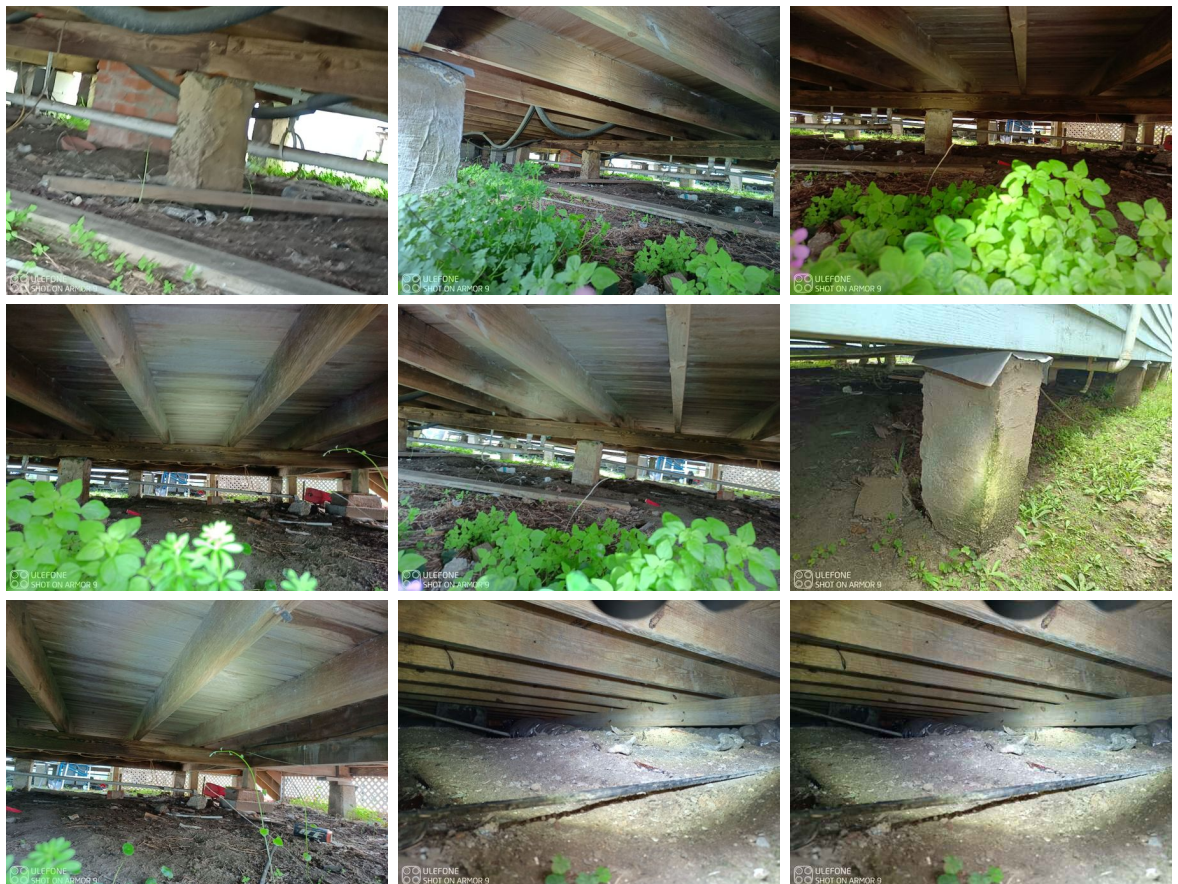
*Type of Foundation(s):* Pier and Beam

There was evidence of prior structural movement. The movement did not indicate any need for invasive action at this time. Monitoring of the foundation is recommended.

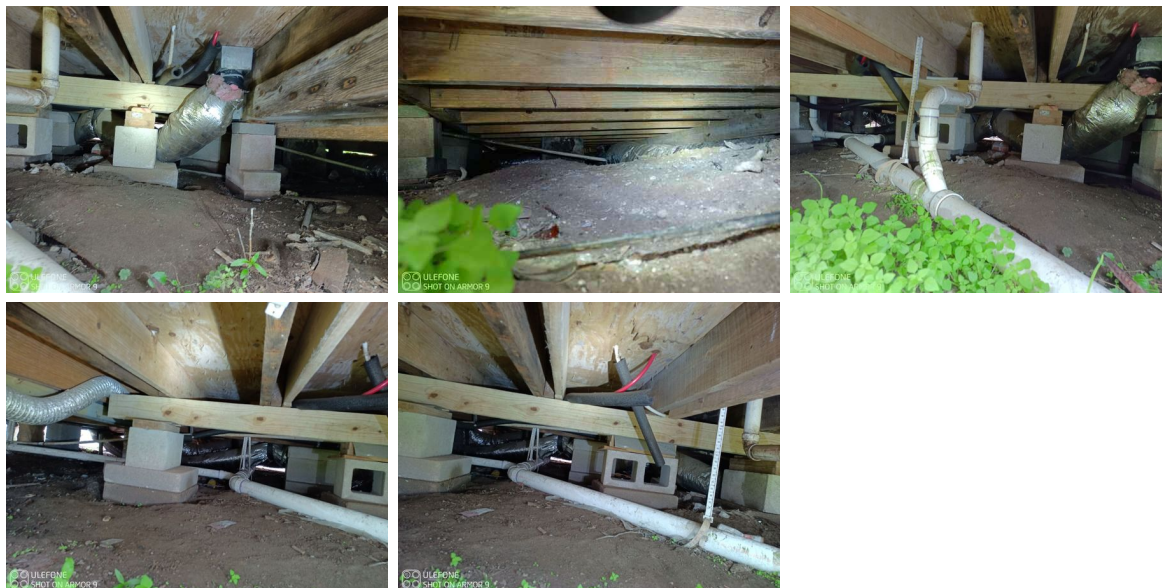
Rear of structure at Primary Bedroom

**1: Crawlspace: Inadequate ventilation****➡Recommendation**

Crawlspace ventilation does not appear to meet current building standards. Poor ventilation under a home can lead to a number of moisture related issues and should be further evaluated by a qualified contractor.

Recommendation: Contact a foundation contractor.

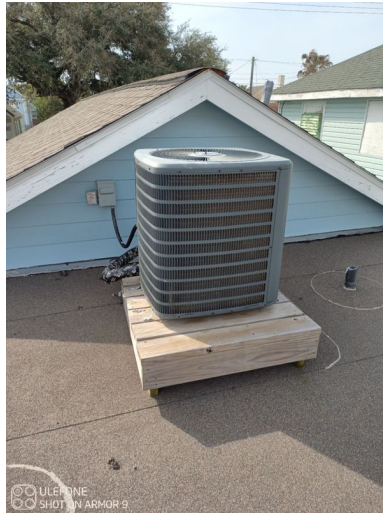
**1: Equipment on Roof**

Equipment was mounted to the roof, including, but not limited to satellite dishes, solar panels and HVAC equipment. The inspector was unable to determine if the equipment was installed per manufacturer's specifications. Further evaluation is recommended.

Recommendation: Contact a qualified roofing professional.

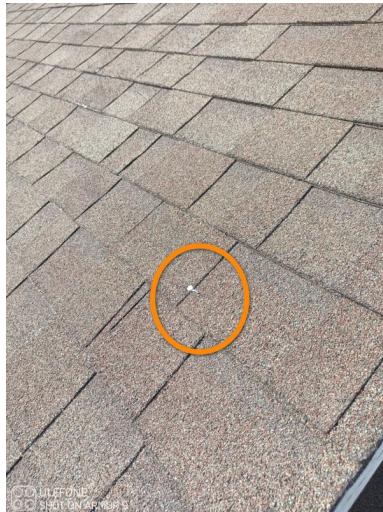
Multiple Locations

## 2: Exposed fasteners

Exposed fasteners were observed. Seal as needed to prevent moisture intrusion.

Recommendation: Contact a qualified roofing professional.

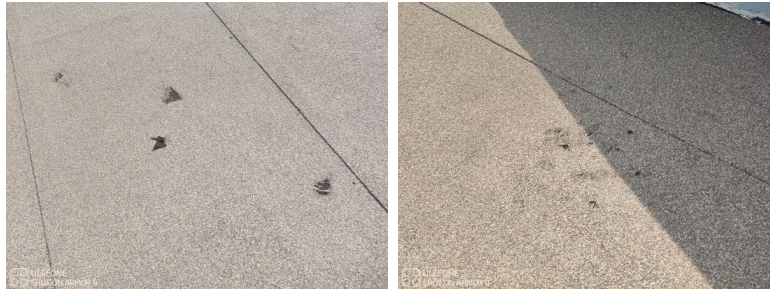
## 3: Shingles: Damaged/Torn/Missing

Roof shingle material was missing, damaged, or torn in areas. Evaluation and/or repair by a qualified roofing professional is recommended.

Recommendation: Contact a qualified roofing professional.

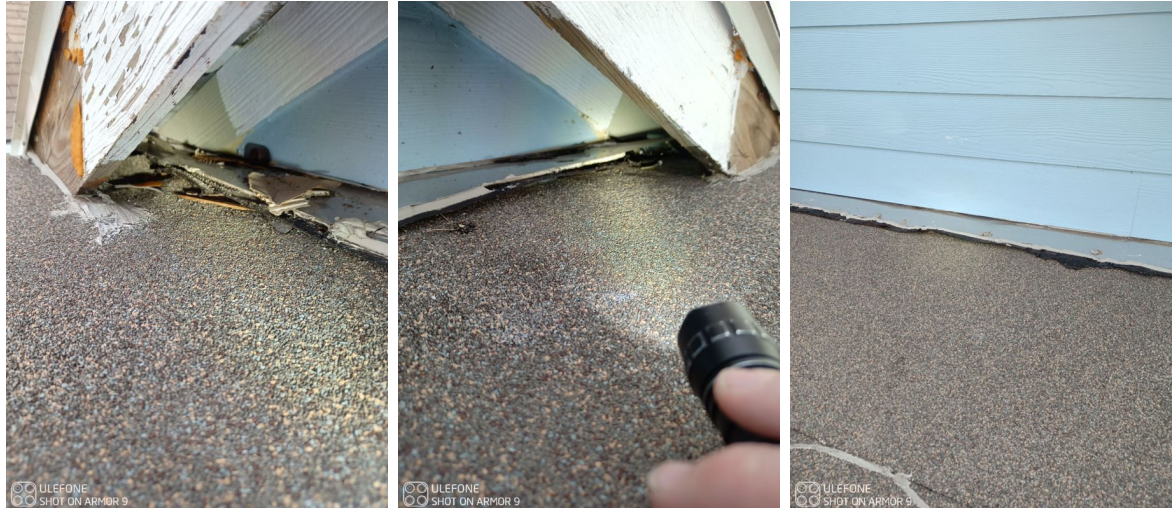
Lifted -

#### 4: Flashing Deficiencies

Deficiencies with the flashings were present at the time of inspection. Evaluation and remediation is recommended.

Recommendation: Contact your builder.

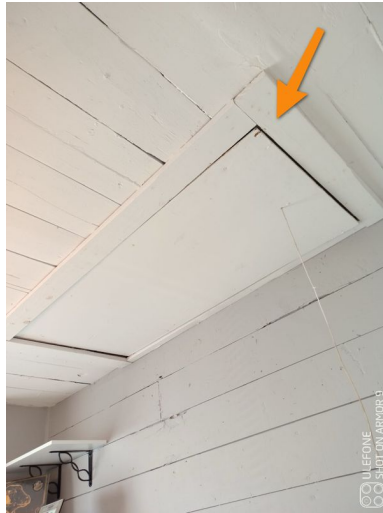
**1: Pulldown stairs/ladder: Improper seal**

The attic pull-down ladder door did not make a proper seal when closed. Evaluation and remediation is recommended.

Recommendation: Contact a qualified professional.

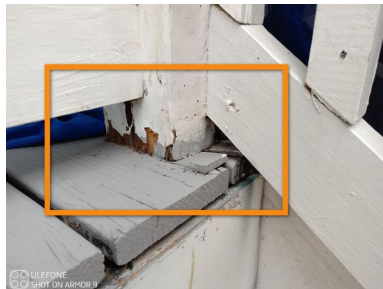
Front Porch

**1: Exterior: Evidence of Wood Rot**

Wood rot/deterioration was observed. Evaluate and remedy as needed.

Recommendation: Contact a qualified professional.

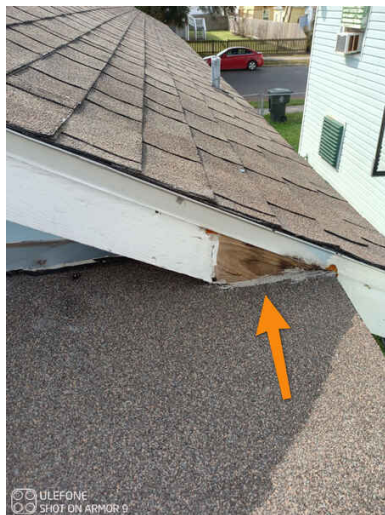
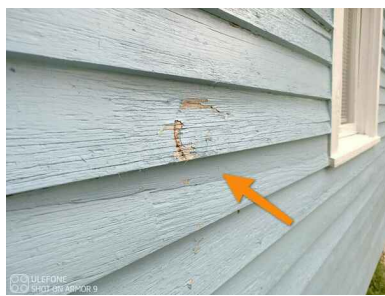
Left Side

**2: Exterior: Paint is deteriorated, damaged, or missing**

There were some areas of the exterior siding or trim that needed painting or staining to prevent premature weathering of building materials. Evaluation and remediation is recommended.

Recommendation: Contact a qualified painting contractor.

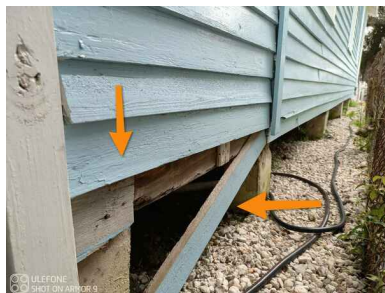
Right Rear

### 3: Exterior: Trim missing, loose, or damaged

Sections of exterior trim were either missing, loose, or damaged. Evaluation and remediation is recommended.

Recommendation: Contact a qualified professional.

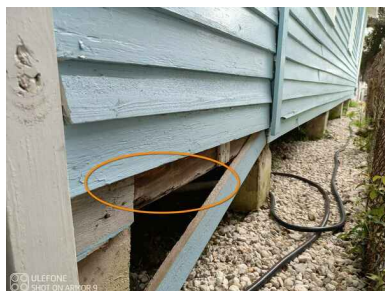
Left Side

### 4: Wood Destroying Insect Activity

There was evidence of wood destroying insects (WDI) in one or more areas. The extent of damage inside walls (if any) is not visible. Further evaluation by a pest control company is recommended.

Recommendation: Contact a qualified pest control specialist.

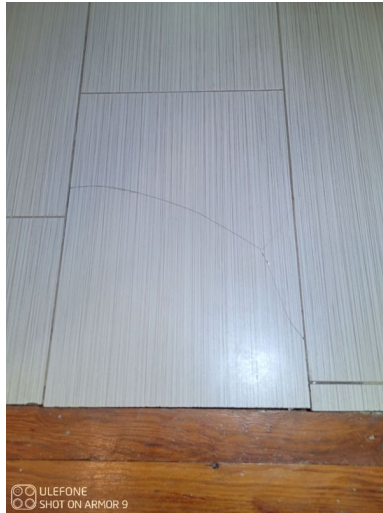
Hall Bathroom

### 2: Flooring: Tiles Cracked/Chipped

Floor tiles were cracked or chipped. Evaluation and remediation is recommended.

Recommendation: Contact a qualified professional.

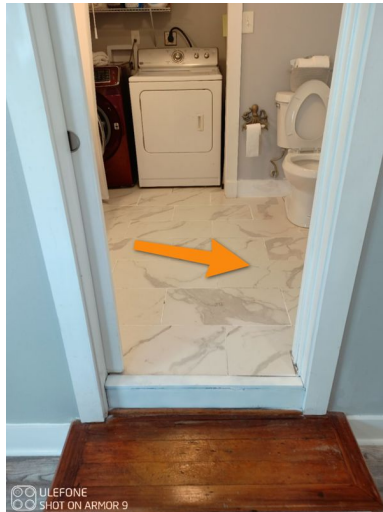
The floor noticeably sloped. Evaluate and remedy as needed.

Recommendation: Contact a qualified professional.

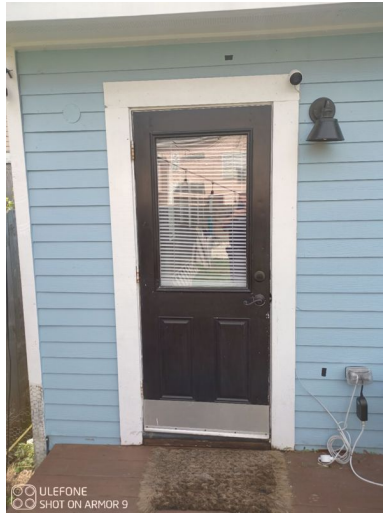
Rear Door

Door sticks and is tough to open. Evaluation and remediation is recommended.

Recommendation: Contact a handyman or DIY project

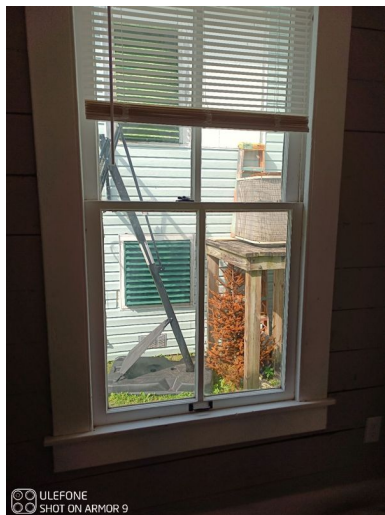
#### 1: Missing/Damaged Screen(s)

One or more windows are missing a screen or had a damaged screen. Replacement of screens is recommended.

Recommendation: Contact a qualified window repair/installation contractor.

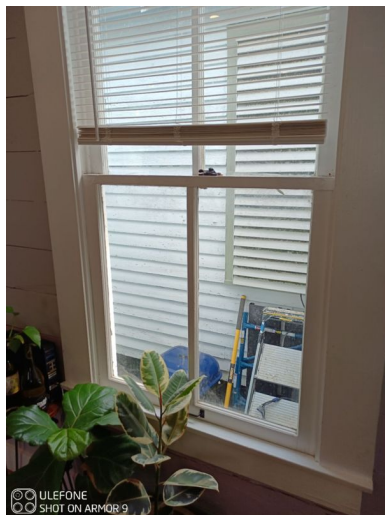
Windows were not operating properly. Evaluation and remediation by a window professional is recommended.

Recommendation: Contact a qualified window repair/installation contractor.

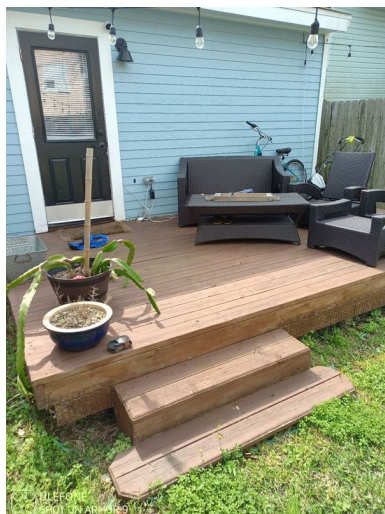
### 1: Wood to Ground Contact

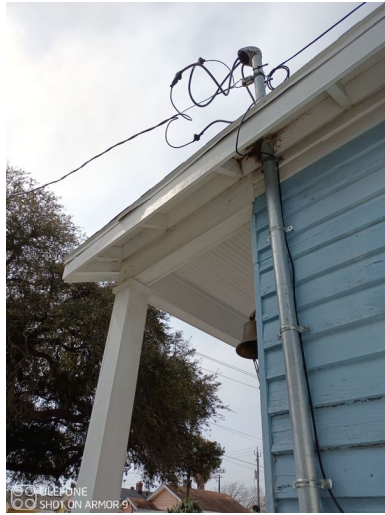
Service size: 200 Amps

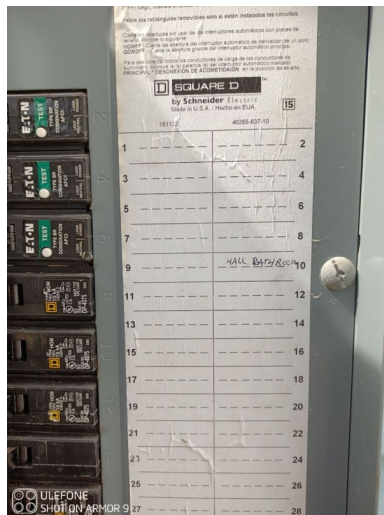
**1: Circuits Not Labeled**

Circuits in the distribution panel were not properly labeled. Evaluation and remediation is recommended.

Recommendation: Contact a qualified electrical contractor.

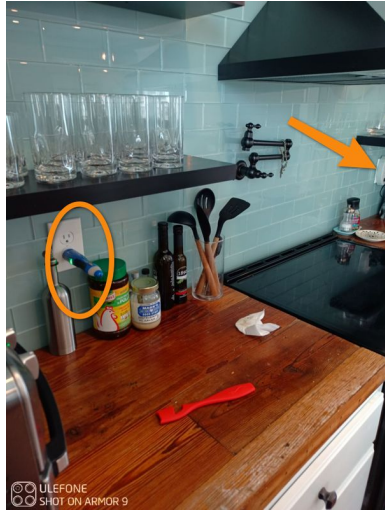
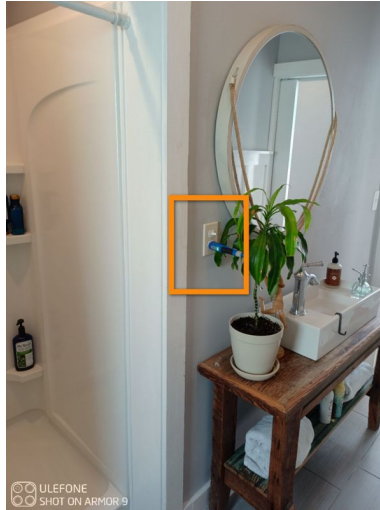
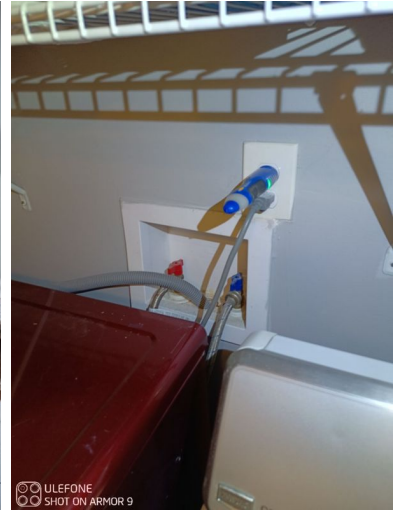
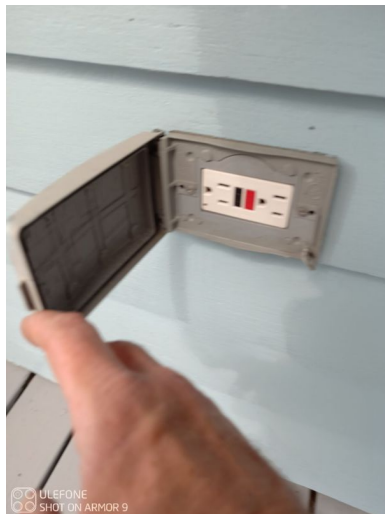
Front Door

**1: Receptacles: GFCI Protection Inadequate/Missing**

Exterior, Bathrooms, Kitchen, Laundry Area, Within 6 feet of damp or wet areas, Within 36" of sinks - GFCI protection was inadequate or missing. Current building standards recommend the installation of ground fault protection:

GFCI protection was not present in one or more of these locations. Evaluate and remedy as needed.

Recommendation: Contact a qualified electrical contractor.

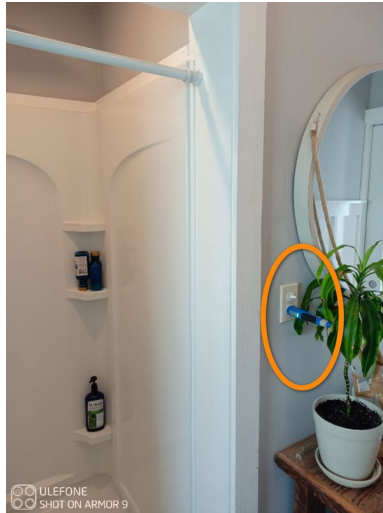
## 2: Receptacles: Light Switch or Receptacle Located within 3' of a Tub or Shower

Close proximity of a light switch or electrical receptacle to a tub or shower is prohibited by current building standards. Evaluation and remediation is recommended.

Recommendation: Contact a qualified electrical contractor.

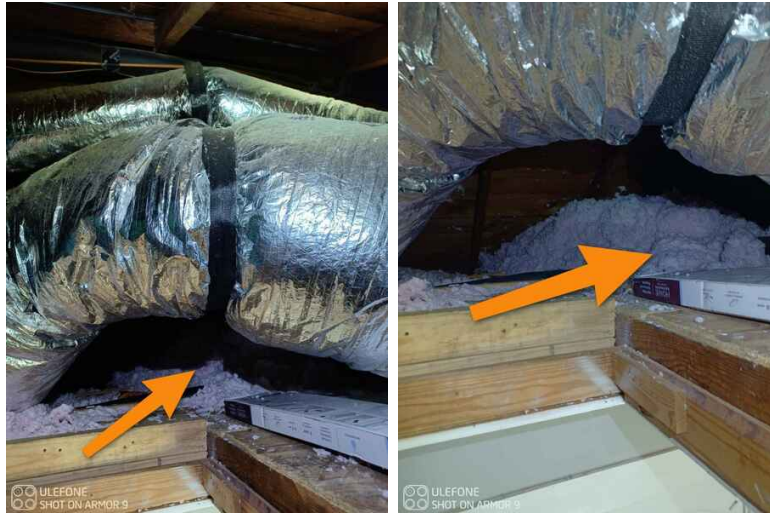
**1: Accessibility: No Deck/Service Platform**

No decking or service platform from attic entrance to the HVAC equipment was present. This is necessary for safety, servicing, replacing, or inspecting the unit. Evaluation and remediation by a qualified professional is recommended.

Recommendation: Contact a qualified professional.

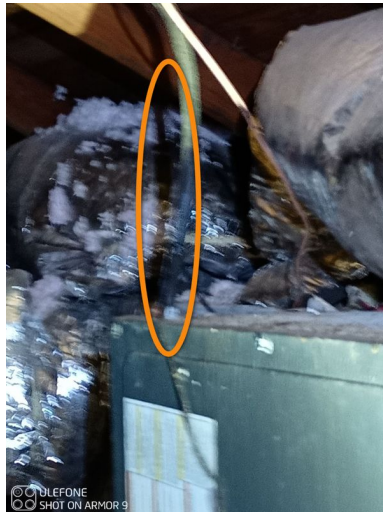
## 2: Electrical: No service disconnect

Localized service disconnect was not installed at the electric furnace. Evaluation and remediation is recommended.

Recommendation: Contact a qualified professional.

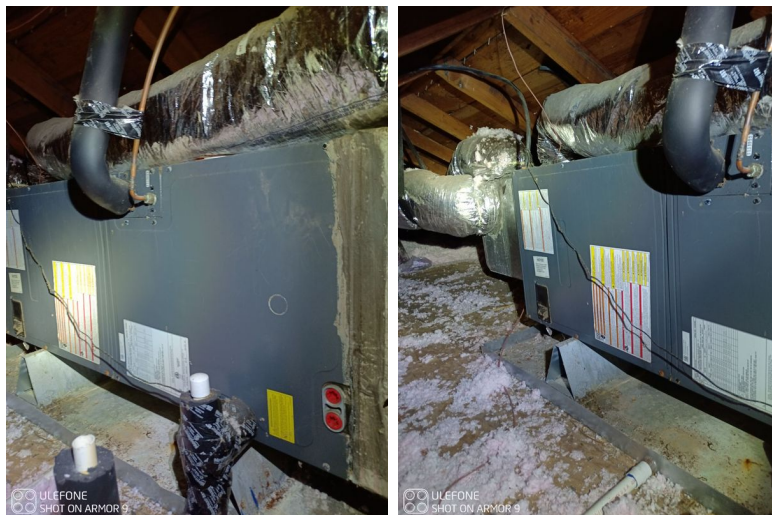
*Comments:*

*Cooling System was Functioning:*

The Cooling System was functioning at the time of inspection. Refer to the Inspection Report for any further recommendations.

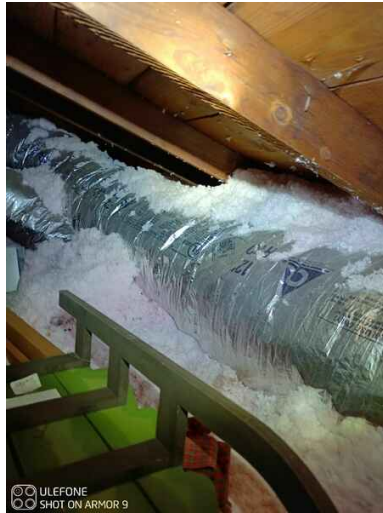
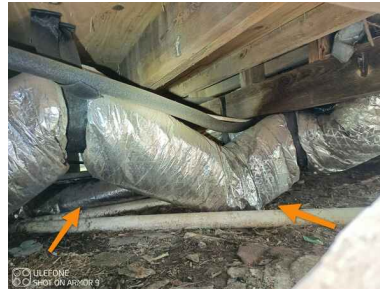
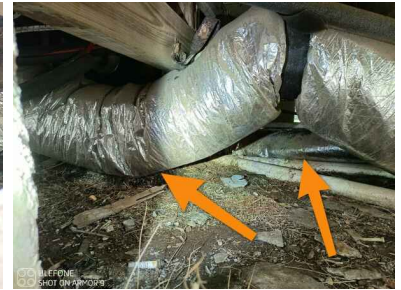
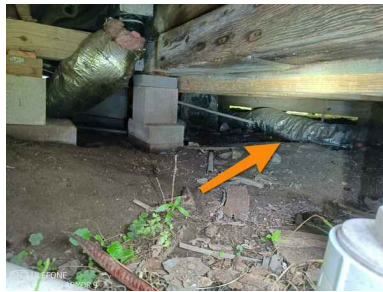
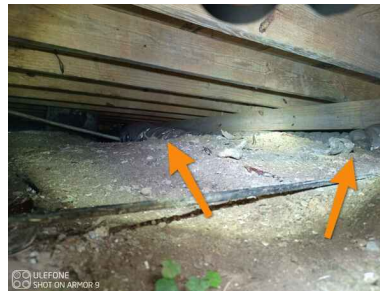
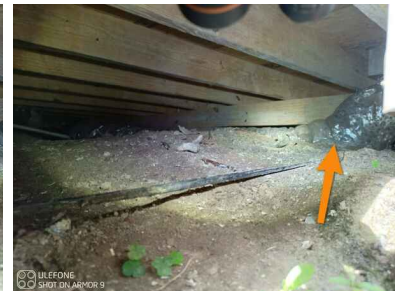
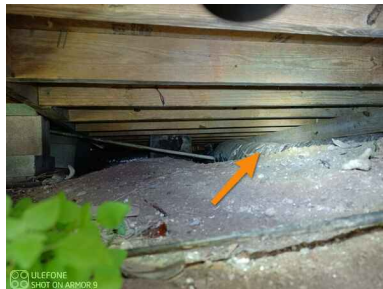
## 2: Ducts: Not Properly Sealed

Air supply ducts were not properly sealed. Evaluation and remediation by a licensed HVAC contractor is recommended.

Recommendation: Contact a qualified HVAC professional.

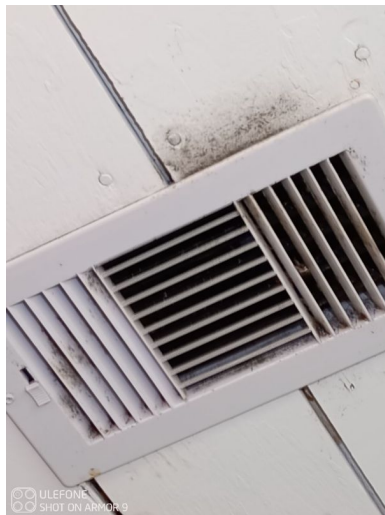
Front Bedroom

### 3: Visible substance observed on Supply Register

A dark substance was observed on an air supply register in the home. Servicing and cleaning of the system by a qualified HVAC contractor is recommended, as this can be a result of excessive water vapor/humidity in the conditioned air.

Recommendation: Contact a qualified HVAC professional.

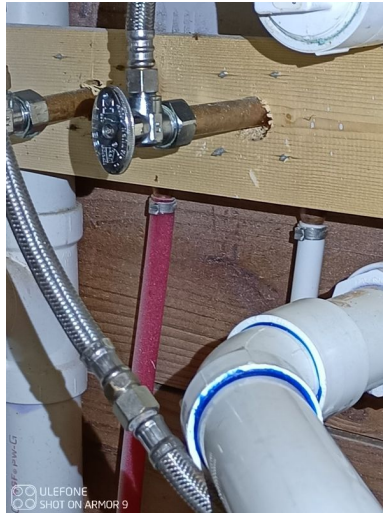
**1: Fixture: Drain Stops Missing or Ineffective**

Drain stops had issues that prevented them from working properly (holding water). Evaluation and remediation is recommended.

Recommendation: Contact a qualified plumbing contractor.

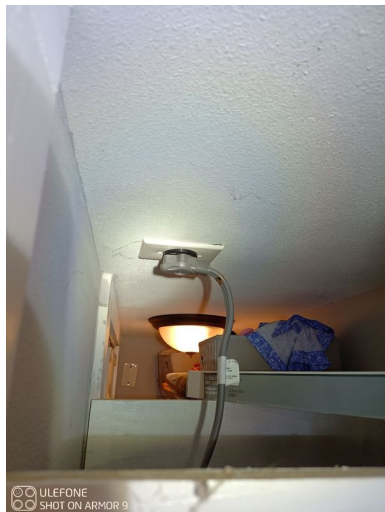
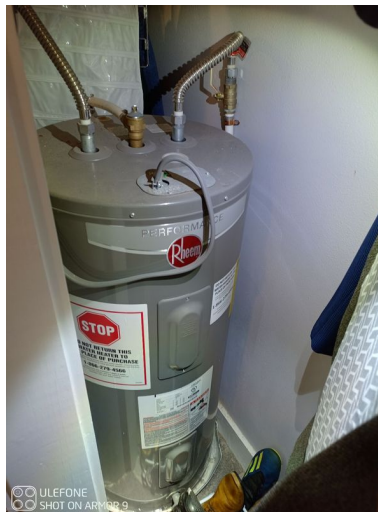
Energy Source: Electric

Capacity: 40 Gallons

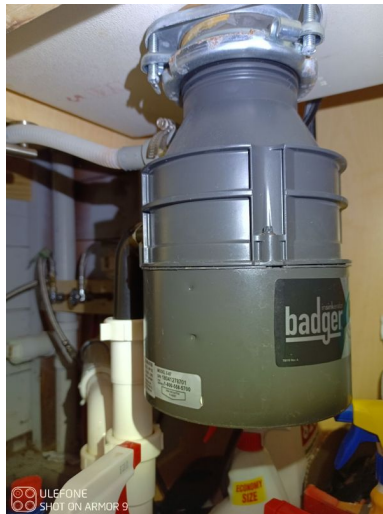
*General Photos of Food Waste Disposer:*

The garbage disposal sounded as if it had debris in it. Evaluation and remediation is recommended.

Recommendation: Contact a qualified professional.

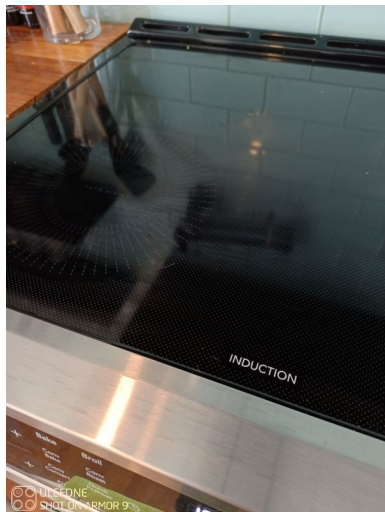
**1: Missing Anti-Tip Device**

There was no anti-tipping device installed on the oven/range to prevent tipping if the door is climbed on while opened. This is a possible safety hazard. Evaluate and remedy as needed.

Recommendation: Contact a qualified professional.
