**Buyer: Will Ayala**  
**1530 Lochstone Dr.**  
**Houston, TX 77073**  
**03/08/2026**

## Big State Home Services

# PROPERTY INSPECTION REPORT FORM

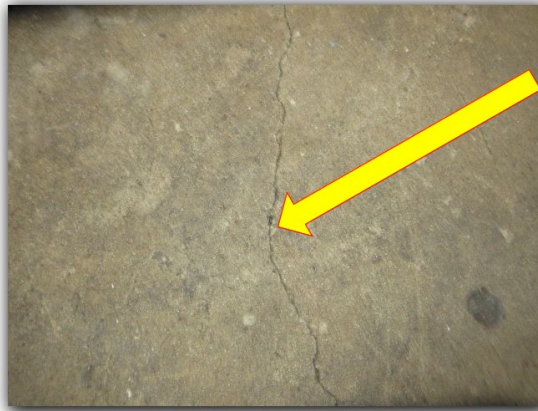
**Note:** Hairline cracks noted to garage flooring. Hairline cracks are not affecting performance of the foundation at this time.

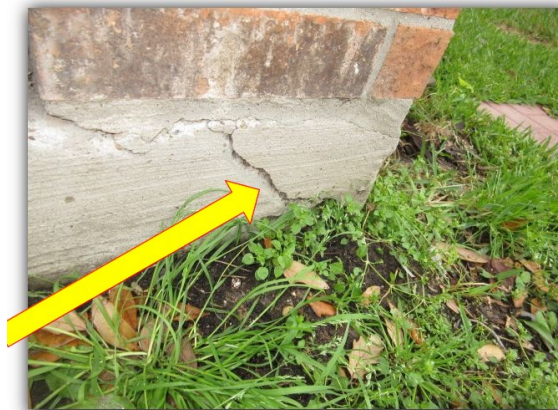
**Note:** Foundation has spalling/corner cracks at one or more locations of the foundation. Corner spalling cracks are cosmetic; they have no effect on the foundation performance. Spalling/corner cracks allow possible termite penetration to be undetected. Spalling/corner cracks can be sealed and or patched with a cement compound.

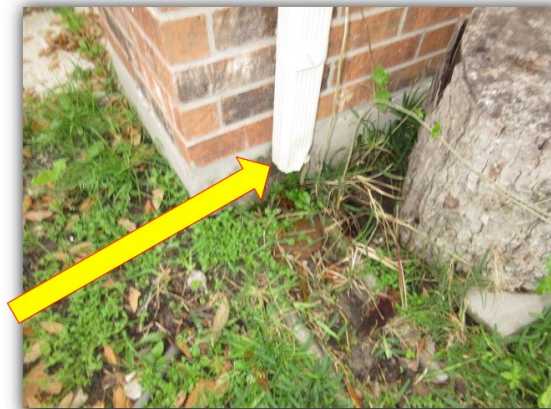
- **Diverter missing at base of downspout to gutters on front right corner of structure.**

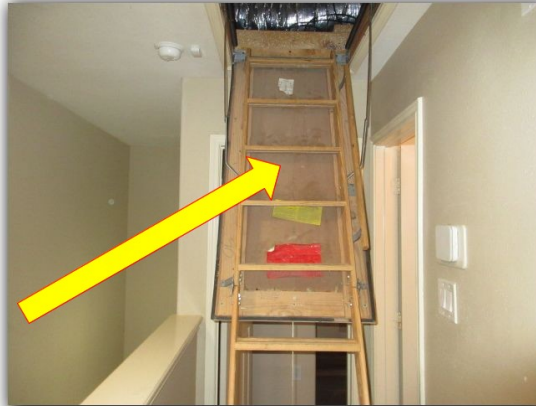
- The attic pull down stairs are installed with either the wrong amount of hardware or the wrong type. The manufacturer calls for 16-16d nails or 1/4 inch diameter lag screws. Nailing must be completed by placing nails (lag screws) in the pre-punched holes in pivot plates, corner braces and spring brackets. Recommend adding the correct nails or screws. Safety concern.

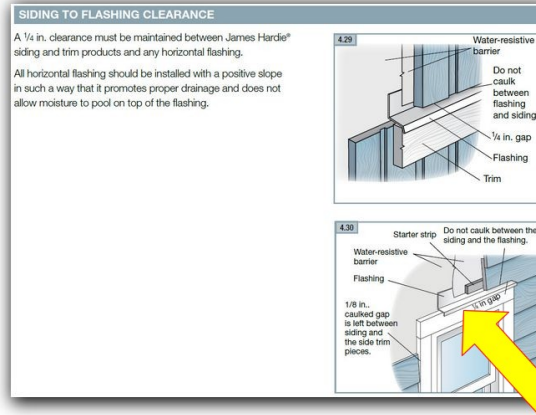
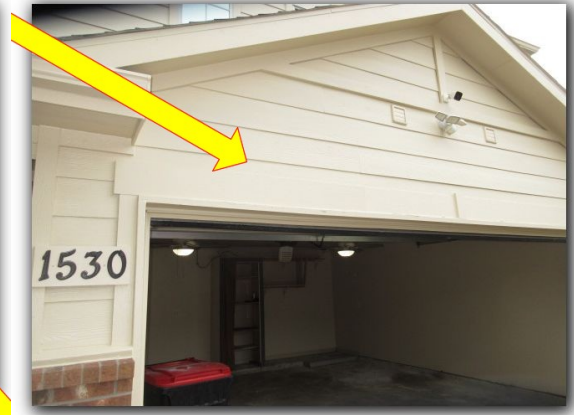
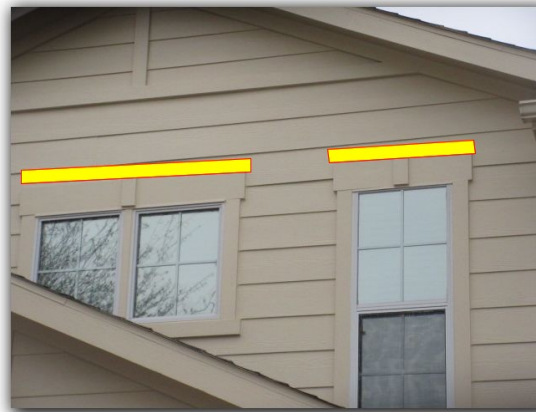
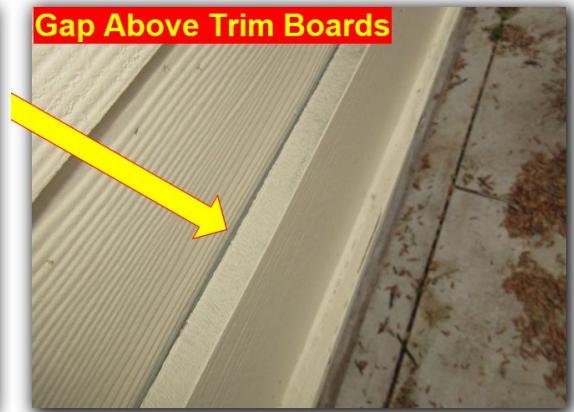
- Top trim board above exterior doors/windows are not equipped with metal flashing. Approve corrosion-resistant flashing required at top of all exterior door openings is such a manner to be leak proof.

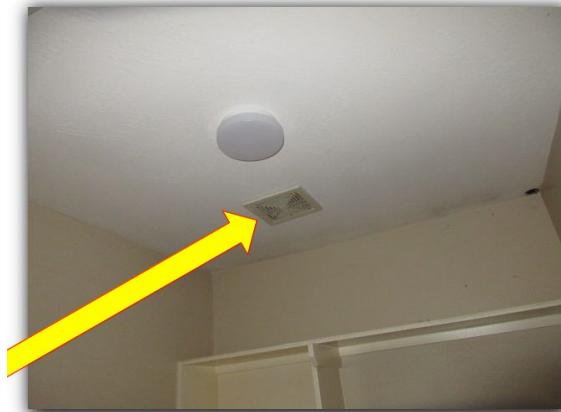
- Inspector observed exhaust fan registers on ceiling of garage. Openings are not allowed into attached garages per current fire blocking codes.

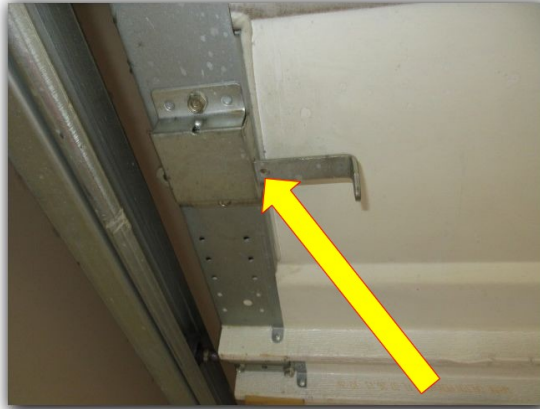
- Overhead garage door with an opener should have the lock disabled to prevent damage to the overhead unit if you try to open it while locked.

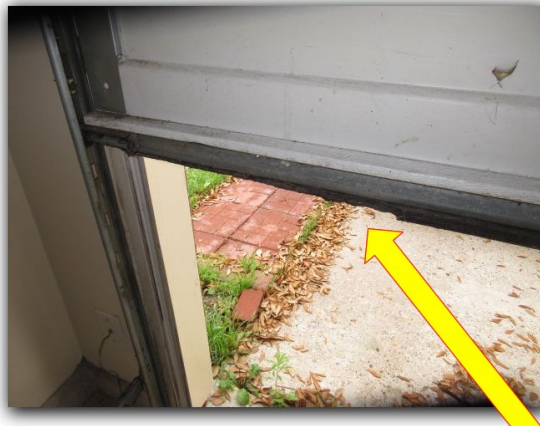
- Weather stripping at the bottom of the garage door(s) is damaged.

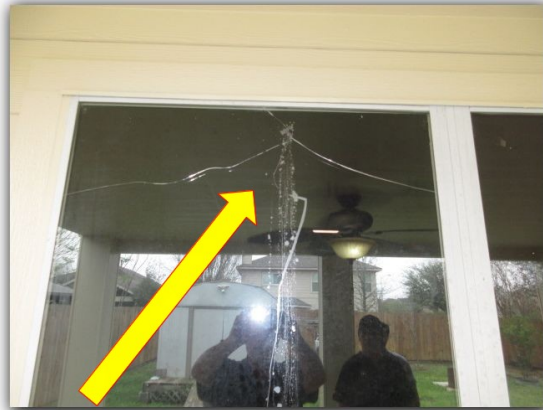
- Window screens torn, damaged and or missing.
- Cracked/damage glass observed; rear right corner master bedroom.

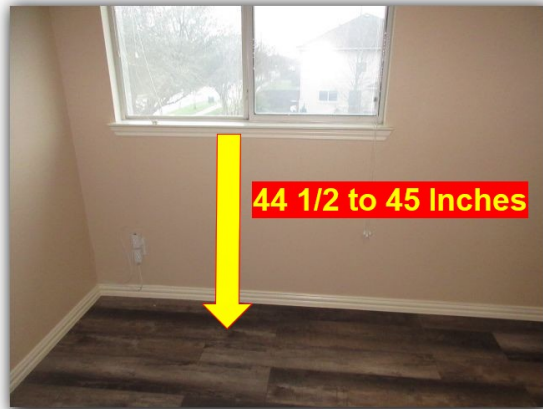
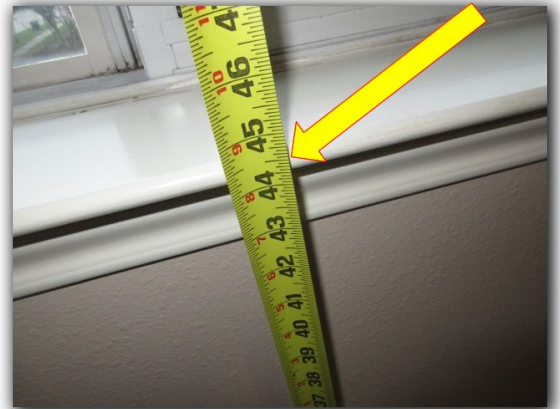
- Thermo pane windows have lost their seals or appear to have a damaged vapor barrier. The window have moisture between the panes and or the window have fogged; 2nd story left middle bedroom window and rear right corner and rear left corner bedroom windows.
- Height to window sills are greater than 44 inches above flooring which is considered difficult to escape thru if used as a emergency egress in case of fire; 2nd story left middle and rear right and left corner guest bedroom windows.

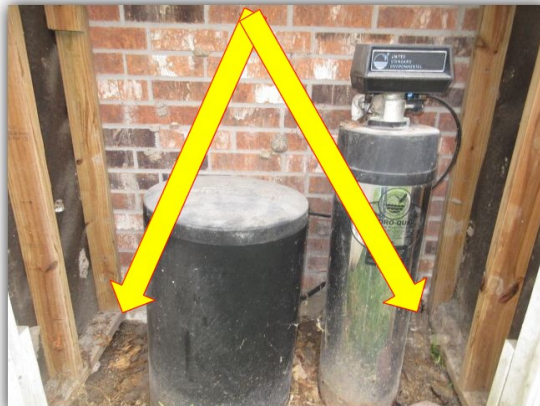
- **Wood framing to shed to water softener system observed adjacent to foundation. Wood to ground contact is conducive to termite infestation.**

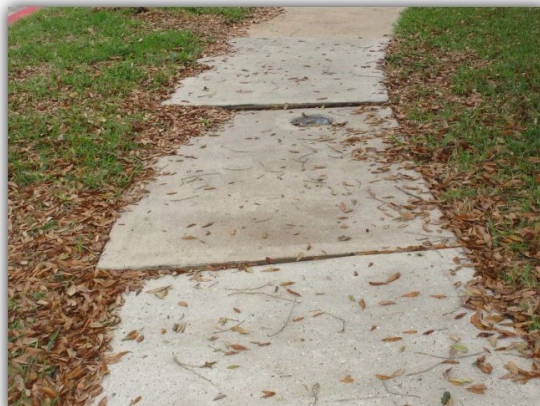
- Sidewalk is unlevel on one or more locations. Possibly due to tree roots. (Tripping Hazard).

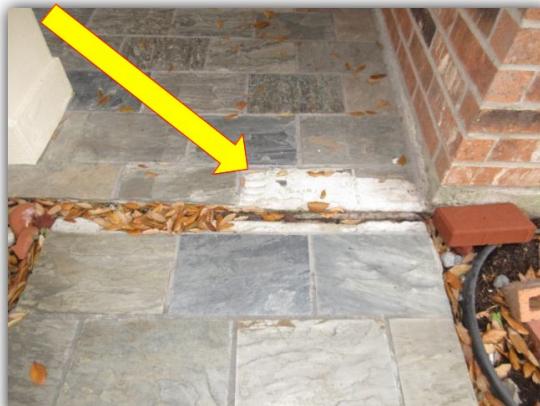
- Paver/tile missing at front porch.

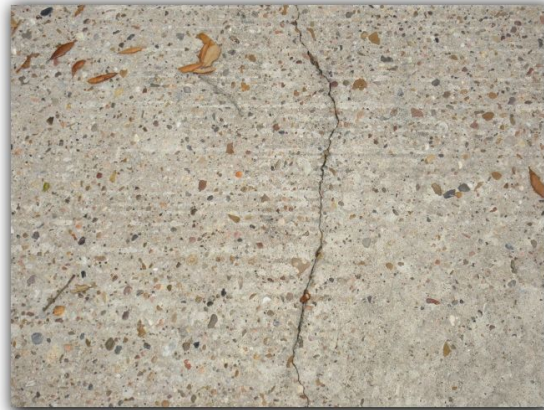
- Multiple cracks noted to driveway.

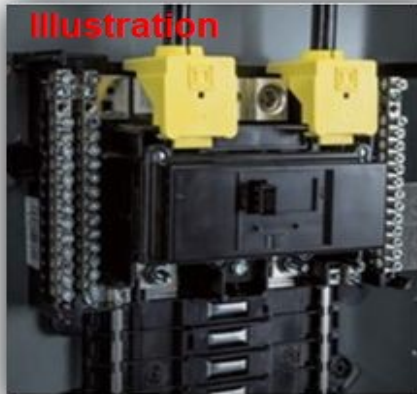
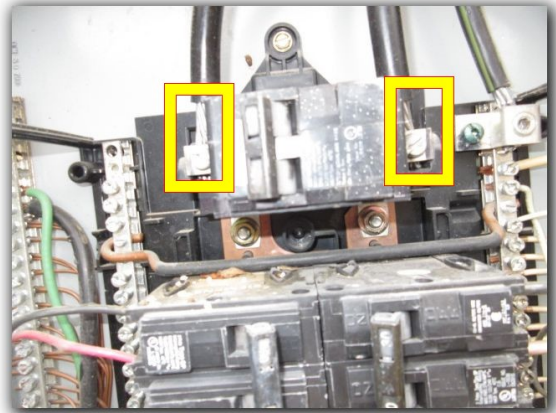
- There is no anti-oxidant compound (grease) on the exposed aluminum wiring.

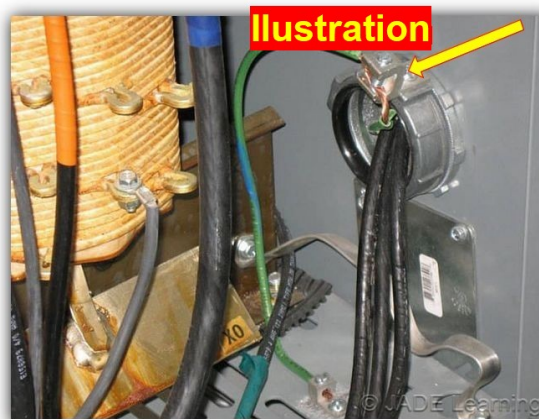
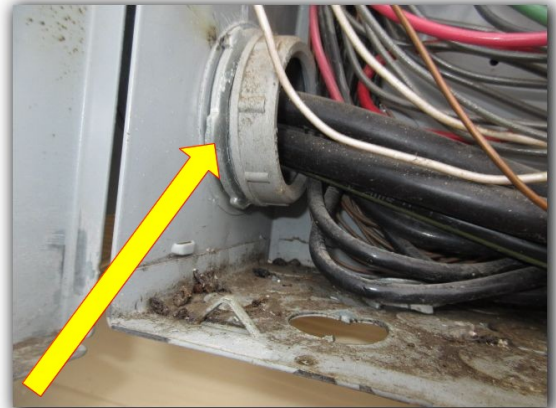
- The wrong type grounding clamp was observed in securing the grounding cable to the grounding rod. The clamp should be an "acorn" type clamp. A weaver clamp was observed. The screws on the weaver clamp tend to rust and will eventually fail and no longer provide a proper grounding connection for the electrical service.

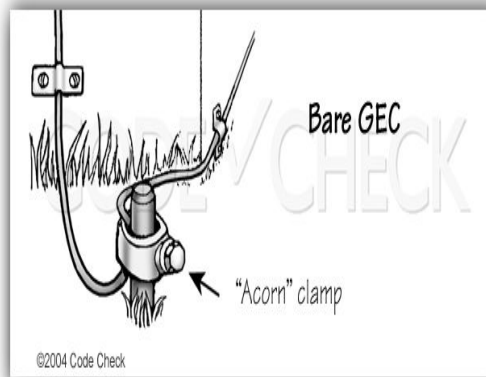
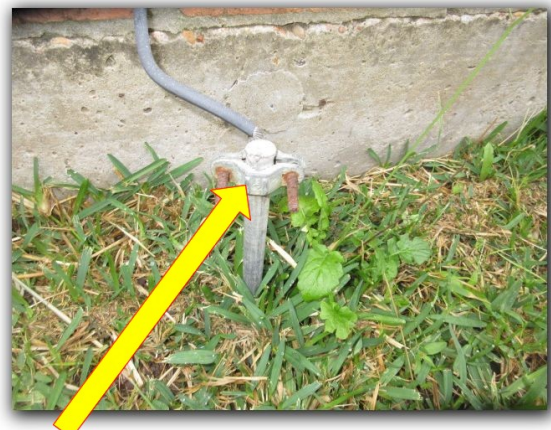
- Grounding cable has come loose from the supplemental grounding rod and or ground rod was not present.

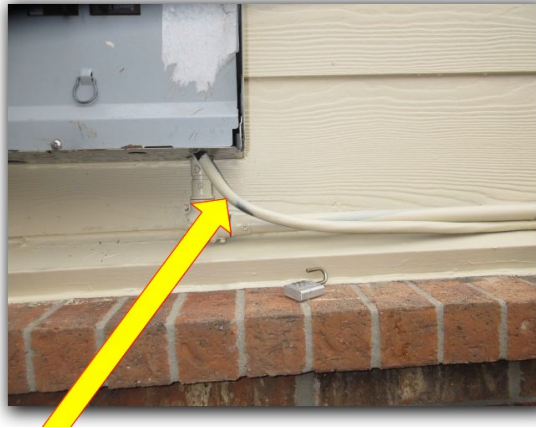
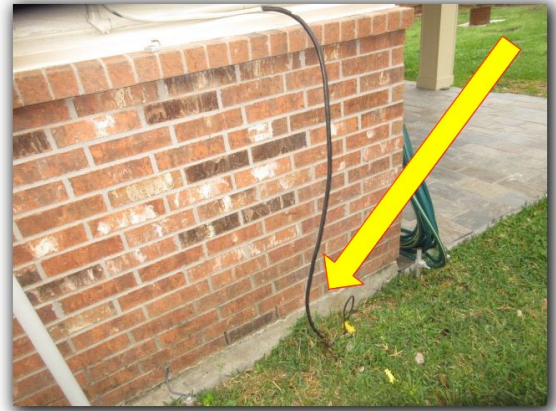
- Inspector observed an electrical cable penetrating out of breaker panel buried in ground leading to metal shed. Electrical cable should be protected in conduit.

**Recommend buyer consult with a licensed electrician for further evaluation and repairs as needed.**

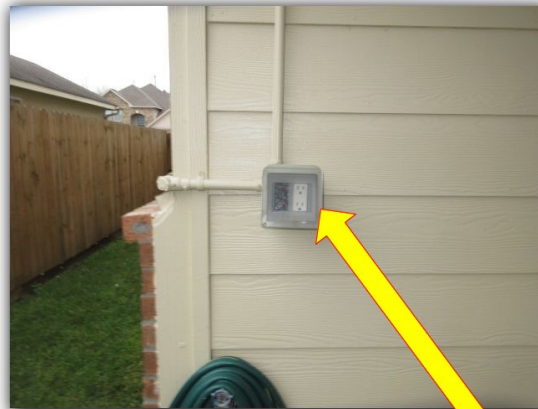
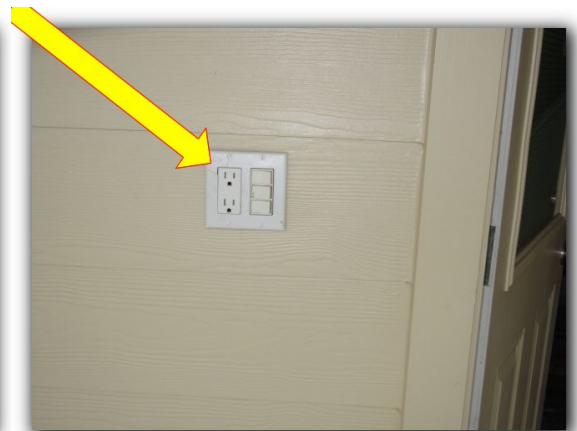
- Outlets throughout structures are not tamper resistant. All outlets less than five and a half feet above the floor required to be tamper resistant. NEC Code required as of 2008. Texas Real Estate Commission Standard of Practice require lack of tamper resistant to be called out. (Typical for a house of this age).
- New 2023 NEC code requires the outlet servicing the HVAC (furnace) equipment in the attic be equipped with GFCI (Ground Fault Circuit Interrupter) protection. Ref: NEC 210.8(E) and 210.63
- All exterior outlets (rear right corner and outlets at patio) are not equipped with GFCI (ground fault circuit interrupter) protection as required by current code.

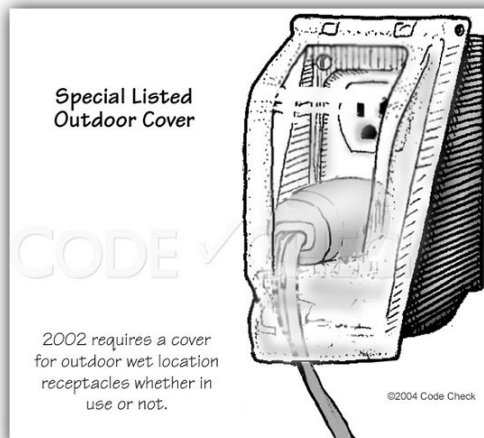
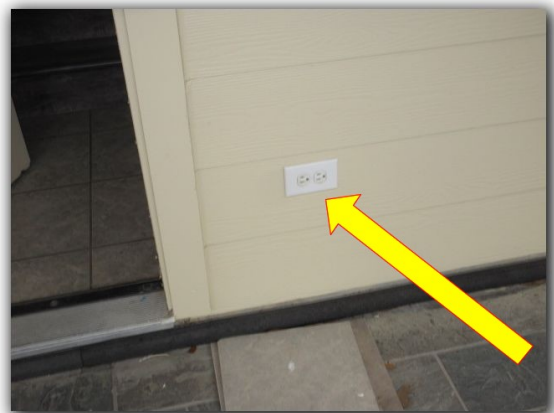
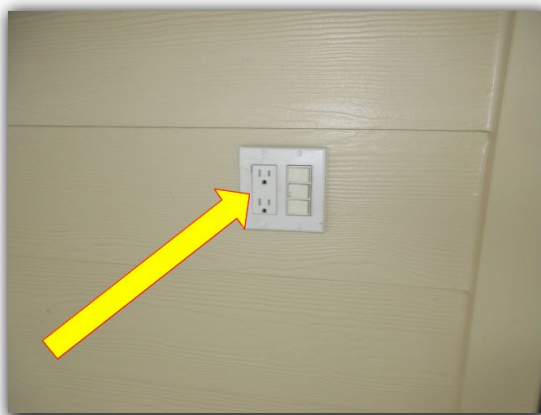
- Missing/incorrect weatherproof cover on an outside outlet observed with a permanent cord plugged in at outside outlet; patio.

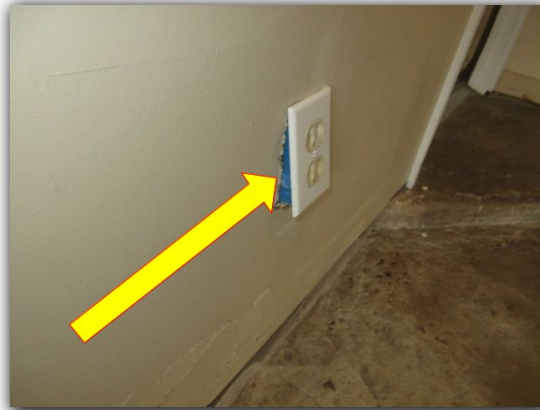
- Outlet left wall of garage is loose.

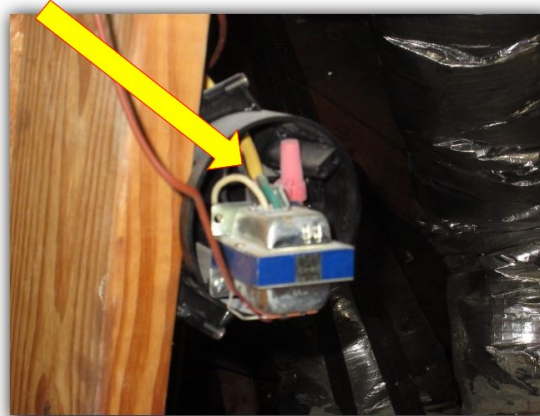
- Junction box in attic and ceiling of garage is missing a cover. Wiring is exposed.

Recommend buyer consult with a licensed electrician for further evaluation and repairs as needed.

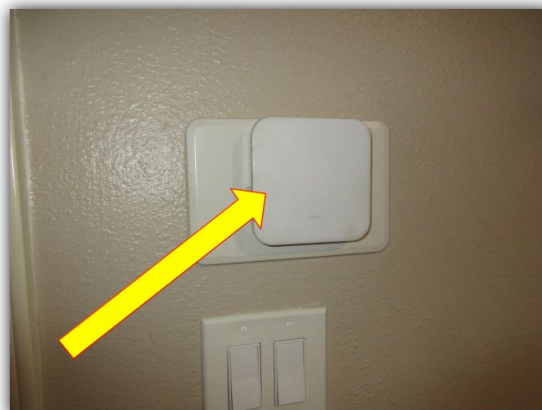
- Thermostat is not functioning. The heat would not come on. Recommend servicing by a licensed HVAC technician.

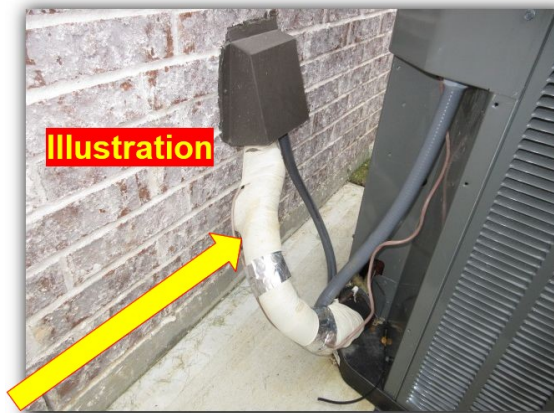
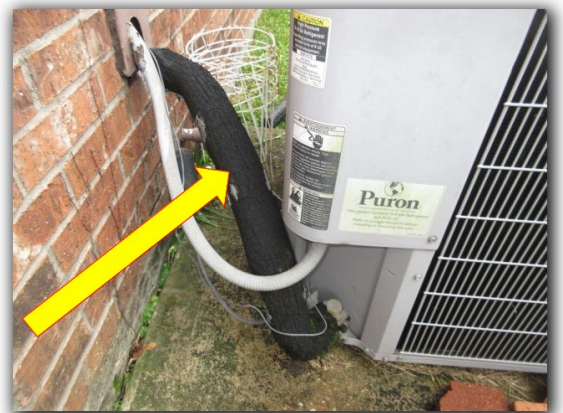
- Piping insulation to refrigerant line to A/C condenser is not protected from damage, including that due to sunlight, moisture, equipment maintenance, wind and shall be provide shielding from solar radiation that can cause degradation of insulation material. (International Energy Conservation Code) Adhesive tape shall not be permitted.

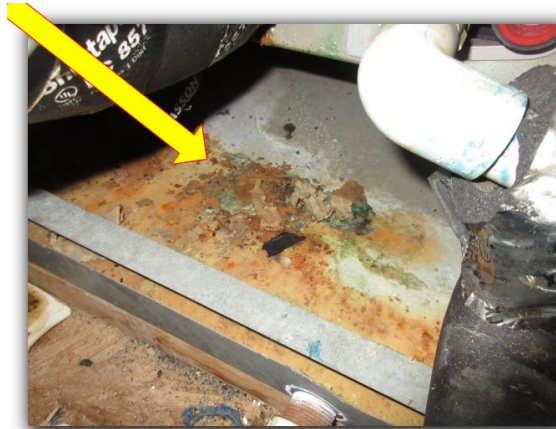
- Rust and corrosion noted to safety pan under the evaporator coil. Rust and corrosion is an indication primary drain line was clogged and evaporator coil was leaking water at sometime. Recommend A/C system be cleaned and serviced and safety pan be replaced if needed by a licensed HVAC specialist. Recommend A/C systems be serviced annually to ensure continued proper operation.

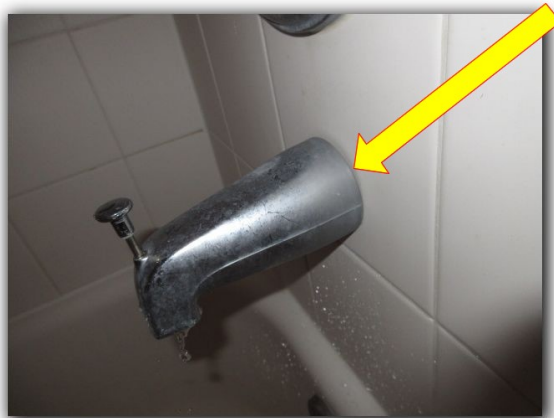
- Caulking deficient and or missing around spout to bathtub.

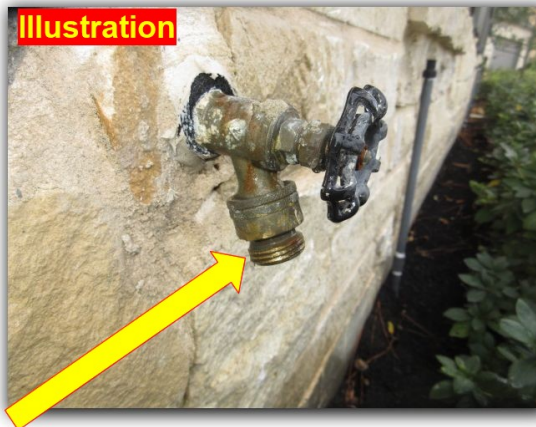
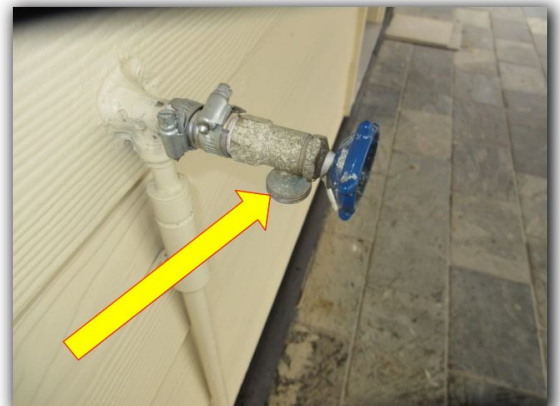
- Backflow (Anti-siphon) device missing at one or more outside facets which can cause contamination to the water supply.

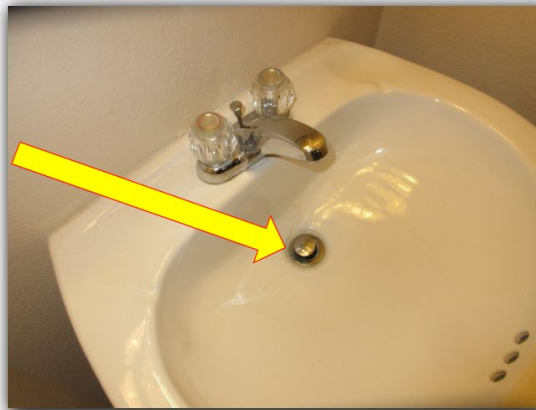
- Sink drain stop not functioning.

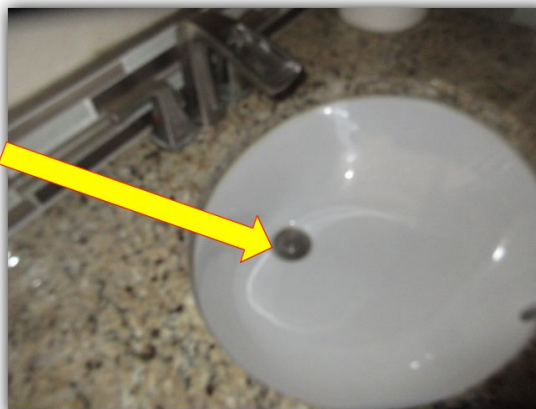
- Drain stops to both sinks not functioning.

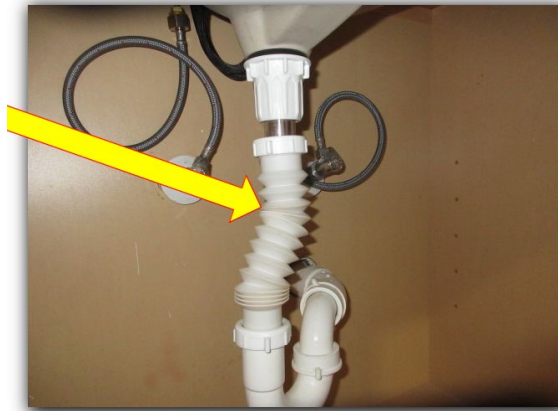
- Improper drain line material observed under right sink. Flex corrugate piping

observed. Smooth drain pipe is recommend to prevent clogged of drain line.

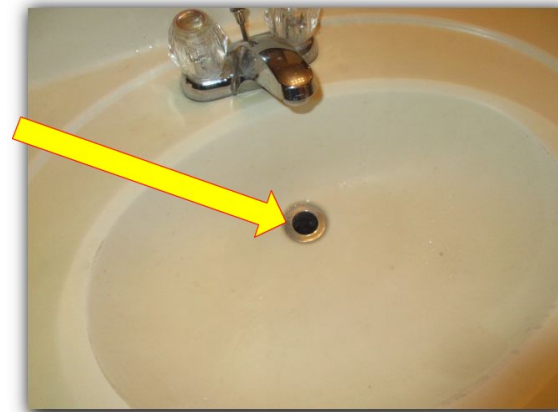
- Sink missing drain stop.

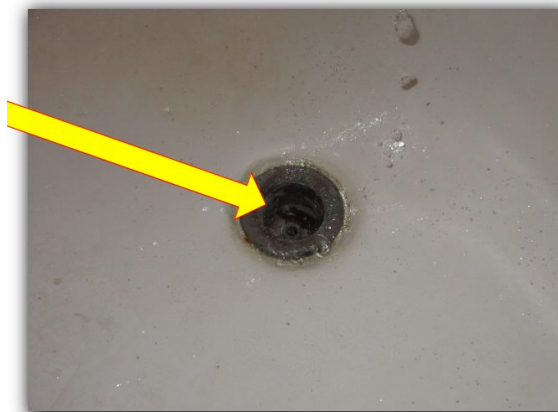
- Bathtub is missing a drain stop.

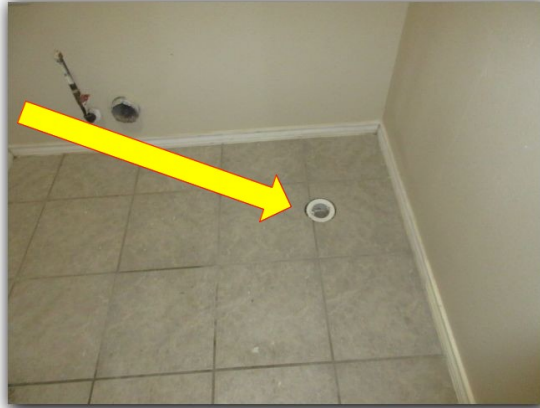
- Laundry room floor does not slope properly towards center floor drain making drain not operational / ineffective when needed. Floor needs curbs along perimeter of laundry room and floor needs to slope down towards center drain for proper operation of a floor drain or an alternative is to install metal drain pan below washing machine with drain line routed to floor drain.

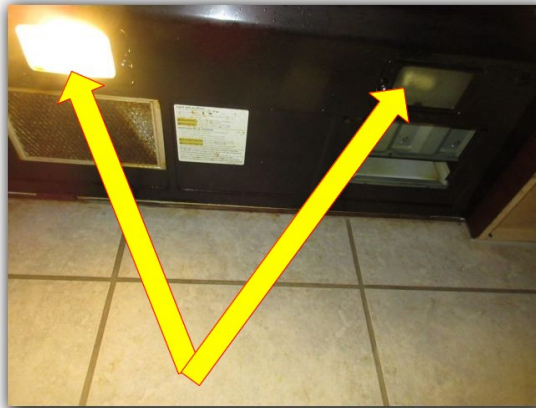
- **Range hood light is not functional. Left side flickers and right side does not turn on.**

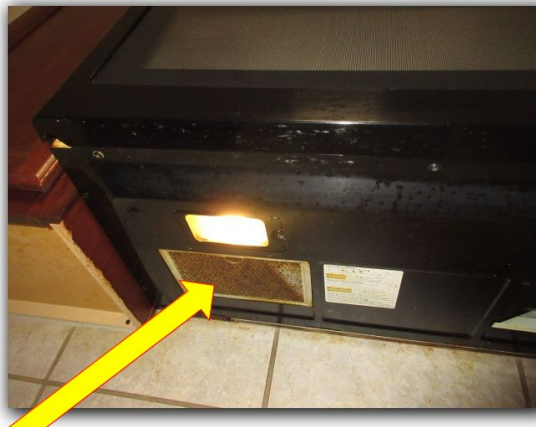
- **The range hood screen/filter needs to be replaced or cleaned due to grease build-up. Safety Hazard.**

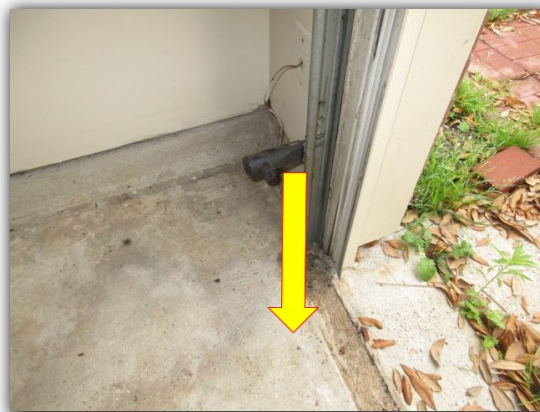
- Opener did not work. Recommend service.
- Electric safety eyes are not to be installed greater than 4-6" above the floor. Recommend lowering. -
