# PROPERTY INSPECTION REPORT BUYERS EYE HOME INSPECTION

Concerning: **16710 Tahiti Way Jamaica Beach, Texas 77554**

By: **Kimble Nobles Lic. No. 6139**

**October 21, 2021**

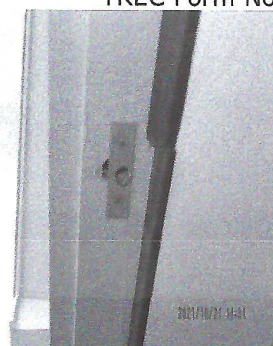
Appears to be functioning as intended for the inspection period. The north main patio doors need to be adjusted. Deficient. The stationary side locking mechanism hole and pins have slack. Deficient. The northeast patio door is a fiberglass material. The door stop damaged the fiberglass. Deficient. The door can be repaired with a fiberglass patch kit. The door stops are the incorrect type. The main entry door drags the threshold. Deficient. The door needs adjustment. The garage side door step is a tripping hazard. Deficient. Simply add a step.

Poor door locking.

**UPDATE: All doors were replaced with Neuma Storm doors in 2024 and 2025.**

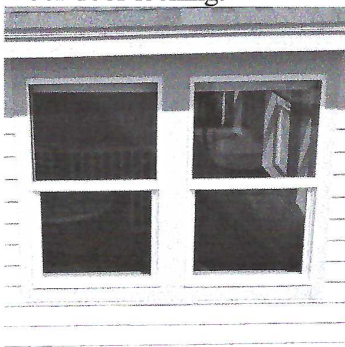
Appears to be functioning as intended for the inspection period. The home is equipped with double pane glass. The bedroom windows are operational for the inspection period. The bedroom windows may be the only means of emergency egress. Check the windows at least once a year. The guides can be cleaned and lubed with a dry lubricant to keep them operating smoothly. Several window screens are missing. Deficient.

Missing screens.

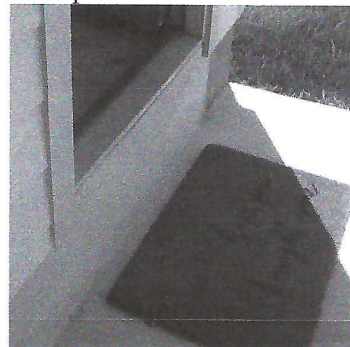
Missing step.

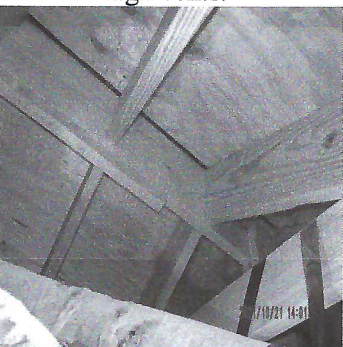
The roof structure appears sound and appears to be functioning as intended for the inspection period. The roof structure was designed for and uses 2X6's as the purlin material. Today's standard requires the purlin be the same size as the supported rafter to prevent deflection of the roof structure. Rafter collars are present. The attic is insulated (approximately 6 inches of bat insulation horizontally and appears 4 inches vertically). The structure decking is not an energy reflective type. The attic space is vented by soffit, and ridge vents.

Roof structure.

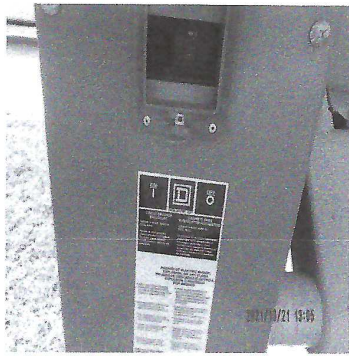
The electrical service panel is a Square "D" 200-amp panel with a Square "D" 200-amp disconnect located at the meter. Copper wiring, correct breaker and wire sizing are present. Appears to be functioning as intended for the inspection period. AFCI breakers are installed. See note below.

Main disconnect.
