**March 19, 2026**

# PROPERTY INSPECTION REPORT FORM

3614 Montrose Blvd Unit 1001, Houston, TX 77006

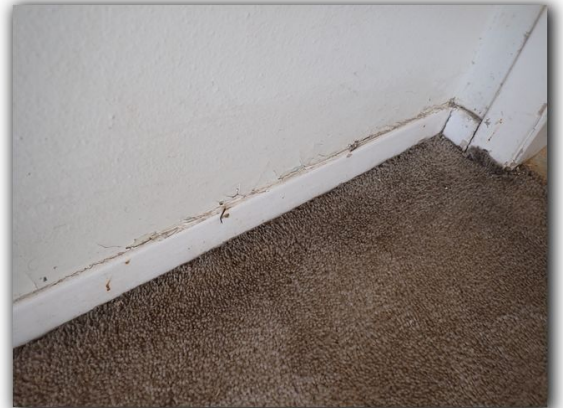
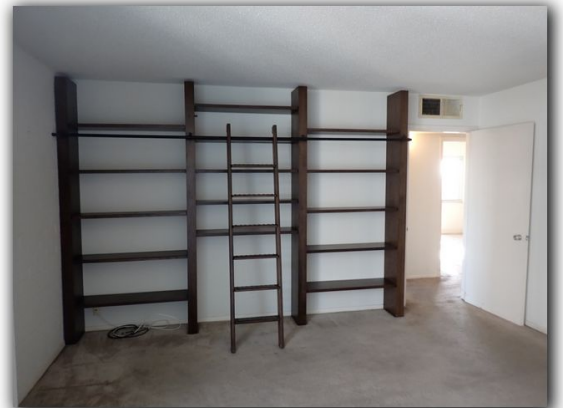
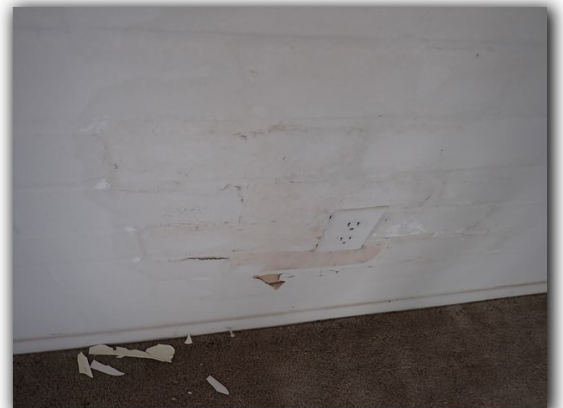
- Wall surface damage was observed in several locations.
- Several locations of cosmetic repair (texture, caulk, paint) are recommended.
- Damage to the cinder block wall was observed in the secondary bedroom closet.
- Water stains and damage were observed on the wall finishes in the bedroom hallway closet, primary bedroom. It is recommended to investigate the source of moisture and make necessary repairs to prevent further deterioration (If necessary).
- Water stains were observed on the walls in the primary and secondary bedroom. It is recommended to identify and address the source of moisture (if necessary) to prevent further damage.
- The closet shelf support is loose in the guest bedroom closet.

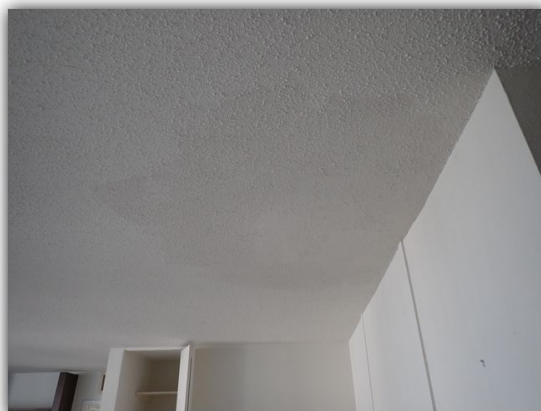
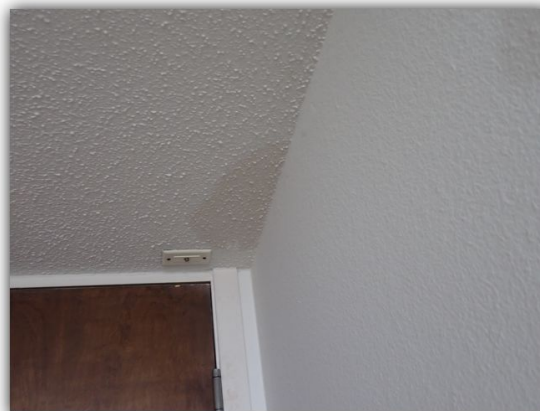
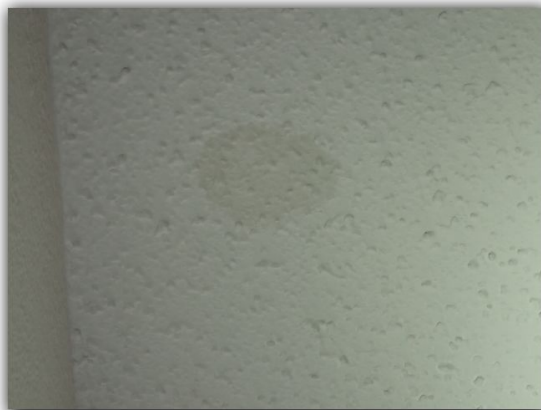
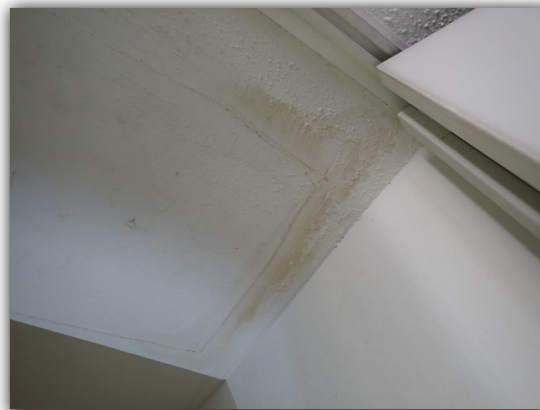
- Water stains were observed on the ceiling(s) in the front entrance area, living room, primary bedroom closet, guest bedroom, living room closet and guest bedroom closet. It is recommended to identify and address the source of moisture (if necessary) to prevent further damage.

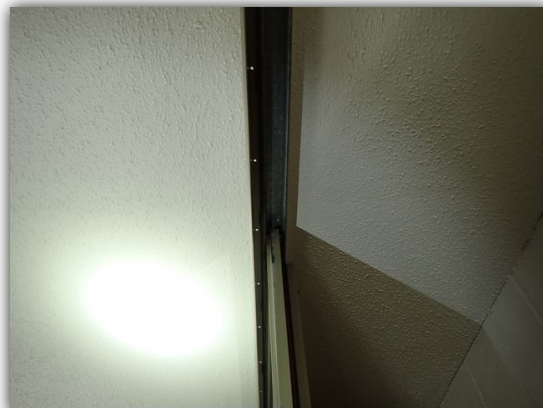
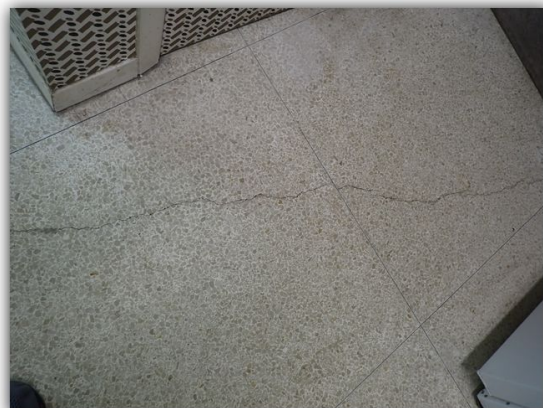
- The floor tile(s) were observed to be cracked and/or damaged in the kitchen.
- The floor covering is worn and/or damaged in one or more locations of the home.
- The floor covering is stained in one or more locations of the home.
- Buckling was observed in the carpet material at one or more locations throughout the home. This condition may present a trip hazard and can worsen over time if not addressed. For safety and appearance, it is recommended that the carpet be professionally re-stretched and secured.

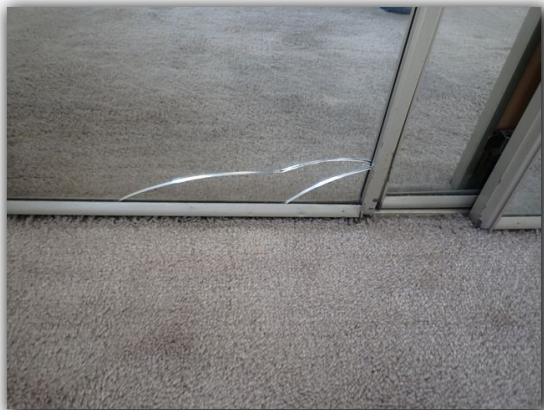
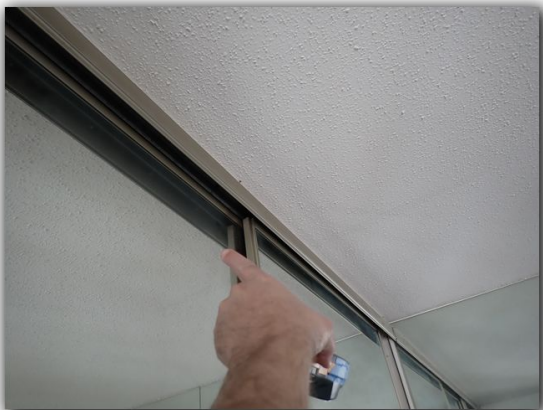
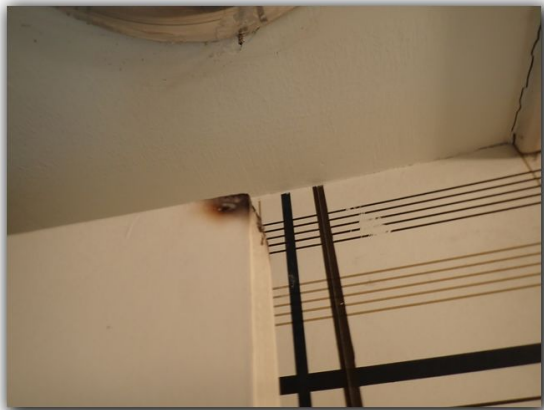
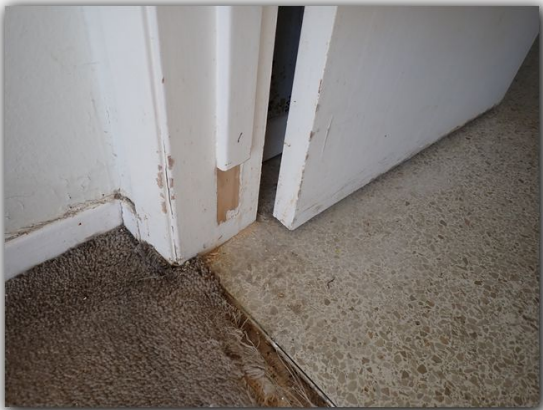
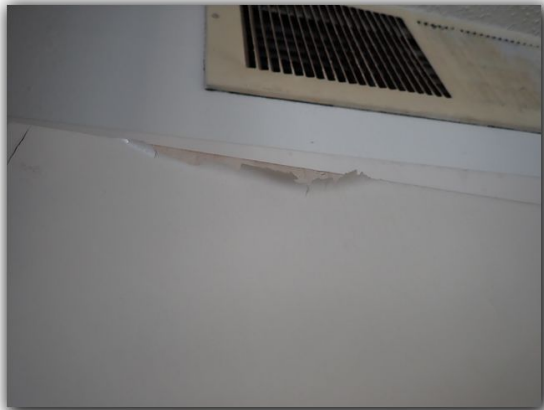
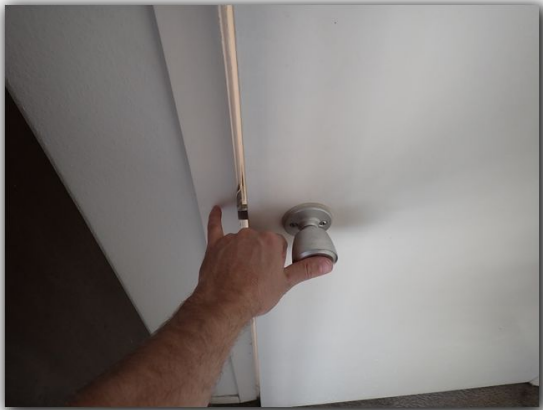
- Several locations of cosmetic repair (texture, caulk, paint) are recommended.
- The door at the following location(s): bedroom hallway, is not latching properly. This may be due to misalignment, worn hardware, and/or damage to the latch mechanism, which can affect functionality.
- The door at the following location(s): guest bedroom, is sticking, making it difficult to open or close smoothly. This issue may be caused by swelling due to moisture, misalignment, or worn hardware.
- Surface damage was observed to the door in the several locations.
- The door hardware is loose to the primary bedroom, primary bedroom closet.
- The closet door is off track in the guest bedroom closet.
- The glass in the guest bedroom closet door(s) were observed to be cracked and/or damaged.
- The door frame is damaged to the primary bathroom.

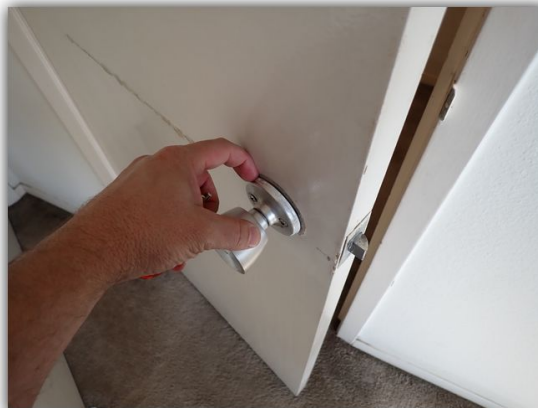
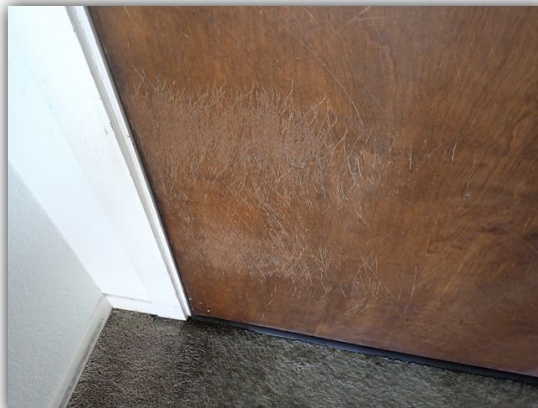
- Surface damage was observed to the door in the front entry door.

**Note:** There is no screen on the balcony sliding glass door.

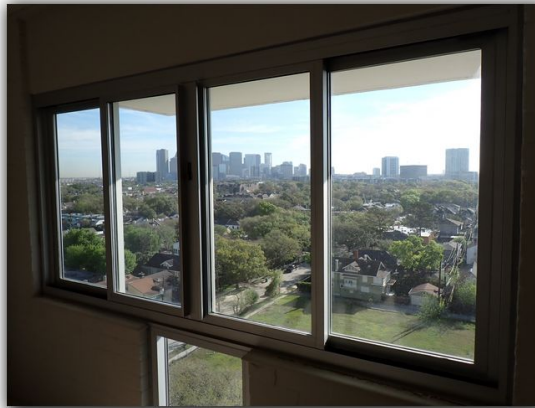
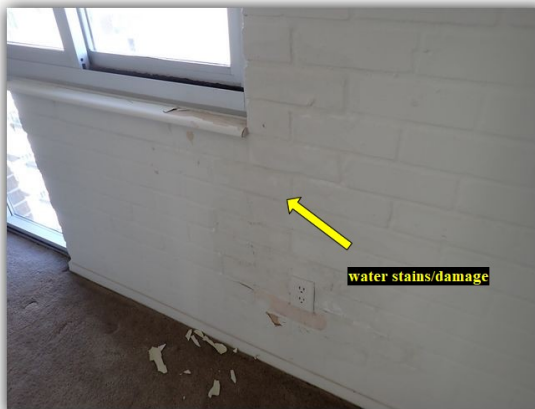
- The window sill(s) in the following area(s): primary and guest bedroom, show signs of deterioration and/or damage. This may be due to moisture intrusion, age, or general wear and tear. Repairs or replacement by a qualified contractor are recommended to restore proper function and appearance and to prevent further deterioration.

- One or more windows in the following area(s): guest bedroom, are stiff and difficult to operate. This may be due to issues such as swelling, damaged hardware, or lack of maintenance. It is recommended to have the windows inspected and serviced by a qualified professional to restore smooth and safe operation.

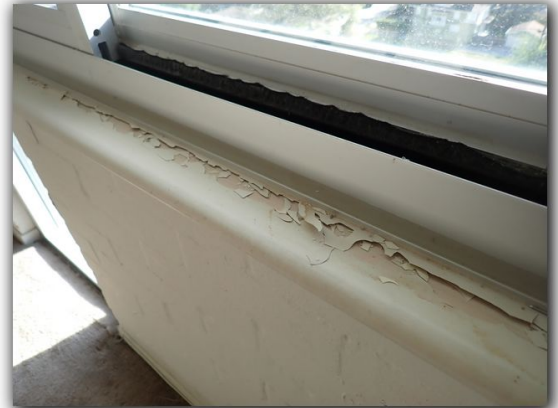
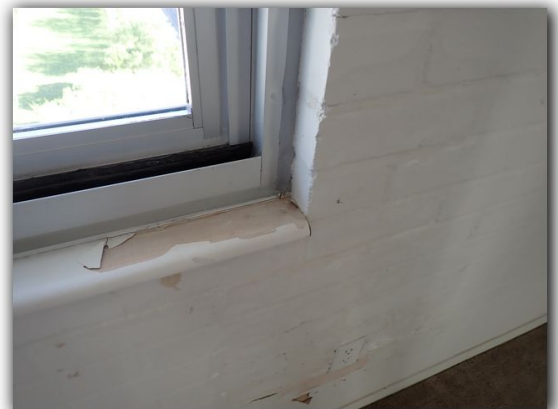
- Water stains were observed at and/or around the window(s) in the following area(s): primary and guest bedroom. This may indicate past or ongoing moisture intrusion. The source of the staining should be investigated by a qualified professional, and appropriate repairs made to prevent further damage and ensure the area remains dry.

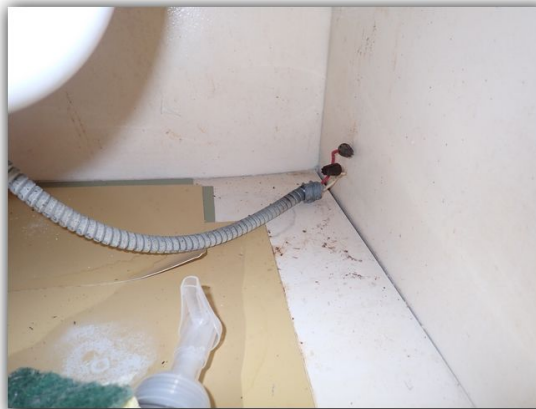
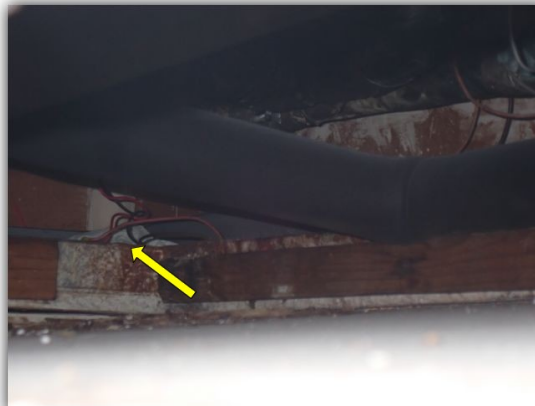
- Open end wires were observed in the kitchen. For safety, all open end wires should be properly enclosed within approved junction boxes.
- Spliced electrical wires were observed in the HVAC access area. For safety, all spliced wires should be properly enclosed within approved junction boxes.

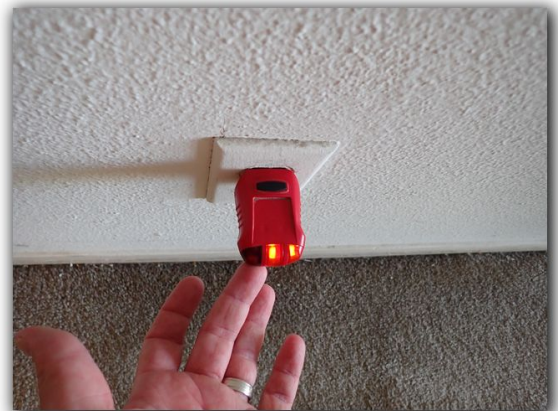
- There are no tamper resistant receptacles installed at the time of inspection. Under current building standards, all receptacles that are less than five and a half feet above the floor should be tamper resistant. This is an "as built" condition, but per TREC standards of practice, we are required to report this condition as deficient. Tamper Resistant outlets are required per the 2008 National Electric Code. You may consider corrective measures for improved safety.

- The receptacles in the wet/damp areas do not have ground fault circuit interrupter (GFCI) protection. Under current electrical standards all of the exterior/accessory building receptacles, all crawl space receptacles, all kitchen counter top receptacles, all bathroom receptacles, all attic receptacles, all laundry room receptacles, all garage receptacles, dishwasher receptacle, receptacle in cabinet under kitchen sink, any receptacle within 6-feet of the sink, all wet bar area receptacles and pool equipment should have GFCI protection.

- One or more of the receptacles were observed to be loose at the wall mount in the living room.
- Several outlets in the unit were observed to have loose connections: open ground and no power observed unless the outlet tester was pressed more firmly and held. Repairs are recommended to repair or replace the affected outlets by a licensed electrician.

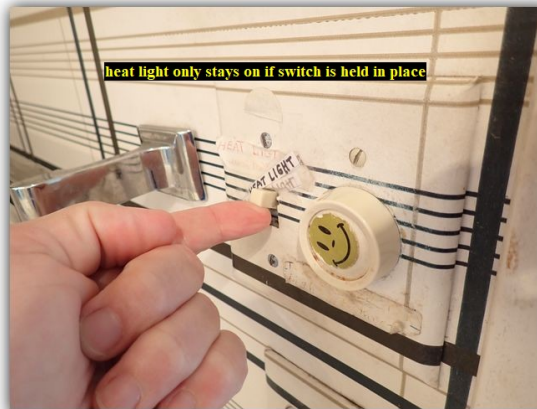
- The switch in the hall bathroom is not functioning properly. Recommend evaluation and repair or replacement by a qualified electrician.
- The hall bathroom heat light has damaged the door. This condition should be closely monitored and corrected if necessary.

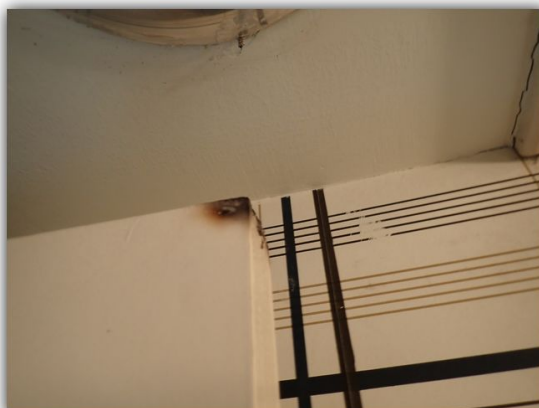
- One or more of the light fixtures are inoperative in the front entry hallway. This may be due to an inoperative bulb or some other unknown condition. This condition should be further evaluated and corrected as necessary.

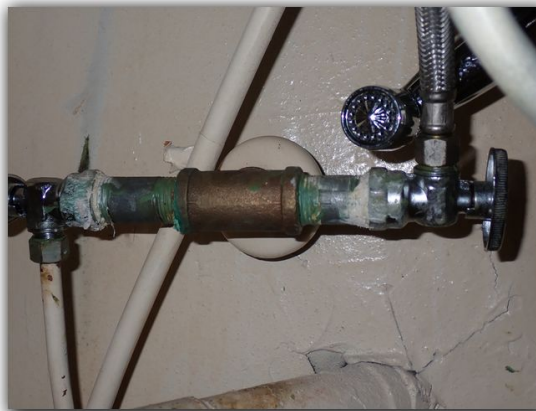
##### Water Supply System

- Rust and corrosion were observed on the exterior surfaces of the galvanized water lines at the time of inspection. This is an older, obsolete water supply system that is prone to leaks and potential failure, and the condition of the lines indicates they may fail in the near future. Full evaluation of all galvanized water line components and their integrity is beyond the scope of this inspection. You are strongly encouraged to have a qualified plumber assess all galvanized water line components prior to the expiration of any option or warranty period. All plumber-recommended repairs should be completed. It is also advisable to budget for eventual replacement of the entire galvanized water supply system and to upgrade to a modern type of water supply system as soon as financially feasible.

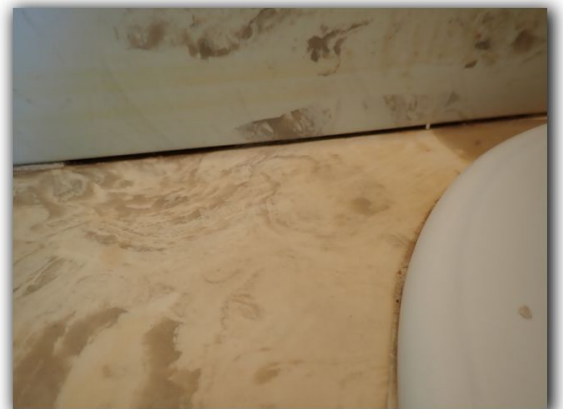
- Cracked, deteriorated, or missing sink caulking should be repaired or replaced as necessary to prevent water damage.

- The commode flapper does not function properly. Evaluation and repair or replacement by a qualified plumber is recommended.

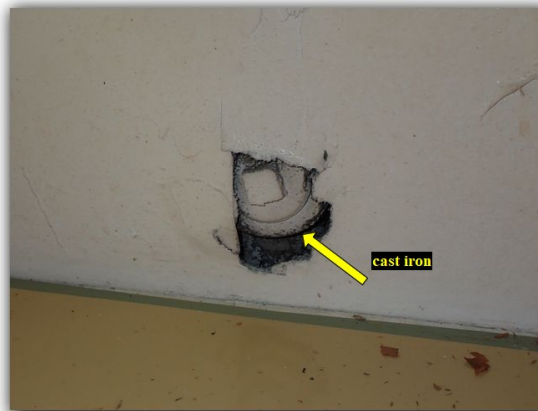
- Cast iron piping was observed in the drain, waste, and vent system. Full evaluation of the integrity of this material is beyond the scope of this inspection. Due to known age-related and latent defects commonly associated with cast iron piping, further evaluation by a qualified plumber is recommended. A hydrostatic test and a camera (sewer scope) inspection of the inaccessible and buried piping should be performed as part of this evaluation. These assessments should be completed prior to the expiration of any option or warranty periods.

**Note:** Prior repairs to the drain system were observed. The inspector is unable to verify the extent or quality of these repairs. The homeowner should be consulted regarding the nature of the repairs performed and any applicable warranty information.

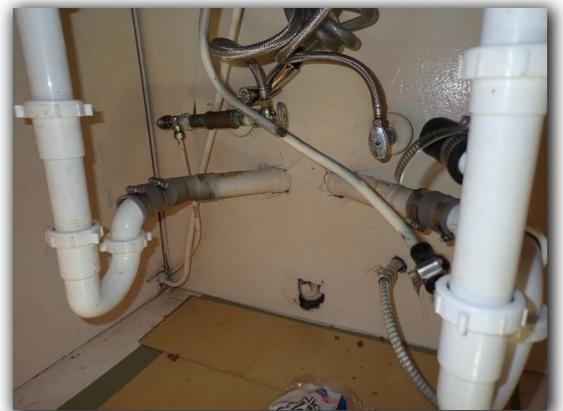
**Notice:** The home is equipped with ABS (Acrylonitrile Butadiene Styrene) plastic waste lines. While commonly used in residential construction due to its lightweight and cost-effective properties, ABS piping has some potential downsides. These include susceptibility to cracking from impact or stress, especially at joints, and degradation from prolonged UV exposure (if improperly stored before installation). Additionally, certain batches of ABS manufactured in the 1980s and 1990s were subject to class-action lawsuits due to premature failure. While no immediate defects were observed, ongoing monitoring is recommended. Repairs or replacement should be performed by a licensed plumber if issues arise.

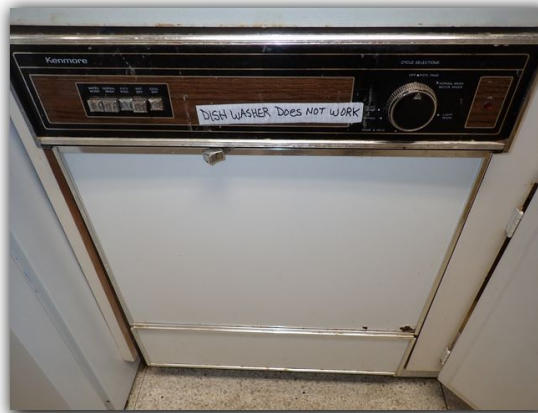
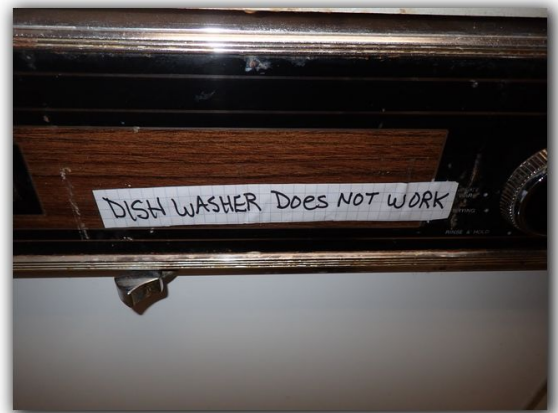
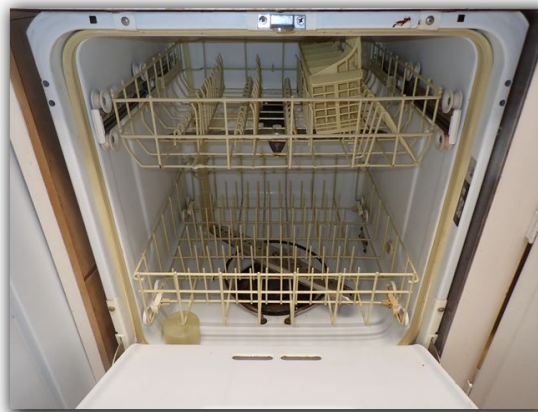
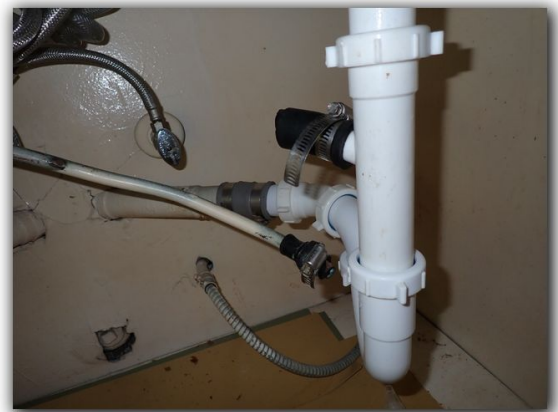
- The dishwasher was inoperative at the time of this inspection. It has been disconnected from the water supply and drain system. This condition should be further evaluated and corrected as necessary.
- The dishwasher has reached the end of its expected service life. Continued operation is possible; however, replacement should be anticipated.
- Some rusting was observed on the dishwasher's interior components. This condition may affect performance and longevity and should be monitored or further evaluated as needed.

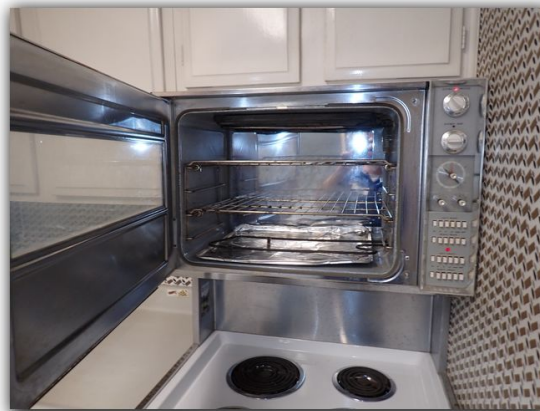
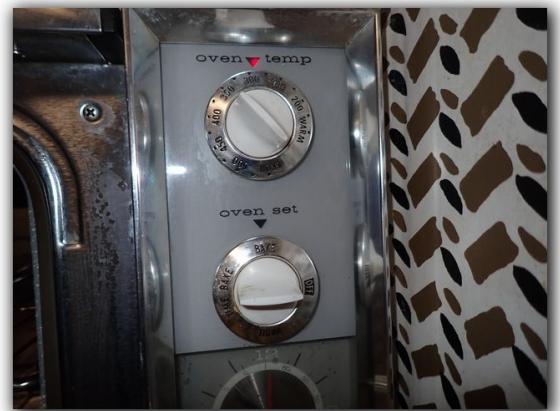
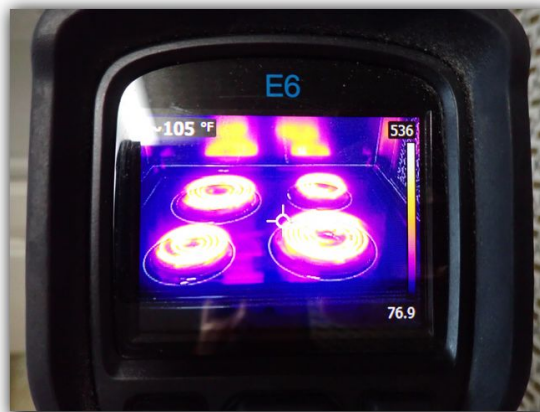
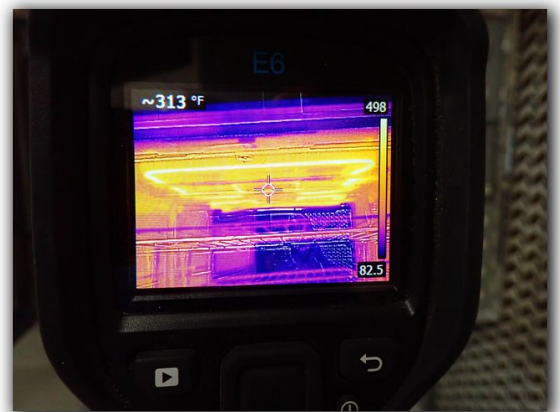
**Note:** The range has reached the end of its serviceable life expectancy.

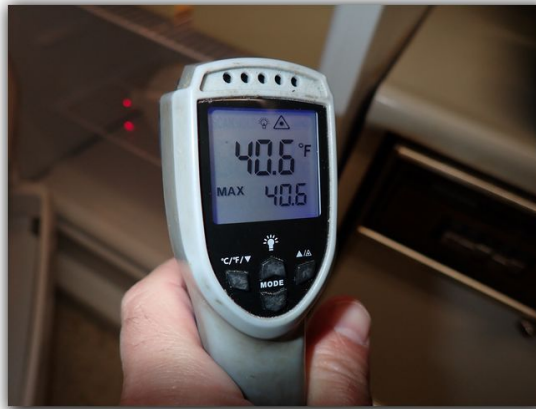
**Refrigerator / Built-in**

- Rust/damage was observed to the side of the refrigerator.
