# Cornerstone Inspection Service

## PROPERTY INSPECTION REPORT

**Concerning:** 17814 Pamukkale Place, Tomball, TX 77377

06/11/2026

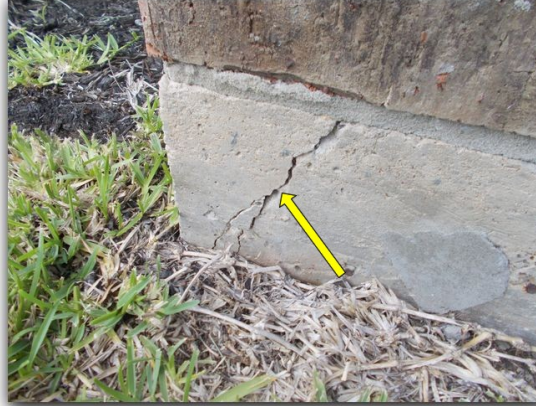
\* There are corner pops on the foundation of the home such as the right front corner, etc. of the foundation – these corner pops are common but need to monitor.

\*\* The foundation is showing evidence of movement such as the corner pops, various stress cracks, etc. This movement appears to be normal for the age of the foundation with the foundation working as designed at the time of the inspection.

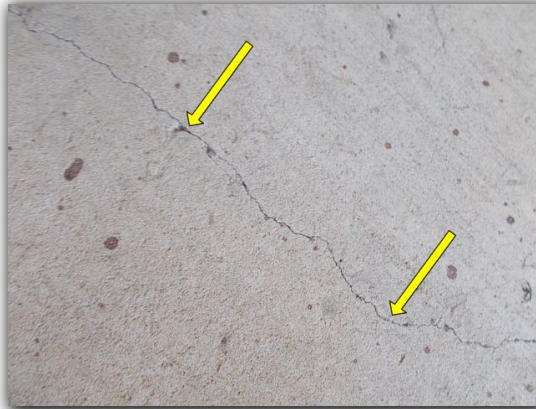
\* There is various cracking in the concrete of the front porch, etc. of the home - this cracking is fairly common but need to monitor as this could be a sign of ground movement.

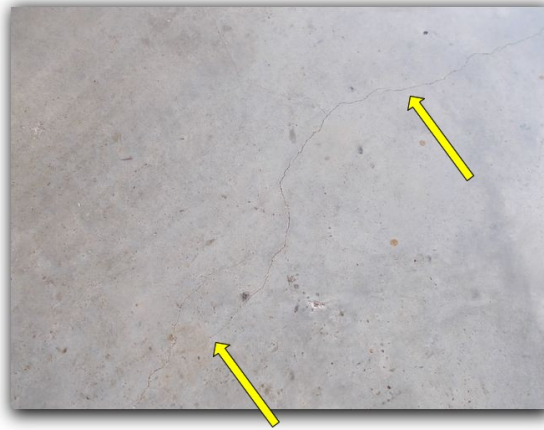
\* There is some cracking in the concrete of the garage floor of the home - this cracking is fairly common but need to monitor as this could be a sign of ground movement.

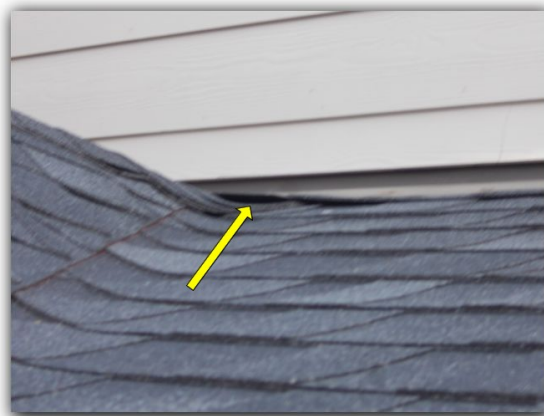
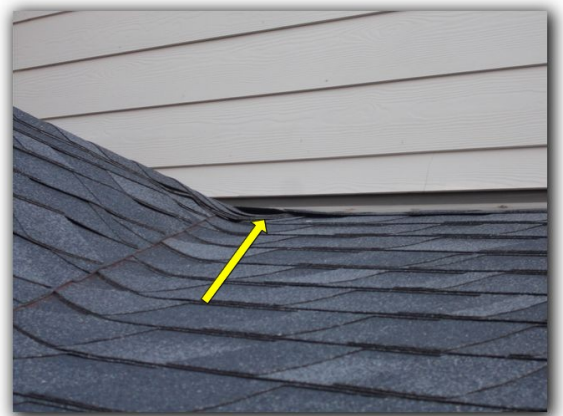
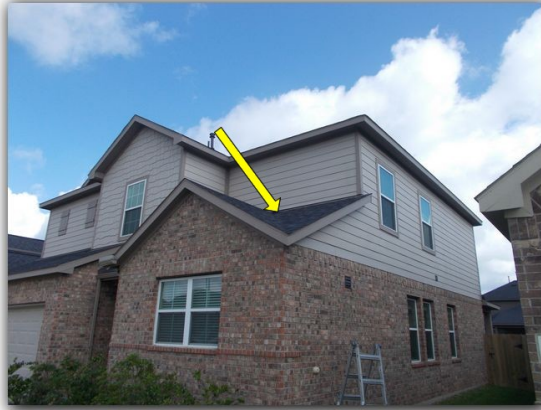
\* There is some loose/not sealed flashing on the roof of the home such as at the front of the home - need to secure and seal all flashing on the roof to the surface of the roof to assure no further damage or leaking will occur.

\* There is some loose/not sealed flashing on the roof of the home such as at the front of the home - need to secure and seal all flashing on the roof to the surface of the roof to assure no further damage or leaking will occur.

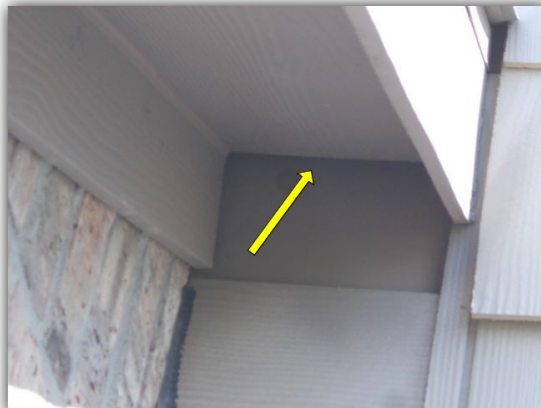
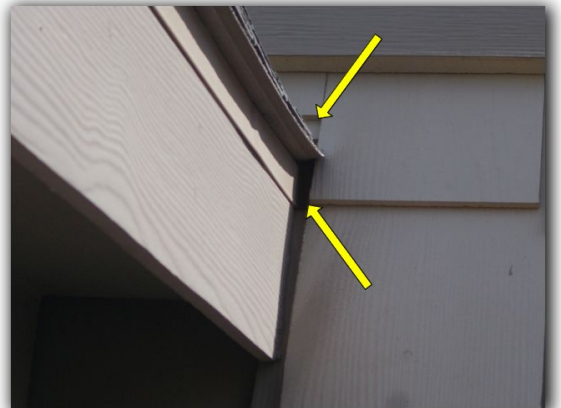
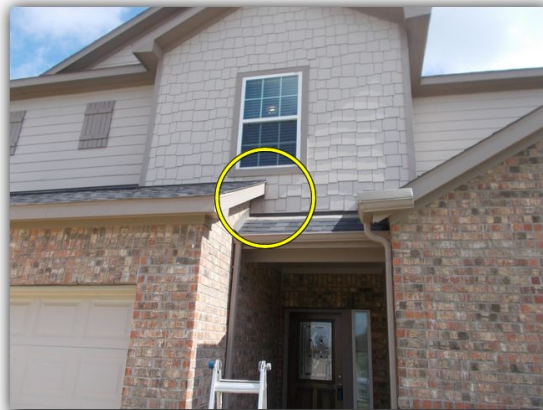
\* There are various openings in the exterior of the home such as at the soffit, the fascia, and the roof drip edging above the front porch of the home - need to seal the exterior trim, etc. of the home to assure no further damage will occur.

\* There are various openings in the exterior of the home such as at the soffit, the fascia, and the roof drip edging above the front porch of the home - need to seal the exterior trim, etc. of the home to assure no further damage will occur.

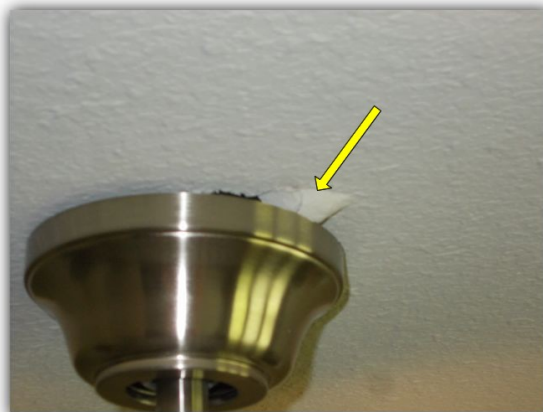
\* There is some damaged sheetrock in the ceiling of the master bedroom where the ceiling fan is attached and this is keeping the ceiling fan from being installed properly - recommend repair of the damaged sheetrock.

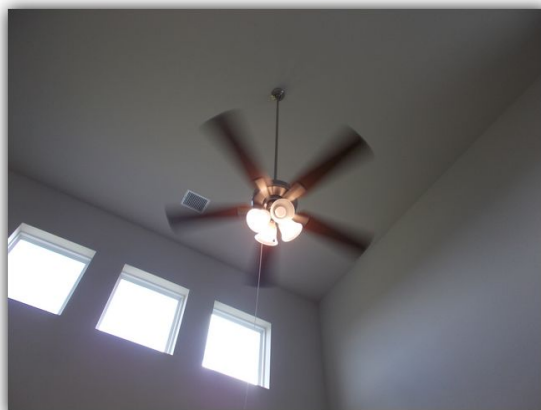
\* Both the ceiling fans located in the living room and the master bedroom of the home are noisy when in operation - recommend repair/replacement of the ceiling fans in the home by a qualified technician.

\* Both the ceiling fans located in the living room and the master bedroom of the home are noisy when in operation - recommend repair/replacement of the ceiling fans in the home by a qualified technician.

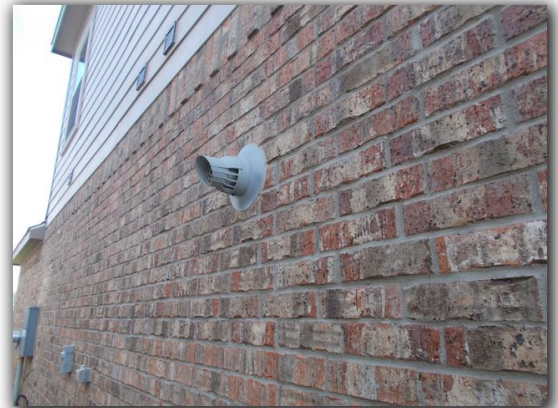
\* The rubber flashing for the water heater exhaust on the left side exterior of the home is loose and not sealed - recommend proper sealing of this flashing to the outside of the home to assure no further damage will occur.

\* The rubber flashing for the water heater exhaust on the left side exterior of the home is loose and not sealed - recommend proper sealing of this flashing to the outside of the home to assure no further damage will occur.

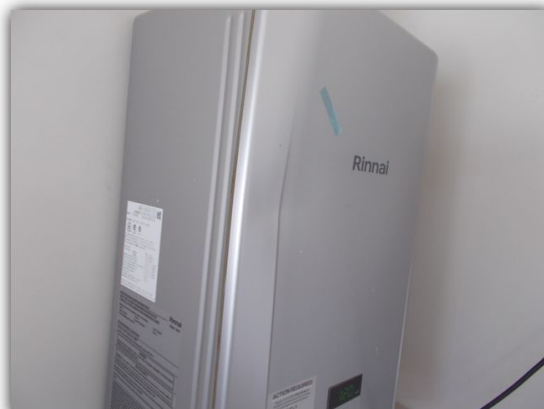
\* The water heater in the garage of the home has a dented/damaged cover - need to repair/replace the cover for the water heater.

\* The water heater in the garage of the home has a dented/damaged cover - need to repair/replace the cover for the water heater.
