# *Duke's Home Inspections, PLLC*

## Property Inspection Report

670 Dayna Ln, Sour Lake, TX 77659  
Inspection prepared for: Brandy Brown  
Real Estate Agent: Heather Stenson - Connect Realty.com

Date of Inspection: 6/21/2024 Time: 1:00 PM  
Age of Home: 2023 Size: 2572  
Weather: Sunny and 89 degrees.  
Home faces East.  
Home was occupied.  
Customer present.

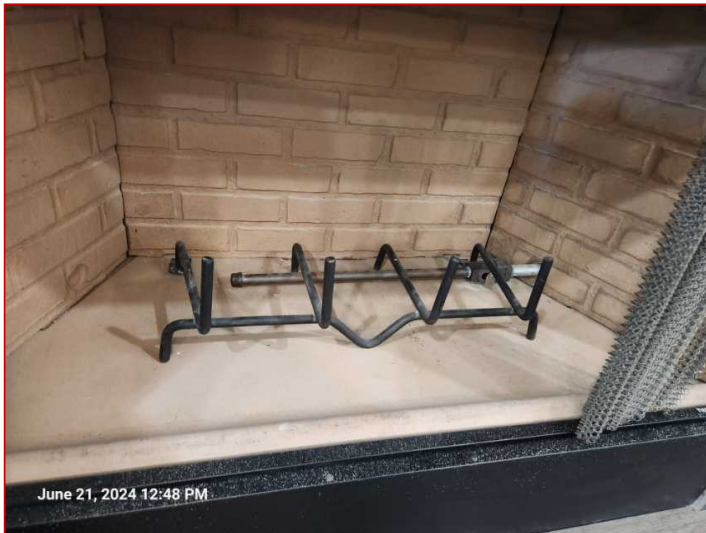
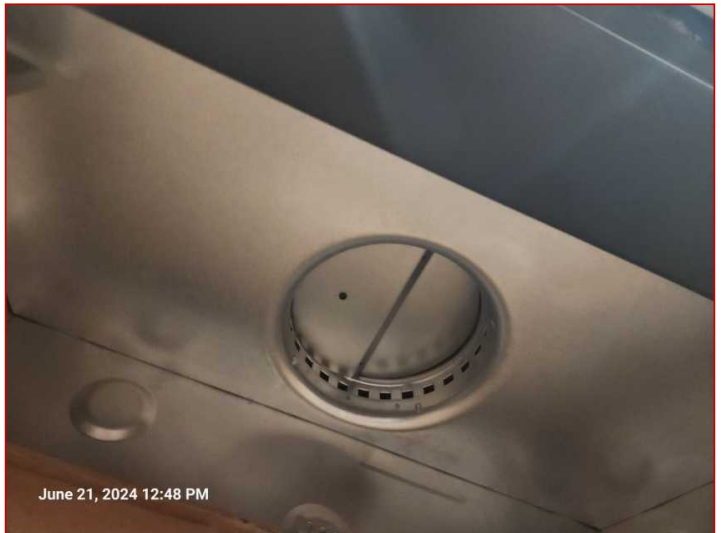
## J. Fireplaces and Chimneys

- Living room
  - Wood burning and or gas
- Comments:
- Satisfactory condition at the time of the inspection

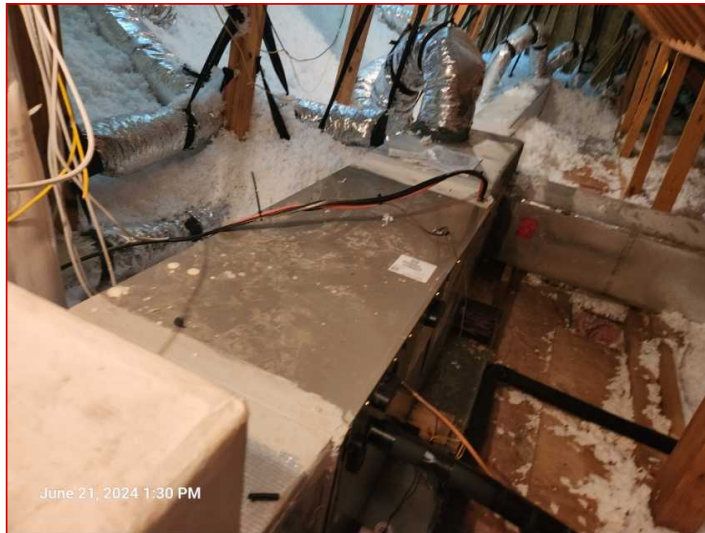
- The functional testing and/or inspection of the heating system was unable to be conducted due to an outside temperature in excess of {80} degrees. A limited visual inspection was performed.

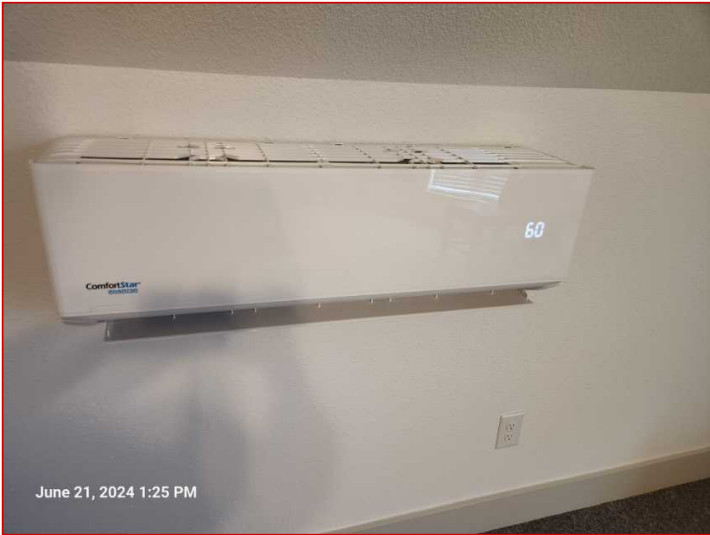
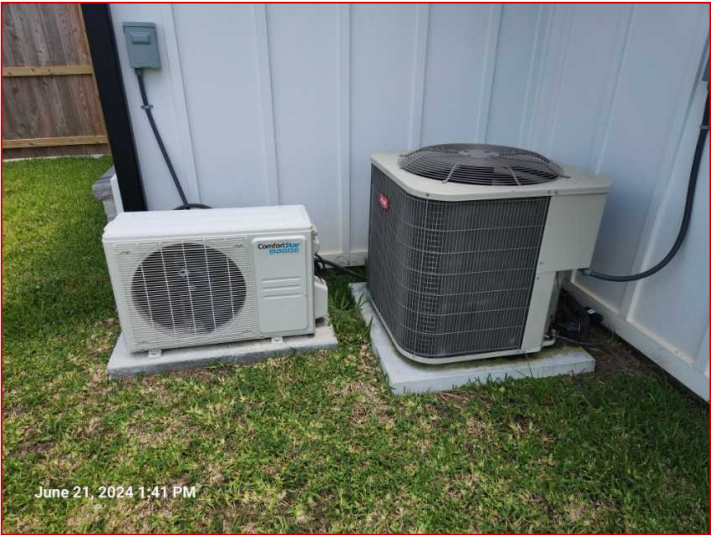
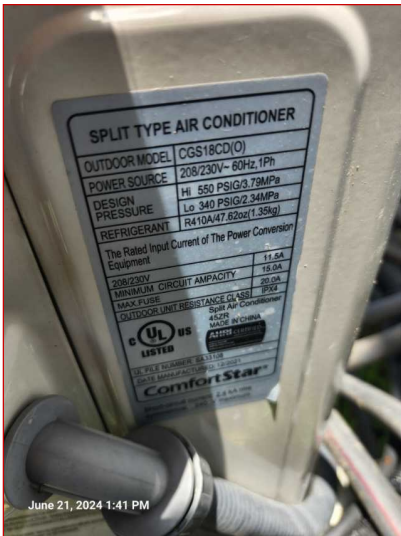
Supply temp 52.3 degrees.

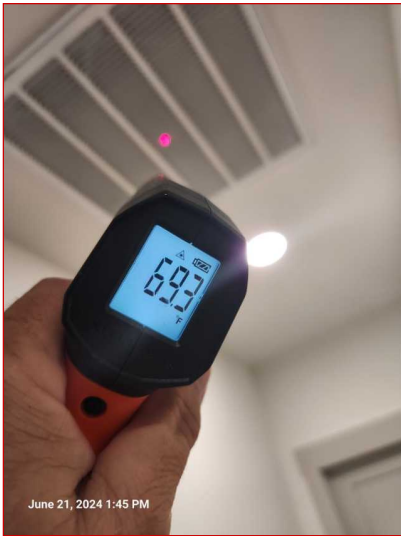
Return temp 69.3 degrees.

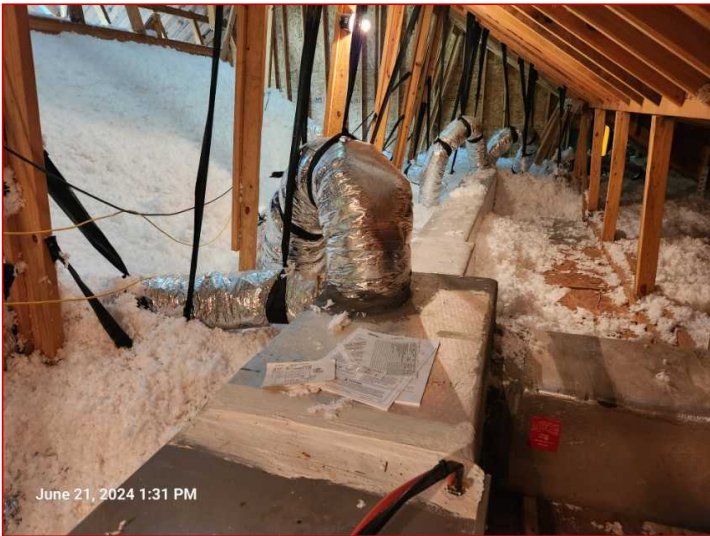
• Duct should be suspended

Duct should be suspended

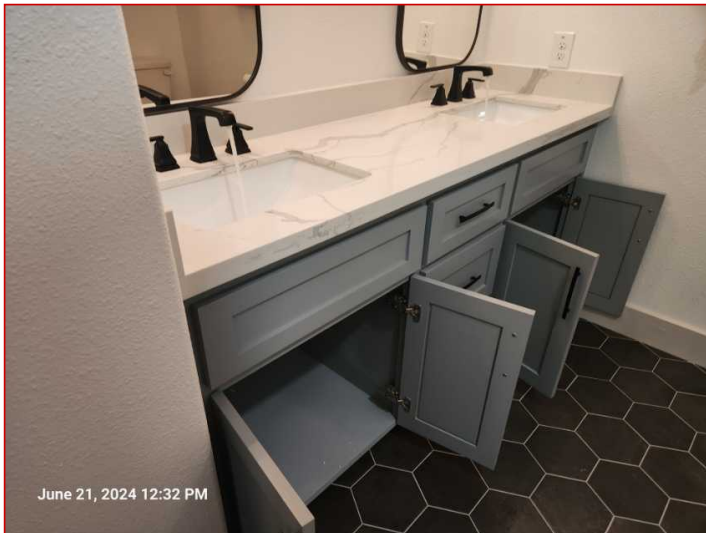
- Water pressure was 65 psi

- One or more of the exterior water hose bibs {faucets} was not equipped with a back flow and/or anti-siphon {vacuum breaker} device. An anti-siphon device prevents unsanitary water from being pulled back through a garden hose and/or lawn sprinklers and contaminating the household water system

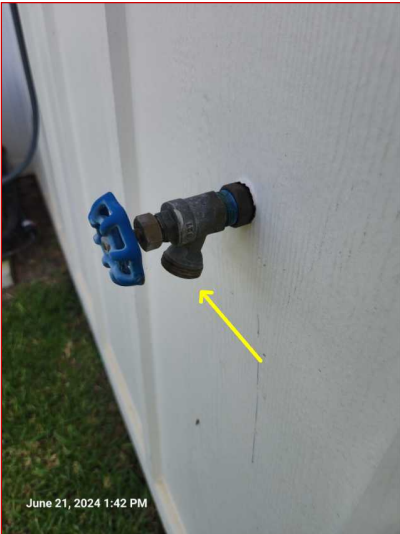
One or more of the exterior water hose bibs {faucets} was not equipped with a back flow and/or anti-siphon {vacuum breaker} device.  
An anti-siphon device prevents unsanitary water from being pulled back through a garden hose and/or lawn sprinklers and  
contaminating the household water system

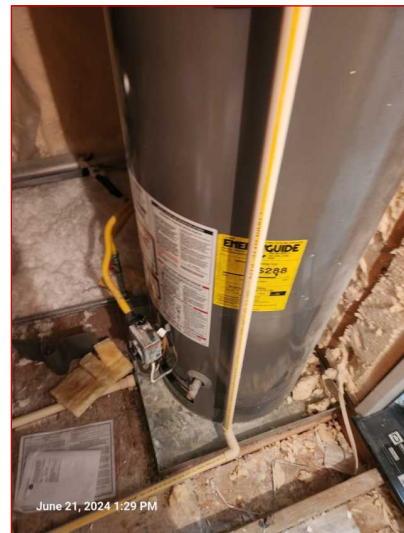
- Satisfactory condition at the time of the inspection.
- The typical life expectancy and/or operational life of a water heater is approximately {10} years depending on usage and maintenance. We do not inspect **TPR valves**. They could start leaking.

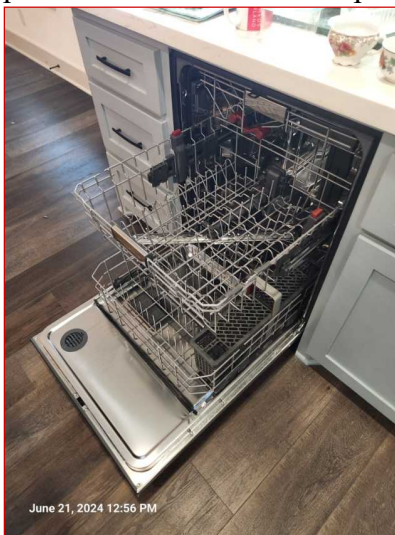
- Dishwasher was operational at the time of inspection.

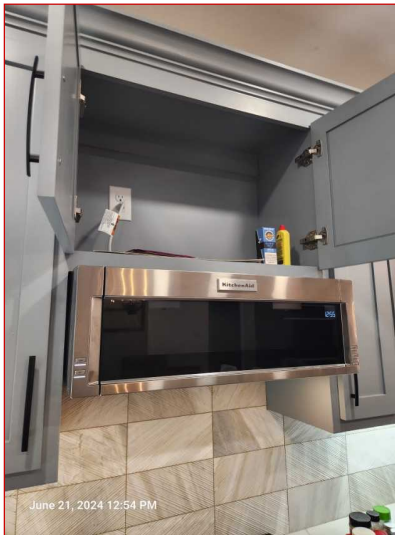
- The vent pipe terminates in the cabinet and should vent to the exterior

*The vent pipe terminates in the cabinet and should vent to the exterior*

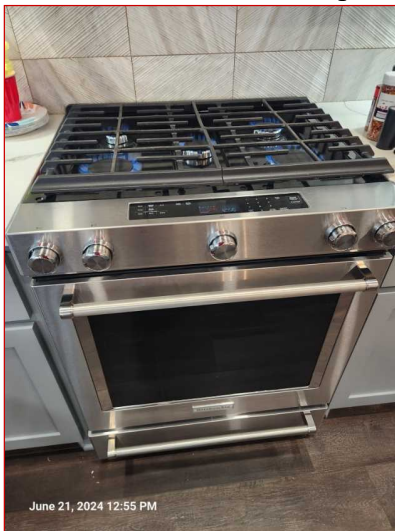
- Oven(s): Electric
- Oven(s) was functional at the time of the inspection

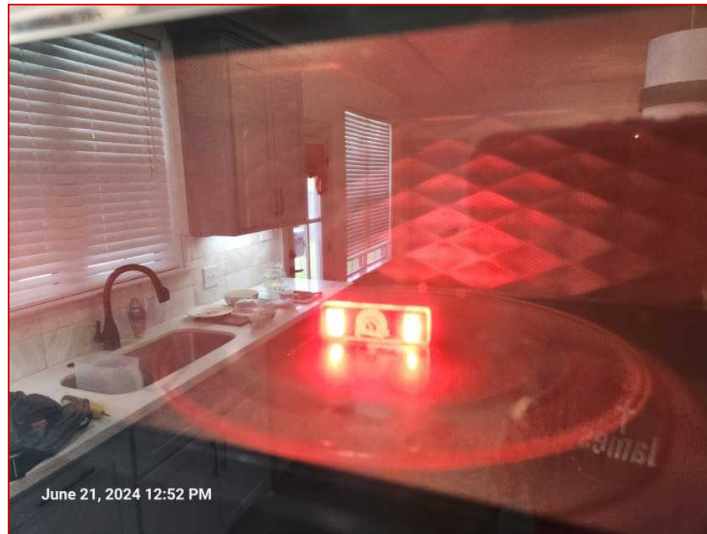
- Microwave ovens are tested using normal operating controls. Unit was tested and appeared to be serviceable at time of inspection. Leak and/or efficiency testing is beyond the scope of this inspection. If concerned, client should seek further review by qualified technician prior to closing.

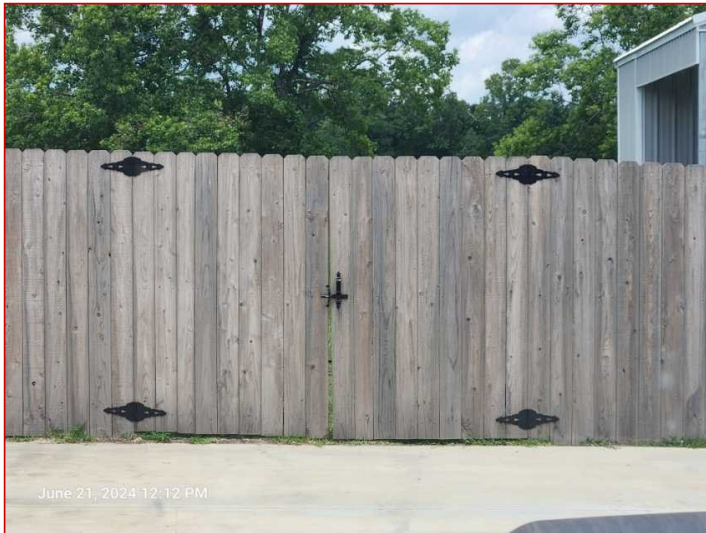
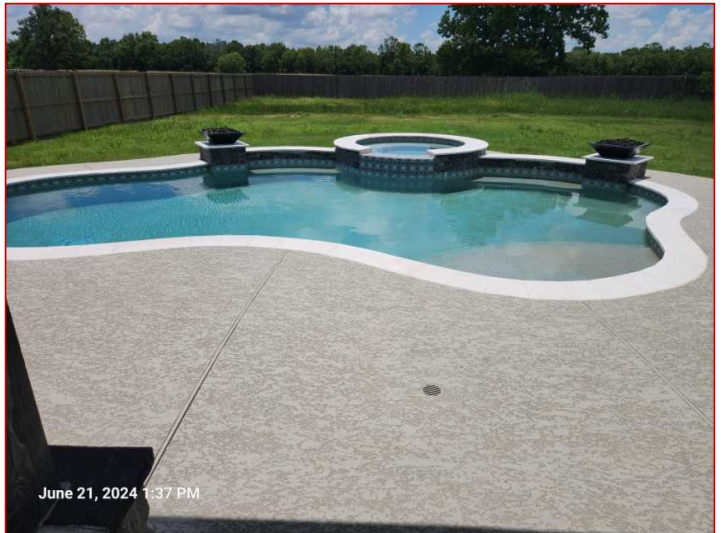
- Under current standards; all pool entrance gates should open outward away from the pool area and be equipped with a self-closing and self-latching device. The latching mechanism is required to be a minimum of {54"} from the bottom of the gate and a secondary release device located on the pool side at a minimum of {3"} from the top of the gate

*Under current standards; all pool entrance gates should open outward away from the pool area and be equipped with a self-closing and self-latching device. The latching mechanism is required to be a minimum of {54"} from the bottom of the gate and a secondary release device located on the pool side at a minimum of {3"} from the top of the gate*

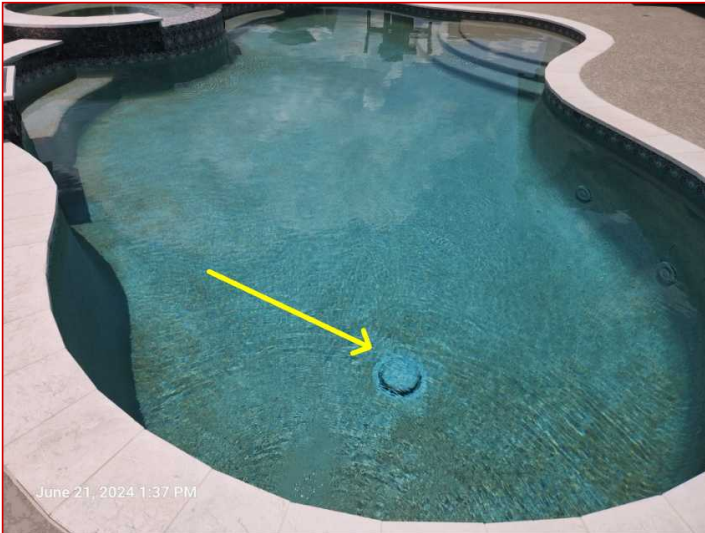
- It was noted that a split lower drain system was not in place at the time of inspection. It is highly recommended that an Anti-Vortex drain be considered for safety concerns

*It was noted that a split lower drain system was not in place at the time of inspection. It is highly recommended that an Anti-Vortex drain be considered for safety concerns*
