## RESIDENTIAL INSPECTION REPORT

7318 Avenue J  
Houston, TX 77011

# PROPERTY INSPECTION REPORT FORM

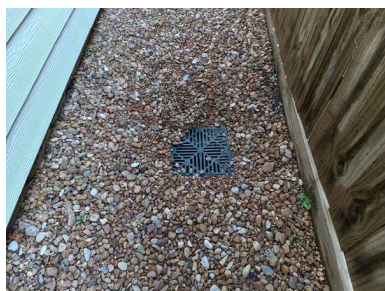
Below-grade drainage components are concealed from view and are outside the scope of this inspection. This inspection does not include determination of their condition, discharge location, or flow performance.

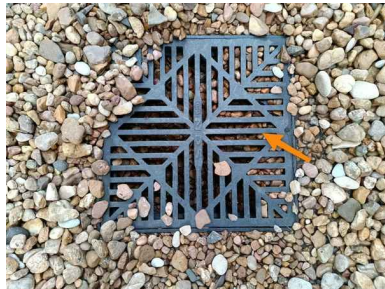
Right

**1: Grading & Drainage: Clogged Catch Basins****Recommendation**

Clogged catch basins will prevent the perimeter drainage system from operating correctly. Evaluate and remedy as needed.

Recommendation: Contact a qualified landscaping contractor

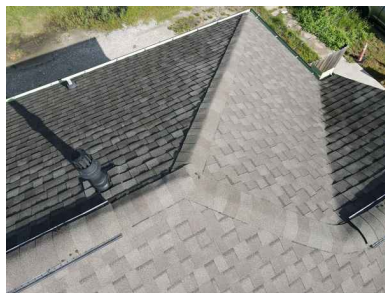
*Roof Access Was Limited:* Too High -

Direct access to the roof was limited because of constraints encountered during the inspection. The inspector did employ other methods in determining the overall functionality of the roof covering. If further evaluation of the roof covering is desired, consult with a qualified roofing contractor.

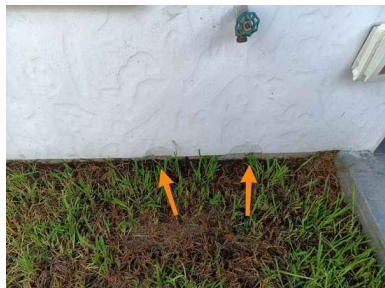
**2: Exterior Walls: Surface Defects****👉Recommendation**

The exterior wall coverings, such as siding, trim, fascia, soffit, and/or eaves had observable defects. Examples include, but are not limited to:

Damaged siding, rear

Recommendation: Contact a qualified professional.

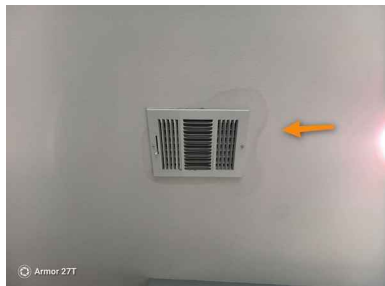
2nd Floor left bedroom

**1: Ceiling: Evidence of Previous Moisture Contact****➡Recommendation**

Ceiling showed signs of previous water intrusion. Tested negative for moisture at the time of the inspection. Evaluation and remediation is recommended.

Recommendation: Contact a qualified professional.

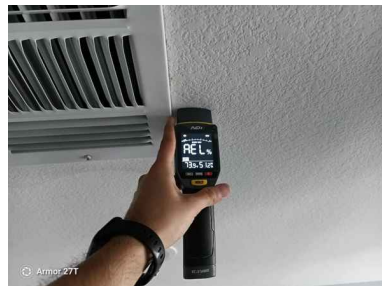
2nd Floor left Bedroom, tested dry

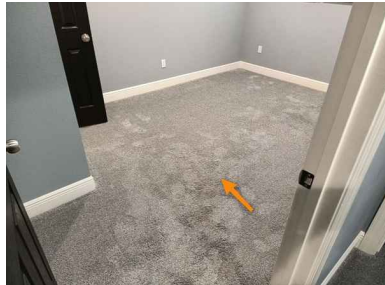
2nd Floor left bedroom

**2: Flooring: Squeaky Subflooring****➡Recommendation**

Squeaky subflooring is not uncommon and is usually caused by wood subflooring that isn't properly attached to the joists. These can generally be repaired by a flooring contractor. Evaluation and remediation is recommended.

Recommendation: Contact a qualified professional.

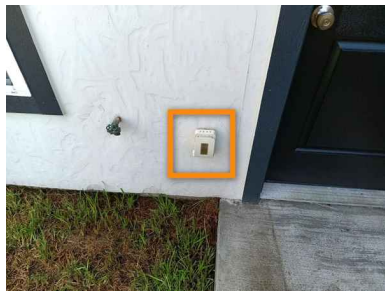
Exterior

**1: Receptacles: GFCI Protection Inadequate/Missing**

GFCI protection was inadequate or missing. Current building standards recommend the installation of ground fault protection:

GFCI protection was not present in one or more of these locations. Evaluation and remediation is recommended.

Recommendation: Contact a qualified electrical contractor.

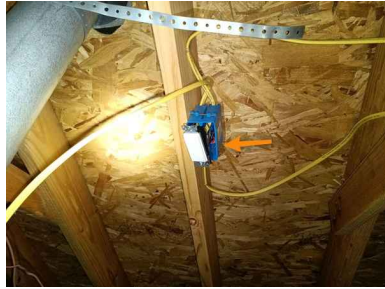
**2: Receptacle/Switch Covers: Missing, Loose or Damaged****🔴Recommendation**

One or more receptacle/switch cover plates were missing, loose or damaged. Replacement of cover plates is recommended for safety. Evaluate and remedy as needed.

Loose, furnace switch

Recommendation: Contact a qualified electrical contractor.

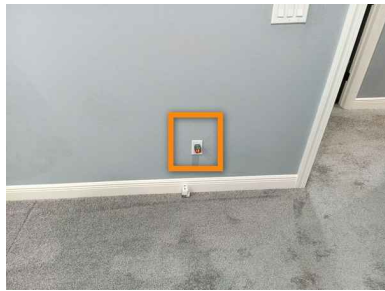
**3: Receptacles: Improper Wiring****🔴Recommendation**

Receptacles were not wired correctly. Evaluation and remediation is recommended.

Hot / neutral reversed, second floor left bedroom

Recommendation: Contact a qualified electrical contractor.

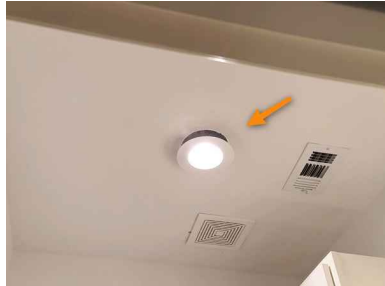
**4: Lights: Fixtures or Globes Damaged/Missing/Loose****🔴Recommendation**

Light fixtures or globes were missing, damaged or loose. Evaluation and remediation is recommended.

Loose, half bathroom

Recommendation: Contact a qualified electrical contractor.

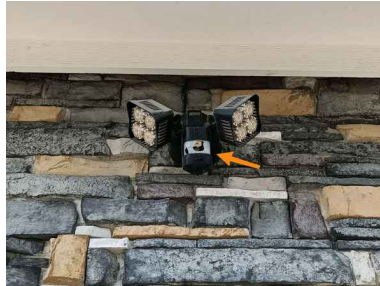
Damaged sensor, front

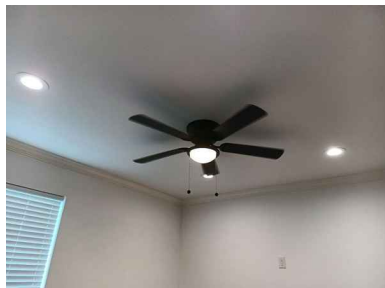
Living Room

**5: Fan only operates when light is off****🔴Recommendation**

When the wall switch is flipped in the up position only the fan works and the light doesn't. And when the switch is flipped to the down position, the fan does not work and the light turns on. The wiring appears to not have been connected correctly. Evaluate and remedy as needed.

Recommendation: Contact a qualified professional.

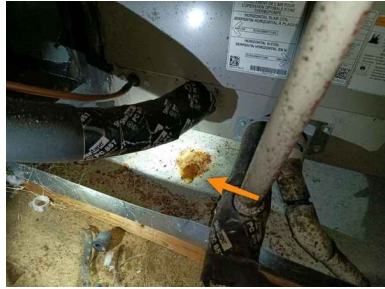
**1: Condenser: Insulation Missing/Damaged on Refrigerant Lines****➡Recommendation**

There was a small gap in the insulation where the refrigerant line connects to the cabinet. This is causing some condensation to drip into the pan, indicated by the arrow in the photo. Evaluate and remedy as needed.

Recommendation: Contact a qualified HVAC professional.

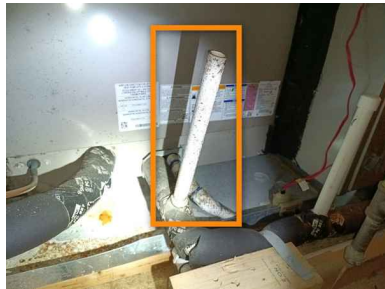
**2: Condensate System: Insulation Missing or Damaged on Drain Lines****➡Recommendation**

The pipe was condensing, adding additional pipe insulation is recommended.

Recommendation: Contact a qualified HVAC professional.

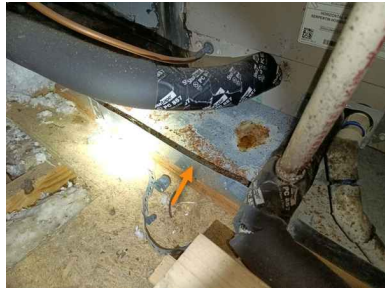
**3: Condensate System: Emergency Pan Defects****☞Recommendation**

The emergency overflow pans had one or more defects at the time of the inspection. Examples include, but are not limited to:

Corrosion, dry at time

Recommendation: Contact a qualified HVAC professional.

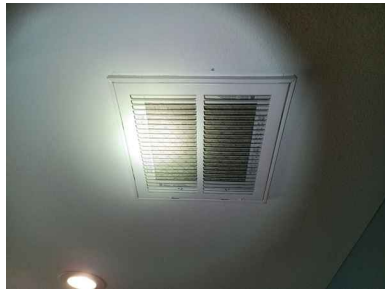
**1: Filters: Requires Replacement or Missing****➡Recommendation**

The furnace filters may have been beyond their expected lifespan or were missing. In addition, inspector cannot determine what effect this has on the temperature readings. Replacement is recommended.

Dirty, primary bedroom

Recommendation: Recommended DIY Project

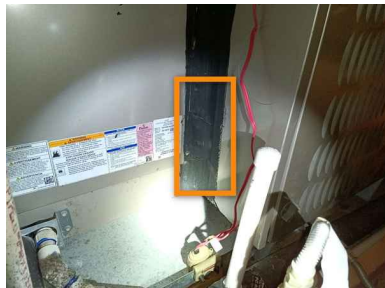
**2: Ducts: Defects Present****➡Recommendation**

The HVAC ducts had one or more defects present at the time of the inspection. Examples include, but are not limited to:

Air leakage, coil cabinet

Recommendation: Contact a qualified HVAC professional.

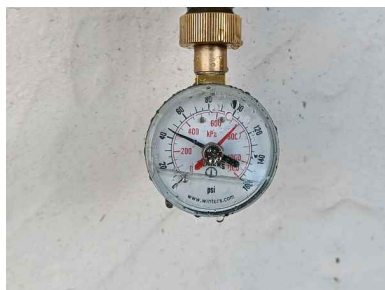
*Static Water Pressure Reading: 45 PSI*

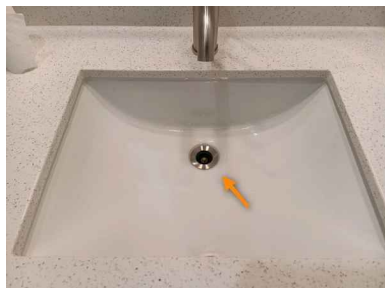
**1: Fixtures: Drain Stops Missing, Damaged or Ineffective****🔴Recommendation**

Drain stops had issues that prevented them from working properly. Evaluation and remediation is recommended.

Missing stopper, half bathroom

Recommendation: Contact a qualified plumbing contractor.

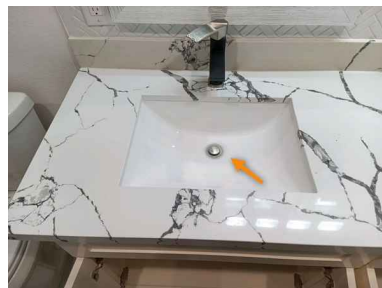
Stuck, Primary Bathroom

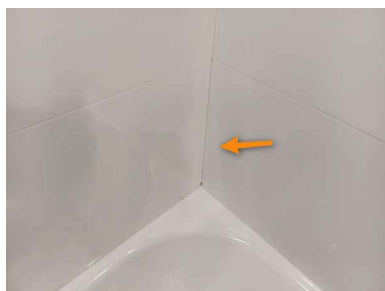
2nd Floor hall bathroom

**2: Shower/Tub: Missing/Deteriorated Caulking or Grout****🔴Recommendation**

Recommendation: Contact a qualified professional.

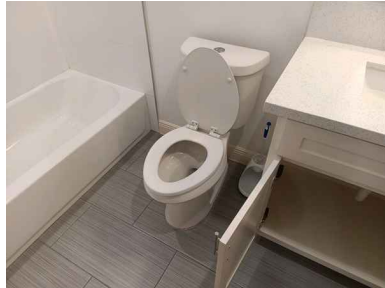
2nd Floor Hall Bathroom

**3: Toilets: Did Not Flush Properly****🔧Recommendation**

The handle needed to be held down to flush properly, typically an adjustment in the tank can be done. Evaluation and remediation is recommended.

Recommendation: Contact a qualified plumbing contractor.

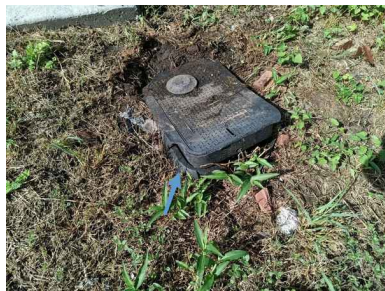
**4: Damaged water meter cover and box****🔧Maintenance Item/Note**

The cover was cracked and the box was damaged. Evaluate and remedy as needed.

Recommendation: Contact a qualified professional.

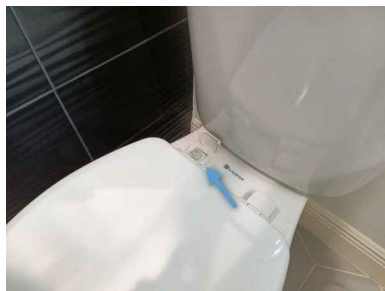
Primary Bathroom

**5: Toilet seat nut****🔧Maintenance Item/Note**

The nut was blocking the seat cover from opening fully. The nut would not allow the cover to stay open. It appeared to be the wrong size.

Recommendation: Contact a qualified professional.

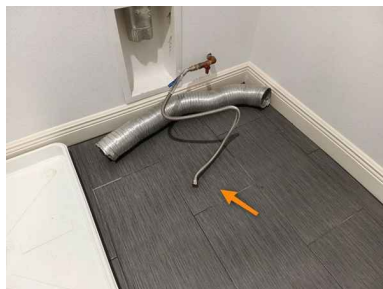
Laundry Area

Uncapped gas supply lines were present. Gas supply lines should be capped for safety when not in use. Evaluation and remediation is recommended.

Recommendation: Contact a qualified plumbing contractor.

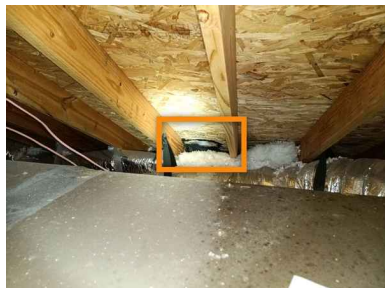
Middle of attic

**1: Loose vent pipes****🔧 Recommendation**

The bathroom exhaust vent pipes came loose from the underside of the roof. This can allow some of the exhaust into the attic. Evaluate and remedy as needed.

Recommendation: Contact a qualified professional.
