REDFISH INSPECTIONS LLC

# PROPERTY INSPECTION REPORT FORM

06/28/2024 8:00 am

18339 Steele Point Dr, Crosby, TX 77532

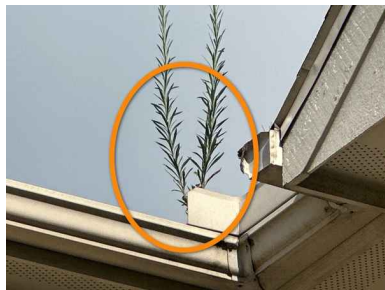
Example Front

The gutters had debris, leaf, and/or granule accumulation. We recommend cleaning to avoid spilling roof runoff around the building; a potential source of water entry or water damage.

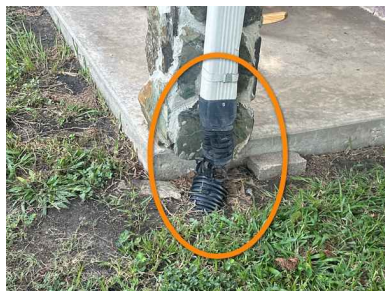
Example Front Right

One or more downspouts were discharging too close to the foundation. We recommend having downspouts discharge water at least five (5) feet from the structure. Storm water should be encouraged to flow away from the building at the point of discharge.

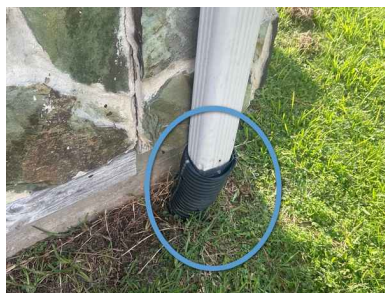
The downspouts that discharged below grade level should be monitored. If they are ever suspected to be clogged or disconnected below grade, We recommend they be redirected to discharge at least five (5) feet from the building.

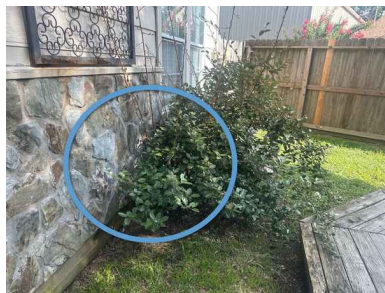
Right

Foliage was noted close to the structure. We recommend trimming all bushes and tree limbs at least 1 foot away from buildings. Bushes and trees too close to the structure can prevent the walls from drying properly, their roots can affect the foundation, and their branches can damage the roof.

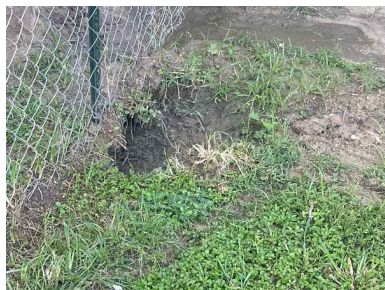
Rear

Holes were noted in the yard around the structure. We recommend to fill all holes. Holes can create a trip hazard.

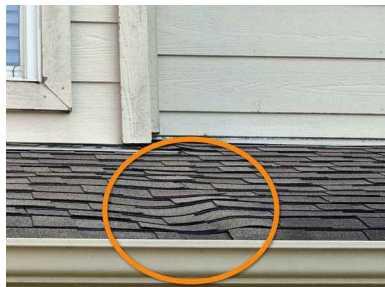
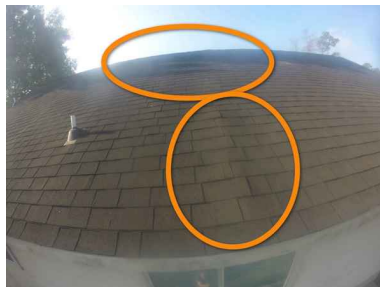
Front

Ripples were noted in the shingles. We recommend having these areas further evaluated and repaired as needed by a qualified roofing contractor.

5 Common Reasons Why Asphalt Roofing Shingles look wavy or rippled are age, poor ventilation, faulty roof material, and/or subpar installation.

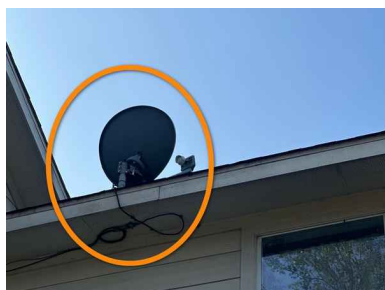
Rear

Attachments had been improperly installed with fasteners drilled directly through the roofing material and roof deck. Maintaining a proper seal at these fasteners will be critical to avoid water intrusion. If the attachment has no current purpose, we recommend having it removed and the resulting holes sealed.

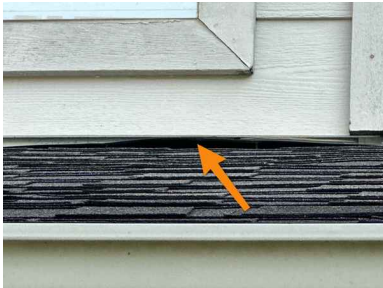
Front

Loose or uplifted flashing was noted on the roof. We recommend having this secured to avoid water intrusion.

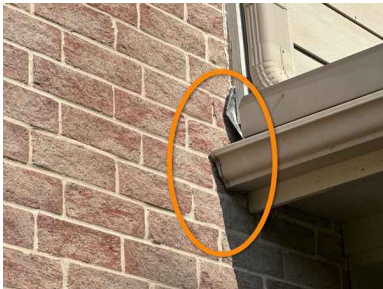
Front

Kickout flashing, also known as diverter flashing, is a special type of flashing that diverts rainwater away from the cladding and into the gutter. When installed properly, they provide excellent protection against the penetration of water into the building envelope. We recommend having this detail added.

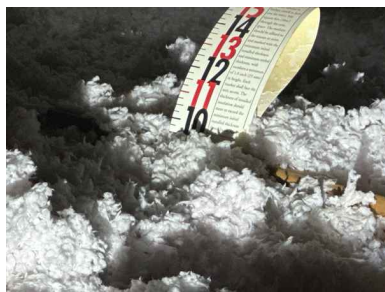
*Approximate Average Depth of Insulation:: 0 to 10 inches*

Per today's standards, insufficient insulation was observed in the attic space. Insulation improvements may be cost effective, depending on the anticipated term of ownership.

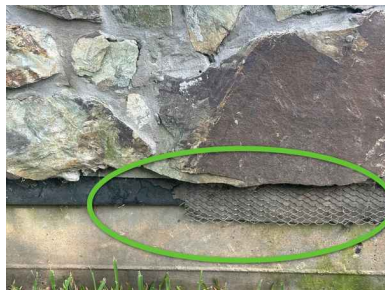
Although this is not a deficiency we recommend cutting off the mesh at the bottom to avoid corrosion.

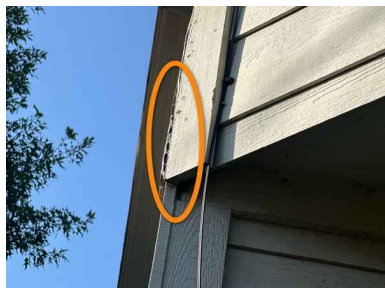
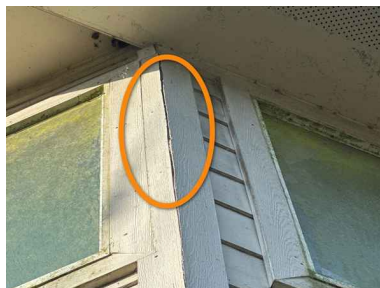
Example Rear Right

The exterior caulking in multiple areas around the house at various siding transitions, expansion joints, wall protrusions, doors, windows and other areas, was deteriorated or insufficient. Exterior caulking is the first energy efficient measure to install. This helps minimize air flow and moisture through cracks, seams, utility penetrations and openings. Controlling air infiltration is one of the most cost effective measure in modern construction practice. Good caulking and sealing will reduce dust, dirt, and prevent damage to structural elements. We recommend updating regularly.

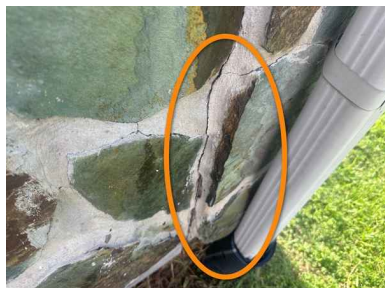
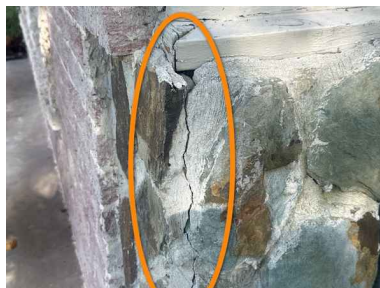
Example Front Left

The mortar at the exterior brick/stone veneer was cracked and/or deteriorated. We recommend having these areas repointed to prevent excess moisture intrusion.

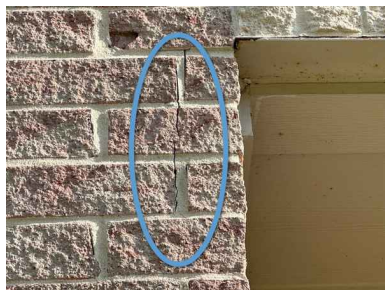
Example Left Front

A crack was noted in the brick veneer. This appeared to have been the result of thermal expansion. We recommend repointing to prevent further deterioration.

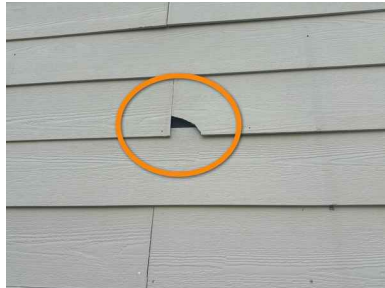
Left

General damaged was found to the exterior siding and/or trim. We recommend to repair as needed.

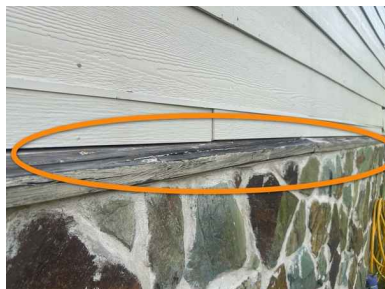
Left

Wood decay was observed on the exterior siding. We recommend repairs/replacement to all decayed wood to prevent further deterioration and creating conducive conditions for wood destroying insect activity.

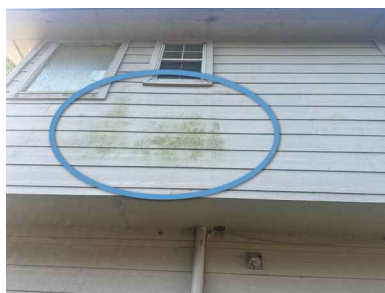
Right

Organic growth was noted on the exterior of the home. This can be the result of multiple conditions such as roof run-off, insufficient grading, amount of sun exposure, and proximity to bodies of water or other structures, among others. While the presence of this growth is typically harmless, it can allow excess moisture into the wall cavity or other parts of the structure. We recommend regular cleaning to help keep the area dry.

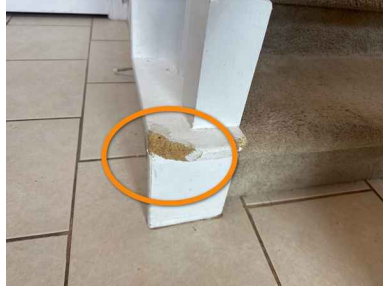
Around house

The baseboards and trim were found to be damaged or missing. We recommend to repair or replace.

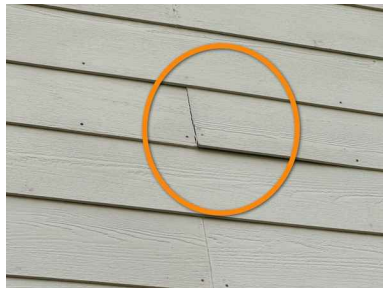
Left

Loose siding/trim was noted. We recommend having this properly secured to prevent additional damage.

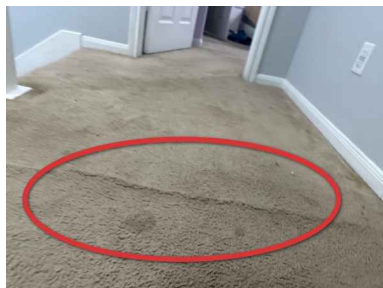
2nd Floor Hallway

Waves were observed in carpet flooring. These could present trip hazards. We recommend having the carpet stretched and secured in these areas.

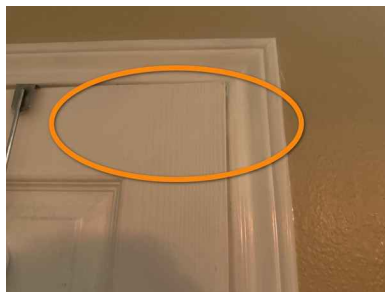
Guest Bedroom 3

A door was found to be rubbing on its frame, threshold, or adjacent door. We recommend having this adjusted so the door operates as intended.

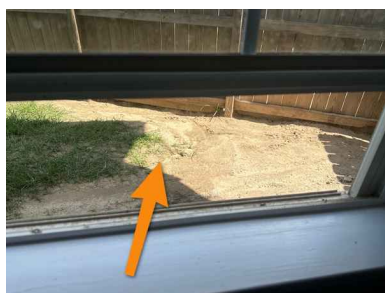
Example Den

It may be desirable to replace window screens where missing. We recommend consulting with the seller regarding any screens that may be in storage.

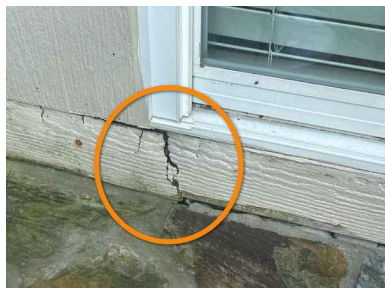
Rear Right

Damaged window trim was noted. We recommend repair/replacement.

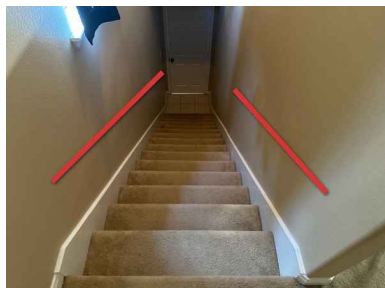
Back stairs

Although it had 4 or more risers and a total rise of more than 30 inches, portions of the staircase had no handrail installed. This is a safety hazard. We recommend a qualified contractor install a proper handrail.

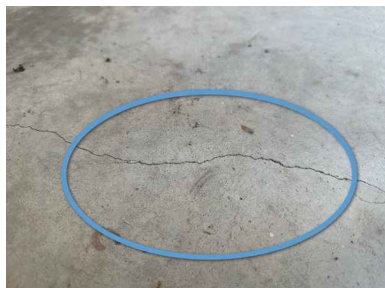
Porch

Cracks were observed in the porch or patio slab. These are not uncommon, where under 1/4 inch wide and should be monitored.

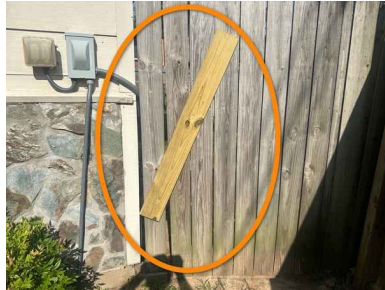
Right

A gate dragged and or did not properly open/close. We recommend repair/adjustment.

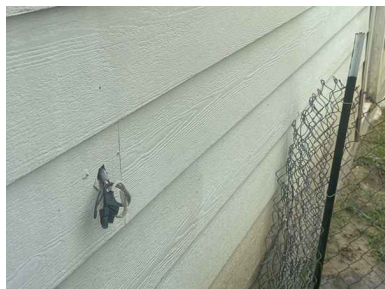
Rear

Abandoned wiring should be removed or appropriately terminated.

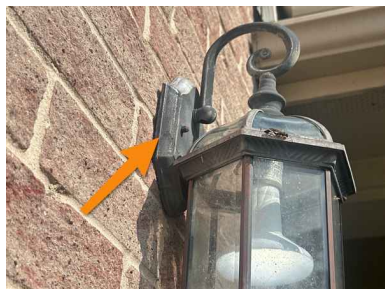
Example Front

All exterior fixtures exposed to the elements should be caulked at the wall connection to prevent water and insect intrusion. We recommend caulking.

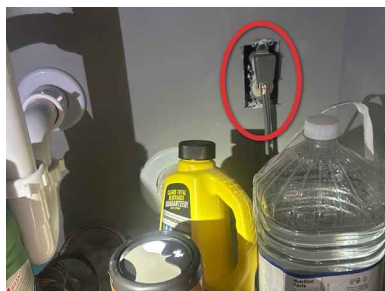
Kitchen

One or more receptacles are missing a cover plate. This causes short and shock risk. Recommend installation of plates.

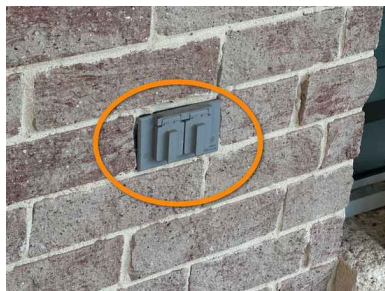
Today's standards require having a bubble cover on all exterior receptacle outlets exposed to the elements. We recommend making the upgrade.

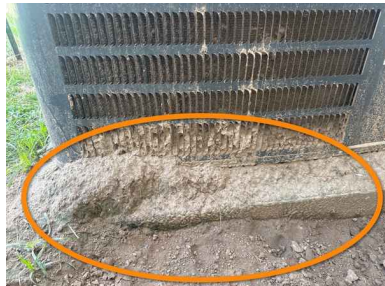
Unit 1

Air flow to the condensing coils was restricted by dirt and/or debris on the exterior which may limit the system's ability to dissipate heat. The cabinet should be cleaned in order to maintain cooling system efficiency and avoid problems from overheating of the compressor.

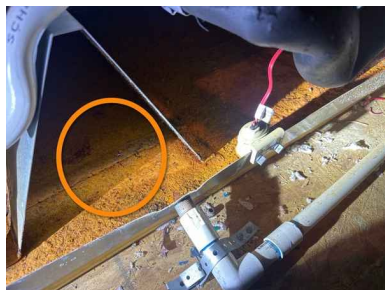
Unit 2

The condensate drain pan was rusted. This indicates that there has been a failure in the primary condensate drainage system at some point in time. This may or may not have been corrected. There is potential for extensive ceiling damage if this pan overflows. You should have a qualified HVAC contractor repair or replace the condensate drainage system.

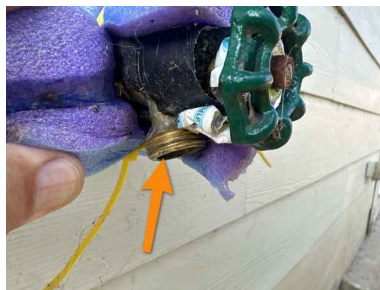
Example Right

One or more exterior hose bibs did not have a back flow preventer. Anti-siphon devices keep contaminated water from entering the potable water of the house plumbing. These devices are typically affordable and can be found in most home improvement stores. We recommend having these added.

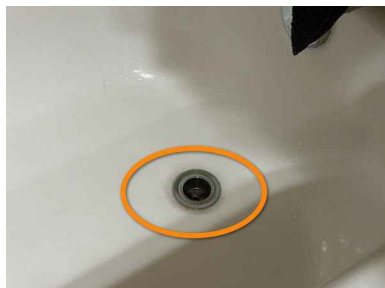
Guest Bathroom 2

Stoppers were noted missing at a bathtub. We recommend having stoppers installed to prevent damage to the drainage system from foreign objects.

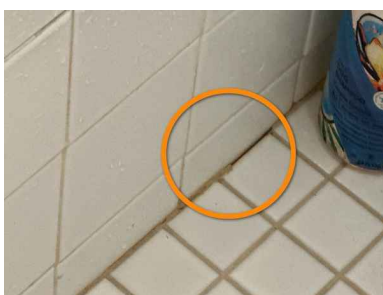
Guest Bathroom 1

Cracked, deteriorated and/or missing shower stall grout and caulk should be replaced.

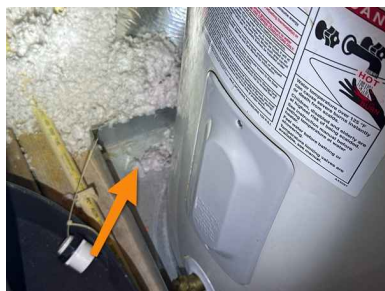
Debris/insulation was noted in the safety pan. We recommend this be cleared to prevent the drain line from clogging.

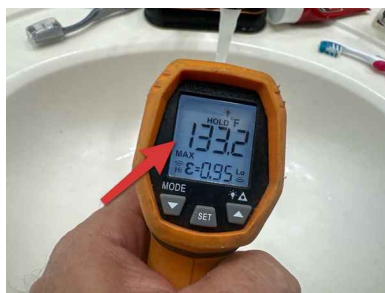
Scalding water temperature was measured. We recommended adjusting the water heater thermostat.

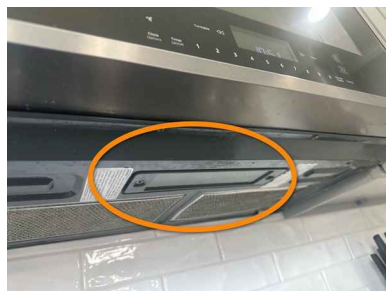
Range hood lights were inoperative at the time of the inspection. The bulb may be burned out, or there may be a problem with the switch, wiring or light fixture. If after replacing the bulb the light fixture still does not respond, the Inspector recommends correction by a qualified contractor

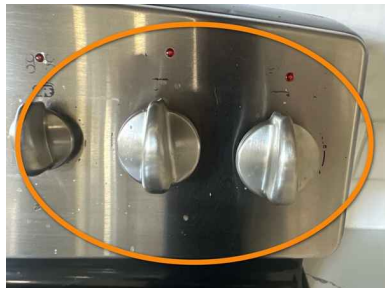
The cooktop burner label markings had faded. We recommend having these replaced.

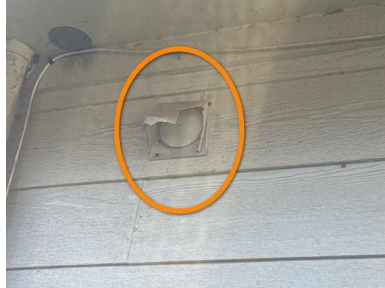
Right

A bathroom fan damper at the exterior of the house was damaged. We recommend replacing. We observed this on the
