**Report#:** 21373-RE

Texas Real Estate Commission Home Inspection (TREC)

## PROPERTY INSPECTION REPORT

**Concerning:** 5 Twin Circle Dr Beaumont TX 77706 21373-RE  
(Address of Inspected Property) (City, State, Zip) (Invoice/Report Number)

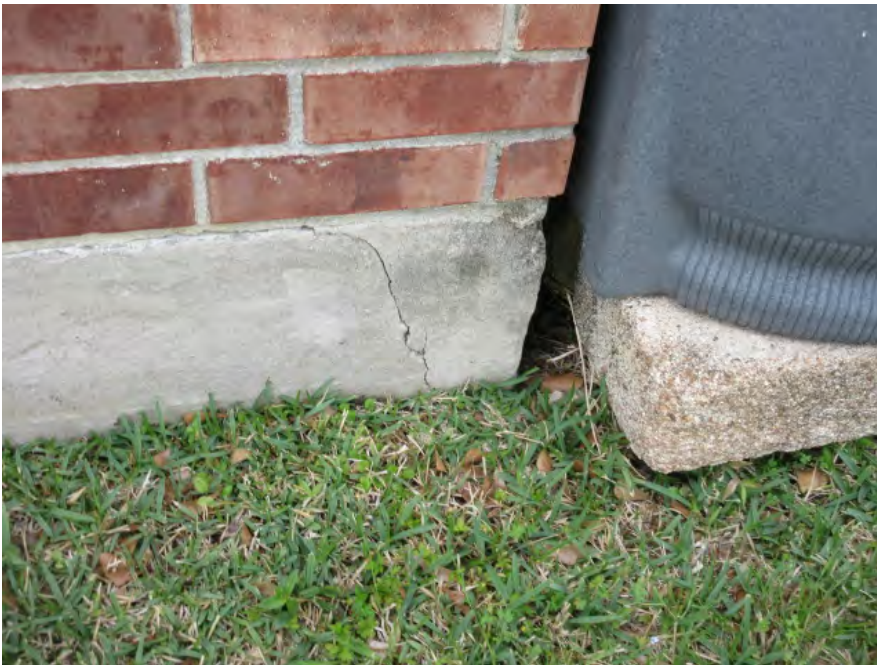
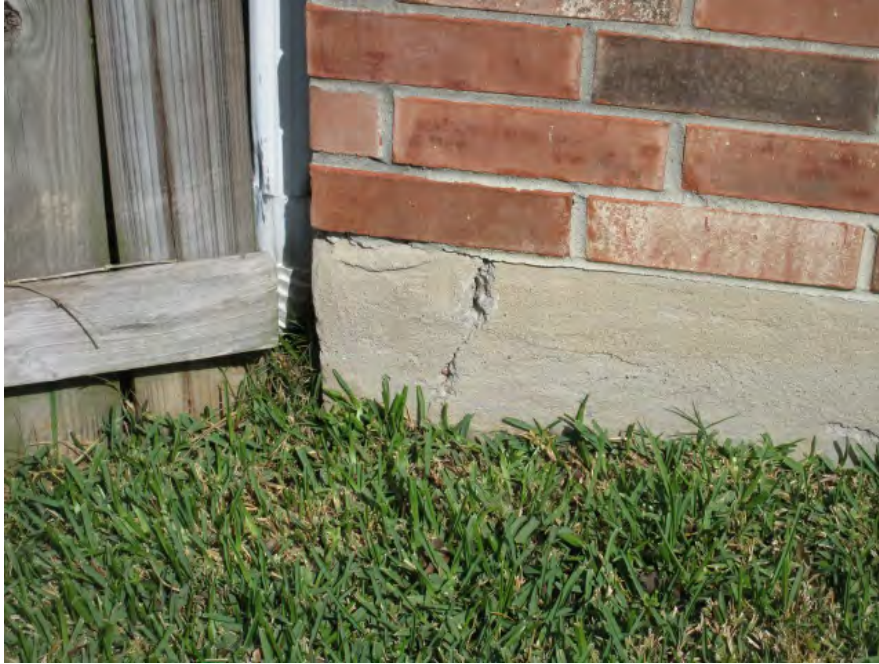
Line Item #: **I.A**

Description:  
**Cracked corners at the exterior foundation.**

Description:  
**Cracked corners at the exterior  
foundation.**

1. Qualified contractor to correct as determined necessary, but not limited to, the cracked corners at the exterior foundation.

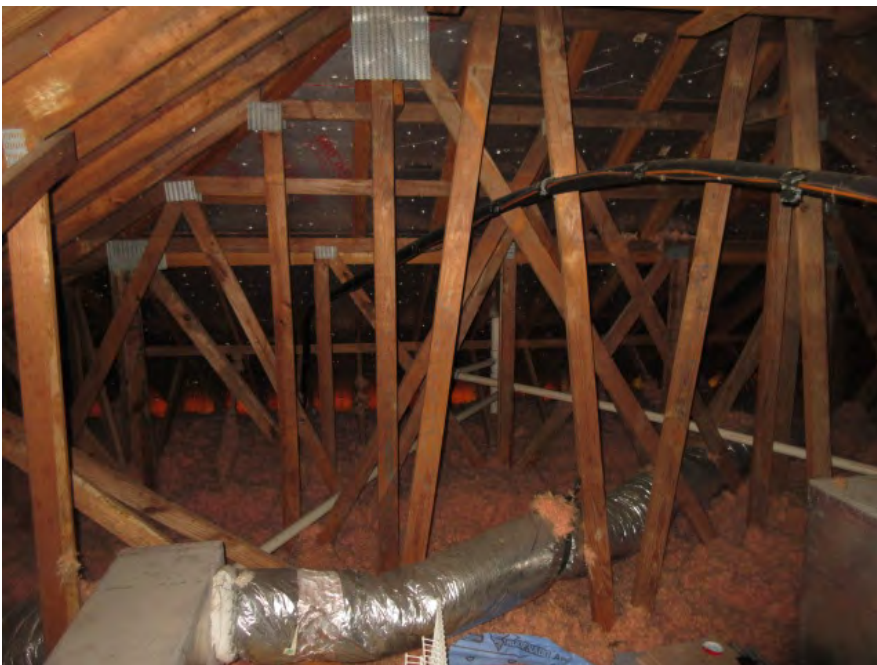
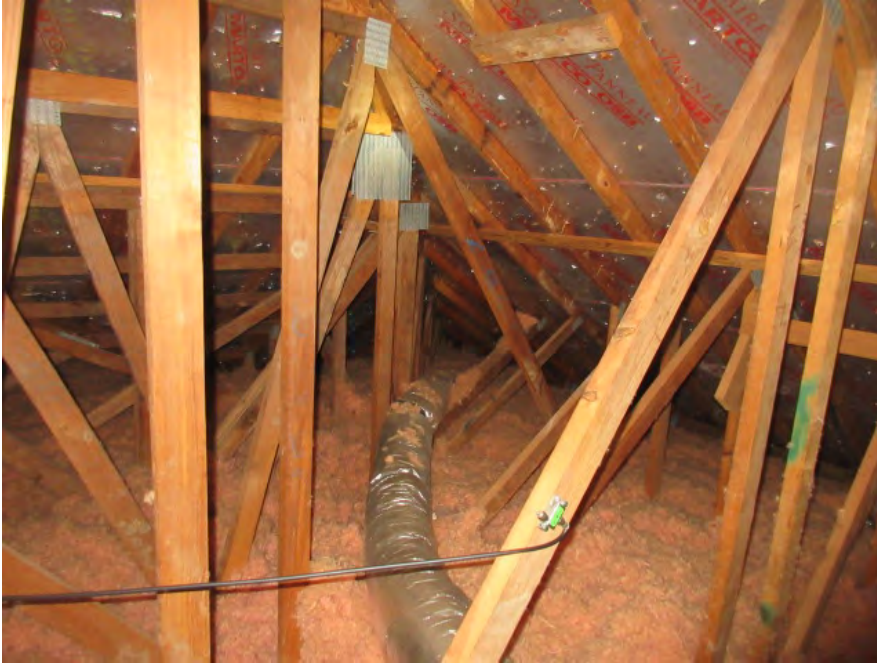
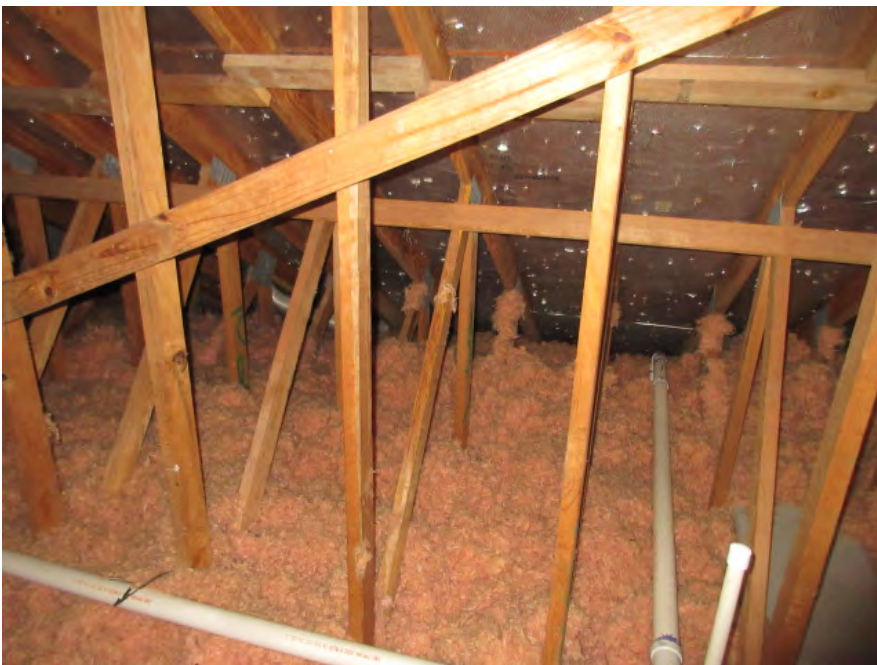
Line Item #: **I.D.**

Description:  
**NOTE: Limited inspection of attic due to design, lack of walk boards, and insulation.**

**NOTE: Limited inspection of attic due to design, lack of walk boards, and insulation.**

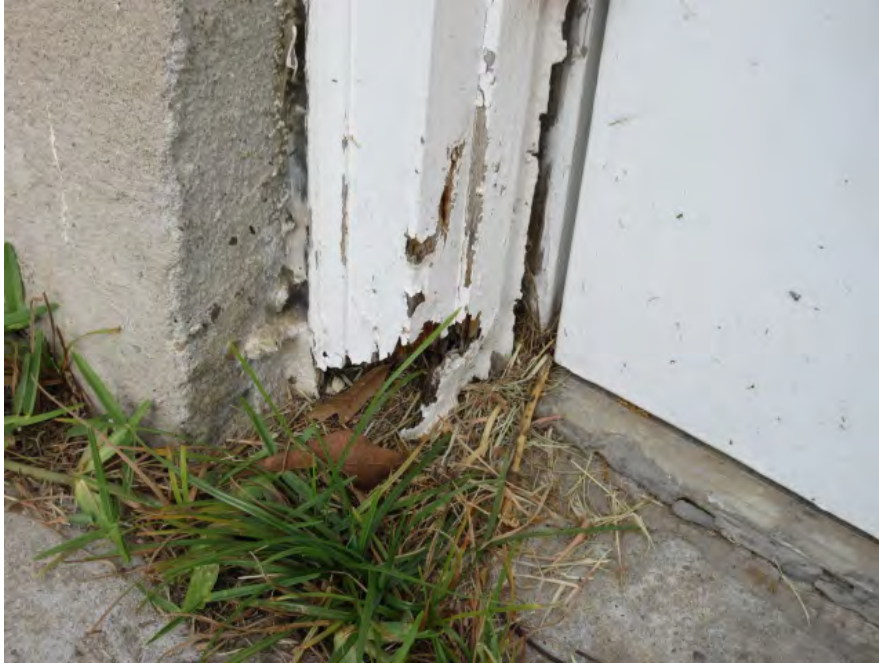
Line Item #: **I.E.**

Description:  
**Rotted exterior trim at the entry door.**

1. Qualified contractor to correct as determined necessary the rotted exterior trim at the entry door.
2. Additional Concerns: a. Damaged sheetrock above the living room exterior rear doors. b. Vegetation against the front right exterior wall. (NMC)

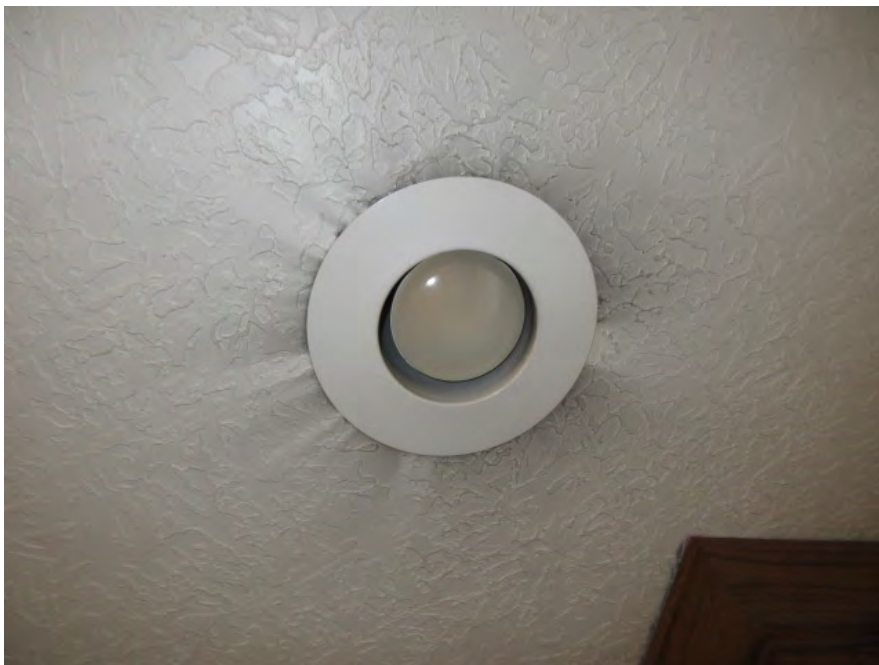
Line Item #: **I.F.**

Description:  
**Scorch marks on the laundry room ceiling.**

1. Qualified contractor to determine cause and correct as determined necessary the scorch marks on the laundry room ceiling.

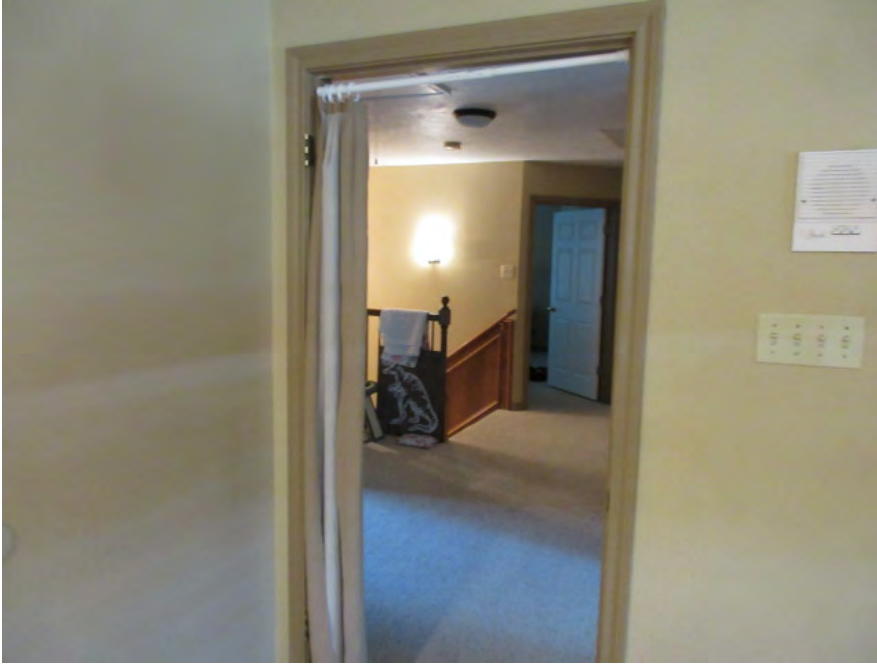
Line Item #: **I.G.**

**Right rear bedroom is missing the entry door.**

1. No visible defects noted at the time of the inspection.
2. Additional Concerns: a. Upstairs hall bathroom entry door will not latch. b. Right rear bedroom is missing the entry door. c. Upstairs hall bathroom rear closet door is missing the ball latch. (NMC)

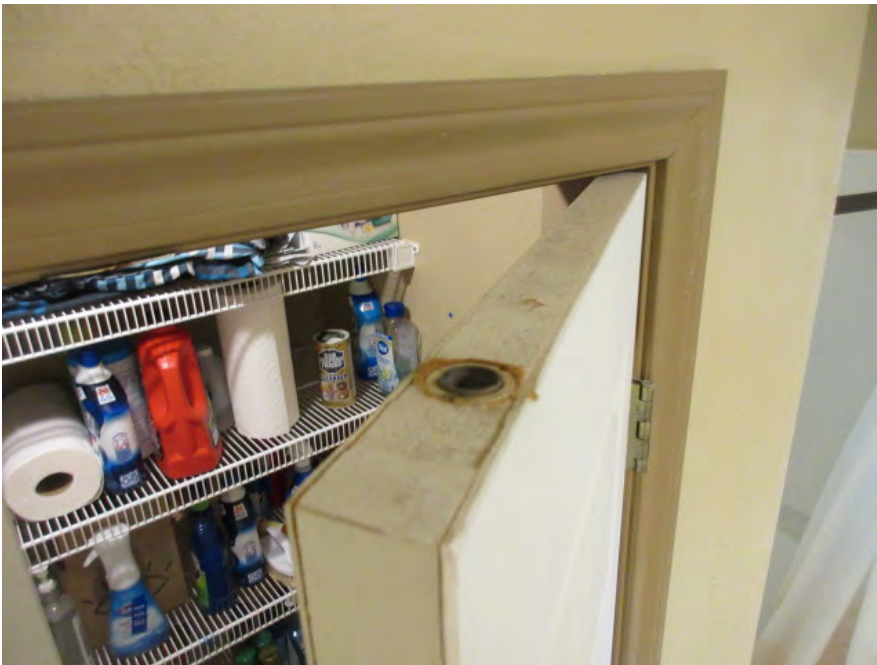
Line Item #: **I.G.**

**Upstairs hall bathroom rear closet door is missing the ball latch.**

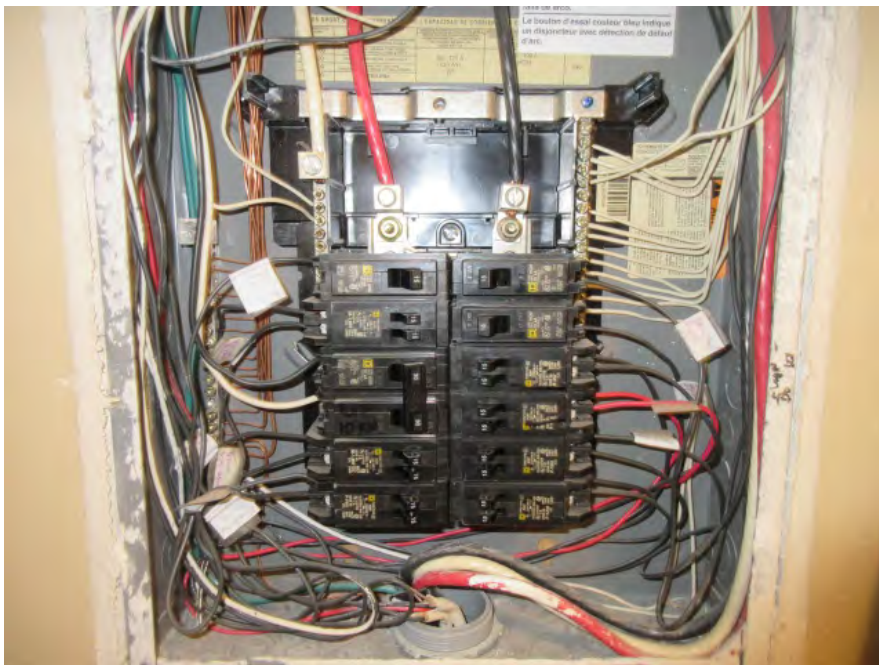
Line Item #: **II.A.**

Description:  
**Electric sub panel with cover off.**

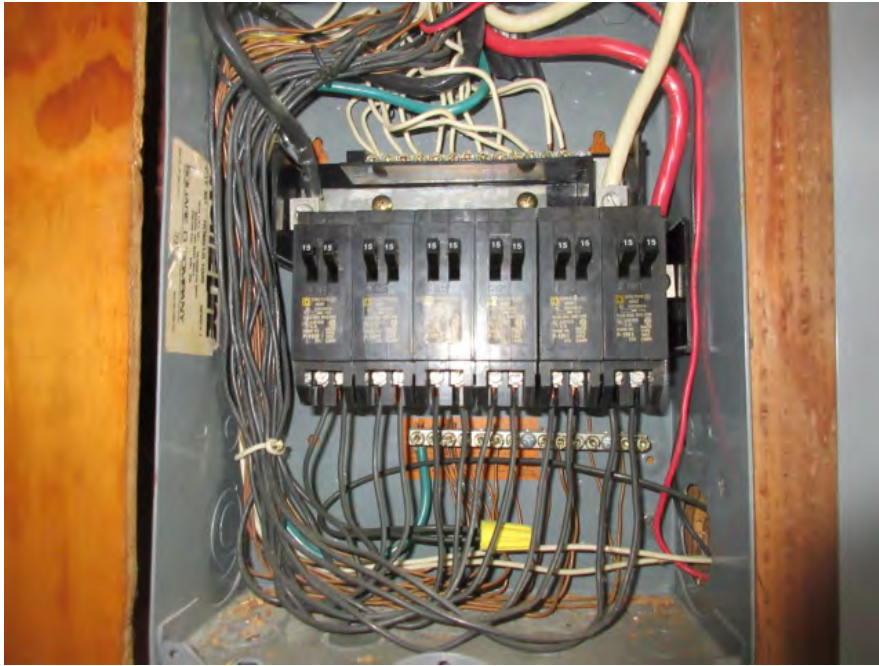
Line Item #: **II.A.**

Description:  
**Open knockout in the sub panel.**

1. Qualified electrical contractor to correct as determined necessary the following conditions:

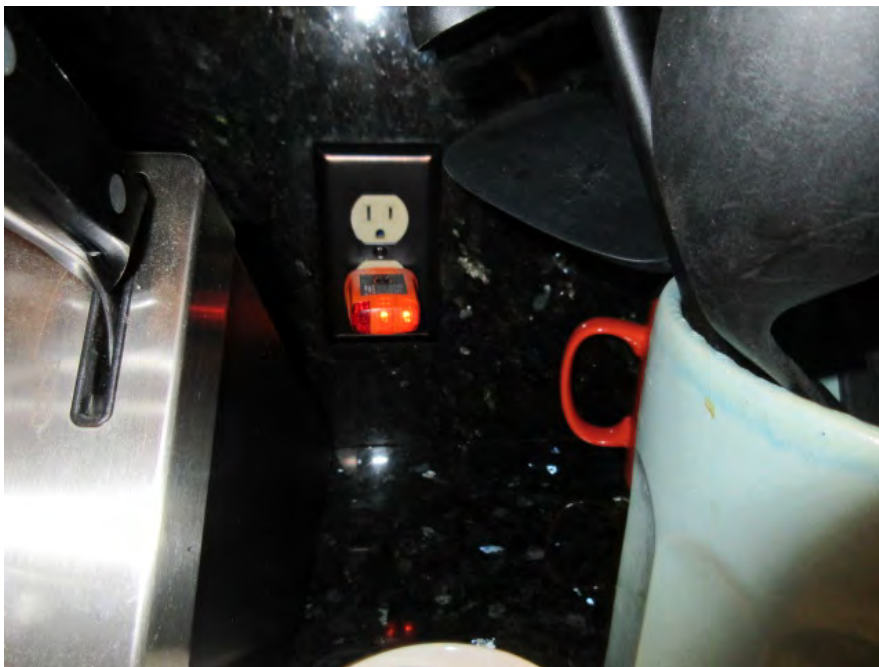
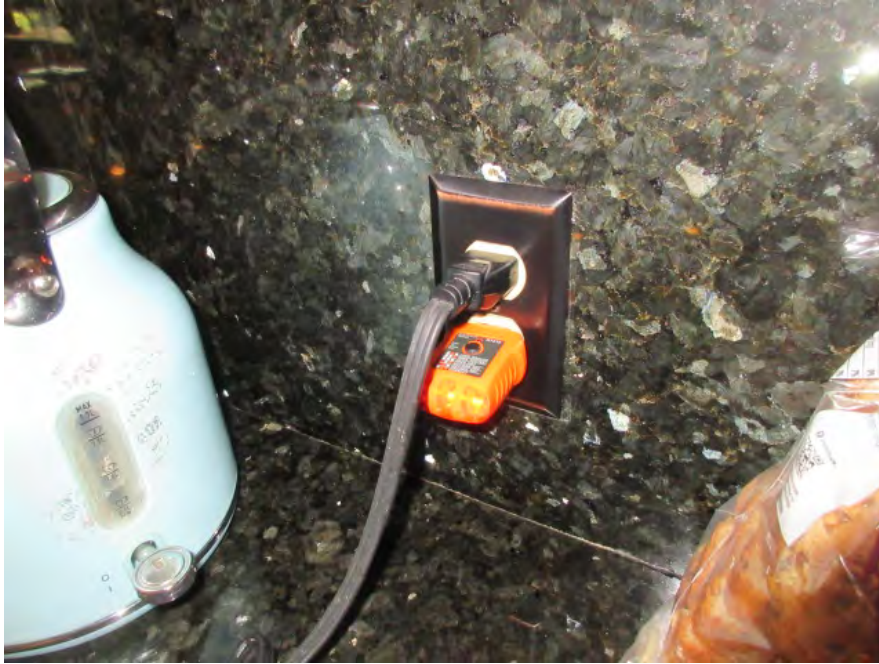
Line Item #: **II.B.**

Description:  
**Example of: Outlets above the kitchen  
counter are not GFCI protected.**

**Example of: Outlets above the kitchen counter are not GFCI protected.**

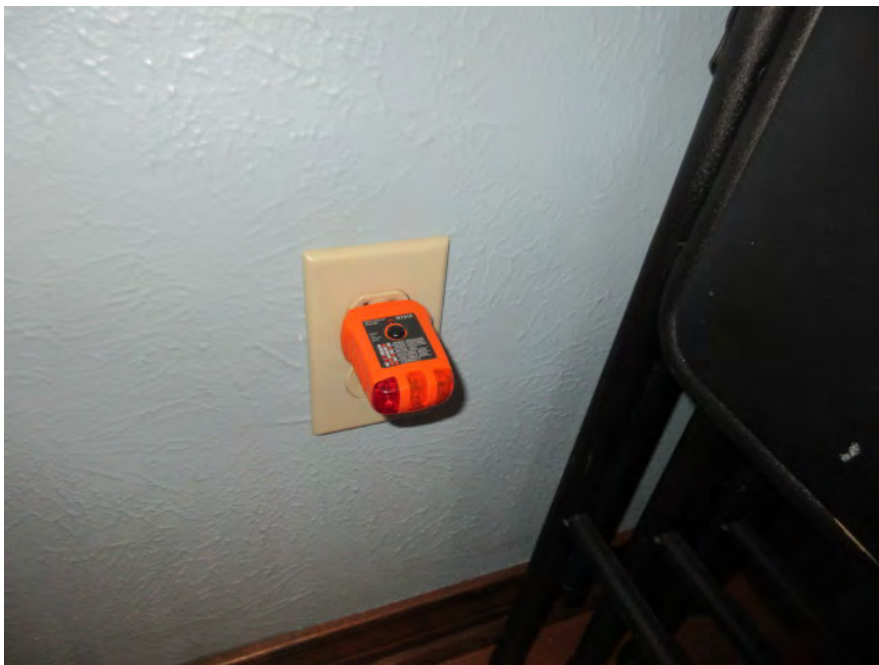
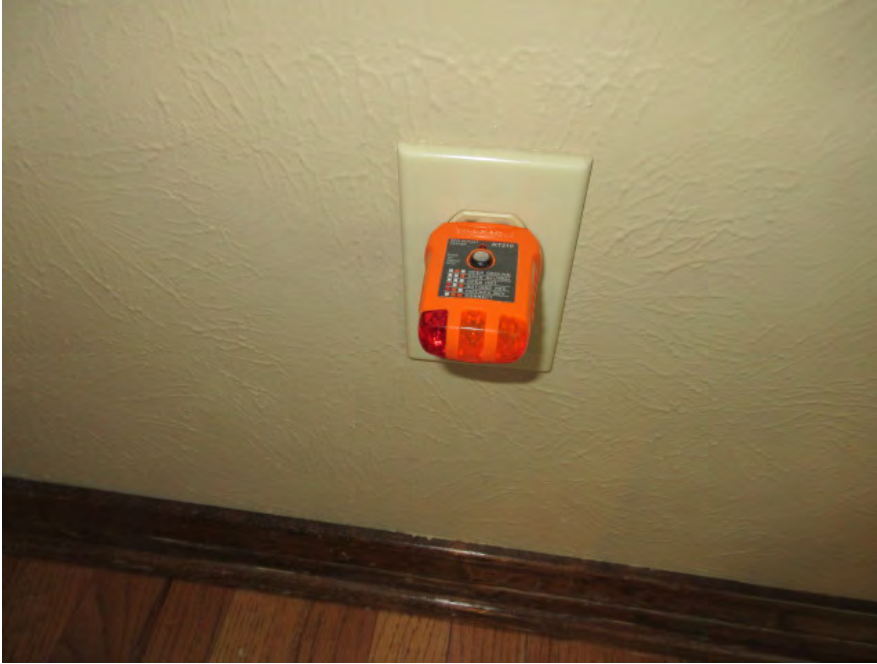
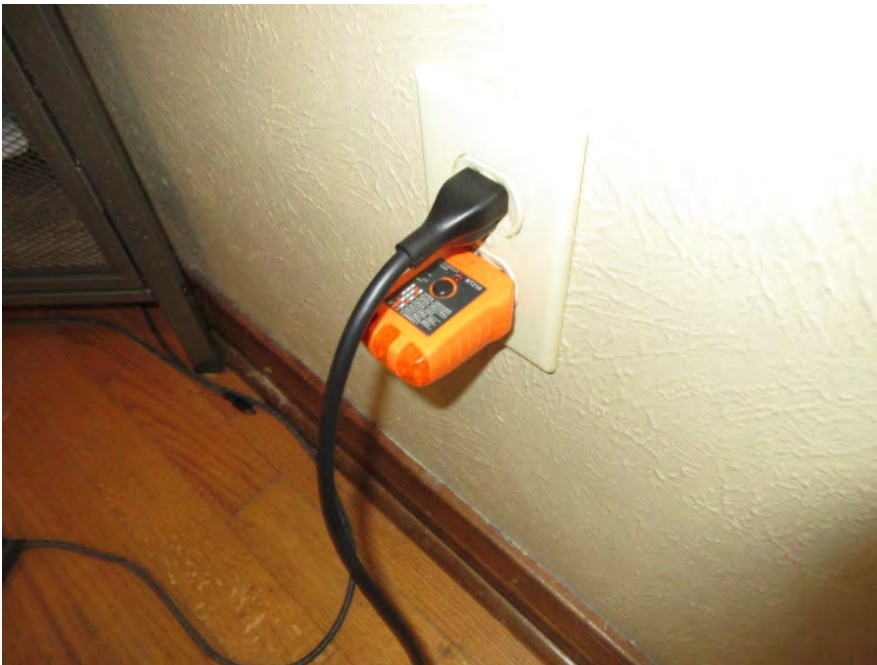
Line Item #: **II.B.**

**Example of: Nonfunctional outlets at the dining room, rear wall of the breakfast area, and left wall of the breakfast area.**

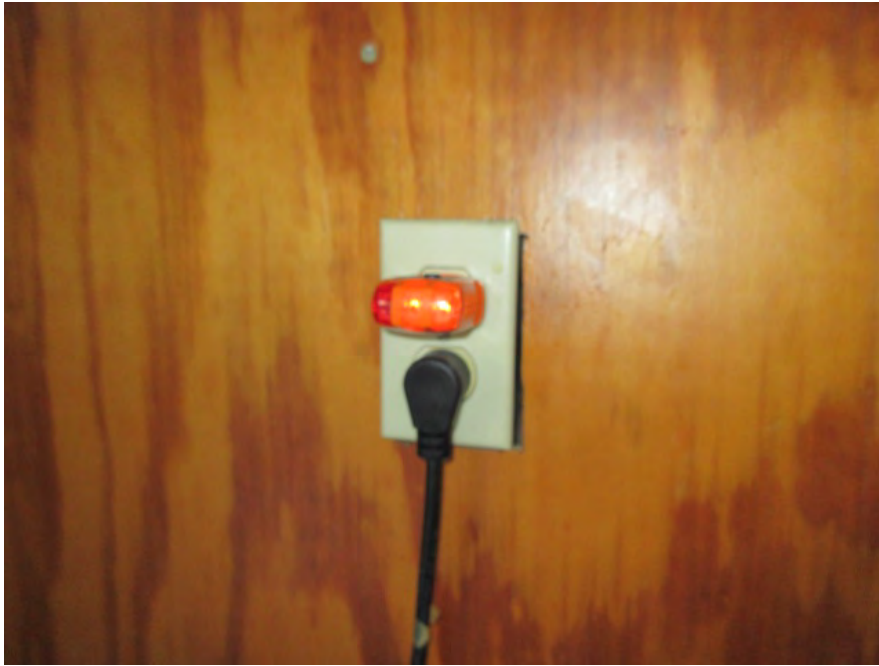
Line Item #: **II.B.**

**Example of: Garage outlets are not GFCI protected.**

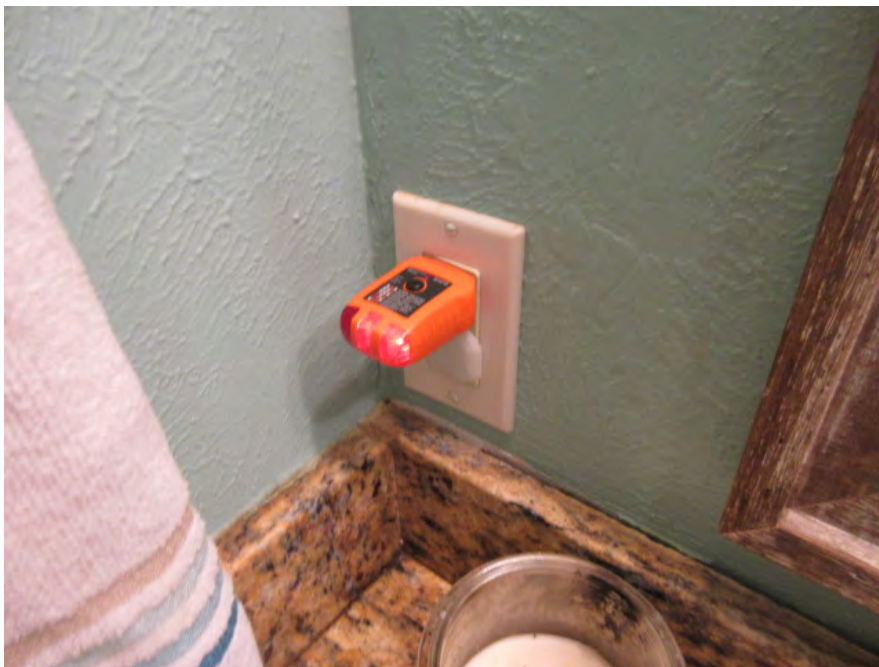
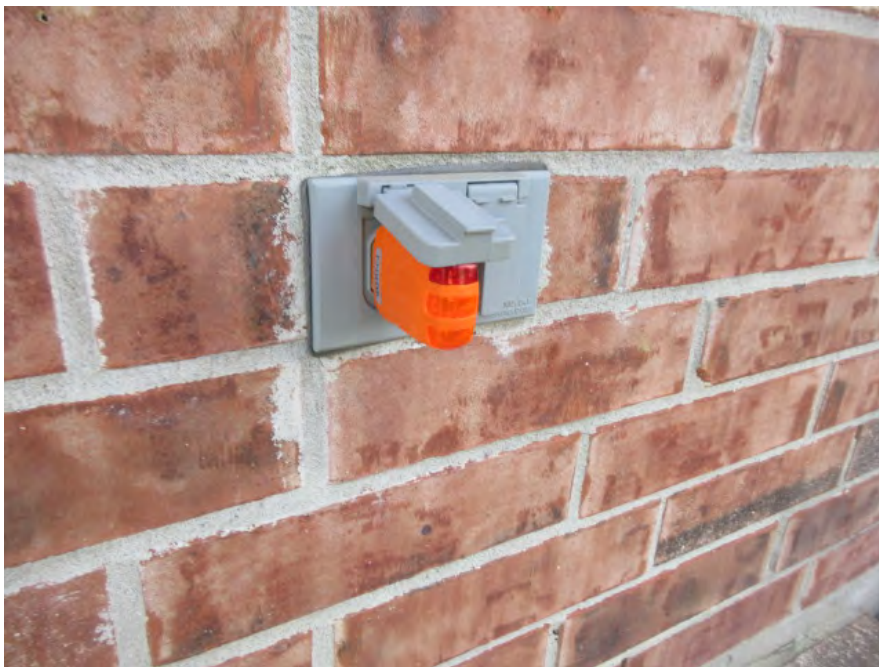
Line Item #: **II.B.**

**Example of: Downstairs bathroom GFCI reset outlet may have the line and load reversed as it protects a rear outlet in the bathroom but not itself.**

**Example of:** Downstairs bathroom GFCI reset outlet may have the line and load reversed as it protects a rear outlet in the bathroom but not itself.

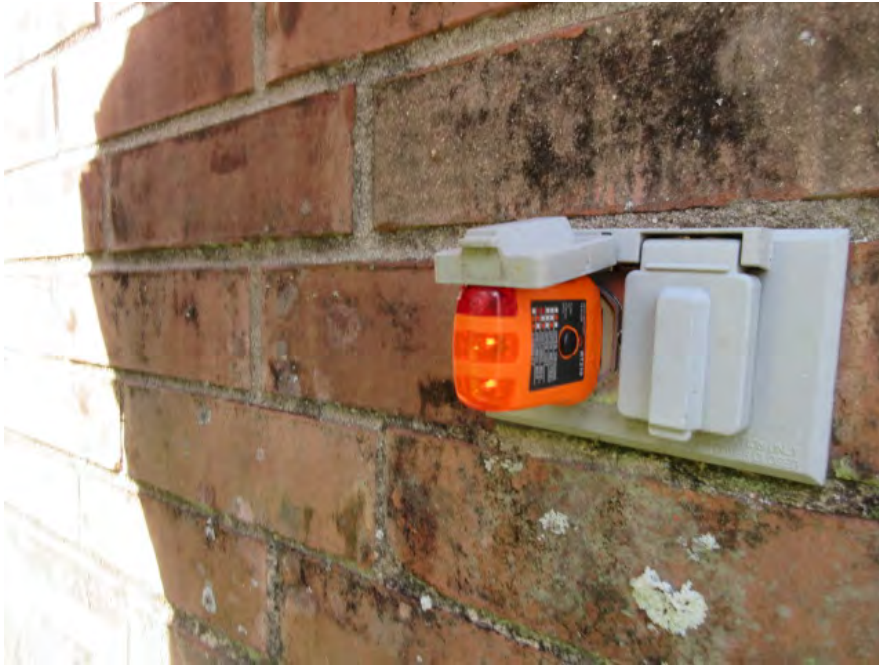
Line Item #: **II.B.**

**Example of:** Exterior right outlet on the front porch and the exterior outlet on the left side are not GFCI protected.

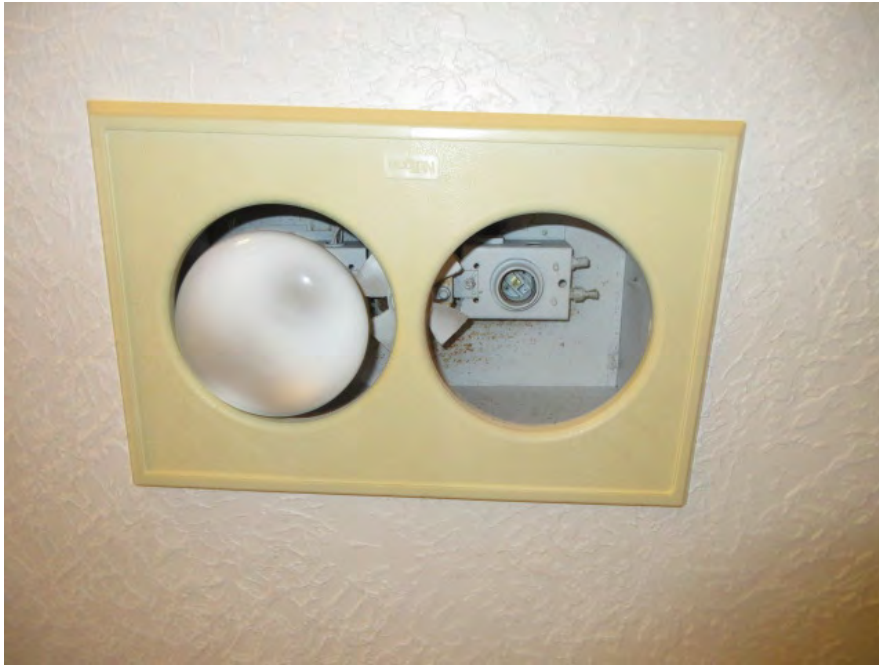
Line Item #: **V.F.**

**Missing bulb at the upstairs right rear bathroom heat lamp.**

1. Qualified contractor to correct as determined necessary the missing bulb at the upstairs right rear bathroom heat lamp.

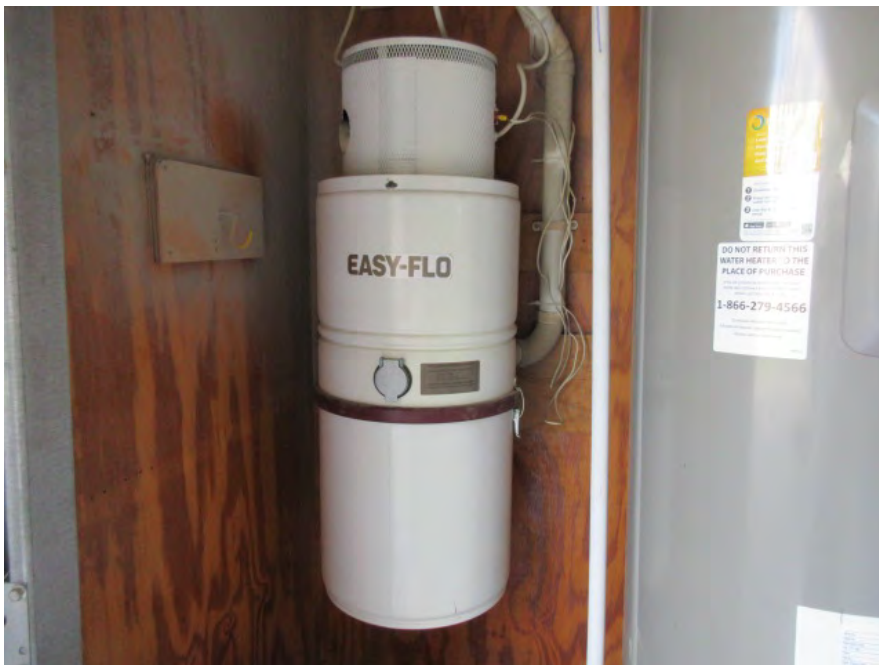
Line Item #: **V.I**

**NOTE: Central vacuum system was not inspected. Beyond the scope.**
