# *Top Choice Home Inspections*

## Property Inspection Report

E8871 Reo Ave., Westby , WI 54667

Date of Inspection: 6/19/2026 Time: 9:00 a.m.

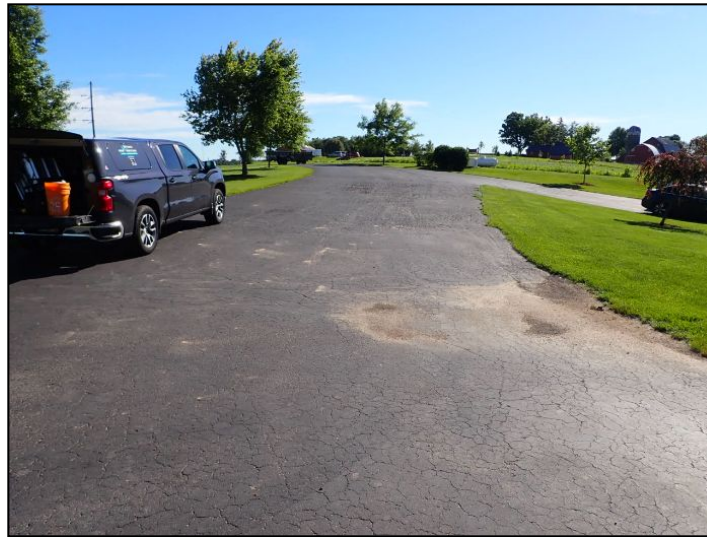
Asphalt driveway noted.

- Asphalt driveways need occasional maintenance. Monitor periodically and repair as needed.

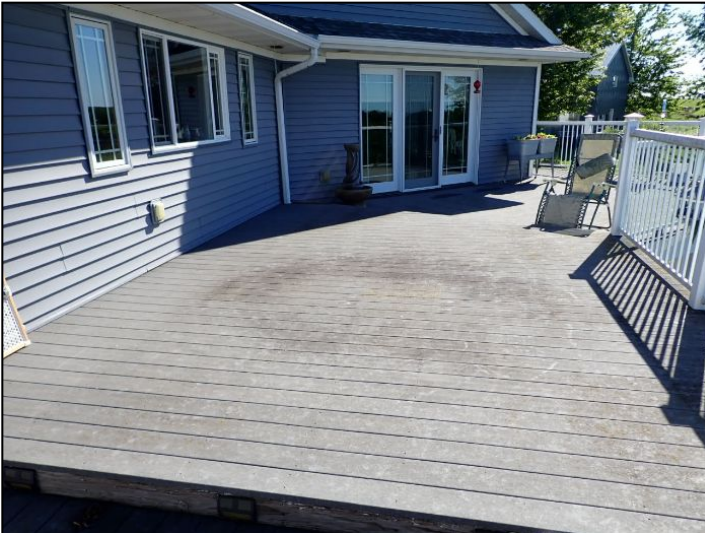
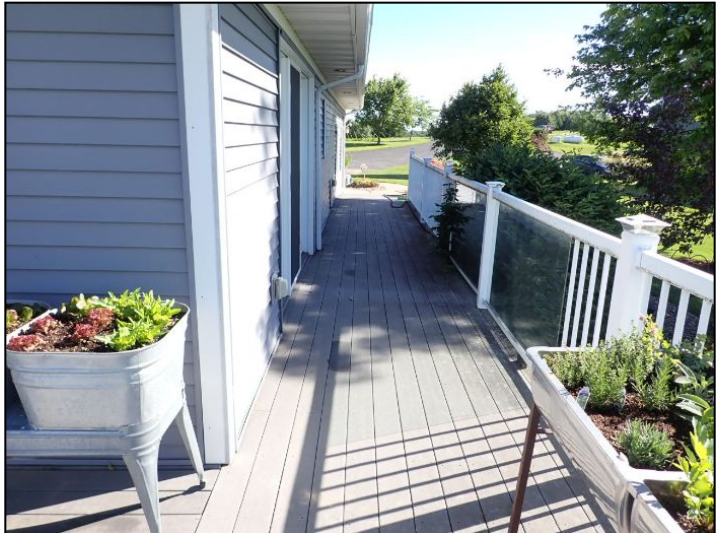
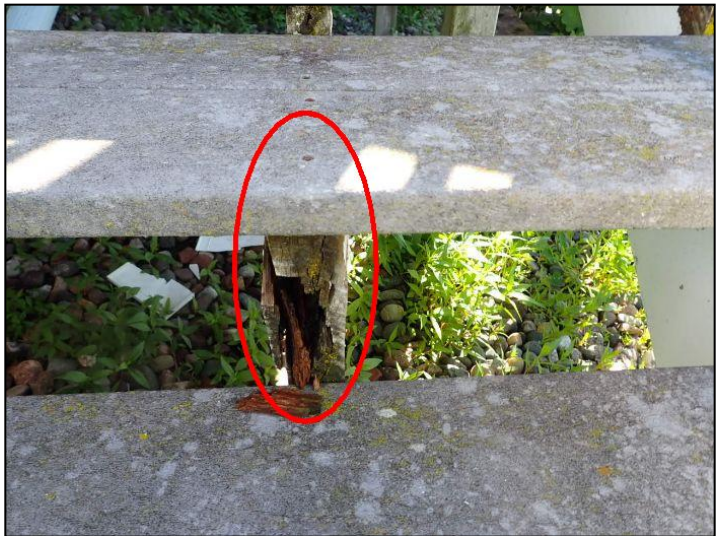
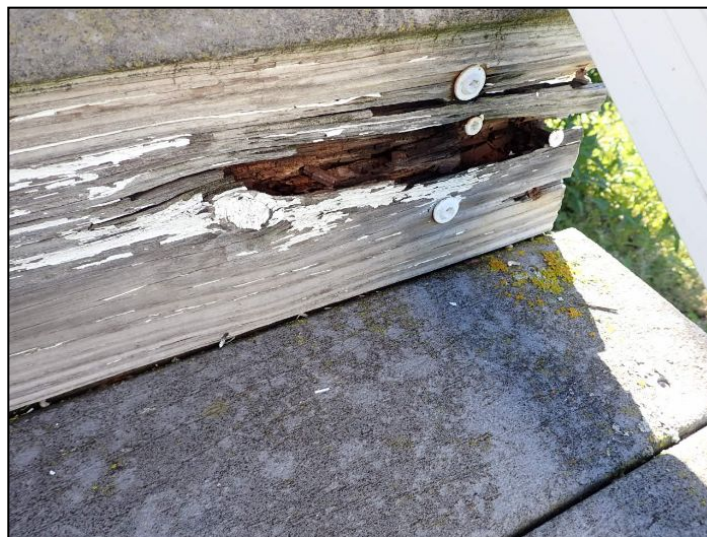
- **MAINTENANCE:** Whether treated or not it is important to keep a wooden deck or porch free of all forms of fungal growth and/or debris that retains moisture and could promote rot. Recommend cleaning when needed and sealing/staining or painting the deck as needed, possibly annually.
- Rot/deterioration was noted, especially on the steps. Recommend identifying and eliminating any moisture source and repairing or replacing any damaged areas and sealing or staining as needed.

| Grounds | | |
|---|---|---|
| Page 4 Item: 3 | Deck/Porch/Balcony | • Rot/deterioration was noted, especially on the steps. Recommend identifying and eliminating any moisture source and repairing or replacing any damaged areas and sealing or staining as needed. |

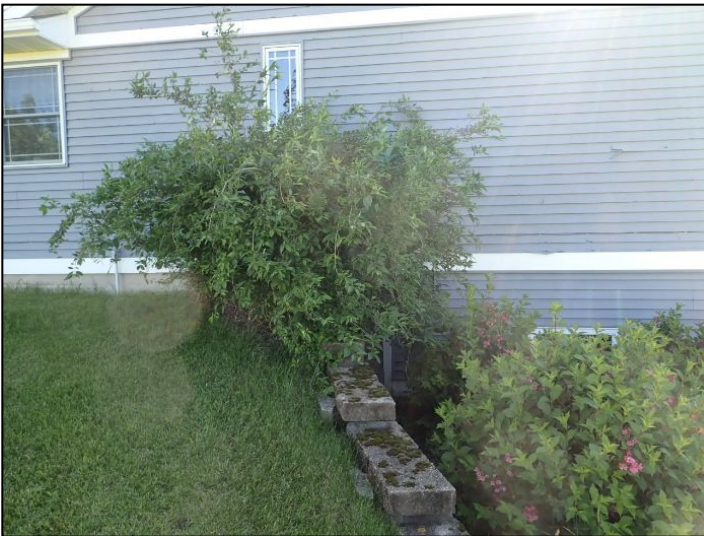
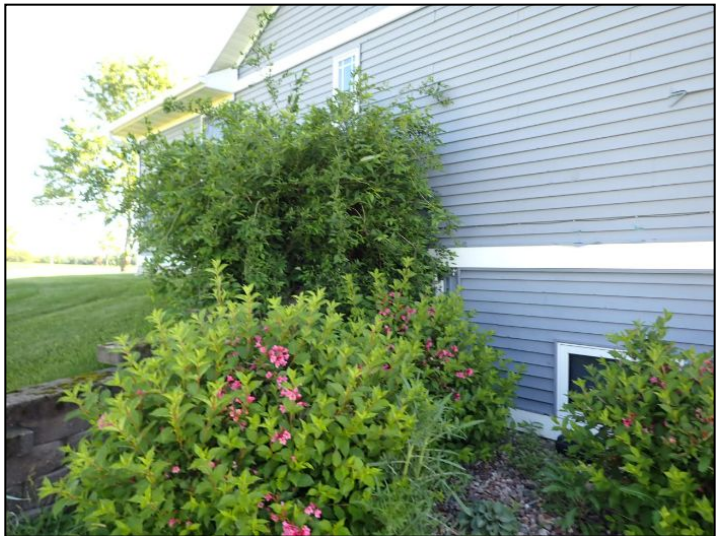
- Recommend tree branches and vegetation are kept trimmed away from the house. Vegetation can hold excess moisture against the house, possibly causing damage to the sheathing below the siding and/or making a pathway for insects. Tree branches can deposit debris on the roof which can shorten the roof covering life or cause physical damage to the roof. This will be a recurring maintenance item.

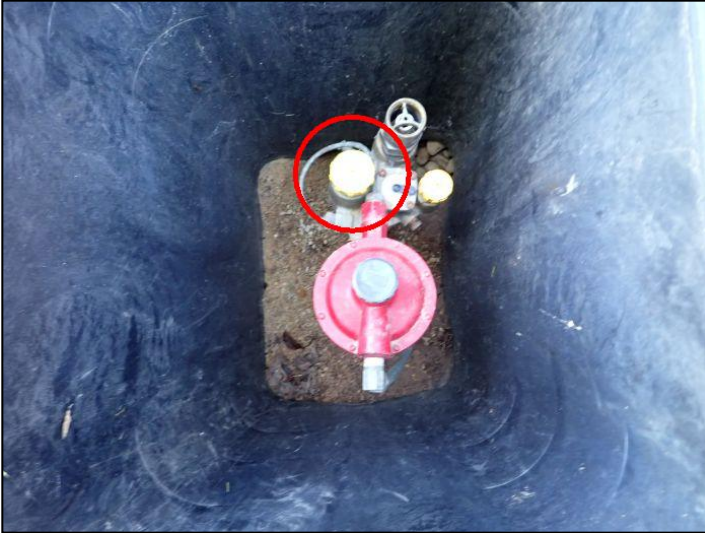
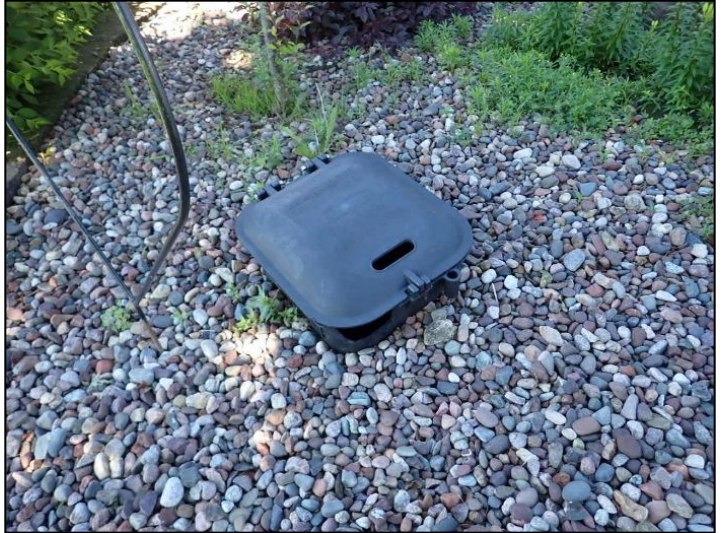
Valve Location: LP gas shutoff is located at the fuel tank. • East side. • Buried Fuel Tank

- The main shut off valve for an L.P. tank is under the lid. Care should be used when lifting the lid in warmer weather, as bees often build nests within the lid.

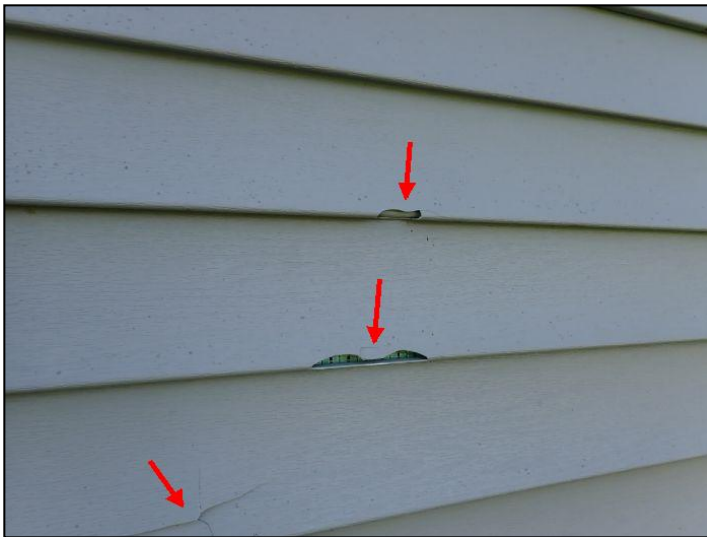
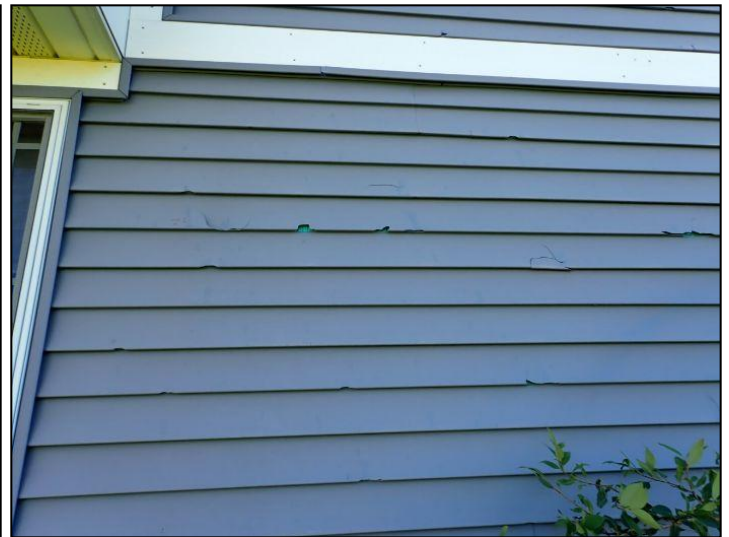
• Damage was noted in the vinyl siding. Sometimes the damage is from a trimmer getting too close or a mower throwing rocks, but the damage was reported to have been part of the storm damage.

| Grounds | | |
|---|---|---|
| Page 9 Item: 1 | Siding Condition | • Damage was noted in the vinyl siding. Sometimes the damage is from a trimmer getting too close or a mower throwing rocks, but the damage was reported to have been part of the storm damage. |

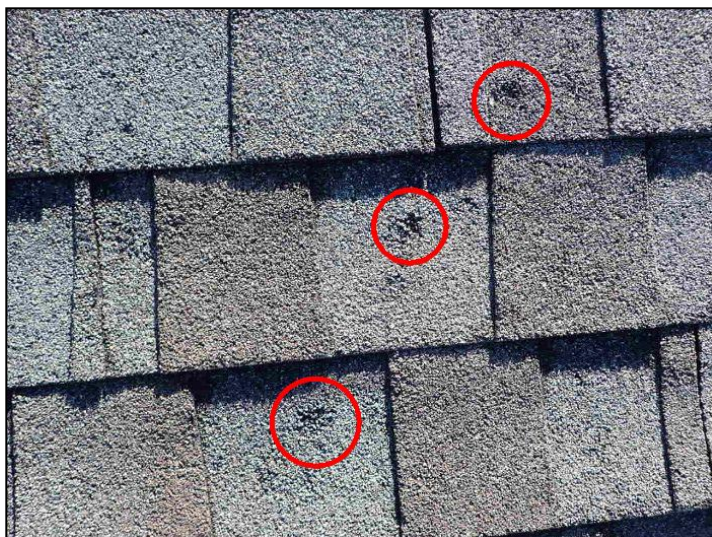
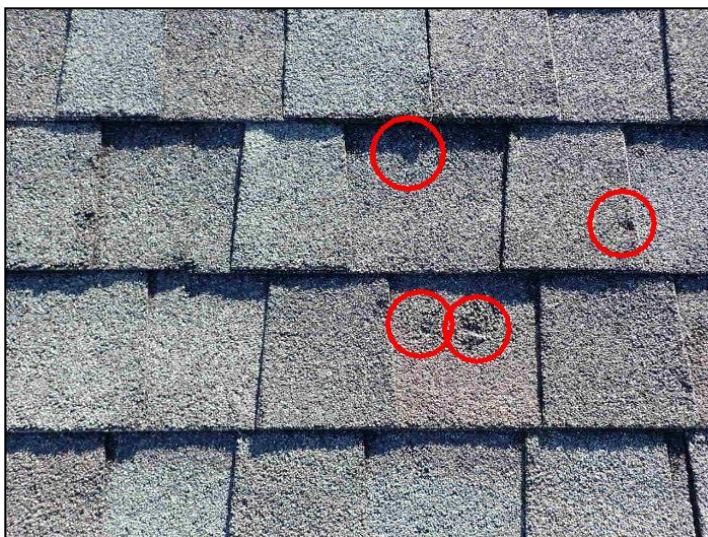
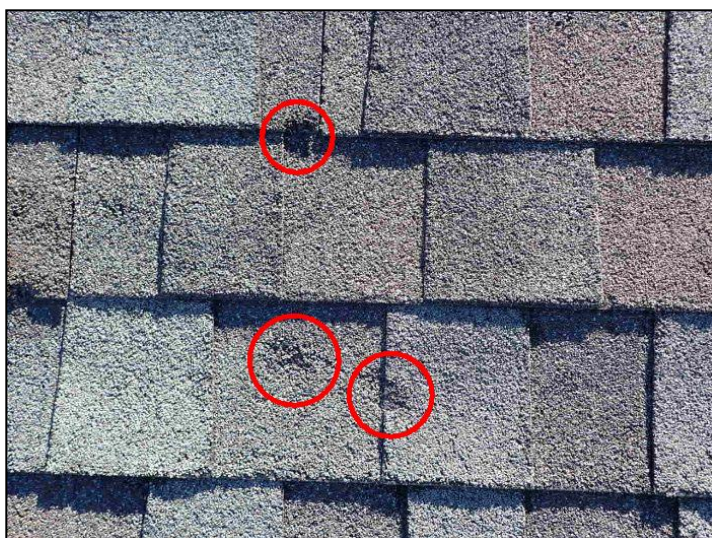
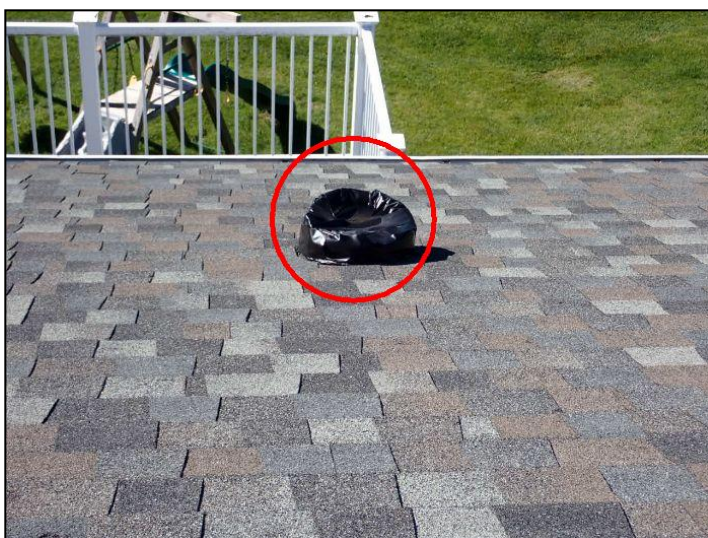
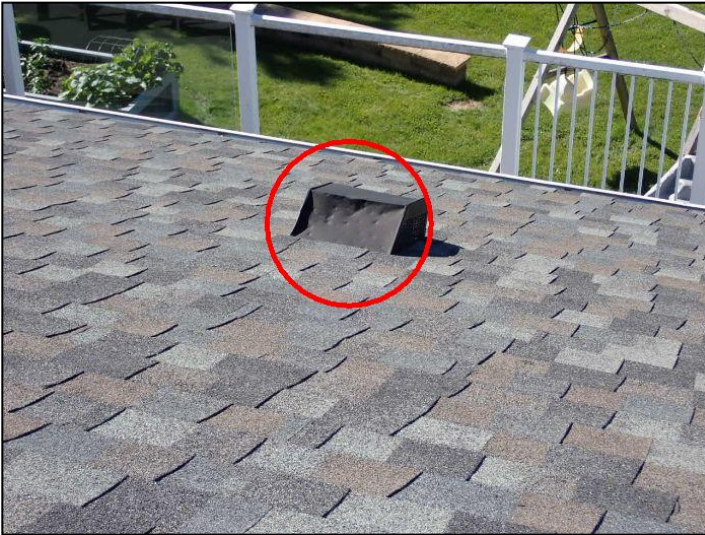
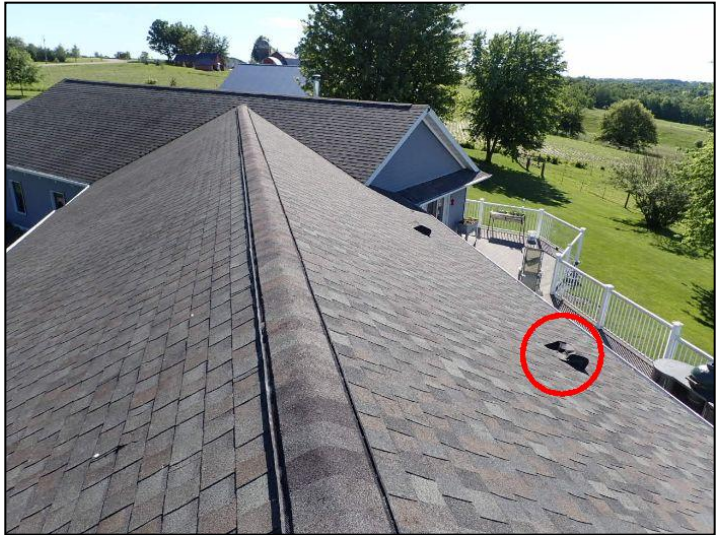
• On A significant hail storm moved through Westby recently and significant damage was noted. The deep dimpling noted (not all circled) in the pictures (in the shingles and other items) appear be from the hail storm. It was reported that along with other areas, the damage is being repaired.

| Grounds | | |
|---|---|---|
| Page 10 Item: 1 | Roof Condition | • On A significant hail storm moved through Westby recently and significant damage was noted. The deep dimpling noted (not all circled) in the pictures (in the shingles and other items) appear be from the hail storm. It was reported that along with other areas, the damage is being repaired. |

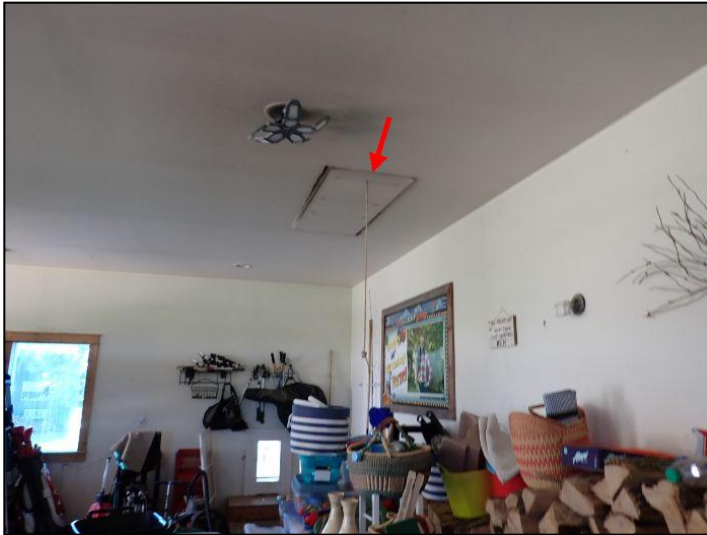
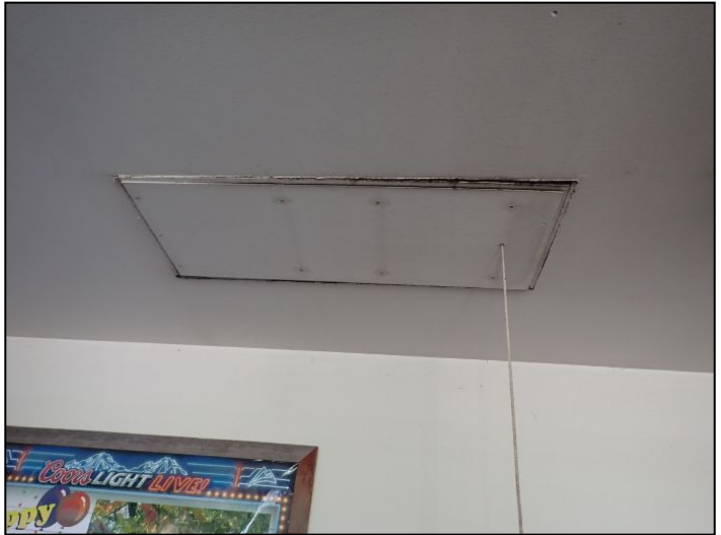
- The attic area was not accessible because of the items below the access (pull down stairs).

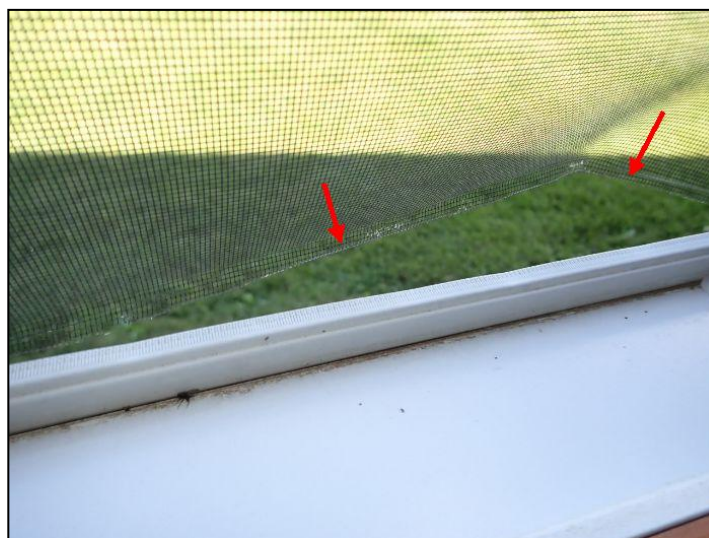
• At least one torn or damaged screen was noted (the picture is from the main floor N.W. bedroom). Repair may not be a priority. Repair as desired.

| Page 14 Item: 2 | Window Observations | <ul style="list-style-type: none"><li>• At least one torn or damaged screen was noted (the picture is from the main floor N.W. bedroom). Repair may not be a priority. Repair as desired.</li></ul> |

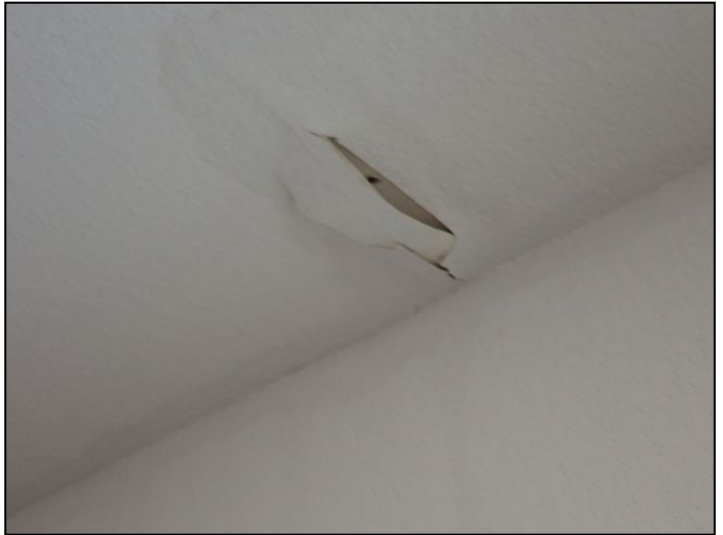
• Apparent water staining was noted (main floor laundry and basement). The areas appeared dry at the time of the inspection and the laundry room ceiling was right below an area of the roof hit especially hard by hail. Recommend consulting the current owner for information regarding the stains. Recommend monitoring and if any active leakage is noted, repairing as needed.

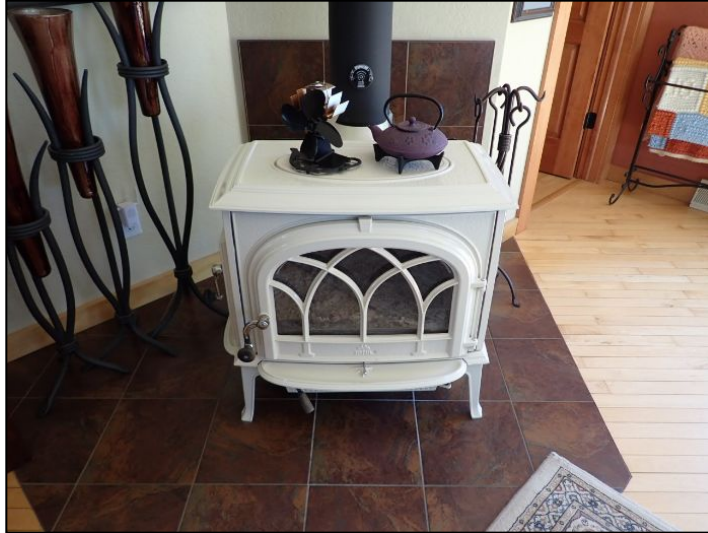
- A home inspector is not required to light a solid fuel burning appliance. The wood stove was not burning at the time of the inspection so the unit was not observed in operation. Recommend the unit, including the chimney, is cleaned and inspected by a specialist before operation. Typically, a level 2 inspection is recommended.

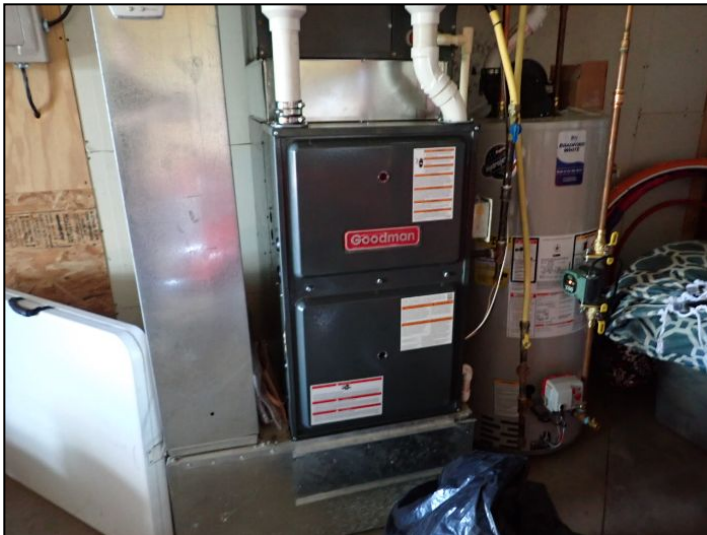
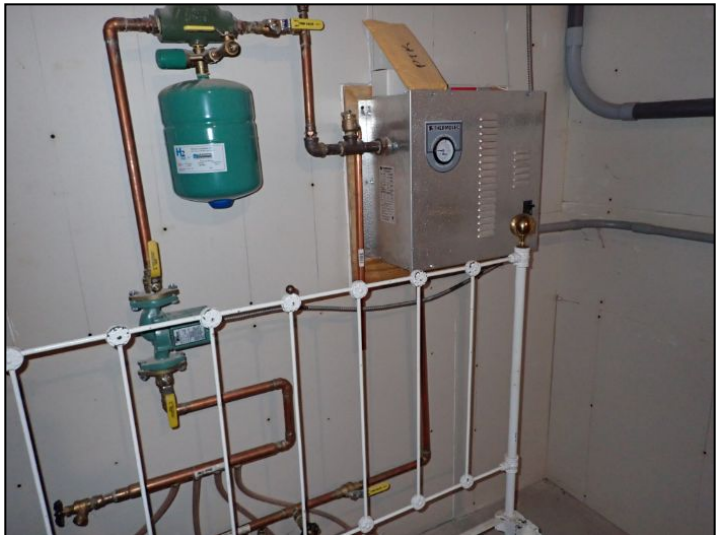
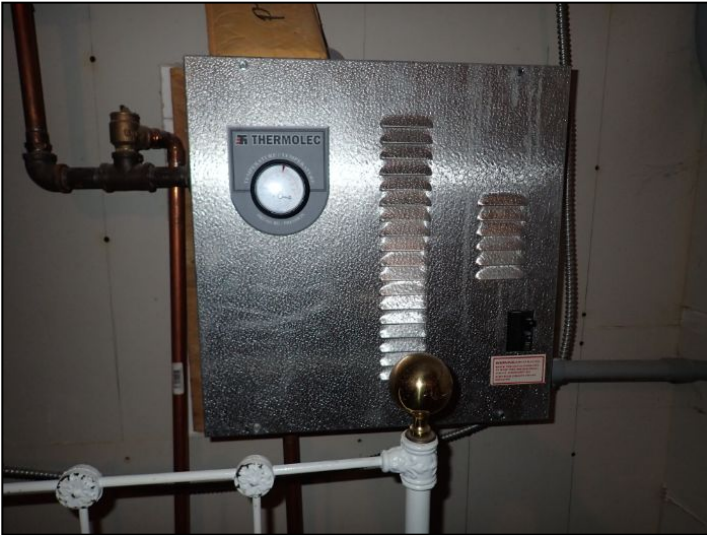
- Maintenance: Annual service of the heating system by a qualified HVAC technician is recommended.
- The outside temperature was warmer and heat was not needed, but the furnace was run briefly for the purpose of the inspection and it appeared to run properly during that time.
- If the serial numbers are being deciphered correctly the Goodman furnace was manufactured in 2025 making it approximately 1 year old, the Thermotec boiler was manufactured in 2019, making it approximately 6 years old and the Mini Boiler was manufactured in 2005, making it approximately 21 years old.

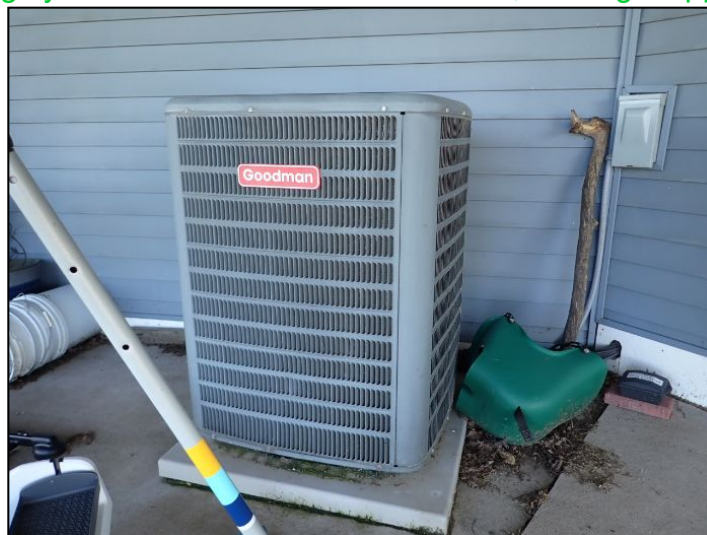
- Maintenance: Annual service of the air conditioning system by a qualified HVAC technician is recommended.
- The typical temperature differential (the difference between the plenum/duct at the furnace and room temperatures) in an air conditioning system of this type is approximately 14 to 24 degrees. The measured temperature differential at the time of the inspection was approximately 19 degrees and the system appeared to run properly during that time.
- If the serial number is being deciphered correctly the outside unit of the air conditioning system was manufactured in 2007, making it approximately 19 years old.

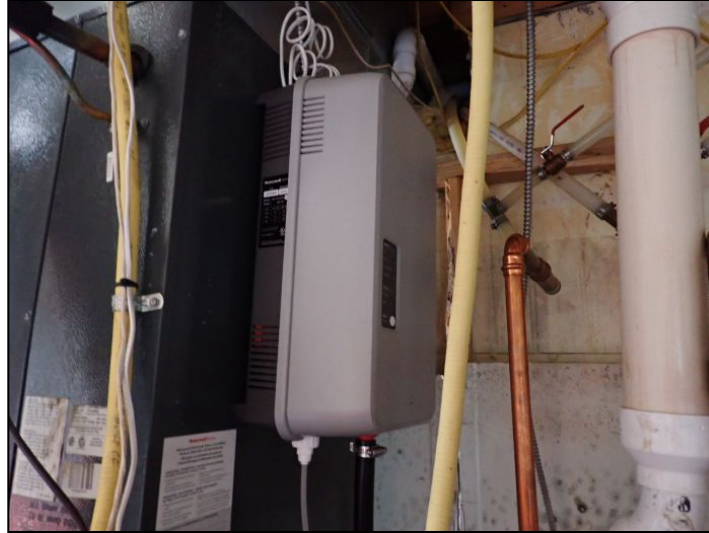
- **Maintenance:** The humidifier has a pad or panel that should be replaced periodically (often annually).
- During a typical home inspection, it is not confirmed whether the humidifier is working. Very specific conditions are needed to observe the humidifier in operation.

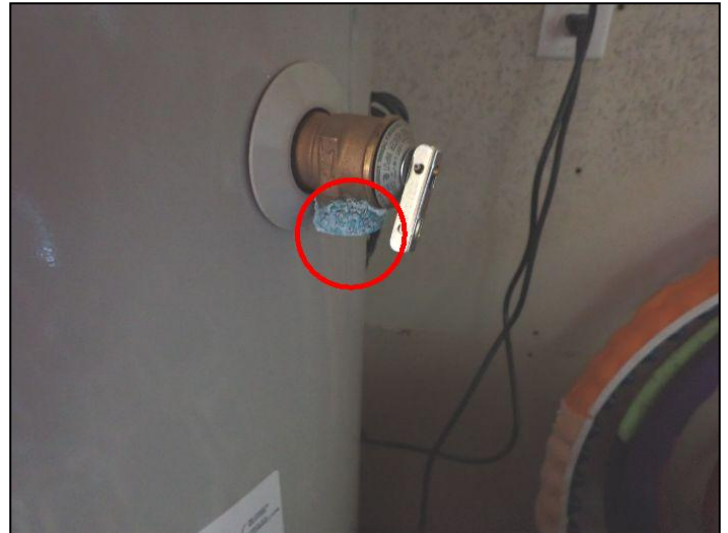
- No relief valve extension was installed. Recommend adding the extension to terminate no more than 6" above the floor for added safety. Temperature and pressure relief valves are factory set to trip at 210 degrees F and could easily scald someone nearby.

| Page 25 Item: 5 | Extension Observations | <ul style="list-style-type: none"><li>• No relief valve extension was installed. Recommend adding the extension to terminate no more than 6" above the floor for added safety. Temperature and pressure relief valves are factory set to trip at 210 degrees F and could easily scald someone nearby.</li></ul> |

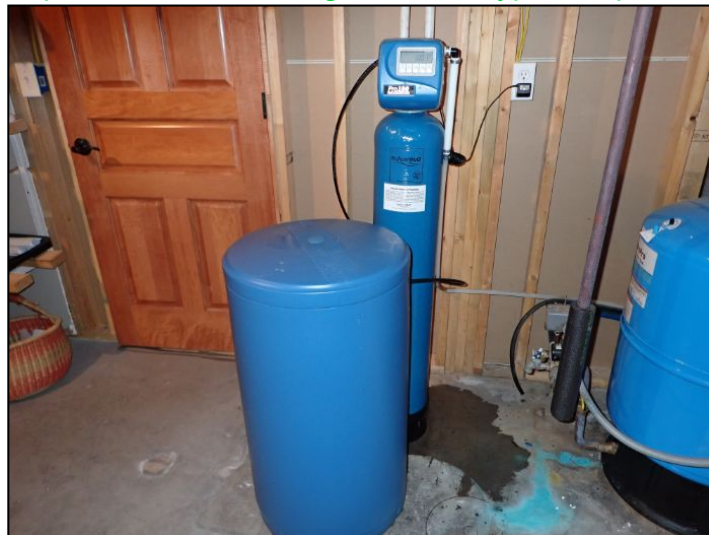
• Water softeners are not tested as part of a home inspection (see limitations). If the softener has not been turned on and contains proper levels of salt, the unit cannot be accurately tested. Plus, a hardness test would be needed to determine the effectiveness of the softener. Water softeners need salt added occasionally. Frequency depends on water usage and salt type is a personal preference.

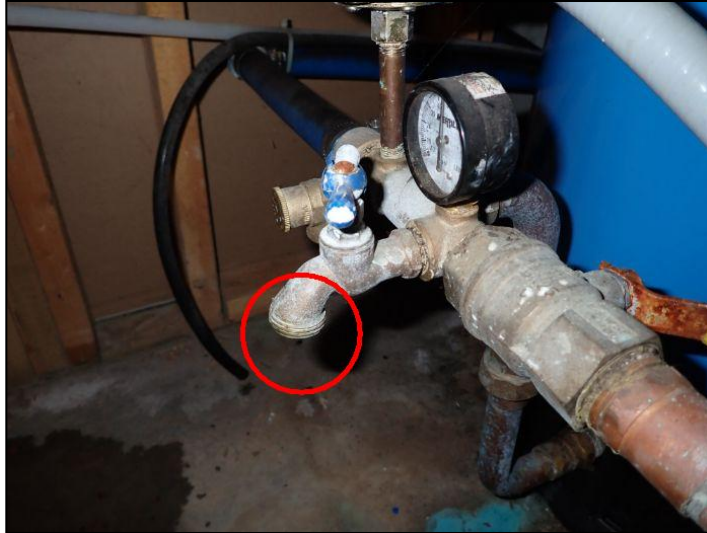
- The sampling valve at the pressure tank should not have hose threads on the end and it should be replaced with a proper sampling valve.

| Page 28 Item: 1 | Well Observations | <ul style="list-style-type: none"><li>• The sampling valve at the pressure tank should not have hose threads on the end and it should be replaced with a proper sampling valve.</li></ul> |

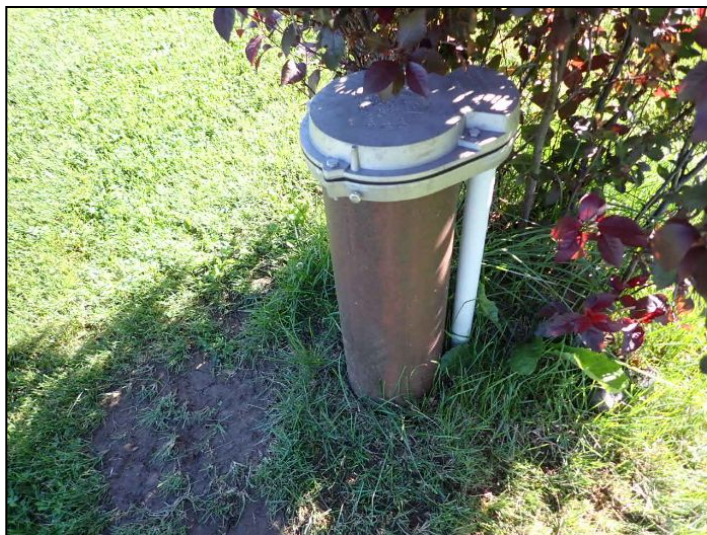
Height: 18" Above Grade

Casing Type & Size: Well construction report shows steel. • 6"

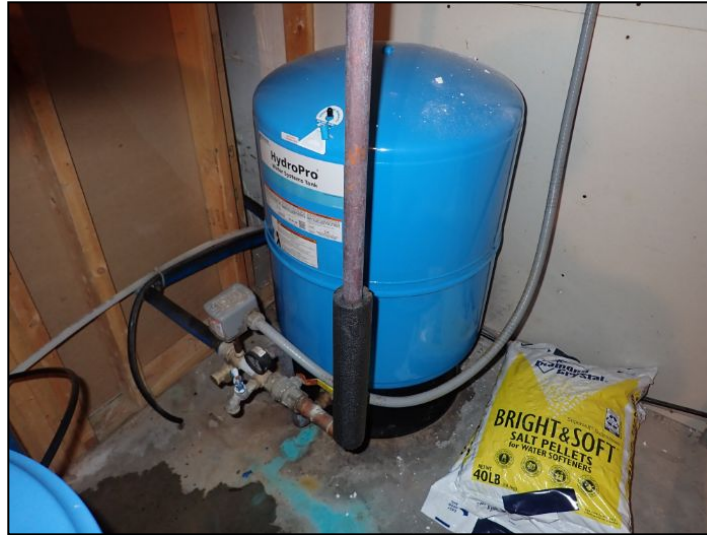
Press Tank: Hydro Pro V140
