# *Top Choice Home Inspections*

## Property Inspection Report

E10978 State Hwy. 82, La Farge , WI 54639

Date of Inspection: 9/1/2026 Time: 9:00 a.m.

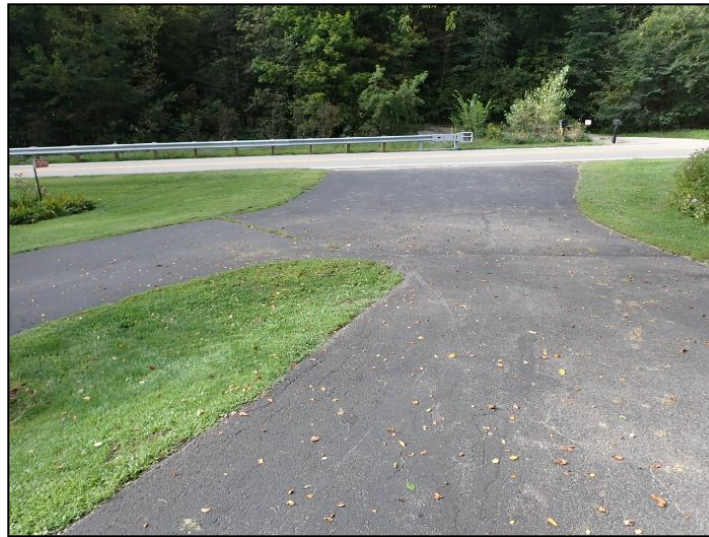
Asphalt driveway noted.

- Asphalt driveways need occasional maintenance. Monitor periodically and repair as needed.

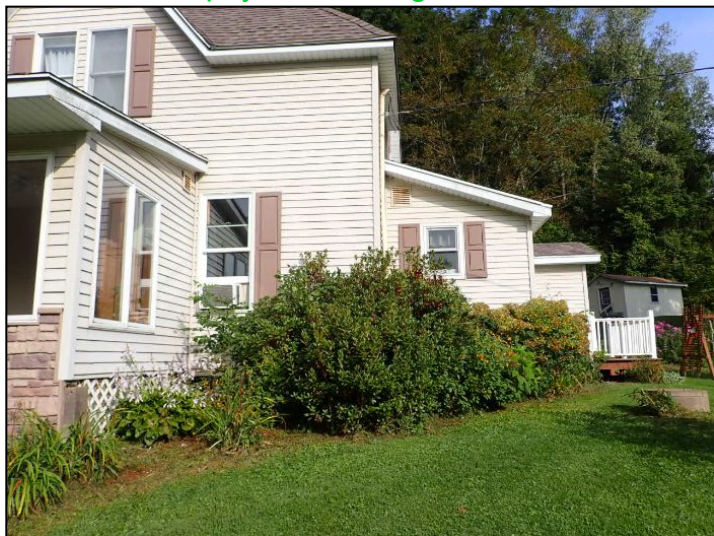
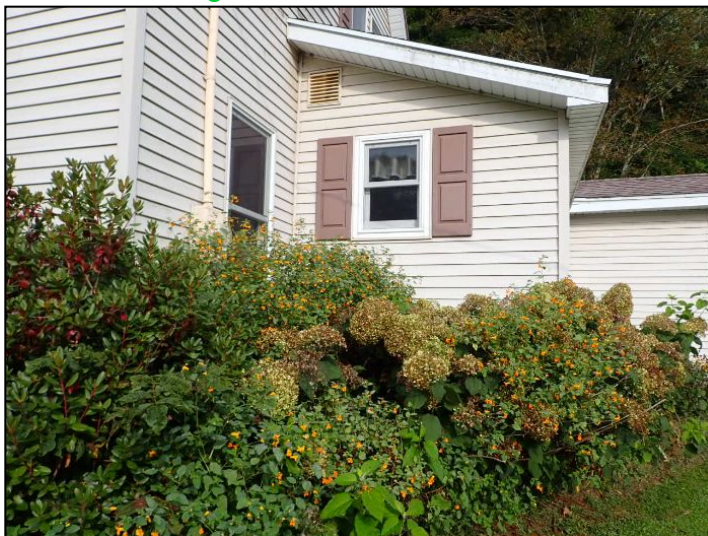
- Recommend tree branches and vegetation are kept trimmed away from the house. Vegetation can hold excess moisture against the house, possibly causing damage to the sheathing below the siding and/or making a pathway for insects. Tree branches can deposit debris on the roof which can shorten the roof covering life or cause physical damage to the roof. This will be a recurring maintenance item.

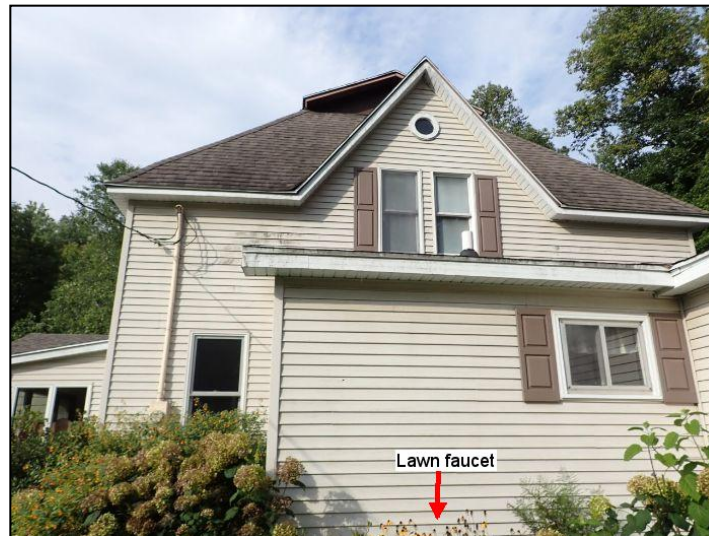
Lawn faucet

- The outside lawn faucet was tested and appeared to work properly at that time.

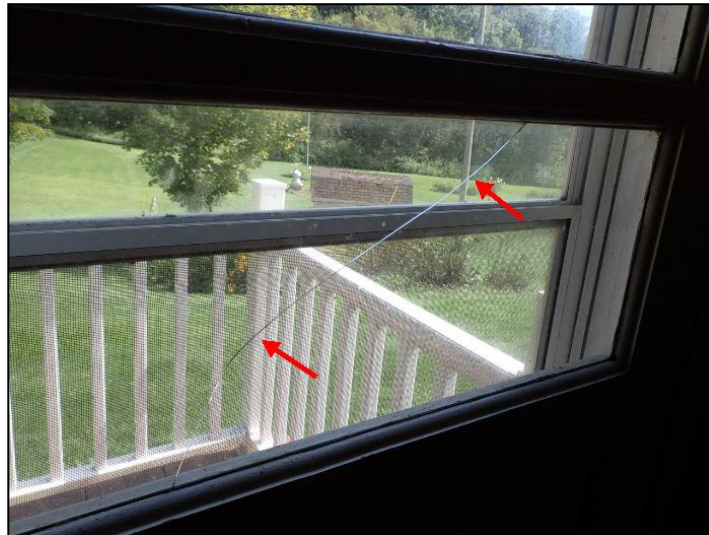
- The back exterior door had a crack in the window. Recommend repair as desired.

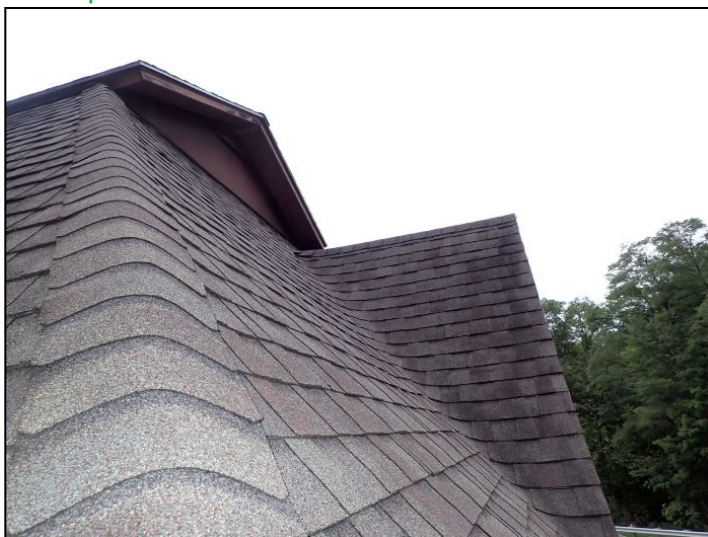
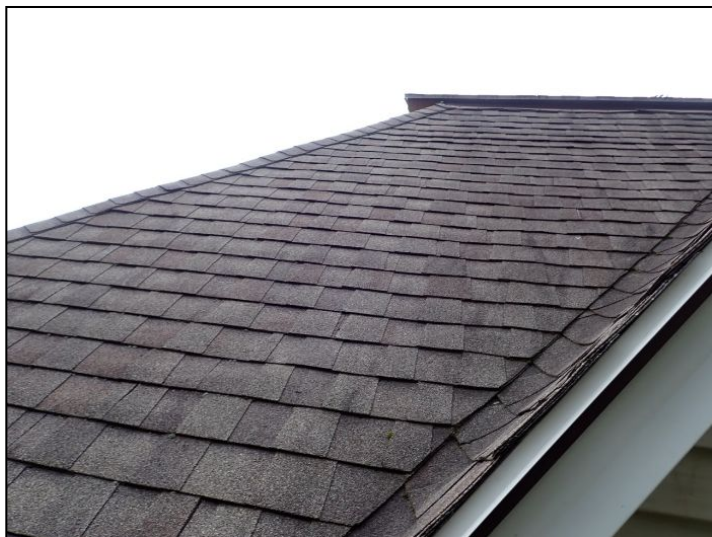
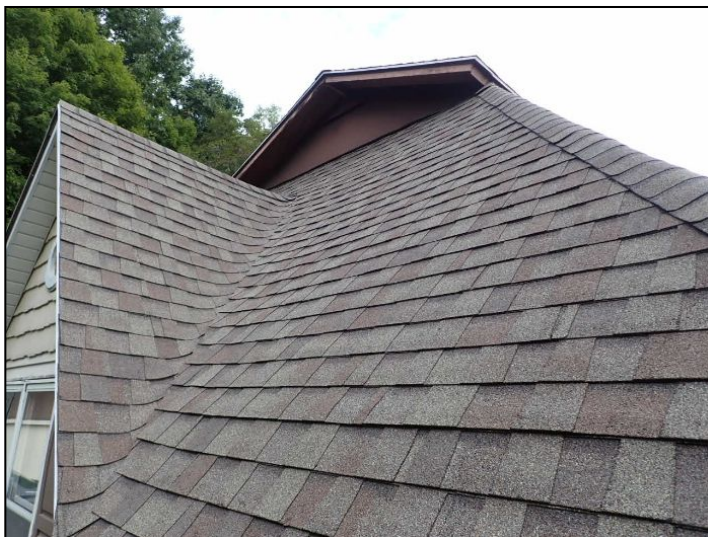
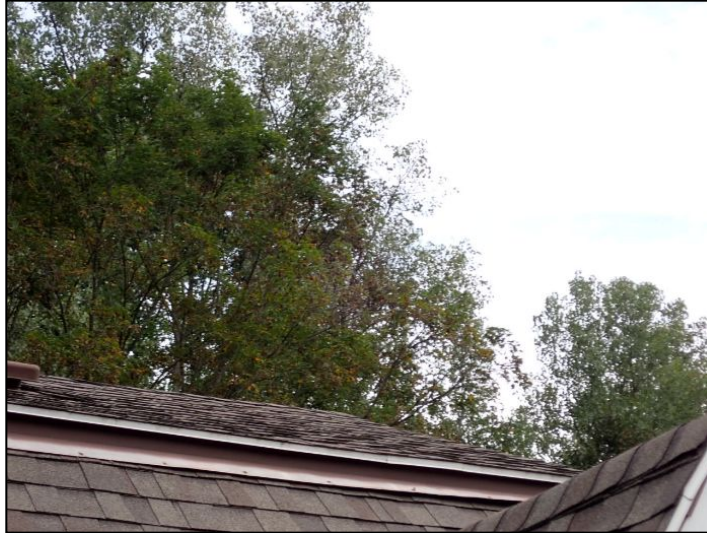
- The pictures show the general roof condition (a visual of what we saw the day of the inspection, if you will), and not necessarily highlighting any issue.
- The roofing was wet at the time of the inspection.

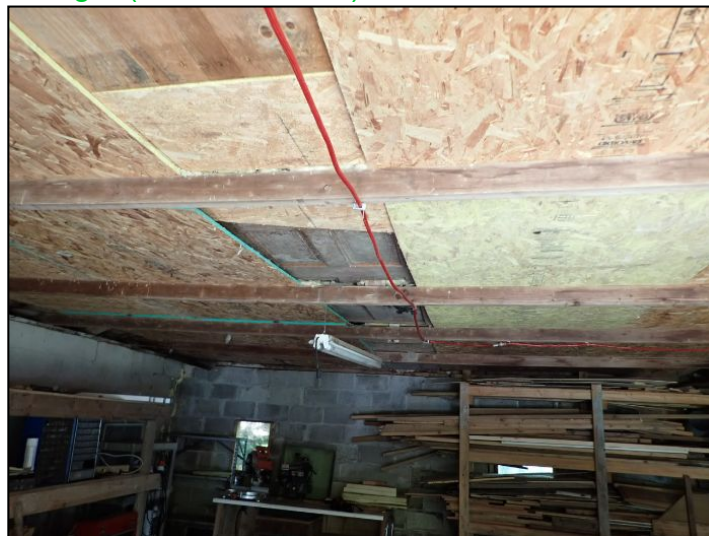
• The garage was in some amount of disrepair. Recommend the garage at least remains water tight (roof, walls, etc.).

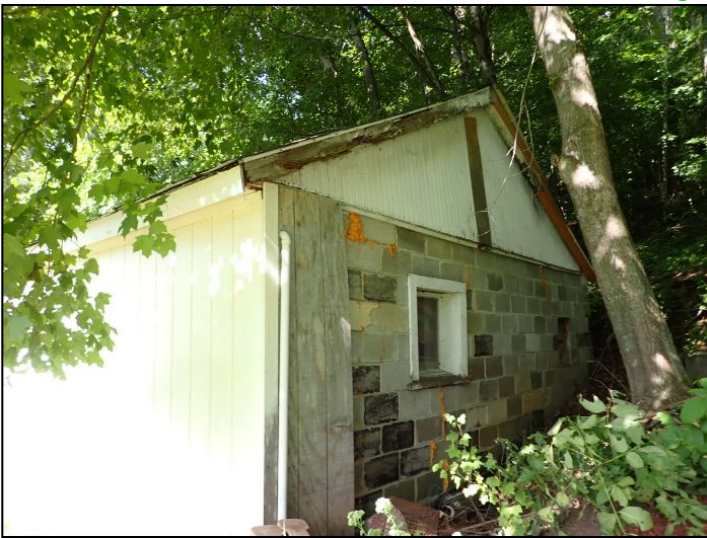
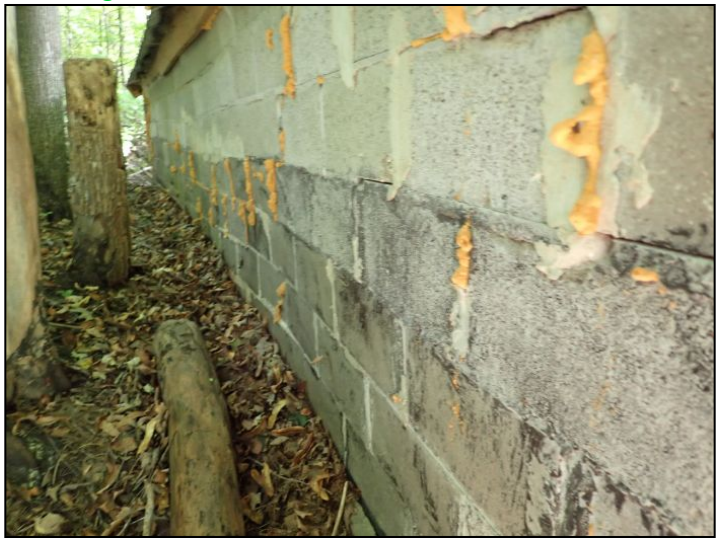
- Recommend tree branches and vegetation are kept trimmed away from the garage. Vegetation can hold excess moisture against the building, possibly causing damage to the sheathing below the siding and/or making a pathway for insects. Tree branches can deposit debris on the roof which can shorten the roof covering life or cause physical damage to the roof. This will be a recurring maintenance item.
- Movement was noted. The amount of movement cannot be determined in a one-time visit. Recommend monitoring for changes or evidence of additional movement.

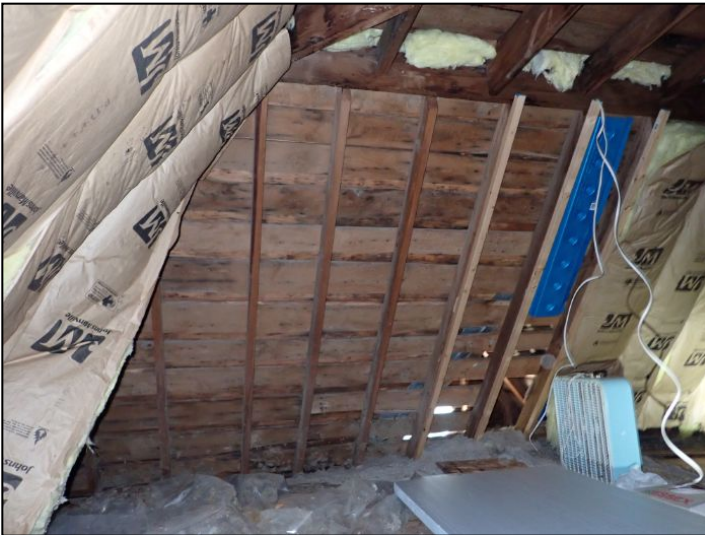
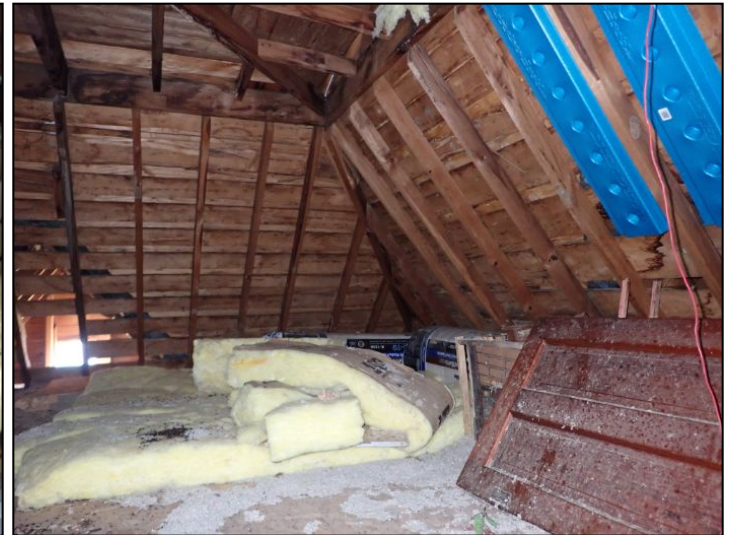
- The pictures show the general condition (a visual of what we saw the day of the inspection, if you will) of the under side of the roofing structure, and not necessarily highlighting any issue.

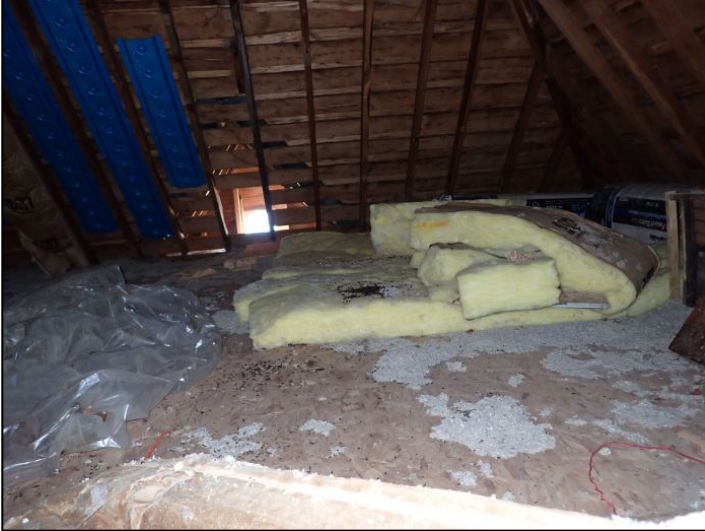
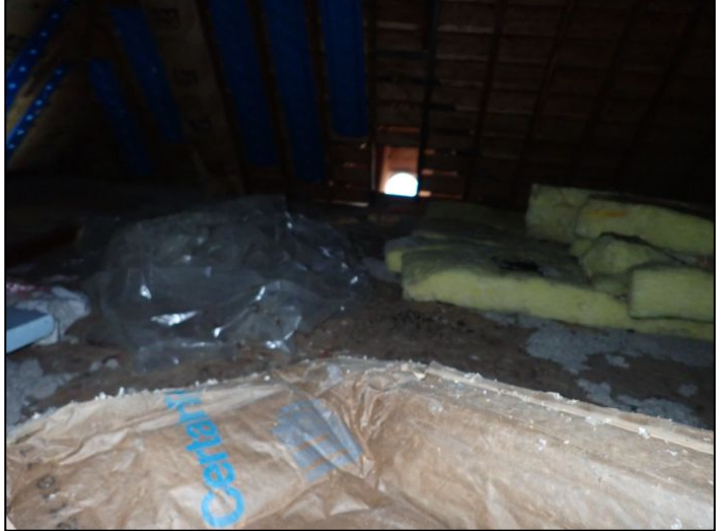
Depth: Insulation averages approximately 6"- 8"

• The pictures show the general condition (a visual of what we saw the day of the inspection, if you will) of the attic insulation, and not necessarily highlighting any issue.

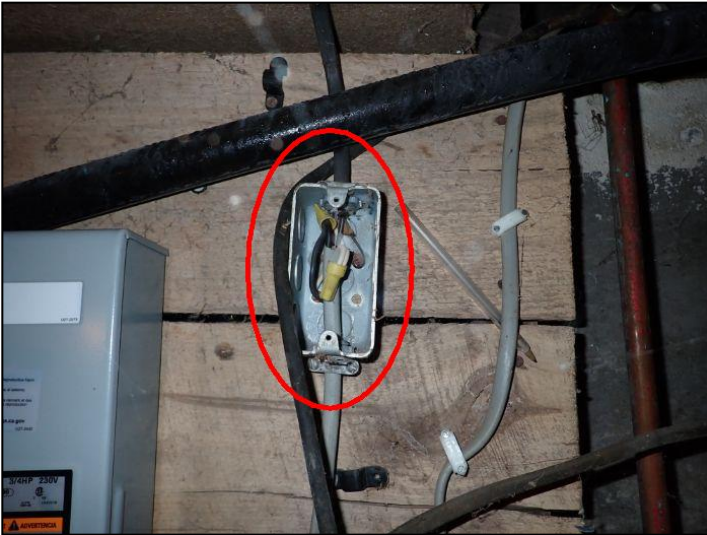
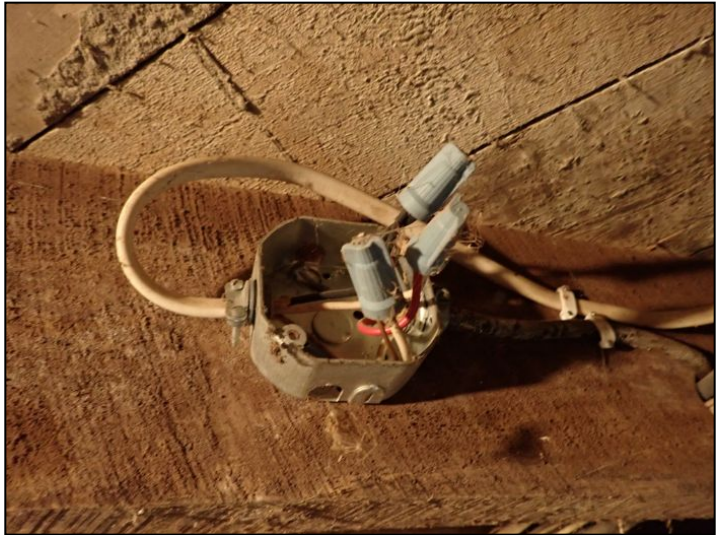
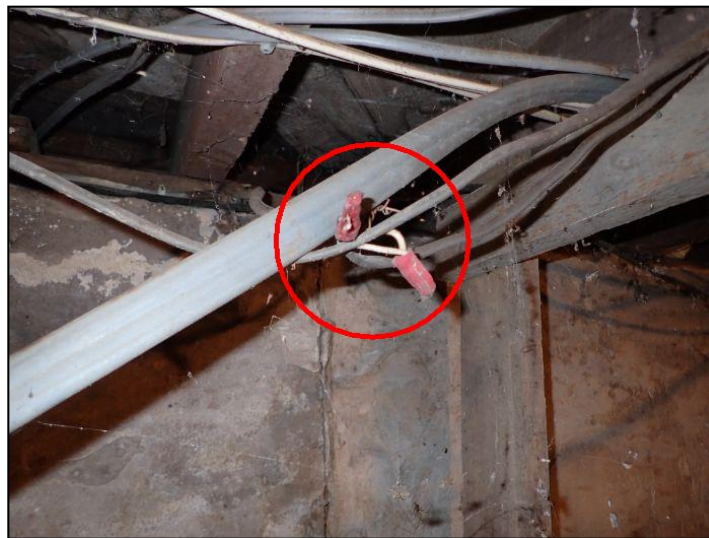
- Any junction boxes should have properly fitted cover plates for added safety.
- Improper electrical connections should be repaired. Recommend a proper junction box with a fitted cover for added safety.

| Roof | | |
|---|---|---|
| Page 16 Item: 7 | Distribution Wiring Observations | <ul style="list-style-type: none"> <li>• Any junction boxes should have properly fitted cover plates for added safety.</li> <li>• Improper electrical connections should be repaired. Recommend a proper junction box with a fitted cover for added safety.</li> </ul> |

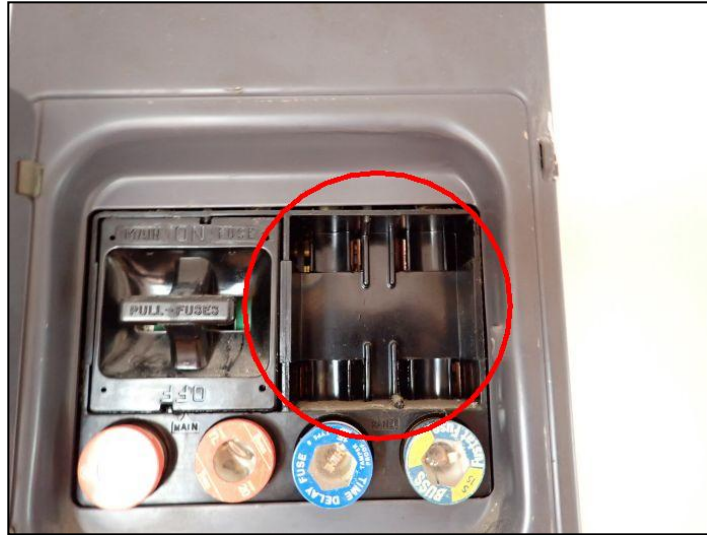
- At least one open fuse block was noted. Recommend a qualified, licensed electrician correct as needed for added safety.

| Roof | | |
|---|---|---|
| Page 18 Item: 11 | Fuse Observations | <ul style="list-style-type: none"> <li>• At least one open fuse block was noted. Recommend a qualified, licensed electrician correct as needed for added safety.</li> </ul> |

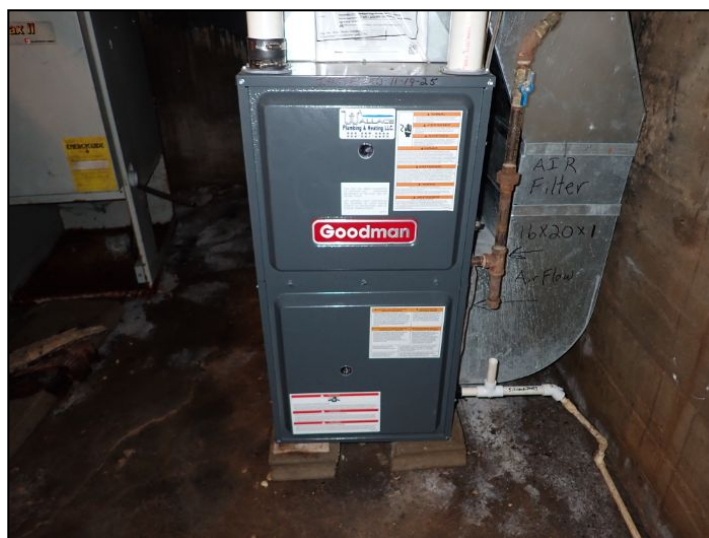
- **Maintenance:** Annual service of the heating system by a qualified HVAC technician is recommended.
- The outside temperature was warmer and heat was not needed, but the furnace was run briefly for the purpose of the inspection and it appeared to run properly during that time.
- If the serial number is being deciphered correctly the furnace was manufactured in 2024 and the recorded installation date was 2025, making it approximately 1 year old.

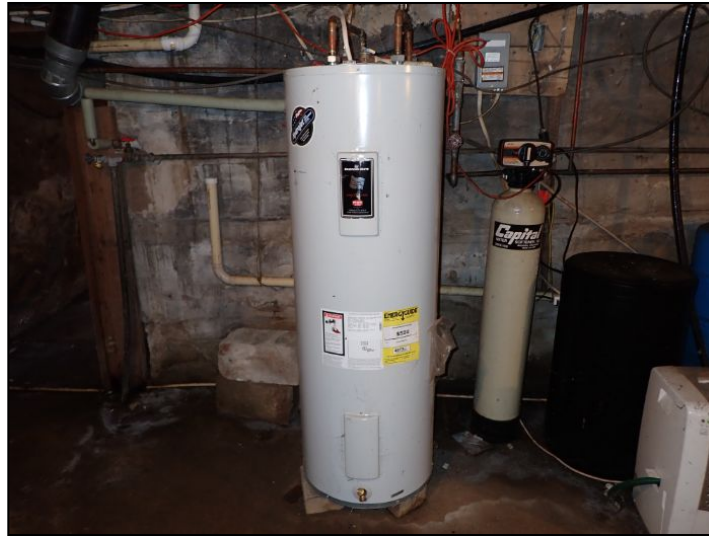
- If the serial number is being deciphered correctly, the water heater was manufactured in 2009, making it approximately 17 years old.

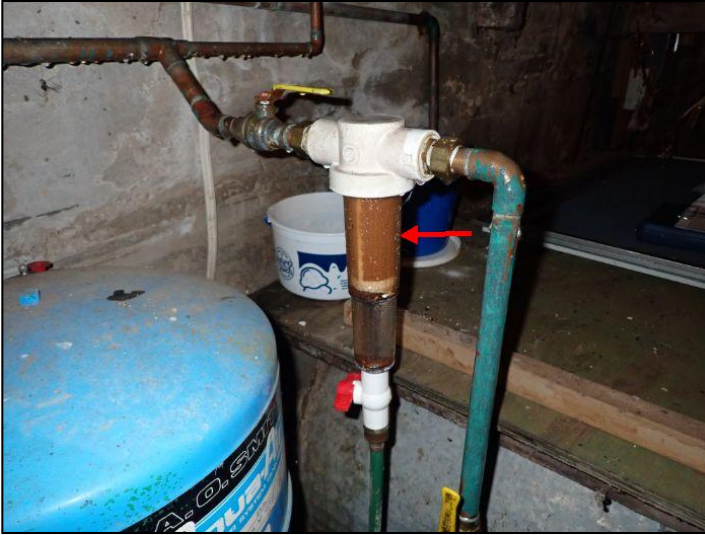
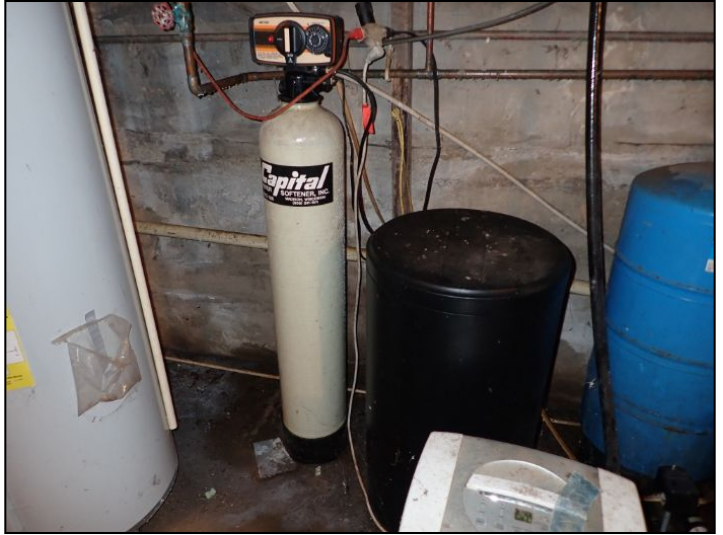
- **Maintenance:** The "spin down" water filter will need flushed periodically. Frequency will vary according to water usage and the amount of sediment in the water system. This type of filter contains a screen which is replaceable, but typically flushing the sediment from the filter is all that is needed.
- Water softeners are not tested as part of a home inspection (see limitations). If the softener has not been turned on and contains proper levels of salt, the unit cannot be accurately tested. Plus, a hardness test would be needed to determine the effectiveness of the softener. Water softeners need salt added occasionally. Frequency depends on water usage and salt type is a personal preference.

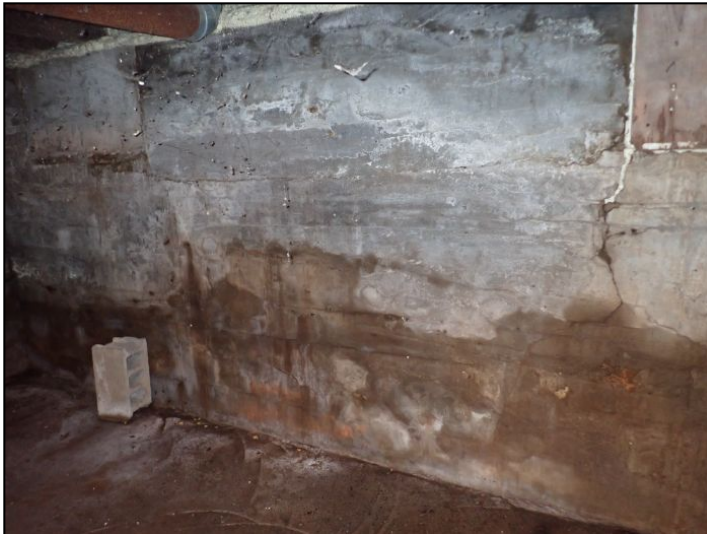
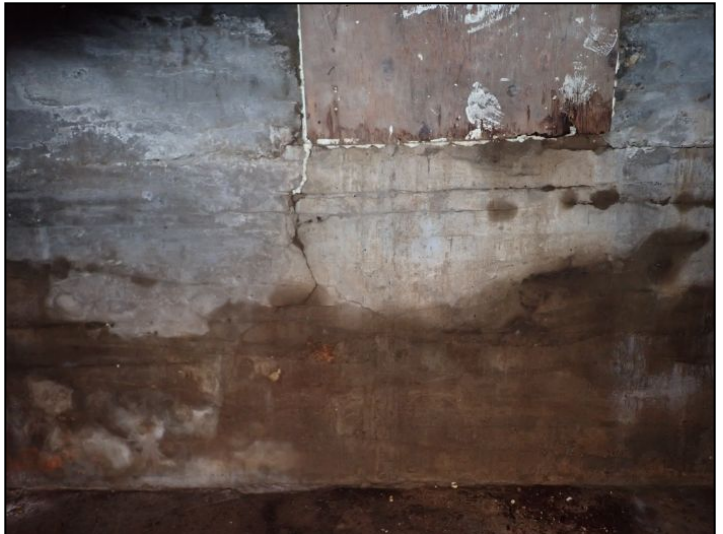
- The basement shows evidence of moisture penetration or seepage. It is not possible to determine the severity in a one-time visit. Further monitoring is recommended. Often, basement seepage is the result of storm water penetration and can be relatively common in an older home. Recommend ensuring proper grading and properly functioning gutters and downspouts exist as a first step. The grading should slope away from the house at a rate of 1 inch per foot for the first 10' (where possible) from the house and the downspouts should direct storm water at least 6' away from the house and should be clear of obstruction.
- Cracking was observed in the foundation walls. Smaller vertical or mostly vertical cracks, especially if less than 1/16", can often be typical. Recommend monitoring for any signs of additional movement or seepage.

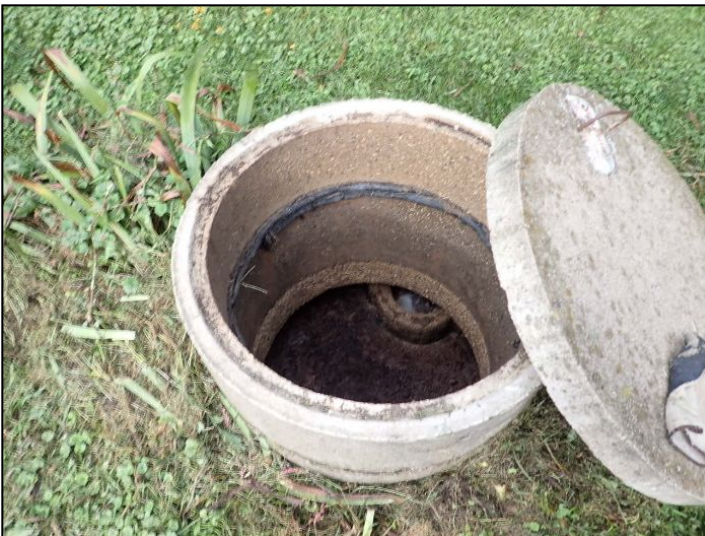
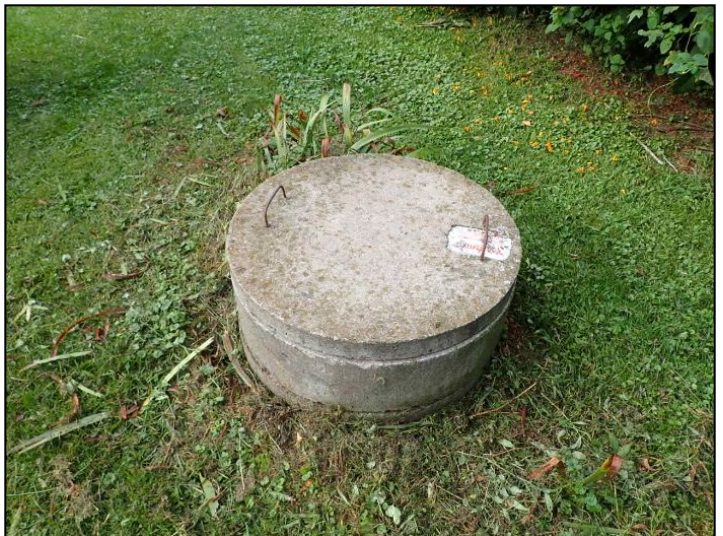
- Septic tank visibility was limited during the inspection, but the liquid (effluent) level was proper and the baffle was in place at the time of the inspection.
- The State of Wisconsin states that when the solids level within the septic tank reaches 1/3 of the effluent (liquid) level, the tank needs to be pumped. A common effluent level is 3', so simple math shows that once there is 1' of solids (in this example), the tank needs pumped. During the inspection the measured solids level was approximately 1/9th.
- The exposed septic tank lids need chains on each side, going through the handles and meeting in the middle with a lock joining the chains.

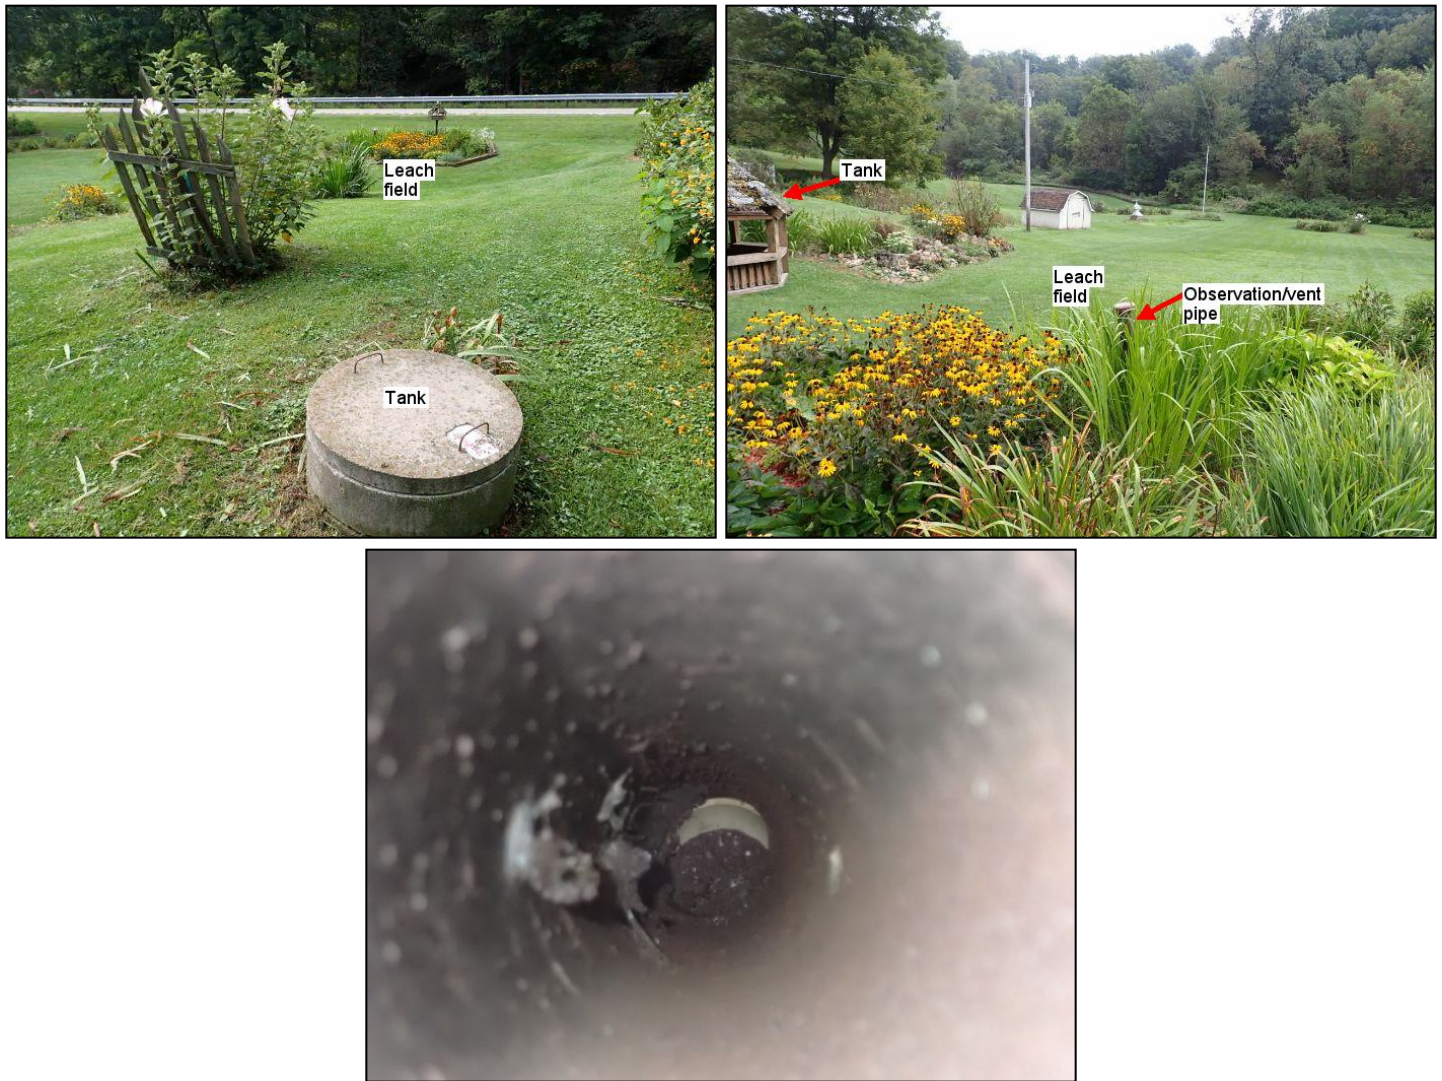
- County Zoning was contacted with a request for the original septic paperwork. The paperwork usually consists of all or part of the following: The original sanitary permit, Zoning inspection report from the day of installation and the system design. Zoning reported that no papers were on file and it is an "unknown" or "pre-1969" system.
- Recommend continuing to mow the leach field regularly during the growing season.
- The observation/vent pipe in the leach field was dry at the time of the inspection.
