## UNATTACHED GARAGE

## 6: GARAGE

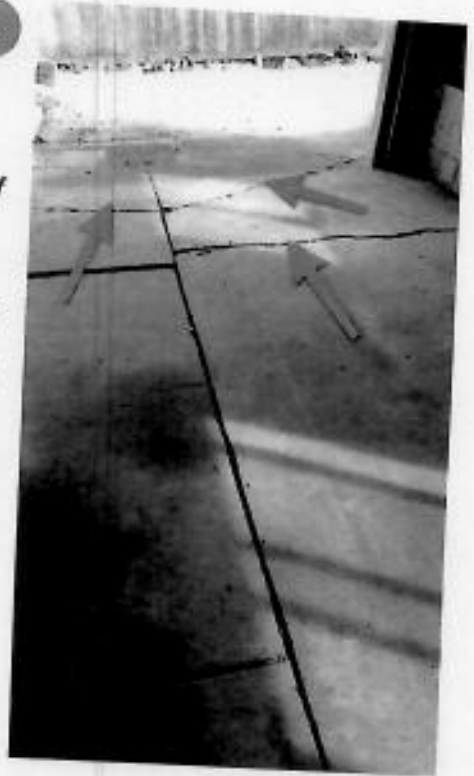
## 6.4.1 Floor

**HEAVING / SETTLING / CRACKING**

Significant Defects

The garage floor showed signs of heaving. It was not level or flat. Control joints showed major cracking. This condition appeared to be the result of expansive soil beneath the slab. Expansive soils are those that expand to many times their original volume with increases in soil content. If expansive soils are the cause of this heaving, it may continue in the future. The poured concrete garage floor was structurally isolated from the home foundation. Heaving of the floor slab will not affect the structural integrity of the foundation. It is possible that the same forces that damaged the slab may damage the foundation. The inspector recommends evaluation by a structural engineer to determine the degree to which this condition is likely to continue and to discuss options for correction or stabilization.

Contact a qualified concrete contractor.

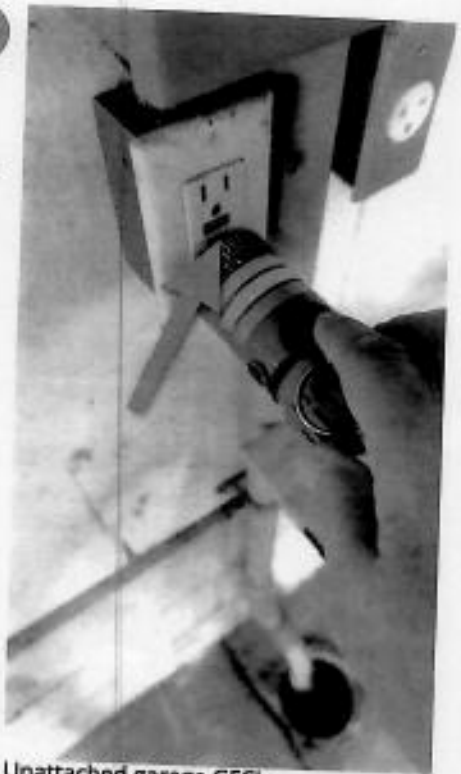
Unattached garage GFCI

**INTERMITTENT / DAMAGED / NOT WORKING / MISSING / LOOSE OUTLET (GFCI)**

Significant Defects

A GFCI (Ground Fault Circuit Interrupter) outlet in the garage is not functioning properly—it may be intermittently tripping, showing visible damage, or failing to provide power. GFCI outlets are critical safety devices designed to prevent electrical shock in wet or damp environments. A malfunctioning GFCI should be tested and repaired or replaced promptly to restore proper electrical protection.

Contact a qualified electrical contractor.

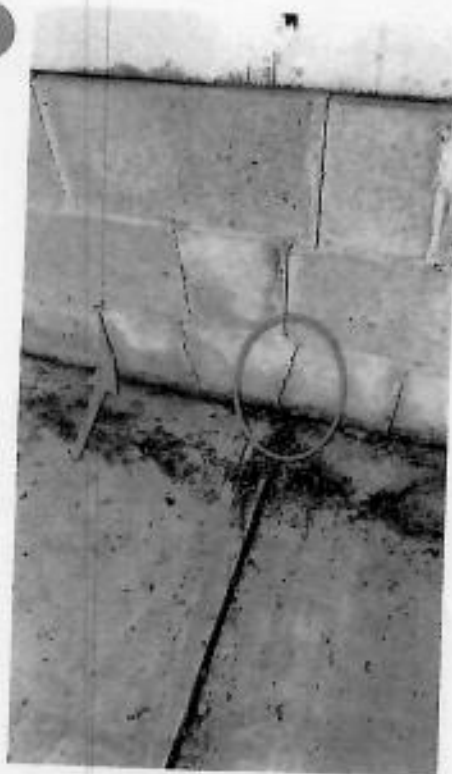
## 6.12.1 Foundation

**FOUNDATION BLOCK CRACKS**

Inspector noticed open mortar joints and cracking of the foundation block. These blocks should be repaired by qualified contractor.

Significant Defects

Contact a qualified professional.

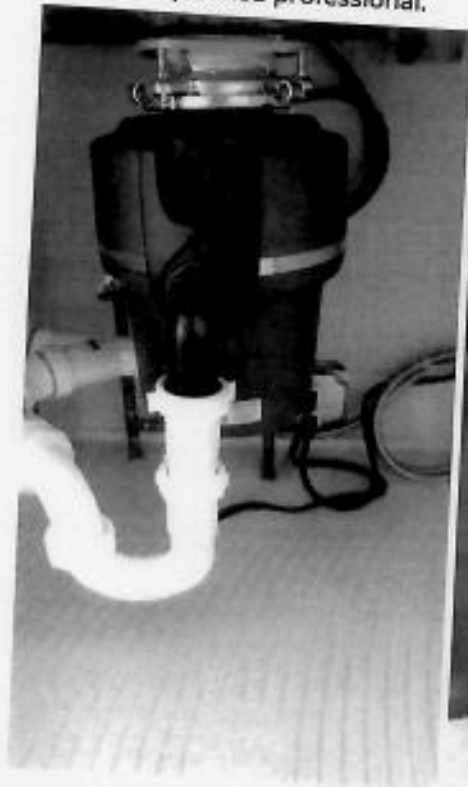
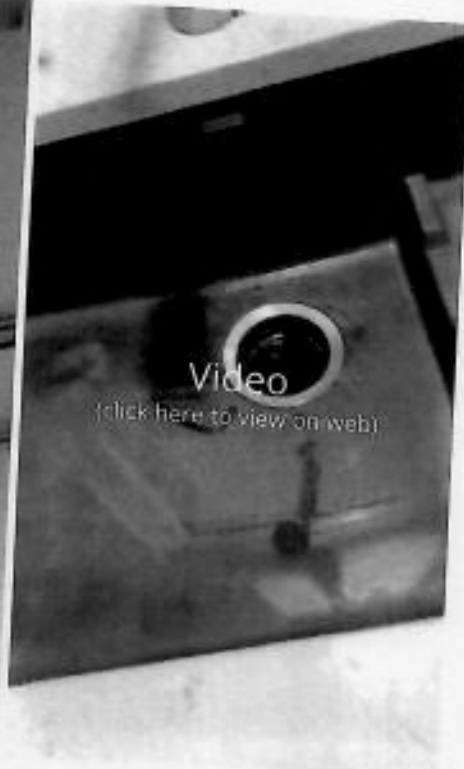
## 8.11.1 Garbage Disposal

**EXCESSIVE NOISE**

We observed that there was excessive noise coming from the garbage disposal when it was operating.  
 Could be bad bearings, But should be possibly replaced by qualified contractor.

Significant Defects

Contact a qualified professional.

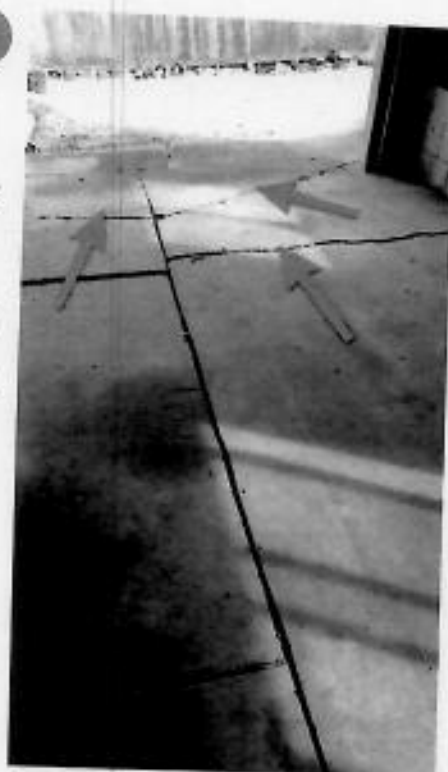
## 6.4.1 Floor

**HEAVING / SETTLING / CRACKING**

Significant Defects

The garage floor showed signs of heaving. It was not level or flat. Control joints showed major cracking. This condition appeared to be the result of expansive soil beneath the slab. Expansive soils are those that expand to many times their original volume with increases in soil content. If expansive soils are the cause of this heaving, it may continue in the future. The poured concrete garage floor was structurally isolated from the home foundation. Heaving of the floor slab will not affect the structural integrity of the foundation. It is possible that the same forces that damaged the slab may damage the foundation. The Inspector recommends evaluation by a structural engineer to determine the degree to which this condition is likely to continue and to discuss options for correction or stabilization.

Contact a qualified concrete contractor.

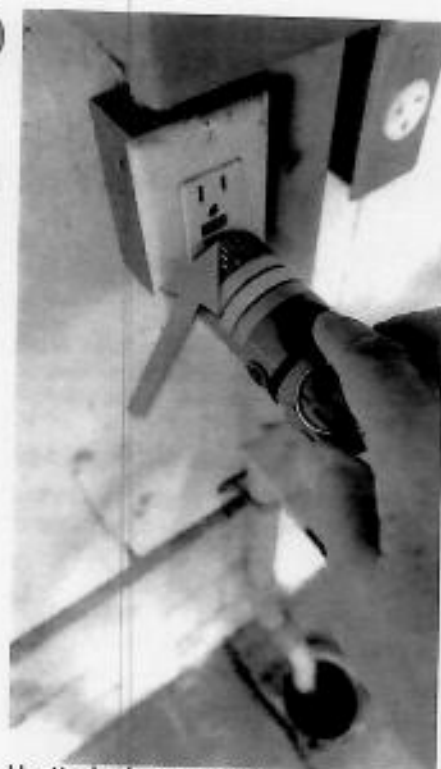
Unattached garage GFCI

**INTERMITTENT / DAMAGED / NOT WORKING / MISSING / LOOSE OUTLET (GFCI)**

Significant Defects

A GFCI (Ground Fault Circuit Interrupter) outlet in the garage is not functioning properly—it may be intermittently tripping, showing visible damage, or failing to provide power. GFCI outlets are critical safety devices designed to prevent electrical shock in wet or damp environments. A malfunctioning GFCI should be tested and repaired or replaced promptly to restore proper electrical protection.

Contact a qualified electrical contractor.

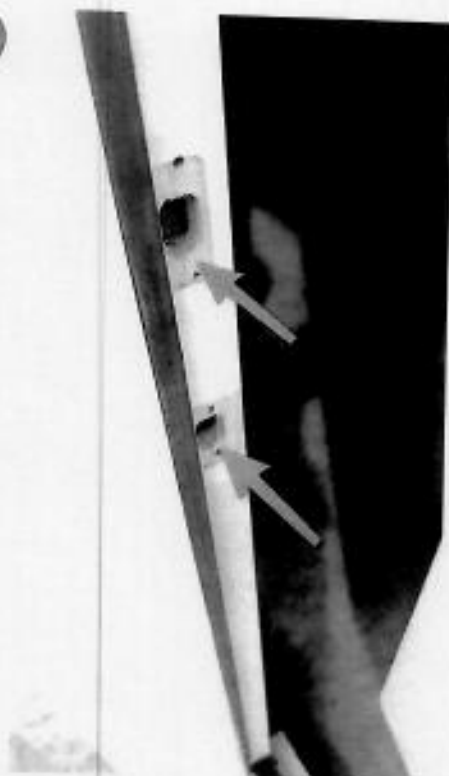
6.9.1 Side Door to  
Exterior

Minor Defects, Maintenance Item, or FYI Item**NO DOOR HARDWARE INSTALLED.**

**At time of inspection, there was no door closure hardware installed.** *Inspector recommends this be done before owner takes occupancy.*

Contact a qualified carpenter.
