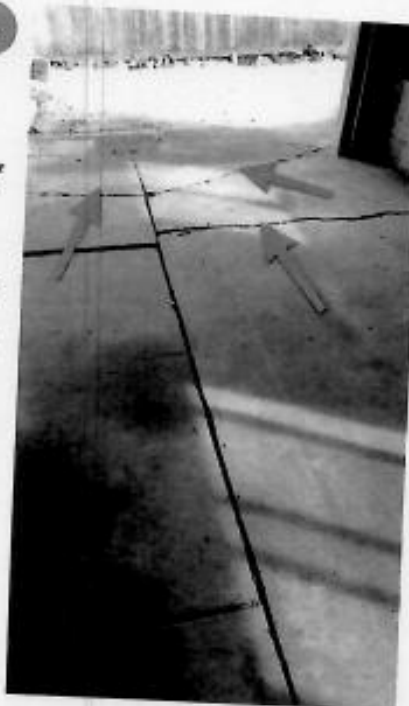
## 6.4.1 Floor

**HEAVING / SETTLING / CRACKING**

Significant Defects

**The garage floor showed signs of heaving. It was not level or flat. Control joints showed major cracking. This condition appeared to be the result of expansive soil beneath the slab. Expansive soils are those that expand to many times their original volume with increases in soil content. If expansive soils are the cause of this heaving, it may continue in the future. The poured concrete garage floor was structurally isolated from the home foundation. Heaving of the floor slab will not affect the structural integrity of the foundation. It is possible that the same forces that damaged the slab may damage the foundation. The inspector recommends evaluation by a structural engineer to determine the degree to which this condition is likely to continue and to discuss options for correction or stabilization.**

Contact a qualified concrete contractor.

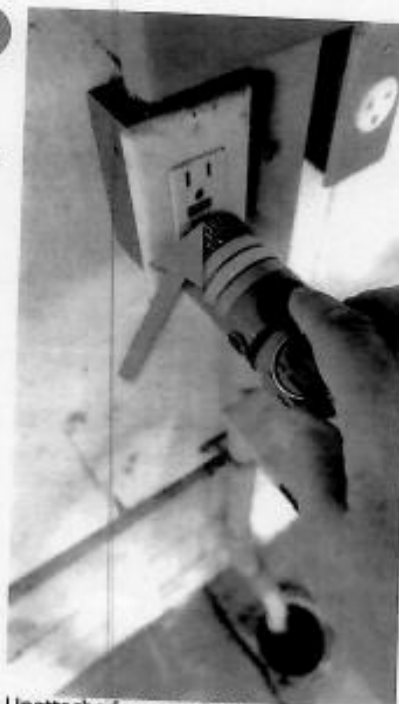
## 6.5.1 Lighting Fixtures, Switches &amp; Receptacles

**INTERMITTENT / DAMAGED / NOT WORKING / MISSING / LOOSE OUTLET (GFCI)**

Significant Defects

**A GFCI (Ground Fault Circuit Interrupter) outlet in the garage is not functioning properly—it may be intermittently tripping, showing visible damage, or failing to provide power. GFCI outlets are critical safety devices designed to prevent electrical shock in wet or damp environments. A malfunctioning GFCI should be tested and repaired or replaced promptly to restore proper electrical protection.**

Unattached garage GFCI

Contact a qualified electrical contractor.

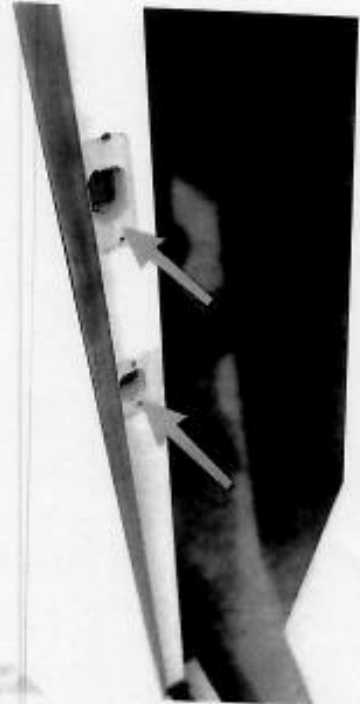
6.9.1 Side Door to  
Exterior

**NO DOOR HARDWARE INSTALLED.**

SEPARATE GARAGE SIDE DOOR

**At time of inspection, there was no door closure hardware installed.** *Inspector recommends this be done before owner takes occupancy.*

Contact a qualified carpenter.

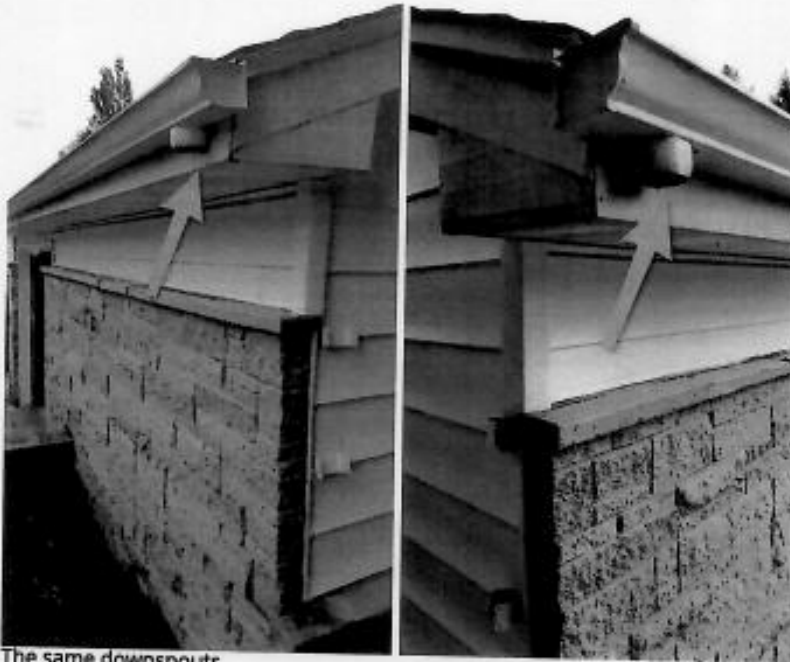
6.11.1 Gutters

**LOOSE / DAMAGED / MISSING GUTTERS.**

**Gutters with loose sections, visible damage, or missing pieces were observed during inspection.** *Damaged gutters cannot properly channel water away from the home's foundation and exterior walls. This can lead to water infiltration, foundation damage, and accelerated deterioration of siding and landscaping. A gutter contractor should evaluate and repair or replace affected sections to restore proper water drainage.*

The same downspouts

Contact a qualified gutter contractor

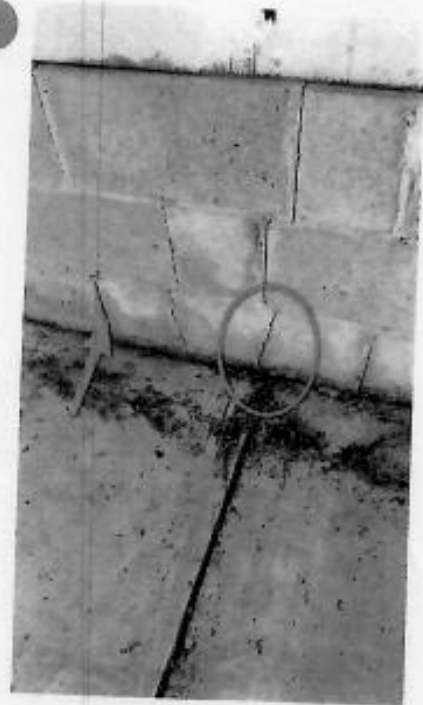
## 6.12.1 Foundation

**FOUNDATION BLOCK CRACKS**

## SEPARATE GARAGE

Inspector noticed open mortar joints and cracking of the foundation block. These blocks should be repaired by qualified contractor.

Significant Defects

Contact a qualified professional.

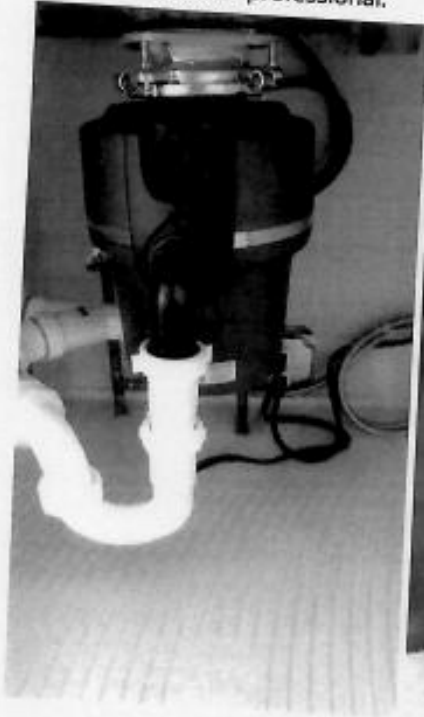
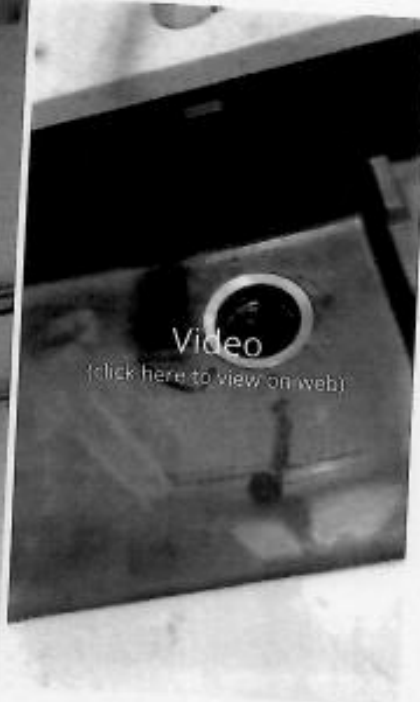
## 8.11.1 Garbage Disposal

**EXCESSIVE NOISE**

We observed that there was excessive noise coming from the garbage disposal when it was operating. Could be bad bearings, But should be possibly replaced by qualified contractor.

Significant Defects

Contact a qualified professional.

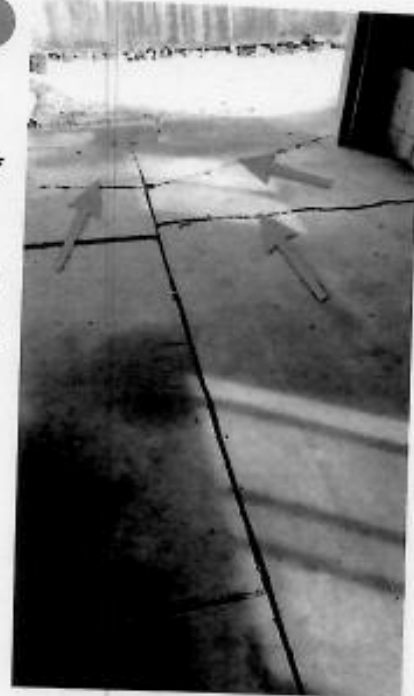
## 6.4.1 Floor

**HEAVING / SETTLING / CRACKING**

Significant Defects

The garage floor showed signs of heaving. It was not level or flat. Control joints showed major cracking. This condition appeared to be the result of expansive soil beneath the slab. Expansive soils are those that expand to many times their original volume with increases in soil content. If expansive soils are the cause of this heaving, it may continue in the future. The poured concrete garage floor was structurally isolated from the home foundation. Heaving of the floor slab will not affect the structural integrity of the foundation. It is possible that the same forces that damaged the slab may damage the foundation. The inspector recommends evaluation by a structural engineer to determine the degree to which this condition is likely to continue and to discuss options for correction or stabilization.

Contact a qualified concrete contractor.

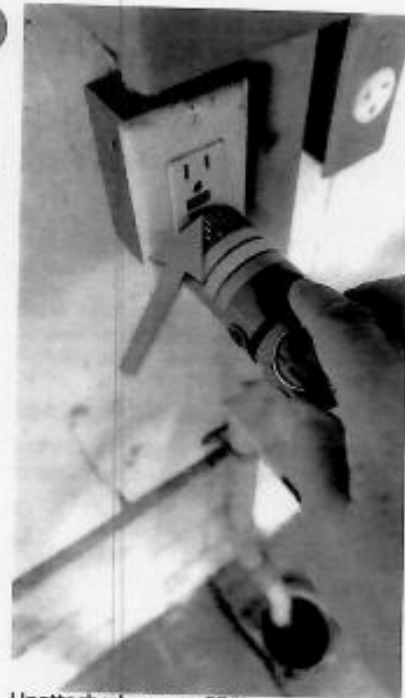
## 6.5.1 Lighting Fixtures, Switches &amp; Receptacles

**INTERMITTENT / DAMAGED / NOT WORKING / MISSING / LOOSE OUTLET (GFCI)**

Significant Defects

A GFCI (Ground Fault Circuit Interrupter) outlet in the garage is not functioning properly—it may be intermittently tripping, showing visible damage, or failing to provide power. GFCI outlets are critical safety devices designed to prevent electrical shock in wet or damp environments. A malfunctioning GFCI should be tested and repaired or replaced promptly to restore proper electrical protection.

Unattached garage GFCI

Contact a qualified electrical contractor.

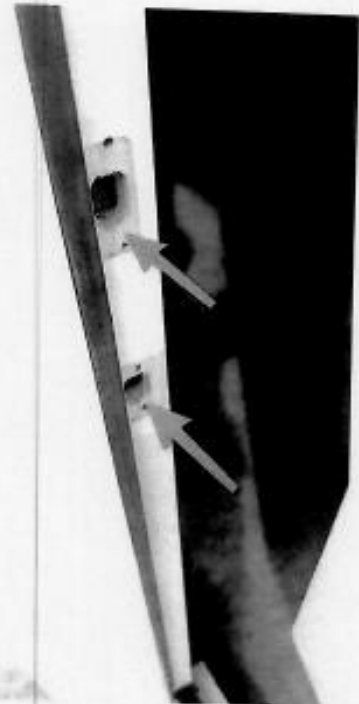
6.9.1 Side Door to  
Exterior

**NO DOOR HARDWARE INSTALLED.**

SEPARATE GARAGE SIDE DOOR

**At time of inspection, there was no door closure hardware installed.** *Inspector recommends this be done before owner takes occupancy.*

Contact a qualified carpenter.
