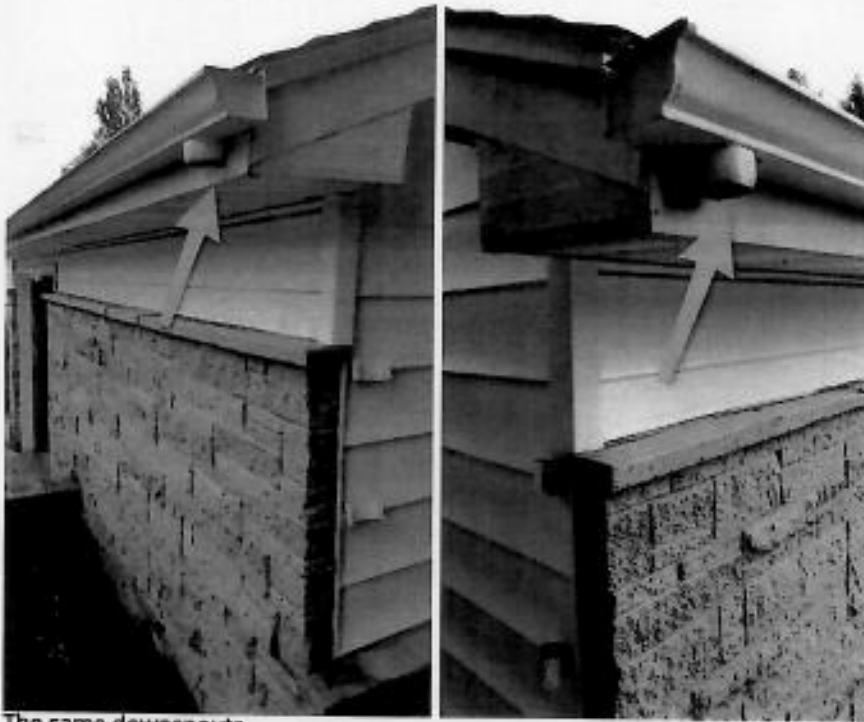
GARAGE

**Gutters with loose sections, visible damage, or missing pieces were observed during inspection.** *Damaged gutters cannot properly channel water away from the home's foundation and exterior walls. This can lead to water infiltration, foundation damage, and accelerated deterioration of siding and landscaping. A gutter contractor should evaluate and repair or replace affected sections to restore proper water drainage.*

The same downspouts

Contact a qualified gutter contractor

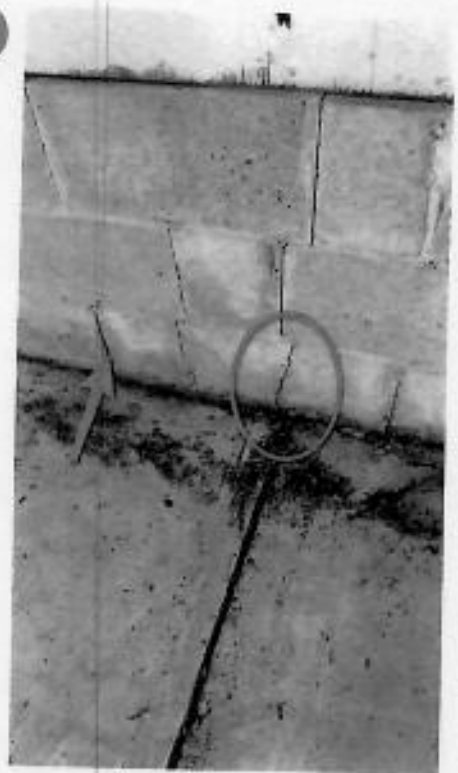
## SEPARATE GARAGE

Inspector noticed open mortar joints and cracking of the foundation block. These blocks should be repaired by qualified contractor.

Contact a qualified professional.

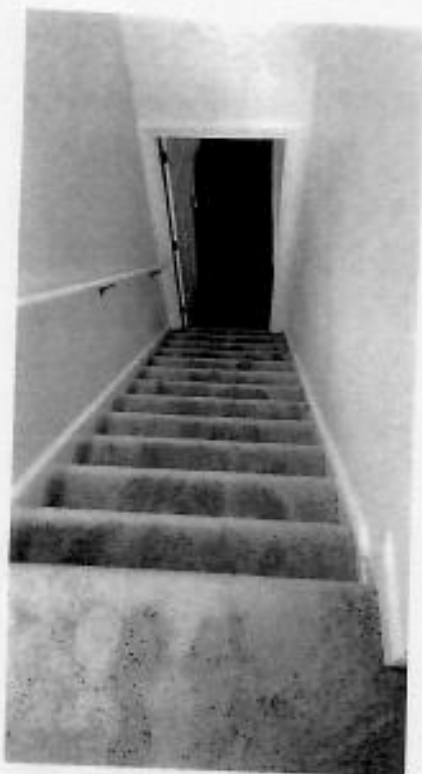
**Attic Structure / Access:** Roof and  
ceiling framing

Rafters/ceiling joists, Finished Attic

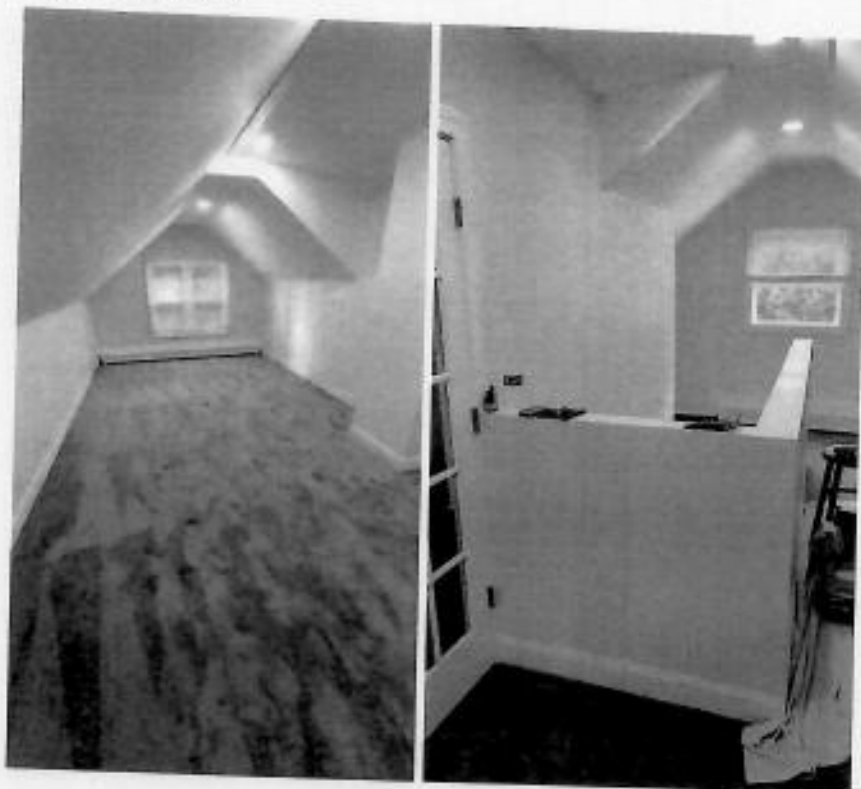
### Attic Structure / Access: Attic Access Performed

By entering attic

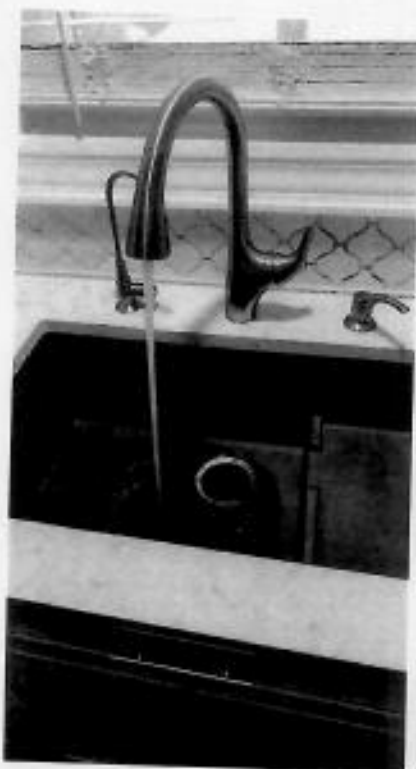
**Plumbing & Fixtures: Kitchen**  
Sprayer

**Kitchen sprayer was tested at**  
time of inspection.

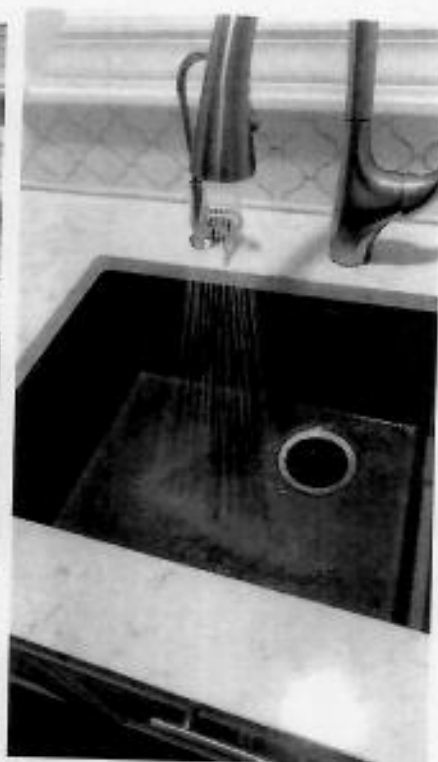
**Countertops and Cabinets:**  
Inspected Cabinets and  
Countertops

We inspected a representative  
number of cabinets and  
countertop surfaces.

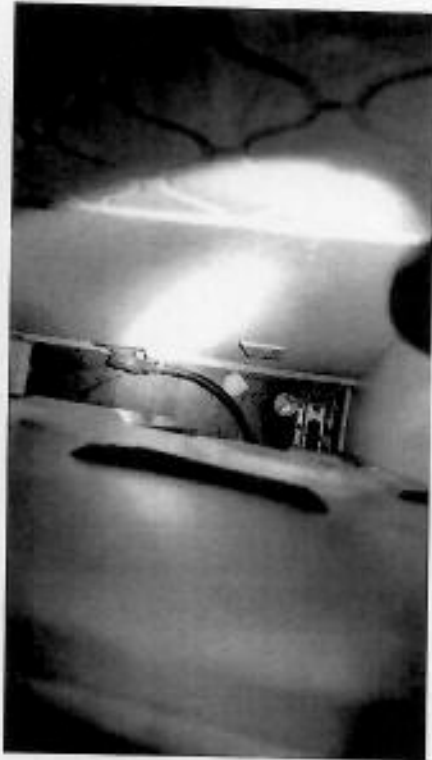
**Garbage Disposal: Turned on  
Garbage Disposal**

We turned on the garbage  
disposal.

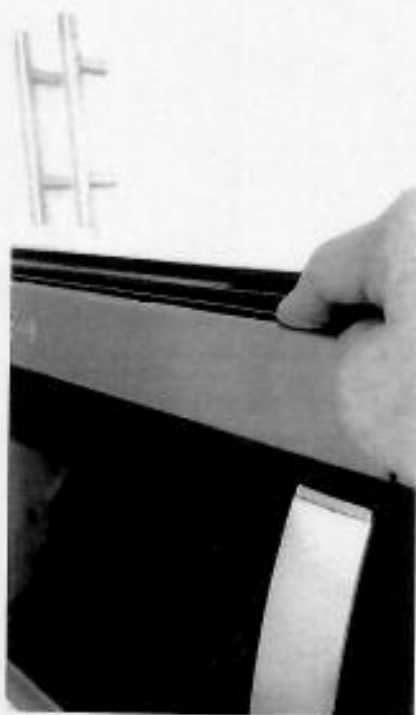
**Exhaust Fan: Recirculating Venting**

**Kitchen had recirculating venting through the microwave. No problems with the recirculation at time of inspection.**

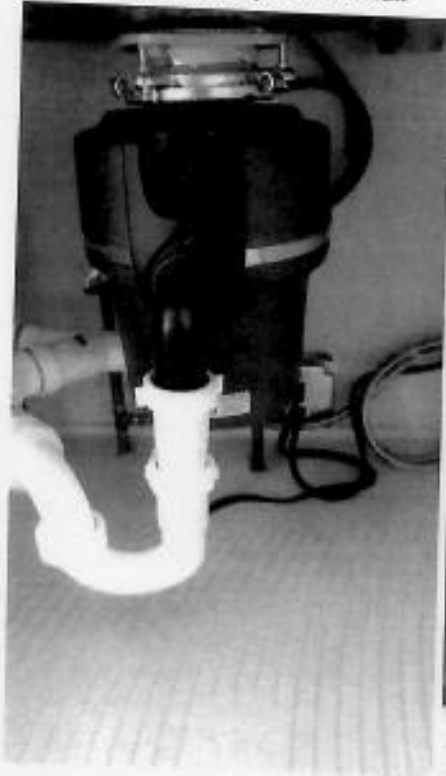
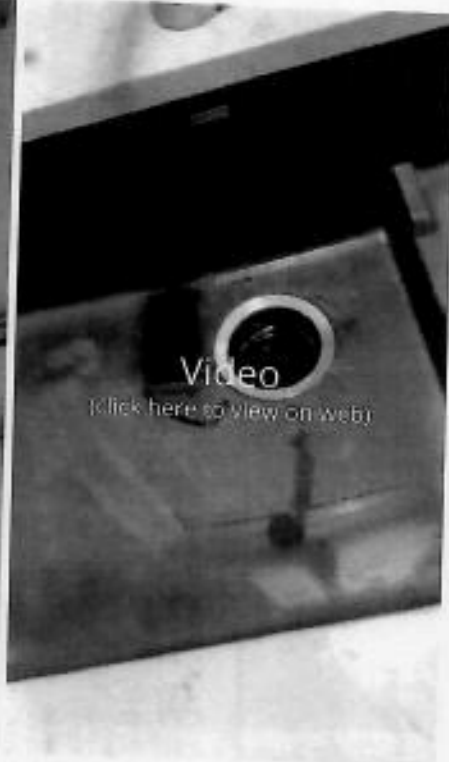
## GARBAGE DISPOSAL

**EXCESSIVE NOISE**

**We observed that there was excessive noise coming from the garbage disposal when it was operating. Could be bad bearings, But should be possibly replaced by qualified contractor.**

Contact a qualified professional.

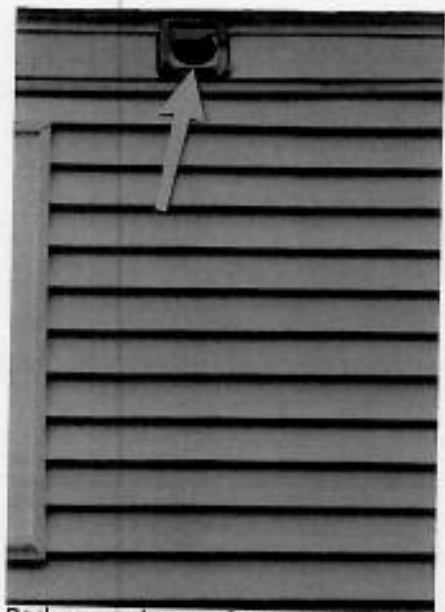
##### EXTERIOR BATH FAN TERMINATION

#### DAMAGED EXTERIOR TERMINATION

Exterior bath fan termination was damaged. Repair replaced by qualified contractor.

Back upper damage fan termination

Contact a qualified carpenter.

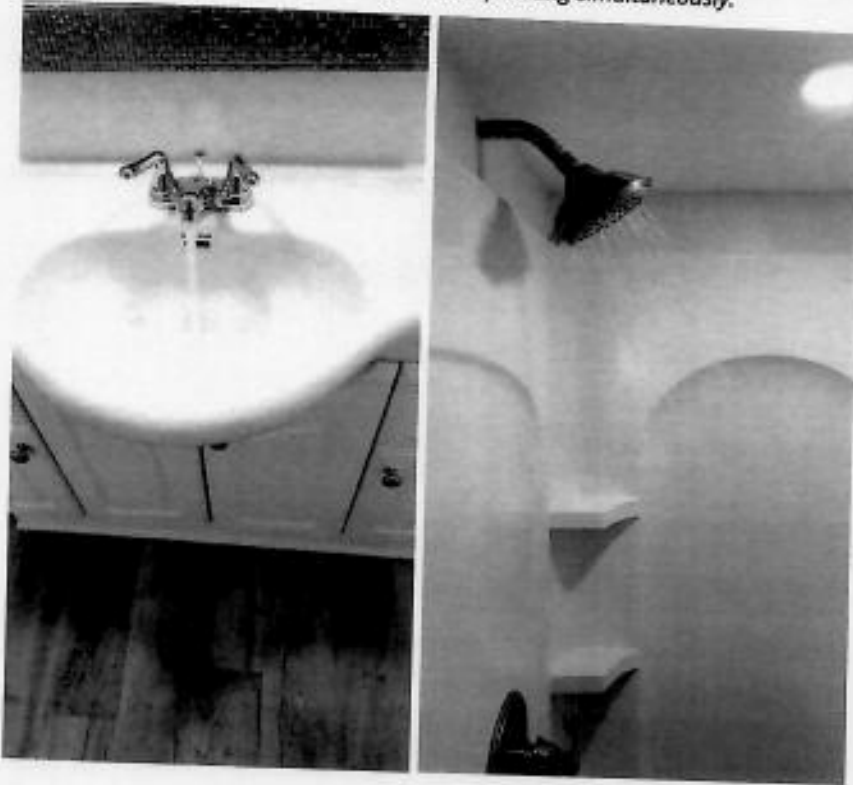
### **Sinks/Tubs/Showers: Ran Water at Sinks, Tubs & Showers**

**Inspector ran water at all bathroom sinks, bathtubs and showers. We inspected for deficiencies in the water supply by viewing the functional flow in two fixtures operating simultaneously.**

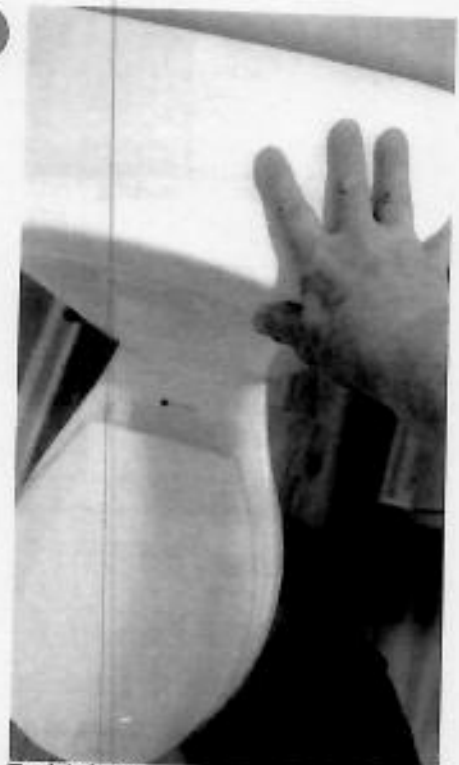
## BASEMENT BATHROOM TOILET

**LOOSE TOILET/TANK**

**Toilet tank was loose at time of inspection.** *Recommend qualified contractor do whatever it takes to fix.*

Tank is loose

Contact a handyman or DIY project

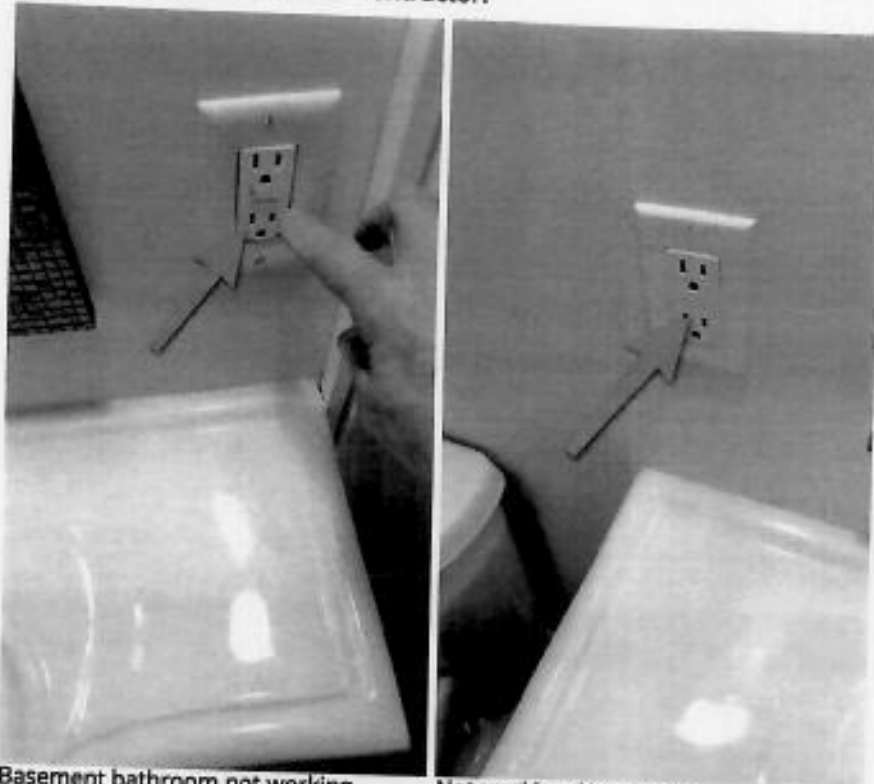
**GFCI IMPROPERLY WIRED / NOT WORKING**

**We observed a defect at the GFCI in the bathroom. It was not properly wired. We suggest the issue be evaluated and repaired or replaced by a qualified contractor.**

Basement bathroom not working

Not working. No power

Contact a qualified electrical contractor.

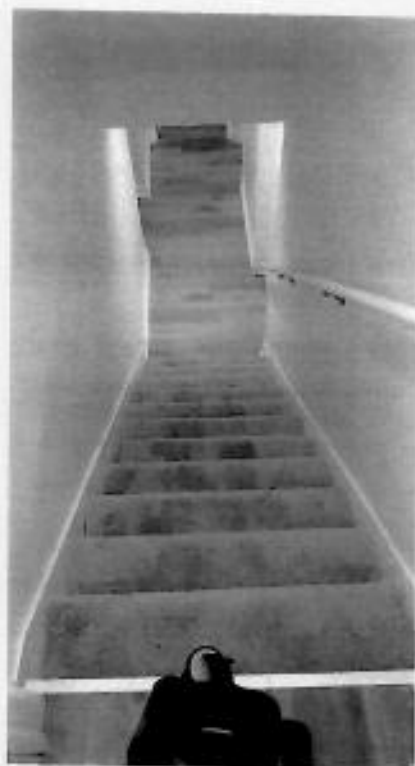
**Steps, Stairways & Railings: Basement Steps and Railings**

**At the time of the inspection the steps, stairways, and railings did not show any defects.** They appear to be installed and functioning properly. Notable exceptions will be listed in the report.

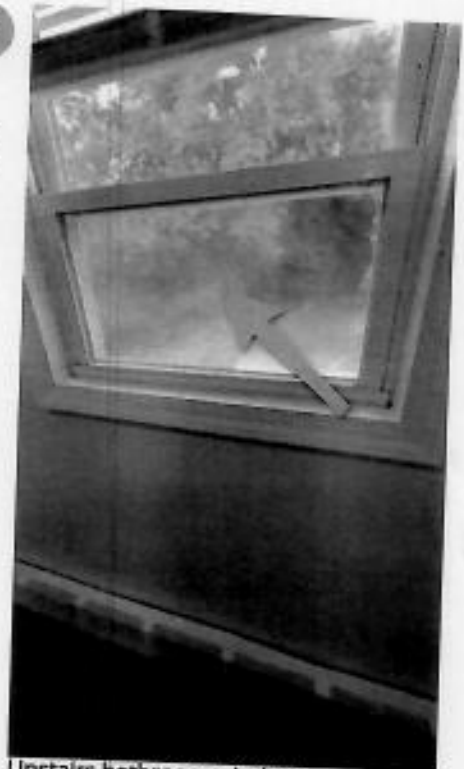
##### UPSTAIRS BEDROOM

#### FAILED SEAL

**Observed condensation between the window panes, which indicates a failed seal.** Recommend qualified window contractor evaluate & replace.

Upstairs bathroom window
