## RESIDENTIAL REPORT

607 W Decorah Rd  
West Bend, WI 53095

09/08/2026

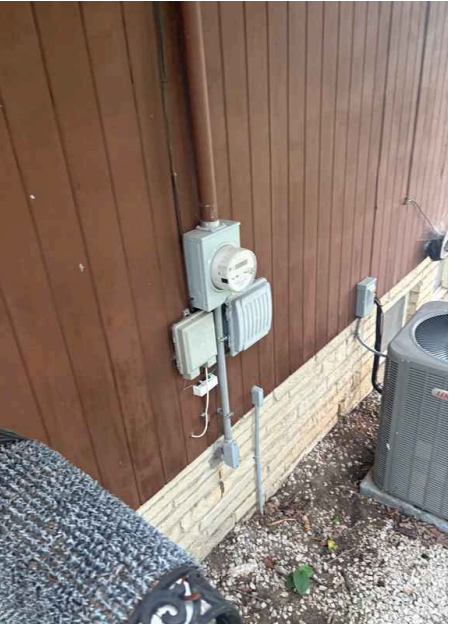
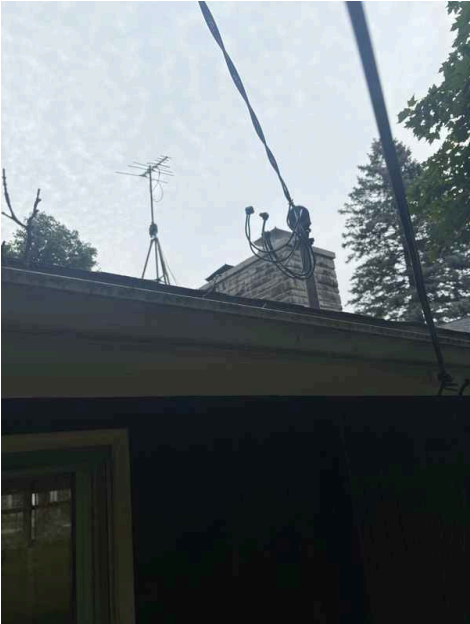
| <b>Electric Meter / Electric Service Entrance: General</b><br>Photo(s) | | |

| <b>Electric Meter / Electric Service Entrance: Type</b><br>Overhead | <b>Electric Meter / Electric Service Entrance: Condition</b><br>Satisfactory | <b>Wiring: Condition</b><br>Recommend Evaluation/Repair |

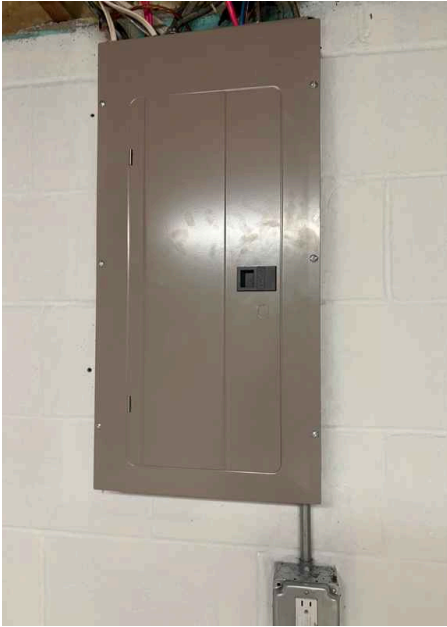
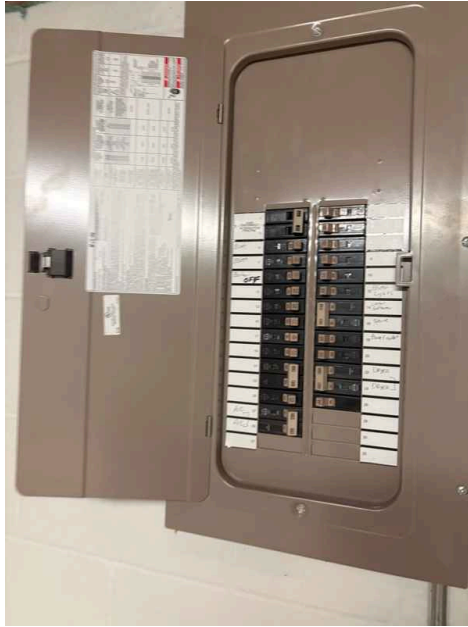
**Main Electric Panel: General**  
Photo(s)

| <b>Main Electric Panel: Main Wires</b><br>Metal type not visible. Covered by wire insulation and breaker housing. | <b>Main Electric Panel: Branch Wires</b><br>Copper | <b>Main Electric Panel: Panel Condition</b><br>Recommend Evaluation/Repair By Qualified Electrician |

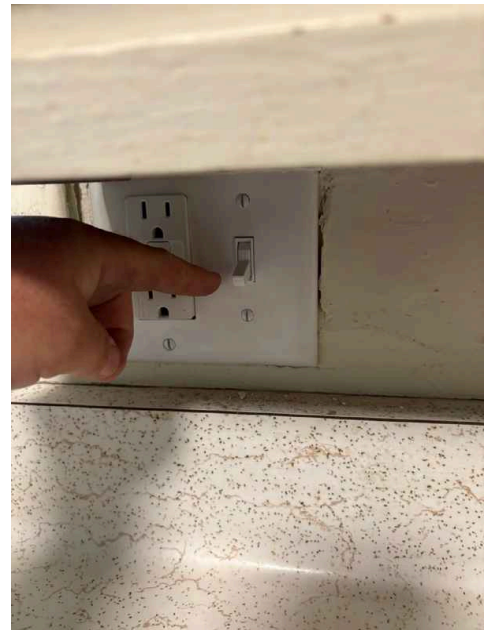
Kitchen

One or more light(s)/switch(es) were not working at time of inspection. Recommend replacing bulb(s). If light(s) are still not working properly, recommend evaluation/repair by qualified electrician.

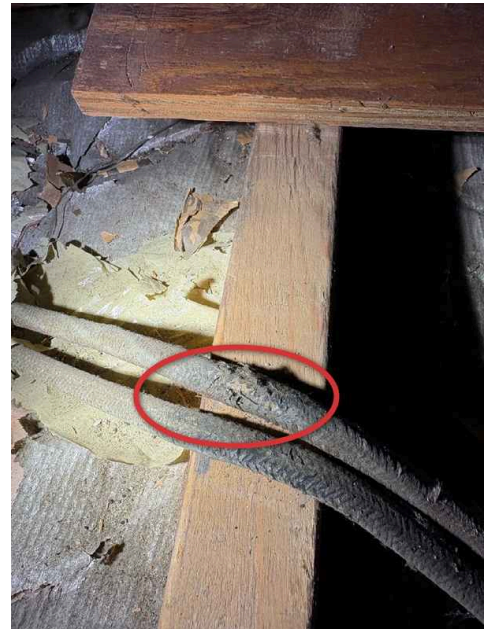
## 2.2.2 Wiring

**CLOTH WIRING, SHEET HUNG  
DETERIORATING**

Some of the cloth wiring was observed to have sheathing that had deteriorated recommend evaluation repaired by qualified contractor.

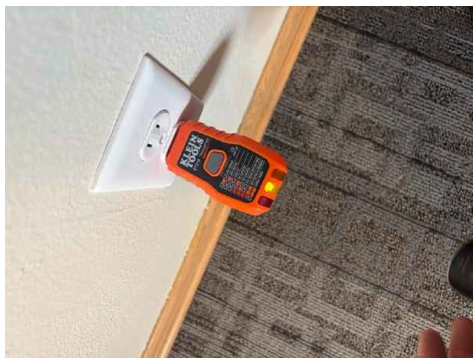
Bedroom 1

Ungrounded 3-prong electrical receptacle(s) were observed throughout the home. Only a sampling of electrical receptacles were tested. Recommend evaluation/repair by qualified electrician.

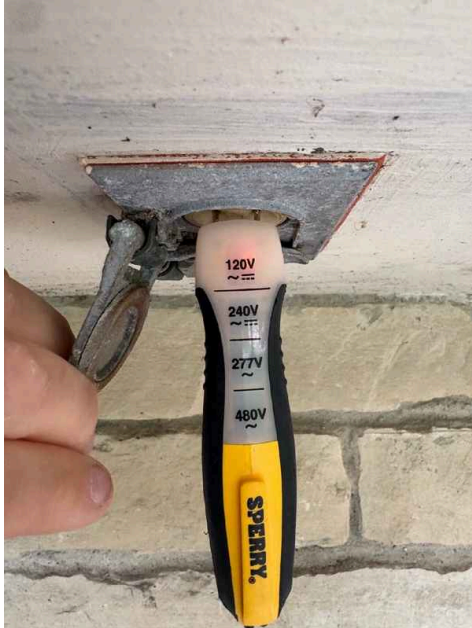
Exterior

**GFCI PROTECTION NOT PRESENT IN RECOMMEND LOCATION(S)**

Receptacle(s) without GFCI protection were observed in locations where GFCI protection is recommended. For enhanced safety, recommend evaluation/repair by qualified electrician.

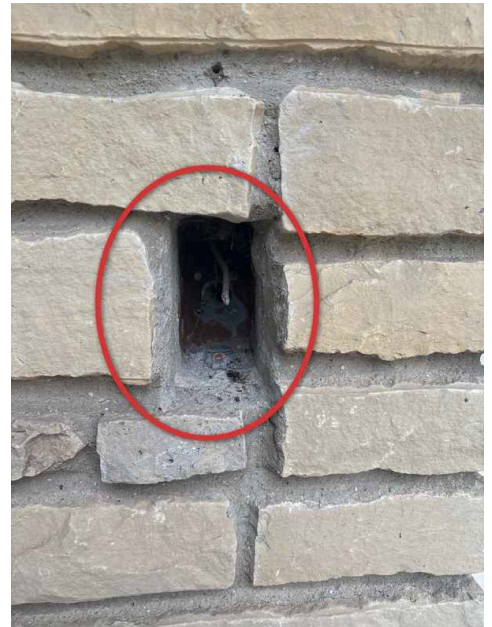
**COVER PLATE(S) MISSING/DAMAGED**

Damaged/Missing cover plate(s) observed at electrical receptacles. Recommend evaluation/repair by qualified electrician.

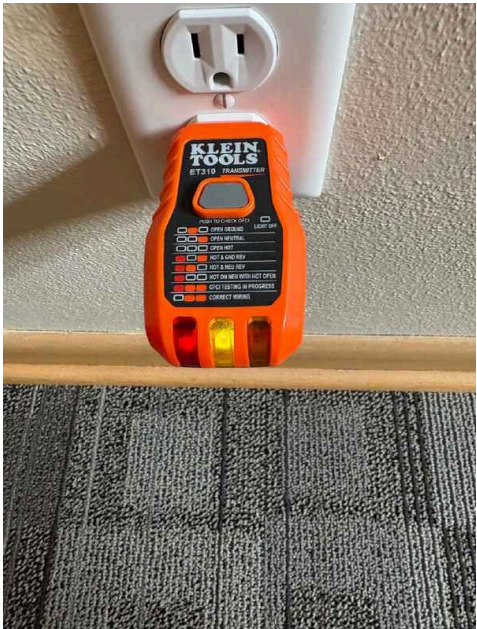
Bedroom 2

REVERSE POLARITY

Reverse polarity outlet(s) observed. Recommend evaluation/repair by qualified electrician.

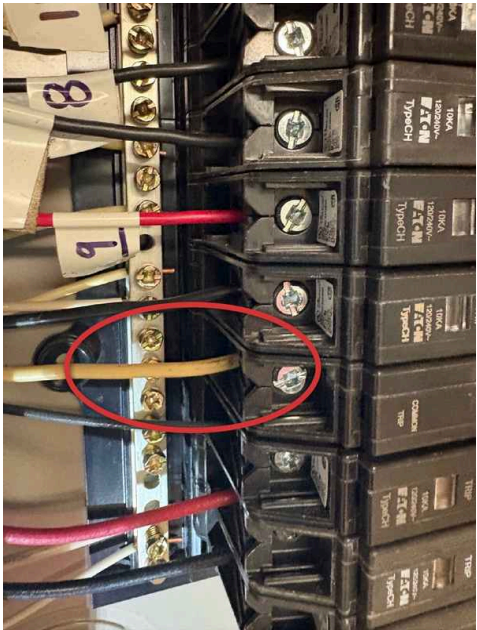
2.4.1 Main Electric Panel

A white wire was observed to be going to the fuse serving as a hot wire, recommend evaluation and repair by qualified contractor.

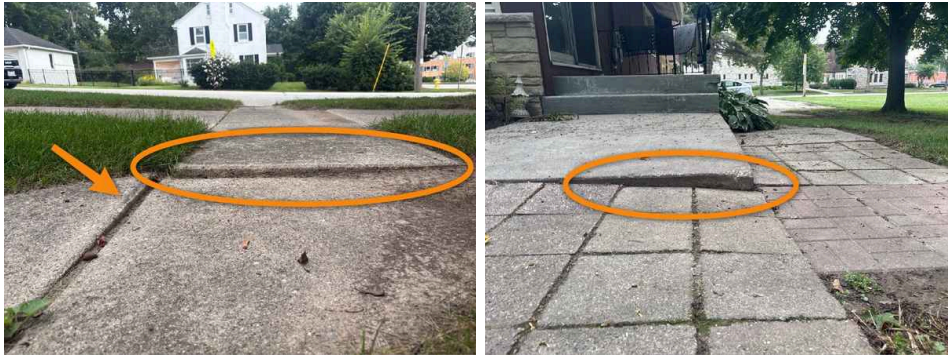
## 3.1.1 Walkways

**TRIP HAZARD(S) OBSERVED AT WALKWAYS**

Trip hazard(s) observed at walkway. Recommend evaluation/repair by qualified contractor.

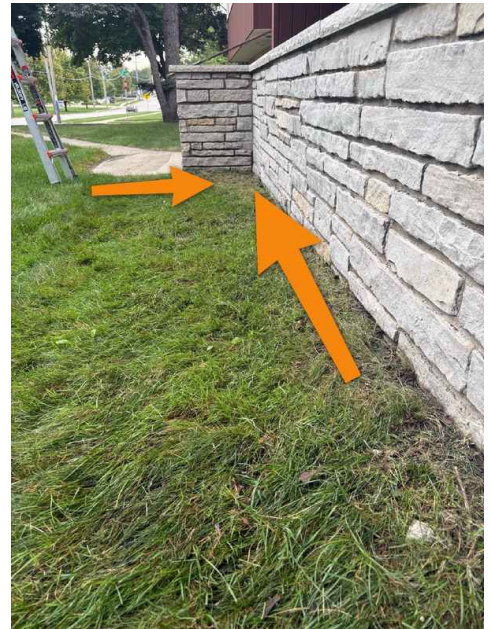
## 3.4.1 Grading Affecting Foundation

**AREAS WITH NEGATIVE GRADING  
OBSERVED AT PERIMETER OF HOME**

Areas with negative grading observed. Recommend establishing and maintaining a positive drainage slope away from home. Recommend evaluation/repair by qualified contractor.

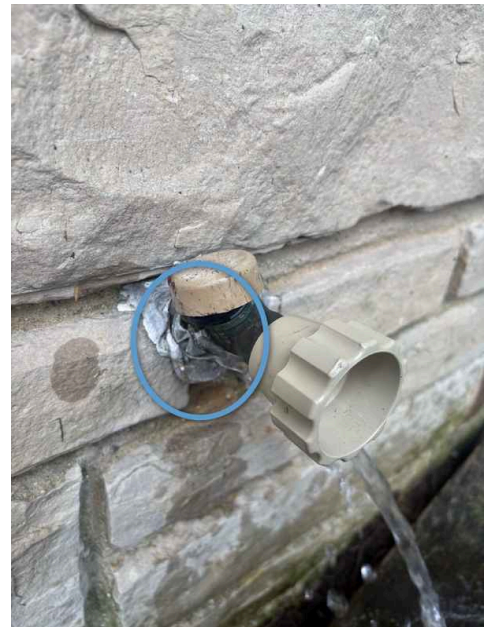
## 3.5.1 Hose Bib(s)

**EXTERIOR HOSE BIB  
LEAKING**

Hose bib leaking at time of inspection, recommend evaluation/repair.

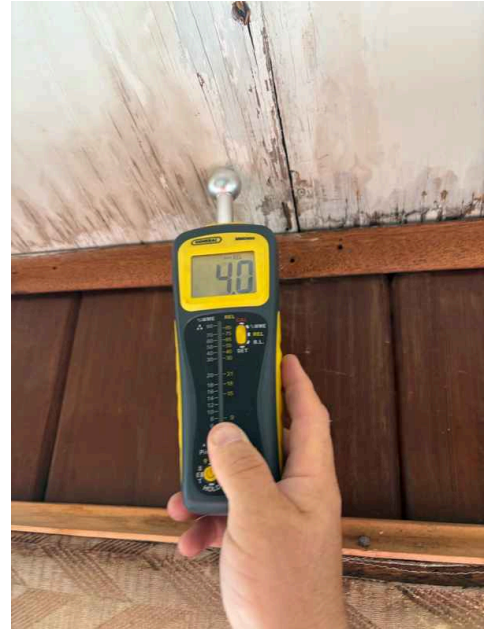
## 3.8.1 Balcony Porch

**PEELING PAINT AND MOISTURE STAINS OBSERVED-DRY AT THE TIME OF INSPECTION**

Peeling paint and moisture stains were observed in the porch, recommend monitoring and evaluation and repair by qualified contractor.

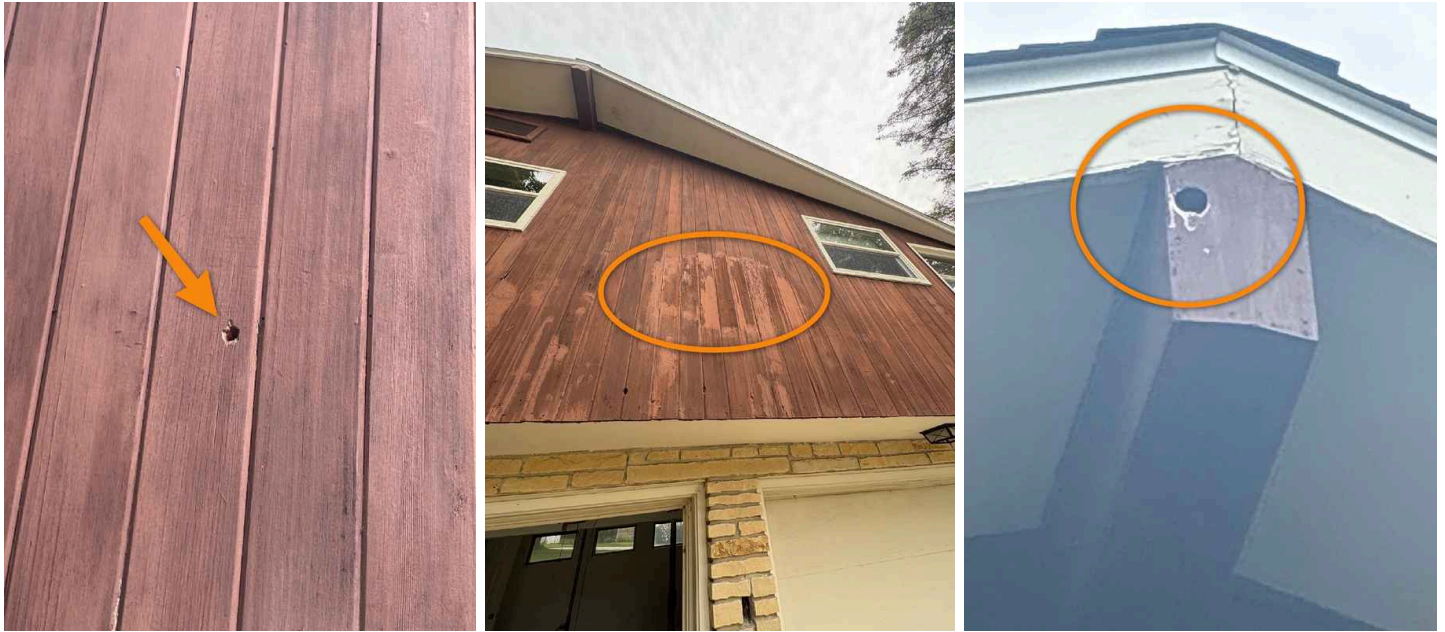
## 3.9.1 Siding

**DAMAGED/DETERIORATED AREAS OBSERVED AT SIDING**

Damaged/Deteriorated areas observed at exterior siding. Recommend evaluation/repair by qualified contractor.

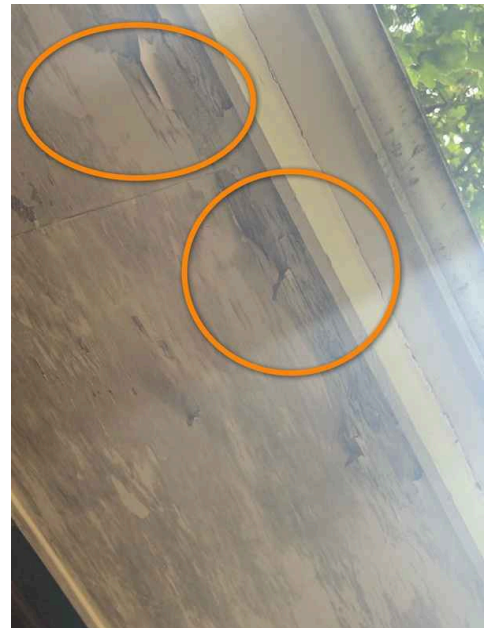
## 3.11.1 Soffit

**DAMAGED/DETERIORATED/MISSING AREAS OBSERVED AT EXTERIOR SOFFIT**

Damaged/Deteriorated/Missing areas observed at soffit. Recommend evaluation/repair by qualified contractor.

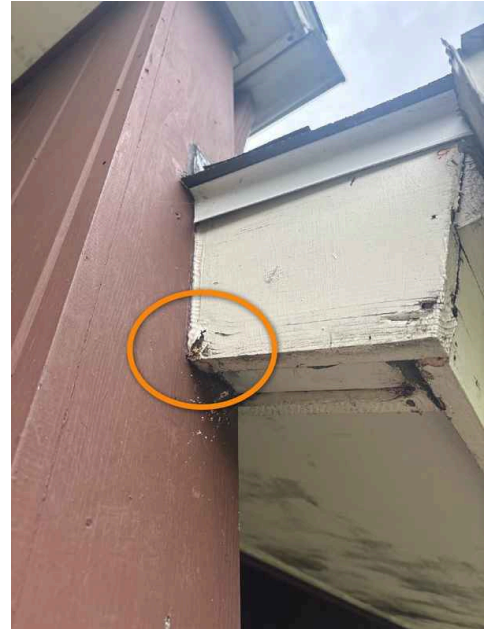
## 3.12.1 Facia

**DAMAGED/DETERIORATED/MISSING AREAS OBSERVED AT EXTERIOR FACIA**

Damaged/Deteriorated/Missing areas observed at fascia. Recommend evaluation/repair by qualified contractor.

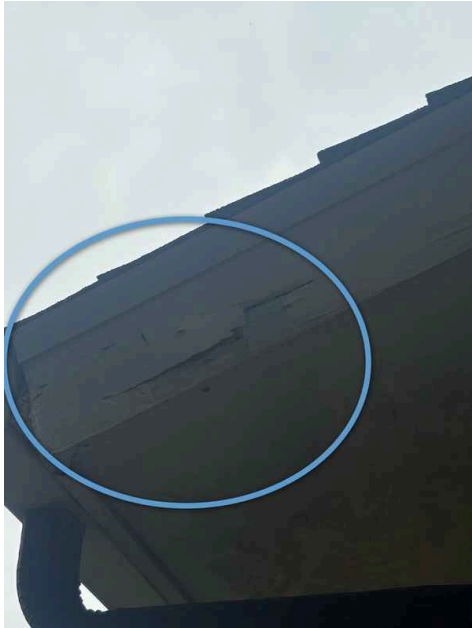
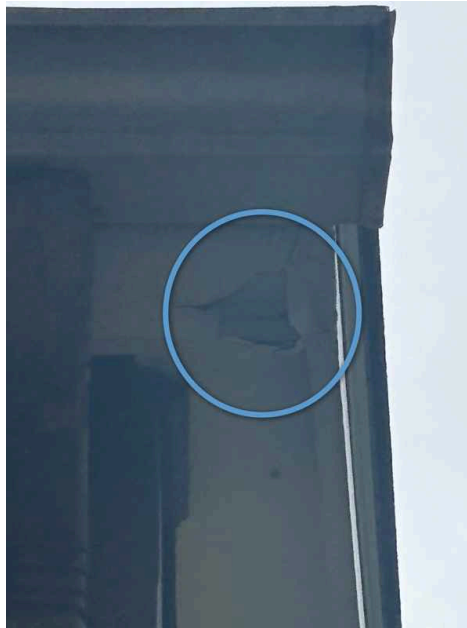
## 3.12.2 Facia

**PEELING PAINT OBSERVED AT EXTERIOR FACIA**

Areas of peeling paint observed at fascia. Recommend evaluation/painting/repair as needed by qualified contractor.

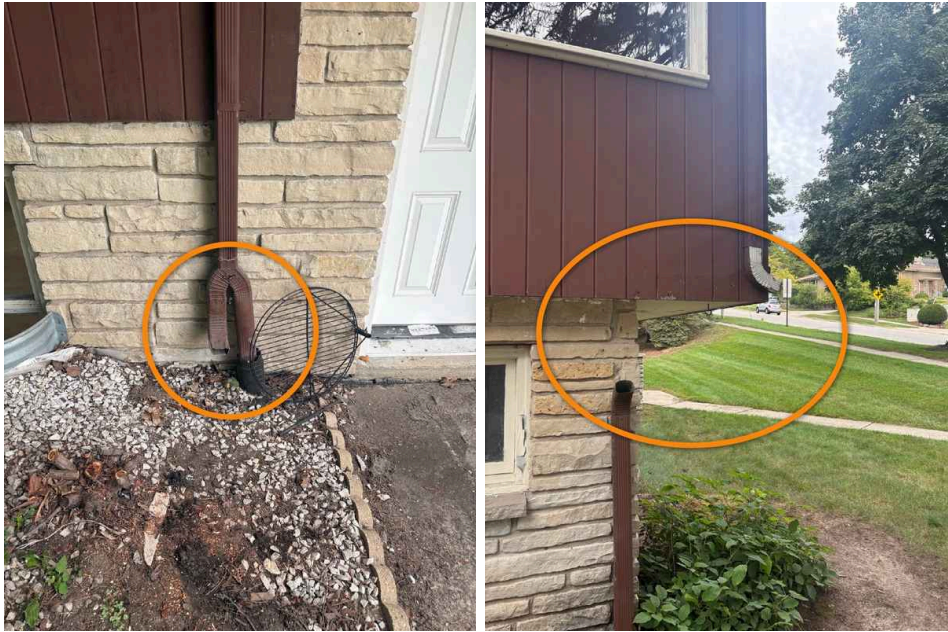
## 3.13.1 Gutters

**GUTTER EXTENSION(S) ARE MISSING/INADEQUATE**

Gutter/Downspout extension(s) were missing and/or not properly connected/extended. Recommend ensuring gutter extensions are in place to discharge water at least 6 feet away from home.

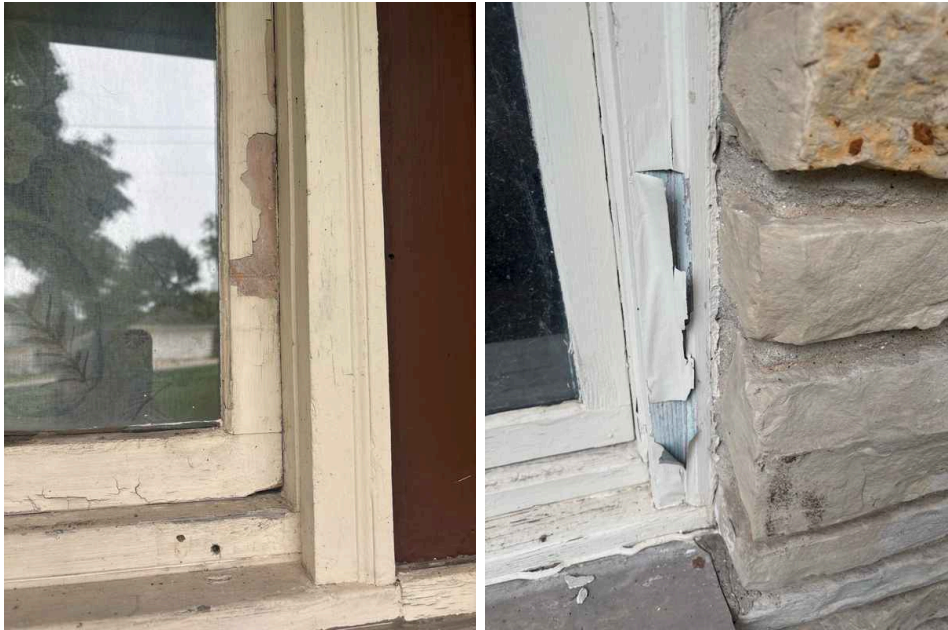
## 3.16.1 Windows

**OLDER WINDOW(S)**

Older Window(s) observed. Some may be difficult to operate or painted shut. Recommend repair as needed.

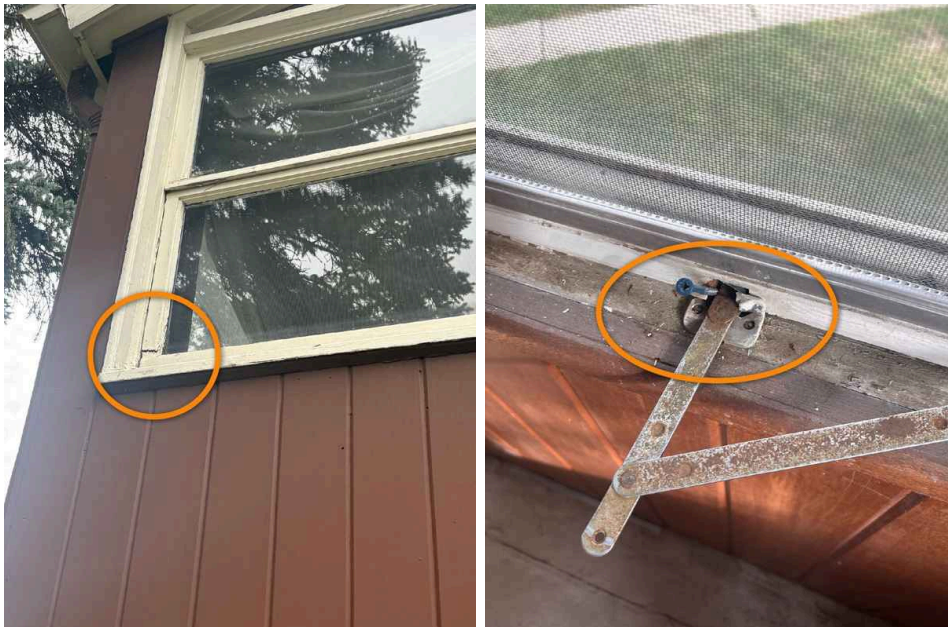
## 3.16.2 Windows

**DAMAGED/DETERIORATED AREAS OBSERVED AT WINDOWS**

Damaged/Deteriorated areas observed at window(s). Recommend evaluation/repair by qualified contractor.

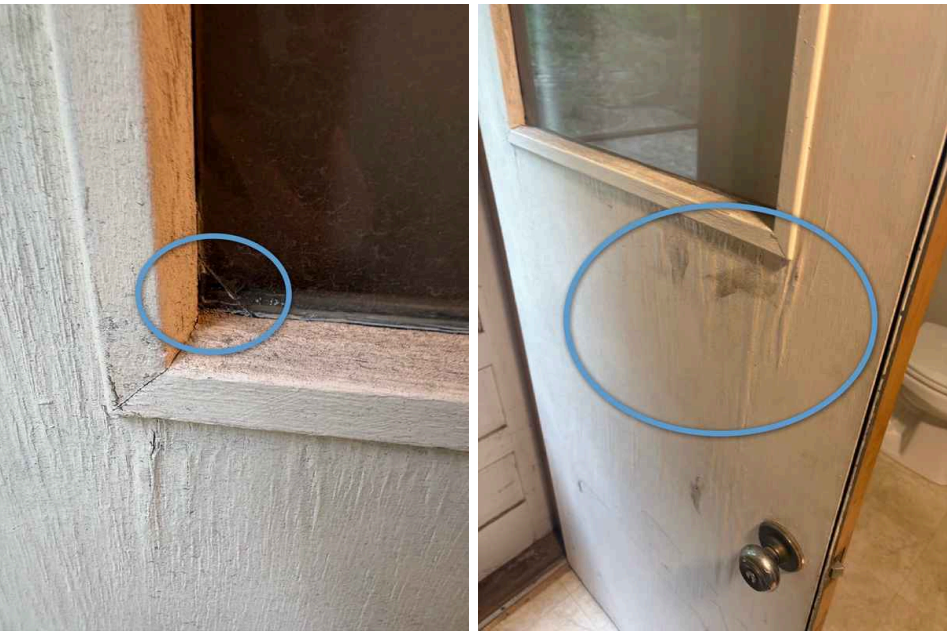
3.17.1 Exterior Doors

DAMAGED/DETERIORATED AREA(S) OBSERVED AT EXTERIOR DOOR(S)

Damaged door. Recommend evaluation/repair by qualified contractor.

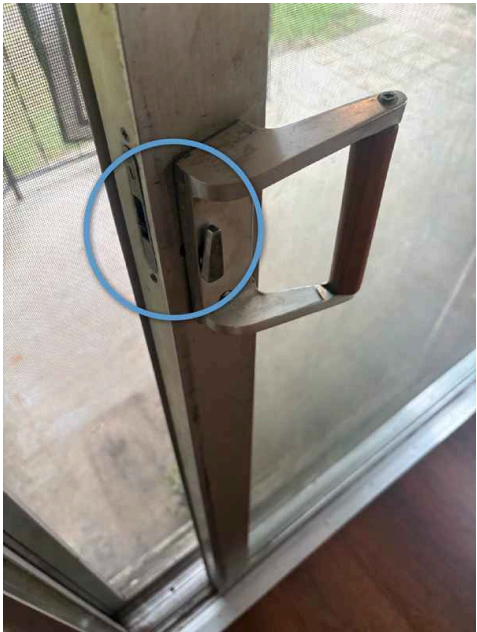
3.17.2 Exterior Doors

EXTERIOR DOOR(S)  
DIFFICULT TO OPERATE

Door(s) difficult to operate. Recommend evaluation/repair by qualified contractor.

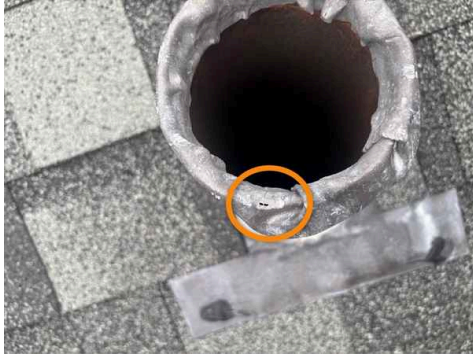
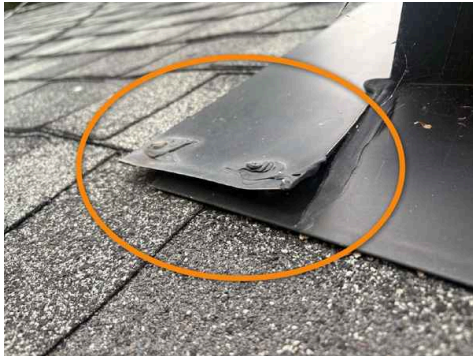
## 4.1.1 Flashings

**FLASHING IS DAMAGED**

Flashing at the at the plumbing stacks, siding and chimney appear to be damaged or not secured properly  
recommend evaluation and repair by qualified contractor

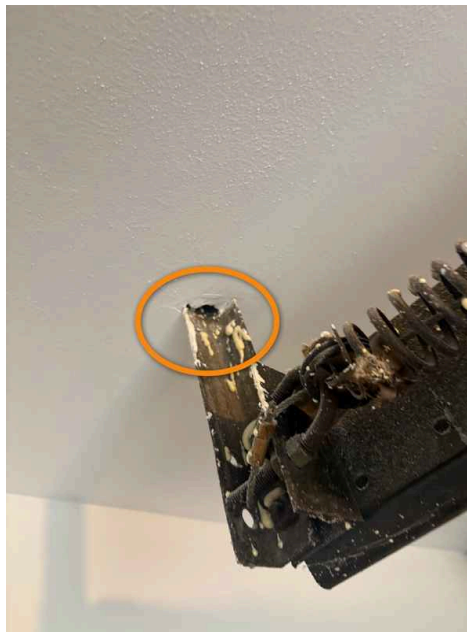
## 5.5.1 Fire Separation Wall

Other Defects**RECOMMEND CONTINUOUS FIRE SEPARATION WALL BETWEEN HOUSE & ATTACHED GARAGE**

For enhanced safety, recommend continuous fire separation wall between house and attached garage. Recommend evaluation/repair by qualified contractor.

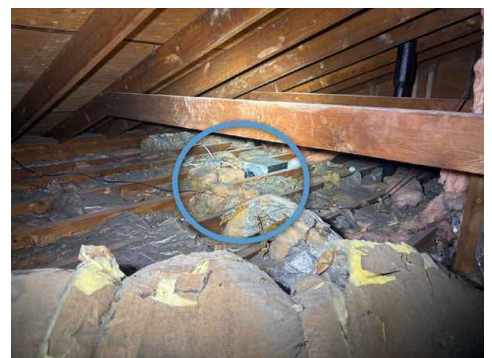
Exhaust fan(s) observed venting into attic. Recommend evaluation/repair by qualified contractor to ensure that all exhaust fans vent to the exterior.

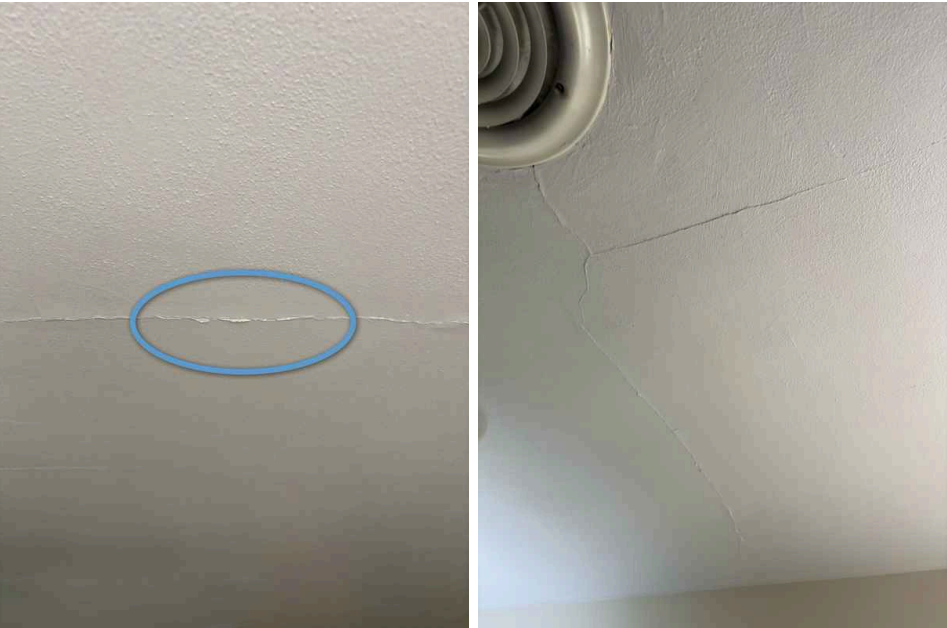
CRACKS OBSERVED

Cracks observed at interior walls. Recommend evaluation/repair by qualified contractor.

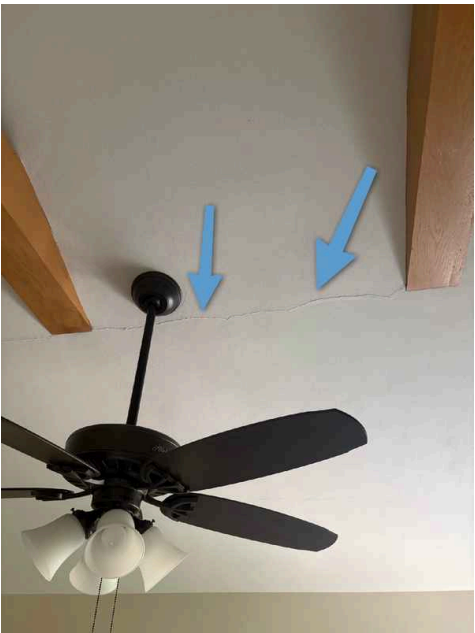
CRACKS OBSERVED

Cracks observed at interior walls. Recommend evaluation/repair by qualified contractor.

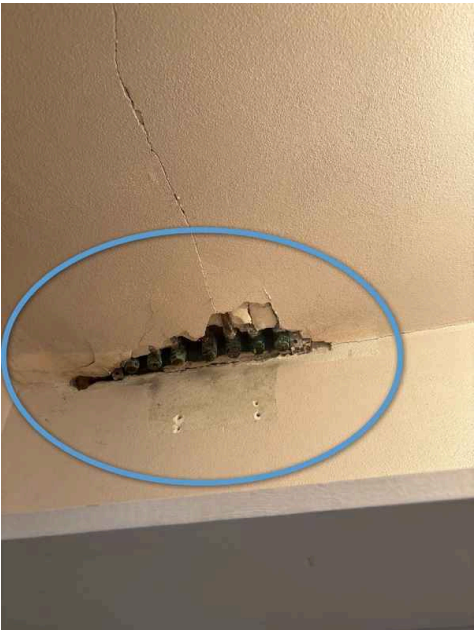
**DAMAGED AREA(S)  
OBSERVED**  
Damaged area(s) observed at wall(s). Recommend evaluation/repair by  
qualified contractor.

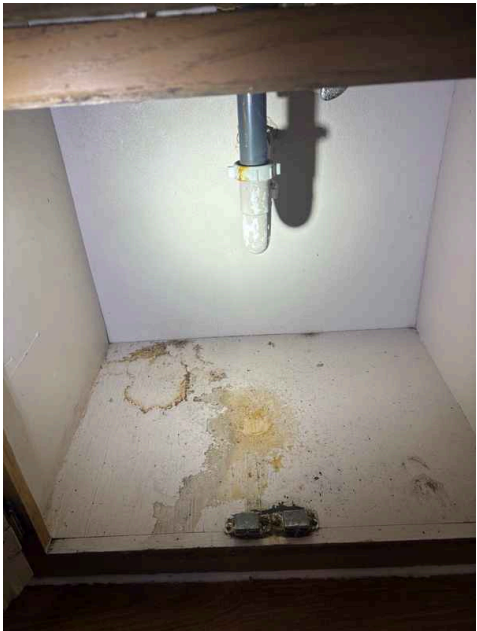
PLUMBING LEAK OBSERVED

Plumbing leak observed. Recommend evaluation/repair by qualified plumber.

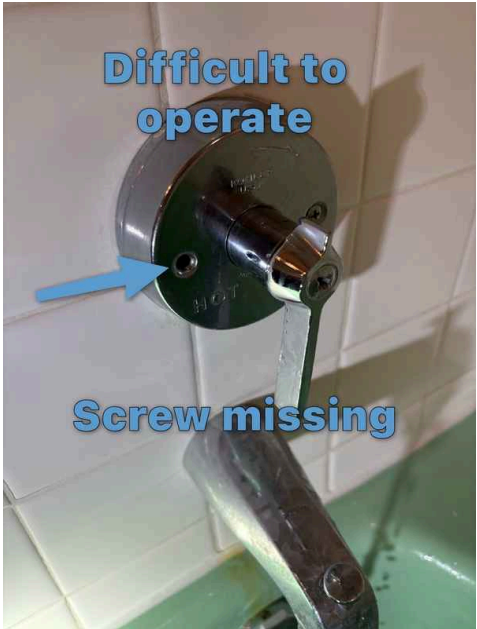
10.11.1 Tub/Shower

DAMAGED/DETERIORATED AREAS OBSERVED AT SHOWER AREA

Damaged/deteriorated areas observed. Recommend evaluation/repair by qualified contractor.

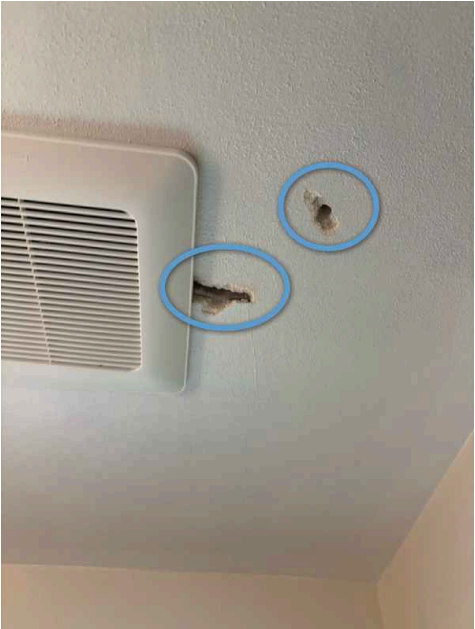
DAMAGED AREA(S)  
OBSERVED

Damaged area(s) observed at wall(s). Recommend evaluation/repair by qualified contractor.

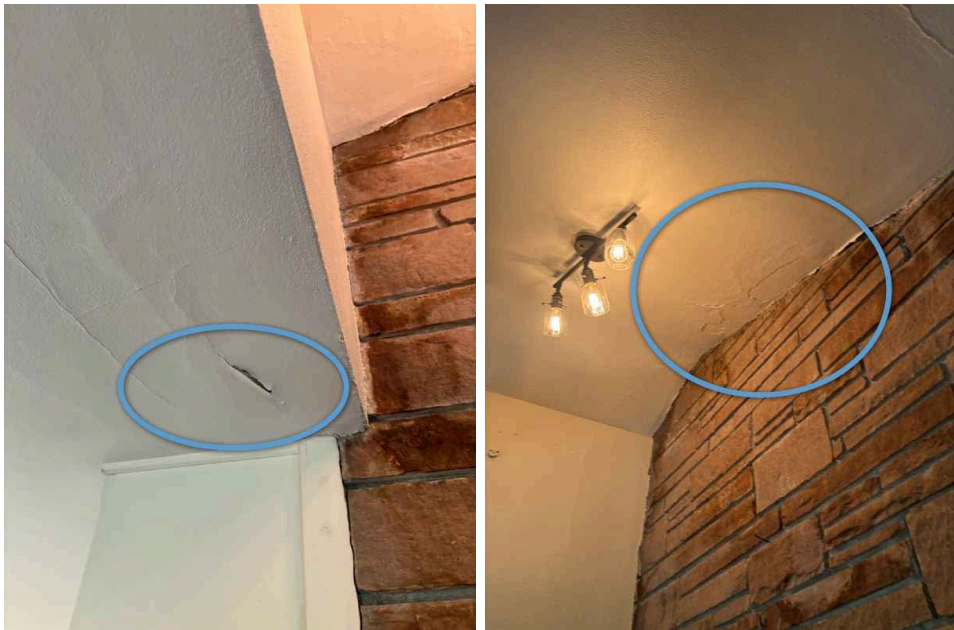
12.2.1 Walls & Ceiling

CRACKS OBSERVED

Cracks observed at interior walls. Recommend evaluation/repair by qualified contractor.

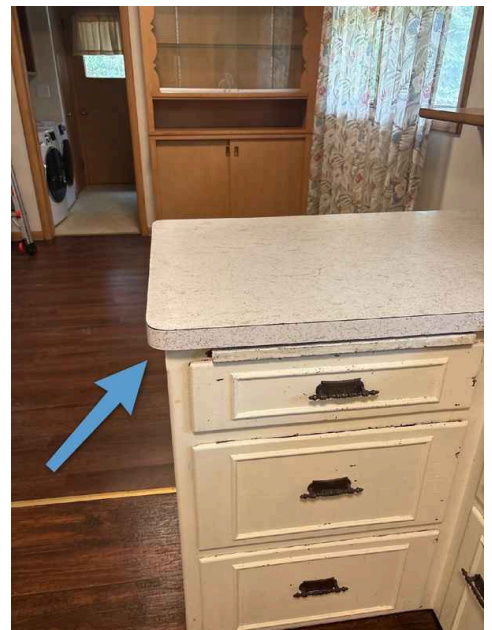
## 15.8.1 Countertops &amp; Cabinets

**LOOSE COUNTERTOP(S)**

Loose countertop(s) observed. Recommend evaluation/repair by qualified contractor.

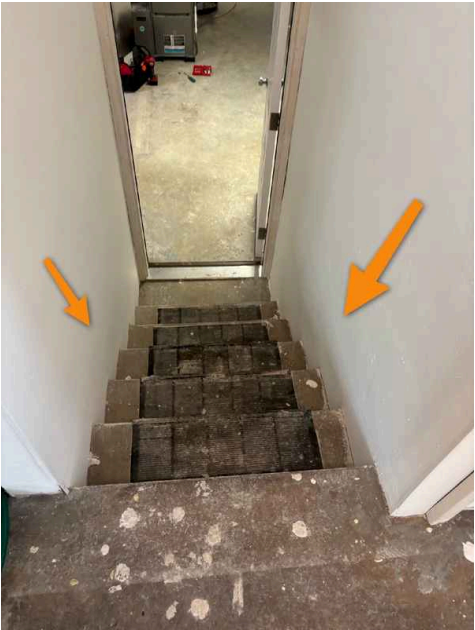
**HANDRAIL MISSING AT AREA WITH 4 OR MORE STEPS.**

Recommend evaluation and repair by qualified contractor.

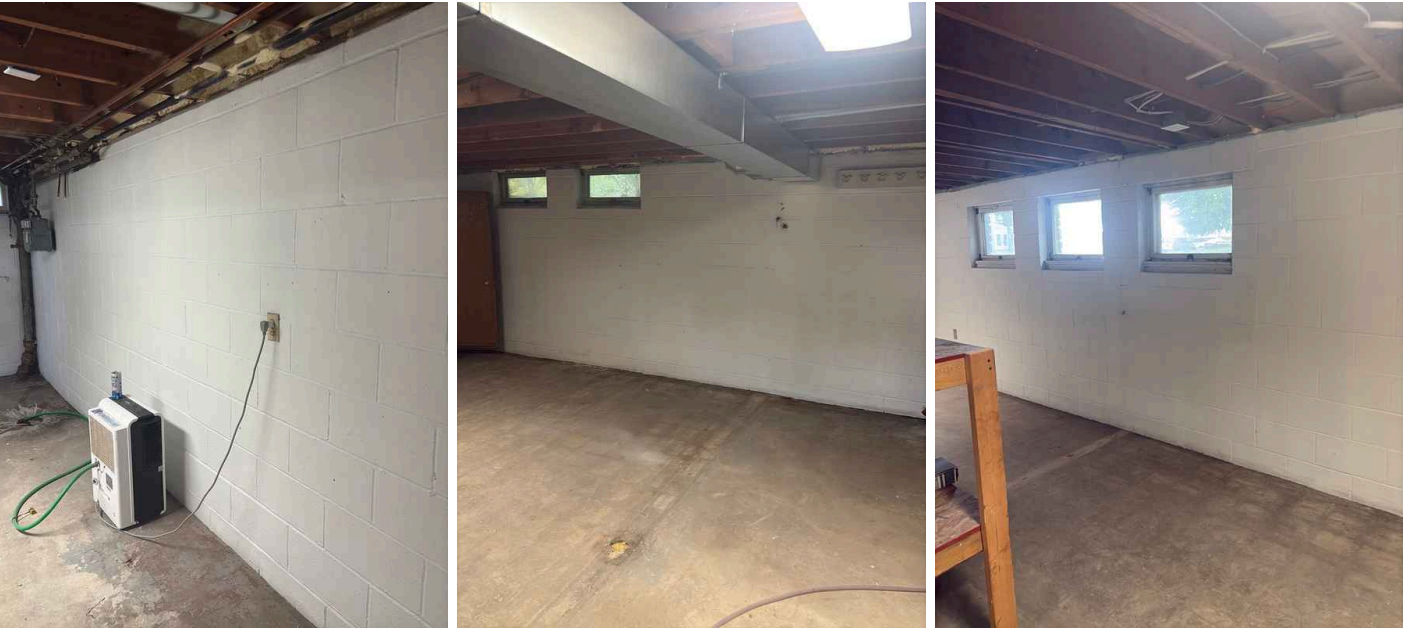
| <b>Foundation Walls: General</b><br>Basement/Foundation Photo(s) | | |

| <b>Support Structure: Sub-Floor Condition</b><br>Moisture Stains Observed -<br>Recommend Monitoring | | |

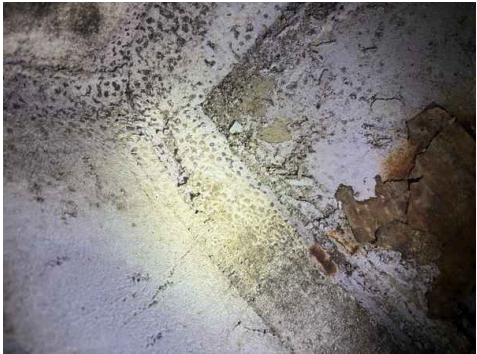
19.1.1 Foundation Walls

**MOLD LIKE GROSS  
OBSERVED ON FOUNDATION WALL**

Mold like growth was observed on foundation wall, recommend evaluation and mitigation by qualified contractor

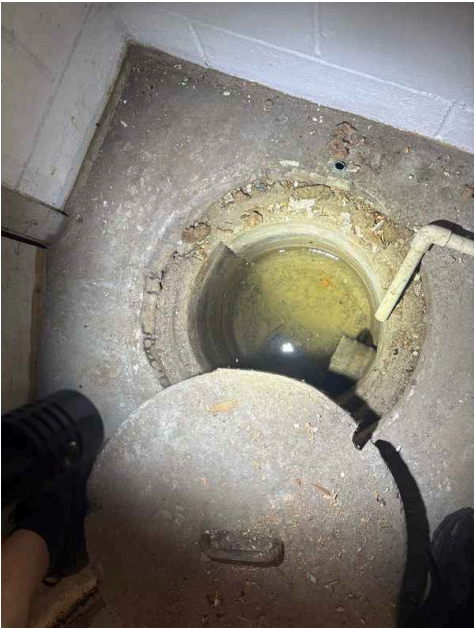
Recommend addition of sump pump to sump crock by qualified contractor

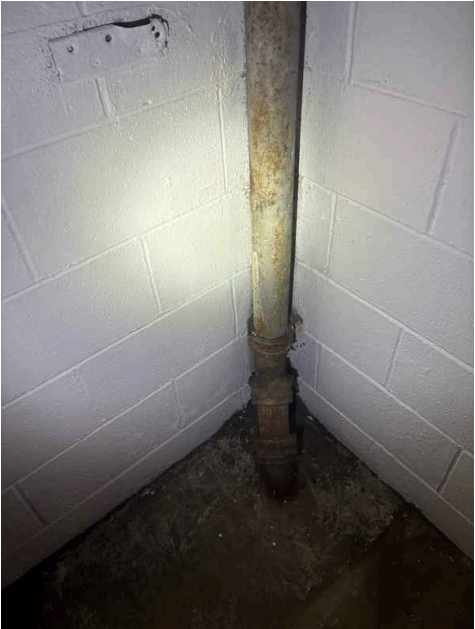
20.3.1 Water Supply & Drain  
Piping

**FURTHER EVALUATION -OR- MONITOR/BUDGET ITEM - GALVANIZED AND/OR CAST IRON PLUMBING PIPES ARE BEYOND NORMAL LIFE EXPECTANCY**

Galvanized and/or cast iron plumbing pipes are beyond normal life expectancy. Recommend monitoring for leaks/blockages and recommend budgeting for repairs or replacement at any time. Inspector cannot determine the condition of pipes under the concrete and the underground lateral. Recommend further evaluation and sewer scoping by qualified plumber.

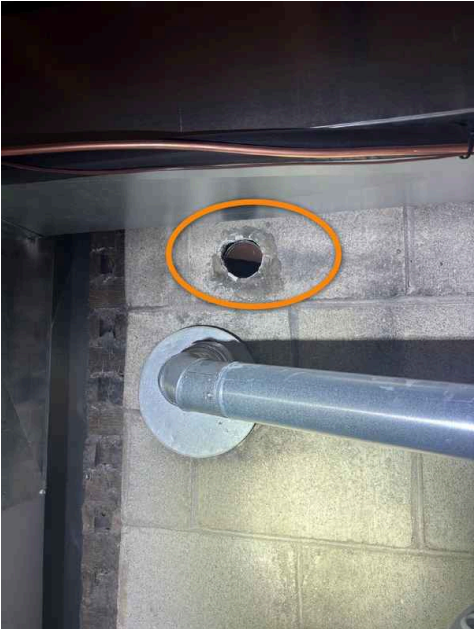
CHIMNEY VENT OPENING, NOT PROPERLY PLUGGED

The chimney opening was observed to be not properly closed recommend evaluation and repaired by qualified contractor

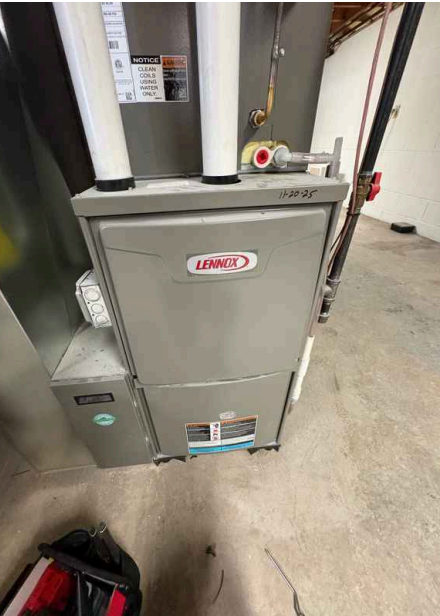
Furnace: Brand  
Lennox

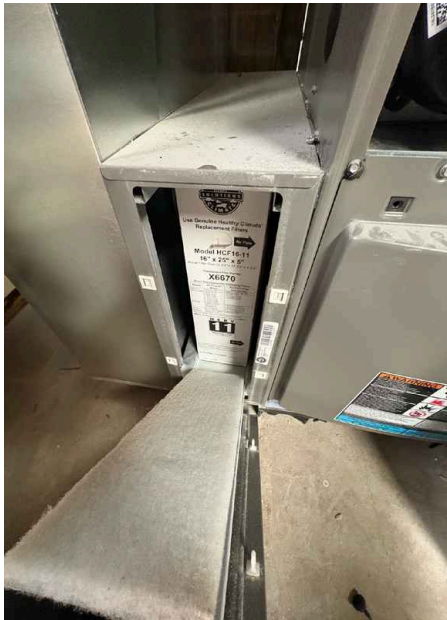
Furnace: Filter  
16x25x5
