HOMESIGHT INC  
414-321-1070, 262-522-0710, 920-212-7967, 608-423-6833  
[Clientcare@myhsight.com](mailto:Clientcare@myhsight.com)  
<http://homesightinc.com>

## RESIDENTIAL REPORT

177 E Washington St  
West Bend, WI 53095

Inspector  
Joey Zimmerman  
414-321-1070  
[joey@myhsight.com](mailto:joey@myhsight.com)

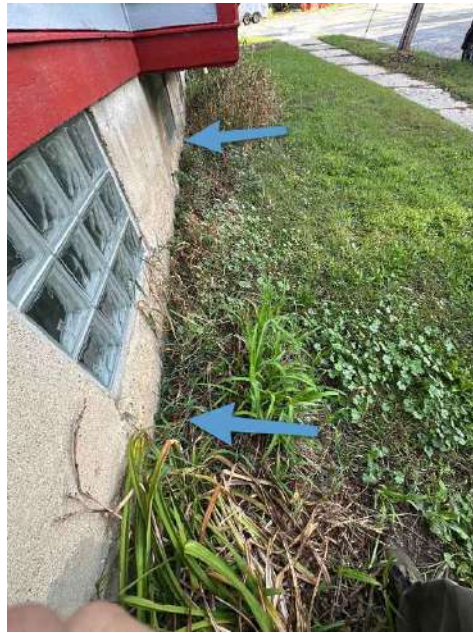
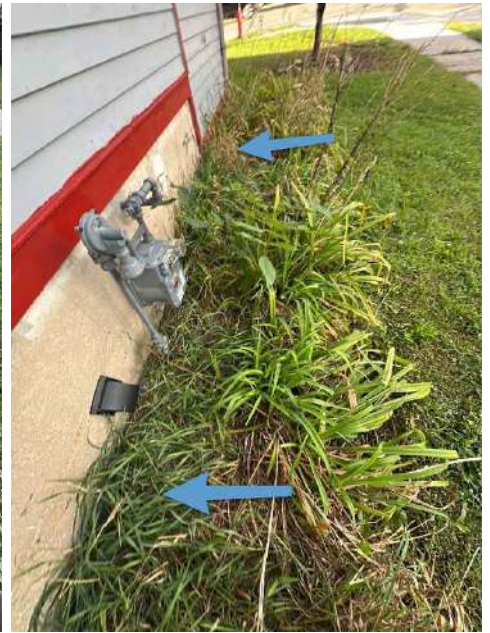
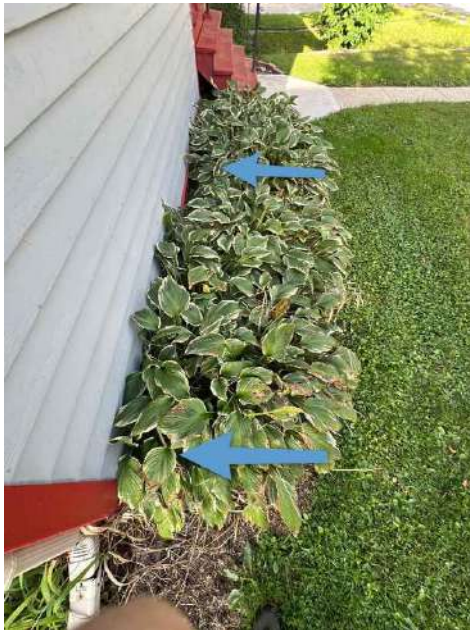
**RECOMMEND GRADING IMPROVEMENTS**

The grading around the structures could be improved, which is common for many homes. Without proper maintenance, water seepage or damage may occur. Ideally, grading should have a slope of 1" drop per foot, extending 6' away from the structure, with no siding-to-dirt contact. It's recommended to have a professional evaluate and make any necessary repairs.

Contact a qualified landscaping contractor

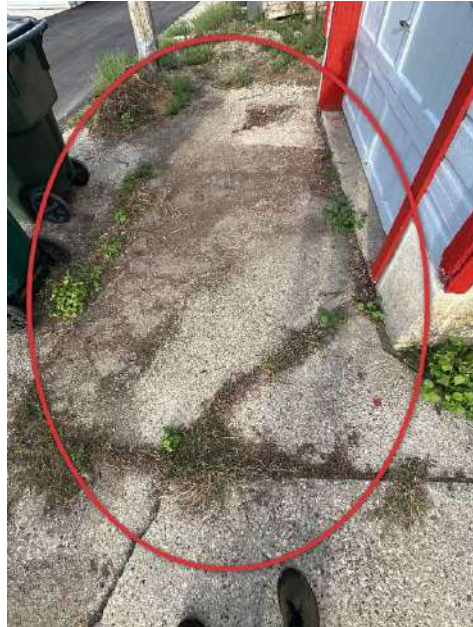
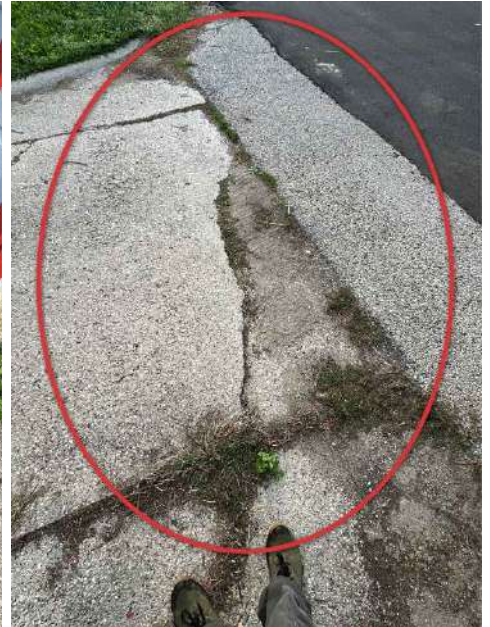
## 2.2.1 Flatwork

**CRACKED/SETTLED SURFACES W/ TRIP HAZARDS**

Evidence of cracked/settled surfaces with potential trip hazards - commonly found. If not corrected additional damage may result. Consult professional for evaluation and corrective action.

Contact a qualified concrete contractor.

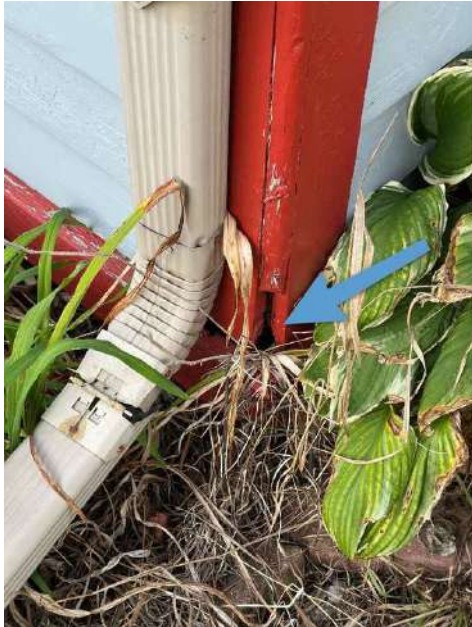
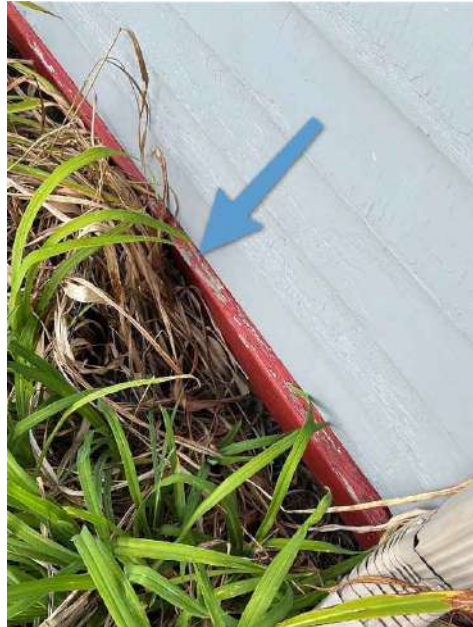
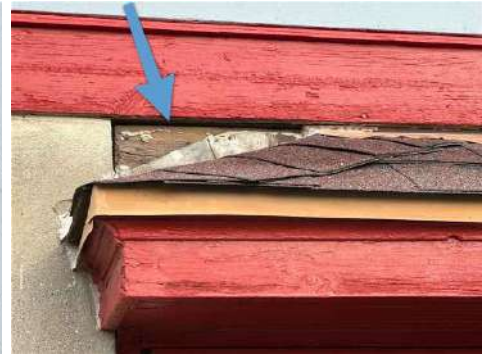
## 2.4.1 Siding / Trim / Caulk

**SIDING/TRIM - RECOMMEND MAINTENANCE**

Siding/Trim appear to need maintenance. If not corrected moisture seepage/damage may result. Recommend professional evaluate further and repair as needed.

Contact a qualified siding specialist.

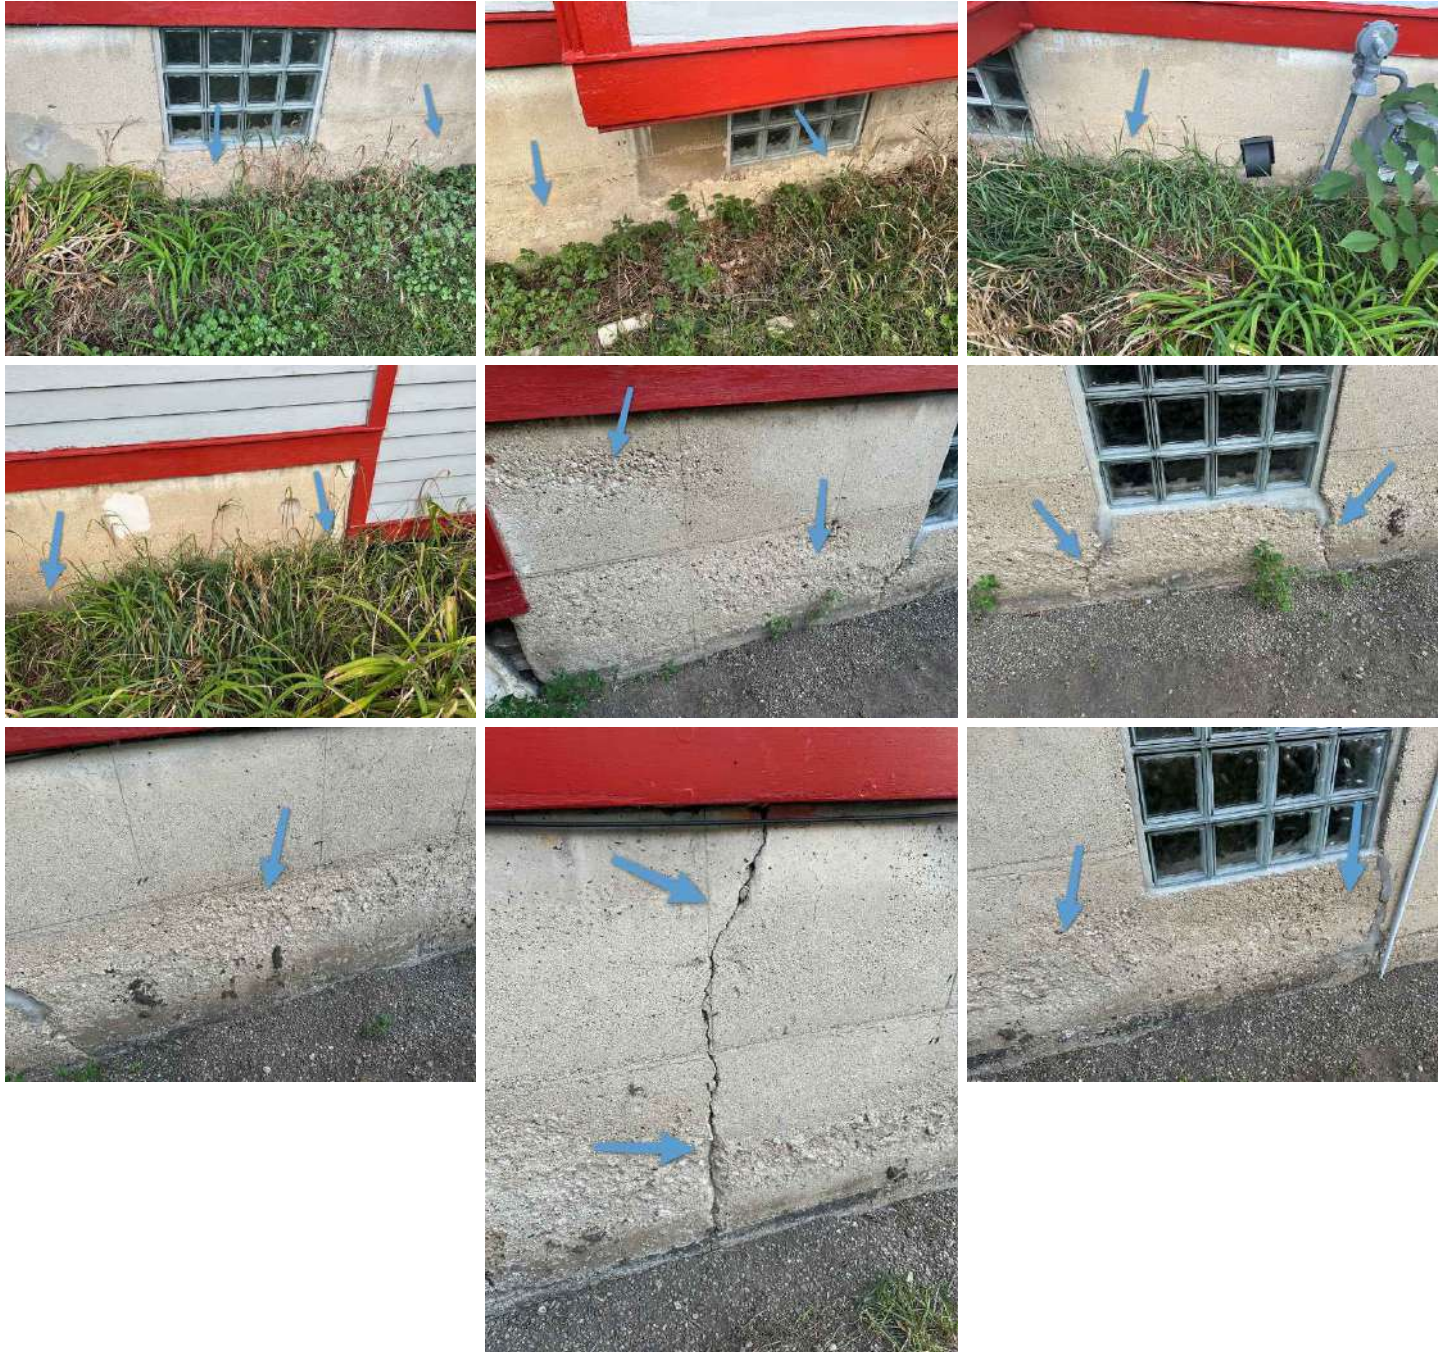
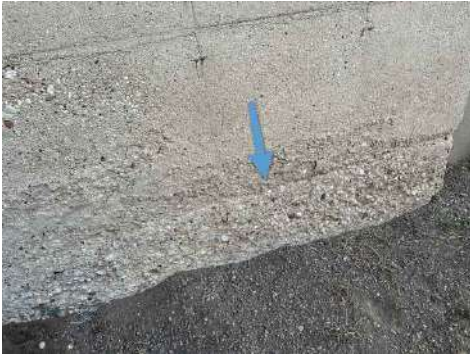
## 2.4.2 Siding / Trim / Caulk

**EXPOSED AREAS OF FOUNDATION**

Monitor / Maintenance

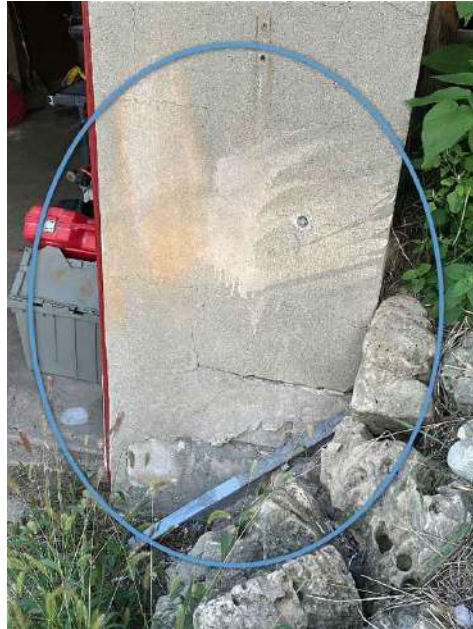
Cracking and moderate surface deterioration/spalling were observed at portions of the foundation walls. Recommend repair of deteriorated areas as needed and monitoring for additional cracking, movement, or deterioration.

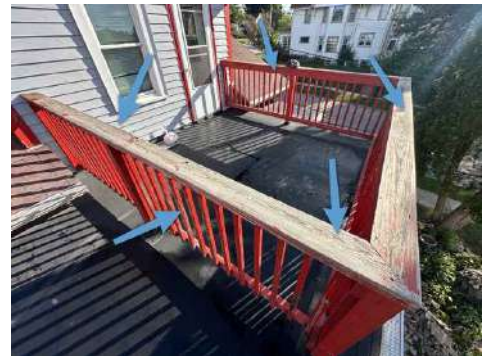
#### 2.5.1 Deck(s) / Balconies

##### **DAMAGED WOOD AND DETERIORATED PAINT**

Deck shows damaged/warped wood with peeling/deteriorated paint - recommend repair per professional.

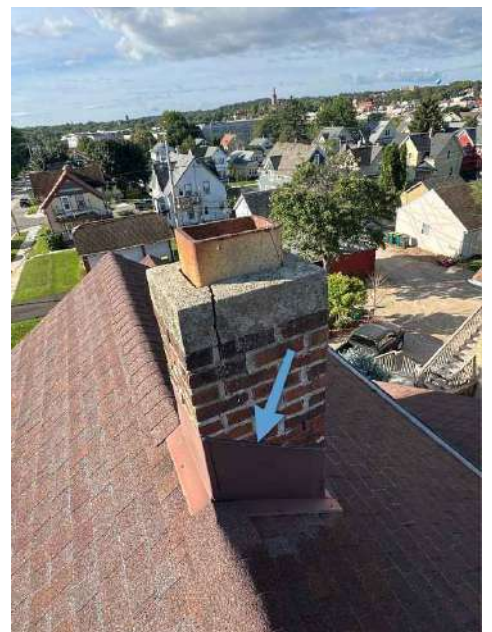
## 3.2.1 Flashings

**RECOMMEND MAINTENANCE**

Flashings appear to need maintenance in areas. If not maintained leaks/damage may result. Consult professional for corrective action as needed.

Contact a qualified roofing professional.

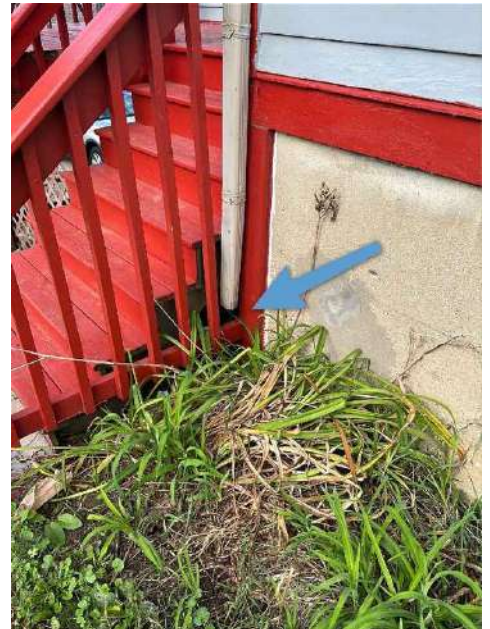
## 3.4.1 Roof Drainage System(s)

**RECOMMEND EXTENDING DOWNSPOUTS**

Recommend extending downspouts at least 6 feet from the structure - if not corrected water seepage may result. Recommend repair per handyman/DIY.

Recommended DIY Project

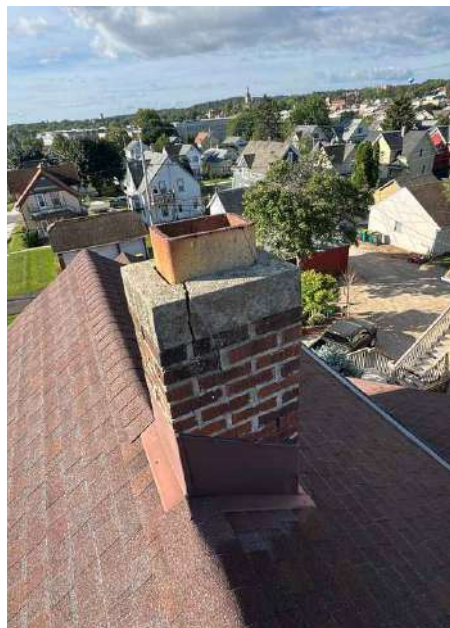
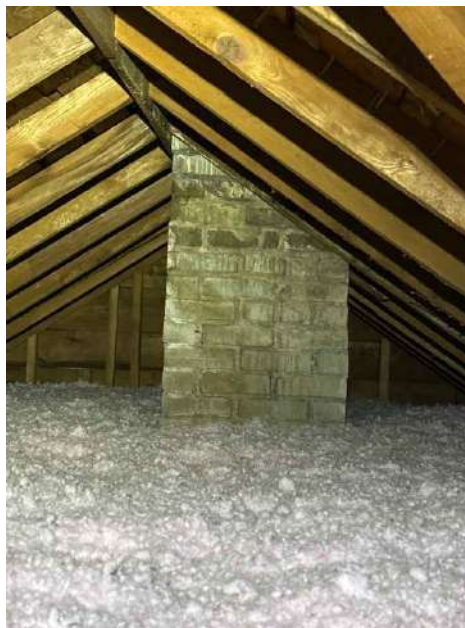
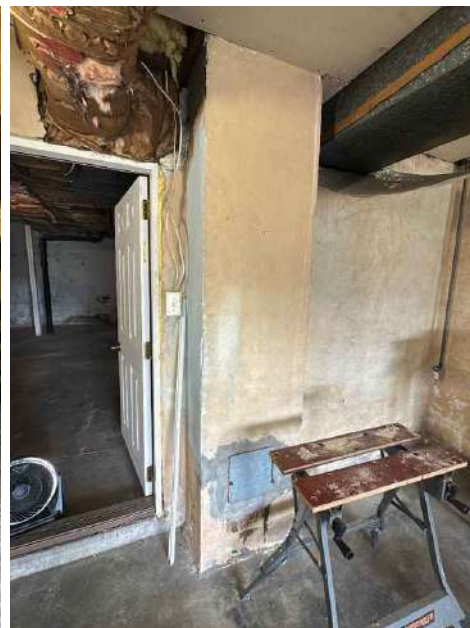
Flue(s) not evaluated, Recommend cover over flue(s)

The existence and state of the flue within the chimney remain unverified. It is advisable to have a professional assess the chimney to determine the condition of the flue. In instances where a chimney is missing a flue or possesses a flue that is in a state of decay or damage, which is common in older property, it is recommended to have a flue installed by a qualified professional.

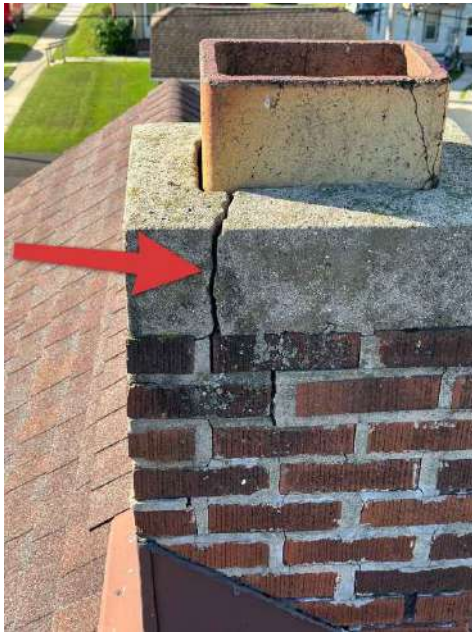
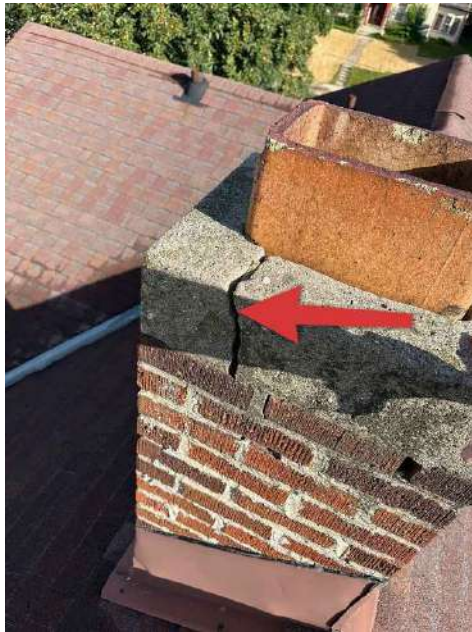
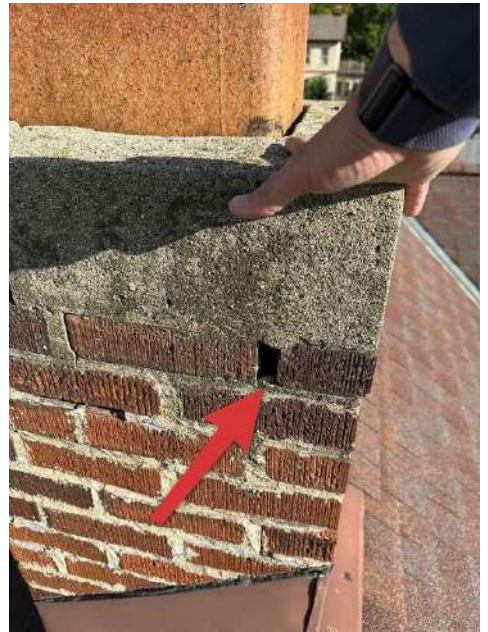
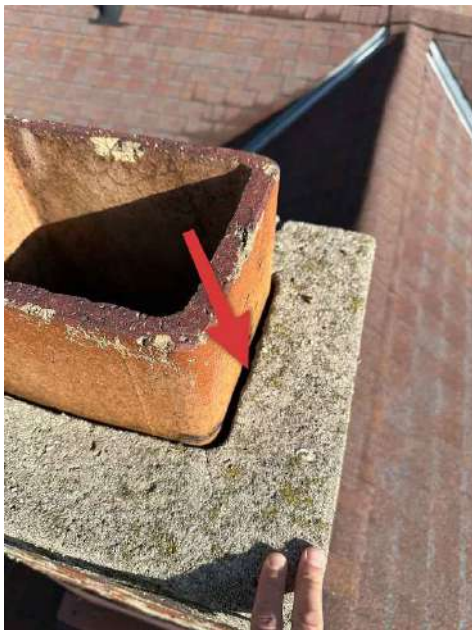
#### CHIMNEY NEEDS REPAIR

In general, the chimney appears to need repair - if not repaired, further damage and/or moisture intrusion will occur. Recommend consulting qualified professional for evaluation and repair options.

Contact a qualified chimney contractor.

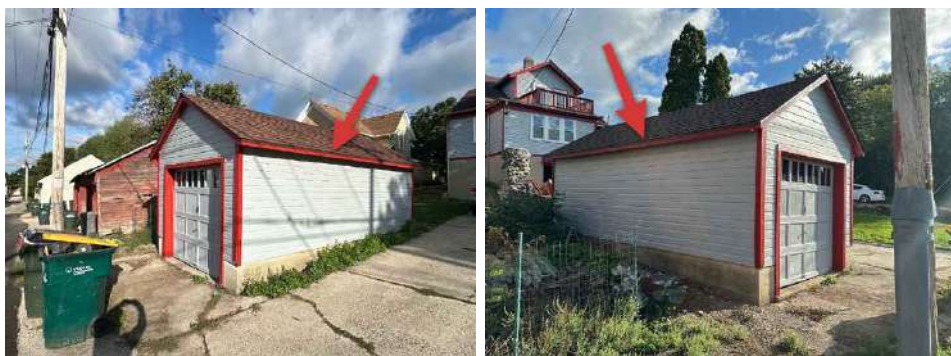
### GUTTER/DOWNSPOUT INSTALLATION RECOMMENDED

Gutter/downspout installation recommended. If not installed roof water cannot be controlled resulting in possible water seepage/damage.

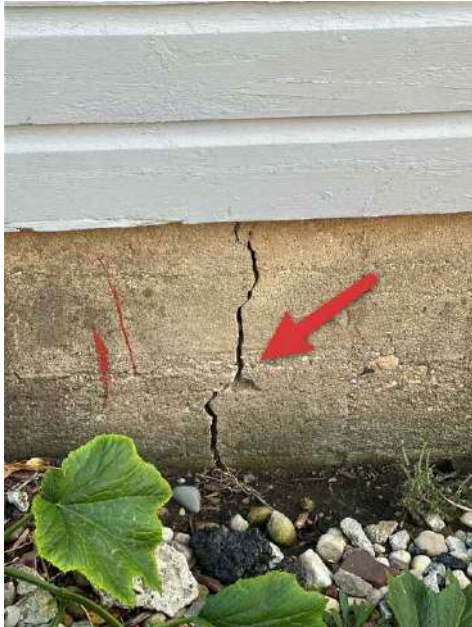
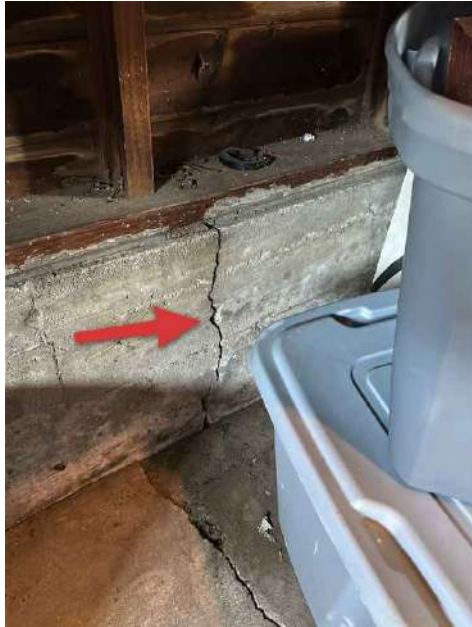
## 5.3.1 Siding / Trim / Caulk

**EXPOSED AREAS OF FOUNDATION**

Exposed areas of the foundation show cracks/movement. Recommend professional evaluate further and repair as needed.

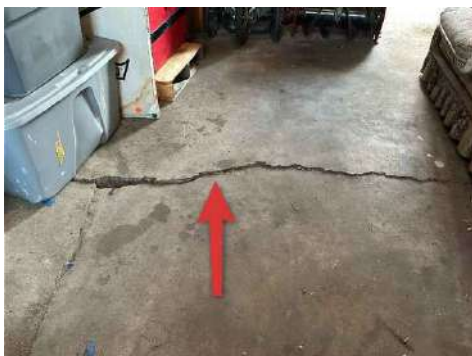
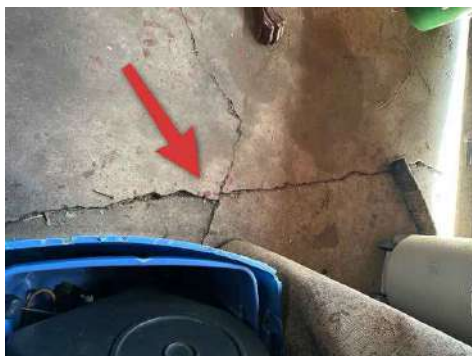
## 5.5.1 Floor

**LARGE CRACKS/SETTLING**

Needs Repair / Further Evaluation / Defect

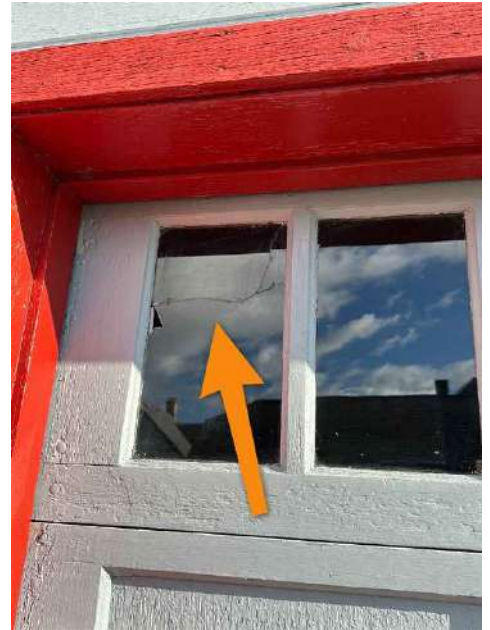
## 5.8.1 Window(s)

**REPAIRS RECOMMENDED**

Windows appear to be in poor condition with damaged wood, leaks and deteriorated paint. If not corrected they will not operate as intended. - recommend professional evaluate further.

Contact a qualified professional.

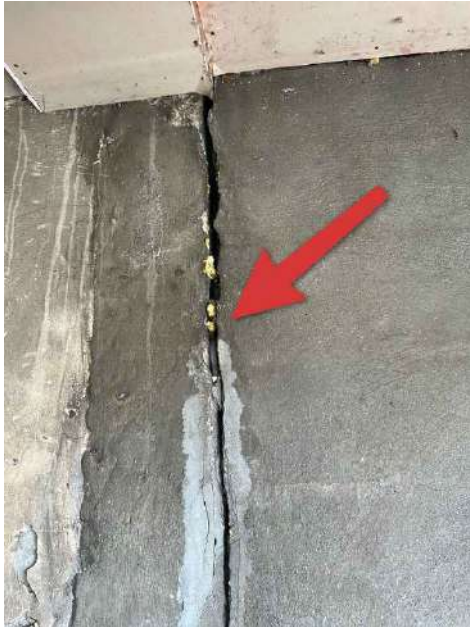
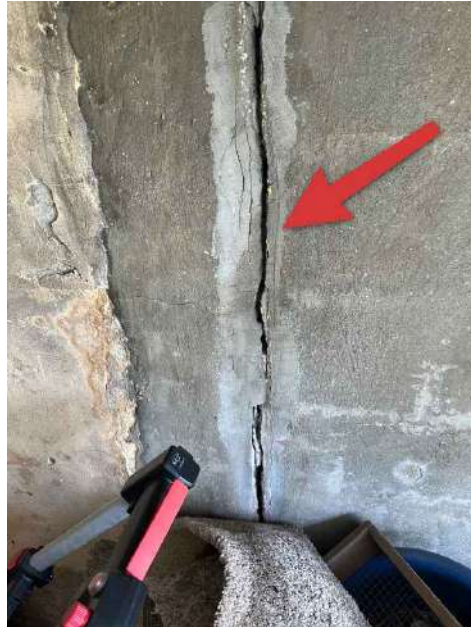
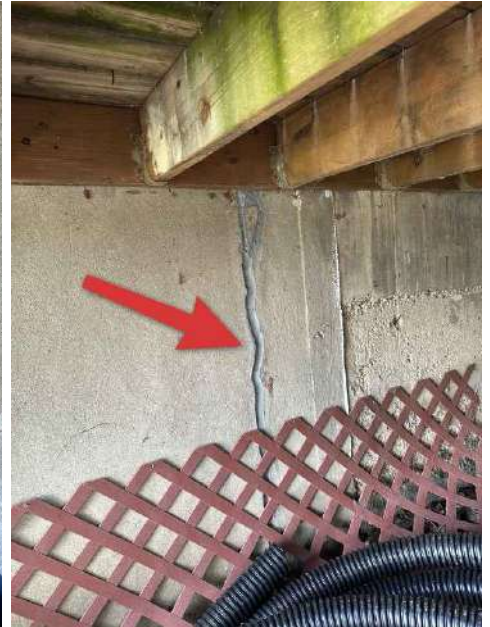
## 6.6.1 Structure

Evidence today of structure movement. If not corrected additional settling and damage may result. Consult professional for evaluation and corrective action.

Contact a qualified general contractor.

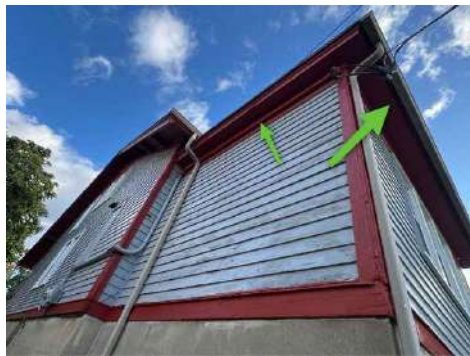
### Ventilation System: No soffit vents - by design

The house was designed without soffit vents, which can make proper ventilation challenging. It's recommended to have a professional assess the situation to ensure the attic is adequately ventilated.

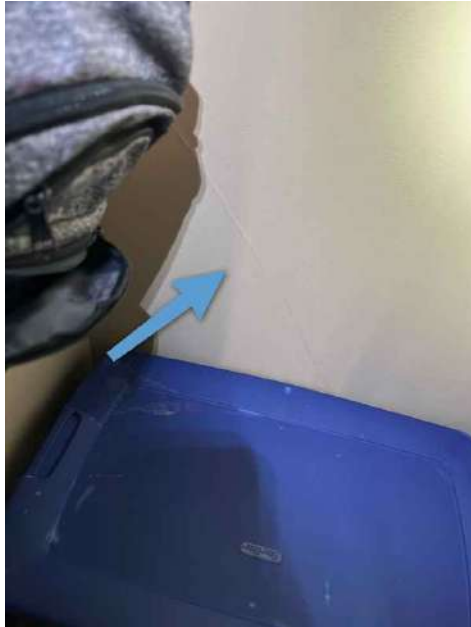
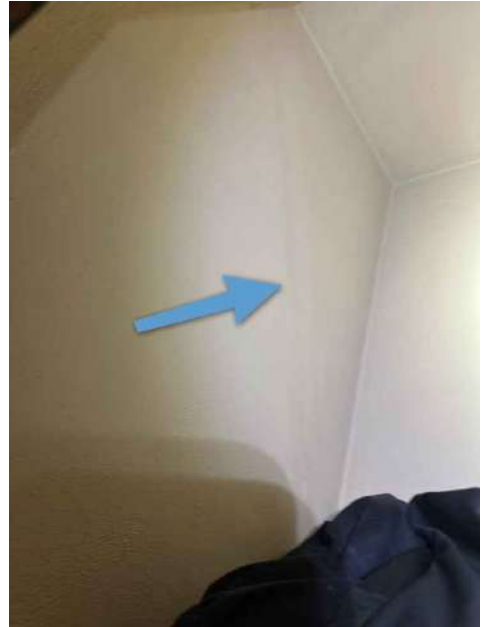
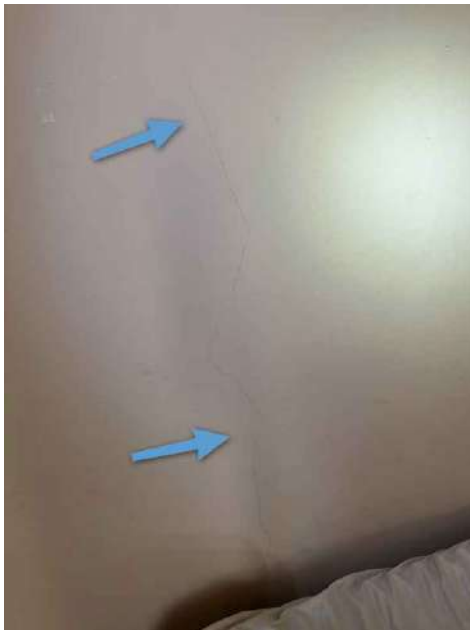
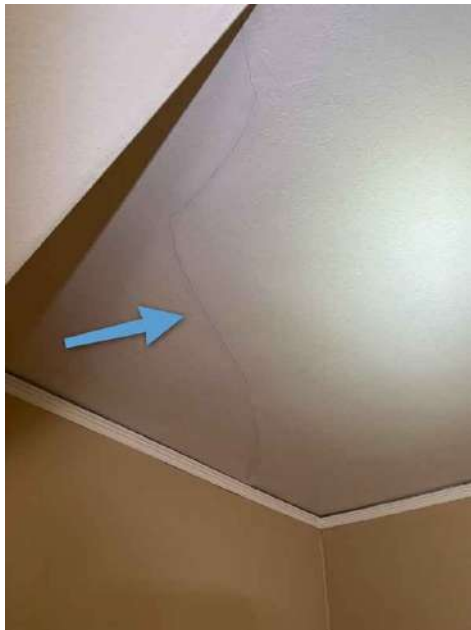
**CRACKS NOTED**

There were areas in the home that had cracked areas - reason unknown. If not repaired additional cracking may result. Monitor and contact professional for evaluation and corrective action as needed.

Recommendation

Monitor / Maintenance

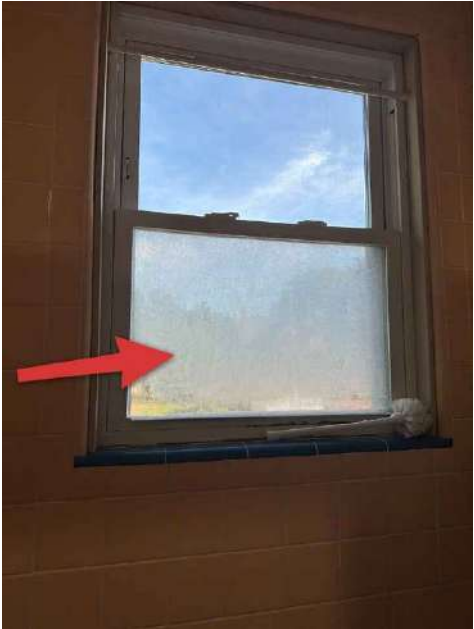
8.2.1 Windows  
(representative number)

FOGGY GLASS

There were windows in the home with potential insulated glass leaks (foggy glass). A window with a an insulated glass leak still operates as intended, but it loses insulation value and may fog up. Signs of lost seals in thermal pane windows may appear and disappear as temperature and humidity changes. Some windows with lost seals may not have been visible at the time of the inspection. Contact a window professional to evaluate all windows for Thermopane leaks and repair/replace as needed.

Recommendation  
Contact a qualified window repair/installation contractor.

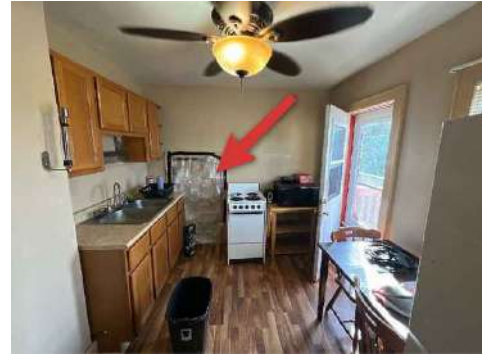
Evidence of past pests (owners said this area is where bats were entering the house. - if not repaired additional pest intrusion may occur. Consult seller on history and pest professional for corrective action.

Contact a qualified professional.

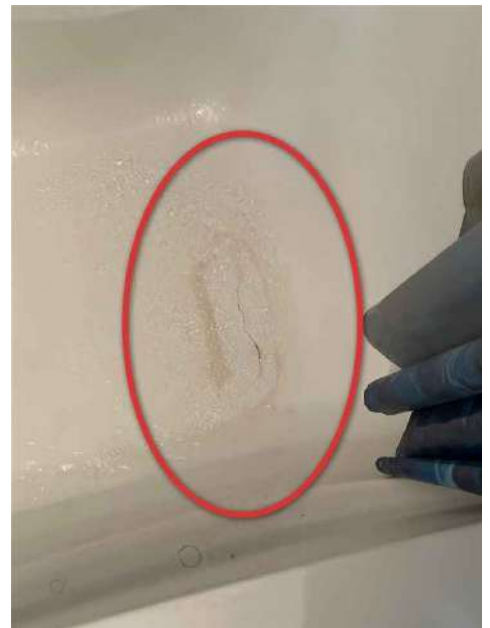
Patch observed at shower surround. Monitor for leaks and contact professional as needed.

Recommend monitoring.

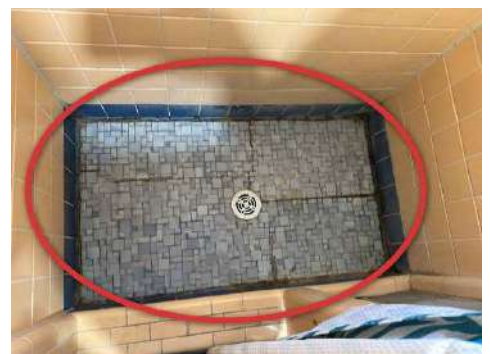
#### **REPAIRS RECOMMENDED**

Shower surround appears to need repairs. If not corrected leaks/damage may result. Consult professional for corrective action.

Contact a qualified professional.

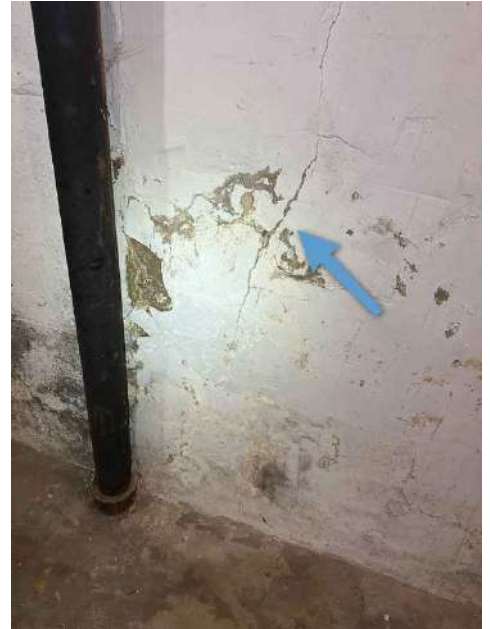
**COMMON CRACKS/MOVEMENT - MONITOR**

Cracks/Movement visible today on foundation walls appear common for the age of the home. Monitor for further movement. If cracks/movement changes have professional re-evaluated.

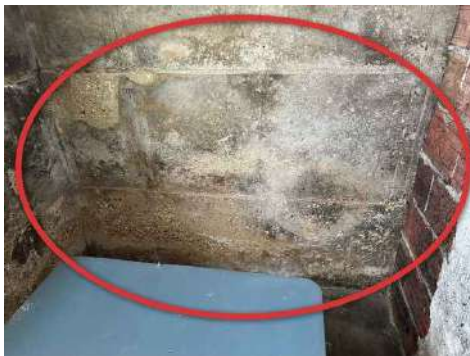
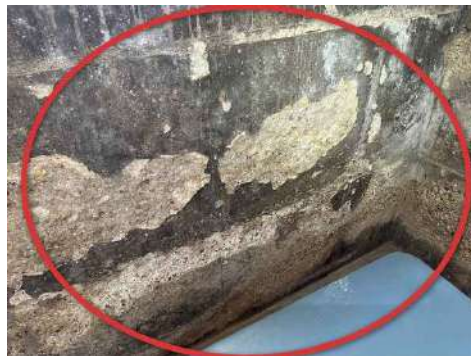
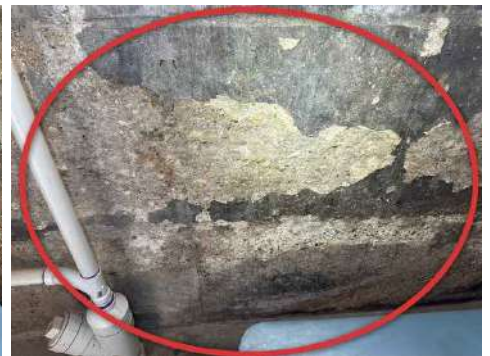
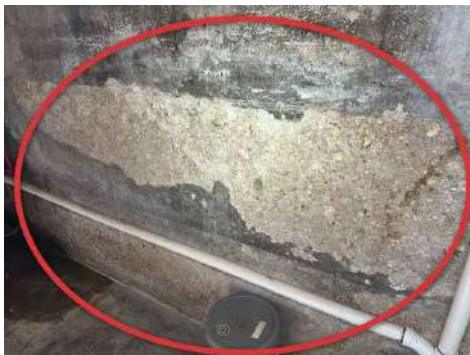
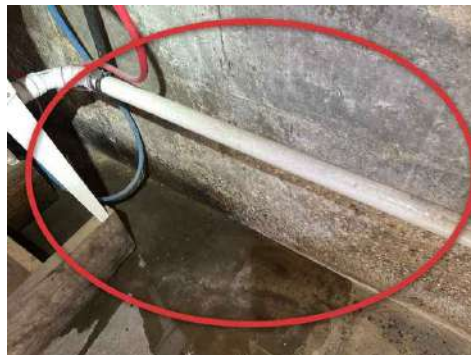
## 11.1.2 Foundation Walls

**SPALLING**

Moderate to significant surface deterioration/spalling was observed at portions of the concrete basement walls, with areas of exposed aggregate. This condition is commonly associated with prolonged moisture exposure and aging of the concrete. Recommend repairing deteriorated areas as needed, addressing sources of moisture, and monitoring for continued deterioration.

Contact a qualified professional.

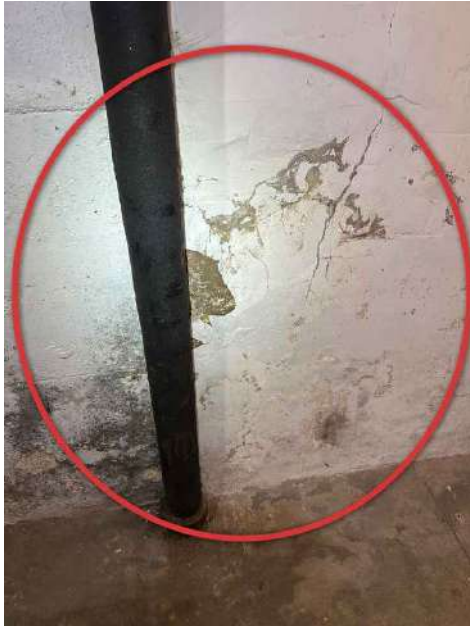
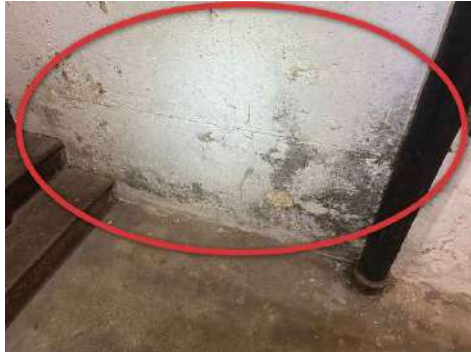
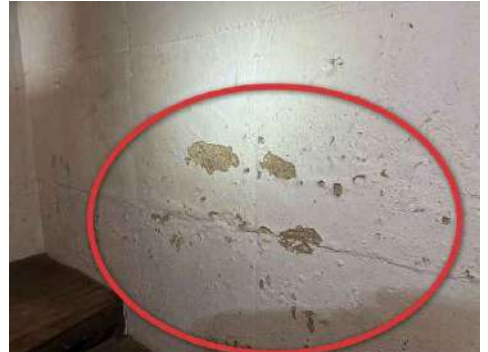
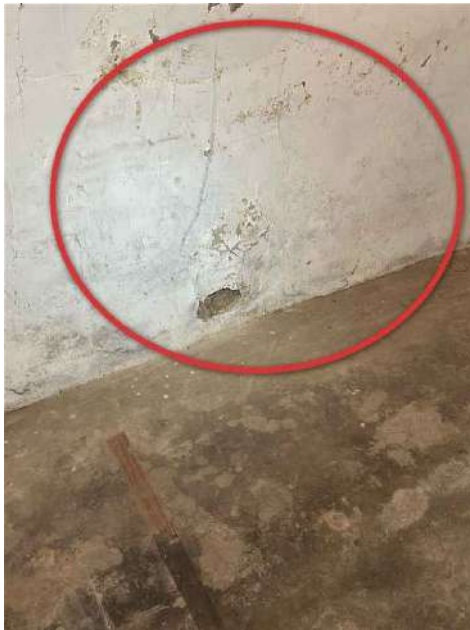
## 11.3.1 General Moisture Observations

**ACTIVE SEEPAGE**

Evidence today of moisture intrusion with active seepage - if not repaired additional moisture intrusion and/or damage may occur. Recommend professional evaluate further for corrective action.

Contact a foundation contractor.

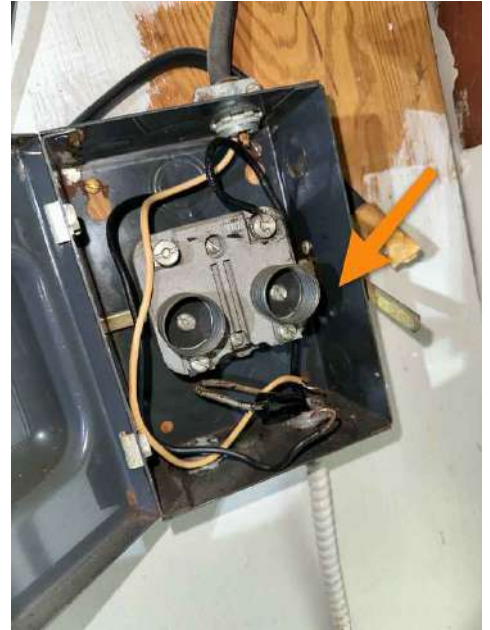
Fuse type sub-panels are obsolete and may be considered unsafe - consider updating per professional.

Contact a qualified electrical contractor.

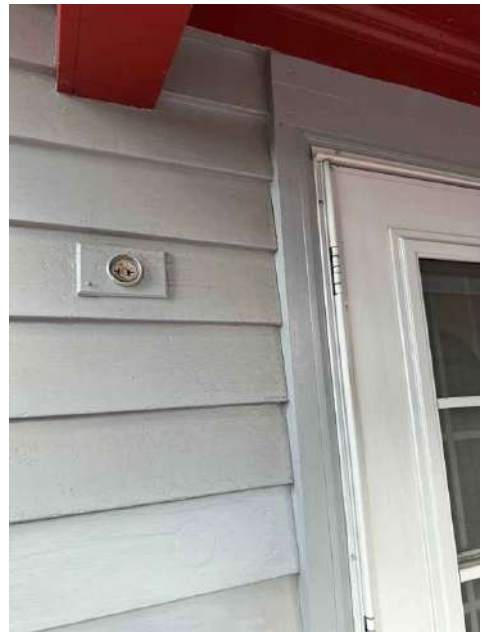
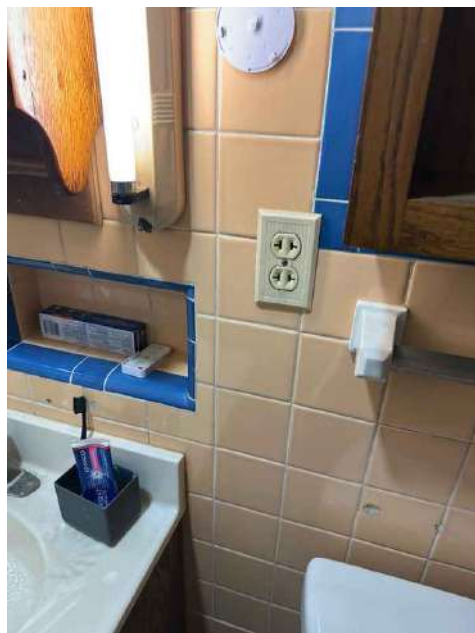
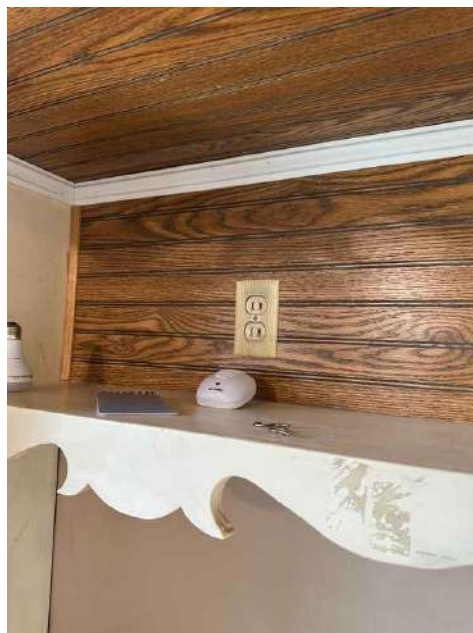
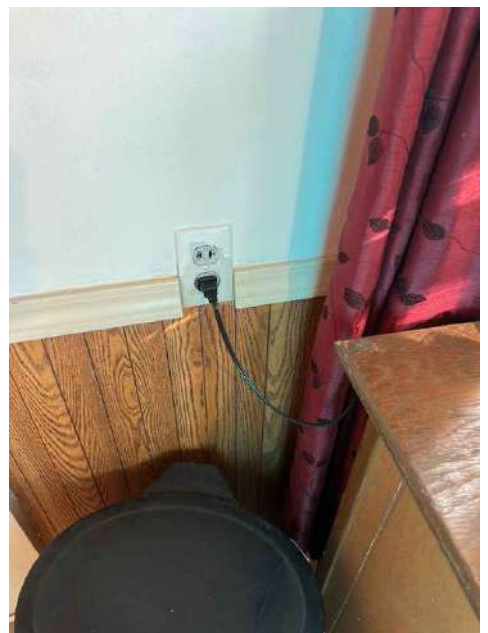
E009  
Grounded outlet

**2 PRONG OUTLETS**

2 prong outlets were observed today - commonly found in older properties. It is recommended that 2-prong outlets be updated to three prong outlets (with ground) for safety reasons. Consult professional and repair as needed.

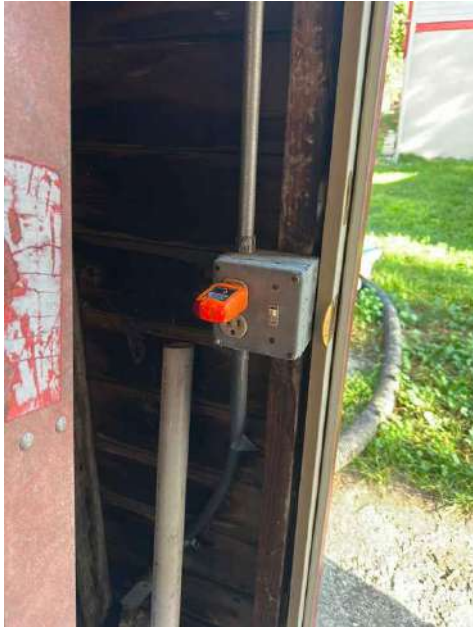
Recommend GFCI Protection

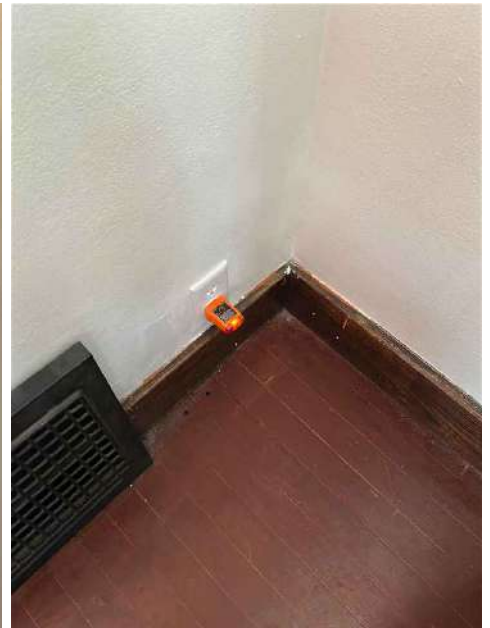
Mis-Wired

Out of the representative number of outlets tested, some appear to need repair (commonly found). If not corrected a safety hazard exists - recommend repair per professional.

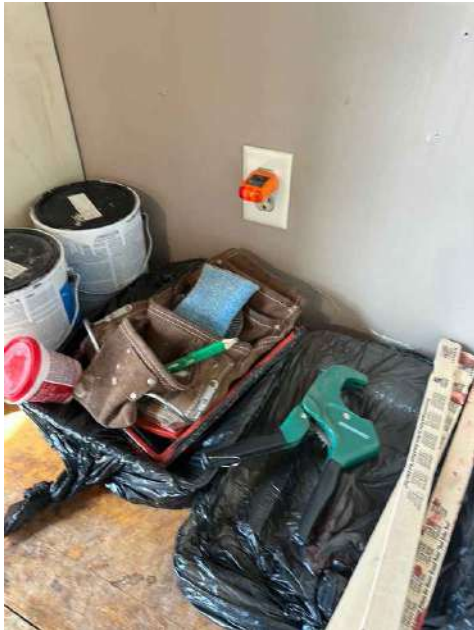
Mis-Wired

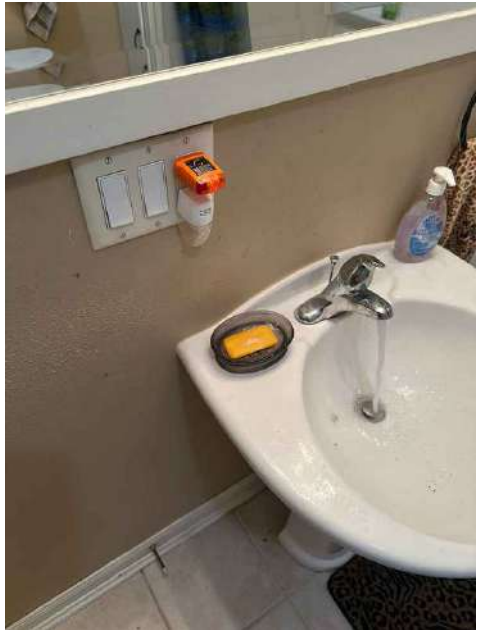
Mis-Wired Recommend GFCI Protection

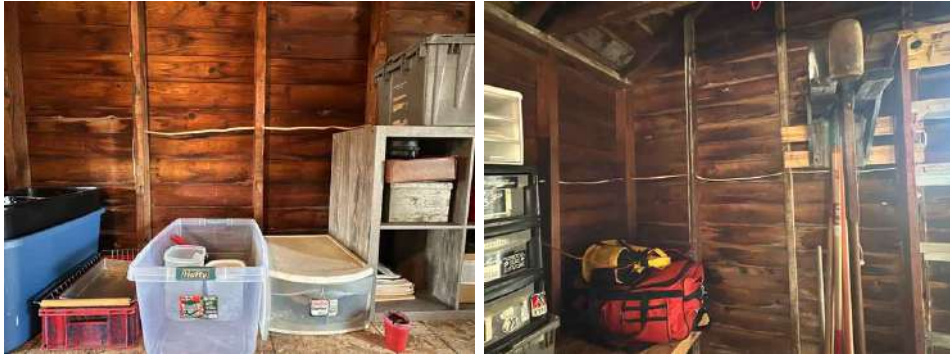
Horizontal unprotected NM cable lower than 6 feet observed in the home (commonly found) - may indicate sub-standard wiring practices (confirm permits). Recommend protecting/installing properly per professional.

Contact a qualified electrical contractor.

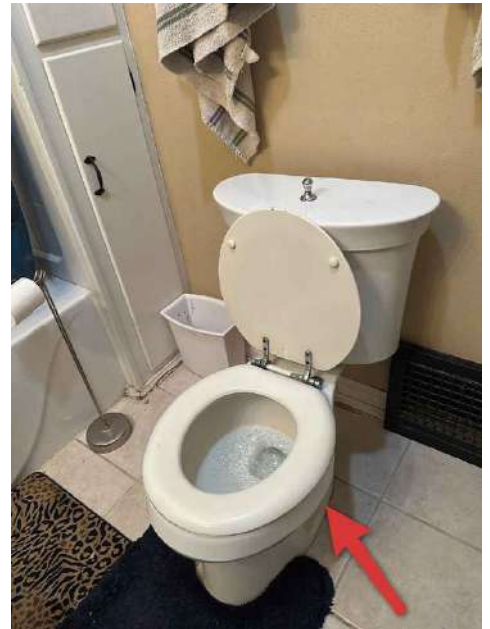
**LOOSE AT FLOOR**

The toilet was not properly secured - loose at the floor. This can lead to leaking from the wax ring. If not repaired, water damage may occur. Contact a qualified person to properly secure the toilet.

Contact a qualified plumbing contractor.

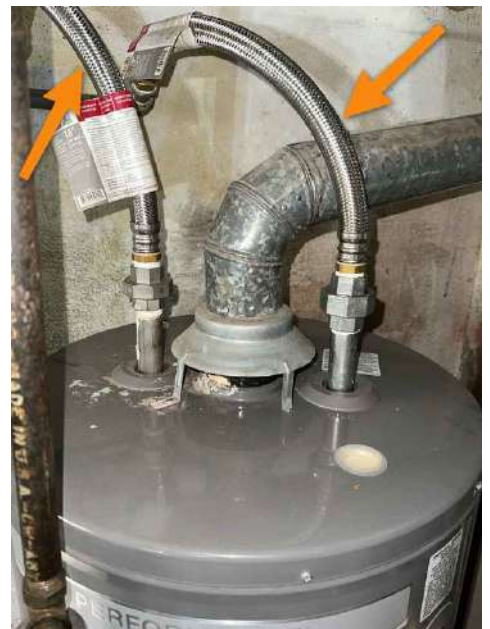
## 13.6.1 Water Heater(s)

The water heater appears to operate however it shows DIY installation. A DIY installation may not be installed the same as if a professional installed it. Recommend professional evaluate further and perform necessary improvements otherwise some safety hazards may exist.

Contact a qualified plumbing contractor.

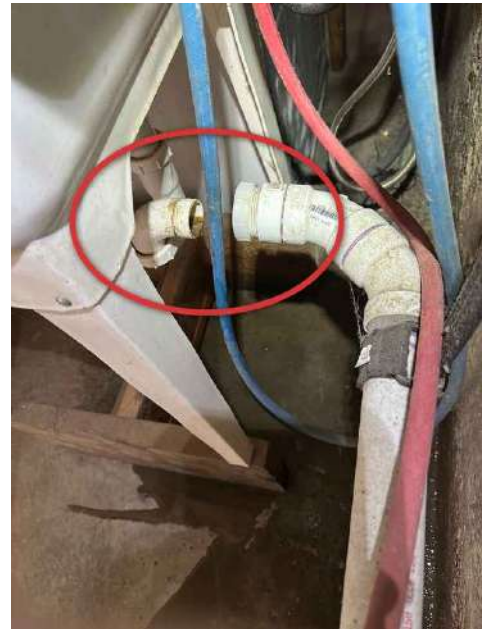
## 13.8.1 Drain Pipes

**ACTIVE LEAKS**

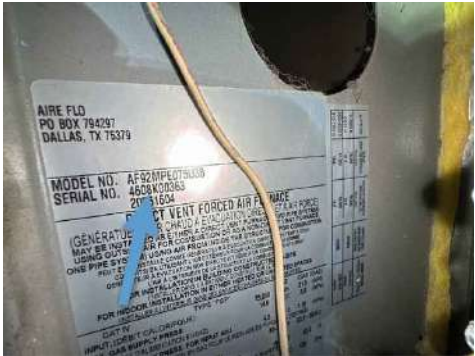
The unit appeared to operate today however the national average life expectancy of a furnace is 15-20 years therefore the unit is near or past its average life cycle. Recommend professional evaluate further to ensure proper operation and safety. Also recommend budgeting for repairs and/or replacement.

Contact a qualified heating and cooling contractor
