## RESIDENTIAL REPORT

N67W25502 Vail Ln  
Sussex, WI 53089

Russ Kloehn  
10/10/2025

## ITEMS ADDRESSED FROM HOME INSPECTION BY PREVIOUS SELLER IN 2025

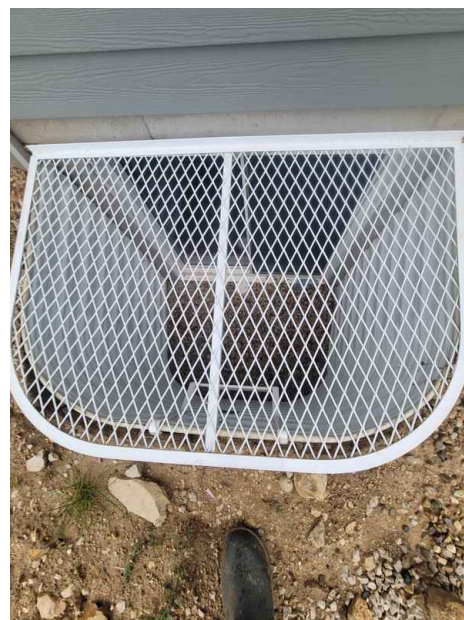
#### Basement Egress: Potential leak area

Common leak area - anticipate possible leaks - drain not tested/verified.

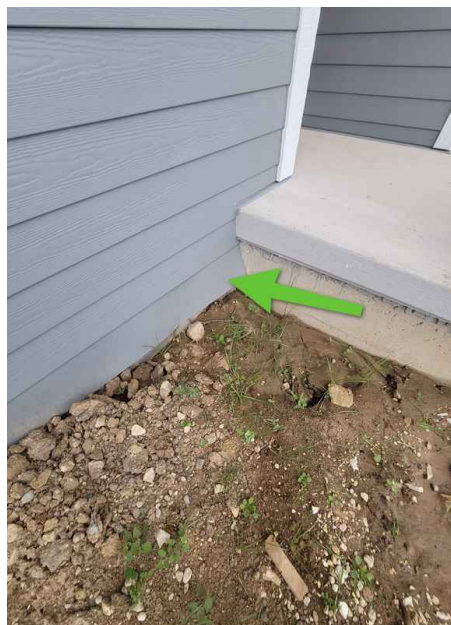
### Siding / Trim / Caulking: Loose foundation cover

Commonly encountered loose exposed foundation cover at the lower grade area of the foundation is typically a cosmetic concern. Repair should be undertaken as necessary by a professional.

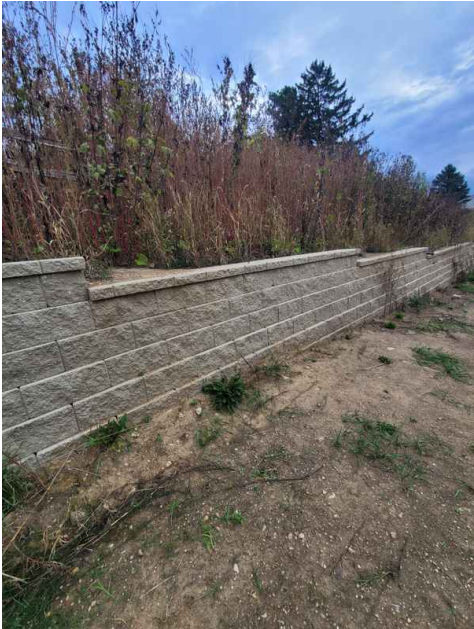
Retaining wall ownership is unknown (consult seller) and is high - caution! Potential safety/fall hazard. - Consult professional on repair options as needed.

Recommendation

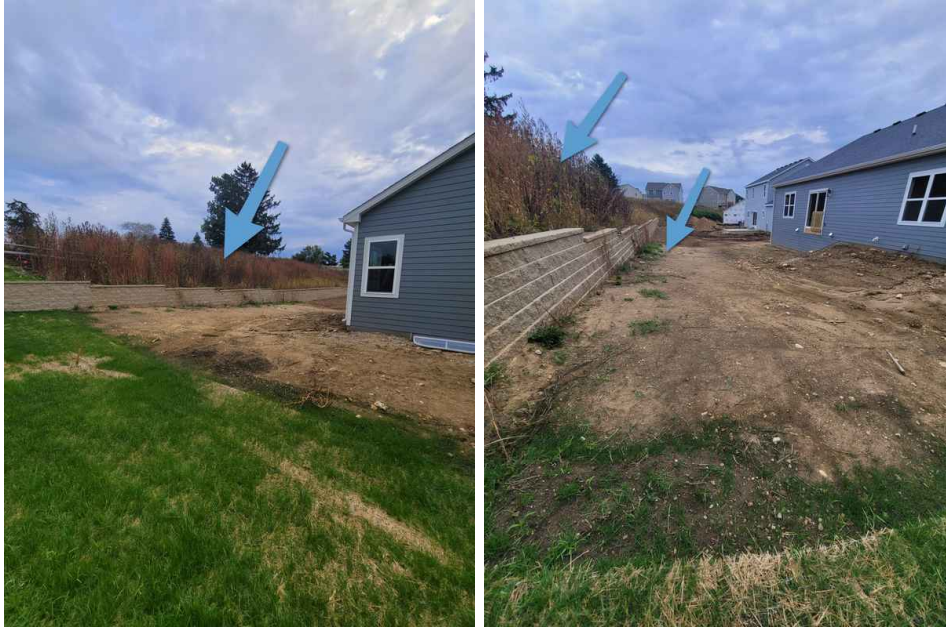
## 2.6.1 Landscaping

**HILL**

Hill observed in the back yard - monitor water flow. Repair is recommended if water is being directed towards the structure. - Monitor and/or consult a professional for options as needed.

Contact a qualified landscaping contractor

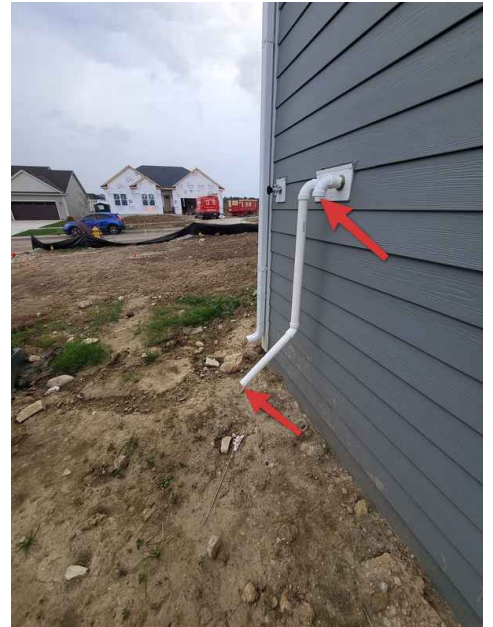
## 2.9.1 General Remarks

Recommend extending sump pump pipes a minimum of 6 feet away from the house. Two pipes present and 2nd pipe appears to be plumbed in for a battery back (battery back up not present). - Consult professional for evaluation and corrective action.

Contact a qualified professional.

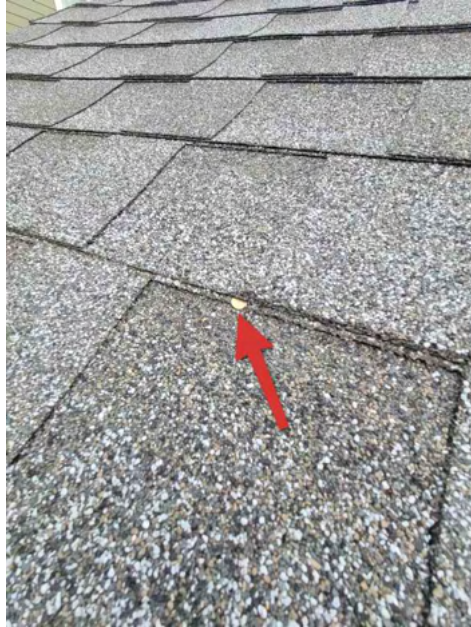
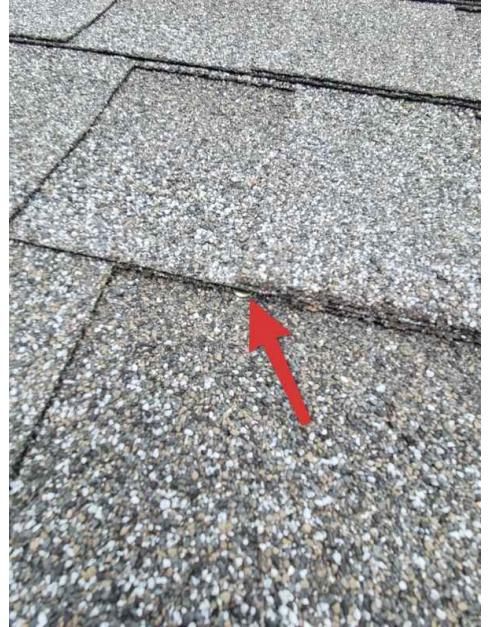
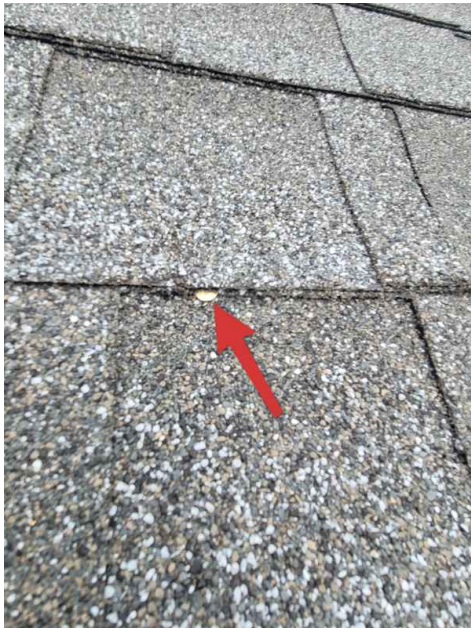
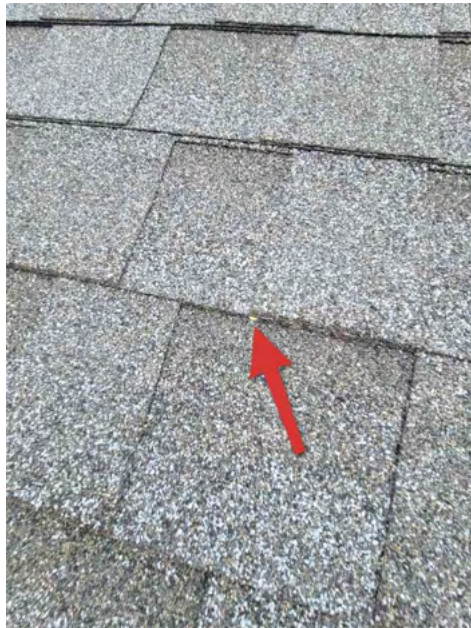
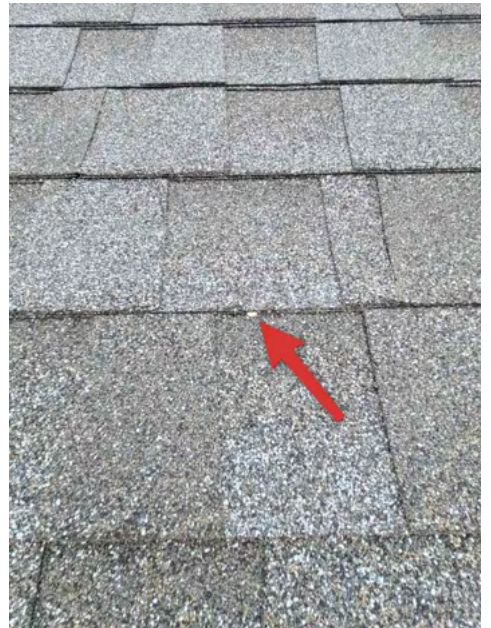
## 3.1.1 Roof Covering(s)

Exposed fasteners observed on roof area. If not repaired leaking may result. - Consult professional for corrective action.

1. Repaired siding defects of damaged seams and face nailing areas as noted on the report.
2. Replaced the shingles that were affected from exposed nail heads on roof as noted on the report.
3. Repaired improperly pitched gutter at garage as indicated on the report.
4. Furnace was cleaned and the air filter was replaced.
5. Verified that the OTR microwave is vented to the outside.
6. Verified that the back retaining wall is the responsibility of the new homeowner. *(Buyer asked for Retaining Wall Maintenance Agreement to be drawn up and recorded for each of the lots/properties that the retaining wall extends onto those specific lots.)* – **See in MLS Docs**
7. Verified that there are control joints in garage and basement slabs – as a standard the Builder uses the **zip strip system** (see below).

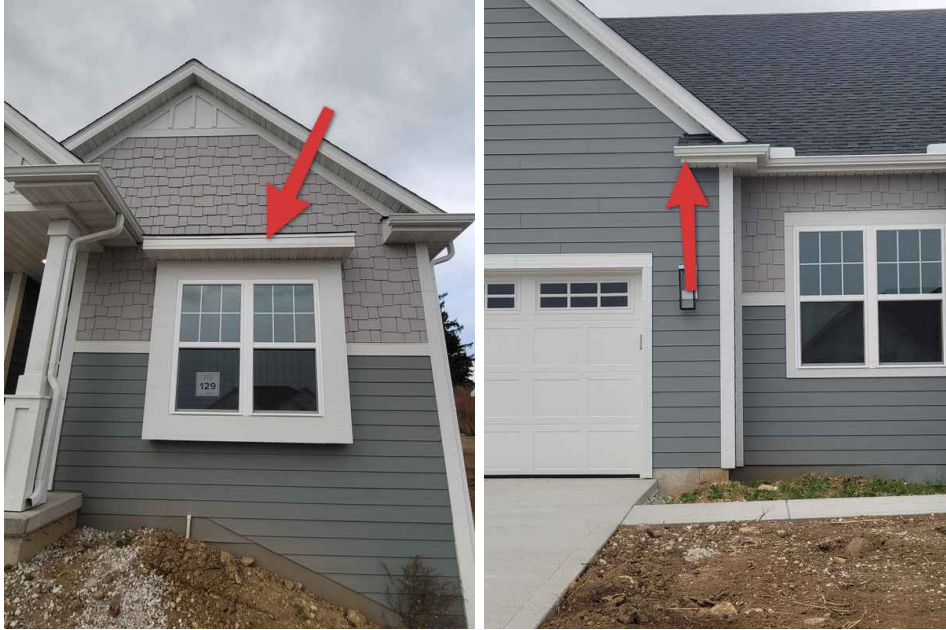
## 3.4.1 Roof Drainage System(s)

**MISSING AREA/IMPROPER PITCH AREA**

Gutter/downspout not installed at small roof over front window and improperly pitched area at front of the home observed today (all gutters should pitch towards a downspout). If not corrected the gutters may not operate as intended. - Recommend repair per professional.

Contact a qualified gutter contractor

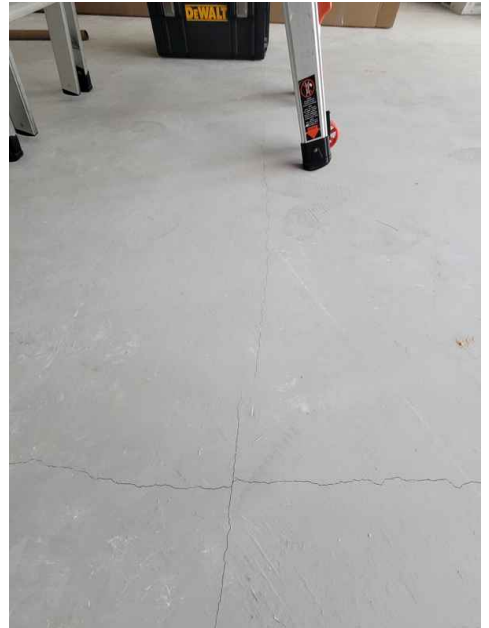
## 5.2.1 Floor

**COMMON CRACKS**

Common cracks observed (no expansion joints - common method). Monitor and if cracks change contact a professional at that time.

Recommend monitoring.

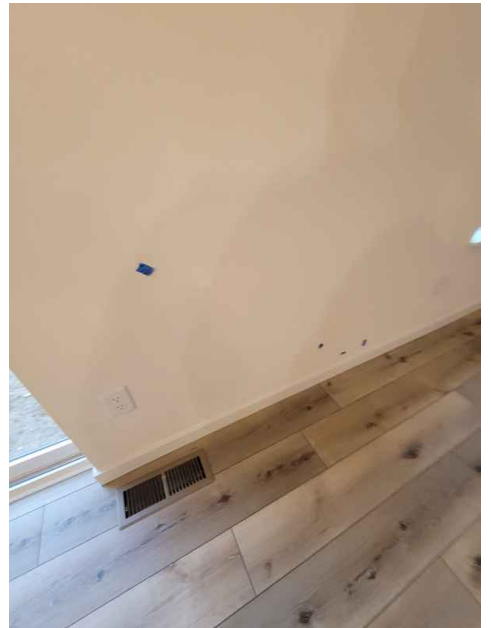
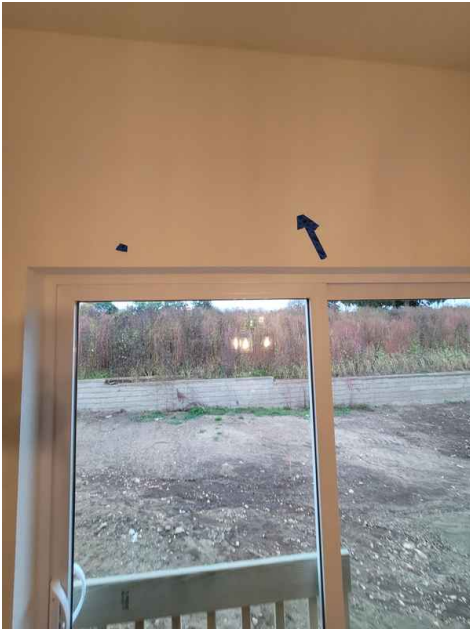
Interior walls/trim in are(s) are marked/taped for touch ups. - Recommend consulting seller/builder prior to closing that work has been completed.

Monitor / Maintenance

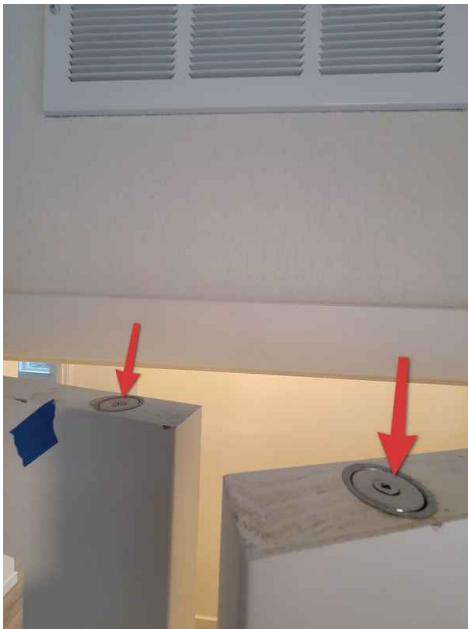
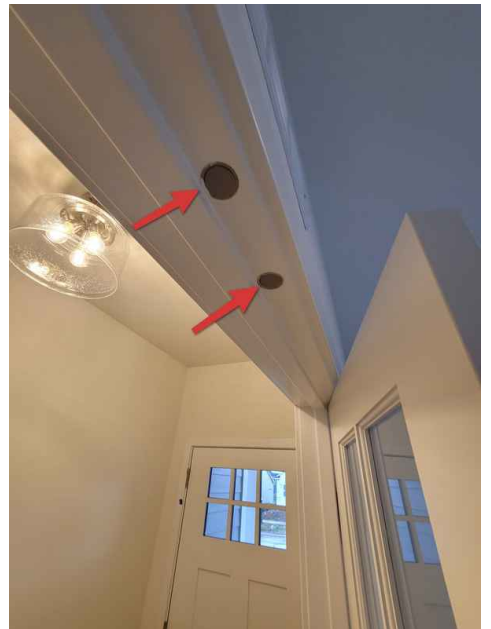
### 7.3.1 Interior Doors (representative number)

#### **MISSING HARDWARE**

Missing hardware at flex room door(s) - if not repaired the door(s) may not operate/latch as intended. - Recommend repair per professional as needed.

Contact a qualified door repair/installation contractor.

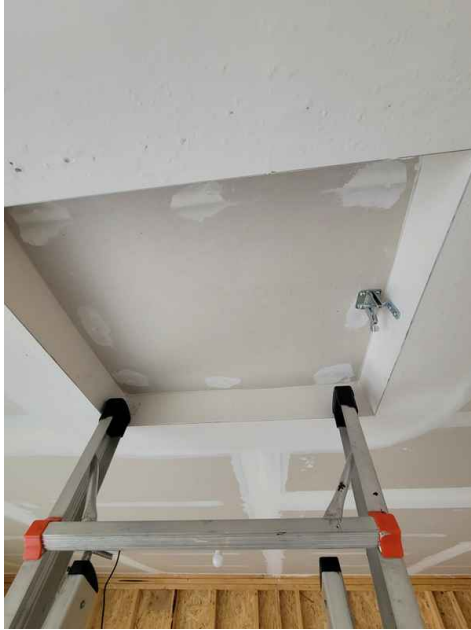
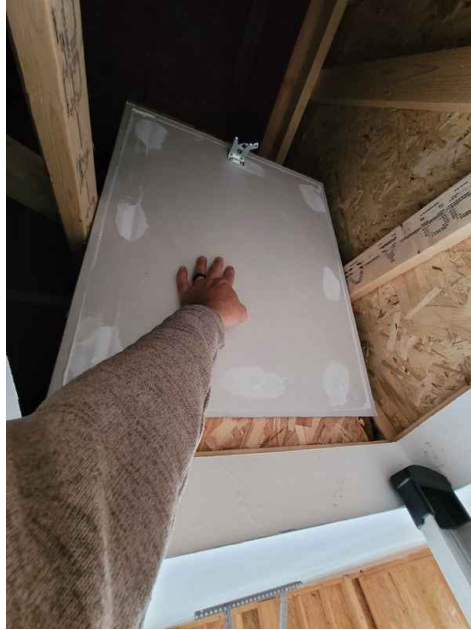
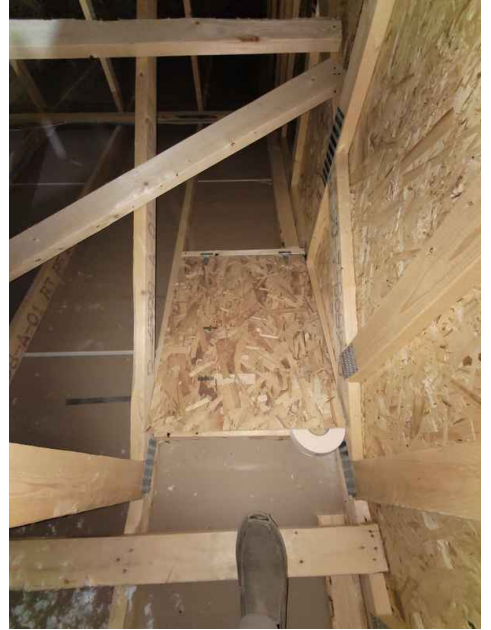
Access to the attic in the garage appears to have issues that may lead to potential safety hazards - scuttle is latch/hinged and is restricted by roof truss - will shut/latch when let go and someone may be stuck inside the attic - Recommend professional evaluate further for repair options.

Contact a qualified professional.

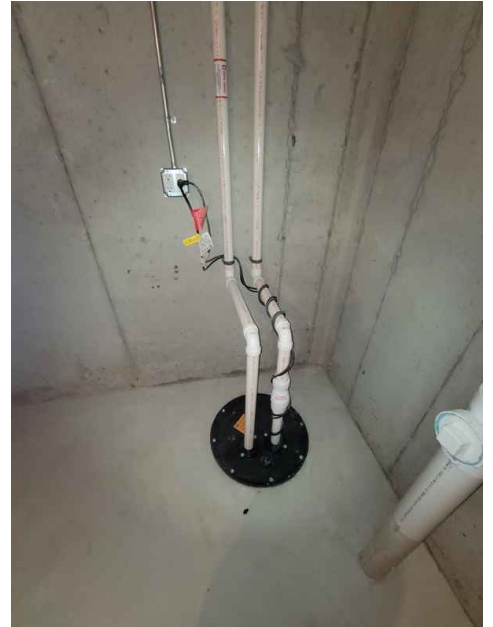
**PUMP NOT INSPECTED DUE TO SEALED LID**

I was not able to inspect the sump pump/crock due to a sealed lid. Pump did appear to operate (double plug). - Further evaluation of pump is recommended.

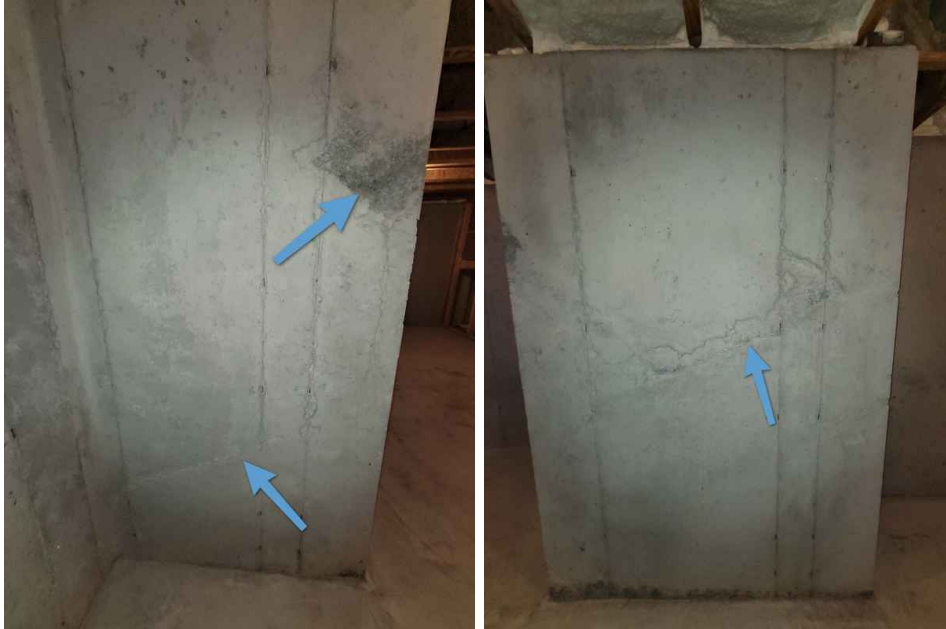
## 11.2.1 Foundation Walls

**DRY RUNS AND/OR CRACKS - NO SEEPAGE**

Common dry runs and/or cracks are noted today on the foundation wall(s). These are usually non-structural though may seep or leak (no evidence of seepage today). Monitor/Consult professional as needed.

Recommend monitoring.

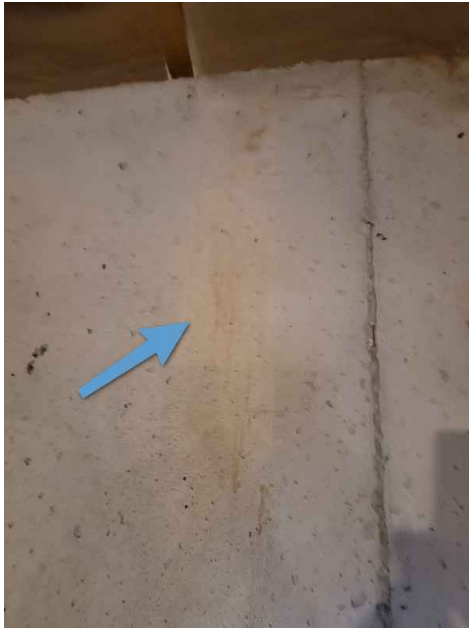
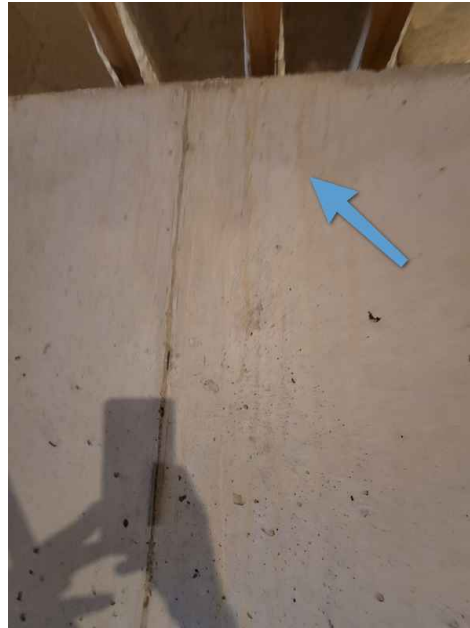
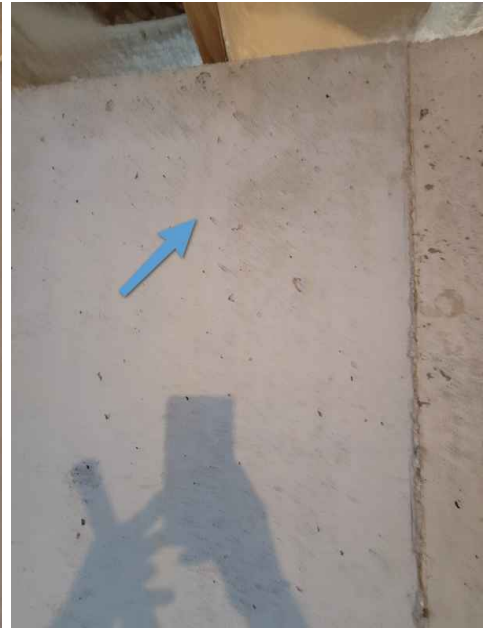
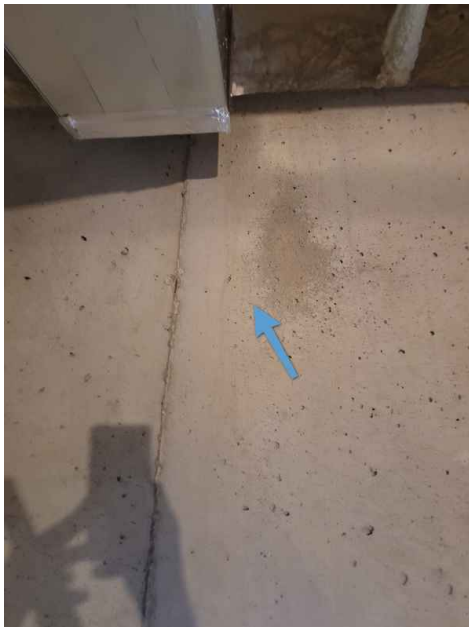
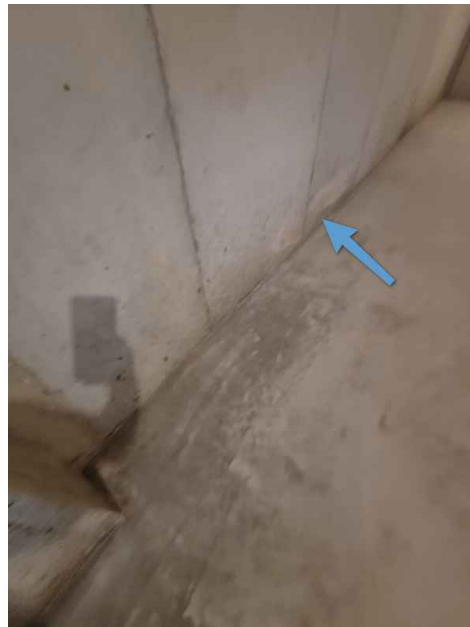
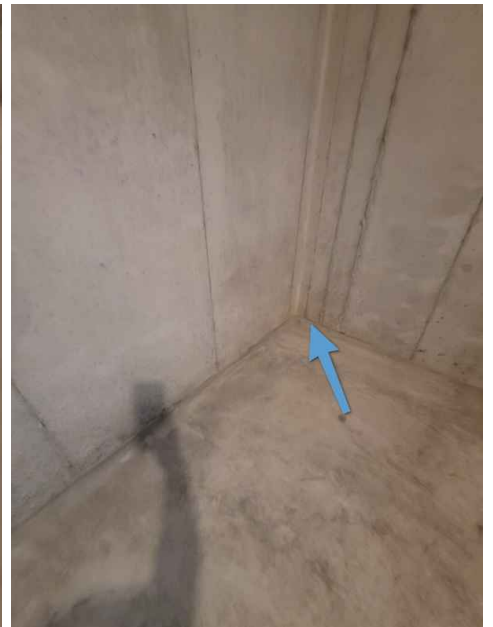
## 11.4.1 General Moisture Observations

**EVIDENCE OF PAST/ACTIVE MOISTURE INTRUSION**

Evidence today of past/active water seepage in the basement (commonly found) and although not confirmed this may have occurred during the construction process when the foundation was open to the weather. Consult owner on seepage history to confirm a dry basement. Recommend all exterior grading be pitch away from the home (1 per foot extended for 6 feet). Also ensure all gutters and downspouts are installed properly, clean and extended 6 feet away from the house. - Recommend monitoring and if seepage issues occur contact a professional at that time.

Recommend monitoring.

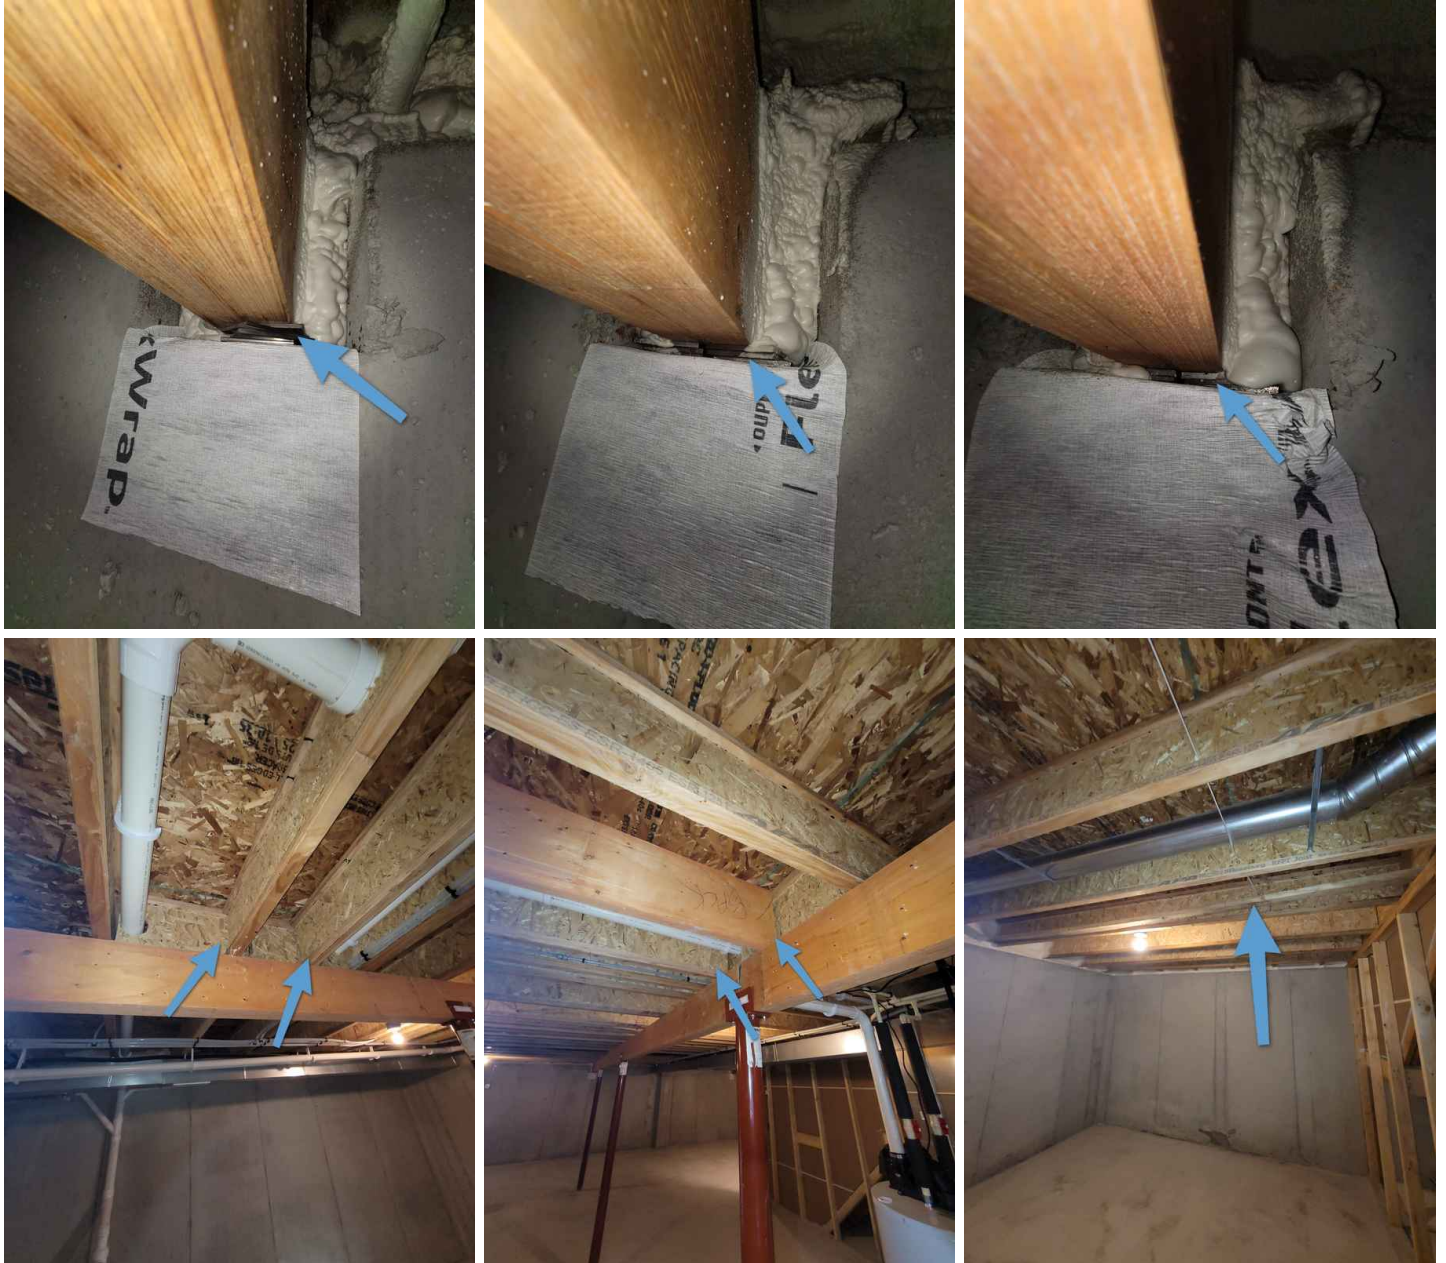
## 11.7.1 Structure

**MODIFICATIONS - NO VISIBLE ISSUES**

Modifications observed today - shimmed house girders, floor joists cut (appears to be for mechanicals) and reason for 2x4 at stairs is unknown. No visible structure issues visible today and modifications appear to be working. - Recommend monitoring and/or consult a seller/professional for proper code compliancy as needed.

Monitor / Maintenance

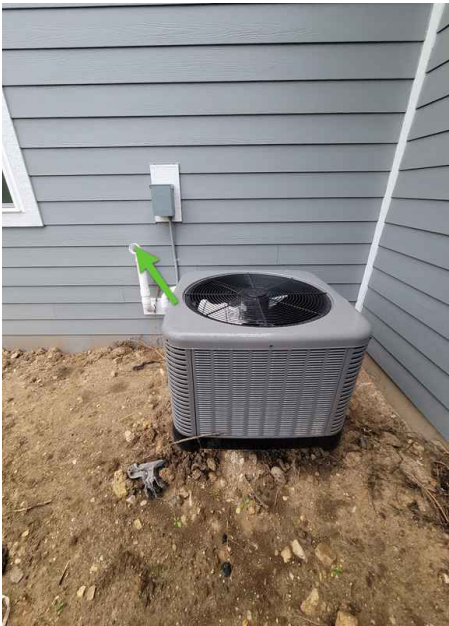
**Condenser / Compressor: Vent close to compressor**

A furnace vent pipe appears to be close to the exterior compressor unit - monitor. As is, the compressor may become rusted or damaged due to the exhaust of the vent coming in contact with the unit long term. Consult professional as needed.

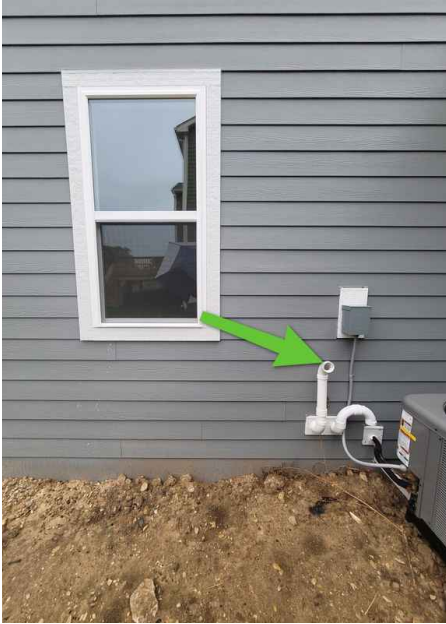
### Condition(s): Furnace flue pipe close to window

The furnace vent pipe at the exterior of the home may be too close to a window (commonly found) - caution! Potential CO hazard if the window is open while the furnace is operating. Repair per professional recommendations as needed.
