# INSPECT WITH HESS

Inspection Report  
710 Krueger Court, Onalaska, Wisconsin 54650

Report ID  
AP-127-001335

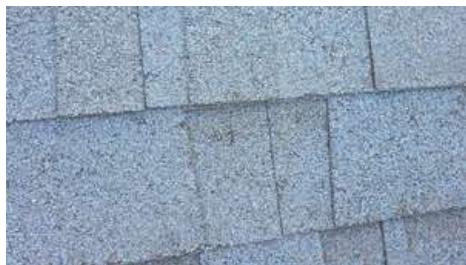
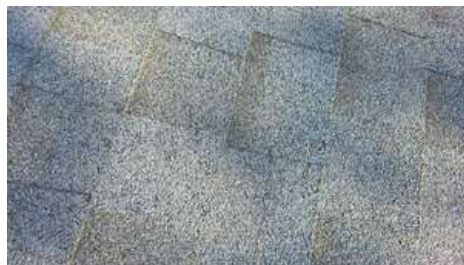
The roof covering shows granule loss consistent with normal aging. This condition is typical as asphalt shingles age. Monitor and plan for eventual replacement as the roof continues to age.

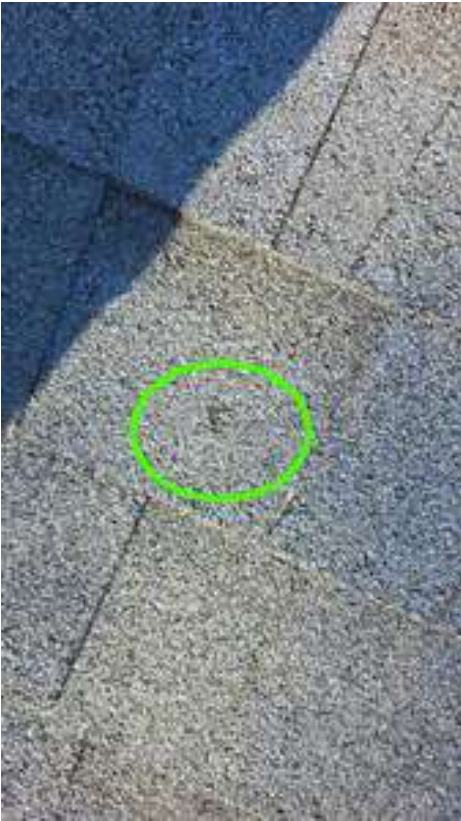
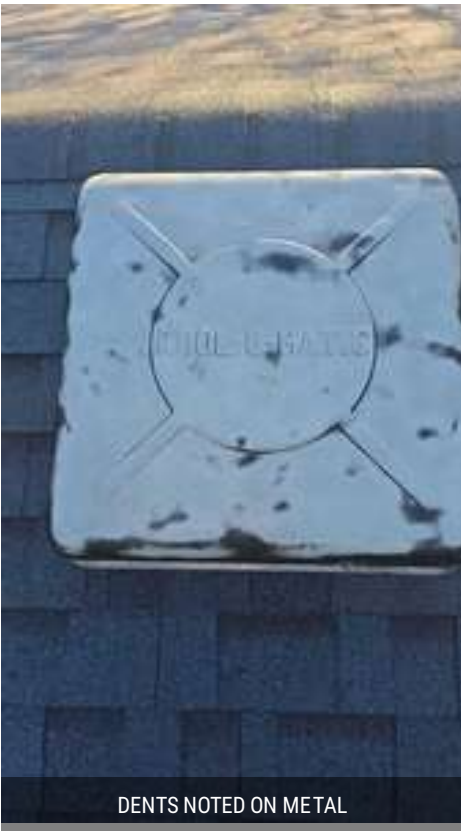
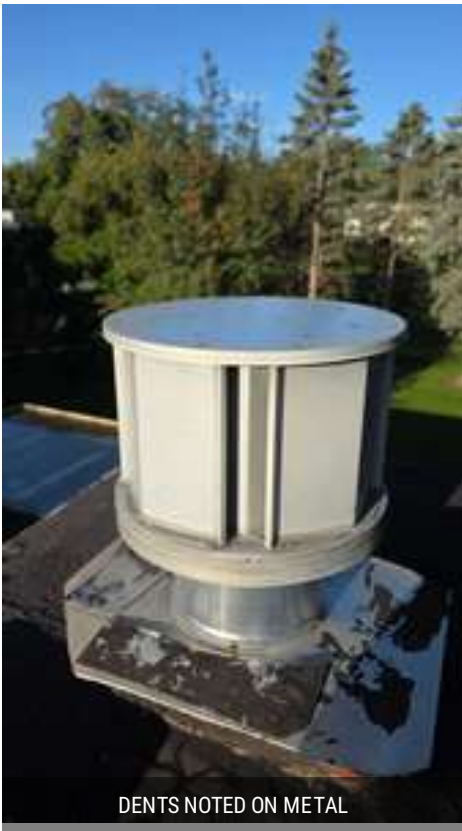
#### 1.5.2 Hail damaged shingles (One or more)

At the time of inspection, one or more areas of the roof had several shingles that were possibly damaged by hail. The Inspector recommends that the affected area(s) be evaluated, replaced or repaired, as needed, by a qualified roofing contractor.

The metal porch roof had multiple small dents/impact marks consistent with possible hail exposure. The damage appeared primarily cosmetic at the time of inspection, and no active leakage or obvious failure of the roof covering was observed. Thin-gauge metal roofing can dent relatively easily from hail or other impact. Recommend monitoring and having a qualified roofing contractor evaluate further if leakage, loose seams, damaged coatings, or additional deterioration is noted.

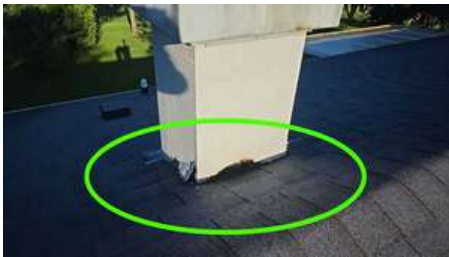
### 1.7.1 Chimney Cladding

The chimney chase is clad with an embossed metal siding designed to resemble brick. Corrosion and deterioration were noted along the lower edges, with localized material loss. The visible roof-to-chimney flashing appeared generally serviceable at the time of inspection. Recommend repair or replacement of the deteriorated cladding and refinishing/protecting exposed metal to prevent further corrosion and potential moisture intrusion.

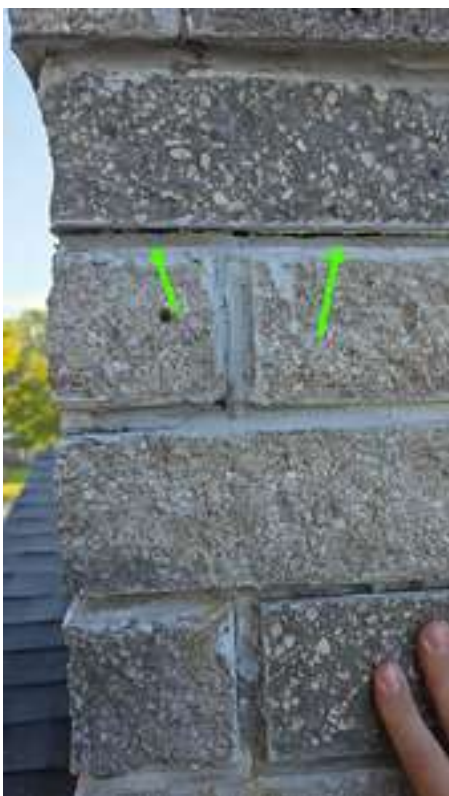
### 1.7.2 Deteriorated brick/mortar

The upper portion of the chimney had deteriorated brick and/or mortar. To extend the lifespan of the brick chimney and to ensure that safe conditions exist, the Inspector recommends that an evaluation and any necessary work be performed by a qualified masonry contractor.

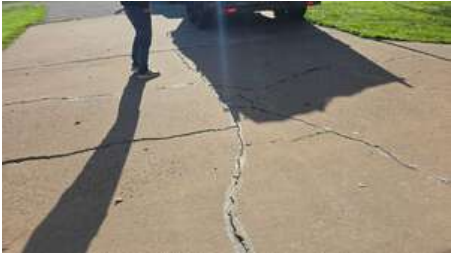
#### 2.4.1 Cracks or damage (Driveway)

Large visible cracks and/or badly damaged areas of the driveway. This can be very costly to repair. The inspector recommends, that the driveway be evaluated and repaired or replaced, by a qualified concrete contractor.

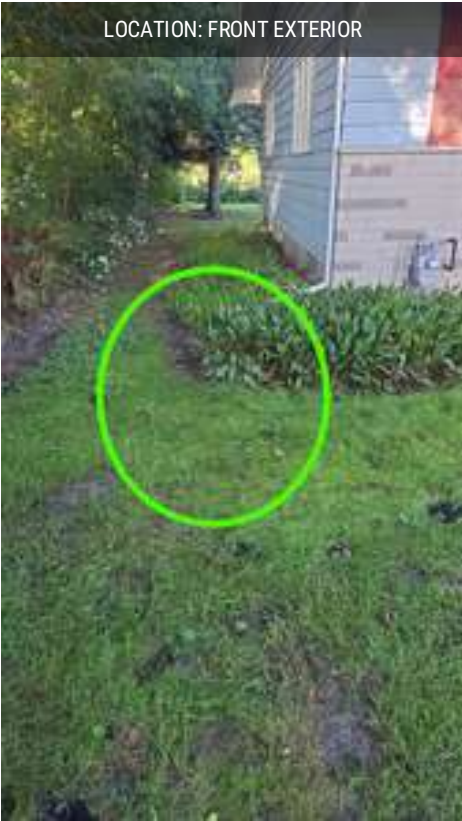
The ground near the foundation was not sloped adequately to direct water away from the foundation. This is very common in new and old homes and often found during inspections. This can lead to moisture intrusion and/or damage to the foundation. This may not be currently having an adverse affect on the property, however, it may be an issue during heavy rainfall. We recommend regrading to direct water runoff away from the foundation by a qualified landscape contractor.

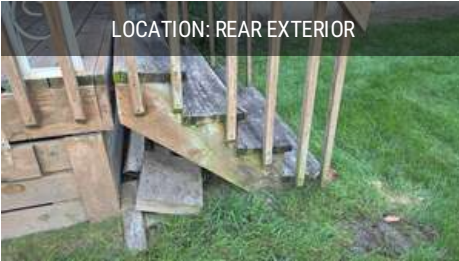
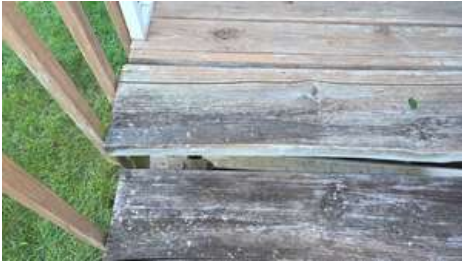
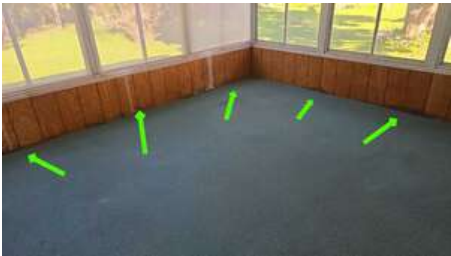
At the time of the inspection, one or more deck components were damaged and/or deteriorated. Recommend repairs be made by a qualified general contractor.

There was moisture damage inside the porch area. Before repairing any damage, the cause needs to be corrected first. All work needs to be done by a qualified contractor.

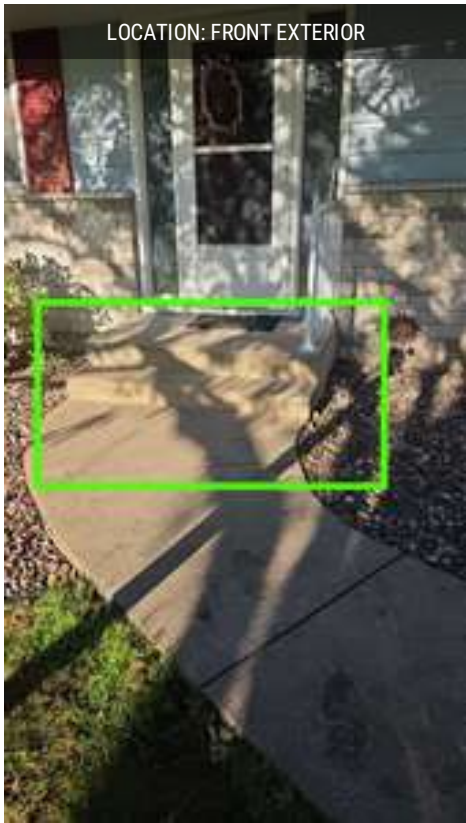
The risers for one or more sets of stairs were more than 3/8 difference. This is a trip/safety hazard. We recommend at the affected steps be repaired as needed by a qualified general contractor.

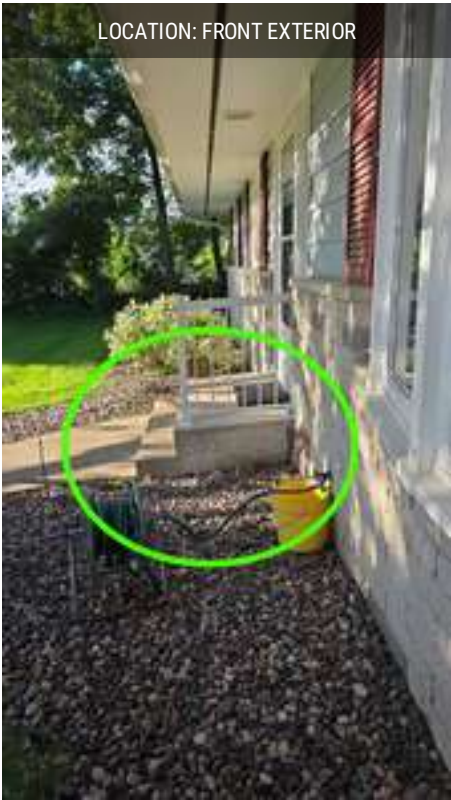
2.9.2 Steps settling

One or more sets of steps are settling. This can or already may be a trip hazard. If they slope towards the home, then it can also lead to moisture intrusion issues. Recommend correction by a qualified general contractor.

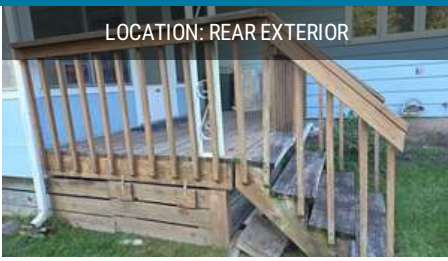
LOCATION: REAR EXTERIOR

Spaces between deck guardrail balusters, beneath the guardrails or at the sides of the guardrails were too wide. Safe building practices dictate that a 4 inch sphere may not pass through the handrail at any point. This condition is hazardous to small children. The Inspector recommends that this condition be updated to meet generally-accepted modern safety standards by a qualified contractor.

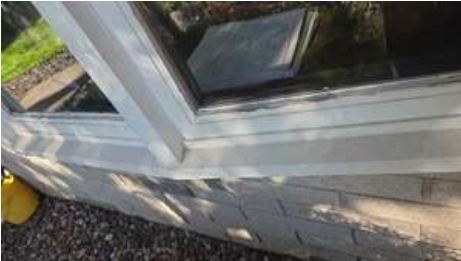
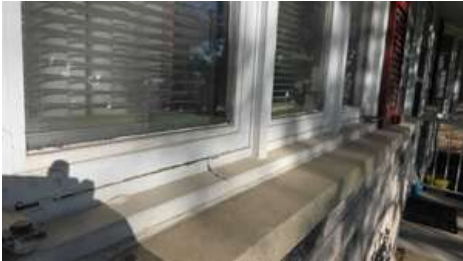
3.3.1 Paint / stain failing / missing

At the time of inspection, paint or stain in some areas was failing or missing. Recommend getting estimates prior to closing. The affected areas should be repainted as needed by a qualified painting contractor.

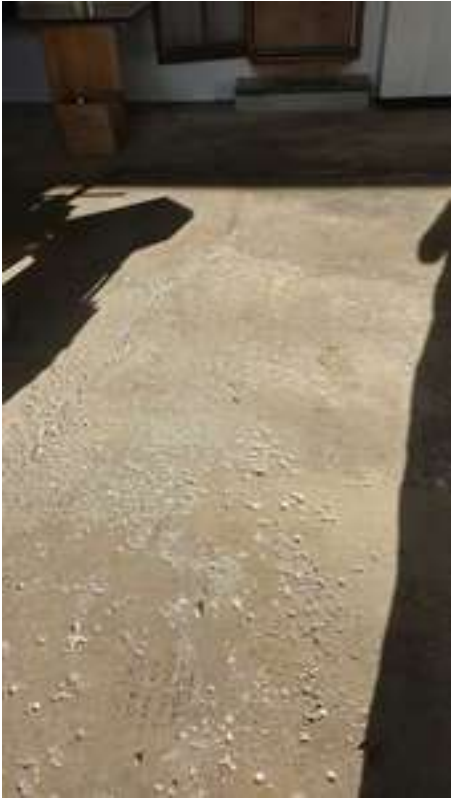
4.2.1 Floor, typical cracks

There were typical cracks identified throughout the garage floor. Recommended sealing to prevent water penetration and expansion by a qualified handyman.

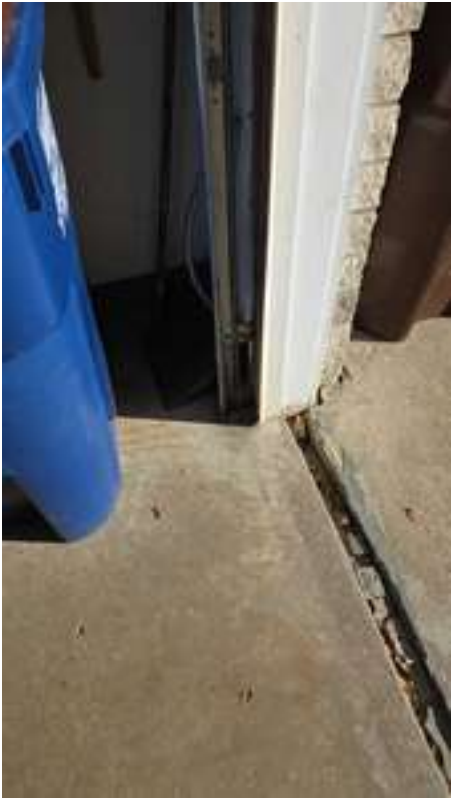
No photo sensors were installed servicing the garage door. This is a safety concern. We recommend that they be installed by a qualified garage door contractor.

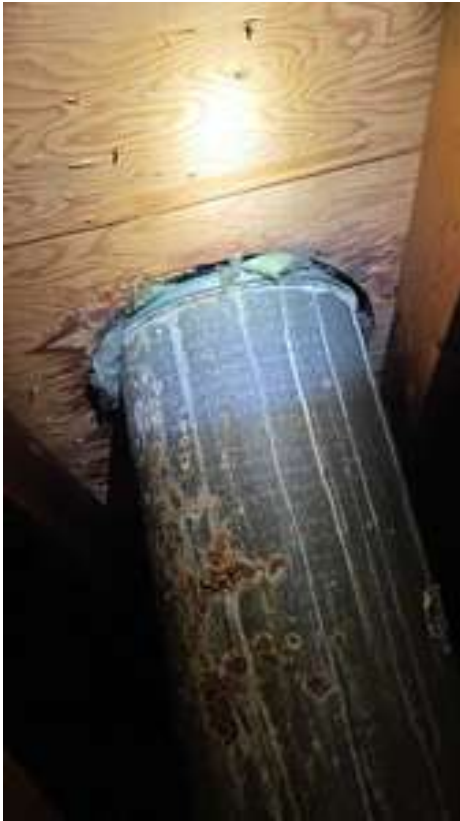
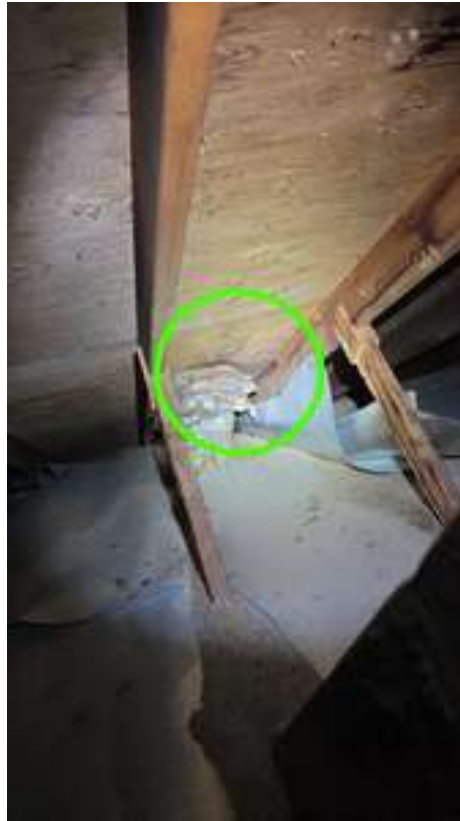
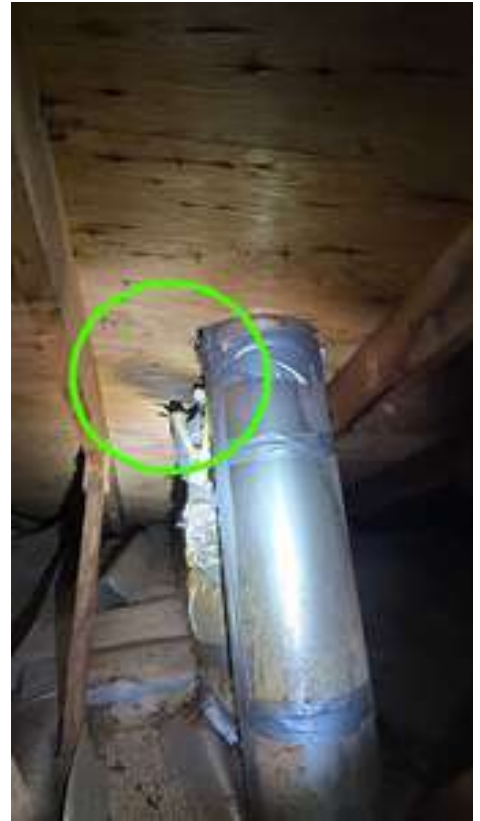
There were one or more areas with water stains where a roof leak happened in the past. The leak was dry at the time of inspection. The inspector recommends asking the seller when this was repaired or if they have knowledge of a past leak and how it was repaired. Note: Until it rains there will be no way to tell if a leak exists. We recommend testing the areas with a garden hose. Any repairs should be made by a qualified roofing contractor.

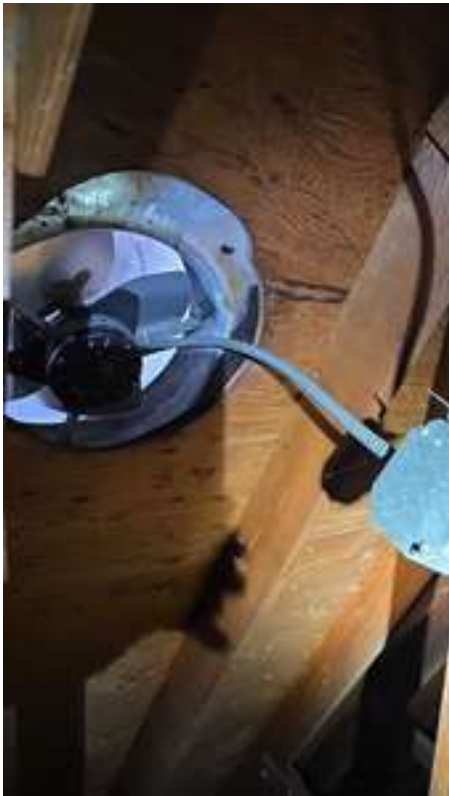
### 5.3.1 Attic Ventilation Fan

An attic ventilation fan was present. Operation was not verified, as these units are typically thermostat-controlled and ambient conditions could not be manipulated to activate the fan. Attic ventilation fans and their automatic controls are outside the scope of this inspection. Recommend confirming proper operation and maintenance with the seller or a qualified contractor as desired.

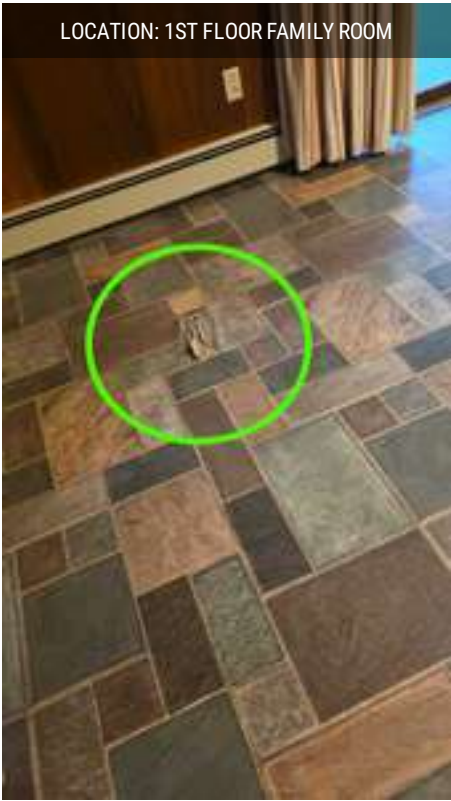
7.2.1 Damaged flooring

Flooring in one or more areas was damaged. This can be costly and/or a trip safety hazard. Ask the seller about the cause of it isn't clear. Also ask about manufacturer info for possible repair. A qualified flooring contractor can also give you repair estimates.

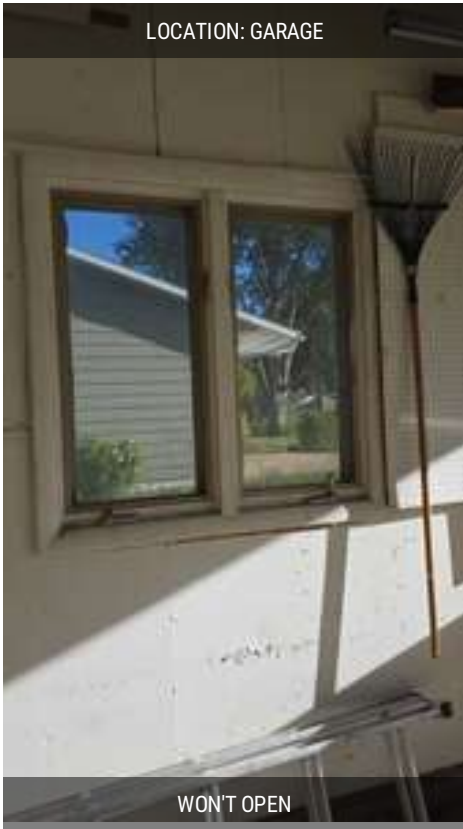
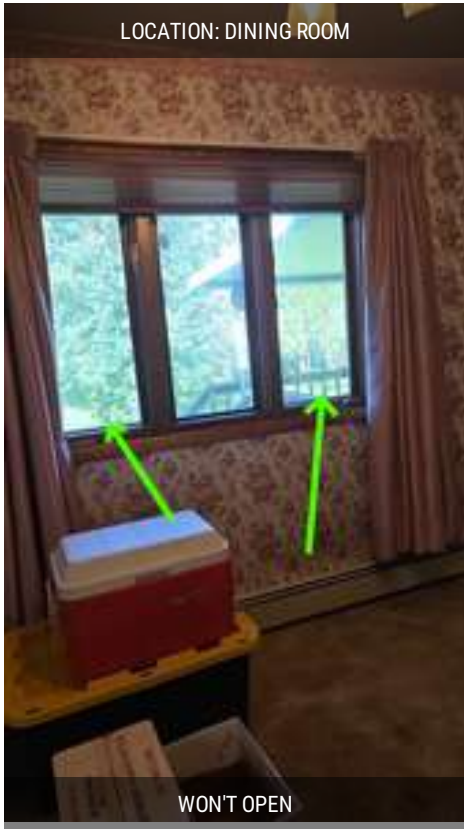
One or more windows were difficult to open and close. This is a safety egress concern and / or high repair cost concern. Recommend repair by a qualified window contractor.

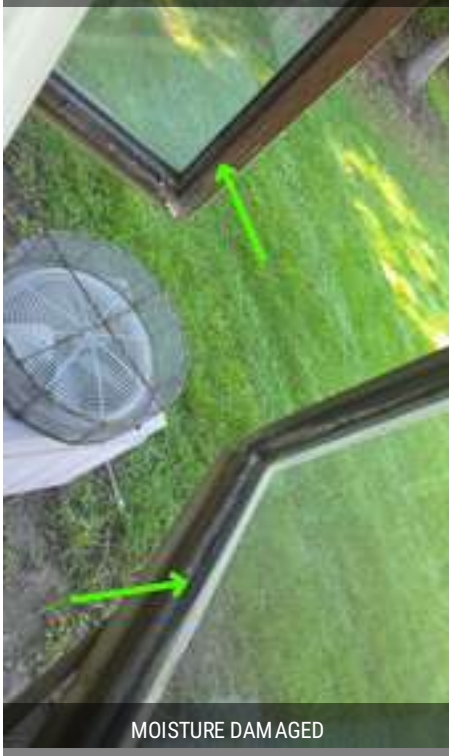
### 7.6.3 Damaged window

LOCATION: MASTER BATHROOM

One or more windows were damaged. This can include damaged vinyl, wood, cracking, chips and any other defect found on the interior of the windows. The inspector recommends that the areas that are damaged be repaired by a qualified window repair contractor to industry standard.

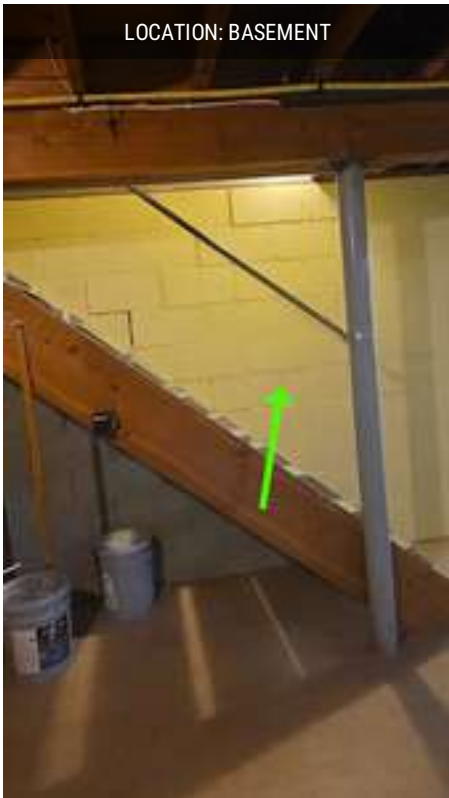
#### 7.8.1 Guardrail loose/ damaged/ missing

LOCATION: BASEMENT

One ore more guardrails were loose. This is a safety concern. We recommend that the guardrails be repaired for safety by a qualified handyman. .

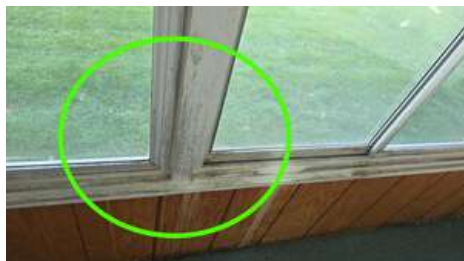
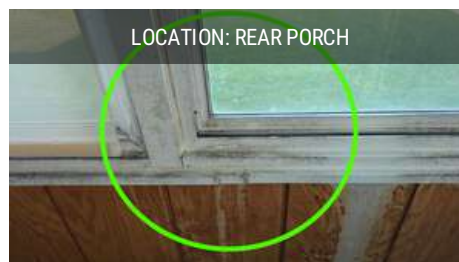
The Inspector observed what appeared to be microbial growth similar to mold. Identifying mold requires laboratory testing. When exposed to moisture levels at or above approximately 27% in materials, mold can produce airborne spores. high concentrations of spores can represent a health hazard to those with asthma, allergies, lung disease, or compromised immune systems. At moisture levels below about 27%, mold fungi do not produce spores. Small amounts of mold can be removed with detergent and a brush and the area treated with a fungicide. Large amounts are typically removed with materials or encapsulated, depending on the location. Mold needs moisture to grow and the source of the moisture should be located and corrected. All work should be done by a qualified contractor. Click [HERE](#) for more info on mold.

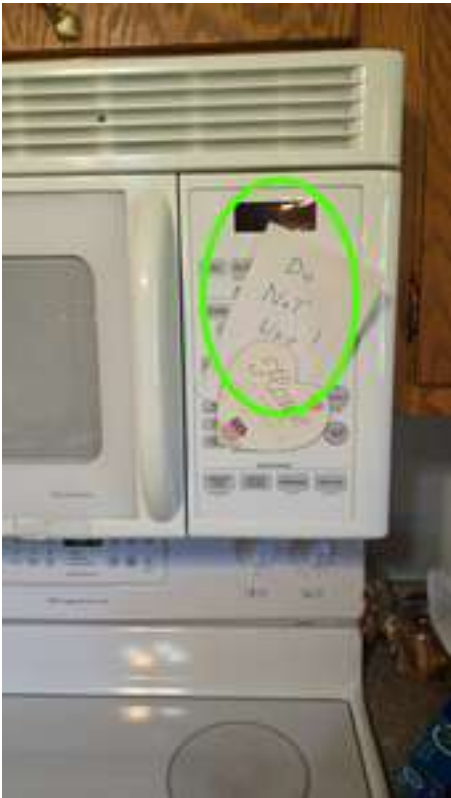
The microwave was inoperable. Recommend repair by a qualified appliance repair contractor.

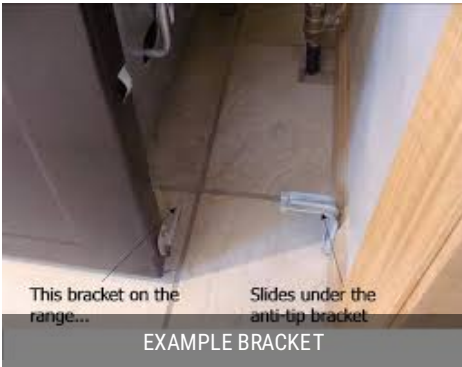
The oven anti-tilt device was not installed. This mechanism comes stock with the stove/range. This attaches to the wall and the oven is placed on it and attaches to it. This is a safety feature for children that tend to step on the bottom drawer to get something in a cabinet above the stove. It is an anti-tilt safety mechanism. We recommend that it be installed per the manufactures installation instructions.

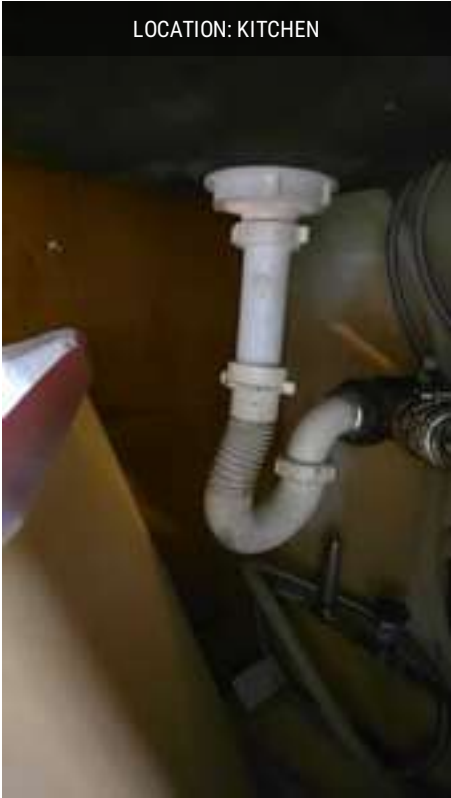
Corrugated flexible drain was installed under the sink one or more sinks. These are a sign of unqualified work and are prone to leaks and or poor function. We recommend replacement by a qualified plumbing contractor. Monitor regularly at a minimum.

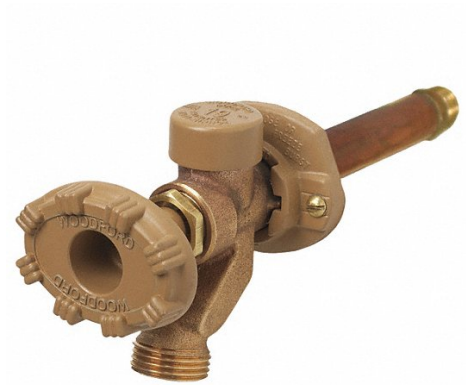
There were no anti-siphon devices installed on the exterior hose bibs. These are needed to help the pipe from freezing if a hose is attached and to prevent water from siphoning back into the house should the end of a hose be left in a pool of water. These can be purchased at most local hardware stores and screw onto the hose bib.

EXAMPLE WITH BUILT IN ANTI-SIPHON

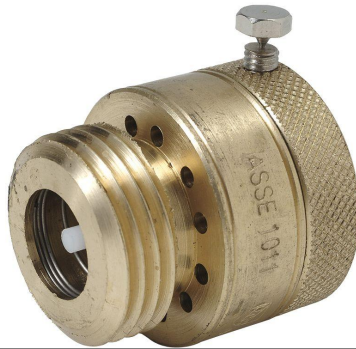
ANTI-SIPHON ATTACHMENT THAT CAN BE SCREWED ONTO EXISTING FAUCET

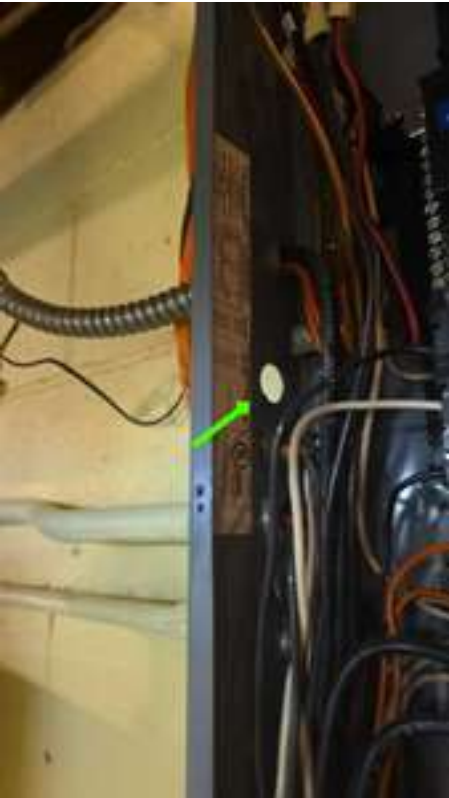
Missing knockouts in electrical panels can be a safety hazard. Unused openings can allow sparks to ignite combustible materials, or allow accidental contact with live parts. This is a safety concern. We recommend a qualified electrician repair as needed.

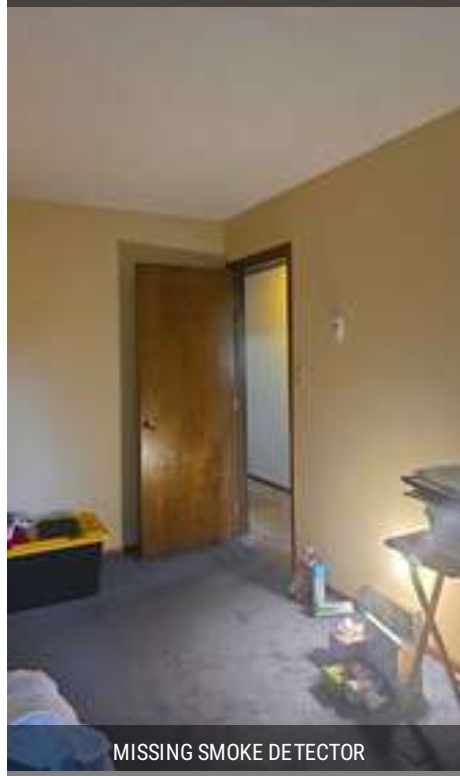
MISSING SMOKE DETECTOR

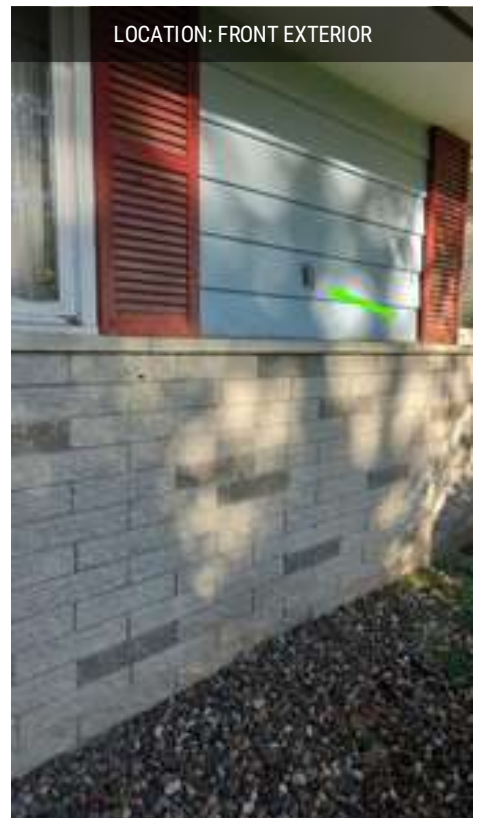
## LOCATION: FRONT EXTERIOR

## 14.11.1 GFCI protection missing

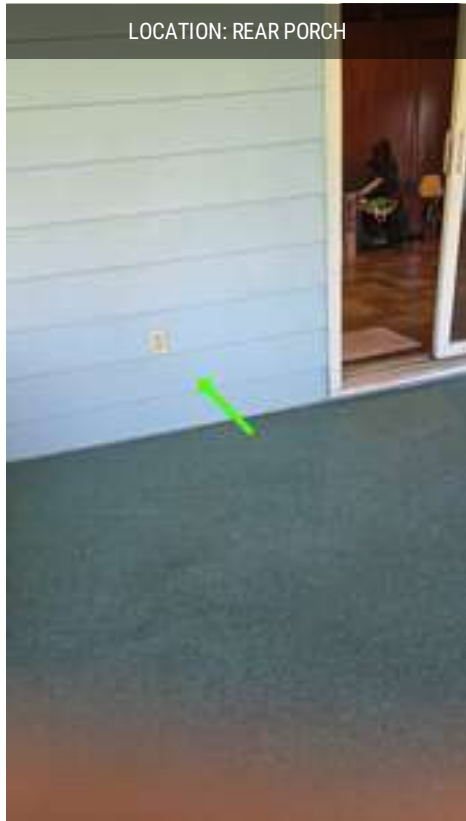
3 prong outlets were installed in areas and tested as open ground. This is a safety concern because metal appliances can become energized in the event of an over current situation and be damaged. With no ground wire to carry away the electricity a person can get shocked. We recommend that the outlets be updated or repaired as needed. The installation of a GFCI protected circuit with is an accepted repair, or the installation of a ground wire back to the panel buss bar. There are other repair options but the evaluation and recommendation for repair should be made by a professional electrical contractor.

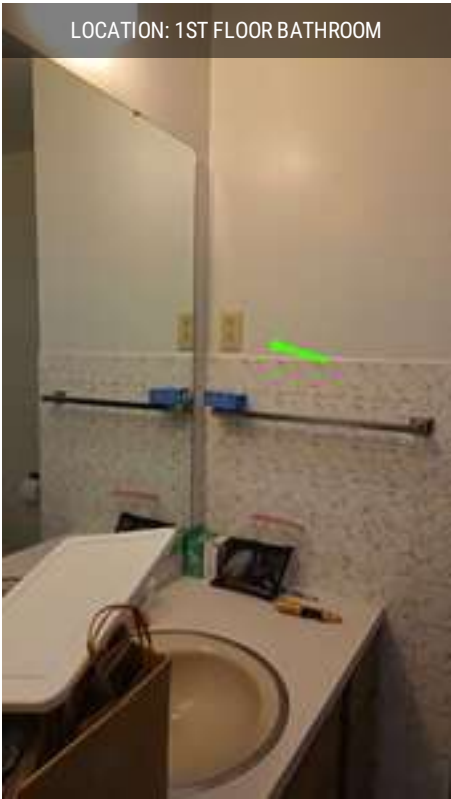
14.11.3 Outlet (Hot Neutral Reverse)

One or more electric outlets had wiring that was hot and neutral wires were reversed. Electrical outlets with reverse polarity can be dangerous to you and your devices. A device plugged into a receptacle with reversed polarity can remain energized even when turned off, which can short-circuit the device. Devices plugged into an outlet with reversed polarity may appear to work as usual but are unsafe and can shock you. We recommend that this repaired as needed by a qualified electrical contractor.

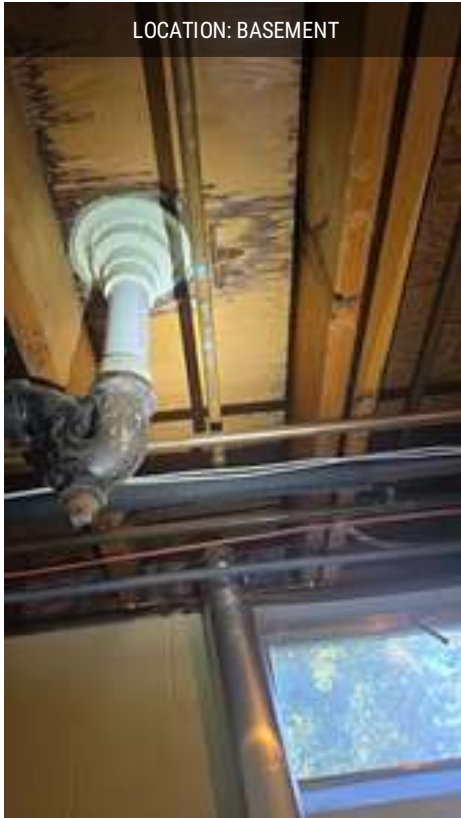
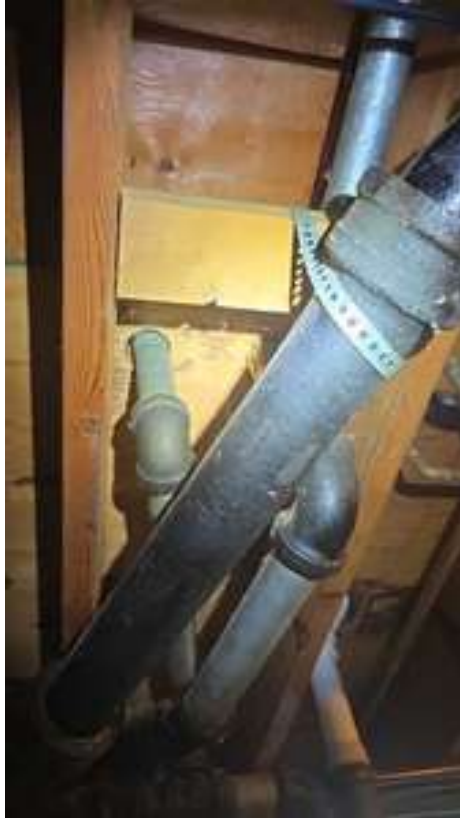
The homes floor framing materials had water damage in areas from a past leak. These areas appeared stable but may be worse underneath the finishing materials above. If future renovations or repairs are needed in the areas above the damage, keep in mind, unplanned repairs may be need when finishing materials above are removed. There may be extra costs associated with that process.

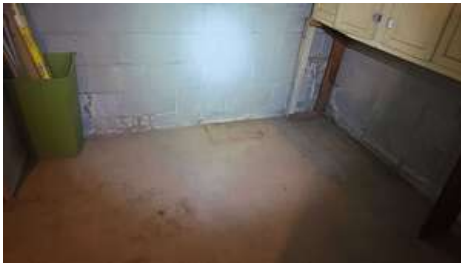
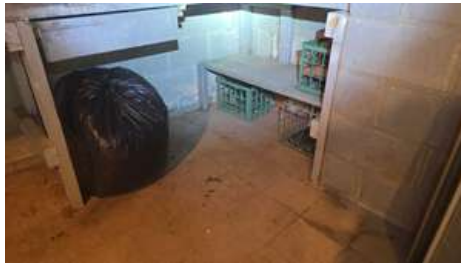
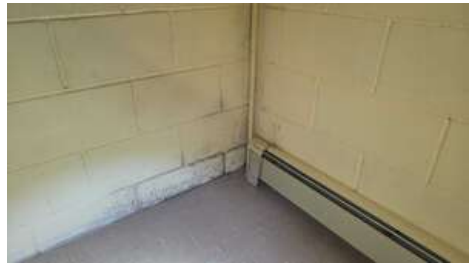
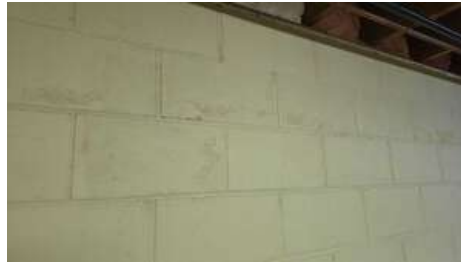
### 15.3.1 Moisture stains (Dry)

Items to monitor

One or more areas in the basement had dry moisture stain evidence. The cause was not evident at the time of the inspection. This could be from, but not limited to, flooding, seepage, plumbing leaks, appliance issues, etc. Ask the seller about its condition. Monitor these areas at a minimum.
