# Your Inspection Report

924 W Grand Ave  
Port Washington, WI 53074

RE: Report No. 4652  
924 W Grand Ave  
Port Washington, WI  
53074

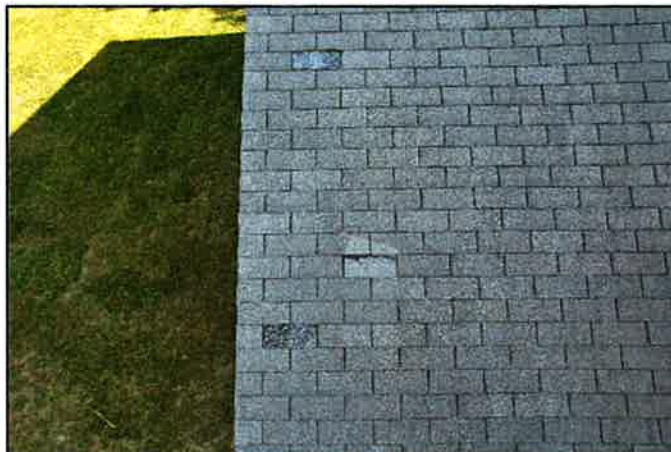
1. Patched

**3. Condition:** • Patched

**Location:** A few areas on garage roof

**Task:** Monitor: and or repair as necessary

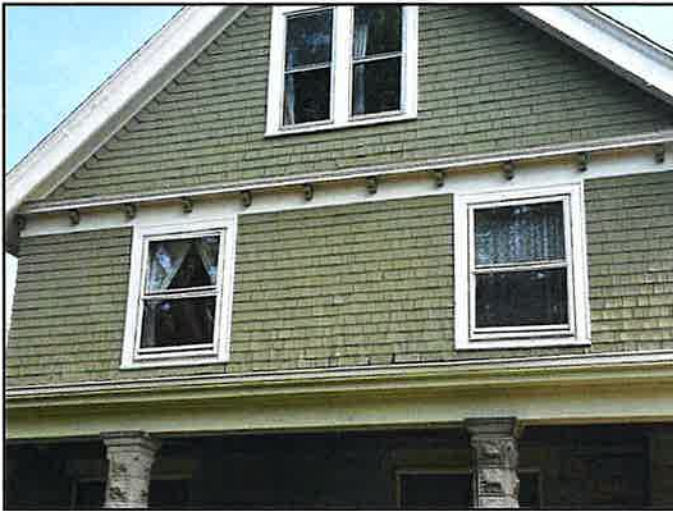
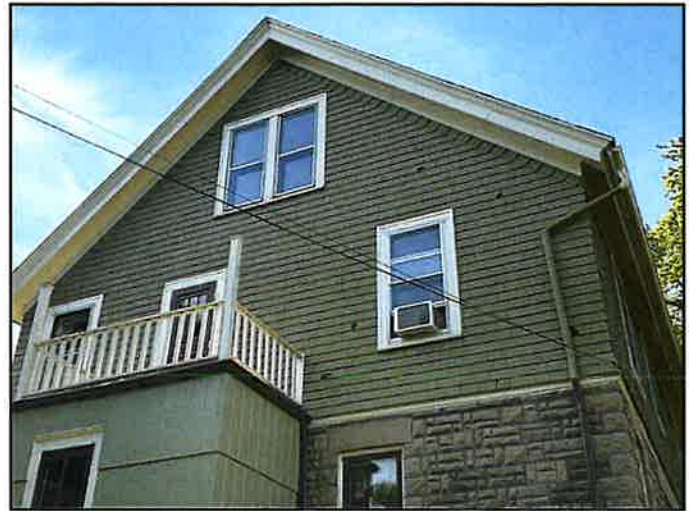
22. Peeling paint and wood rot

**4. Condition:** • Peeling paint and wood rot

**Location:** Few areas on wood siding

**Task:** Repair: as necessary

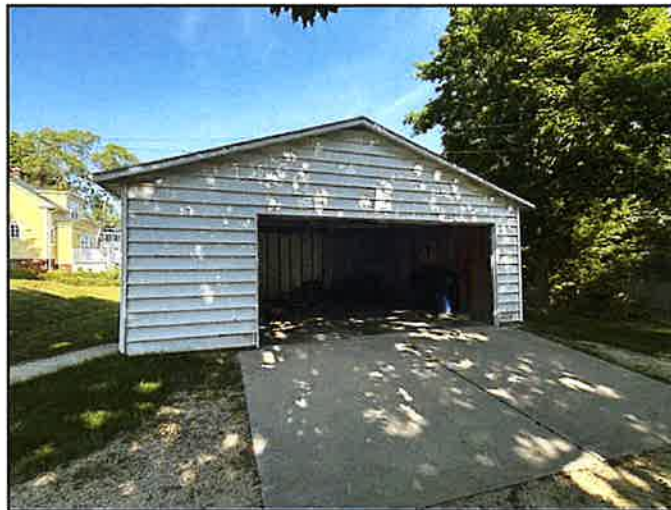
24. Missing

**5. Condition:** • Missing

**Location:** Exterior of garage

Install gutters and downspouts. This is a recommendation only

**Task:** Repair: as necessary

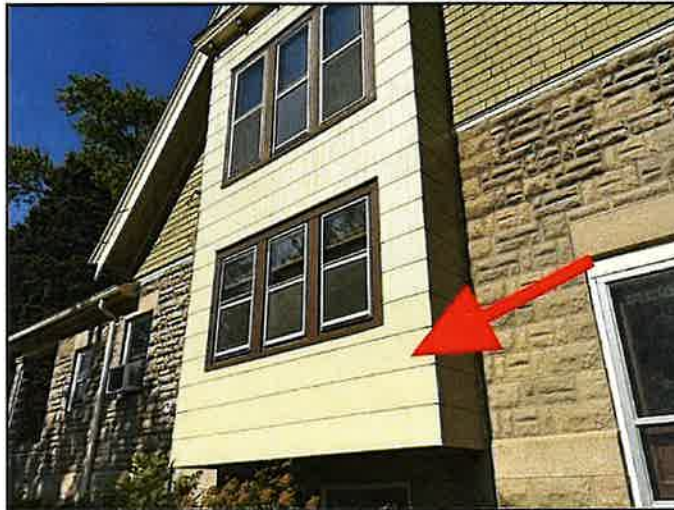
25.

**6. Condition:** • The exterior siding appears to be cementitious siding. Due to the age and appearance, it may contain asbestos. The presence of asbestos cannot be confirmed during a visual inspection. Laboratory testing of a sample is recommended if identification is desired, particularly before any cutting, drilling, sanding, or removal.

**Location:** East Side of home

**Task:** Monitor: and or repair as necessary

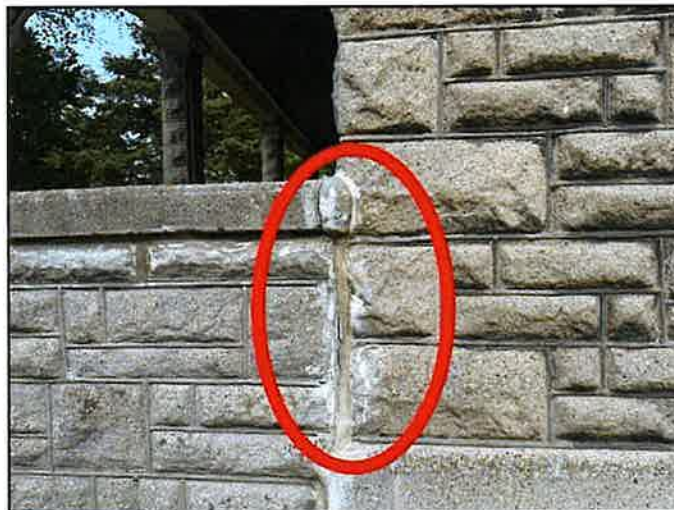
26. Cracks on exterior stone mortar

**7. Condition:** • Cracks on exterior stone mortar joints on home

**Location:** A few areas around the home

**Task:** Repair: as necessary

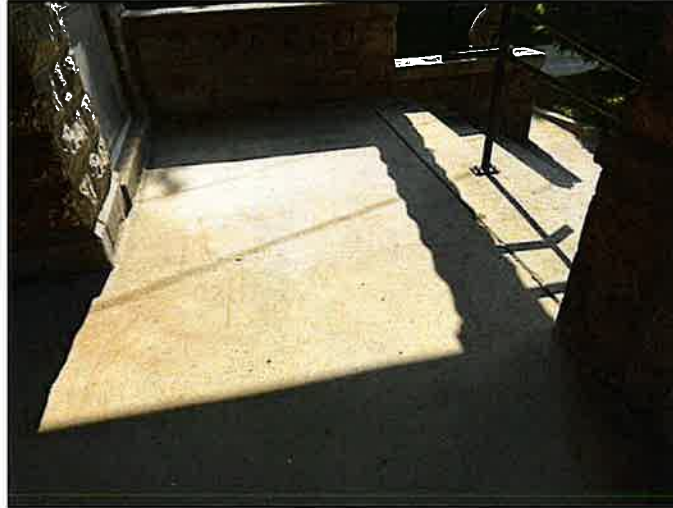
27. Concrete cracked

**8. Condition:** • Concrete cracked

**Location:** Front porch

**Task:** Monitor: and or repair as necessary

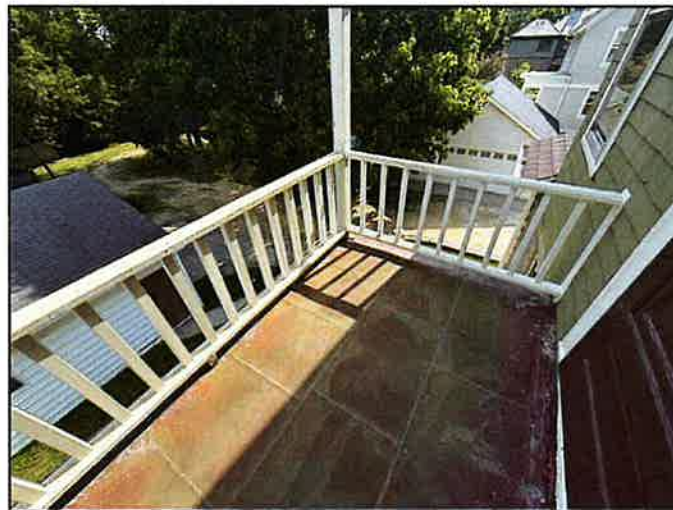
28. Guardrail is not to today's standard

**10. Condition:** • Guardrail is not to today's standard

**Location:** Rear balcony

**Task:** Repair: as necessary

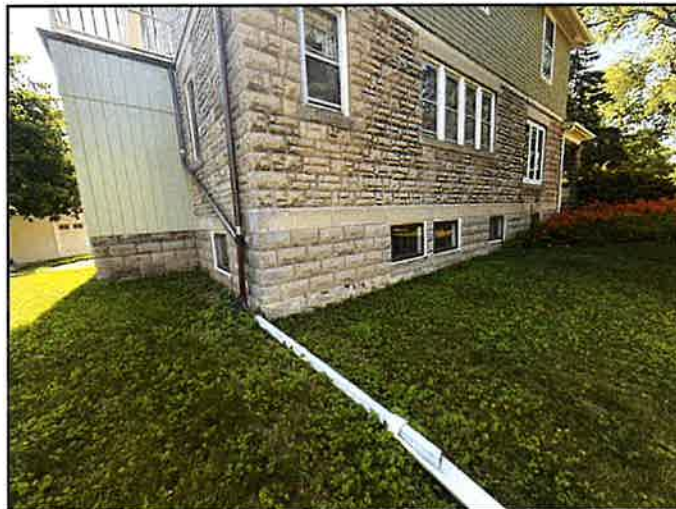
31. Improper slope or drainage

13. **Condition:** • Improper slope or drainage

Exterior grade has low spots. Recommend improving to ensure surface water flows away from the foundation.

**Task:** Maintenance item: Repair as necessary

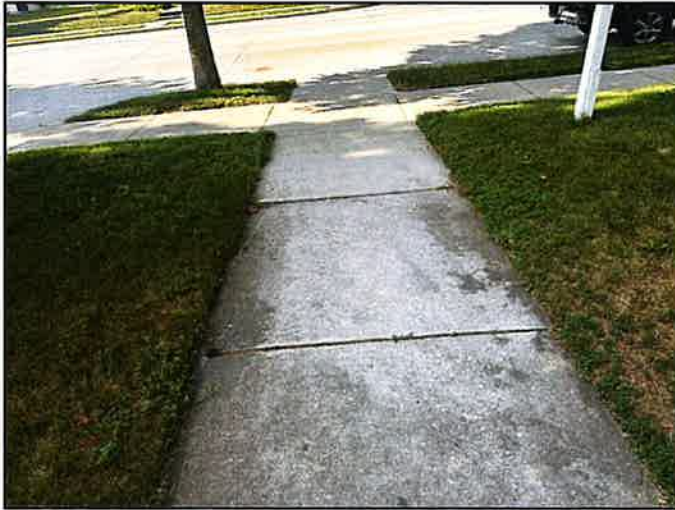
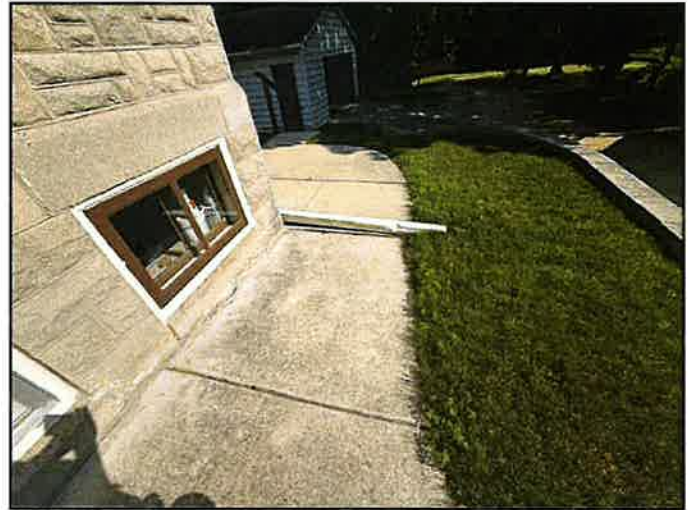
32. Uneven (trip hazard)

14. Condition: • Uneven (trip hazard)

Task: Defect: Repair as necessary by qualified contractor

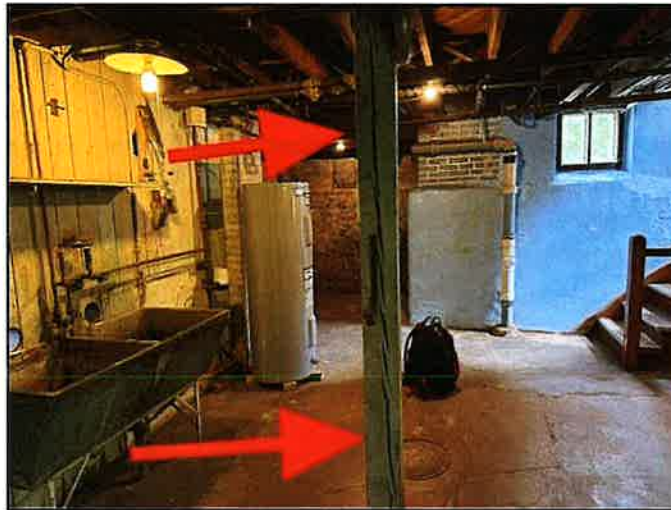
**34.** Cracks on wood columns. These are normal

**15. Condition:** • Cracks on wood columns. These are normally cracks for the age

**Location:** Basement

**Task:** Monitor and repair as necessary

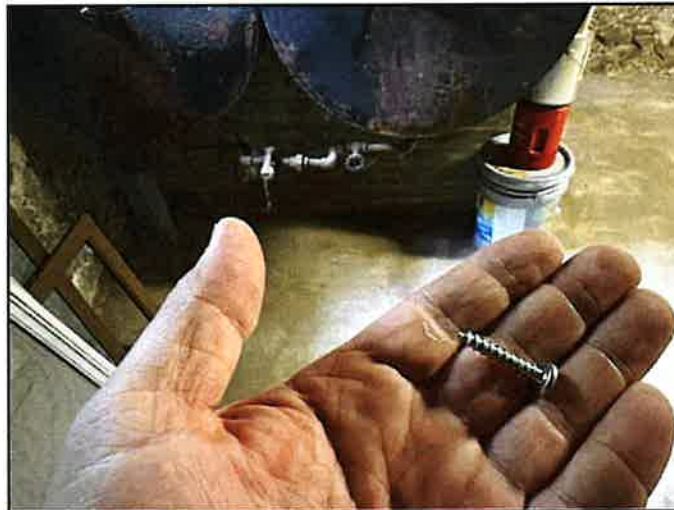
47. It is not recommend nor is it a standard

**16. Condition:** • It is not recommend nor is it a standard of practice to use screws with pointed tips for securing electrical panel covers

**Location:** Electrical panel in basement

**Task:** Defect: Repair as necessary by qualified contractor

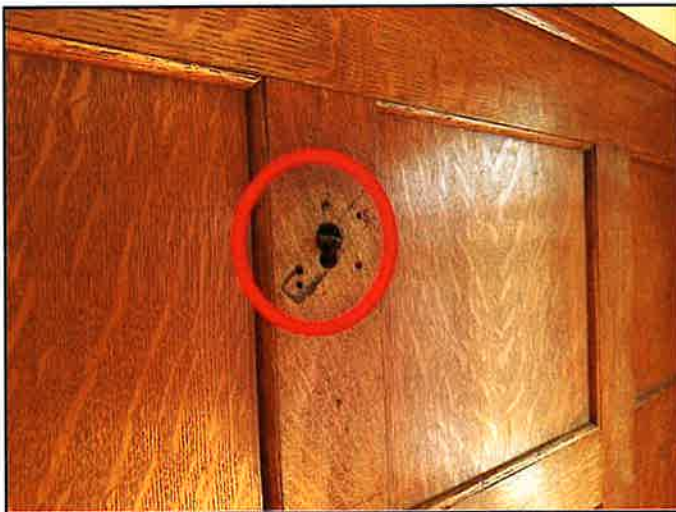
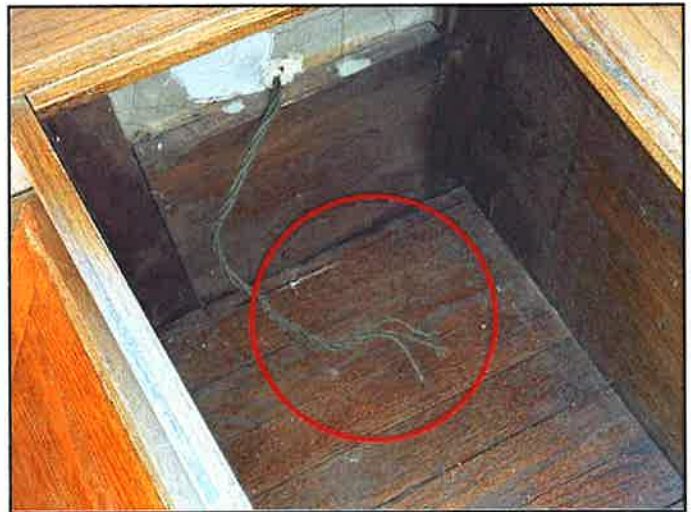
48. Exposed wires should be installed inside

**17. Condition:** • Exposed wires should be installed inside a junction box  
Wires were not live at time of inspection. Or remove if not in use

**Location:** Dining area, 2nd floor landing inside built-in seat

**Task:** Defect: Repair as necessary by qualified contractor

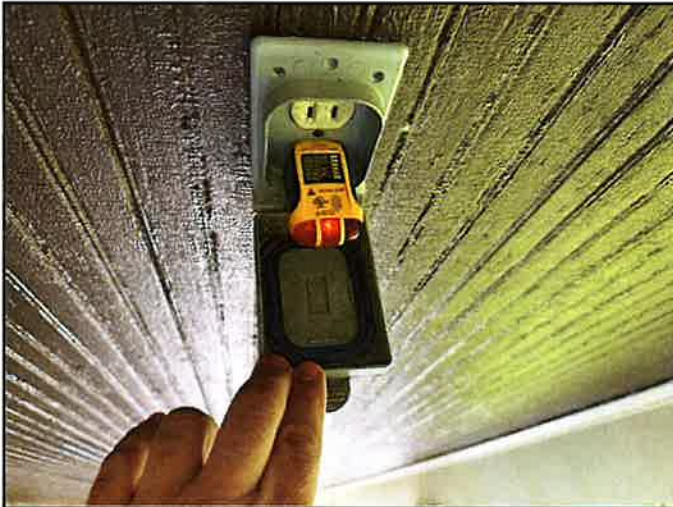
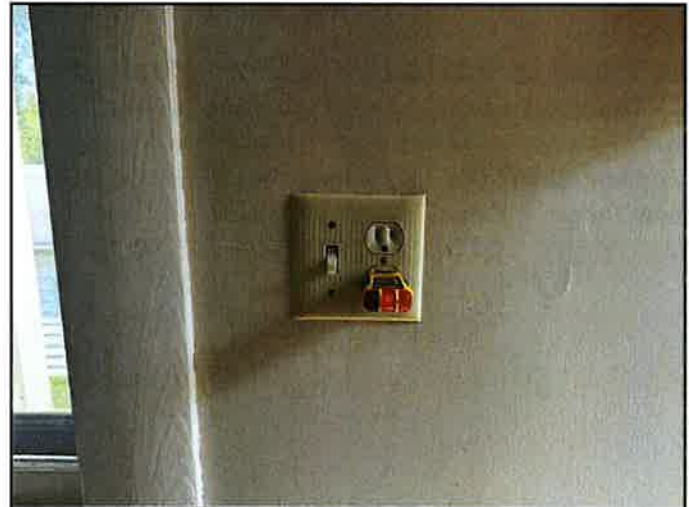
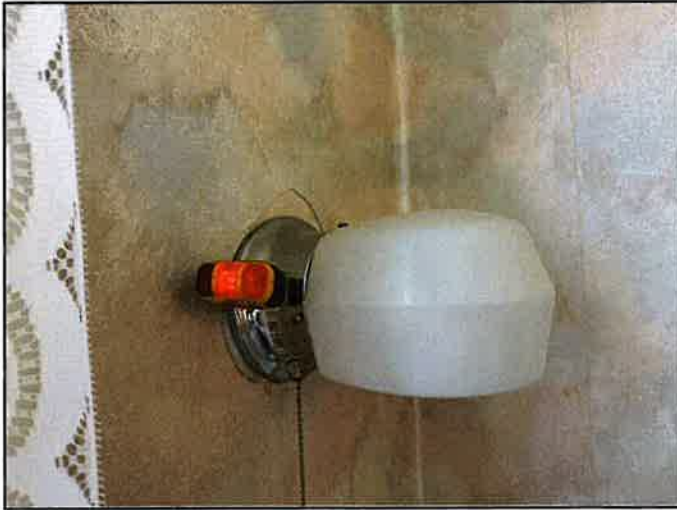
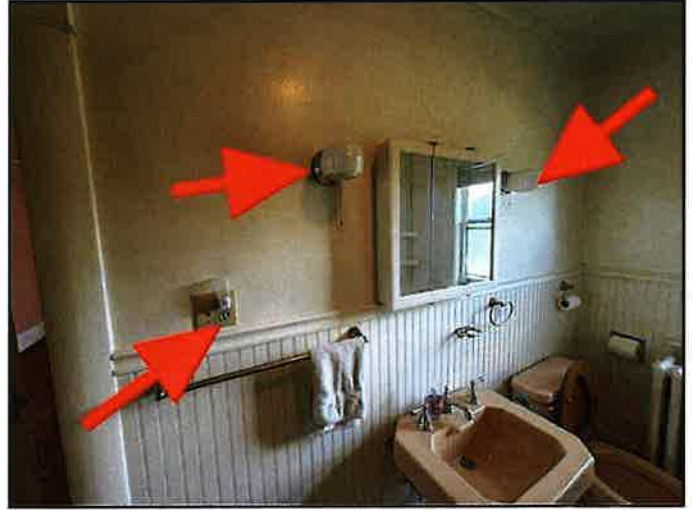
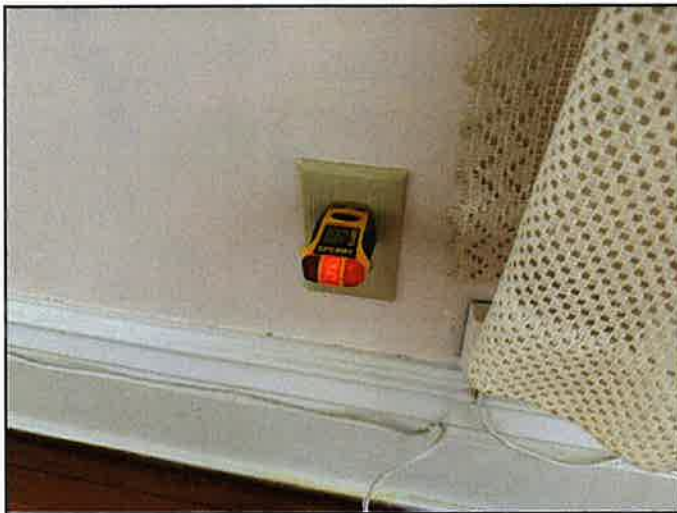
51. Ungrounded

18. Condition: • Ungrounded

Location: Front porch on ceiling, kitchen, main floor half bathroom, 2nd floor bathroom outlets 2nd floor NE bedroom outlet on North wall, 2nd floor NW bedroom outlet on South wall, finished room in attic

Task: Defect: Repair as necessary by qualified contractor

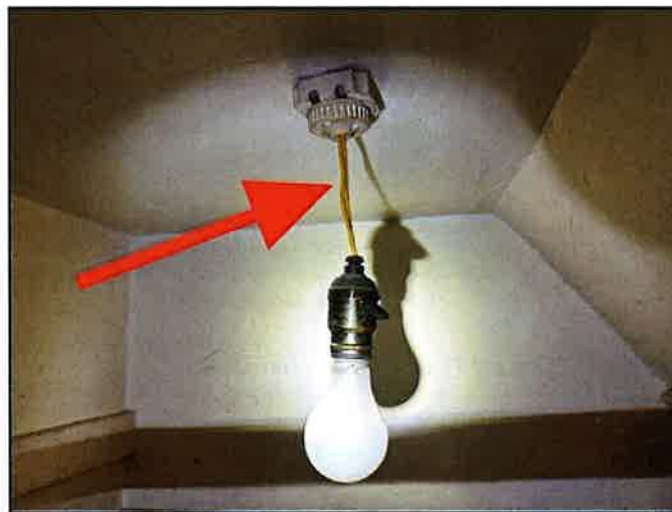
58.

**20. Condition:** • The light fixture has been repaired using newer wiring connected to an older fixture. This type of modification may not provide a reliable or safe electrical connection. Recommend replacement of the fixture with a modern, properly installed light fixture.

**Location:** 2nd floor NE bedroom closet light fixture

**Task:** Defect: repair/replace as necessary by qualified contractor

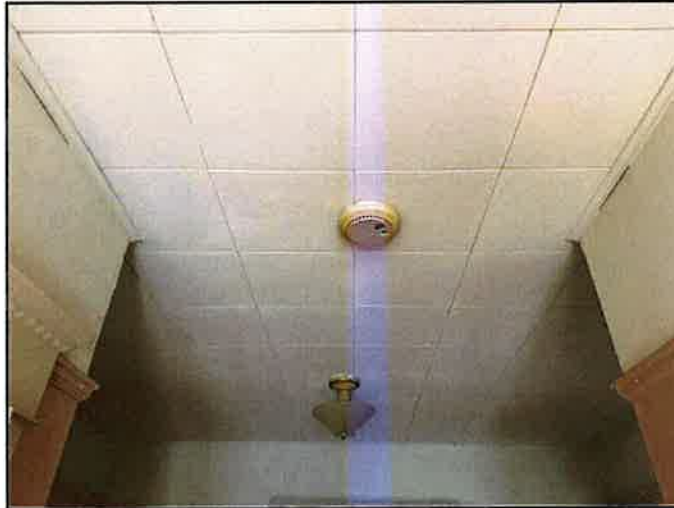
59. Old

**21. Condition:** • Old

Smoke detectors need to be replaced 10 years from their date of manufacture. Recommend testing the batteries on your smoke detectors at least once a month and replacing them every year

**Task:** Defect: Replace as necessary

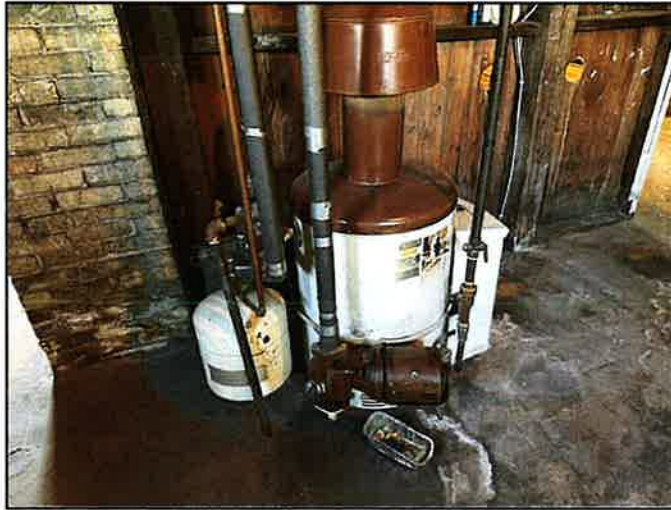
64.

**22. Condition:** • The boiler was shut down at the time of the inspection due to warm seasonal weather. As a result, the heating system could not be operated or fully evaluated. Recommend having the boiler evaluated and serviced by a qualified HVAC contractor before the next heating season to verify proper operation.

**Location:** Boiler in Basement

**Task:** Defect: further evaluate, repair as necessary by qualified contractor

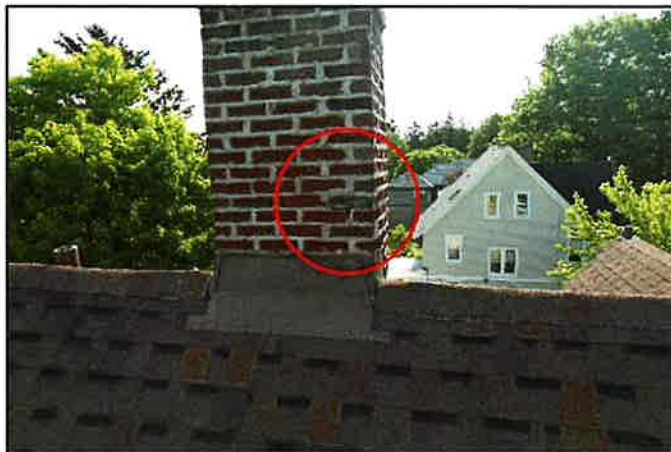
65. *Open or loose mortar joints around bricks*

**23. Condition:** • Open or loose mortar joints around bricks

**Location:** Exterior chimney chase on roof of home

**Task:** Repair: as necessary

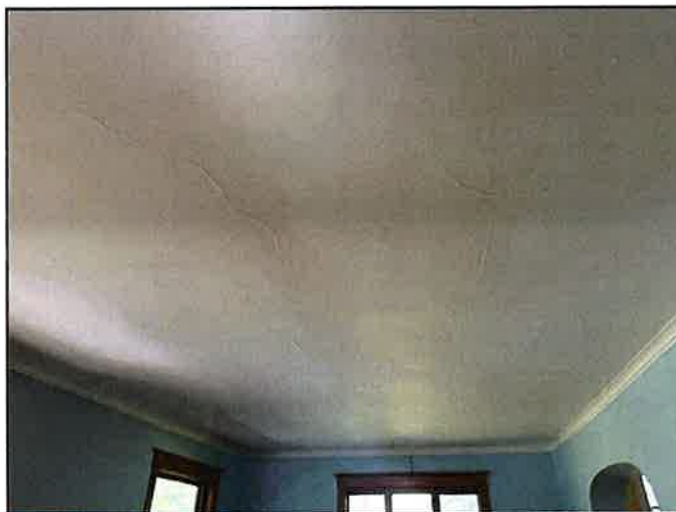
77. Cracks

**27. Condition:** • Cracks

**Location:** A few areas in the home

**Task:** Monitor: and or repair as necessary

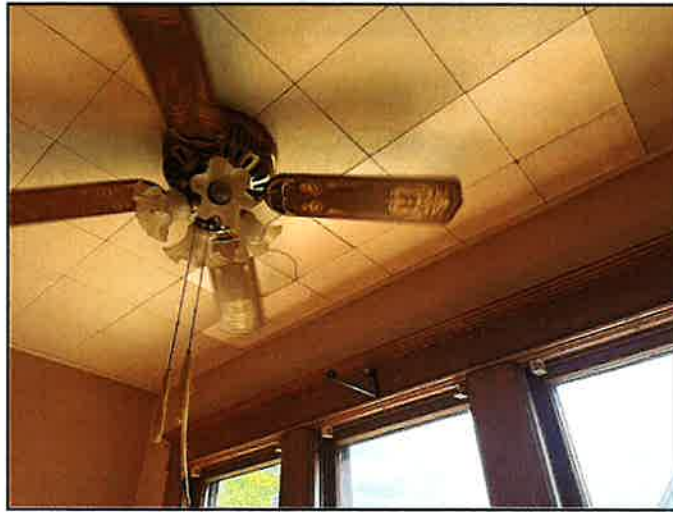
78. Moisture staining, appears to be old. Wa

**28. Condition:** • Moisture staining, appears to be old. Was dry at time of inspection

**Task:** Monitor: and or repair as necessary

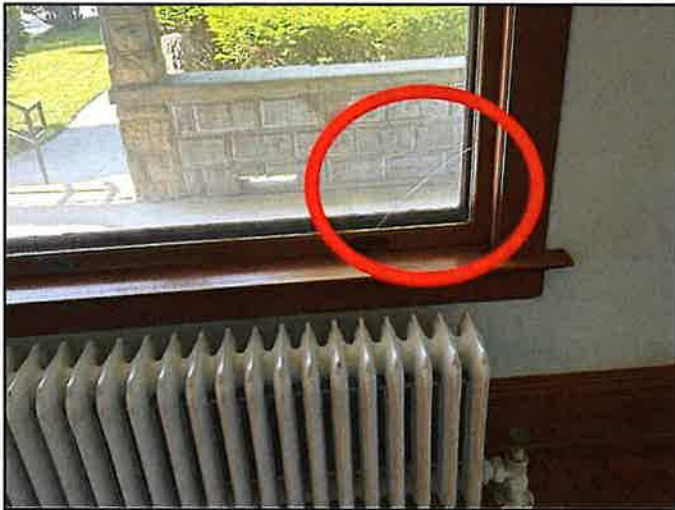
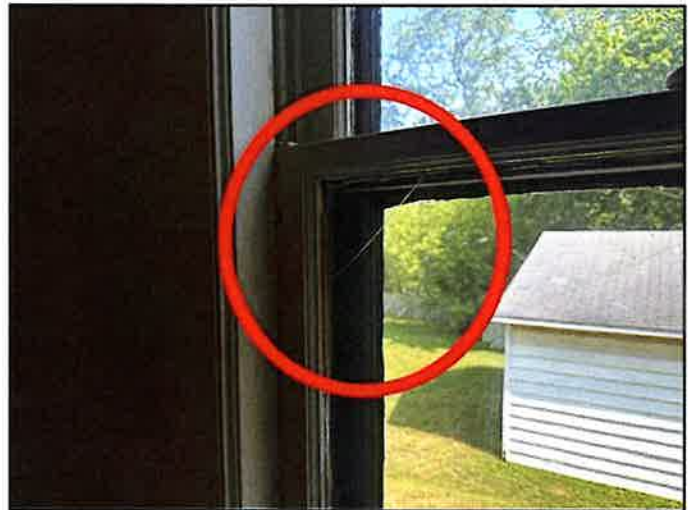
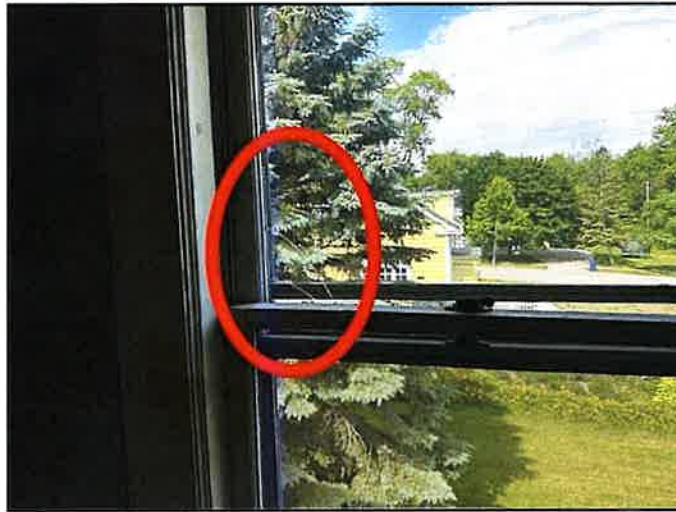
79. Cracked

29. Condition: • Cracked

Location: Living room window on South wall, kitchen pantry window, 2nd floor NW bedroom window on West wall

Task: Repair: as necessary

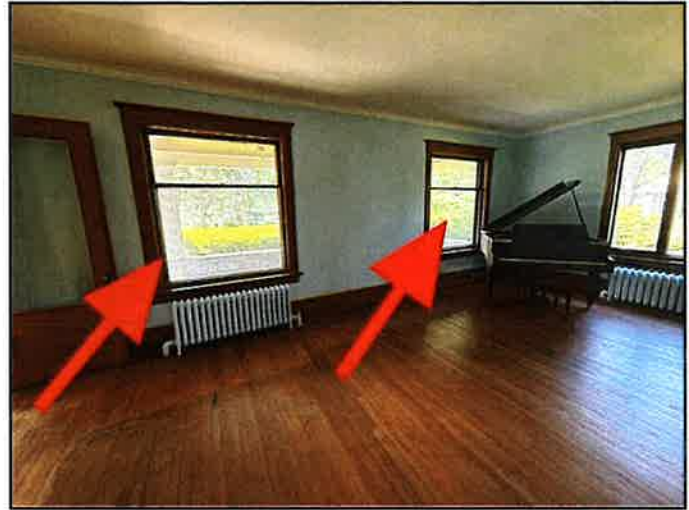
83. Inoperable

**30. Condition:** • Inoperable

**Task:** Repair: as necessary

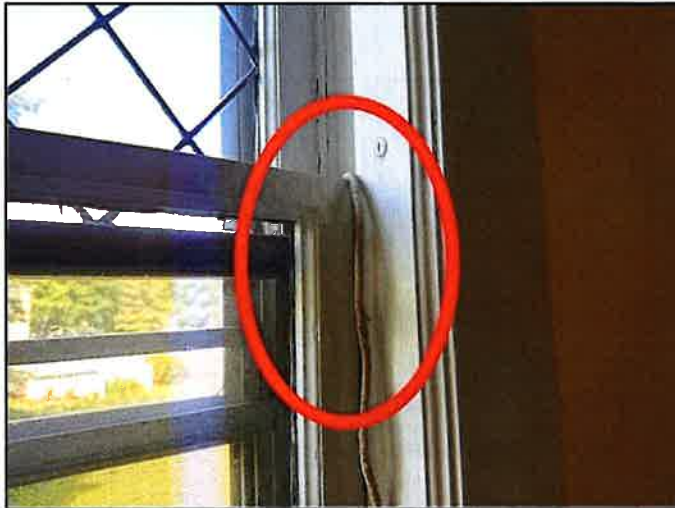
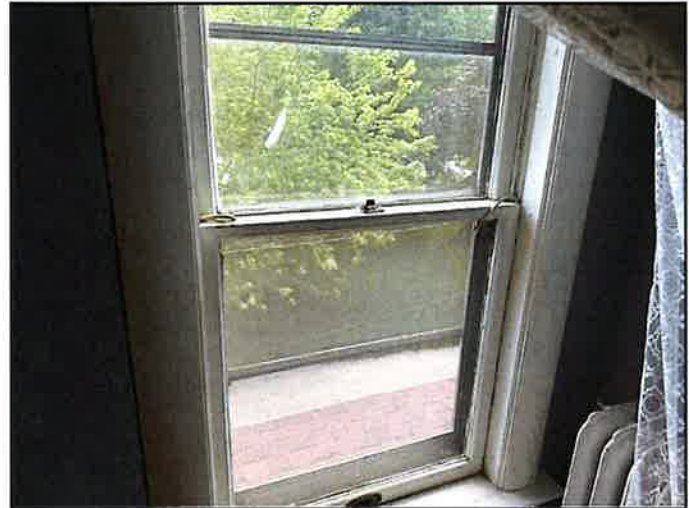
84. Broken sash cord/spring

**31. Condition:** • Broken sash cord/spring

**Location:** Dining room window, 2nd floor SE bedroom window on West wall

**Task:** Defect: repair as necessary

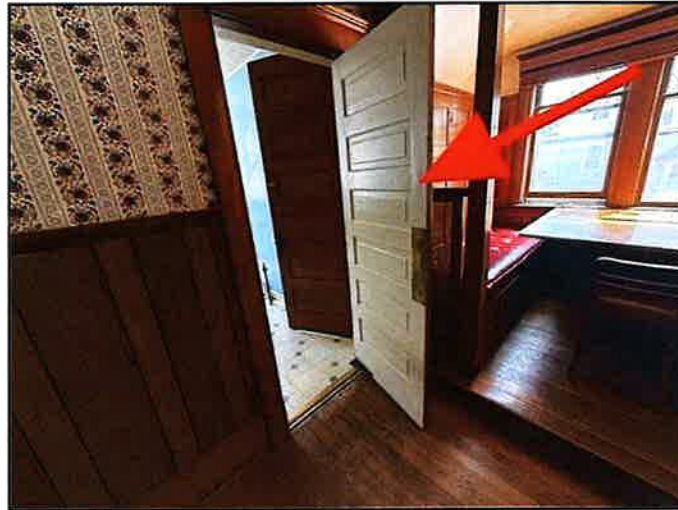
86.

**32. Condition:** • Swing door does not open or close properly

**Task:** Repair: as necessary

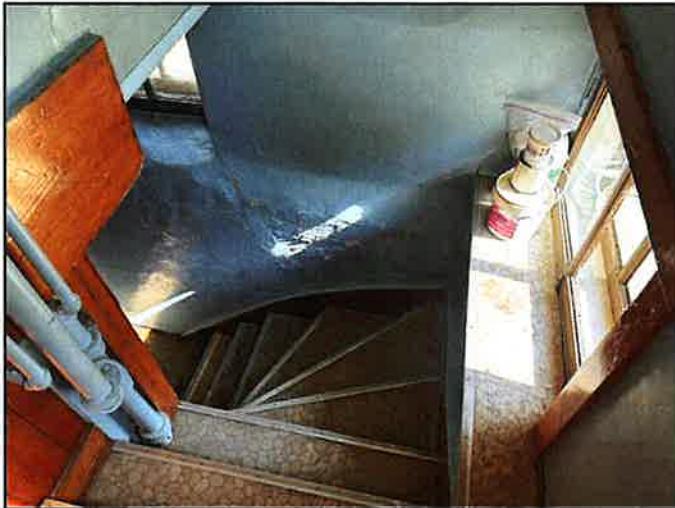
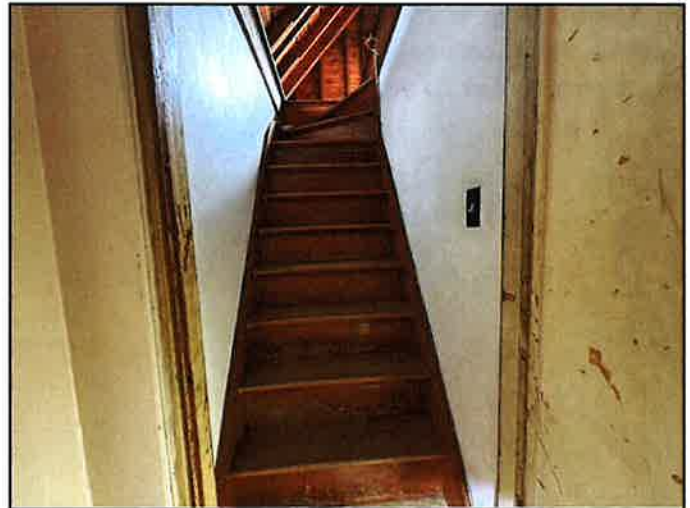
87. Missing

**34. Condition:** • Missing

**Task:** Defect: Repair as necessary

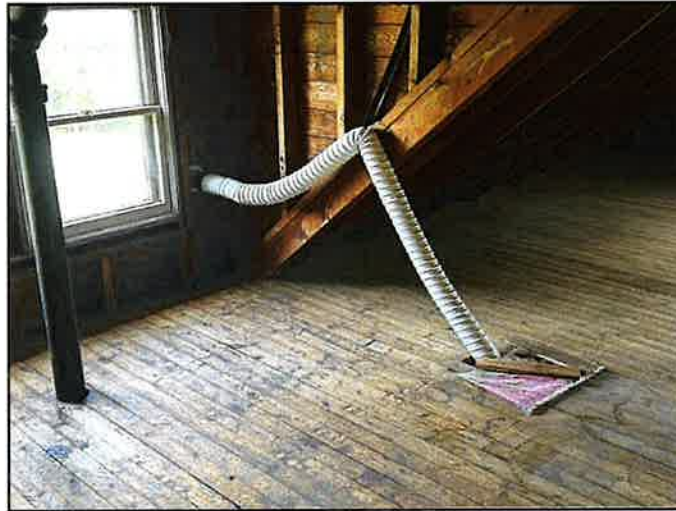
89. Not insulated in unconditioned space

**35. Condition:** • Not insulated in unconditioned space

Plastic exhaust vent material is not a standard practice for bathrooms fans venting to the exterior through attic space. Recommend installing insulated metal ductwork

**Location:** Attic space

**Task:** Repair: as necessary

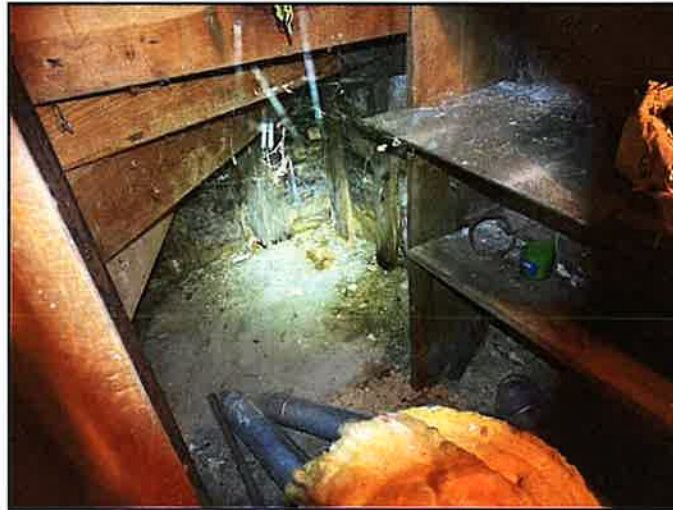
90. Mildew

## 37. Condition: • Mildew

Suspected microbial growth was observed on wood/brick walls beneath the basement stairwell. Recommend clean and keeping gutters clean with downspouts extended, window wells covered and exterior grade properly pitched away from the home to ensure roof and surface water is not pooling near the foundation. Clean area as necessary, install dehumidifier in basement and monitor

**Location:** Basement underneath stairwell

**Task:** Repair: clean as necessary and monitor

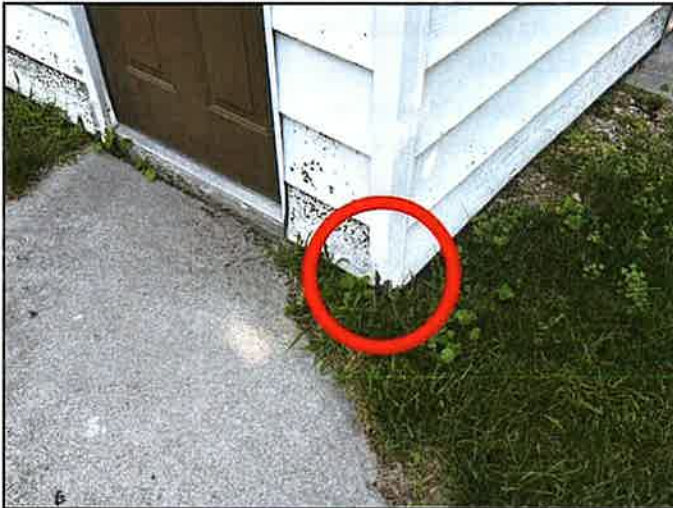
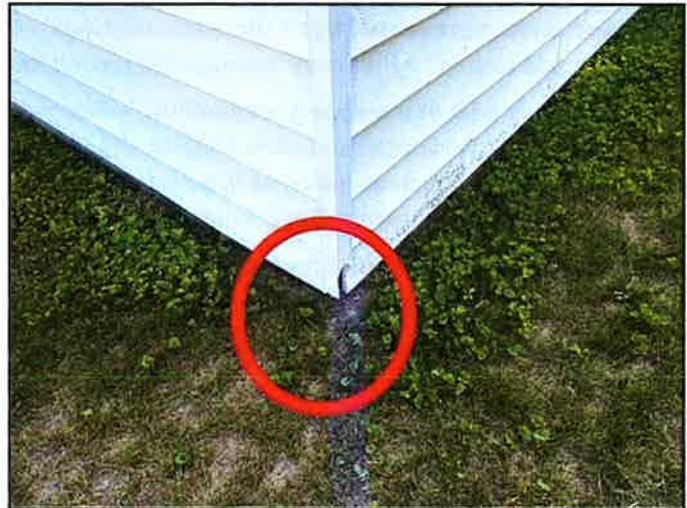
91.

**Location:** Few areas and exterior of the garage

**Task:** Monitor: and or repair as necessary
