# Building Inspection Report

**414 Prospect Ave Waukesha, WI 53188**

**Report Number:**

**CS518626**

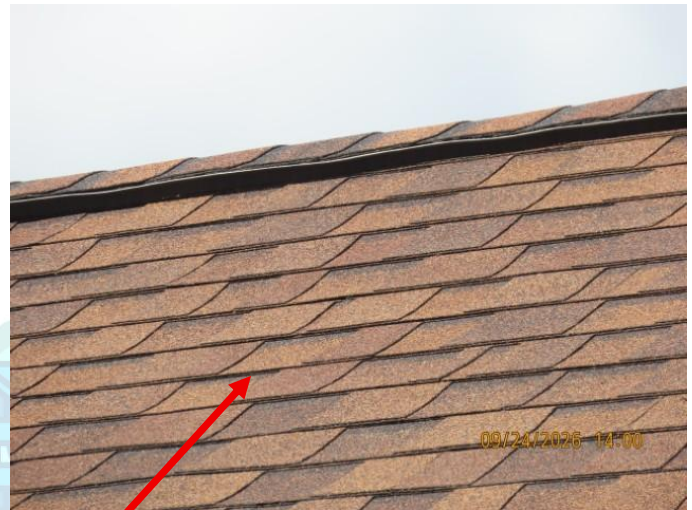
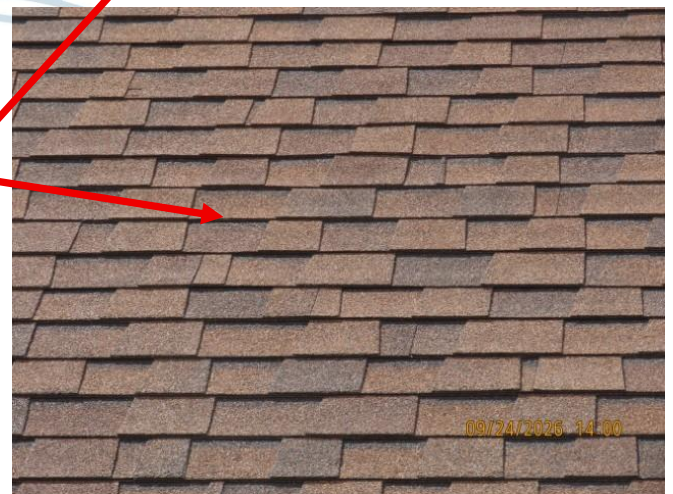
- **Monitor:** The sloped roofing is newer and in good condition. We did not see evidence of active leaks nor need for immediate major repair.
- It is recommended that the present layers of roofing materials be removed prior to re-roofing. This adds cost to the demolition and debris removal.
- The south and west sides of a roof typically wear faster than the other exposures of the roof. If the best roof sections have less than five years of life remaining while the worst sections are already in need of replacement, it is usually logical to replace all roof slopes during re-roofing.

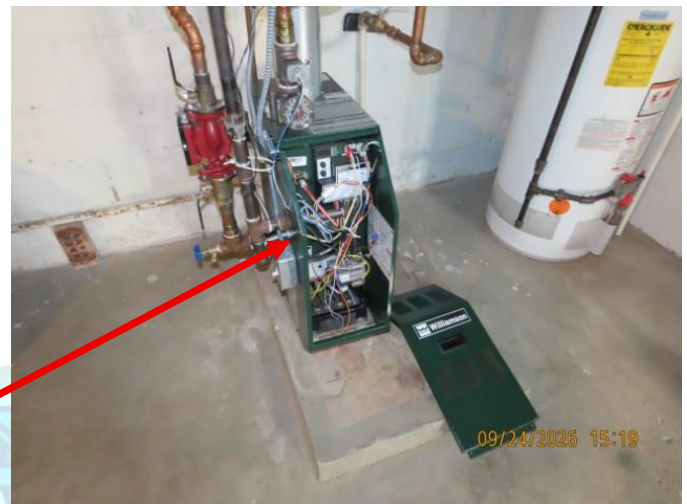
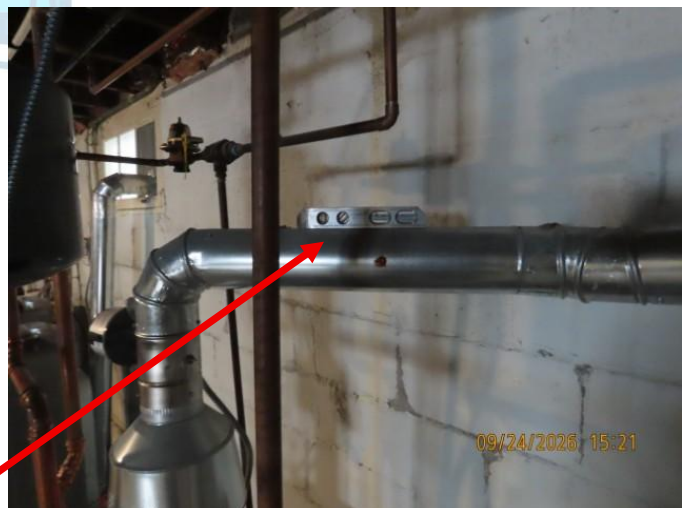
- **Defect:** The slope of the exhaust flue does not appear to be sufficient to allow the safe flow of exhaust gases. This condition should be repaired by a qualified heating technician.(Heating)

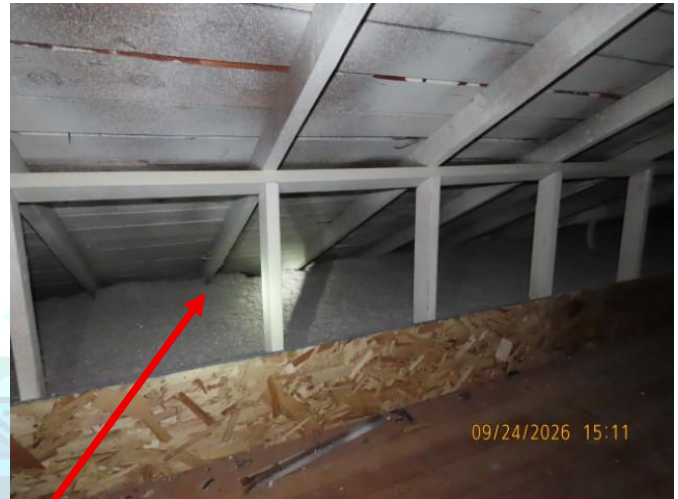
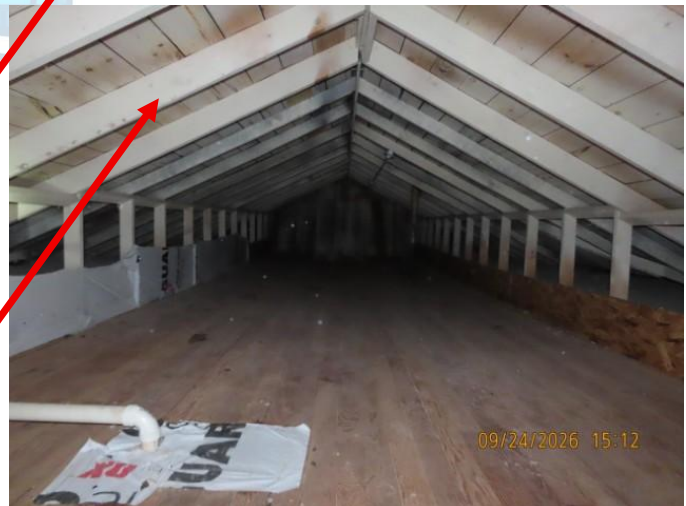
- **Repair:** The passage of air between the soffit vents and the roof cavity appears to be obstructed. "Baffles" should be provided to hold back insulation and allow for free movement of air within the roof space. This area should be further investigated and improved where necessary.
- **Monitor:** There has been a mold remediation done in the attic. I recommend that you investigate what protocol was used and any warranties that accompany this repair.

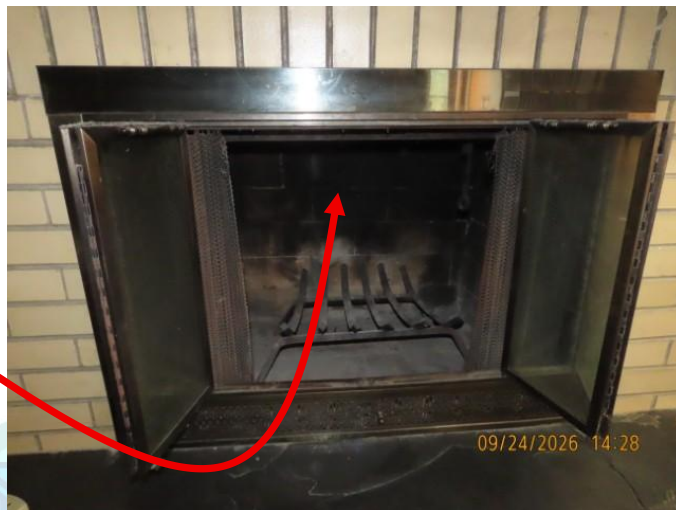
- **Further Evaluation, Defect:** The fireplace chimney should be inspected and scoped prior to operation. The fireplace flue was reported to be incomplete. (Fireplaces)

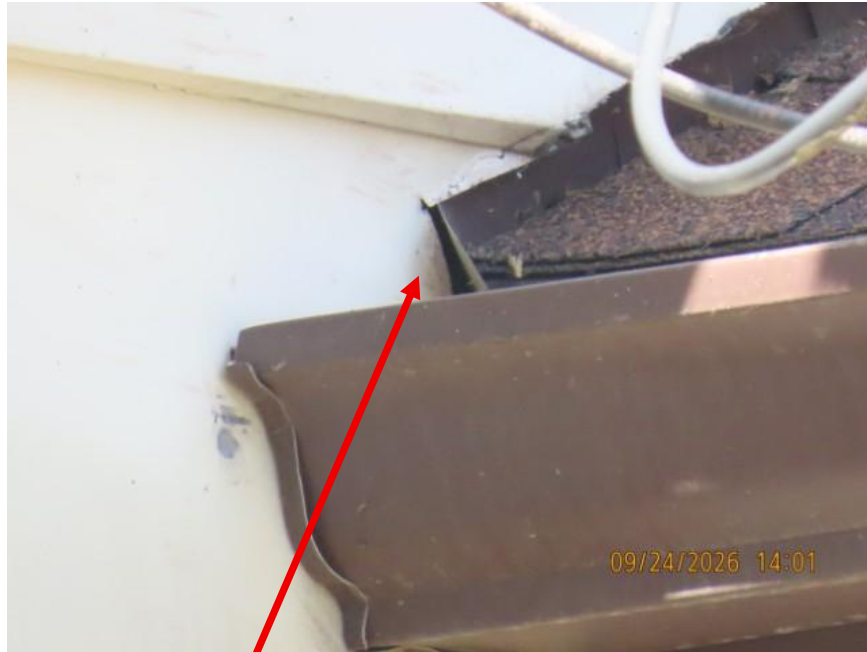
Kick out flashings were observed

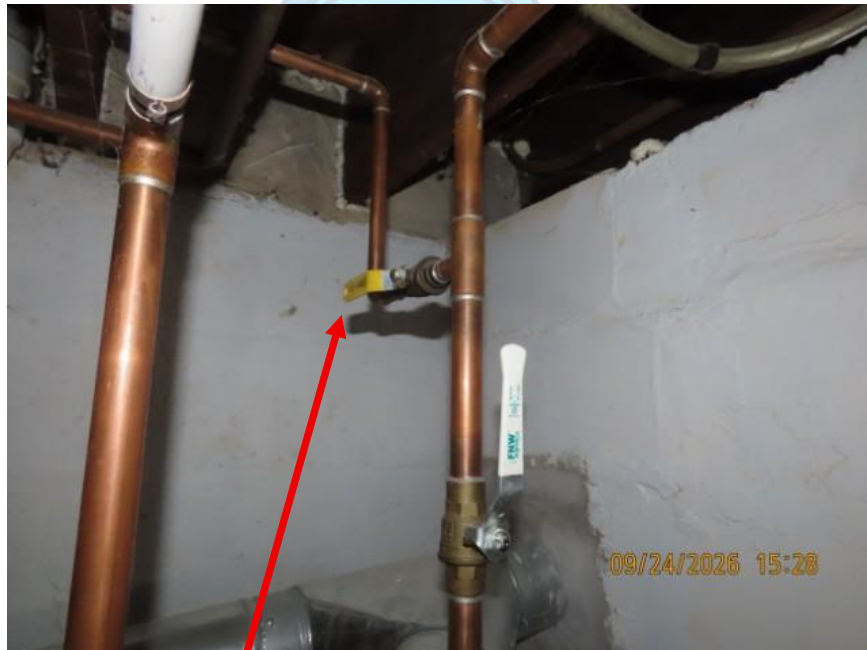
Maine water shut off for the boiler

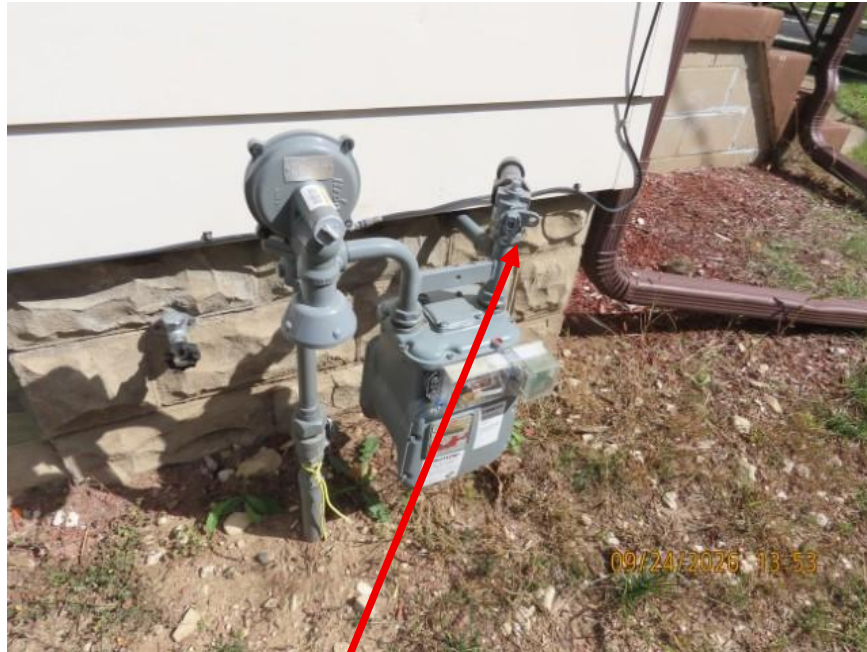
Main gas shutoff

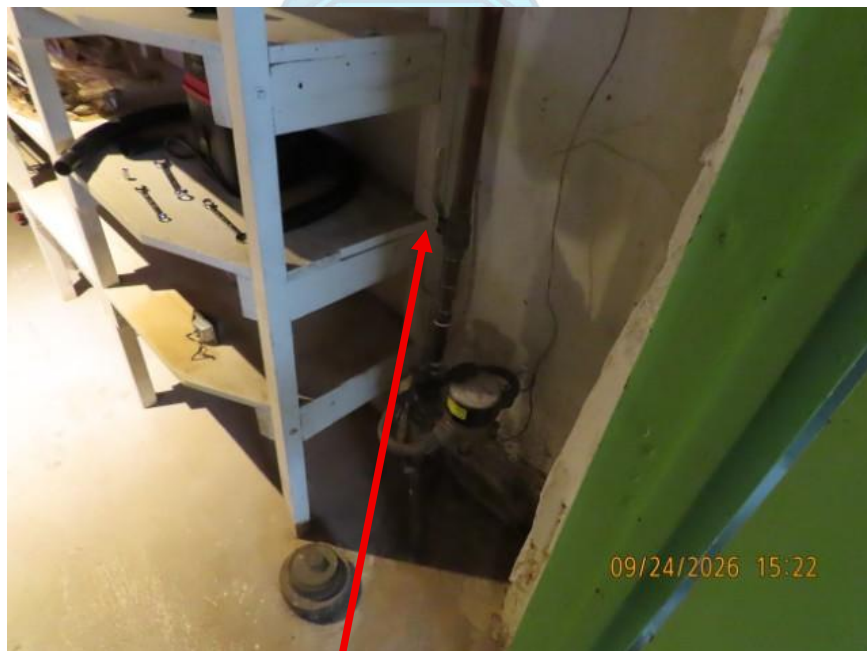
Main water shutoff
