## ***INSPECTION REPORT***

N7341 County Rd XX, Holmen, WI, 54636

*Date of Inspection: 4/2/2026*

**Report Number: Order ID: 5314**

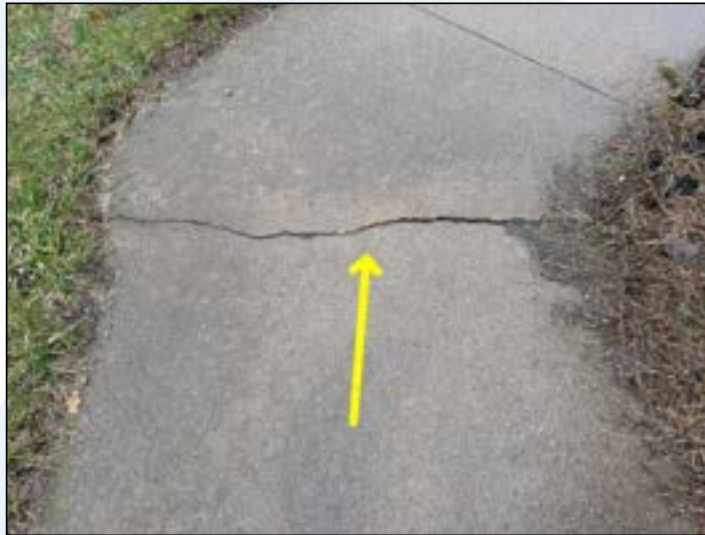
- Common cracks (1/4 inch or less) were visible in the sidewalk at the time of the inspection. Cracks exceeding 1/4 inch should be patched with an appropriate sealant to avoid continued damage to the walkway surface from freezing moisture.

Typical cracking

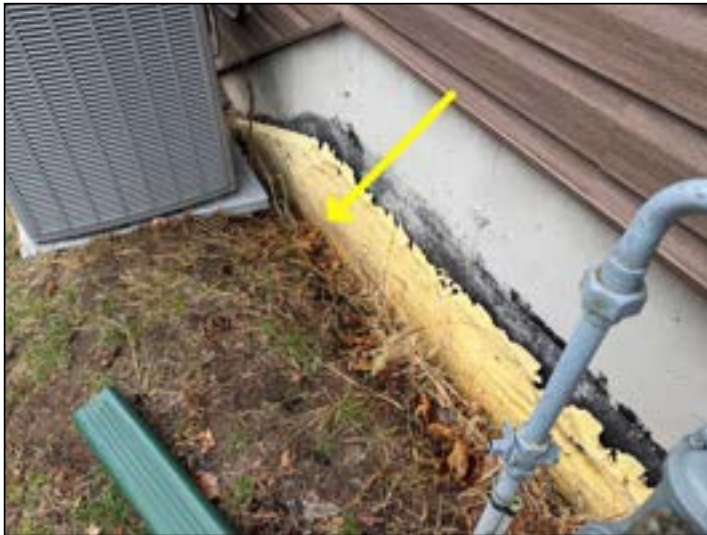
- The home had areas of neutral or negative drainage that will route runoff from precipitation toward the foundation. Excessively high moisture levels in soil supporting the foundation can cause moisture related issues such as but not limited too: seepage and settlement. The ground should slope away from the home a minimum of 1/4-inch per foot for a distance of at least six feet from the foundation. The Inspector recommends that these areas be re-graded to improve drainage near the foundation.

Negative grading in the north

| Page 13 Item: 3 | Grading Observations | <ul style="list-style-type: none"> <li>The home had areas of neutral or negative drainage that will route runoff from precipitation toward the foundation. Excessively high moisture levels in soil supporting the foundation can cause moisture related issues such as but not limited too: seepage and settlement. The ground should slope away from the home a minimum of ¼-inch per foot for a distance of at least six feet from the foundation. The Inspector recommends that these areas be re-graded to improve drainage near the foundation.</li> </ul> |

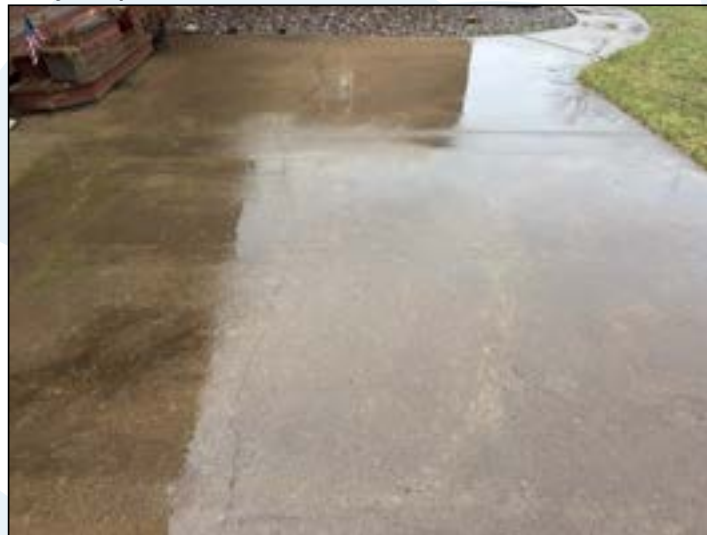
- The patio surface had moderate cracking visible at the time of the inspection. Cracks wider than  $\frac{1}{4}$ -inch should be filled with an appropriate material to help prevent continued deterioration. All work should be performed by a qualified contractor.

Typical cracking

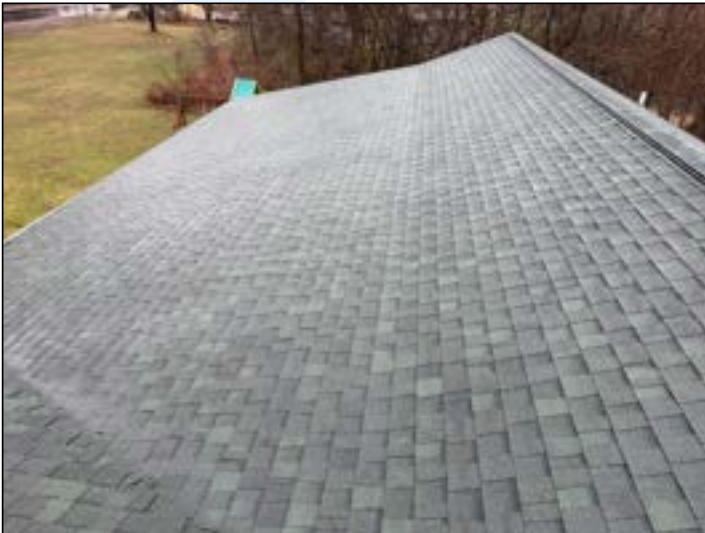
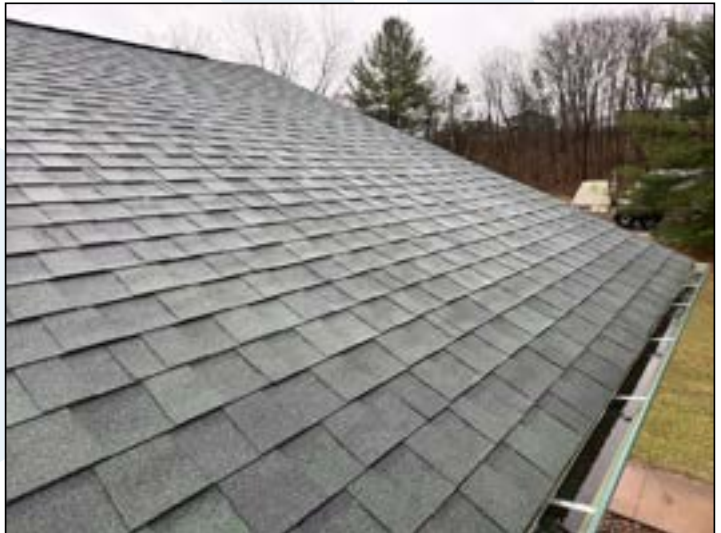
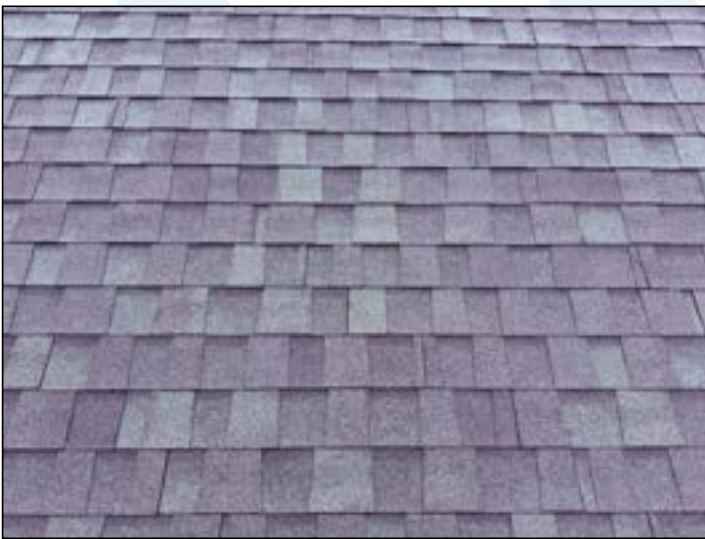
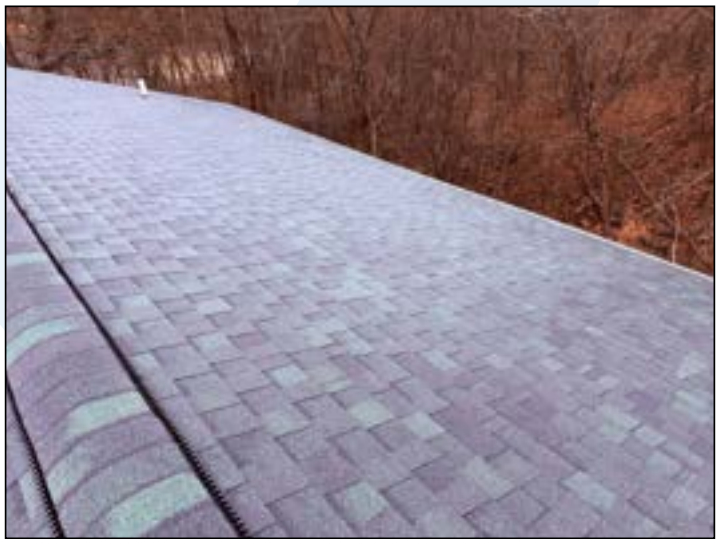
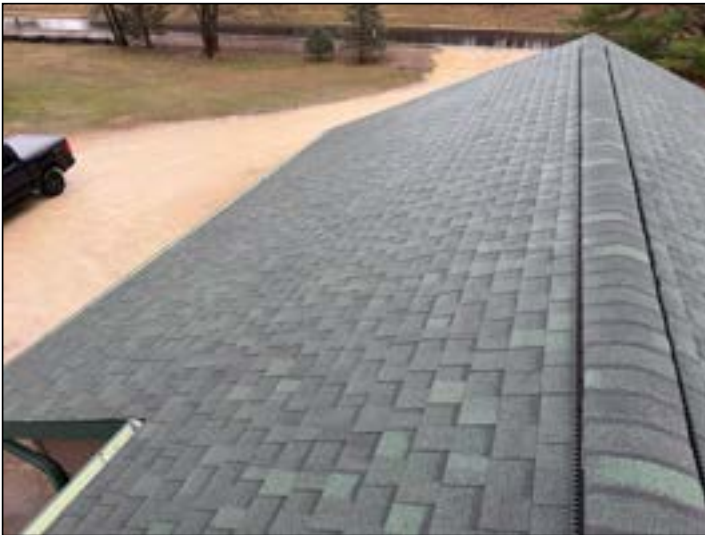
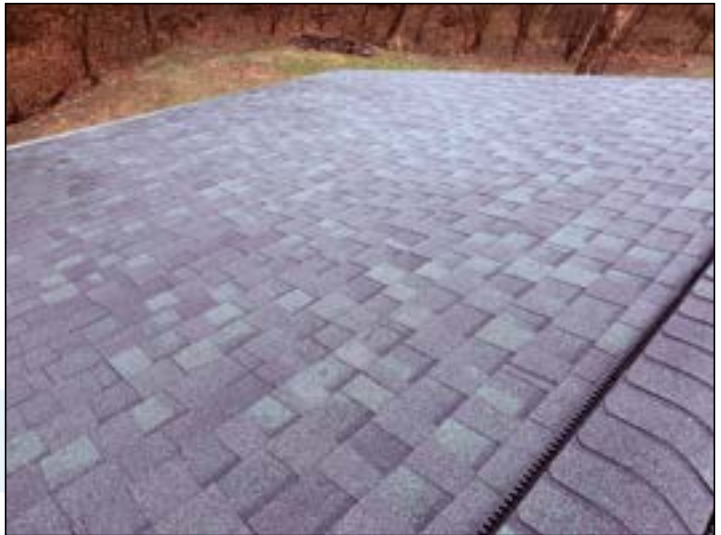
- The Inspector observed no deficiencies in the condition of the asphalt composition shingle roof-covering material.

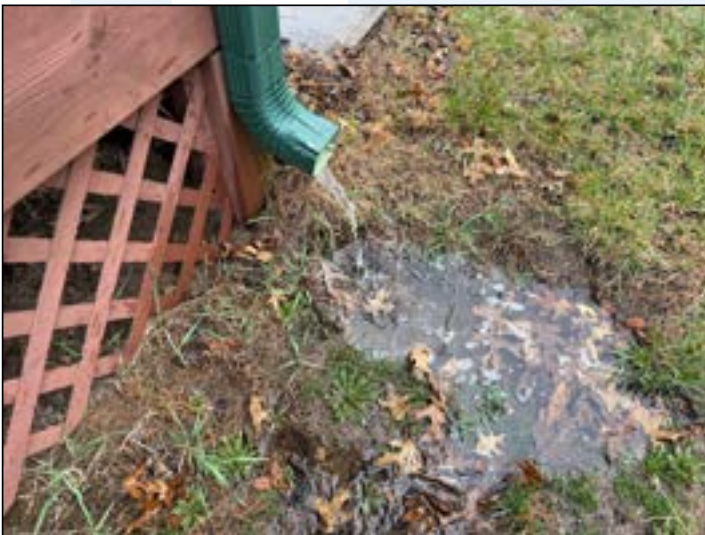
- The Inspector observed no deficiencies in the condition of the gutters.
- Downspout extensions in areas were routed below grade. Extensions below grade make it difficult to see the early indications of nonperformance, since water can discharge below grade and collect, saturating the soil for some time before it is noticed. Downspout extensions below grade can also freeze in the winter months resulting in lack of proper management of melting snow and/or ice from the roof and in the gutters. Recommend cleaning annually to prevent any potential clogging and to ensure proper drainage/performance of the system.
- [Missing downspout extensions. Recommend adding downspout extensions to discharge away from the house to prevent water seepage and other water related issues 5-6' extensions are recommended.](#)

Missing down spout extensions

| Page 22 Item: 6 | Gutter System Condition | <ul style="list-style-type: none"> <li>Missing downspout extensions. Recommend adding downspout extensions to discharge away from the house to prevent water seepage and other water related issues 5-6' extensions are recommended.</li> </ul> |

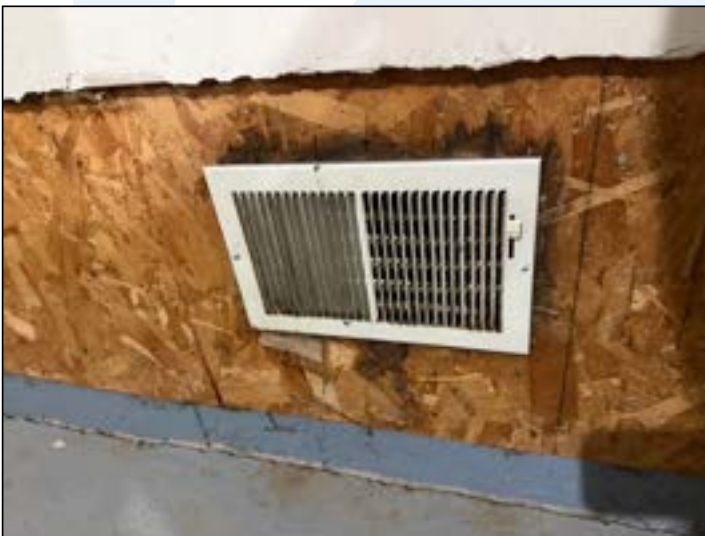
- The garage firewall had a heating register in the garage improperly supplying heat into the garage. This improper installation should be repaired to provide an intact fire-resistant barrier between the garage and the adjoining living space. All work should be preformed by a qualified contractor.
- The access door in the ceiling between the garage and the attic did not meet generally-accepted current safety standards. Access in firewalls must be a 20 minute fire-rated. Recommend a qualified contractor to install a fire rated door that meets these requirements.

Heat register improperly terminated through the fire separation

| DEFECT/SAFETY HAZARDS | | |
|---|---|---|
| Page 26 Item: 8 | Fire Separation Walls & Ceiling | <ul style="list-style-type: none"> <li>• The garage firewall had a heating register in the garage improperly supplying heat into the garage. This improper installation should be repaired to provide an intact fire-resistant barrier between the garage and the adjoining living space. All work should be preformed by a qualified contractor.</li> <li>• The access door in the ceiling between the garage and the attic did not meet generally-accepted current safety standards. Access in firewalls must be a 20 minute fire-rated. Recommend a qualified contractor to install a fire rated door that meets these requirements.</li> </ul> |

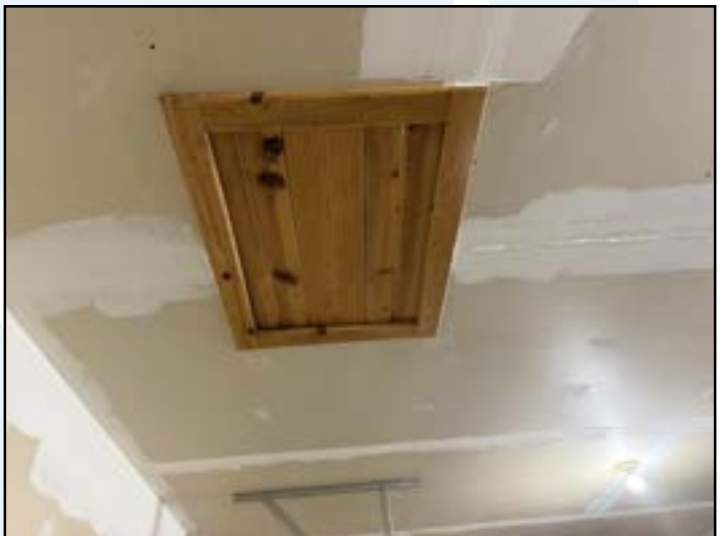
Access to the attic was not fire rated

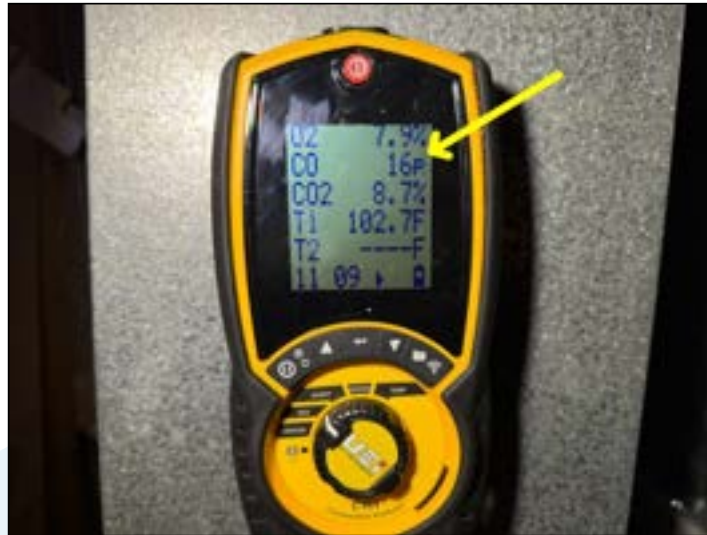
- The furnace system and had a sealed combustion chamber which would require invasive measures which lie beyond the scope of the General Home Inspection to inspect. No determination could be made to its condition.
- Normal combustion levels observed at the time of the inspection. The maximum CO an appliance is allowed to produce and exhaust out the venting is approx 300-400 ppm. A general rule of thumb is to have the units levels below 50 ppm to ensure the best combustion, efficiency, and safety for the occupants. Conditions of proper combustion can change over time from varying conditions normal maintenance is recommended for safe proper operation.

Good combustion levels

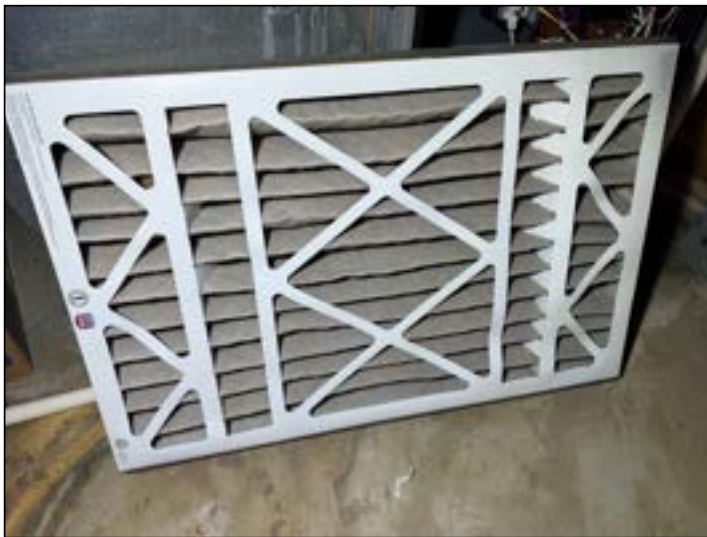
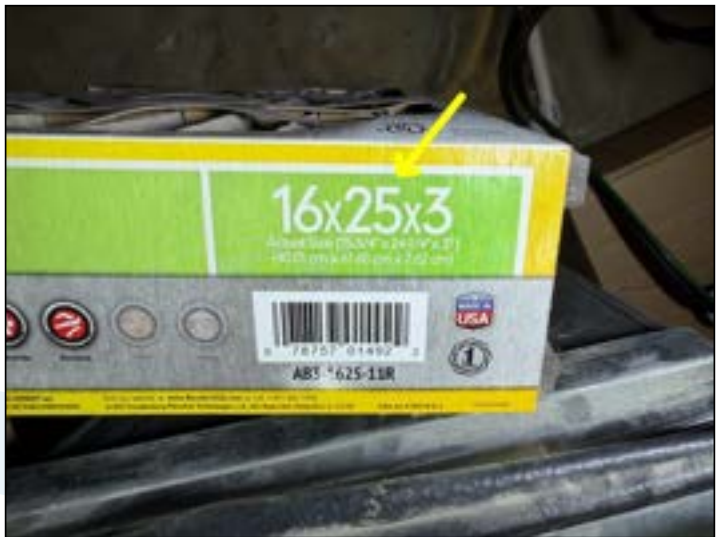
- The air filter for this furnace appeared to be in serviceable condition at the time of the inspection. Filters should be checked every three months and replaced when they reach a condition in which accumulation of particles becomes so thick that particles may be blown loose from the filter and into indoor air. Homes in areas with high indoor levels of airborne pollen or dust may need to have air filters checked and changed more frequently. Failure to change the filter when needed may result in the following problems:- Reduced blower life due to dirt build-up on vanes, which increases operating costs.- Reduced effectiveness of air filtration resulting in deterioration of indoor air quality.- Increased resistance resulting in the filter being sucked into the blower. This condition can be a potential fire hazard.- Frost build-up on air-conditioner evaporator coils, resulting in reduced cooling efficiency and possible damage.- Reduced air flow through the home.

Filter size

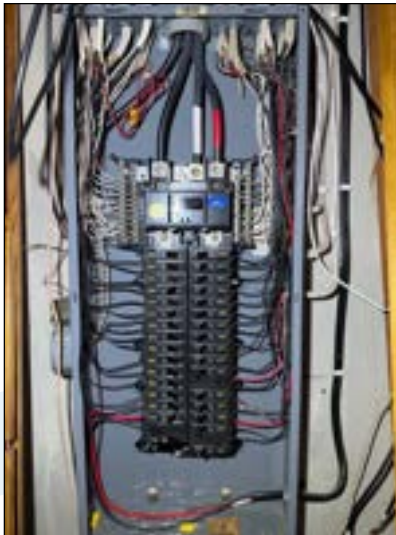
- At the time of the inspection, the Inspector observed no deficiencies in the condition of this sub-panel cabinet.
- The electrical components the sub-panel(s) appeared to be properly bonded at the time of the inspection. This sub-panel had a floating neutral bus bar.

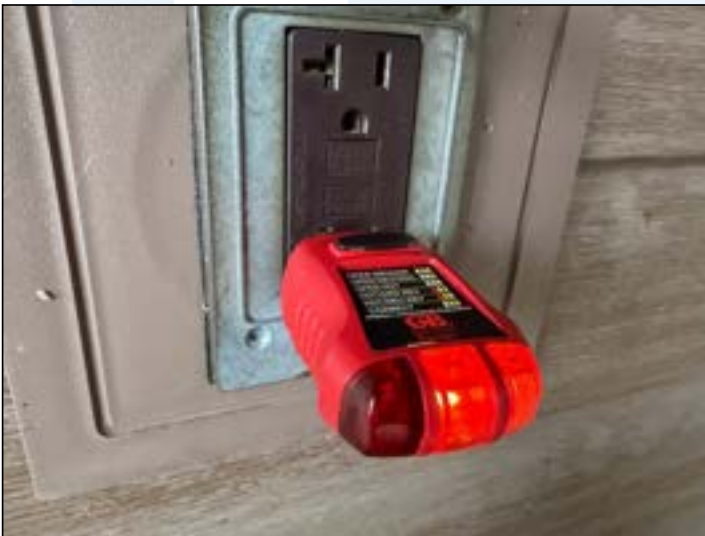
- A ground fault circuit interrupter (GFCI) electrical receptacle on the porch did not respond to testing at the time of the inspection. The Inspector recommends that this receptacle be replaced with a new GFCI receptacle by a qualified electrical contractor.

GFCI function would not trip

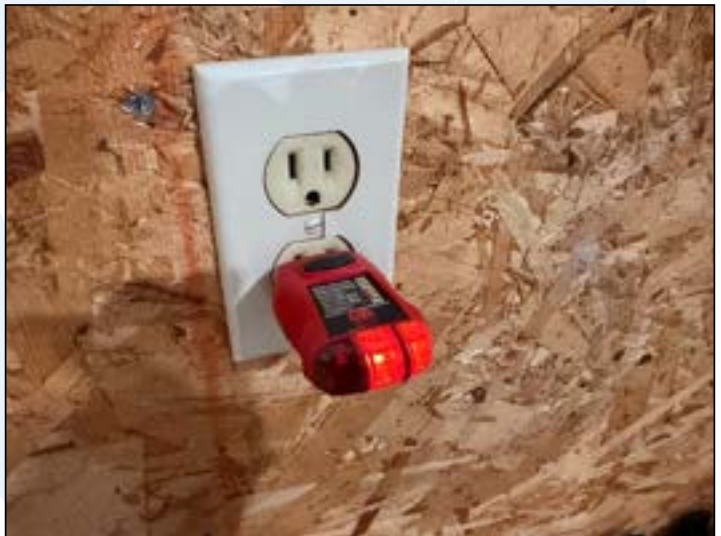
Missing GFCI protection for the garage

| DEFECT/SAFETY HAZARDS | | |
|---|---|---|
| Page 39 Item: 8 | Receptacles Condition | <ul style="list-style-type: none"> <li>• No ground fault circuit interrupter (<u>GFCI</u>) protection of home electrical receptacles was provided at garage at the time of inspection. Although GFCI protection may not have been required at the time the home was built, for safety reasons, the Inspector recommends that electrical receptacles located in basements, crawlspaces, garages, the home exterior, and interior receptacles located within 6 feet of a plumbing fixture be provided with ground fault circuit interrupter (GFCI) protection in good working order to avoid potential electric shock or electrocution hazards. This can be achieved relatively inexpensively by: 1. Replacing an individual standard receptacle with a GFCI receptacle.2. Replacing the circuit receptacle located closest to the electrical circuit overcurrent protection device (usually a breaker) with a GFCI receptacle.3. Replacing the breaker currently protecting the electrical circuit that contains the receptacles of concern with a GFCI breaker.</li> <li>• A ground fault circuit interrupter (GFCI) electrical receptacle on the porch did not respond to testing at the time of the inspection. The Inspector recommends that this receptacle be replaced with a new GFCI receptacle by a qualified electrical contractor.</li> </ul> |

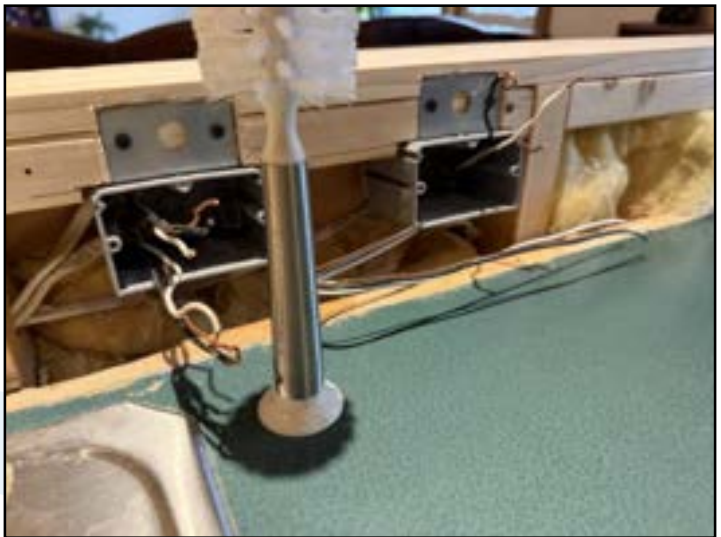
missing receptacles on the kitchen countertop from remodel

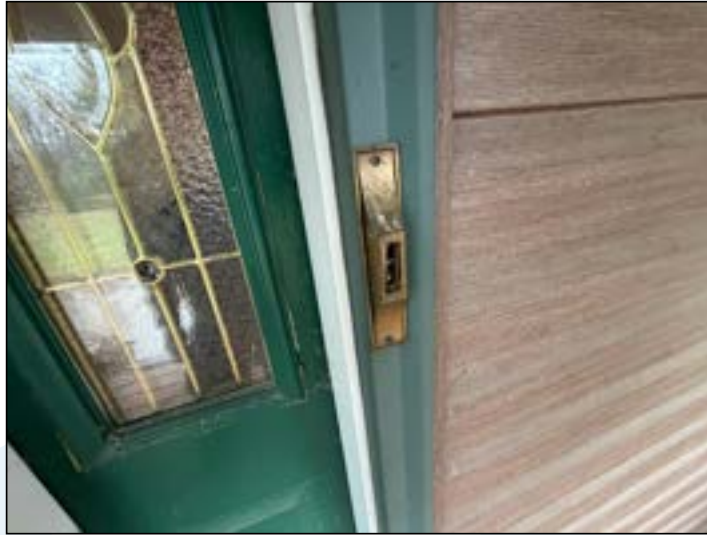
- Damaged doorbell button. Replace as needed.

Broken doorbell button

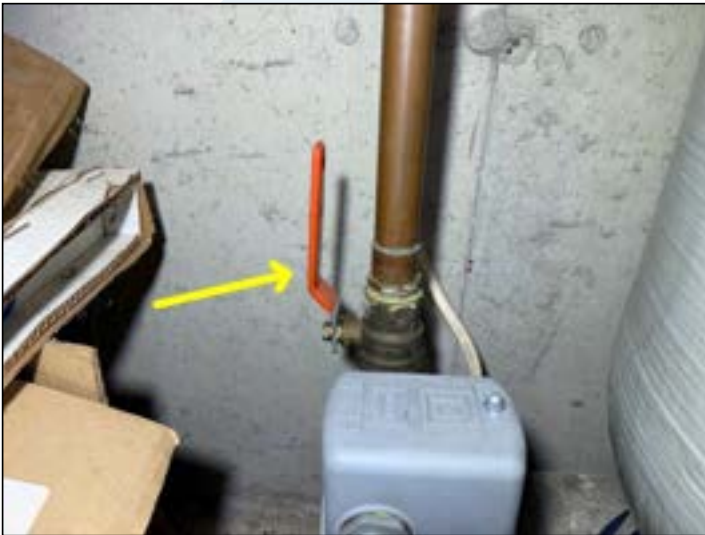
- At the time of the inspection, the Inspector observed no deficiencies in the condition of the main water supply pipe.
- At the time of the inspection, the Inspector observed no deficiencies in the condition of the main water supply shut-off valve (s). They were not operated but were visually inspected.
- At the time of the inspection, the Inspector observed no deficiencies in the condition of the visible water supply pipes.

Main water shut off

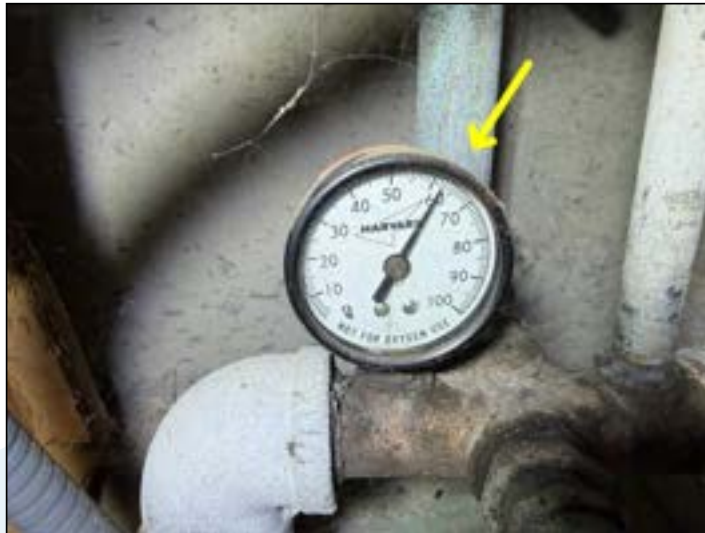
- All plumbing fixtures in the home exhibited functional flow at the time of the inspection. Several faucets were operated at the same time for several minutes

Good water pressure

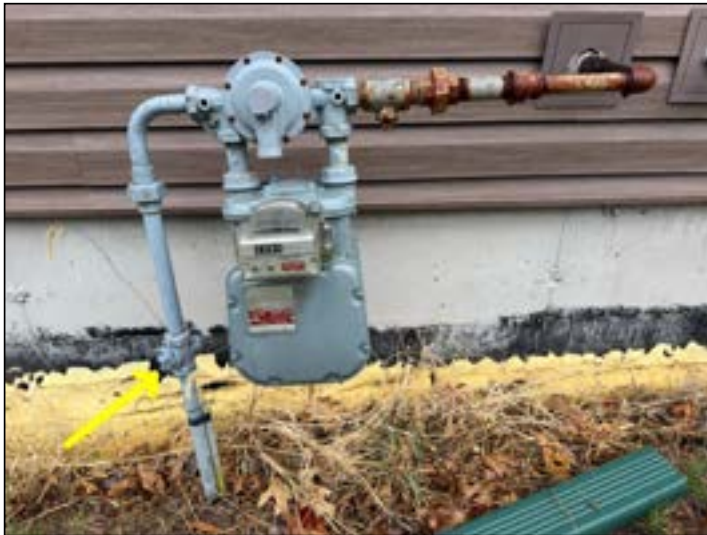
- The gas shut-off appeared to be in serviceable condition at the time of the inspection. Shut-offs were not operated, but were visually inspected.
- The CSST gas piping was not properly bonded. Properly bonding and grounding of a Corrugated Stainless Steel Tubing (CSST) system may reduce the risk of damage and fire from a lightning strike. Lightning is a highly destructive force. Even a nearby lightning strike that does not strike a structure directly can cause systems in the structure to become electrically energized. As a safety measure, the Inspector recommends that the CSST gas pipes be bonded by a qualified electrical contractor.

Main gas valve shut off

| DEFECT/SAFETY HAZARDS | | |
|---|---|---|
| Page 45 Item: 7 | Gas System Condition | <ul style="list-style-type: none"> <li>• The <u>CSST</u> gas piping was not properly bonded. Properly bonding and grounding of a Corrugated Stainless Steel Tubing (CSST) system may reduce the risk of damage and fire from a lightning strike. Lightning is a highly destructive force. Even a nearby lightning strike that does not strike a structure directly can cause systems in the structure to become electrically energized. As a safety measure, the Inspector recommends that the CSST gas pipes be bonded by a qualified electrical contractor.</li> </ul> |

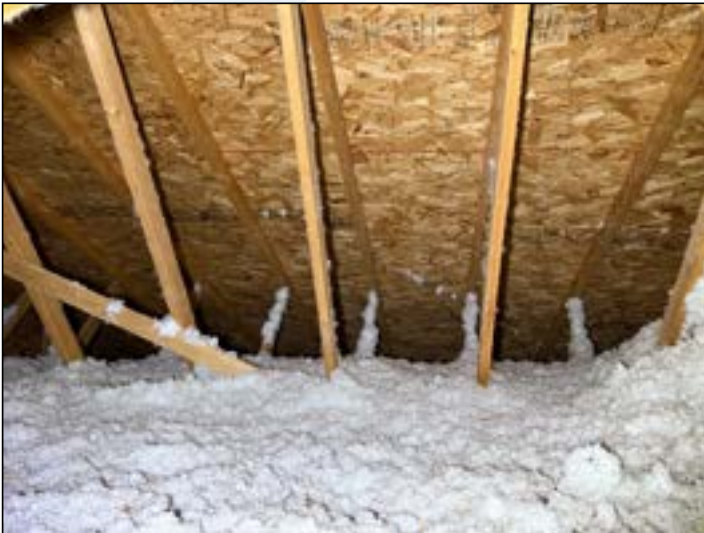
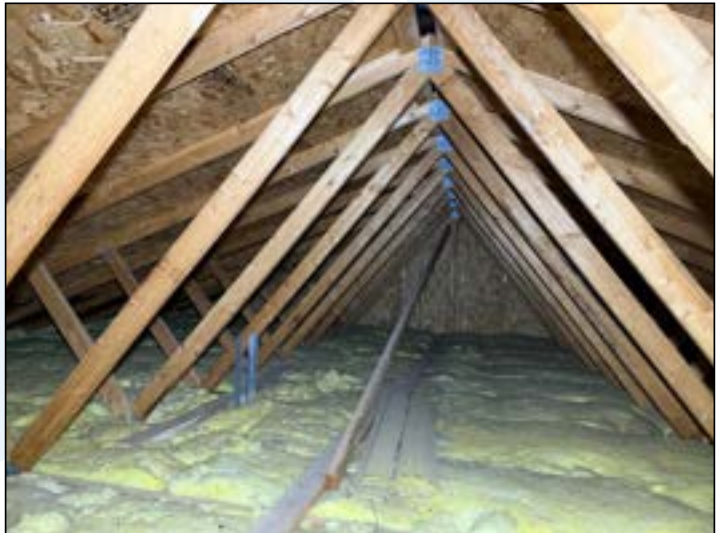
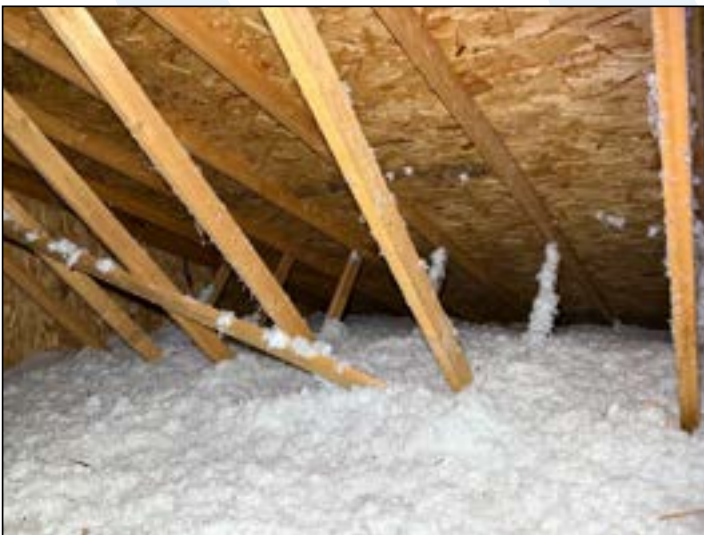
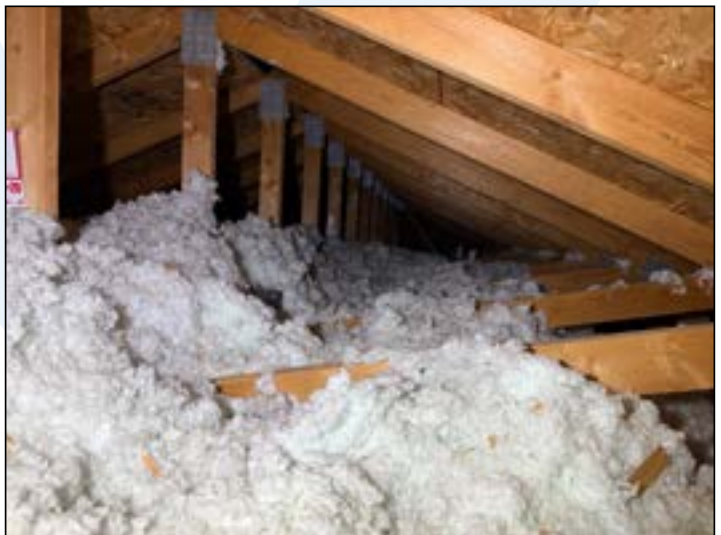
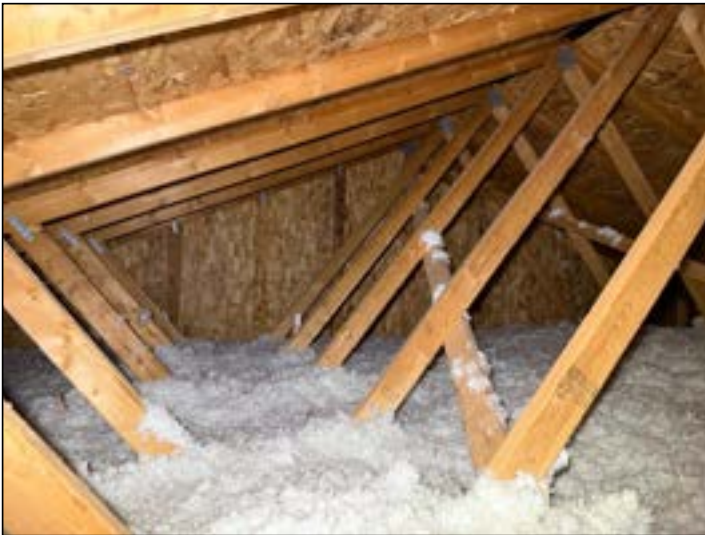
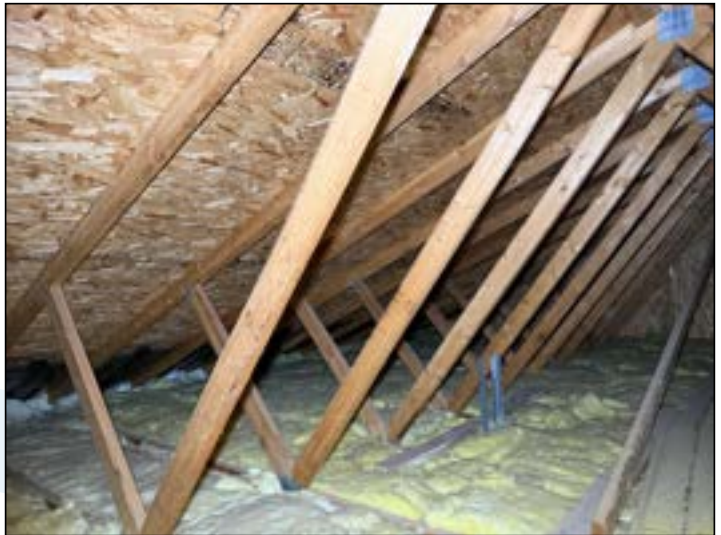
- The inspector observed no deficiencies in the condition of the visible portions of the roof trusses. At the time of the inspection, portions of the trusses were hidden beneath thermal insulation.

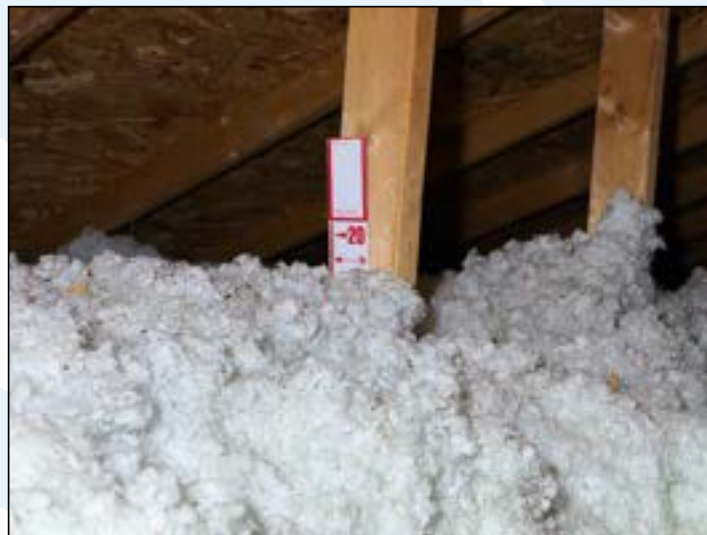
**Materials:** The attic floor was insulated with blown-in fiberglass.

**Depth:** Attic floor insulation depth averages 16 to 18 inches.

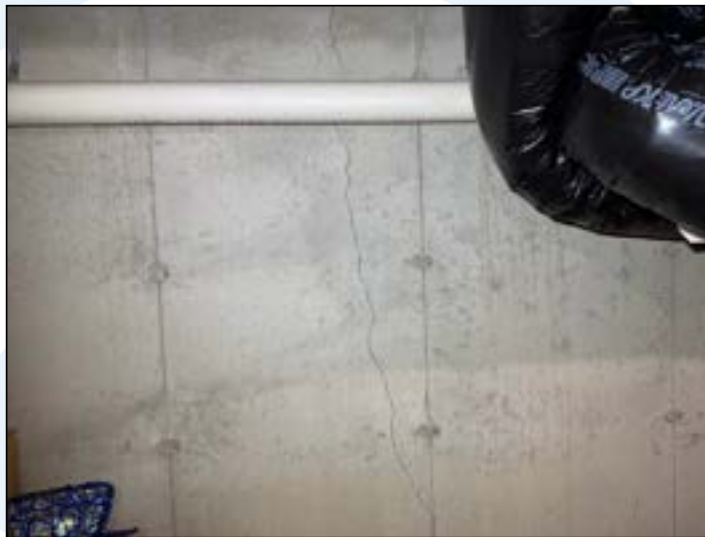
- The Inspector observed no deficiencies in the condition of the visible portions of the poured concrete foundation walls.
- Cracks visible in the basement foundation walls appeared to be typical shrinkage cracks that commonly develop as concrete cures. Shrinkage cracks are surface cracks and are not a structural concern.

Shrinkage cracking observed

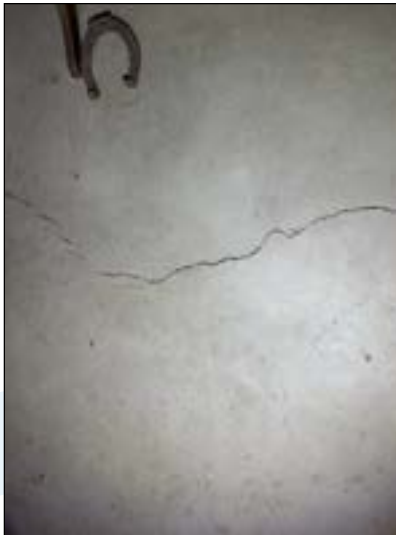
- Missing control cuts/joints observed in the concrete slab. Control cuts/joints are pre-planned cuts in concrete that help control where and how cracks appear in poured concrete.
- Typical shrinkage cracks visible in the basement concrete floor slab are not a structural concern. Shrinkage is a natural part of the curing process of concrete and surface cracking is common.

Typical cracking

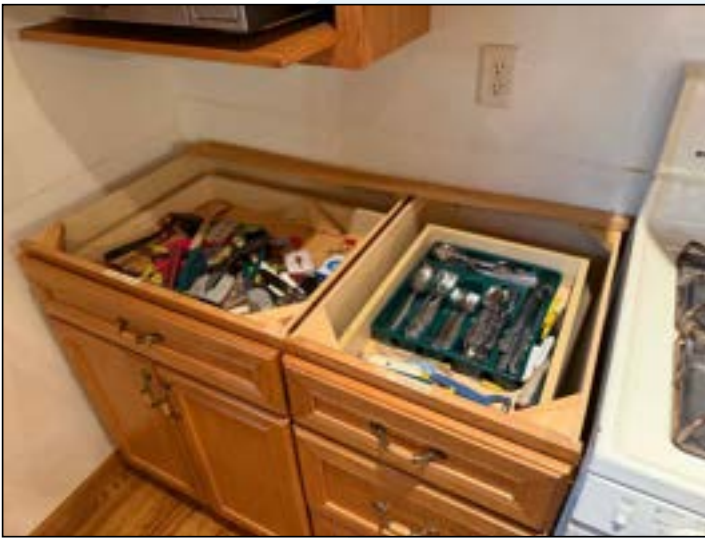
- At the time of the inspection, the Inspector observed few deficiencies in the condition of the kitchen countertops. Notable exceptions will be listed in this report.
- Installation of a portion of the kitchen countertops was incomplete at the time of the inspection. The Inspector recommends completion of counters by a qualified contractor.

Missing countertop(s)

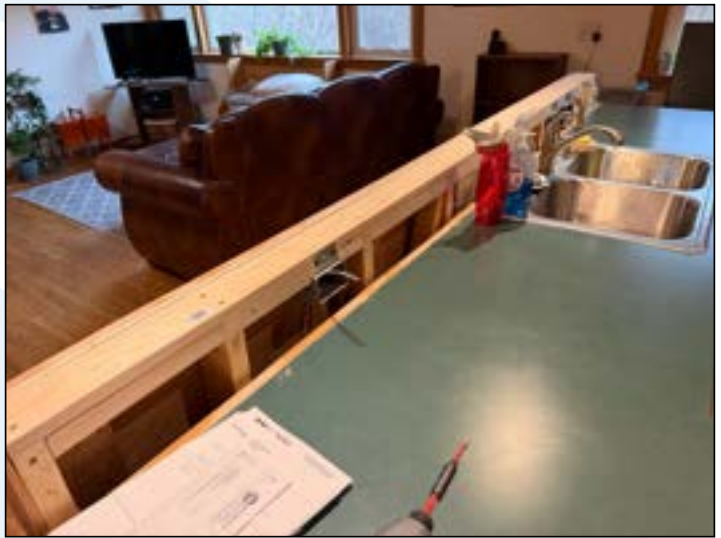
Missing countertop(s)

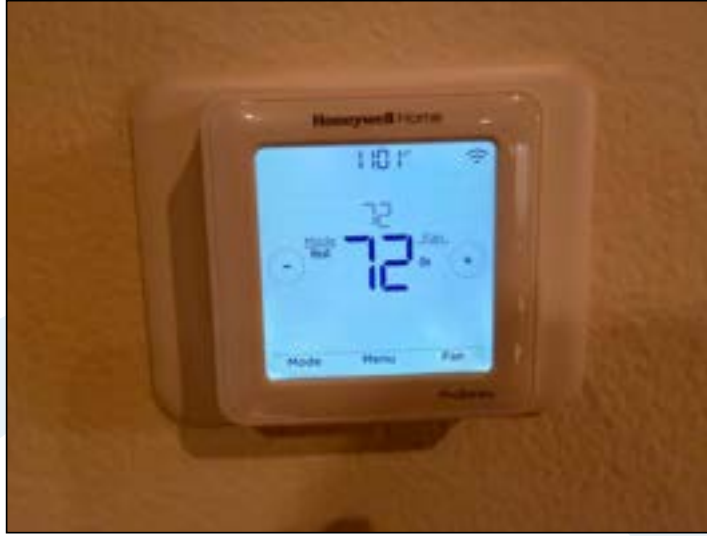
- The system was on heating mode and set at 72 degrees.
